Pembrokeshire County Council Eco Park

Ground Investigation and Geotechnical
Design Report

For Pembrokeshire County Council

June 2022

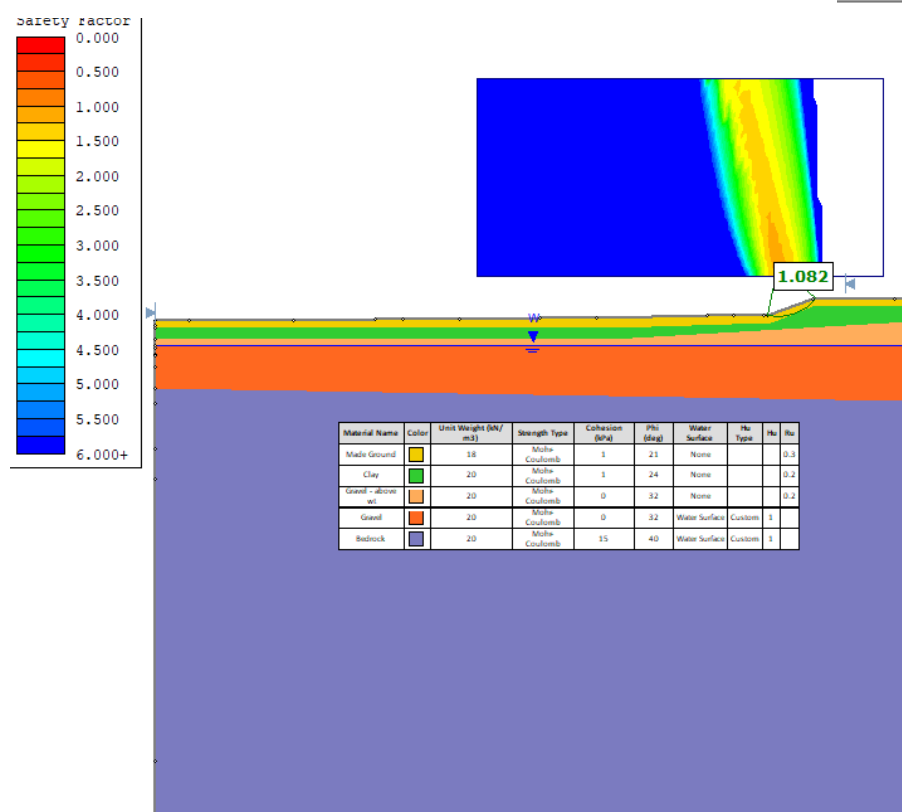
Figure 8.1 Section 520 modelling output

A pore water coefficient (R_u) of 0.3 and 0.2 was applied to the strata above the water table to account for seasonal fluctuations and climate change. The results are presented in Figure 8.1 and the outputs indicate a satisfactory factor of safety (≥ 1) which is considered satisfactory.

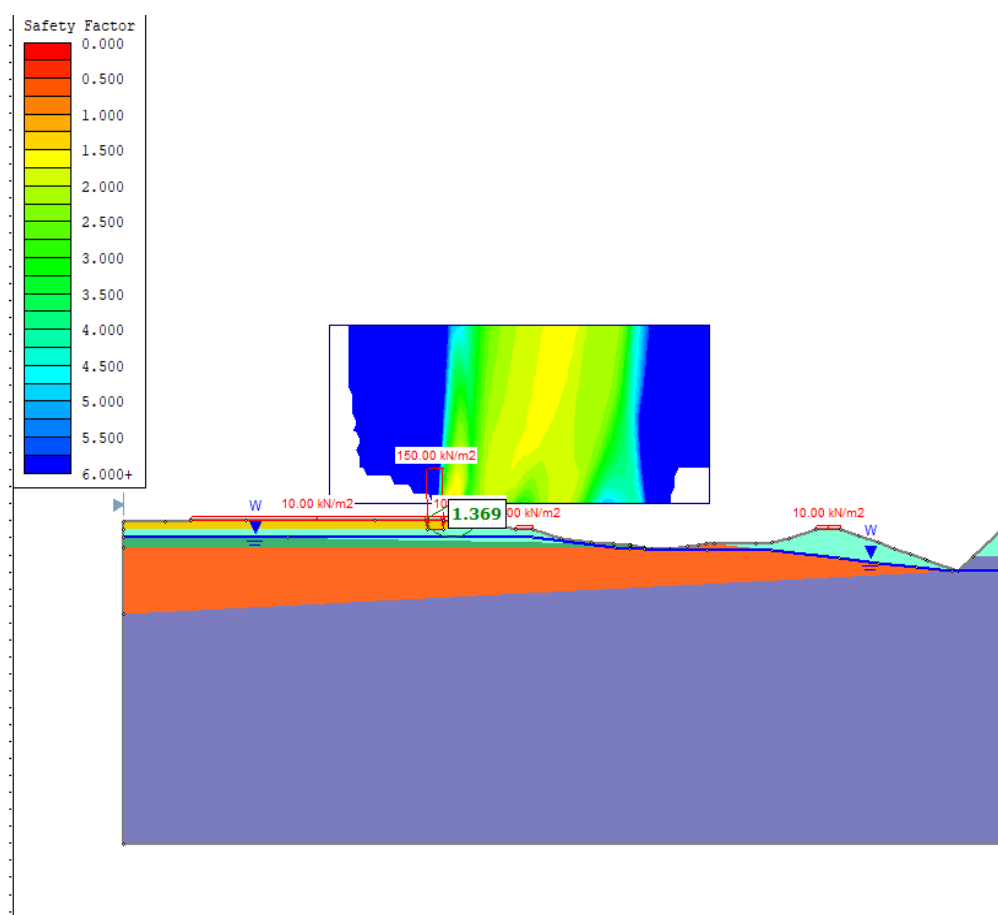
Figure 8.2 slope stability modelling output for chainage 420 beneath building 3

The factory safety derived by the modelling is $F=1.3$ which shows that a stable slope is present in this locality.

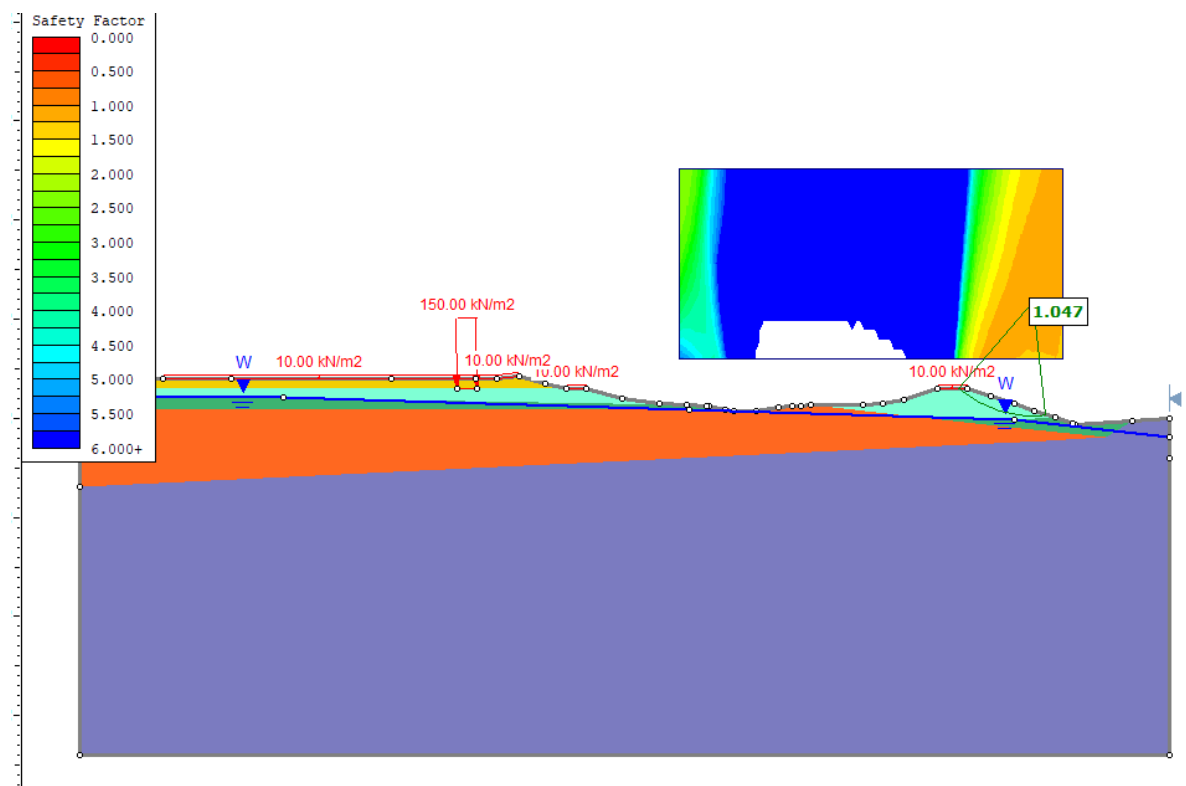
Figure 8.3 slope stability modelling output for chainage 420 for retention basin berm

The factory safety derived by the modelling is F-1.05 which shows that a stable slope is present in this locality. Whilst the stability is marginal it is noted that conservative input parameters have been used in the modelling.
