**MORFA NON-  
HAZARDOUS LANDFILL,  
PORT TALBOT**

**PERMIT BV7311IE**

**2022 Annual Review of  
Environmental  
Monitoring**

*Report Number 2295r1v1d0223*

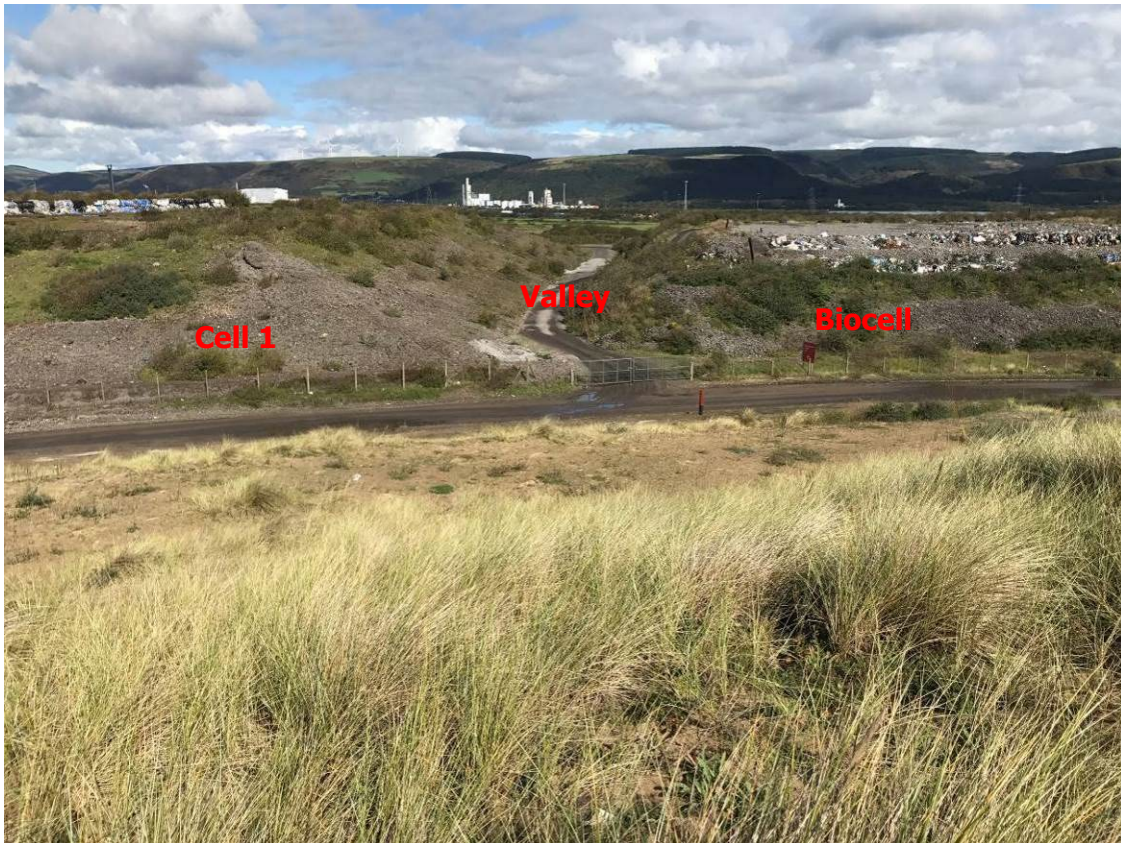
The existing Biocell was separated from non-hazardous Cell 1 by a deep narrow valley where the opposing south flank of Cell 1 met the north flank of the Biocell, as shown in Plate 4-1. The approved restoration contours for the landfill require that this valley is infilled to produce a single elevated landform. To secure additional biodegradable void space, NRW approved a cut into the upper part of the southern flank of Cell 1 and extension of the biodegradable waste cell lining system into the void to provide sufficient biodegradable waste capacity to 2028. The new biocell extension is referred to as Cell C at this stage.

**Plate 4-1 View north towards Non-Hazardous Cell 1, valley feature and Biocell**

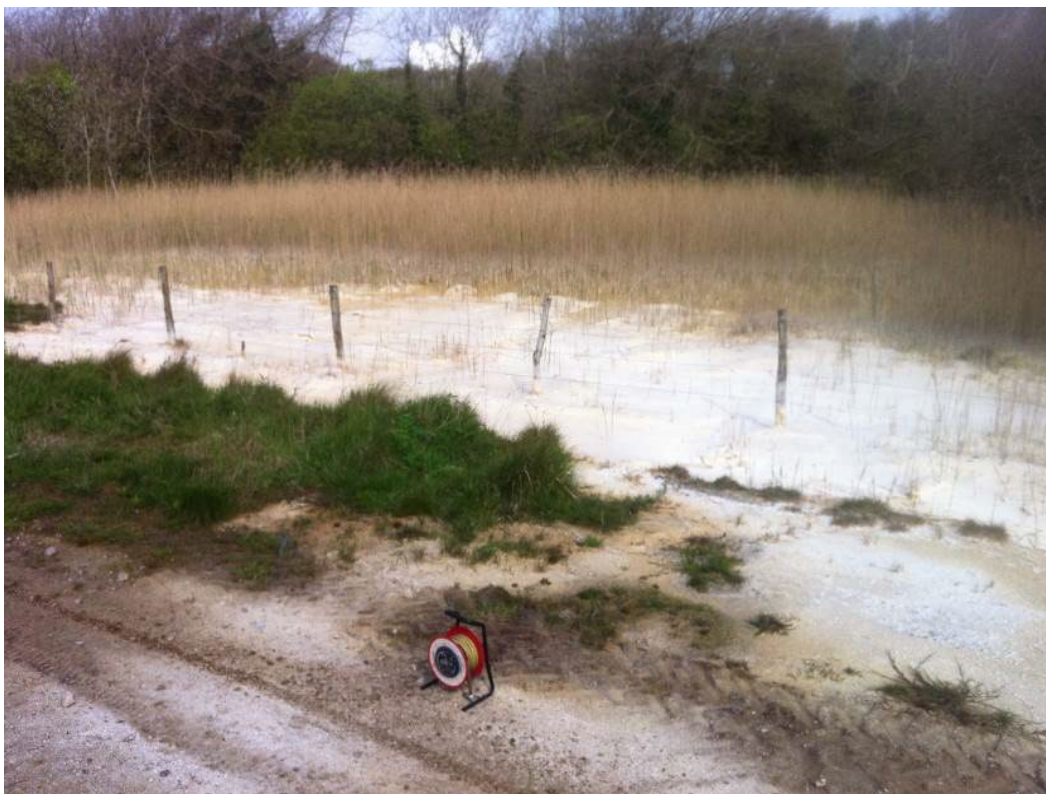
The accumulation of secondary precipitation in localised areas along the boundary of the site with Margam Moors is well documented. These have formed due to near surface interactions between shallow groundwater that is impacted by leachate from the unlined MCL and the atmosphere. Precipitates and poor-quality groundwater are present throughout this area but become visible in topographically low areas, where groundwater may be sometimes exposed. Wider dispersion and leaching of these previously accumulated precipitates and groundwater has been previously observed in response to changes in shallow groundwater levels. NRW has approved the covering of these areas with site won sand to limit direct access.

**Plate 4-3 Accumulation of secondary precipitates adjacent to MCL  
(between BH17 and P12)**

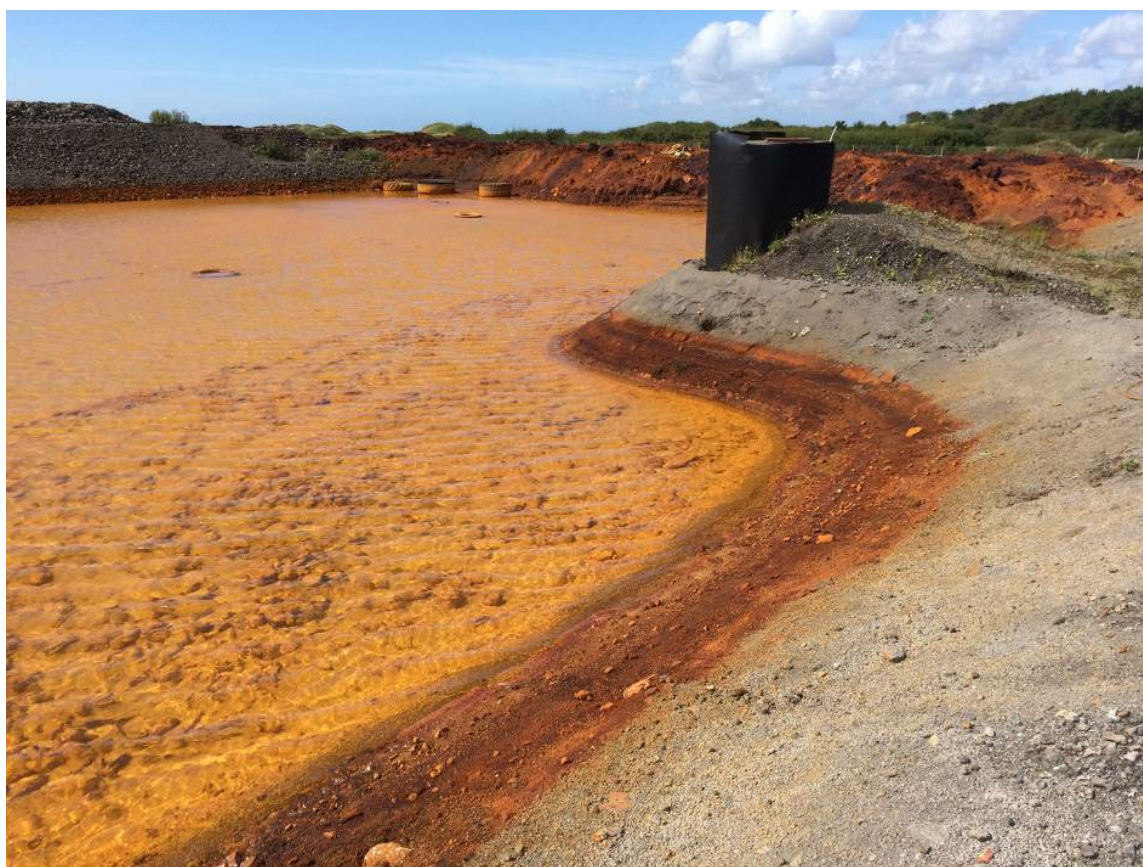
Filter cake (EWC code 11 01 10) has been placed into Cells 1 and 2 (with leachate draining to sumps L7 and L8) at a rate of up to 500 - 800t/month since the start of monitoring. Produced by the lime neutralisation of acidic ferrous chloride and pickling solutions at the cold mill effluent treatment plant, the waste principally comprises iron oxyhydroxide chloride phases, calcium chloride, iron chloride and mixed oxides. Within the landfill, the soluble components of the waste are leached by infiltration. This process is suspected to be the main source of the elevated levels of chloride and calcium. As the waste becomes buried and less oxygenated, the oxyhydroxide iron phases may also start to undergo changes. Some may start to age and crystallise, forming more stable iron oxide phases and some may undergo reductive dissolution in anaerobic conditions that may be present in parts of the landfill. This latter process could potentially release iron into the leachate along with other trace metals adsorbed to the iron precipitates.

**Plate 6-1 Cell 2 leachate sump L8. Note staining due to iron.**

This latter process was previously considered to be occurring within Cell 2 at L8, as iron significantly increased in concentration from <1mg/l to over 1000 mg/l during the latter part of 2012 and was elevated on several occasions during 2013. At the same time, the leachate sampled at sump L8 was found to be green in colour and the laboratory measured pH variable over a relatively brief time i.e. dropping from over pH 11 to pH 4 and then returning to pH 11 within 12 weeks (see chart below). Similar patterns were observed during 2014, 2015 and 2016. Since 2019, these variations have been less pronounced.

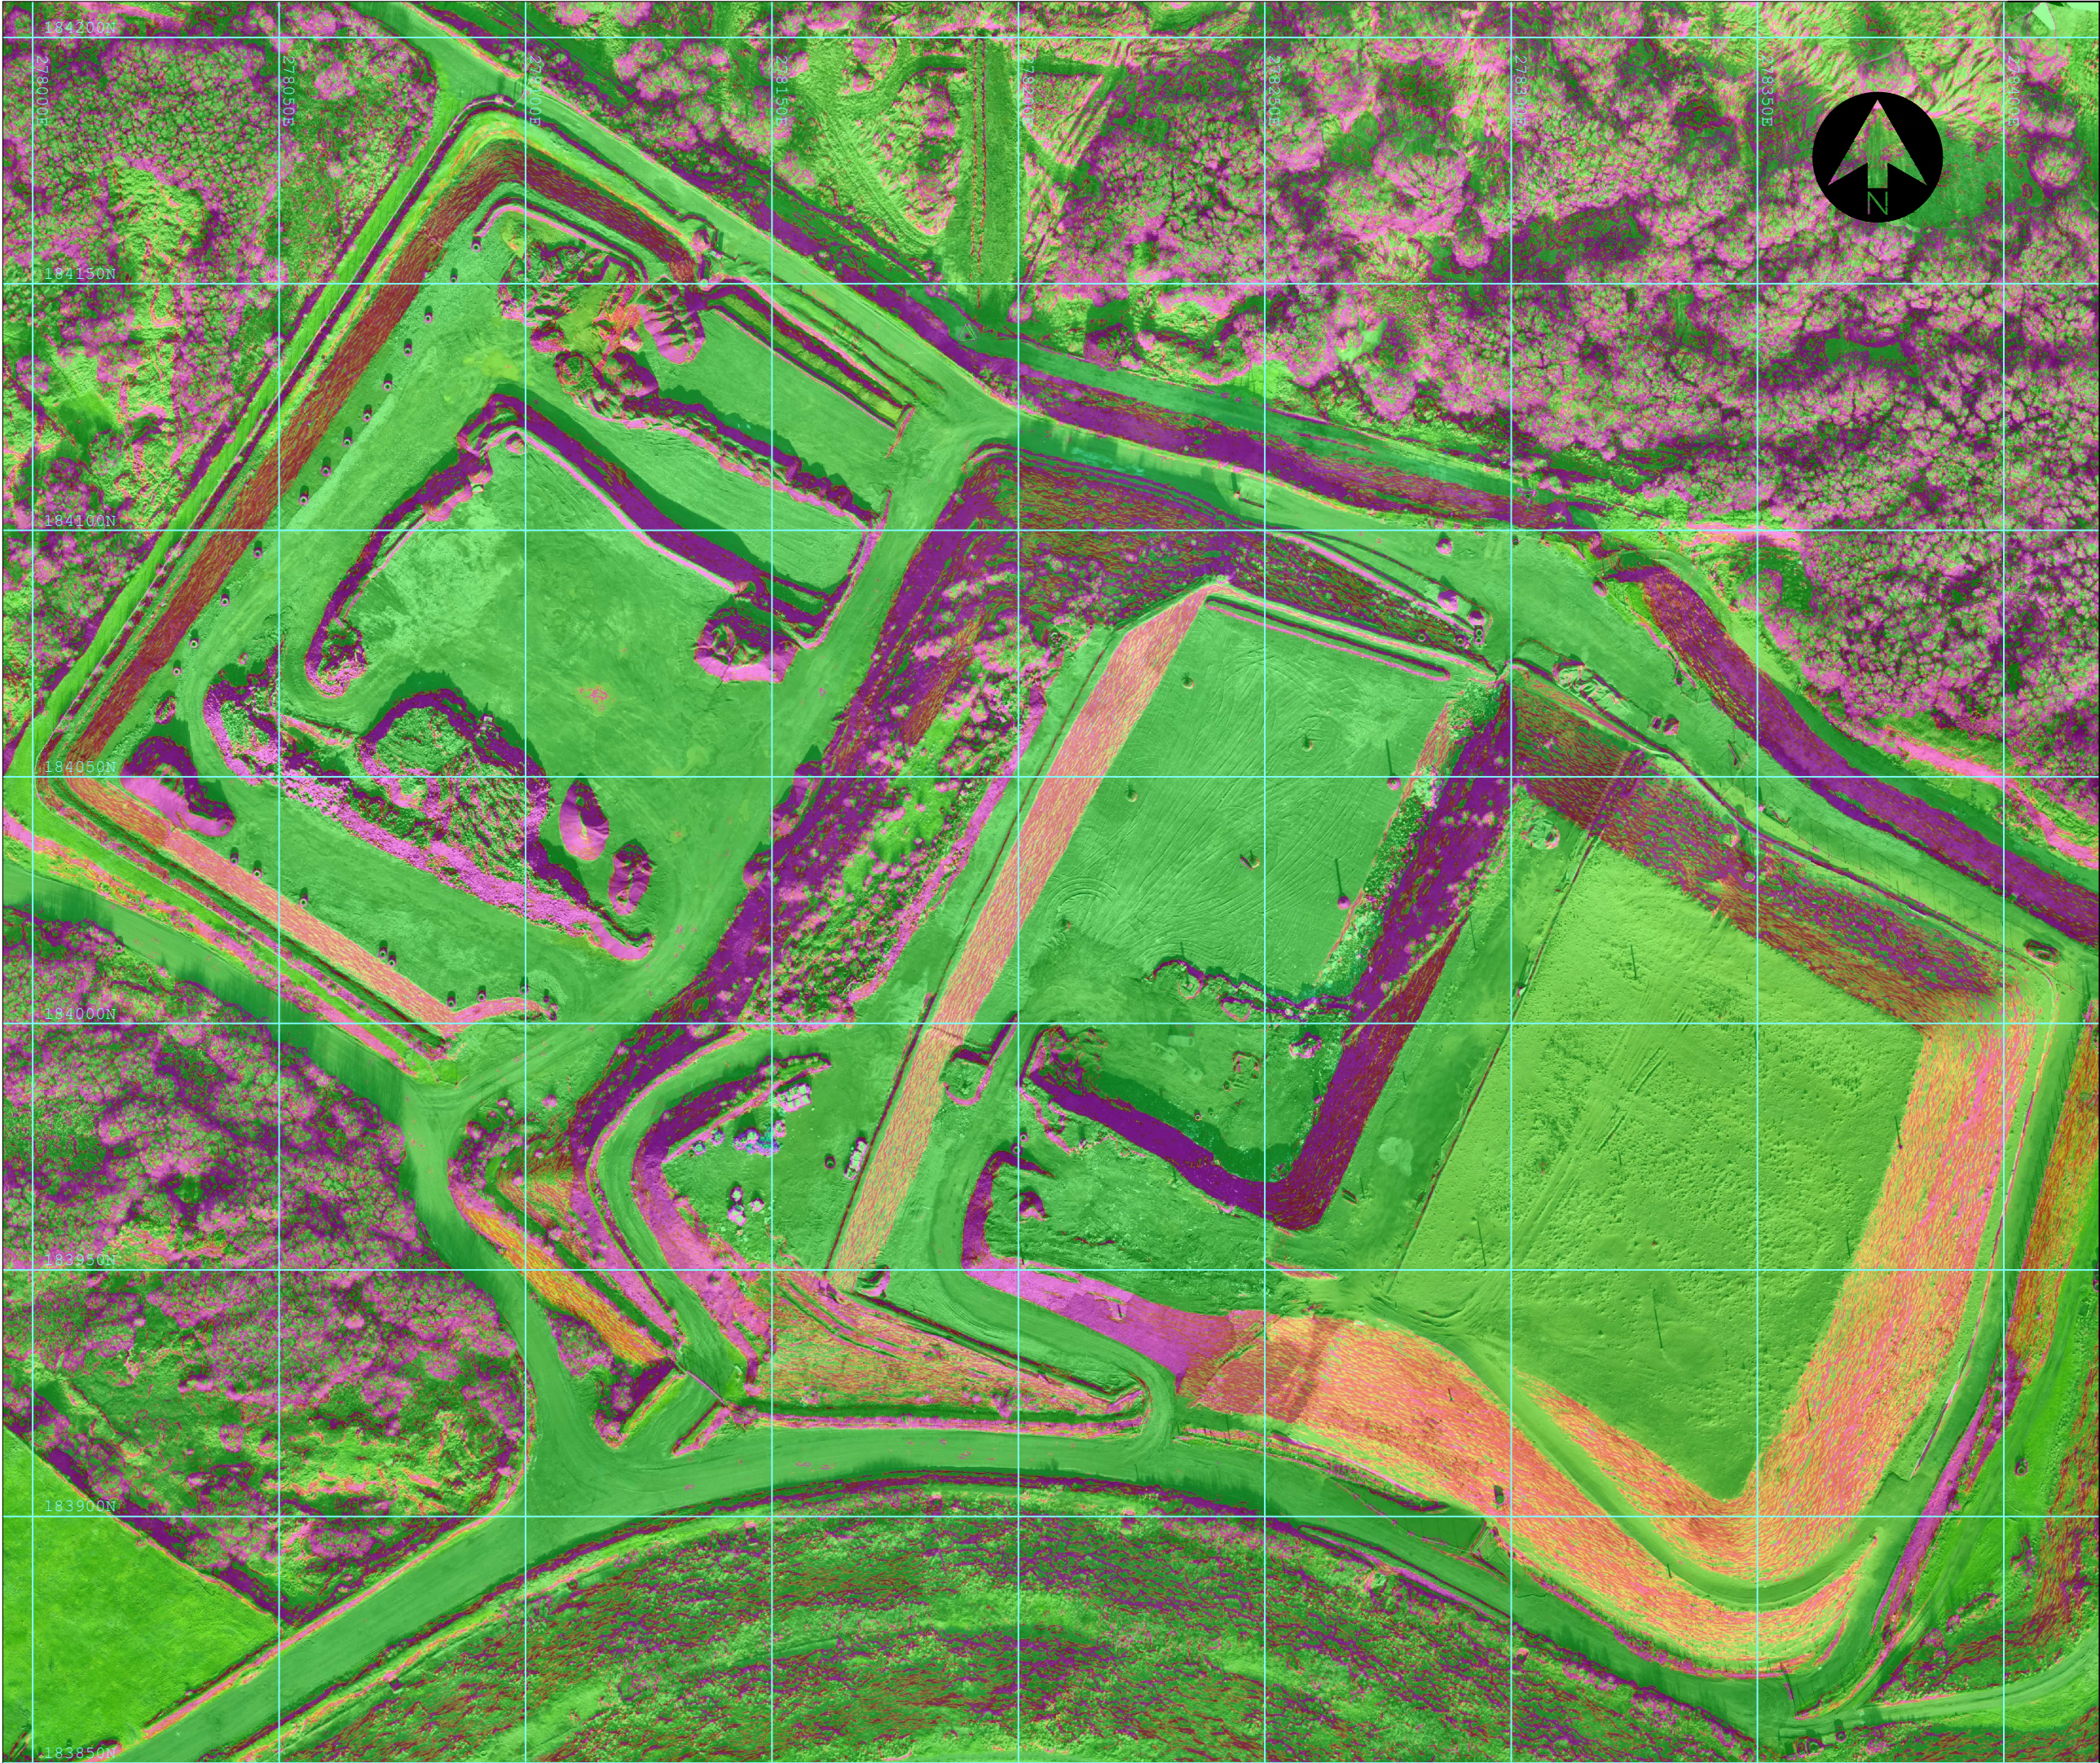
Both the internal and external slopes of Biocell C exceed permissible permanent and temporary slope gradients. This is largely due to the placement of waste which has been compacted into bales which is inherently more stable than loose waste. The vertical sided bales are placed in a

stack which will stand at an angle much steeper than the loose waste accounted for in the original SRA, though these bales should not form the external face of any permanent slopes.

The external slopes of Non-Hazardous Cell 1 are generally shallower than a 1:2 gradient, though it does appear that some reprofiling will be required to achieve a 1:2.5 gradient prior to capping. The exceptions to this are the short slopes either side of the southern access track, where slope gradients are in excess of 1:1.75. These slopes should be reprofiled to ensure both short and long-term stability.

The western slope of the cell also has areas where slope gradient locally exceeds 1:1.75. However, when the overall slope gradient is considered, it is found to range between 1:1.75 and 1:2. This entire face will eventually be buried by wastes deposited in Non-Hazardous Cell 2.
