## SCHEDULE 5 Notification

### Part B

| Name of Operator: | Tata Steel UK Ltd |
| Location of Facility: | Port Talbot Works |

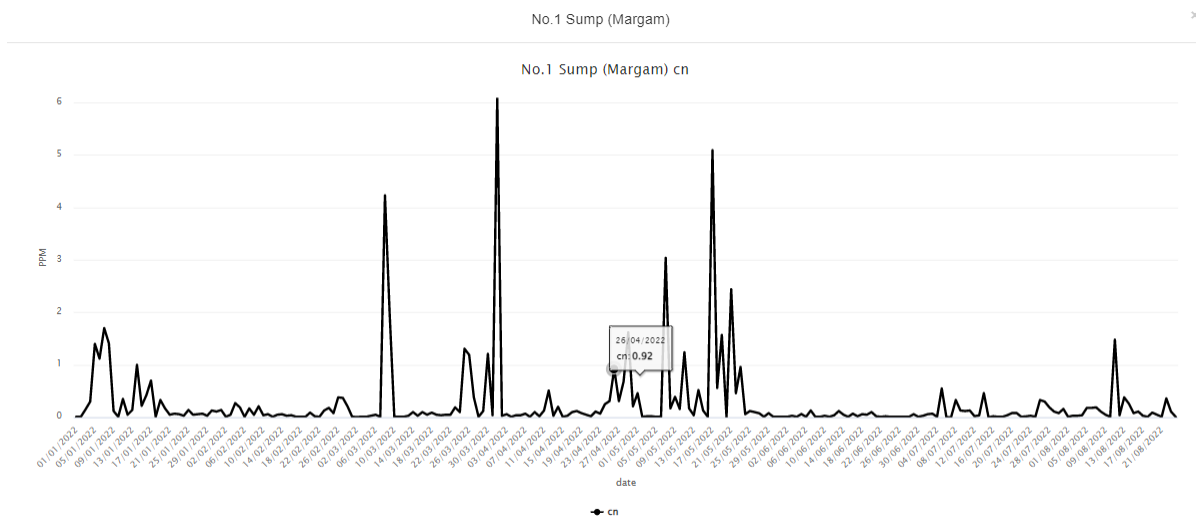
| Measures taken, or intended to be taken, to prevent a recurrence of the incident | <ul style="list-style-type: none"> <li>• Process has since stabilised and CN formation from the furnaces has reduced. This is seen from both daily Sump 1 sampling (please see figure 1 above), and weekly DORR pond sampling for CN.</li> <li>• CN concentration and process stability monitoring to be continued to ensure that issues are identified quickly.</li> <li>• Continue to use Aerator 1 at the Coke Ovens Biological Effluent Treatment Plant as a more efficient remover of CN and other analytes.</li> <li>• Aerators 1 and 2 are to be run in parallel to identify operational issues with Aerator 2. This will allow the business to bring Aerator 2 up to standard, allowing for redundancy should Aerator 1 need to be taken off for maintenance etc.</li> </ul> |

**Figure 1: CN Concentrations in Sump 1.**

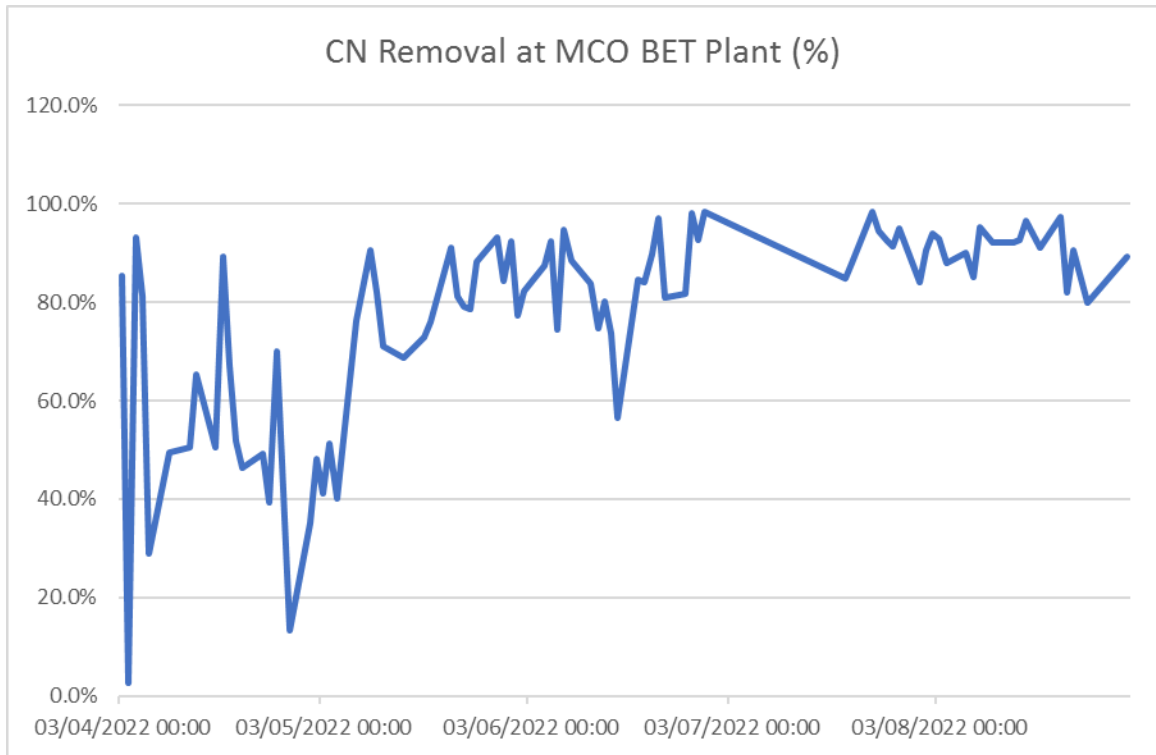
| Any more accurate information on the matters notified under Part A | <p>A period of high cyanide (CN) was observed at the Long Sea Outfall (LSO), causing the following breaches (measured value enclosed below):</p> <ul style="list-style-type: none"> <li>• CY Week 17 (24/04/22 – 30/04/22): 0.16 mg/l</li> <li>• CY Week 18 (01/05/22 – 07/05/22): 0.22 mg/l</li> <li>• CY Week 19 (08/05/22 – 14/05/22): 0.12 mg/l</li> <li>• CY Week 20 (15/05/22 – 21/05/22): 0.15 mg/l</li> </ul> <p>Investigations identified Sump No.1 as the main contributor of the CN. Over the time period, the blast furnaces suffered a period of instability as a result of furnace recovery. High top temperatures were observed on the furnaces, which pushes CN through to the gas wash system and infiltrates the effluent system via the DORR ponds.</p> <p>CN is formed low down in the furnaces but breaks down again as the gas ascends through the furnace. However, if all furnace isotherms are elevated (including higher top temperatures) CN formation will continue higher up in the furnace, and therefore is more likely to increase the amount of CN leaving the top of the furnace. Moreover, if the furnace process is unstable there are gas surges from low down in the furnace, which may be more likely to carry higher CN concentrations with them.</p> <p>Additionally, failures at the Morfa Coke Ovens Biological Effluent Treatment Plant caused increased CN output. Moving from Aerator 1 to Aerator 2 in August 2020 caused CNS, CN and phenol removal rates to decline. In July 2022 Aerator 1 was brought back online, and the removal rates of CN have increased back up to ~90% (please see figure 2 below).</p> |

**Figure 2: CN removal at MCO BET Plant.**
