| | | NETWORK RAIL | | | | | | | | | | |
| BRIDGE VISUAL | | | | | | | | | | | | |
| ELR: LJT1 | | Contract Mileage: 001 m 1501 yds 68.23 ch | | | | | | Struc. Ref 2 | | | | |
| Structure Name: MILL RIVER | | | | | Type: BU | | | Exam ID: 14462979 | | | | |

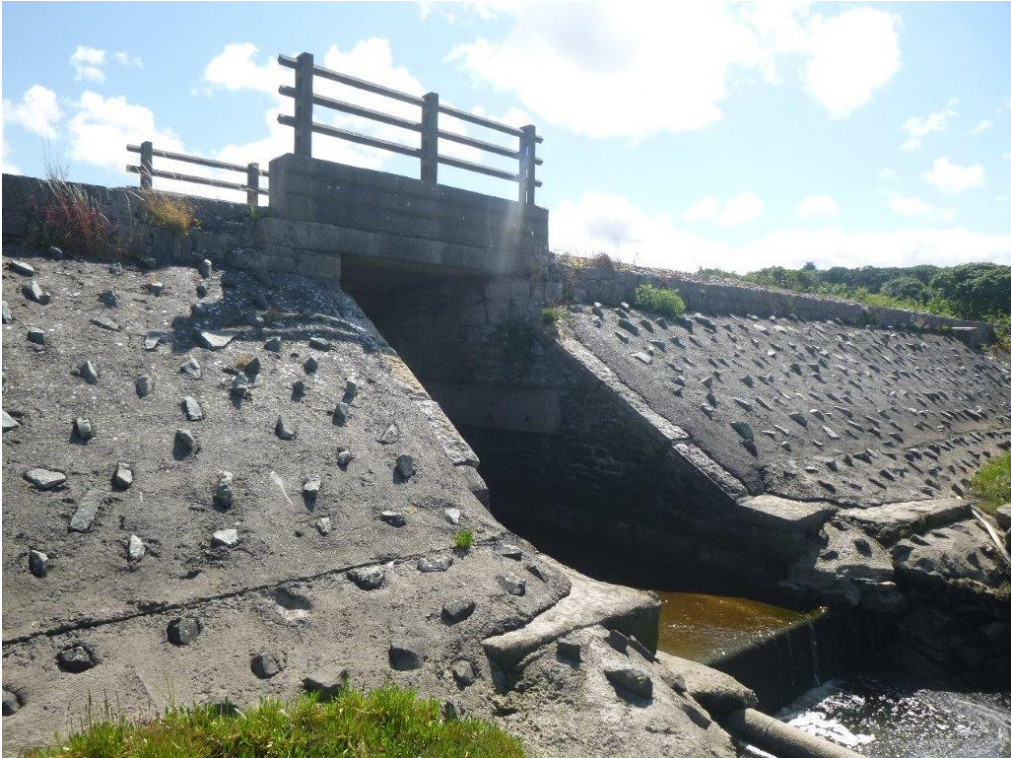
Photo 2 - Upside elevation (Taken 040822)

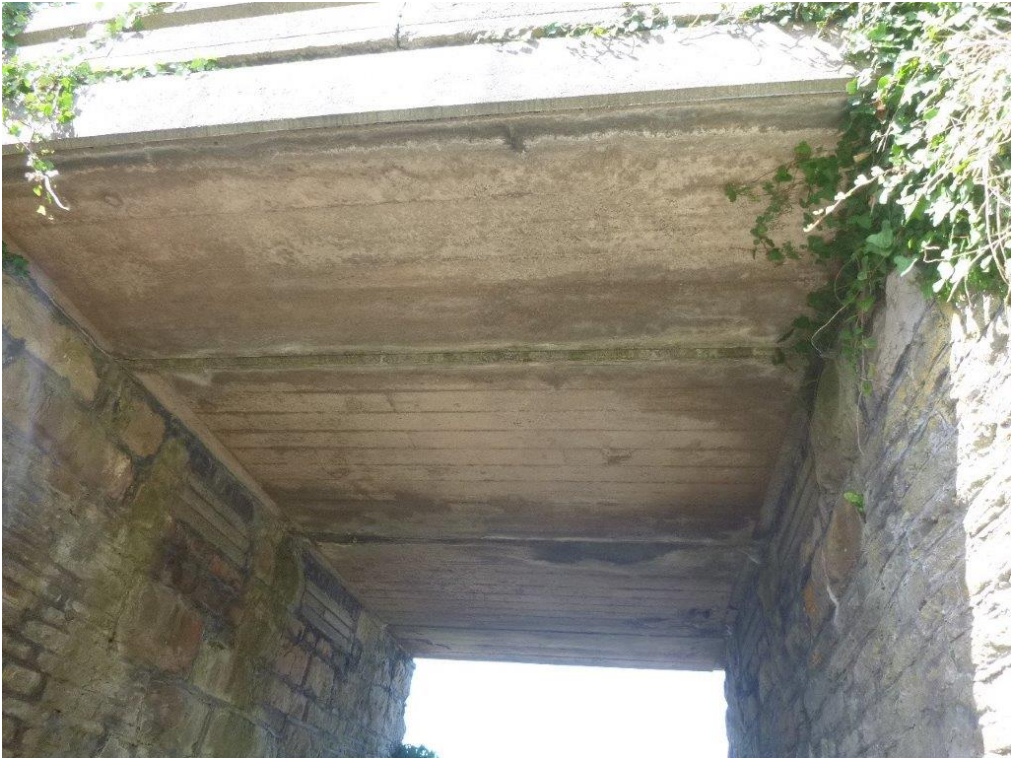
Photo 3 - Soffit general view (Taken 040822)

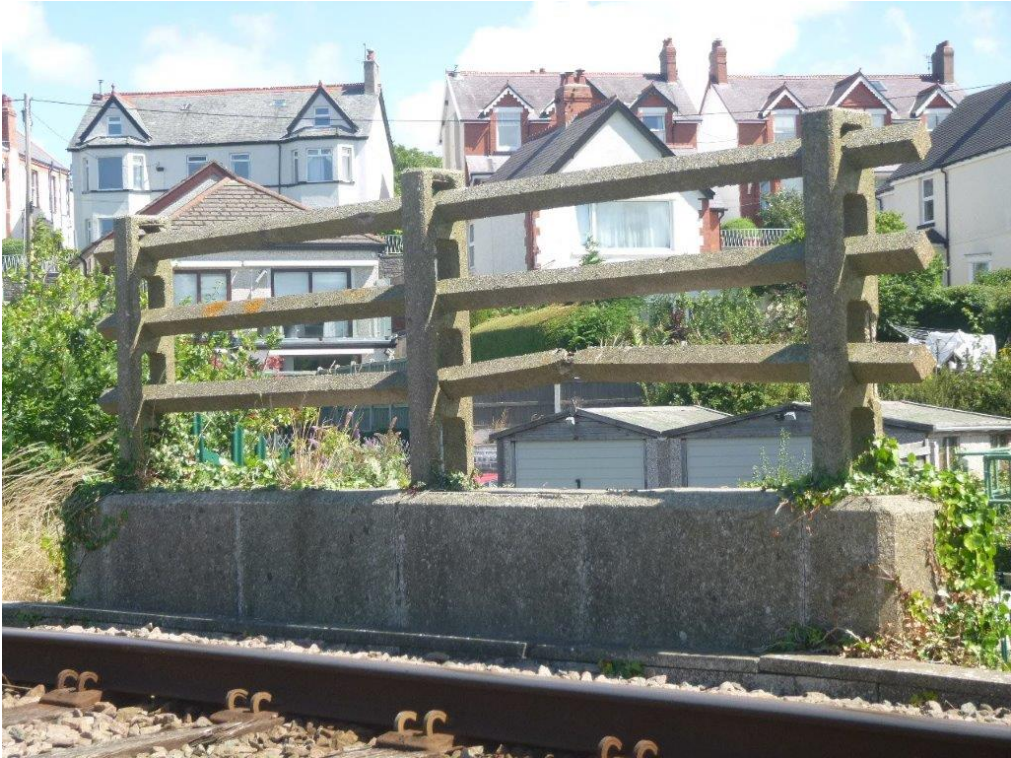
Photo 10 - Live significant defect (Taken 040822)

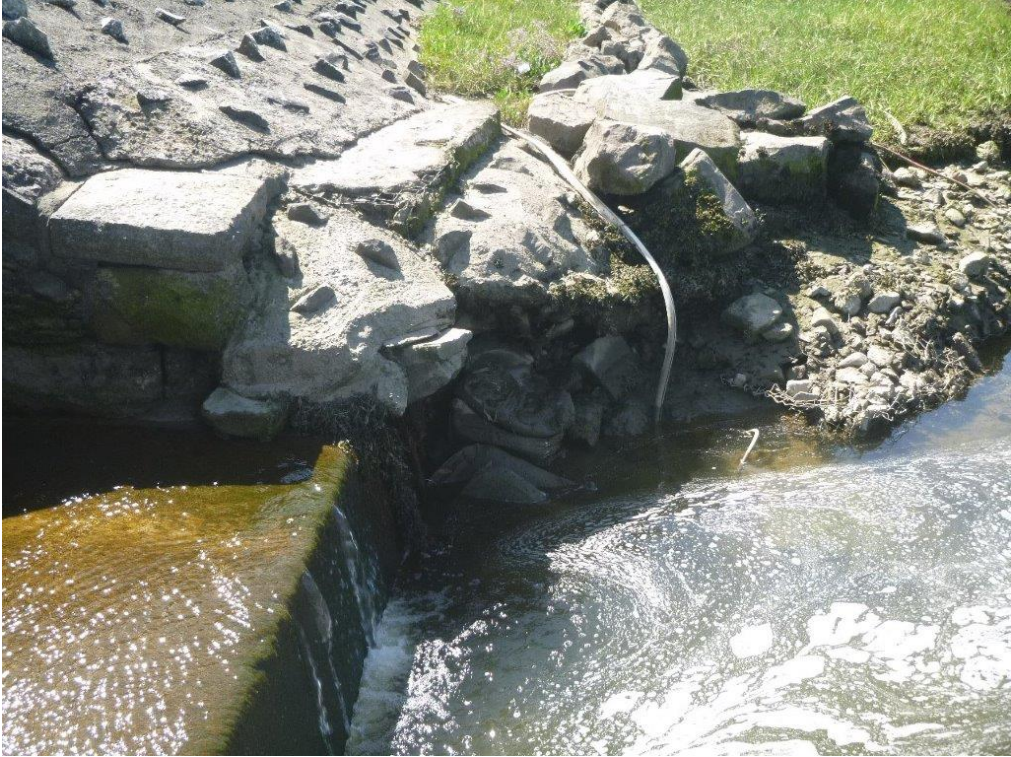
| <p>Status: Cannot determine<br/>See Existing (Open) Significant Defect Photo: 11</p> <p>DEFECT NUMBER 6: Last observed at a Visual Examination on 07/06/21<br/>Defect Location: U/S LM Revetment.<br/>Defect Description: Active Scour/ Undermining (3m Long; 400mm High; Max Penetration 300mm).<br/>Dimensions Not Provided<br/>Urgent: No<br/>Status: Cannot determine<br/>See Existing (Open) Significant Defect Photo: 12</p> <p>DEFECT NUMBER 7: Last observed at a Visual Examination on 07/06/21<br/>Defect Location: Downstream Edge of Invert.<br/>Defect Description: Active Scour/ Undermining (1300mm Over Approx 20m2).<br/>Dimensions Not Provided<br/>Urgent: No<br/>Status: Cannot determine<br/>See Existing (Open) Significant Defect Photo: 13</p> <p>DEFECT NUMBER 8: Last observed at a Visual Examination on 07/06/21<br/>Defect Location: Soffit of U/S Outer Main Deck Units.<br/>Defect Description: Spalled Concrete and Exposed Primary Reinforcement (0.5m2).<br/>Dimensions Not Provided<br/>Urgent: No<br/>Status: Little deterioration<br/>See Existing (Open) Significant Defect Photo: 14</p> <p>DEFECT NUMBER 9: Last observed at a Visual Examination on 07/06/21<br/>Defect Location: U/S and D/S Track Level Approaches.<br/>Defect Description: No Limited Clearance Signage. NB Clearance U/S 1.460m and D/S 1.600m Min Measured at Detailed Examination.<br/>Dimensions Not Provided<br/>Urgent: No<br/>Status: No deterioration<br/>See Existing (Open) Significant Defect Photo: 15</p> <p>DEFECT NUMBER 11: Last observed at a Visual Examination on 07/06/21<br/>Defect Location: HM ABT Elevation.<br/>Defect Description: Open Core Holes (NB Cores presumably extend to/ beyond foundations and are now allowing water to access this area).<br/>Dimensions Not Provided<br/>Urgent: No<br/>Status: No deterioration<br/>See Existing (Open) Significant Defect Photo: 16</p> <p>DEFECT NUMBER 12: Last observed at a Visual Examination on 07/06/21<br/>Defect Location: D/S LM WWL.<br/>Defect Description: Displaced (Upto 50mm) Section of Top of Wall (Inc Copings/ Newel) (1.5m2).<br/>Dimensions Not Provided<br/>Urgent: No<br/>Status: Repaired<br/>See Existing (Open) Significant Defect Photo: 17</p> <p>DEFECT NUMBER 13: Last observed at a Visual Examination on 07/06/21<br/>Defect Location: Parts to underside of structure<br/>Defect Description: PNE - Restricted access<br/>Dimensions Not Provided<br/>Urgent: No<br/>Status: Repaired<br/>See Existing (Open) Significant Defect Photo: 18</p> <p>PREVIOUS RECOMMENDATION(S)<br/>- See Recommendation(s) below</p> <p>Previous Recommendation: 1<br/>Date Raised: 07/06/21<br/>Location: Both U/S (Downstream) Revetments and Edge of Invert.<br/>Description: Consider the need to undertake a hydraulic assessment and install appropriately graded rock</p> | | |

Photo 11 - Live significant defect (Taken 040822)

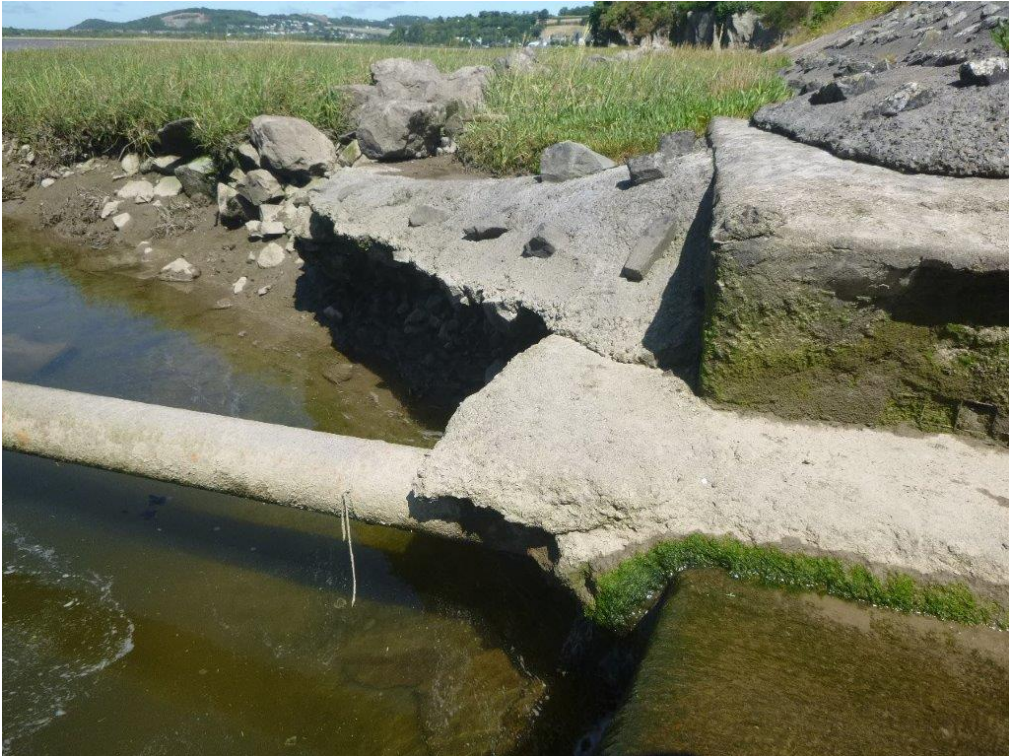
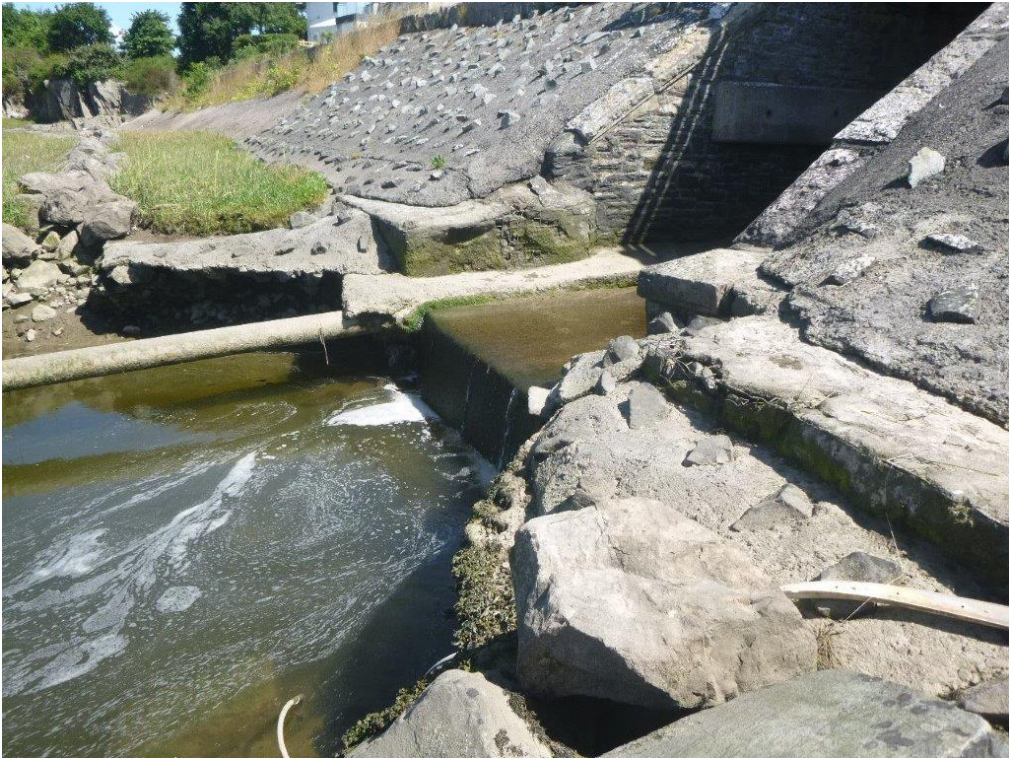
| | <div data-bbox="233 305 1246 1057" data-label="Image"> </div> <div data-bbox="555 1081 1051 1107" data-label="Caption"> <p>Photo 12 - Live significant defect (Taken 040822)</p> </div> <div data-bbox="233 1119 1246 1873" data-label="Image"> </div> <div data-bbox="555 1897 1051 1923" data-label="Caption"> <p>Photo 13 - Live significant defect (Taken 040822)</p> </div> | |

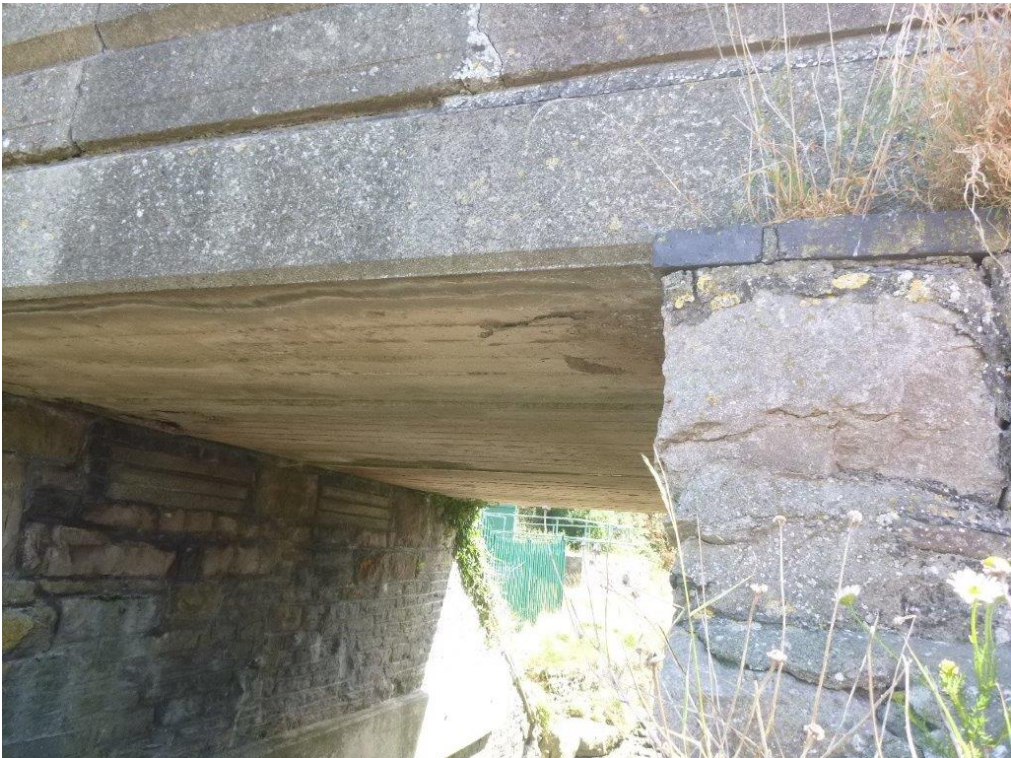
Photo 14 - Live significant defect (Taken 040822)

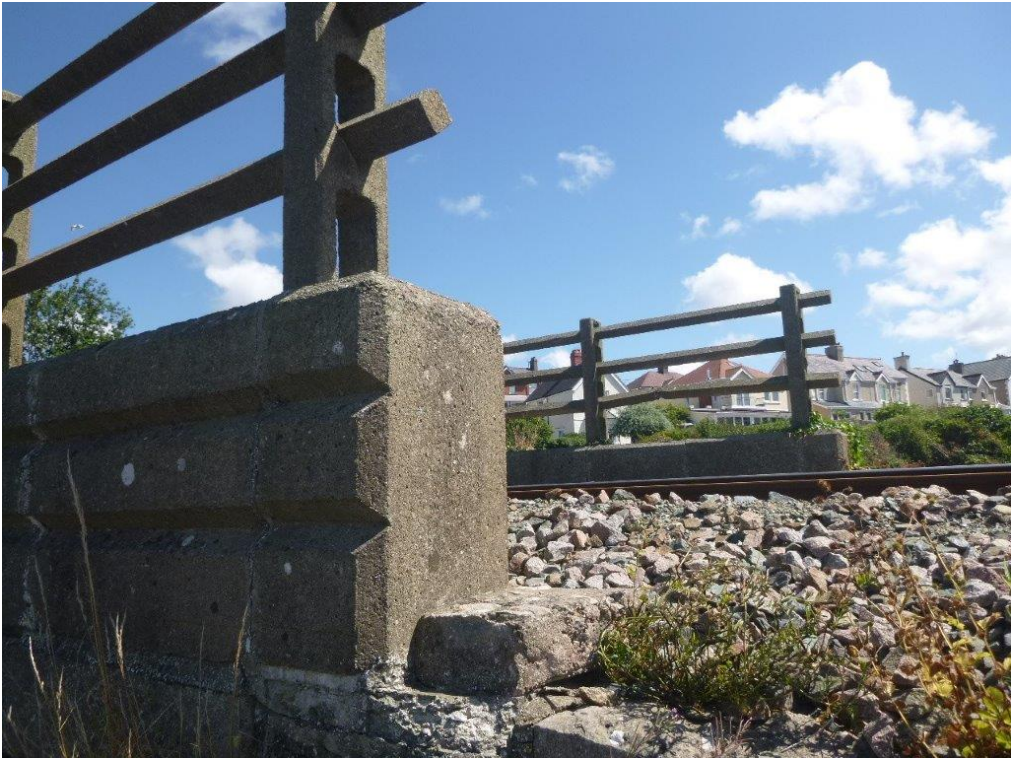
Photo 15 - Live significant defect (Taken 040822)

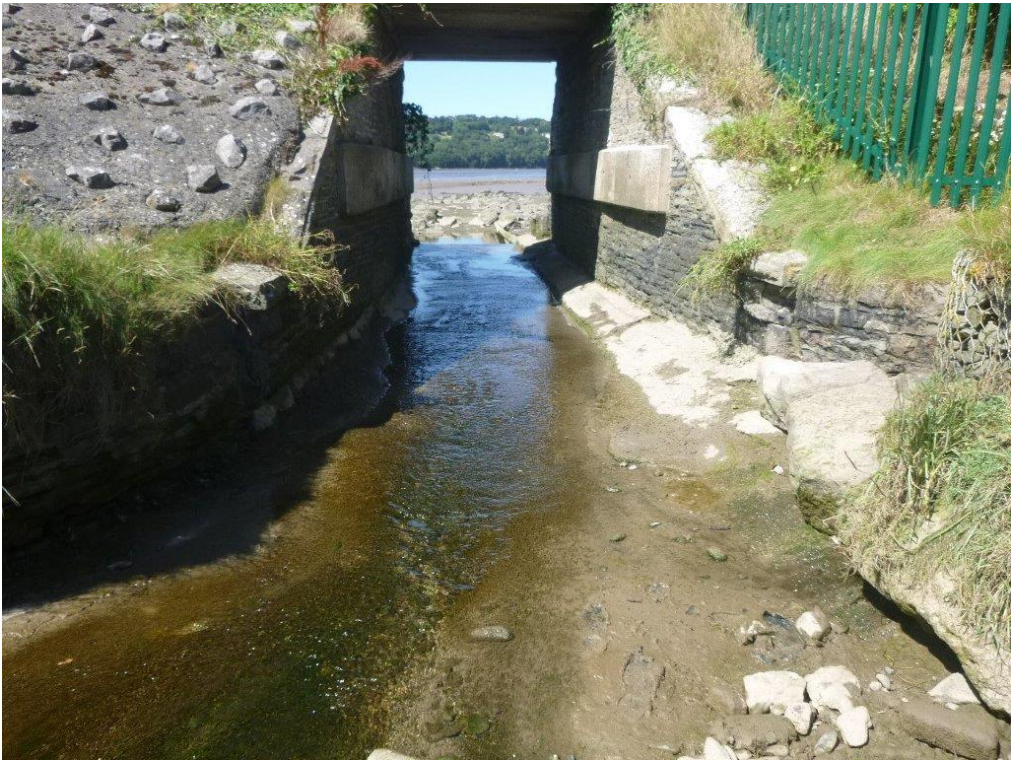
Photo 18 - Live significant defect (Taken 040822)
