# NETWORK RAIL

## Bridge Detailed Examination Report

| Structure Name: BONT FURNACE STREAM | | Type: BU | | Exam ID: 14462980 | |
| Route: Betws-y-Coed Branch | | | | Complete Exam: No | |

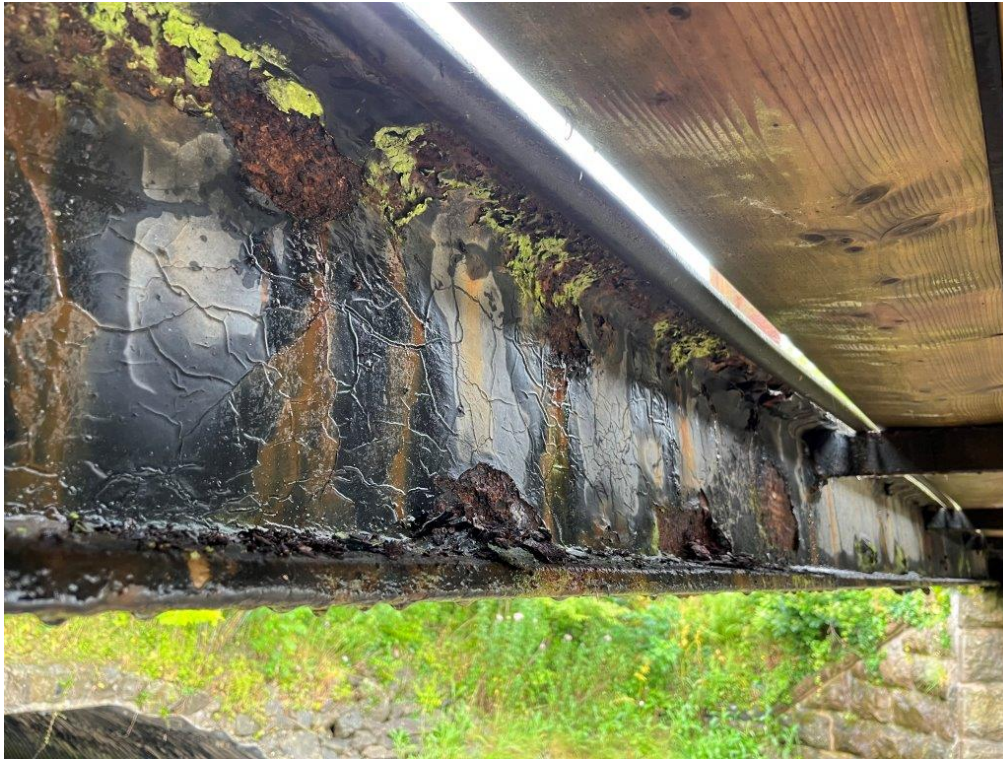
Both generally in fair condition showing areas of total paint loss particularly at the handrail fixing points to the outer web and the bottom flange up to 40% total, with associated corrosion loss, 1-3mm (worst top face of Top Flange, P9-10).

Photo 9: Inner face of DS Walkway Girder (02/08/22)

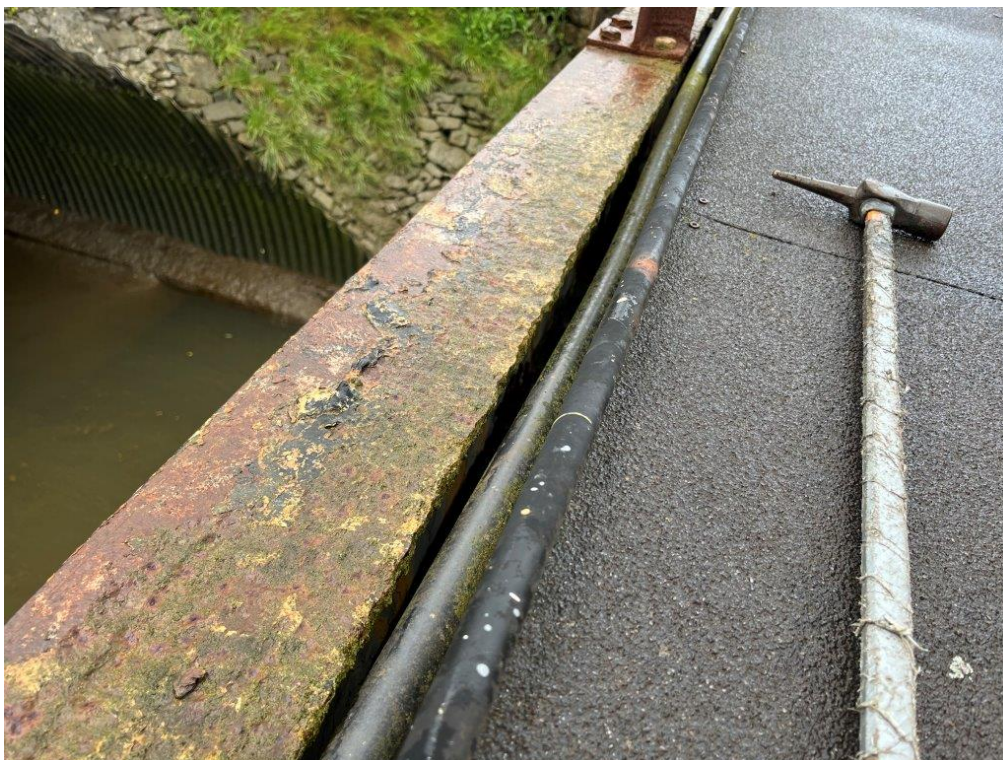
Bottom Flange inner edge shows light notching at connections (new) with the Top Flange inner edge (trackside) showing light notching throughout (P10). Rest shows light corrosion loss throughout.

Photo 10: Top Flange of DS Walkway Support Girder (02/08/22)

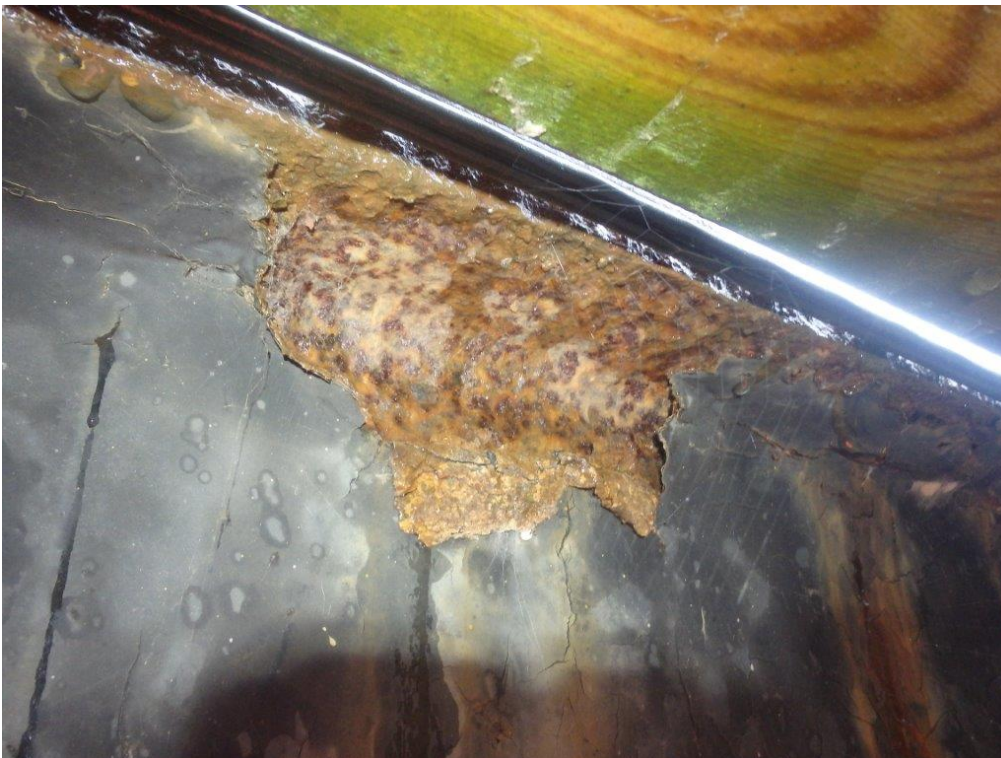
Photo 14: Odd example of corrosion loss to US Walkway Support Girder (02/08/22)

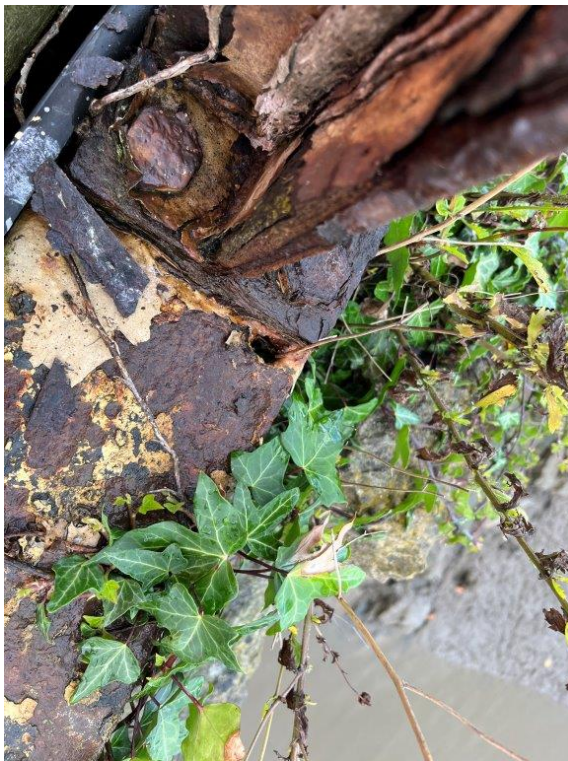
Photo 15: LOS to US Walkway Support Girder (02/08/22)

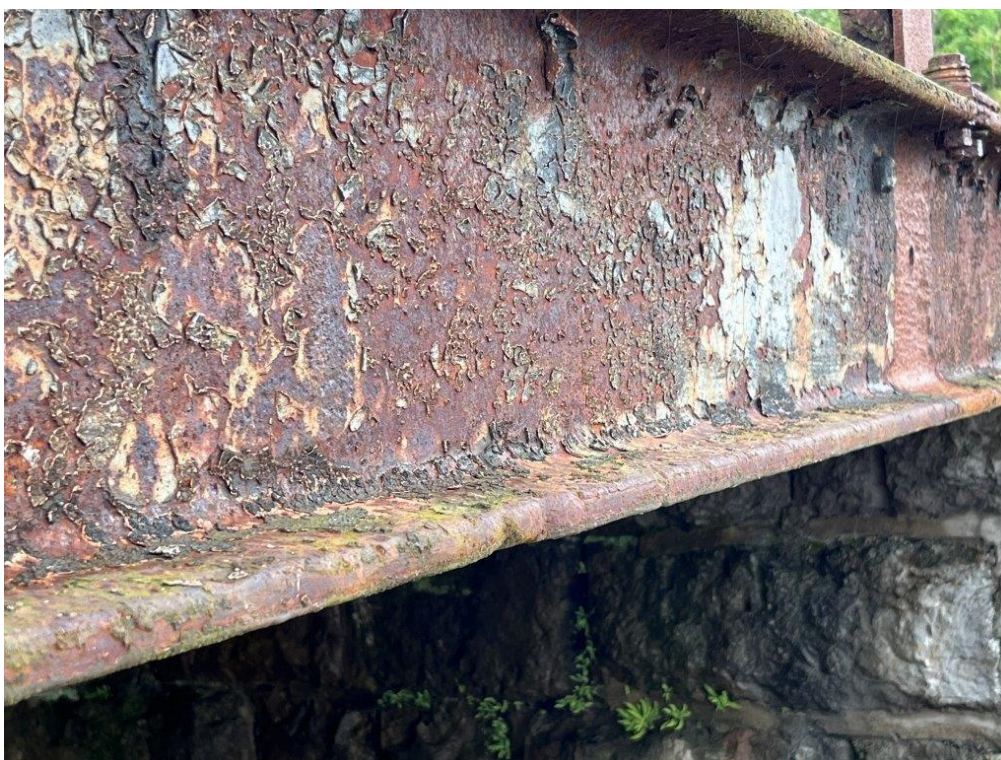
Photo 16: Area of notching to US Walkway Support Girder, HM 1/4 point (02/08/22)

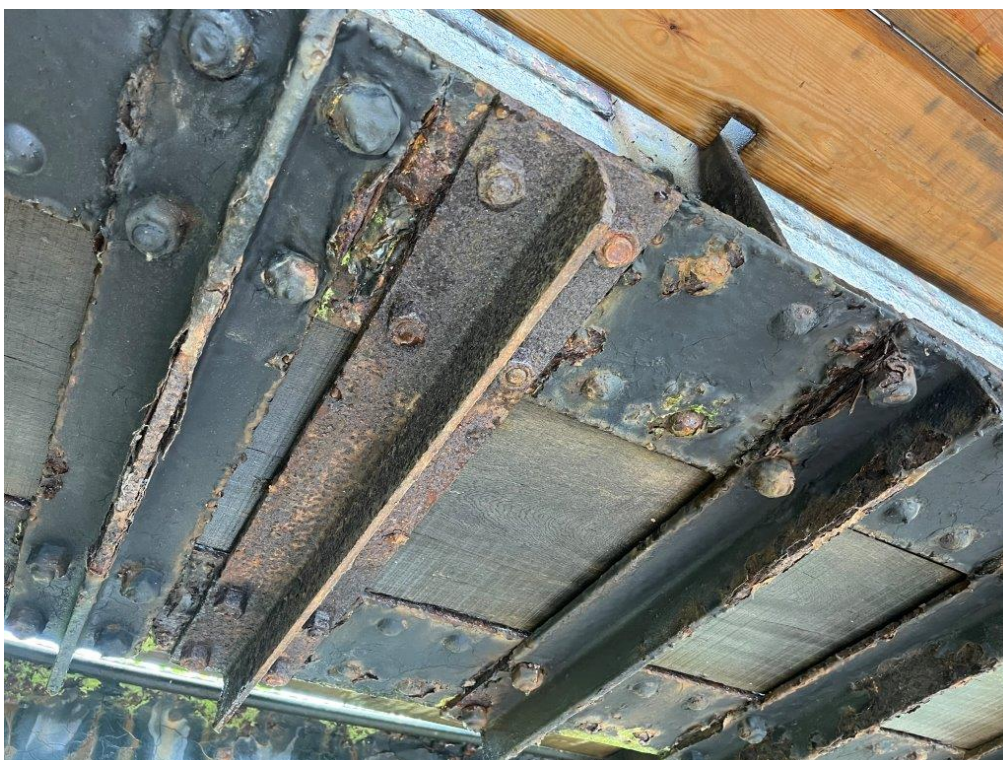
Main Girders typically show thick lamination (requiring removal) at corroded area, where visible shows corrosion loss to 5mm at connections.

BOTTOM FLANGE: Isolated areas of flaking paintwork over approx. 20%, where lost corrosion loss 1-3mm deep increasing to 5mm at connections. Lamination present scattered throughout, unable to remove due to watercourse below.

Photo 20: Typical view of condition of DS Main Girder, note corrosion loss at connections and lamination (02/08/22)

| HIDDEN PARTS NOT EXAMINED<br>(EXCLUDING FOUNDATIONS) | | Part | | | Reason | | | | |
|---|---|---|---|---|---|---|---|---|---|
| 2 | Grit blast and paint all metallic elements to deck and structure, carry out repairs to corroded steelwork revealed following grit blasting. Review if Coastal environment is applicable to structure and paint system. New recommendation. | Structure | 50000.00 | 2yrs | 1 unit | 3 | 2 | E6 | Painting |

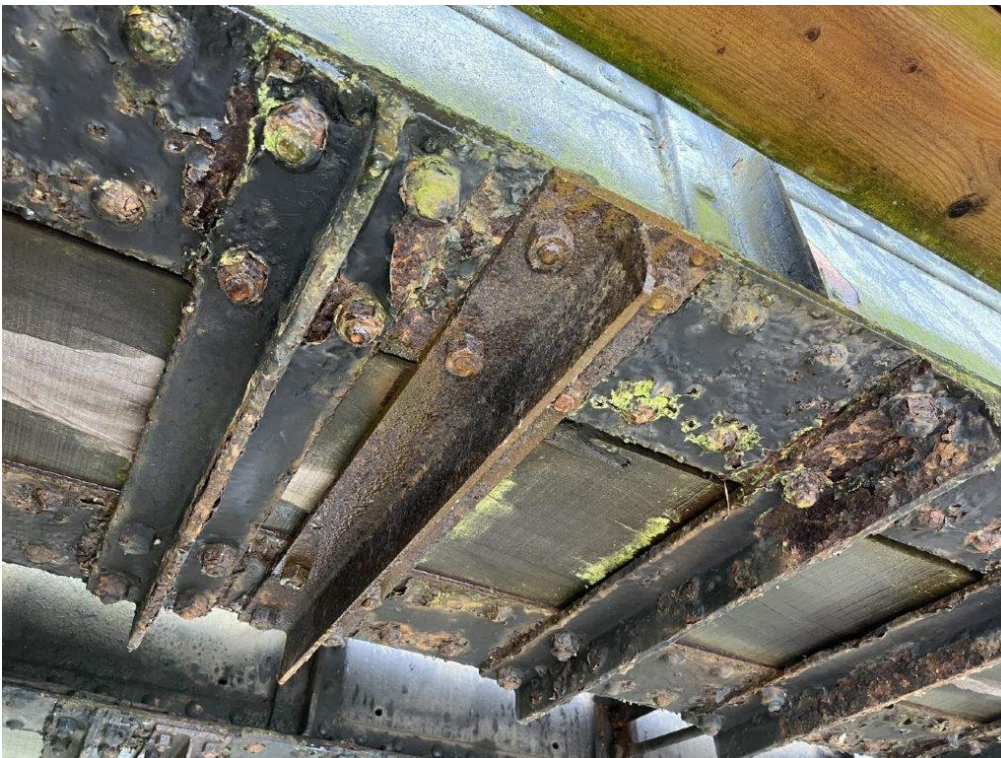
**Photo 24: Typical corrosion loss to US Main Girder (02/08/22)**

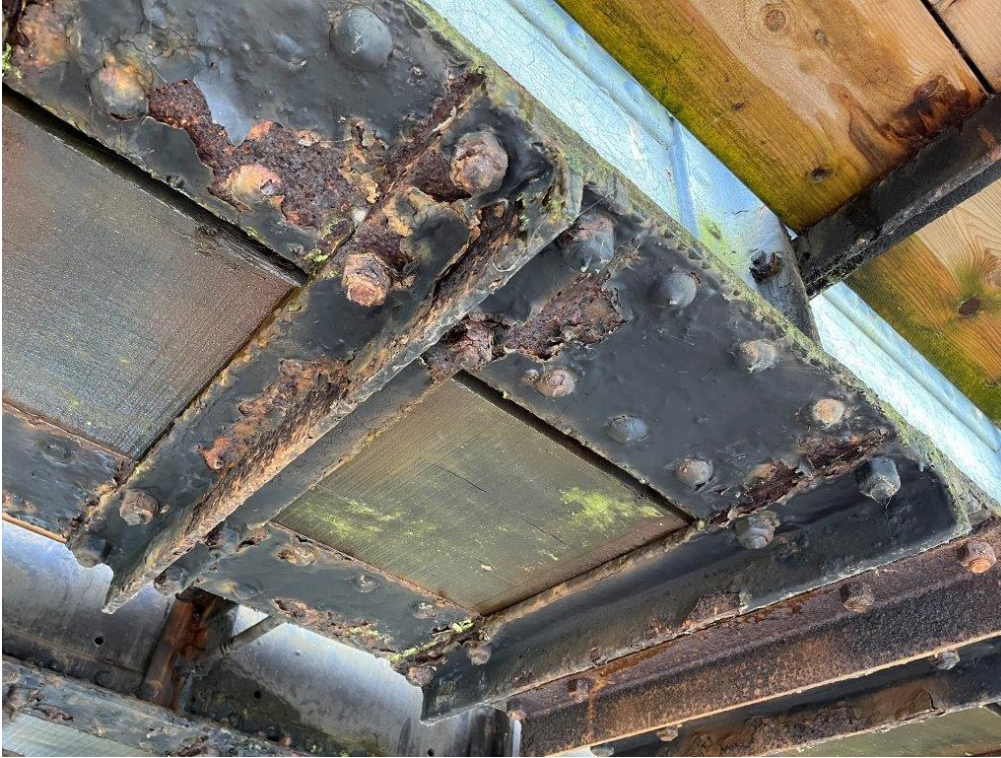
Photo 25: Further view of corrosion loss to US Main Girder (02/08/22)

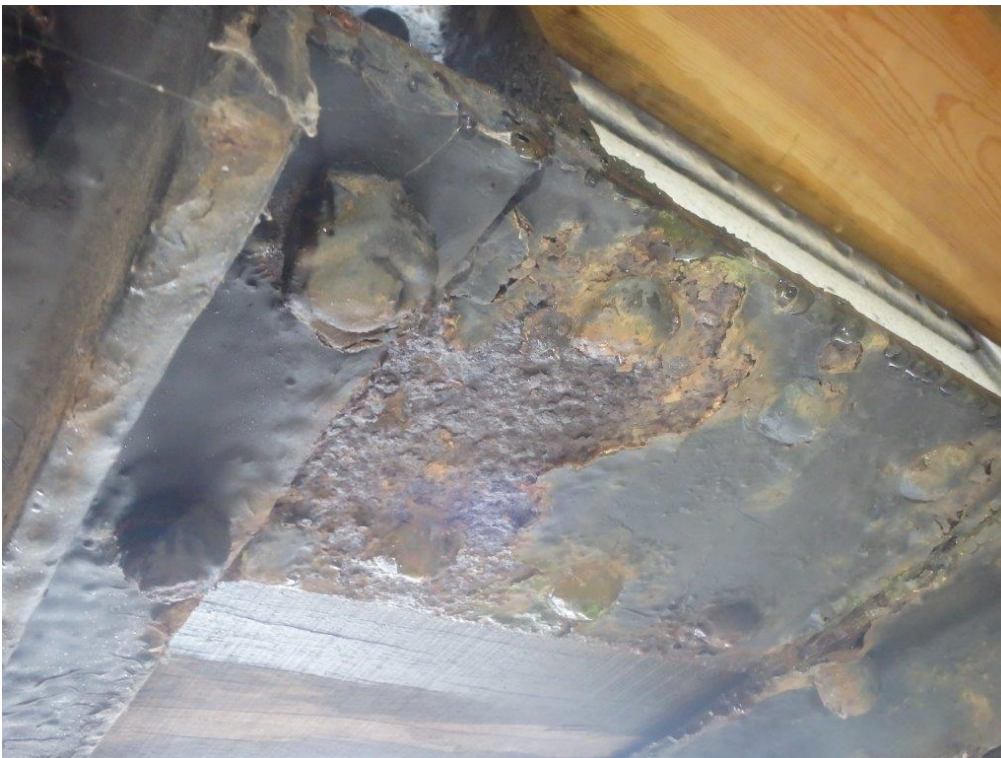
Photo 26: Increased corrosion loss to US Main Girder at connections (02/08/22)

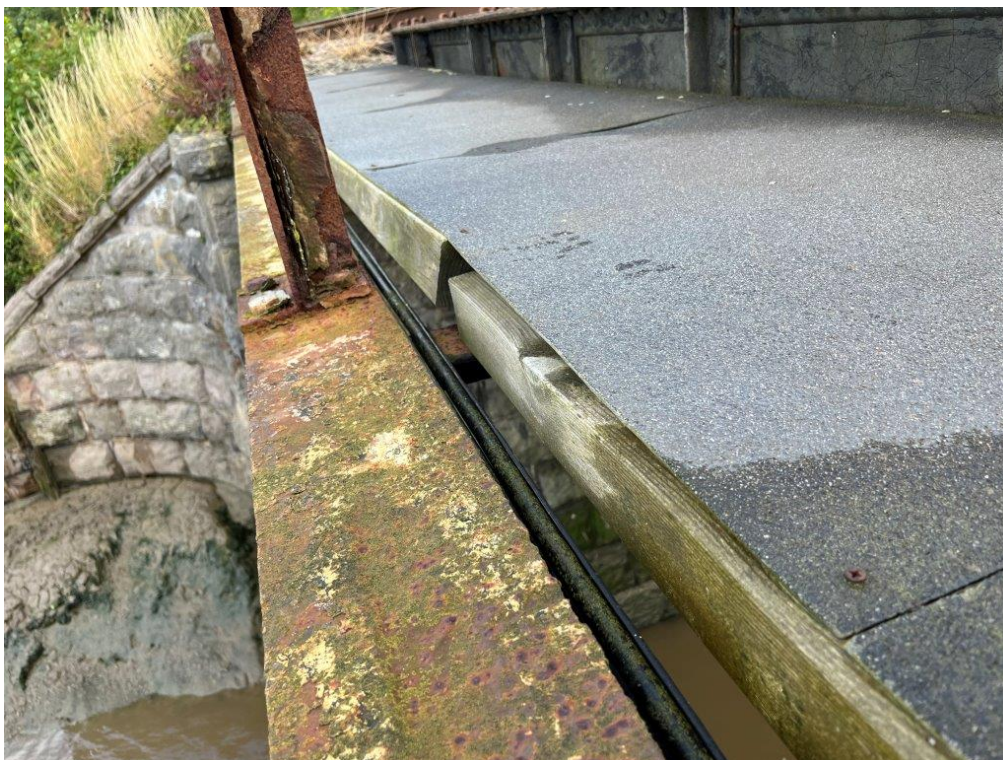
Photo 30: Displacement to US Walkway (02/08/22)

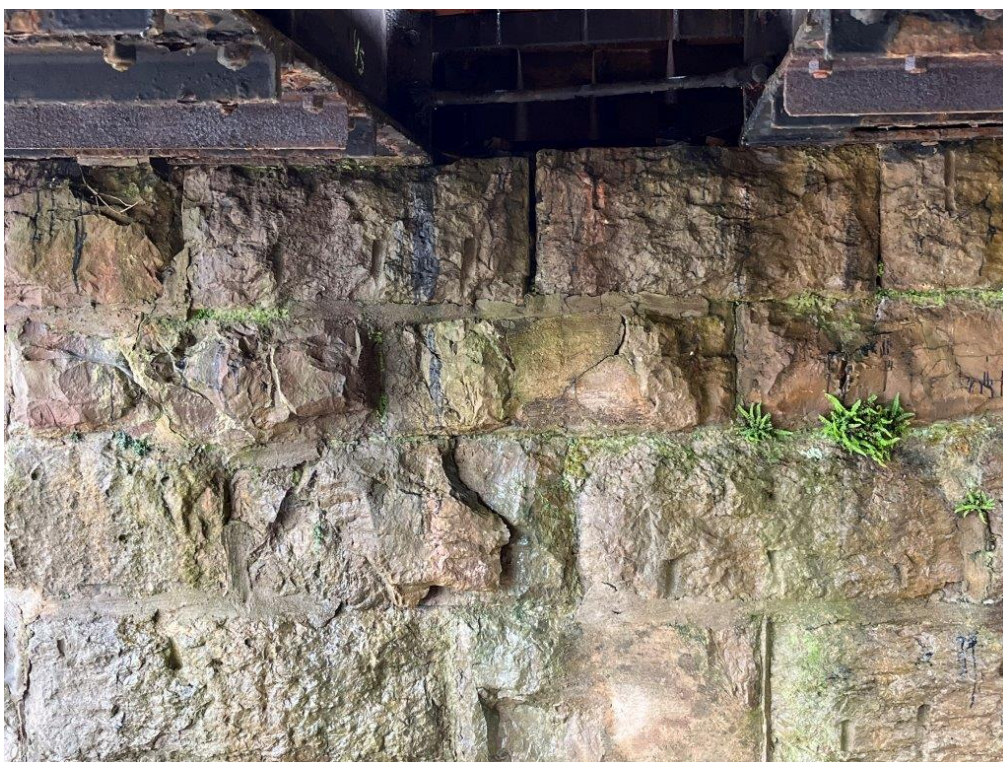
At midpoint, 2-3 courses down from the top: 3no. stones show evidence of fracturing and breaking up, this has now been pointed around (P32).

Photo 32: Area of split stones to LM Abutment (02/08/22)

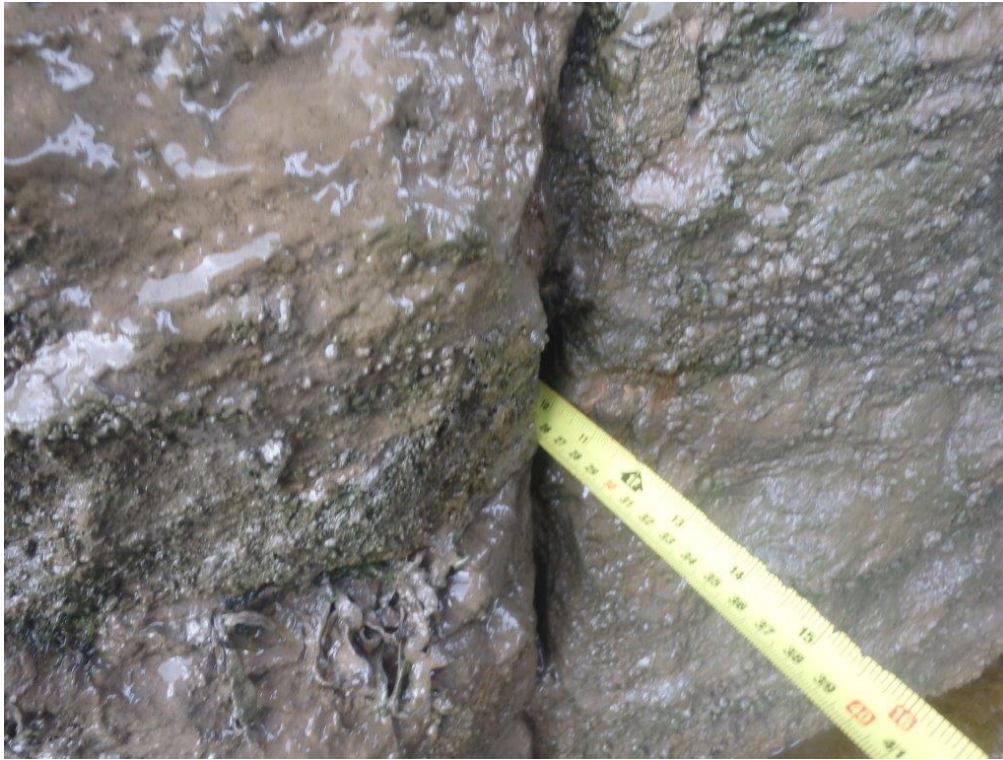
Photo 33: OJs to LM Abutment (02/08/22)

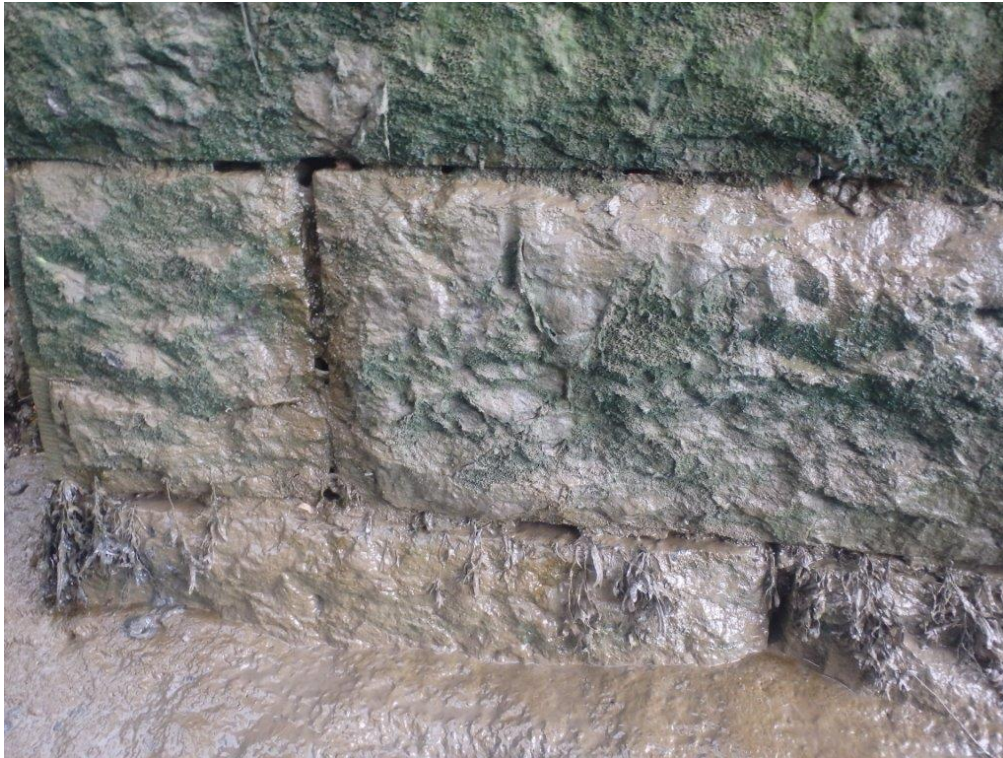
Photo 35: OJs to lower reaches of HM Abutment (02/08/22)

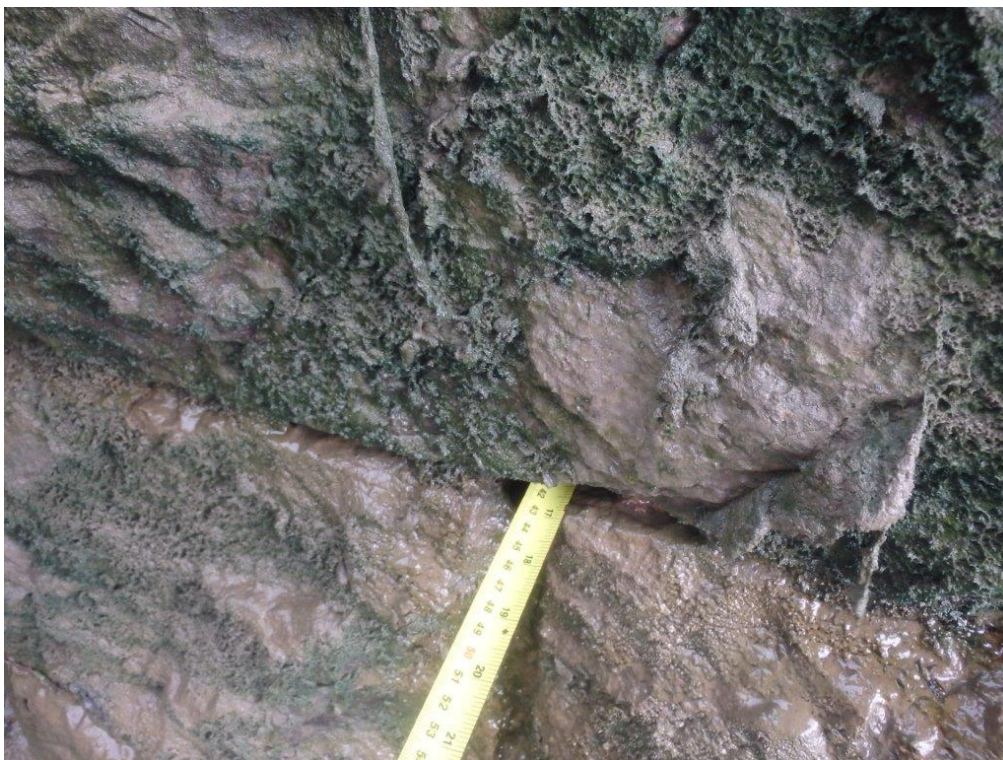
Photo 36: View of depth of OJs to HM Abutment (02/08/22)

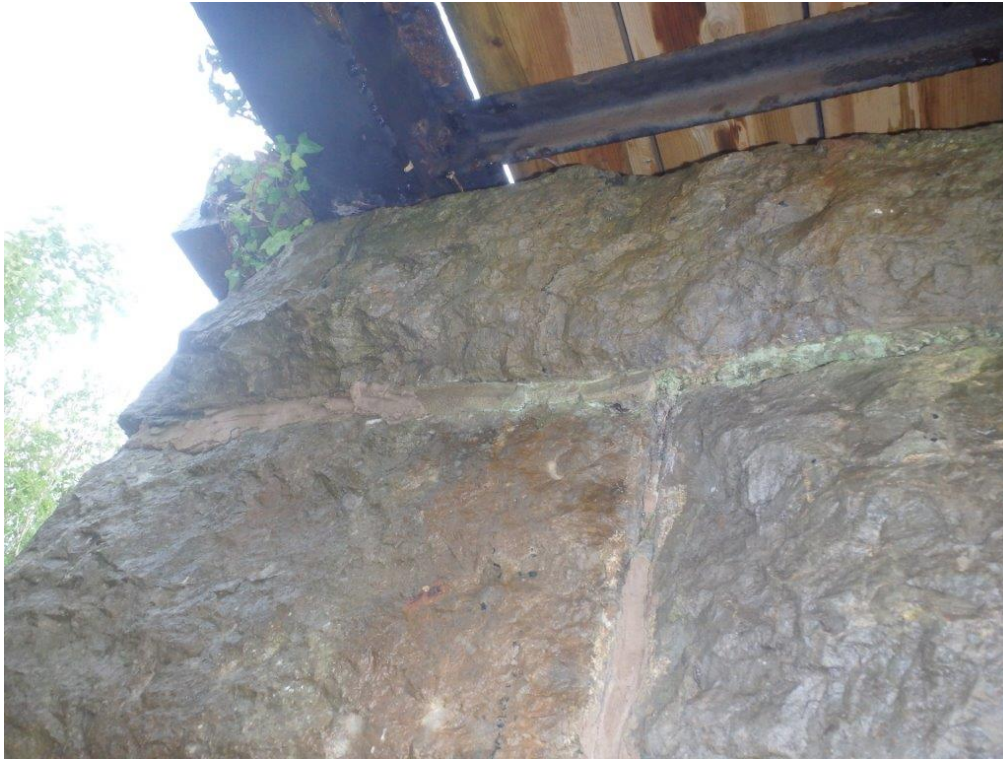
Photo 37: 1no stone to DS quoin, top course, set forward 10mm (02/08/22)

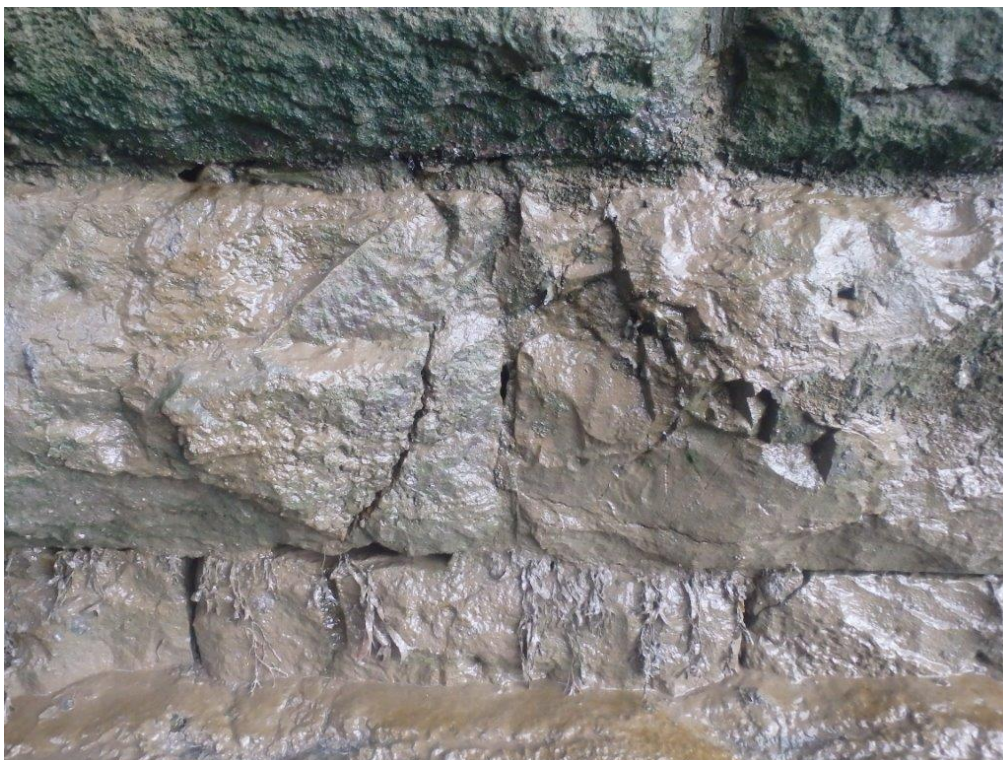
open (NFD), with OJs surrounding (as above) and 1no stone at GL split to its DS top corner (P38). Remainder shows facial weathering / spalling throughout with further 1.5m<sup>2</sup> spalling to 30mm deep max beyond the pointing line, typical 10mm. Run down stain throughout, damp with mud caking and algae growth at low level caused by tide changes. Thick silt at lower reaches.

Photo 38: 1no split stone to HM Abutment with stone adjacent split to its corner (02/08/22)

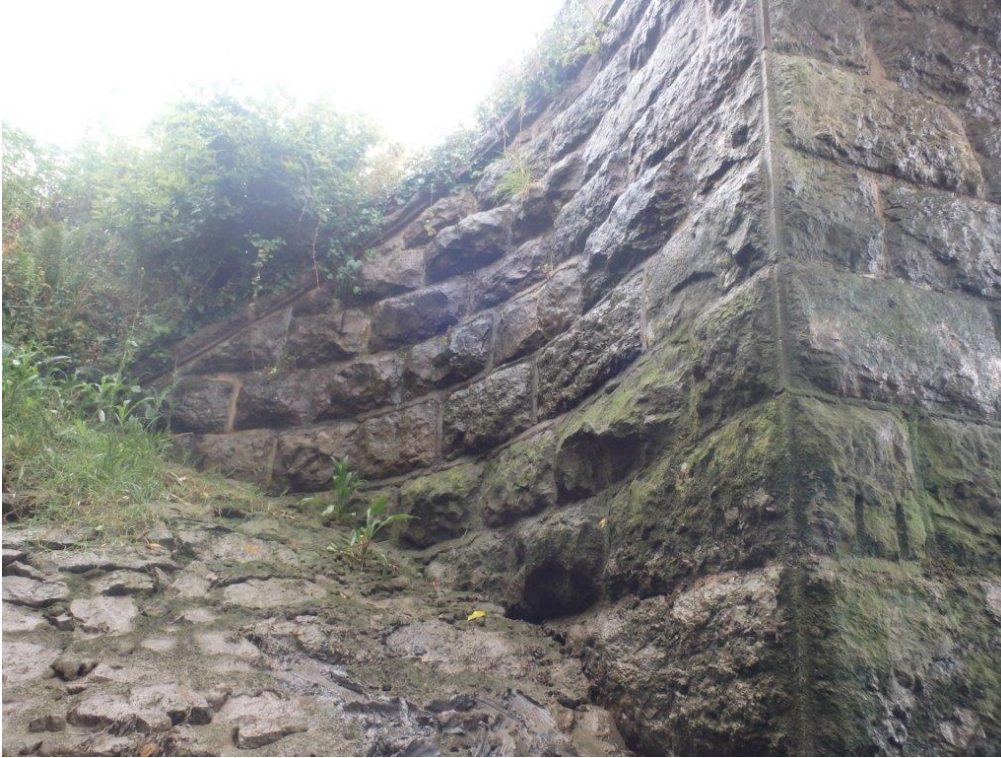
Generally in fair condition showing: 500mm from outer end, beneath the copings: Diagonal through fracture (through 1 stone) 2.3m long x 10-25mm wide (10mm through, 25mm joints), with slight 6mm displacement at the top (this appears to have now been pointed up, unknown if any reopens or if displacement remains, P39).

Photo 39: Downside High Mileage Wing Wall (02/08/22)

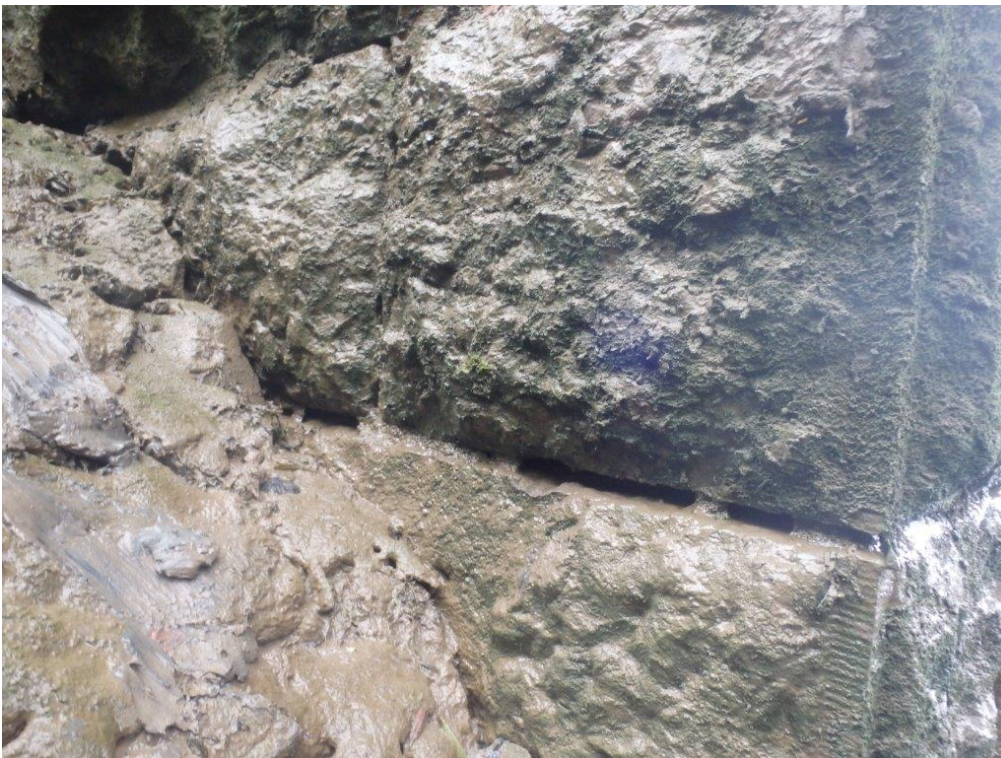
Photo 40: OJs to DS HM Wing Wall (02/08/22)

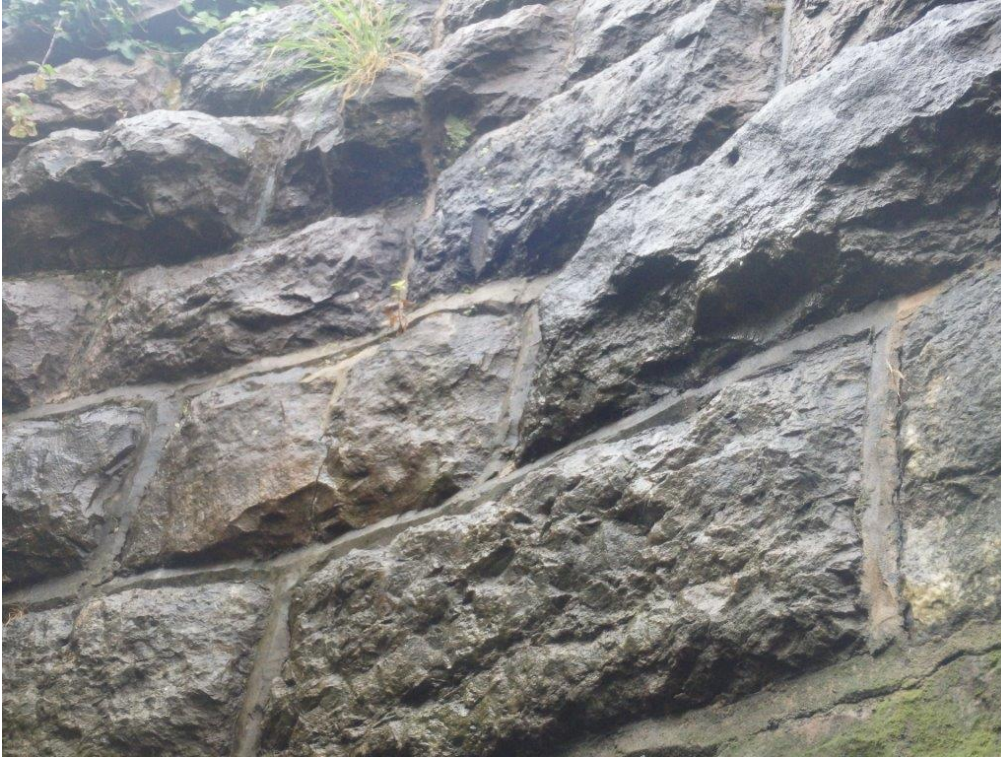
Photo 41: View of split stones, DS HM Wing Wall (02/08/22)

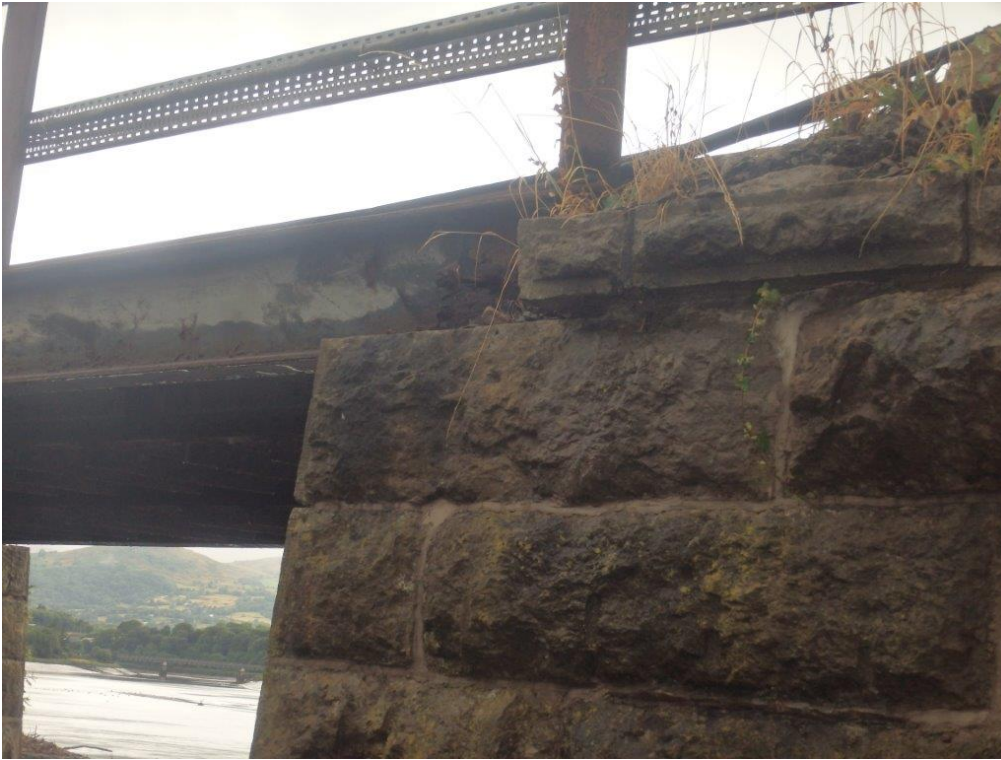
The topmost coping is missing (possibly removed), 400mm long (NFD, P43). Light overgrowing vegetation (new).

Photo 43: Missing top coping stone, DS LM Wing Wall (02/08/22)

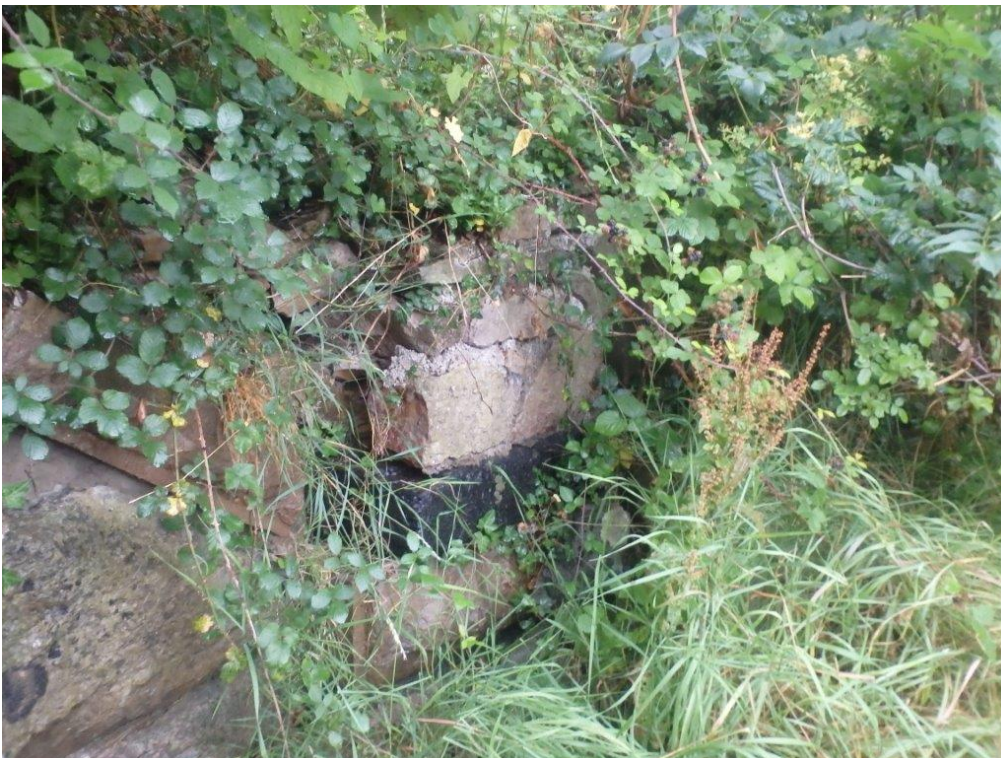
In front of the DS / LM Wingwall, there is a timber retaining wall 450mm wide x 600mm high, which shows significant rot and loss of section throughout – it appears that the wall may have continued another 400mm to the DS but is now missing.

Newel shows missing stonework with retaining wall as noted above adjacent (SSD).

Photo 44: Displaced/missing to Newel and adjacent Retaining Wall (02/08/22)

Description: Replace decayed timber wall and recase are of loose / missing and undercut stonework behind.

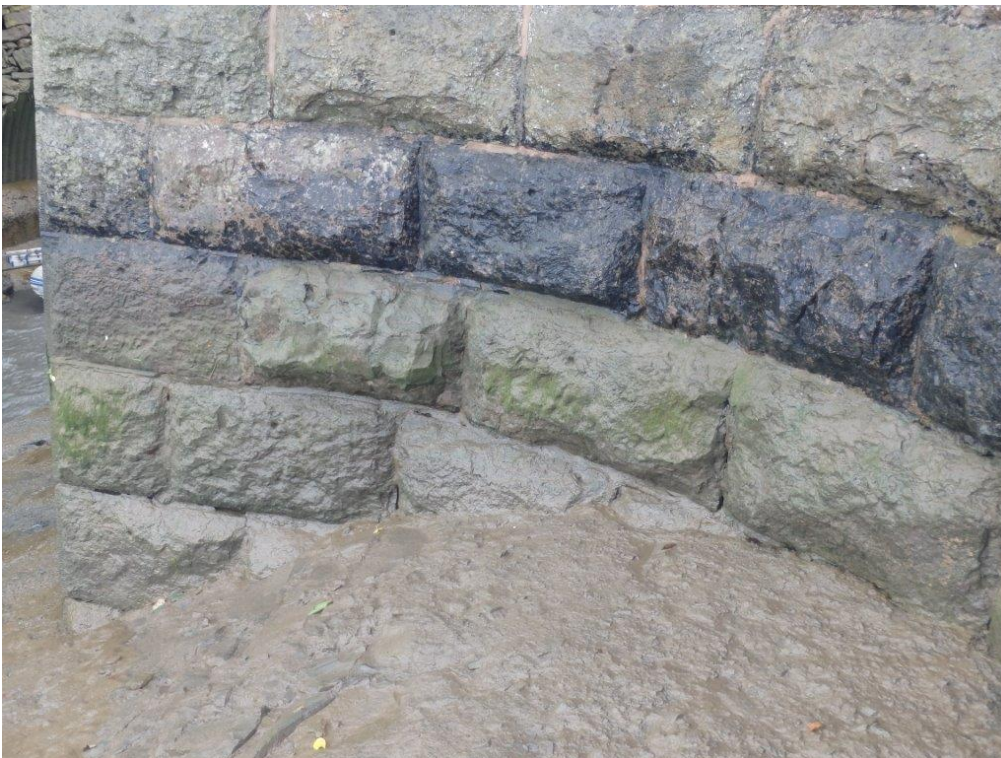
Generally in fair condition. 0.5m<sup>2</sup> OJs to 60mm deep max, typical 20-30mm (P46, was 0.75m<sup>2</sup>, some repointing works carried out).

**Photo 46: OJs to US HM Wing Wall (02/08/22)**

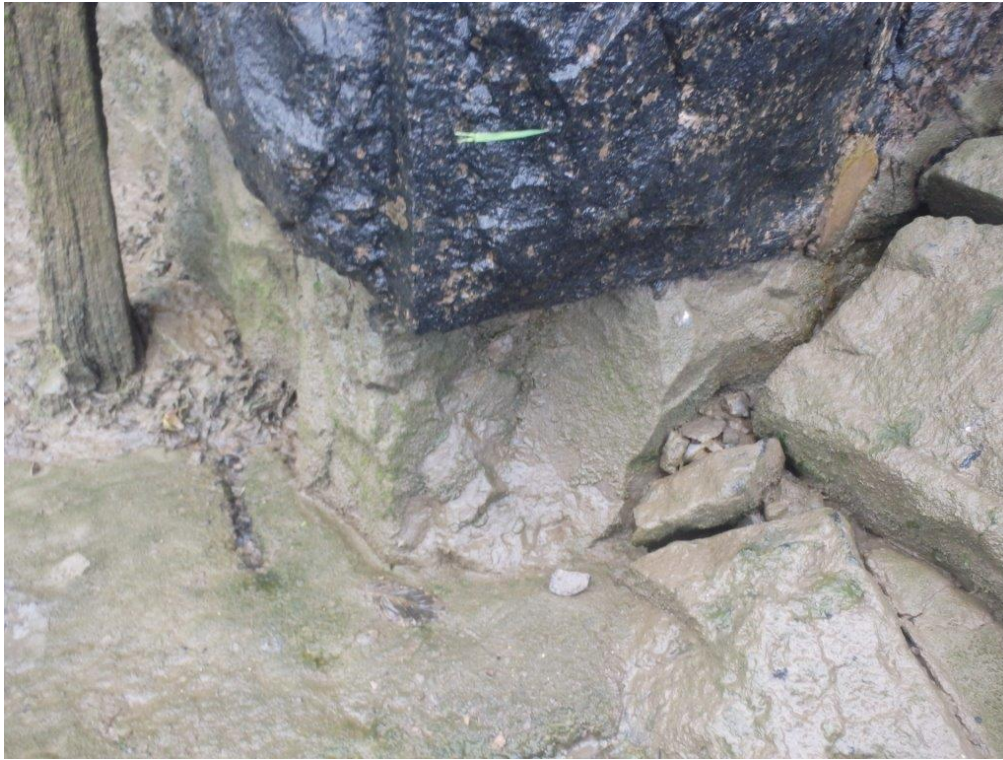
1no. stone at GL on the newel shows spalling on the edge to 150mm deep beyond the pointing line x 250mm high (NFD, P47), with stone 2nd course from top shattered (new, P48).

Photo 47: Newel quoin stone spalled to 150mm, US HM Wing Wall (02/08/22)

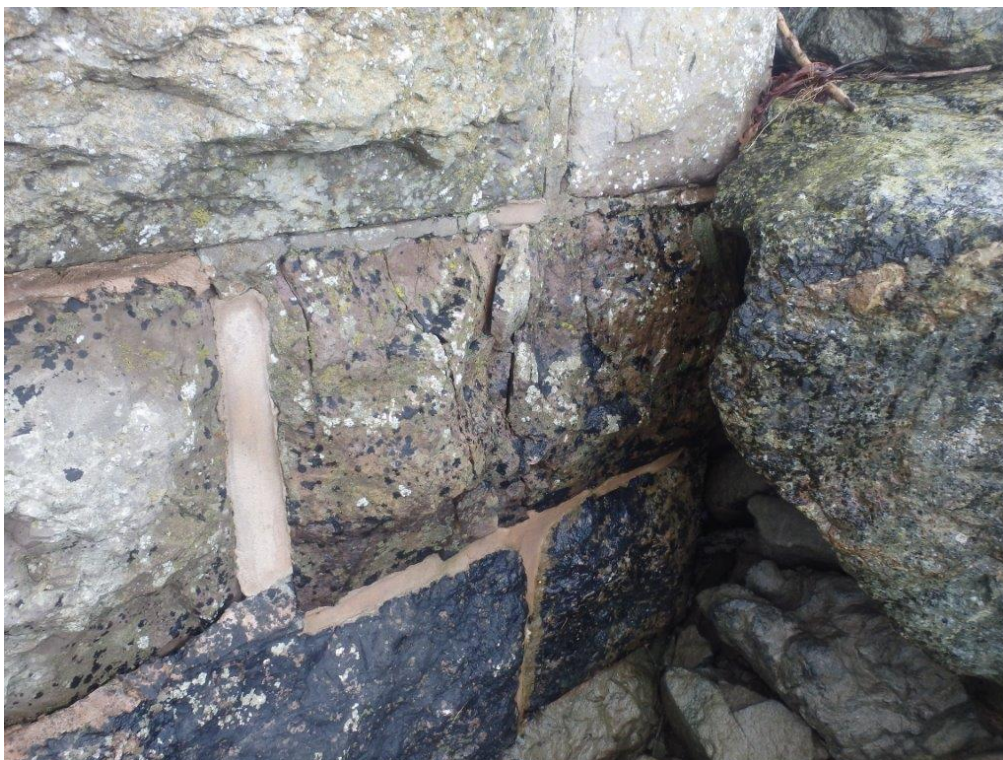
Photo 48: Shattered stone to Newel, US HM Wing Wall (02/08/22)

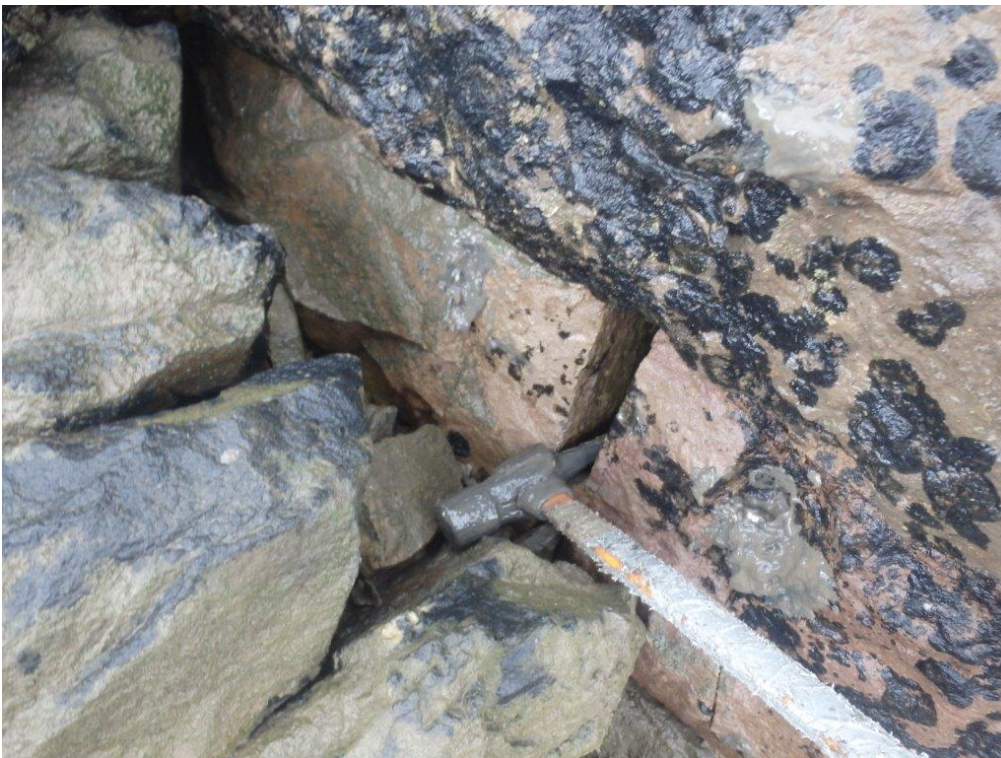
Generally in fair condition. 0.75m<sup>2</sup> OJs (was 0.5m<sup>2</sup>) to 50mm deep max, typical 20-30mm, notable to lower reaches (P50), repointing carried out to upper reaches (P51).

Photo 50: OJs to US LM Wing Wall (02/08/22)

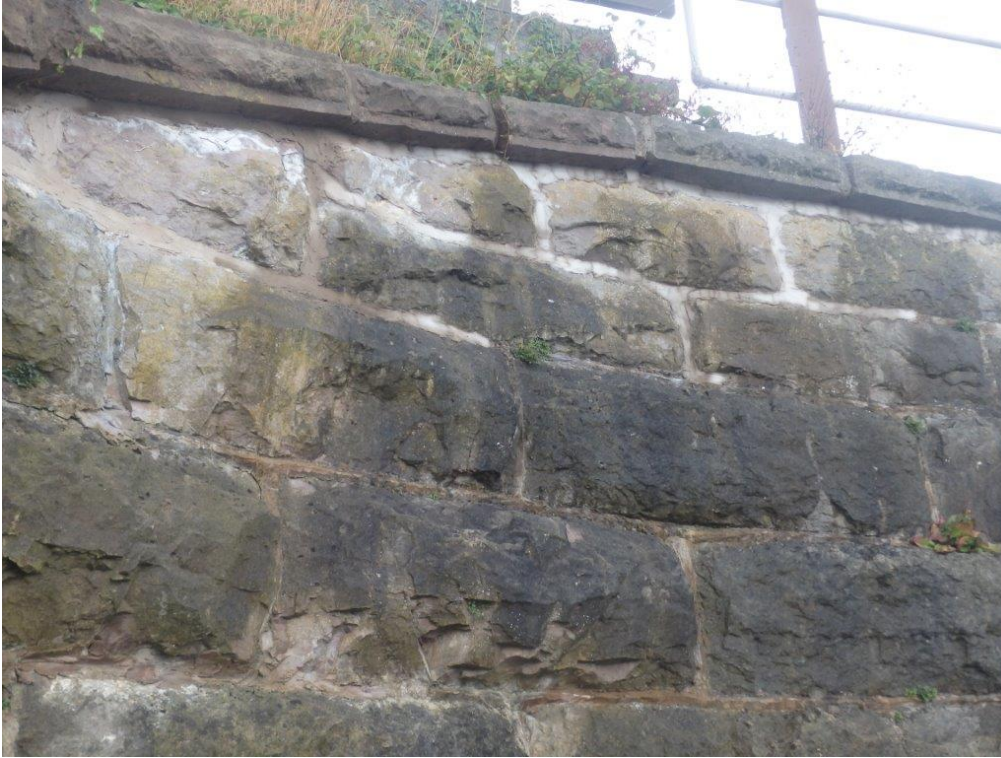
Photo 51: Repointing works to upper reaches, US LM Wing Wall (02/08/22)

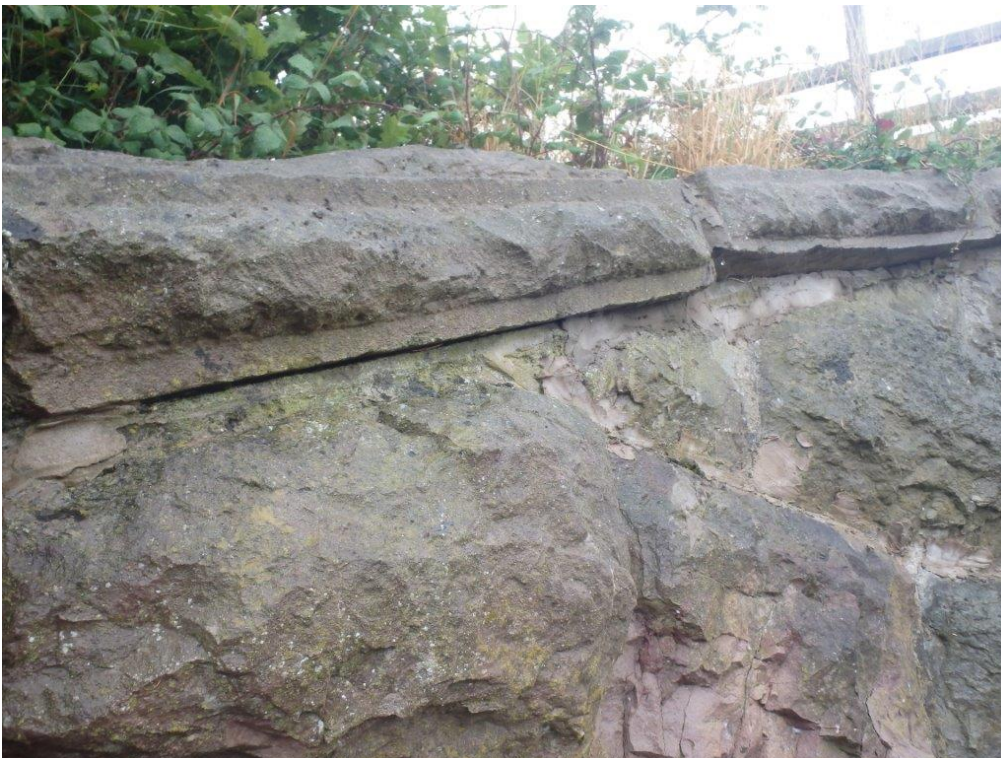
Bed joint fracture below Copings noted in lower half, open to 5mm (new, P52).

Photo 52: Bed joint fracture below copings, US LM Wing Wall (02/08/22)

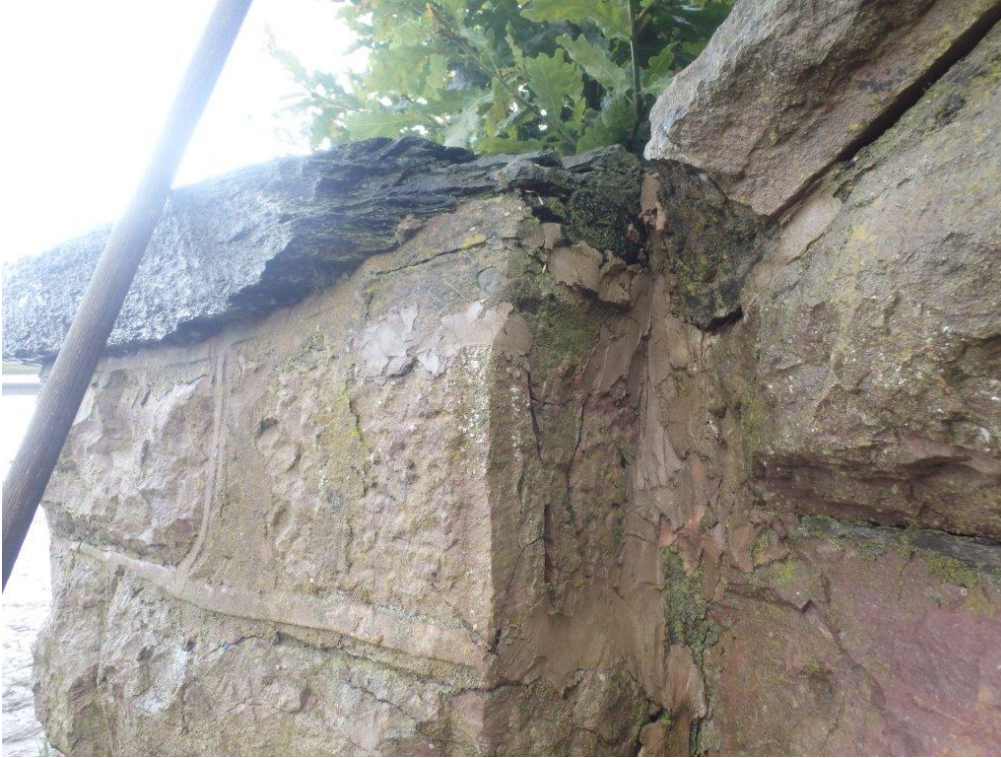
Newel stone also shattered to its inner quoin, with Coping above spalled 250mm back 100mm (new).

Photo 53: Newel stone shattered with spalled coping above, US LM Wing Wall (02/08/22)

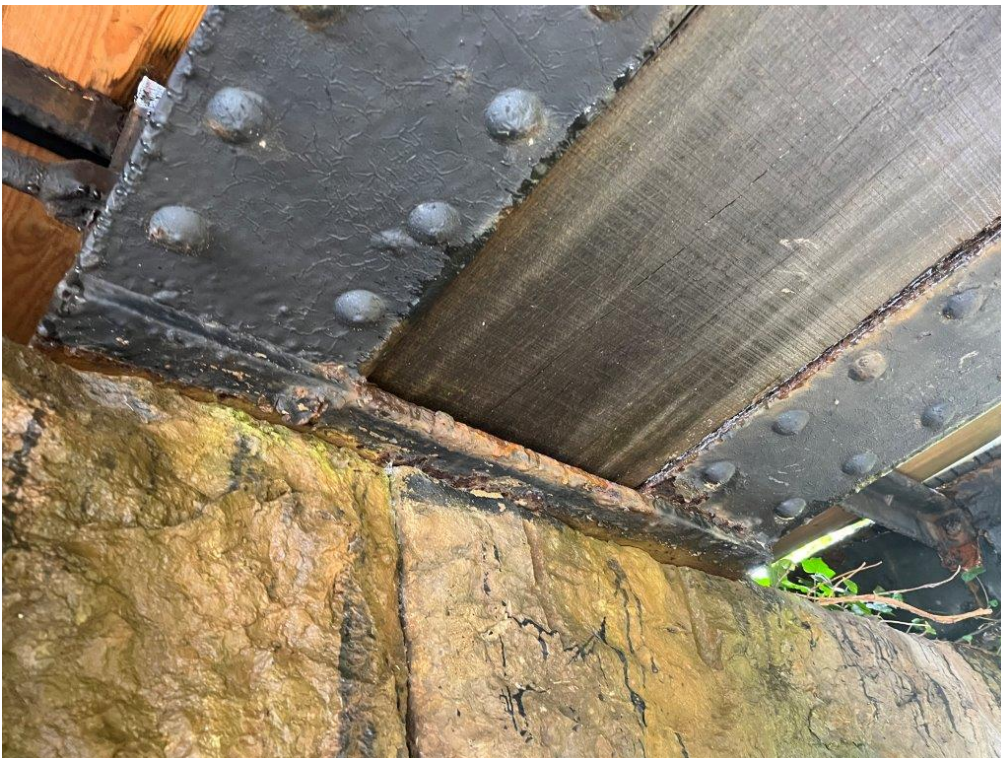
Very little visible due to debris and ballast covering them over each Abutment (P55), where visible they appear in fair condition. The only real view is to their outer edge, these show corrosion loss to their soffits adjacent to the Abutments, 2-3mm (P54).

Photo 54: Typical view of bearing plate (02/08/22)
