# NETWORK RAIL

## Bridge Detailed Examination Report

| Structure Name: BONT FURNACE STREAM | | Type: BU | | Exam ID: 14462980 | |
| Route: Betws-y-Coed Branch | | | | Complete Exam: No | |

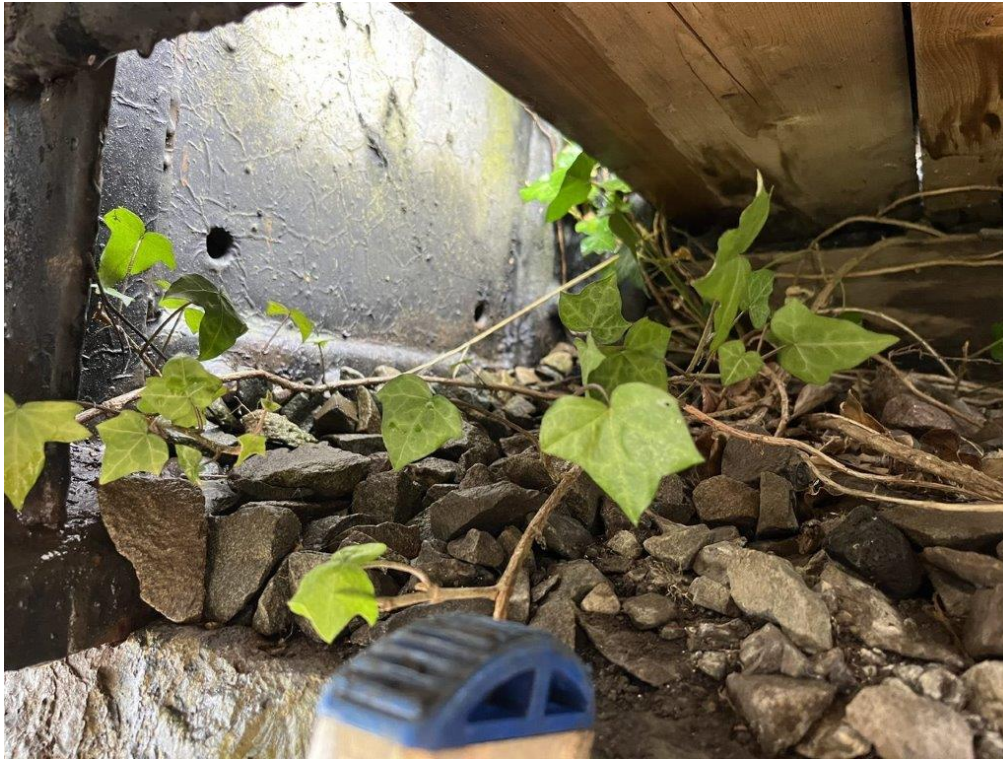
Very little visible due to debris and ballast covering them over each Abutment (P55), where visible they appear in fair condition. The only real view is to their outer edge, these show corrosion loss to their soffits adjacent to the Abutments, 2-3mm (P54).

Photo 55: Typical view of ballast/debris to bearing shelf/Abutment (02/08/22)

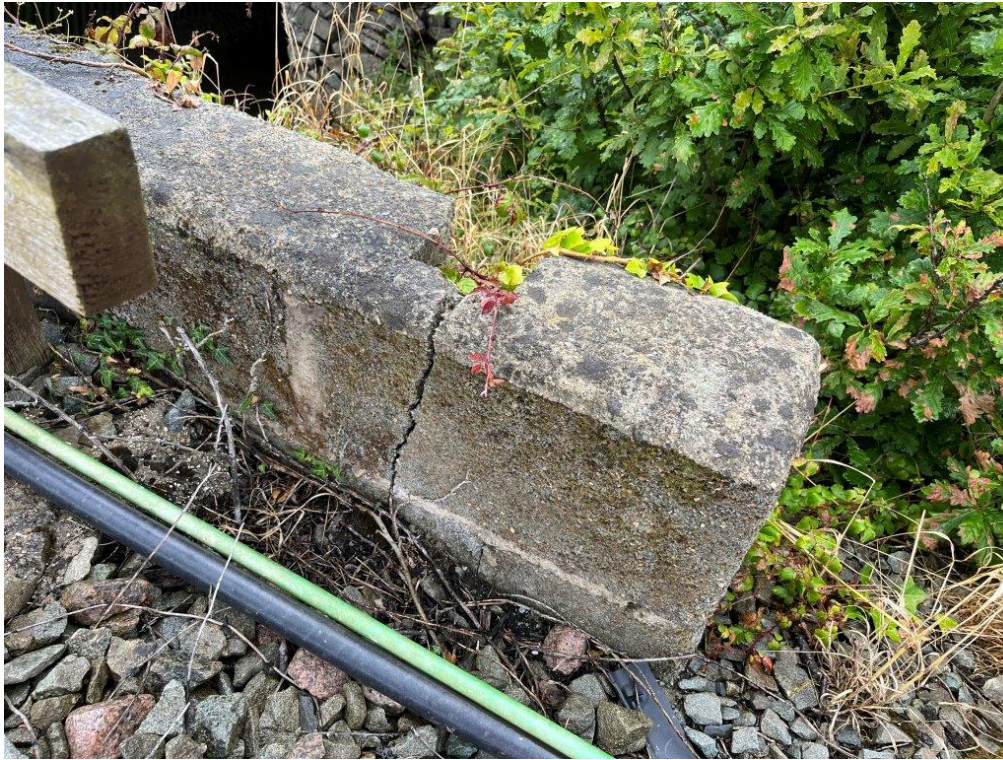
Photo 57: Typical fracture to Ballast Wall (02/08/22)

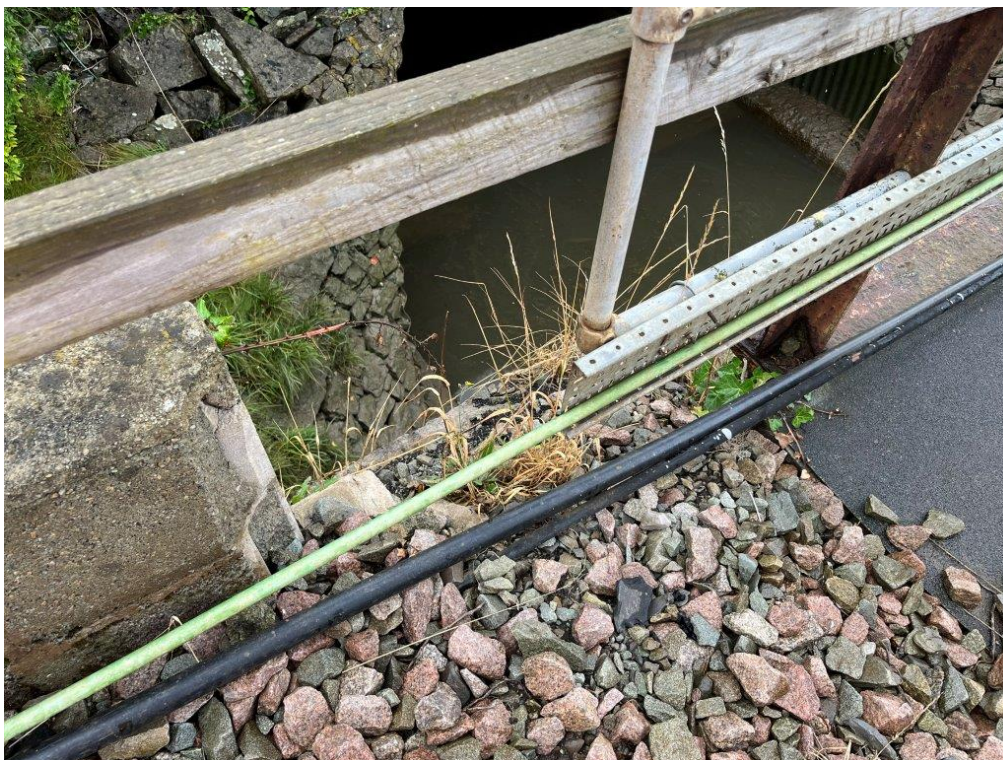
Photo 58: Section of DS LM Ballast Wall now missing (02/08/22)

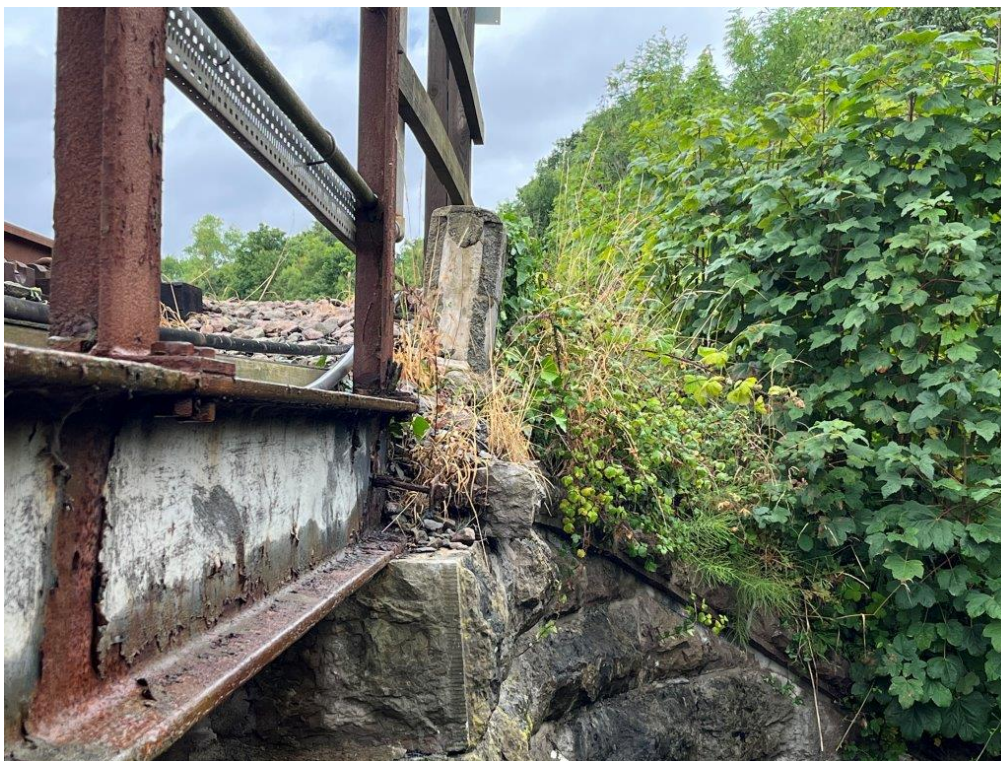
Photo 59: Lean to DS LM Ballast Wall (02/08/22)

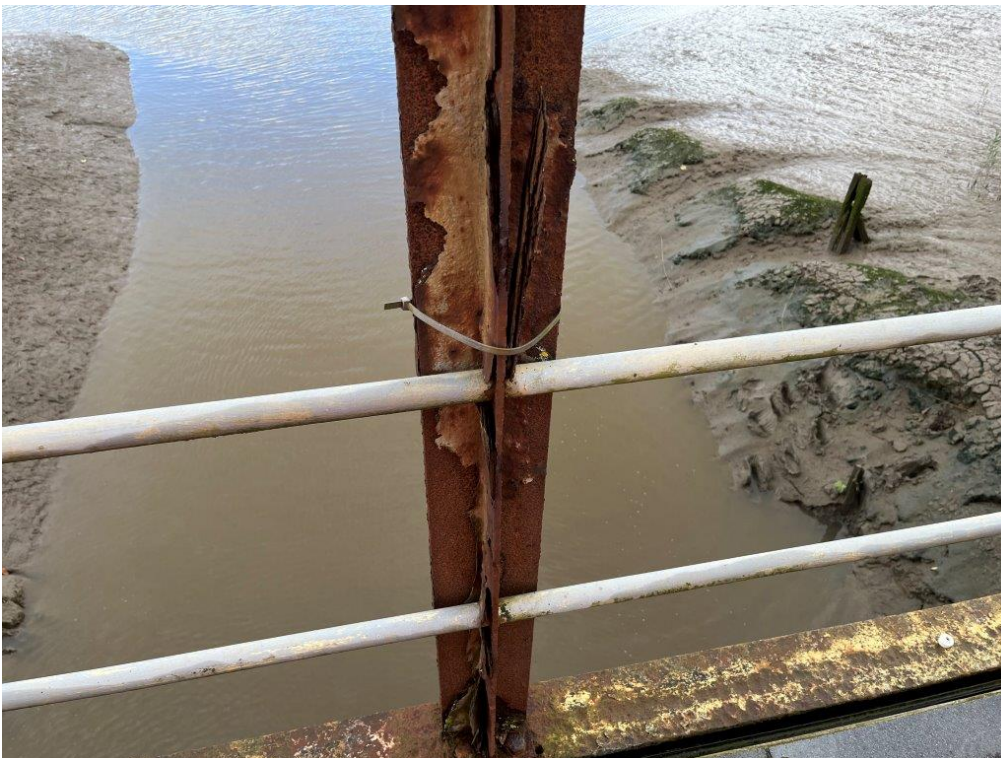
Photo 62: Thick lamination to US Handrail uprights (02/08/22)

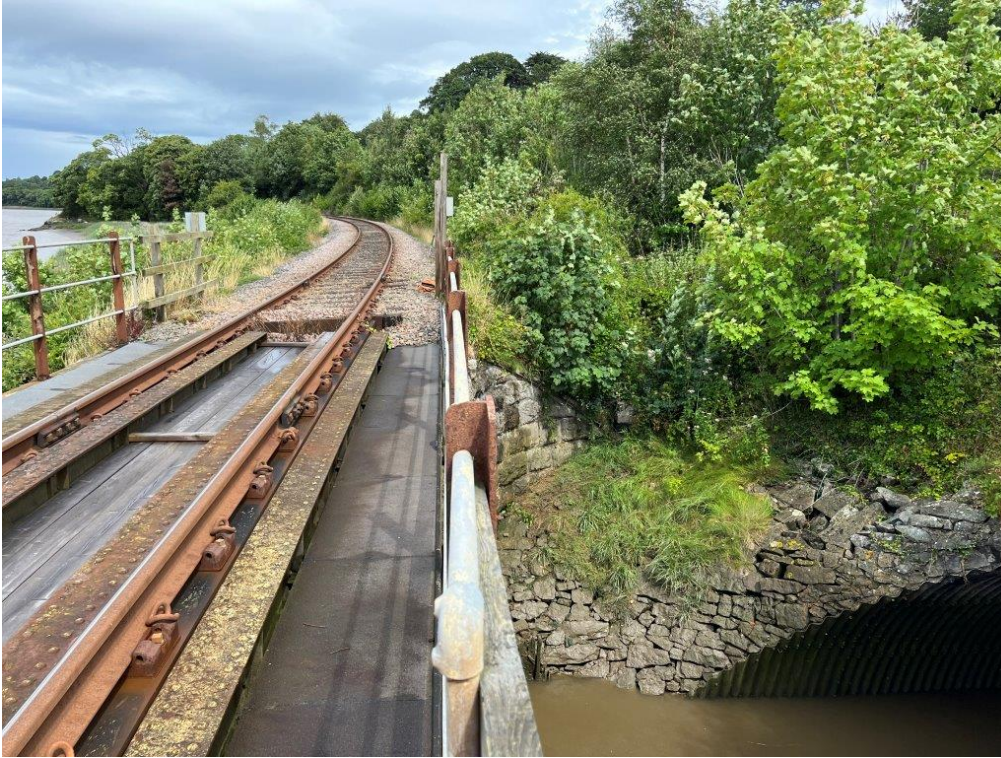
Viewed from each Abutment and mid-point only from ladders (and Top Flange/upper reaches from track level). Both appear bodily slightly loose (new). Downside appears to bow (P63) with the Upside handrails showing poor profile (P64).

Photo 63: Downside Handrails appearing to bow (02/08/22)

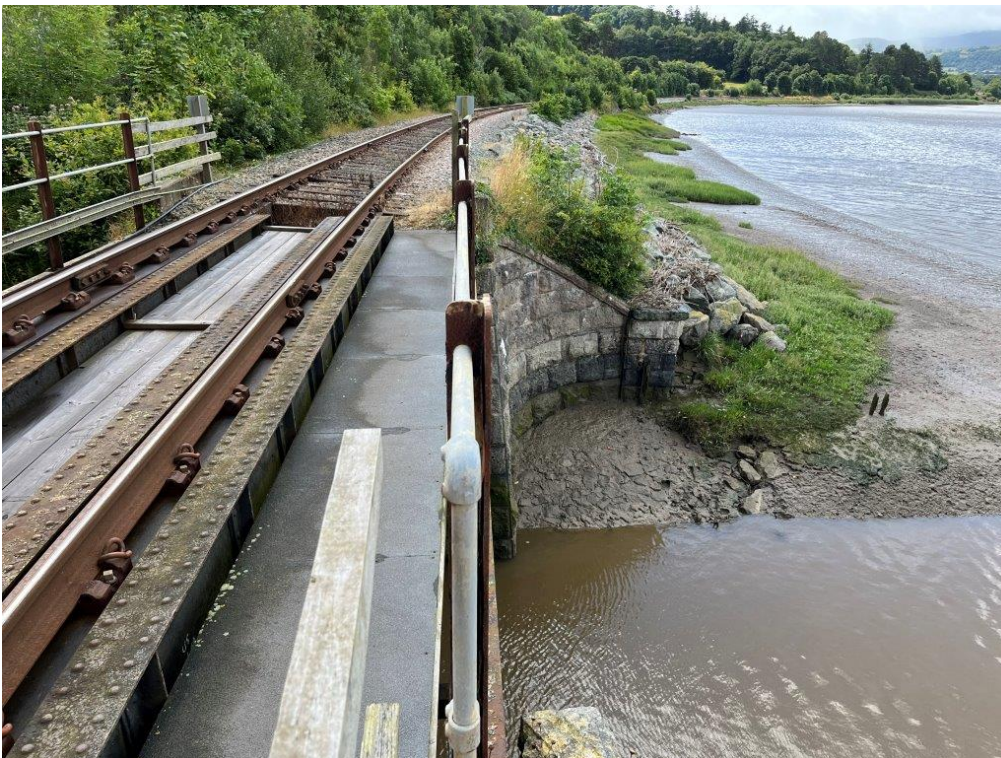
Photo 64: Poor profile to US Handrails (02/08/22)

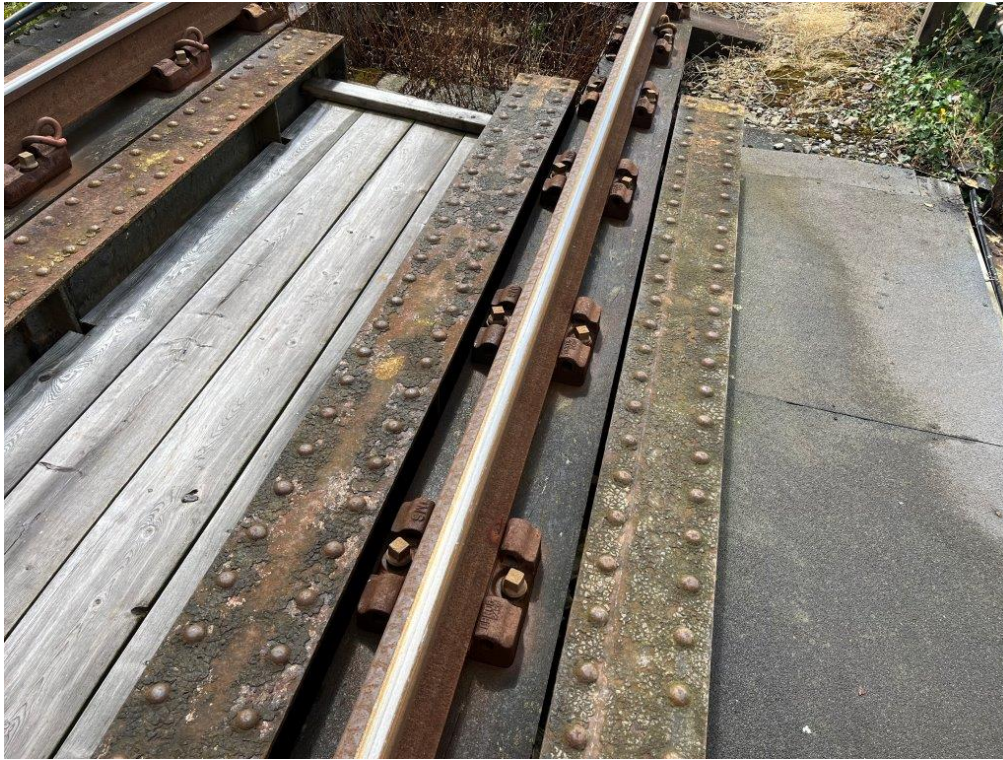
Photo 65: Missing clips prior to replacement (02/08/22)

11no clips were found to be missing from the US rail during the examination, P-way attended site and replaced all the missing units.
