**Site Photos**

Maerdy Mill, Corwen, LL21 0NR

Photographs taken 01/07/2023

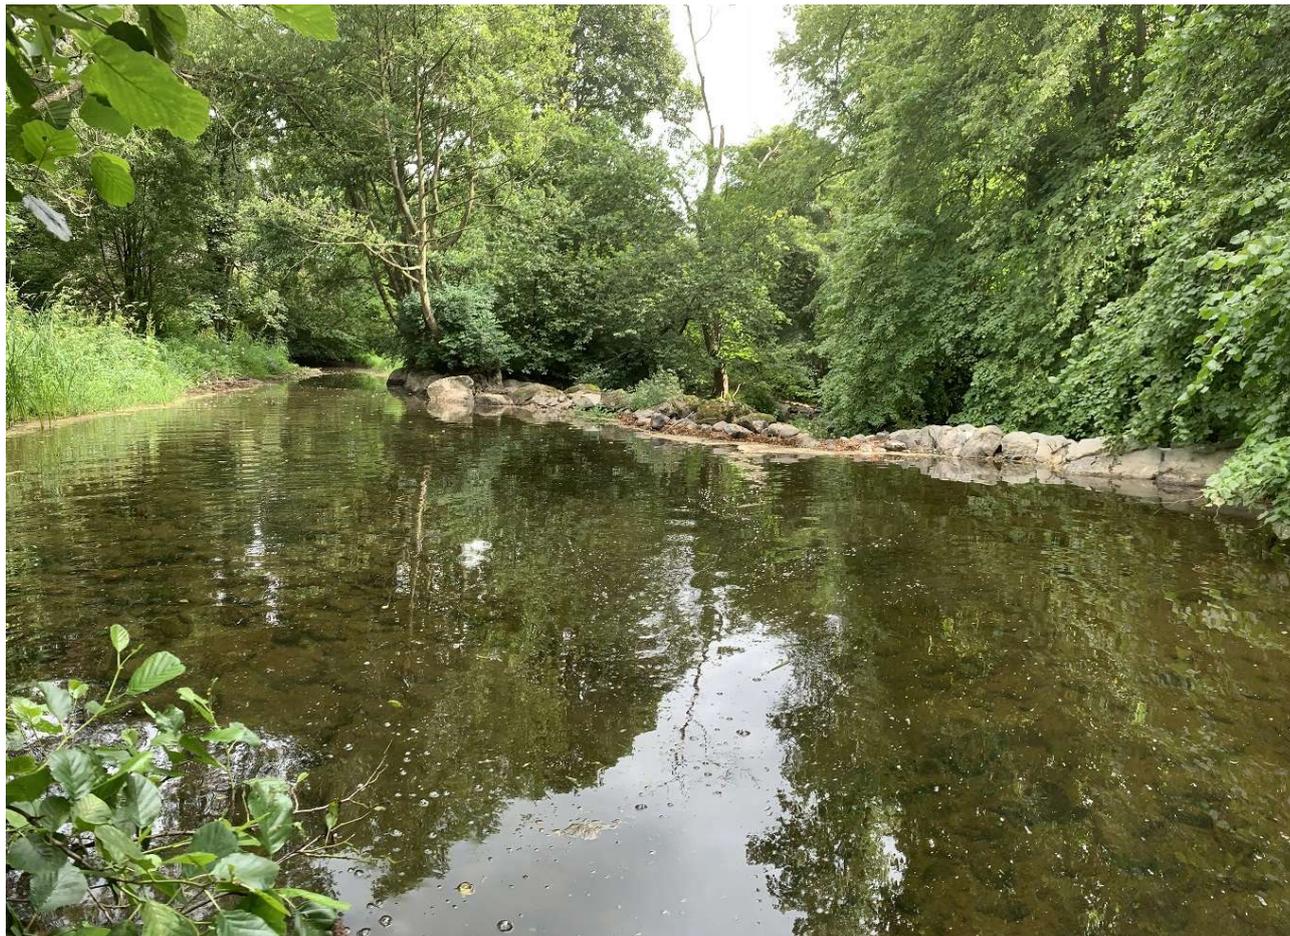
1a Weir: Upstream of the weir looking downstream towards leat entrance

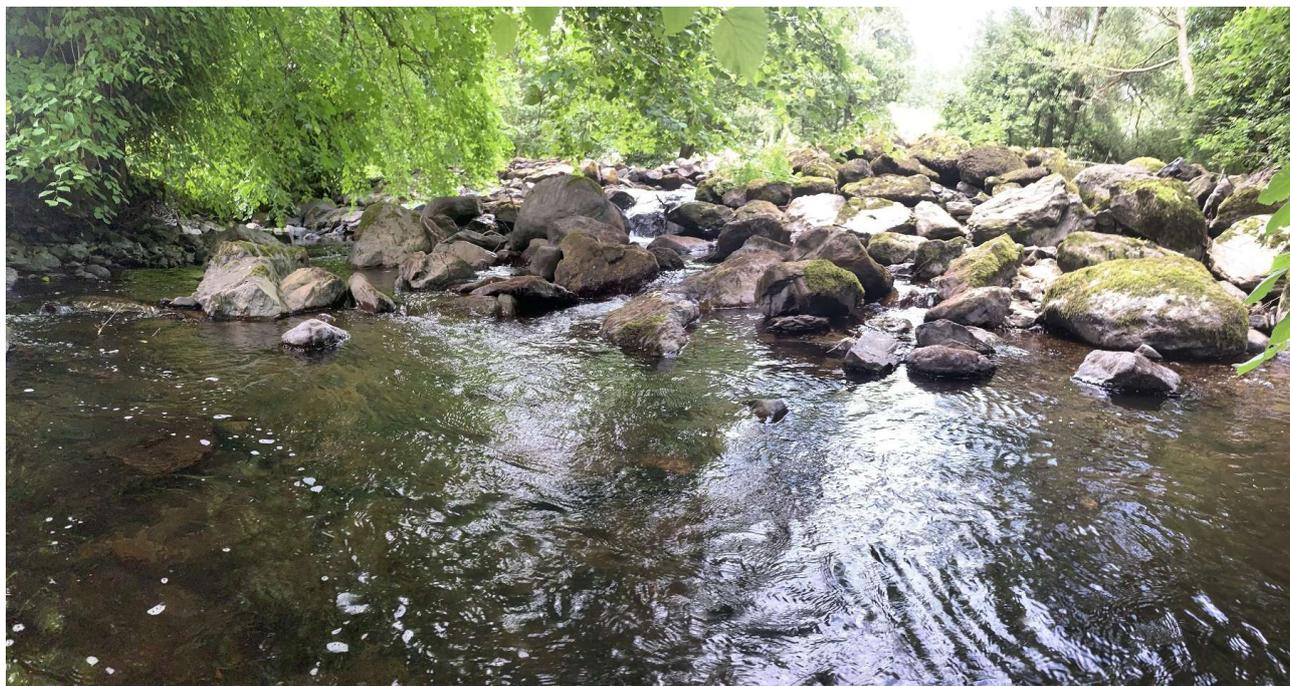
1b Weir: Downstream of the weir looking back up

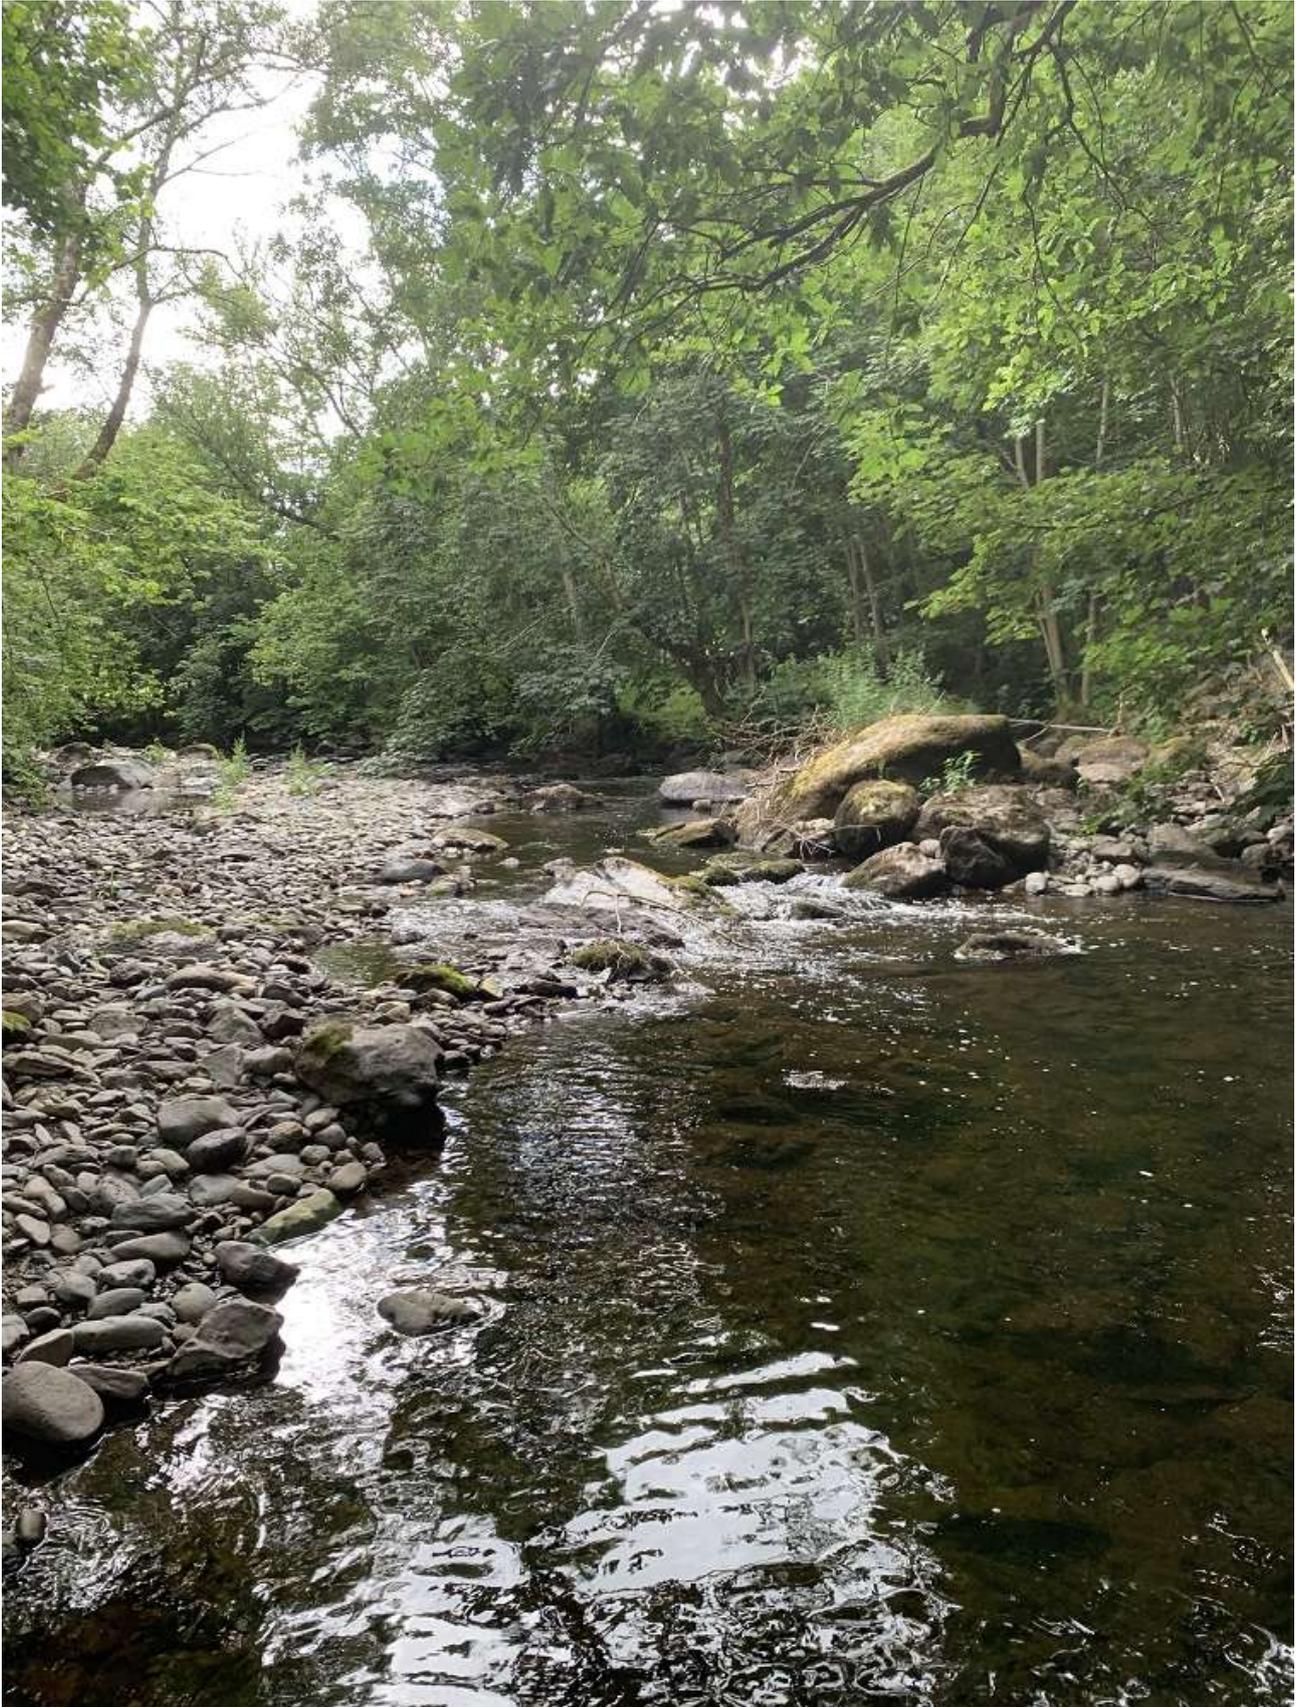
1c Weir: Downstream of the weir

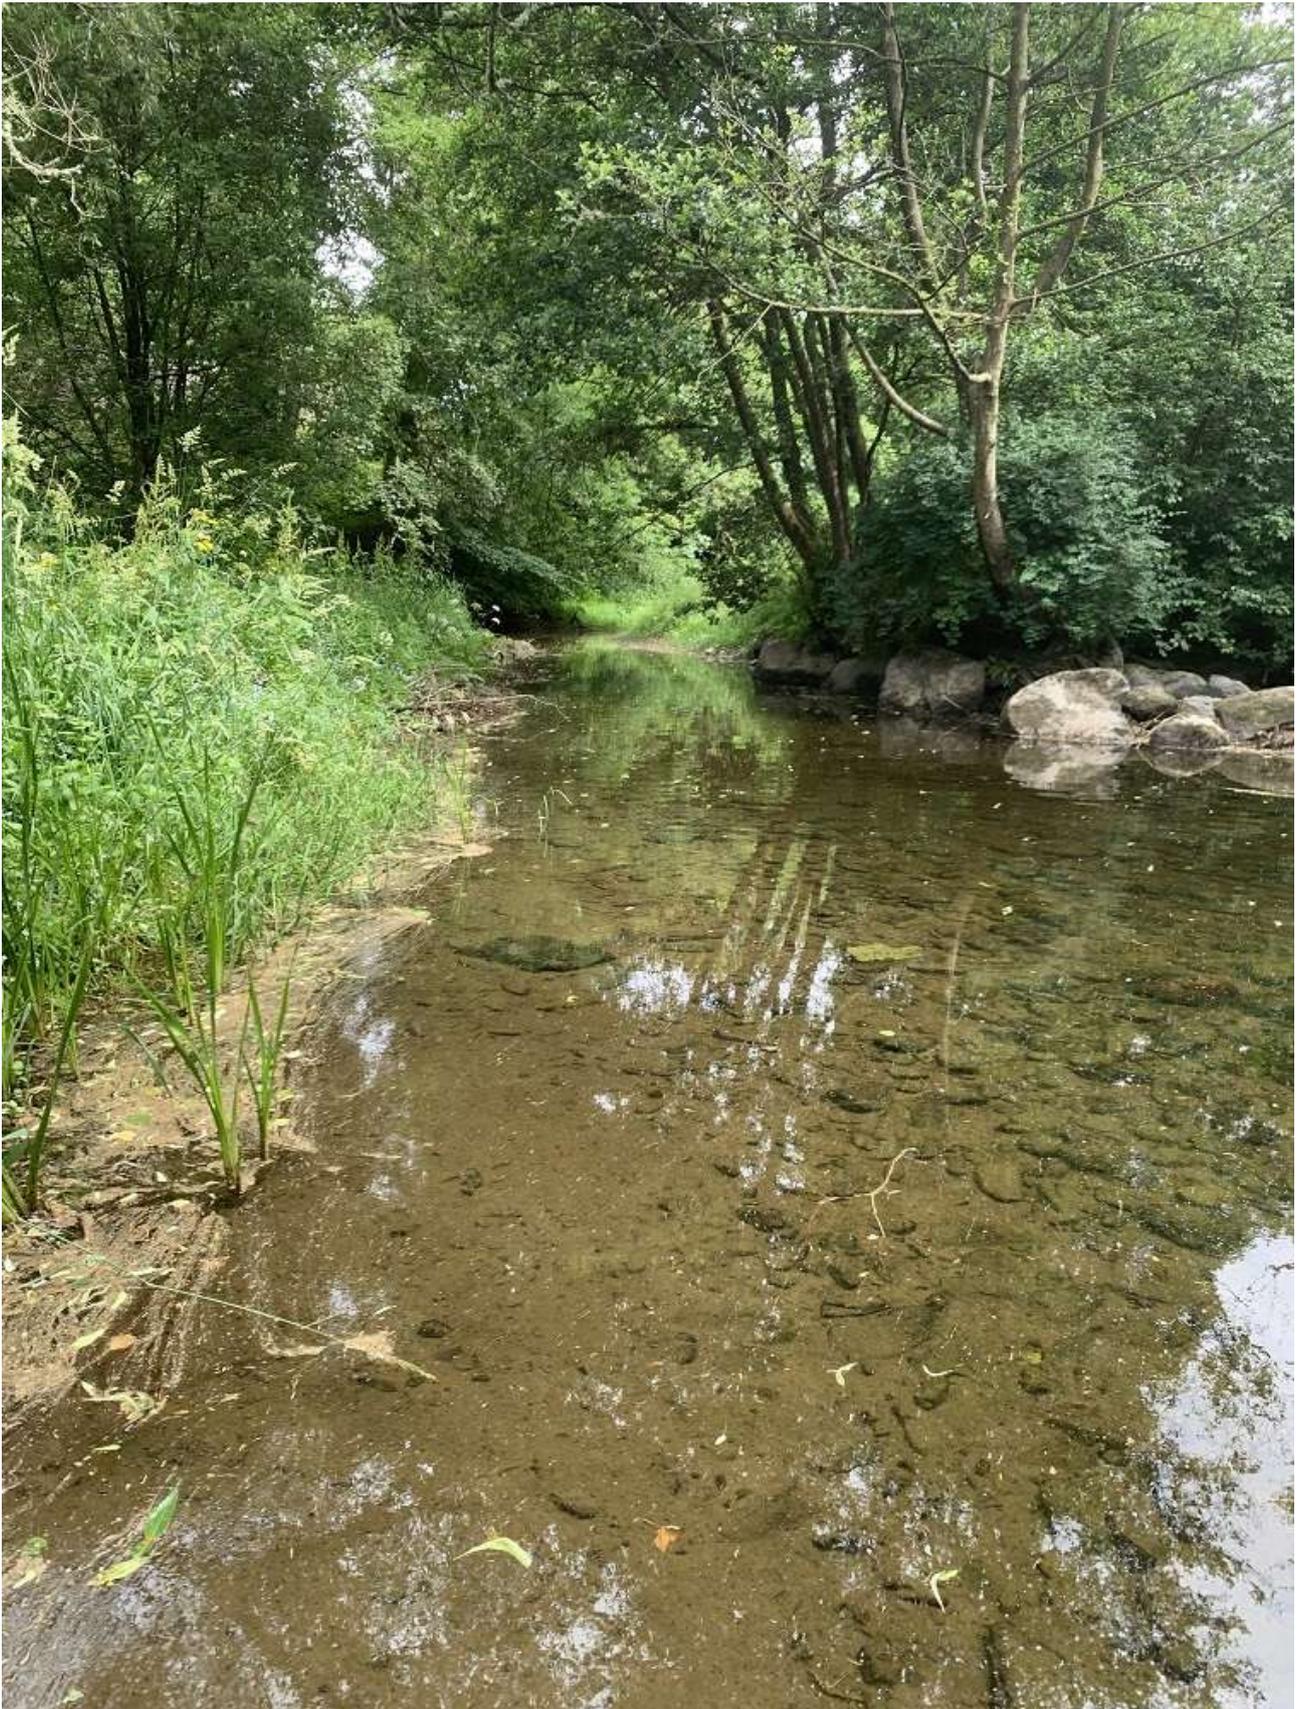
2a Leat channel: The channel running down to the sluice gate

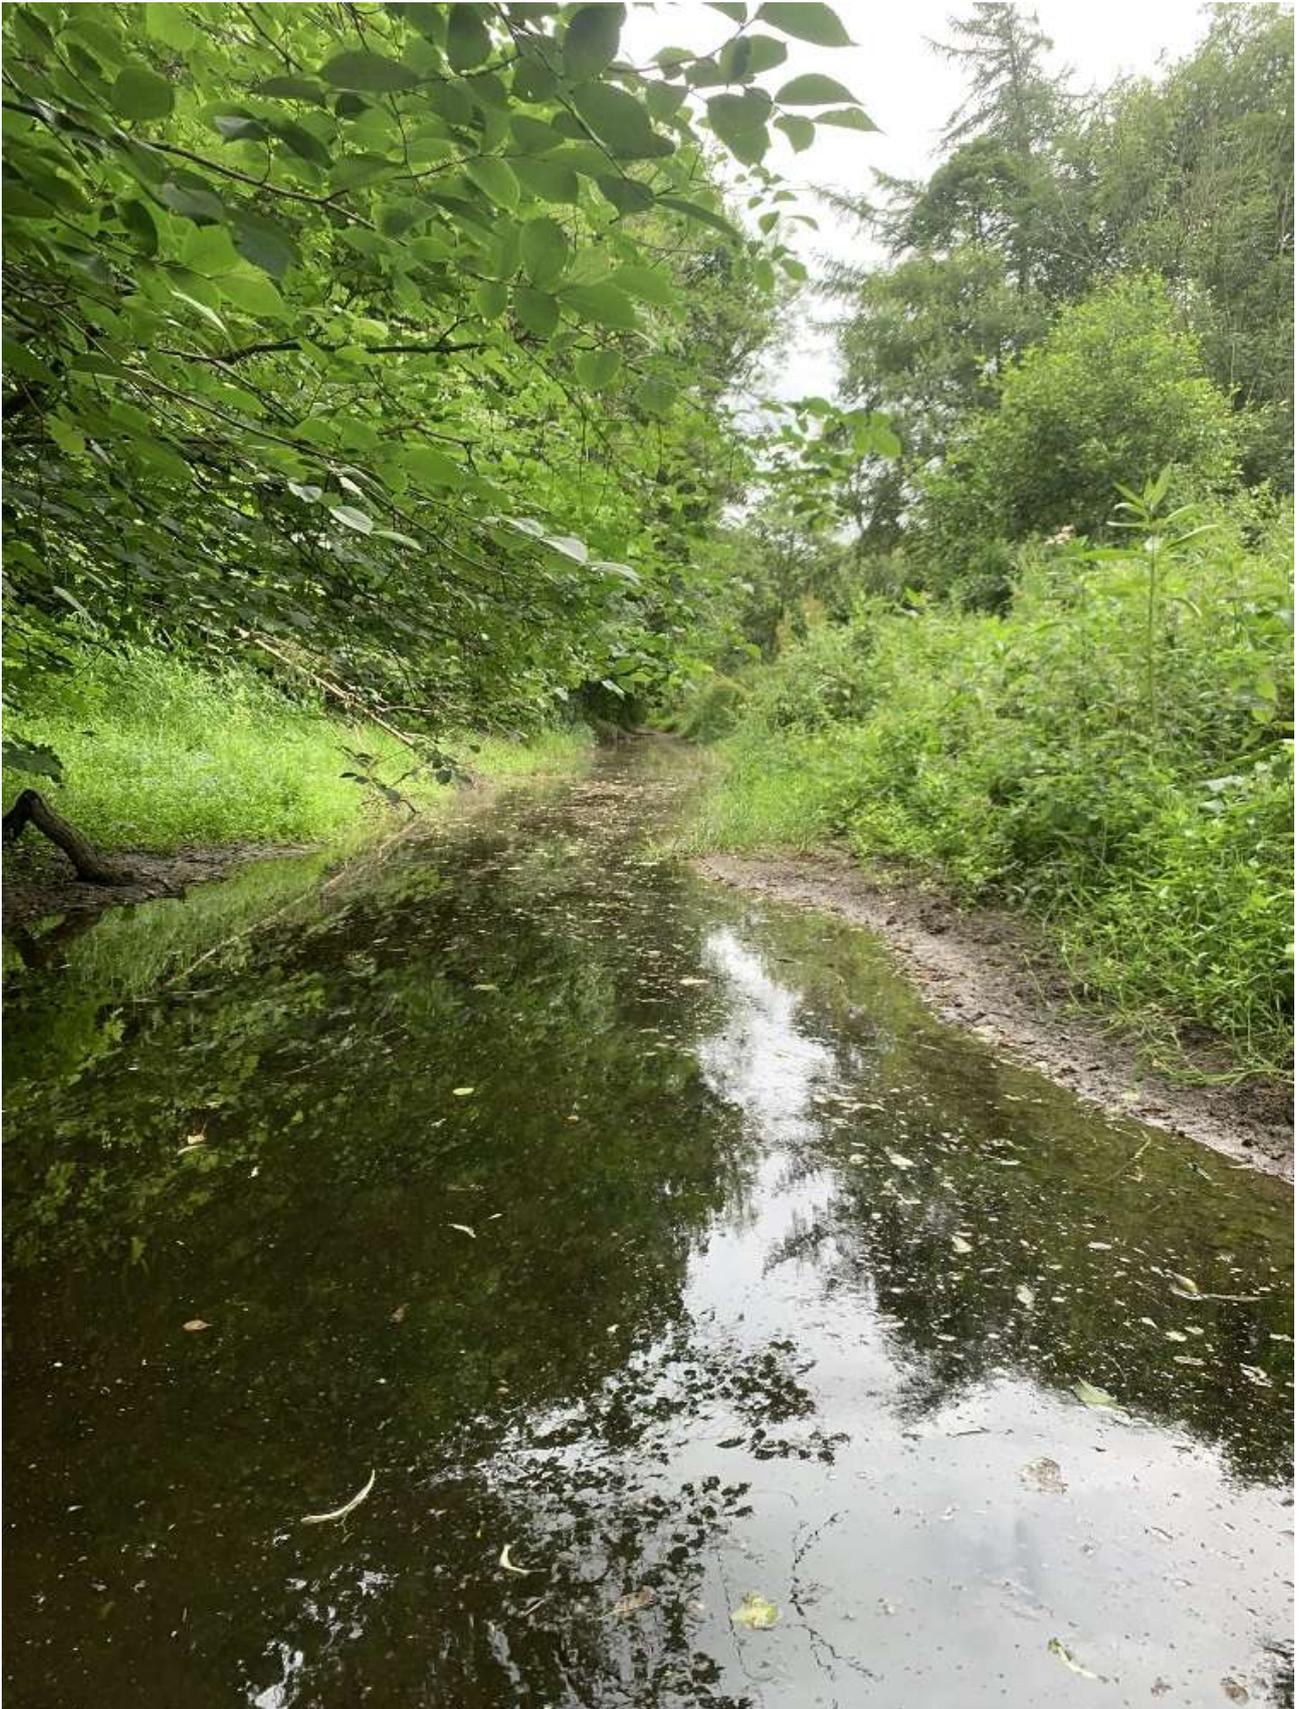
2b Leat channel: The channel running down to the sluice gate

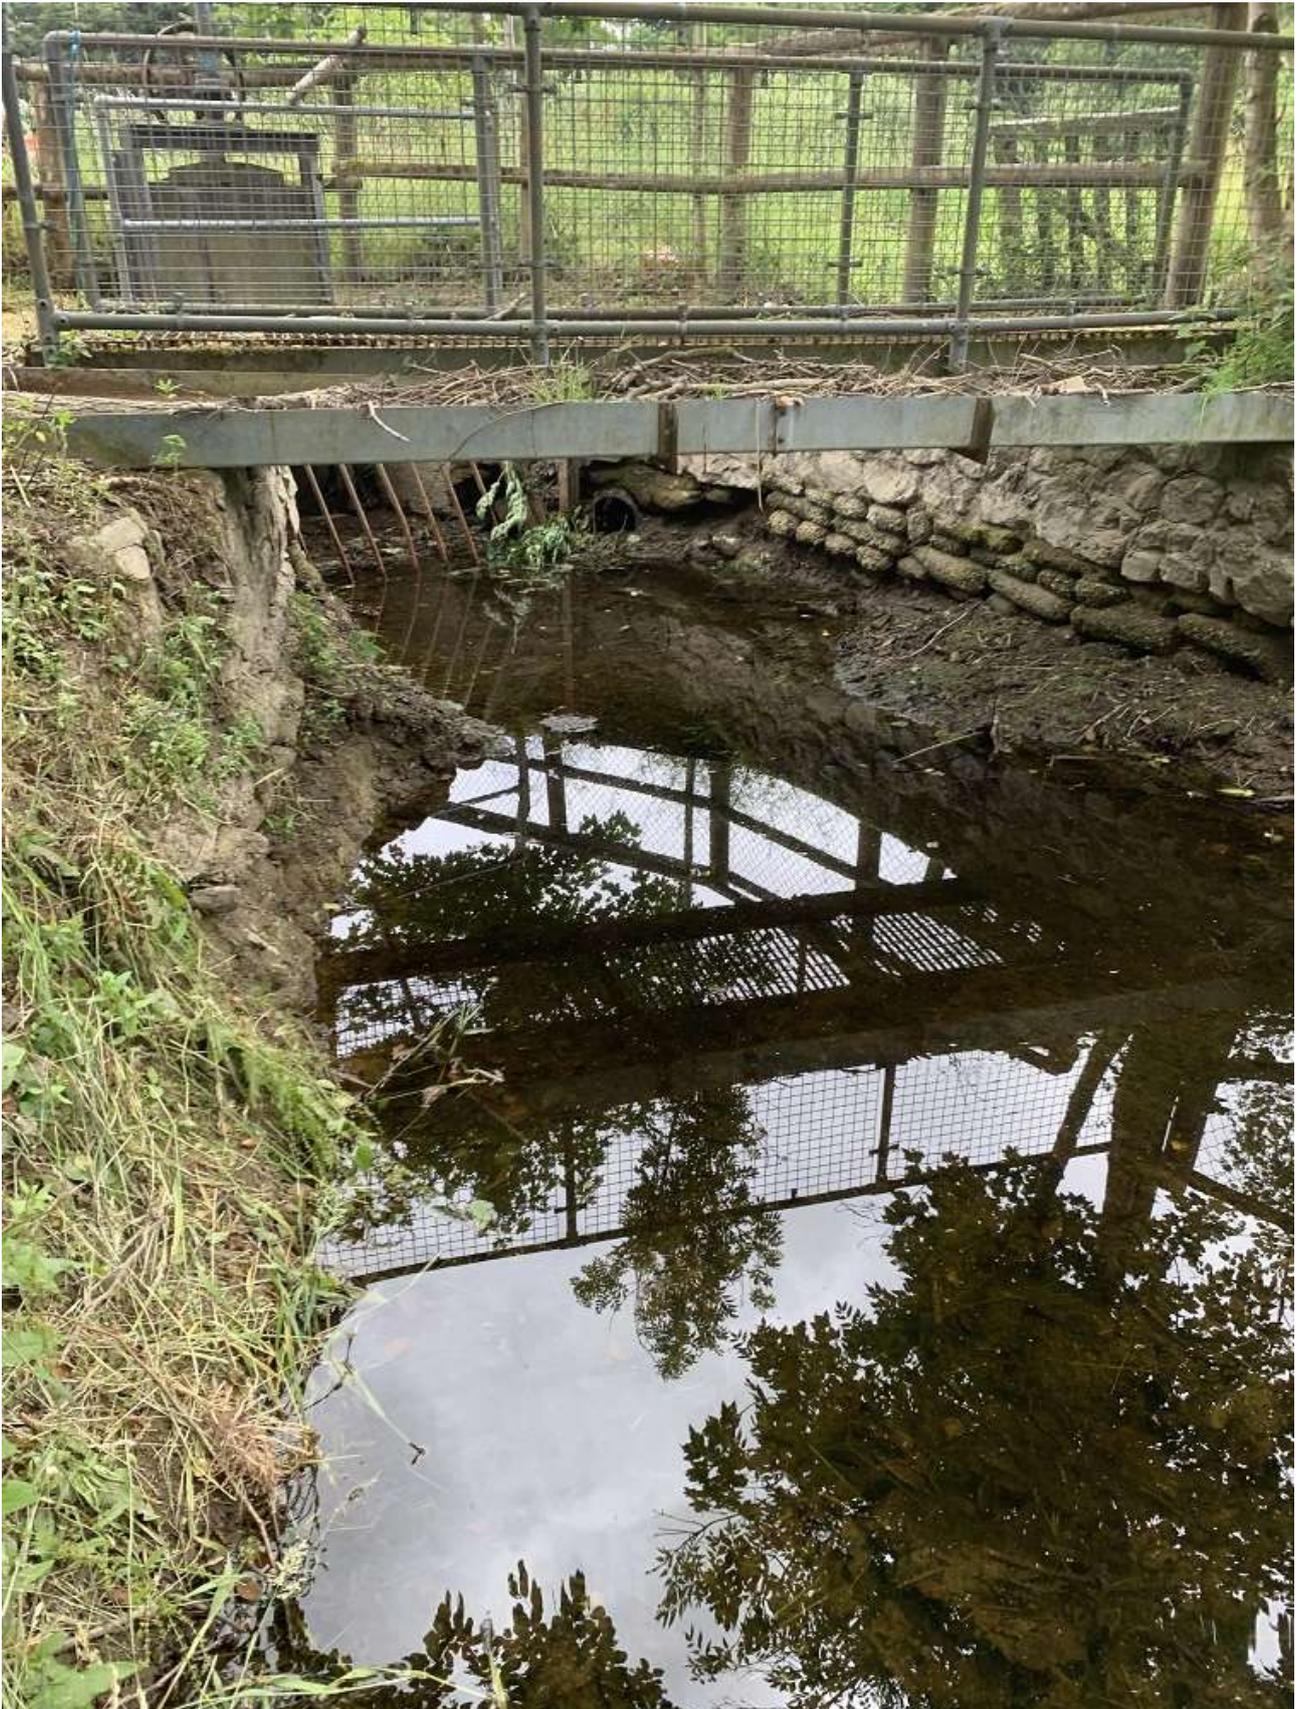
2c Leat channel: The channel running down to the sluice gate

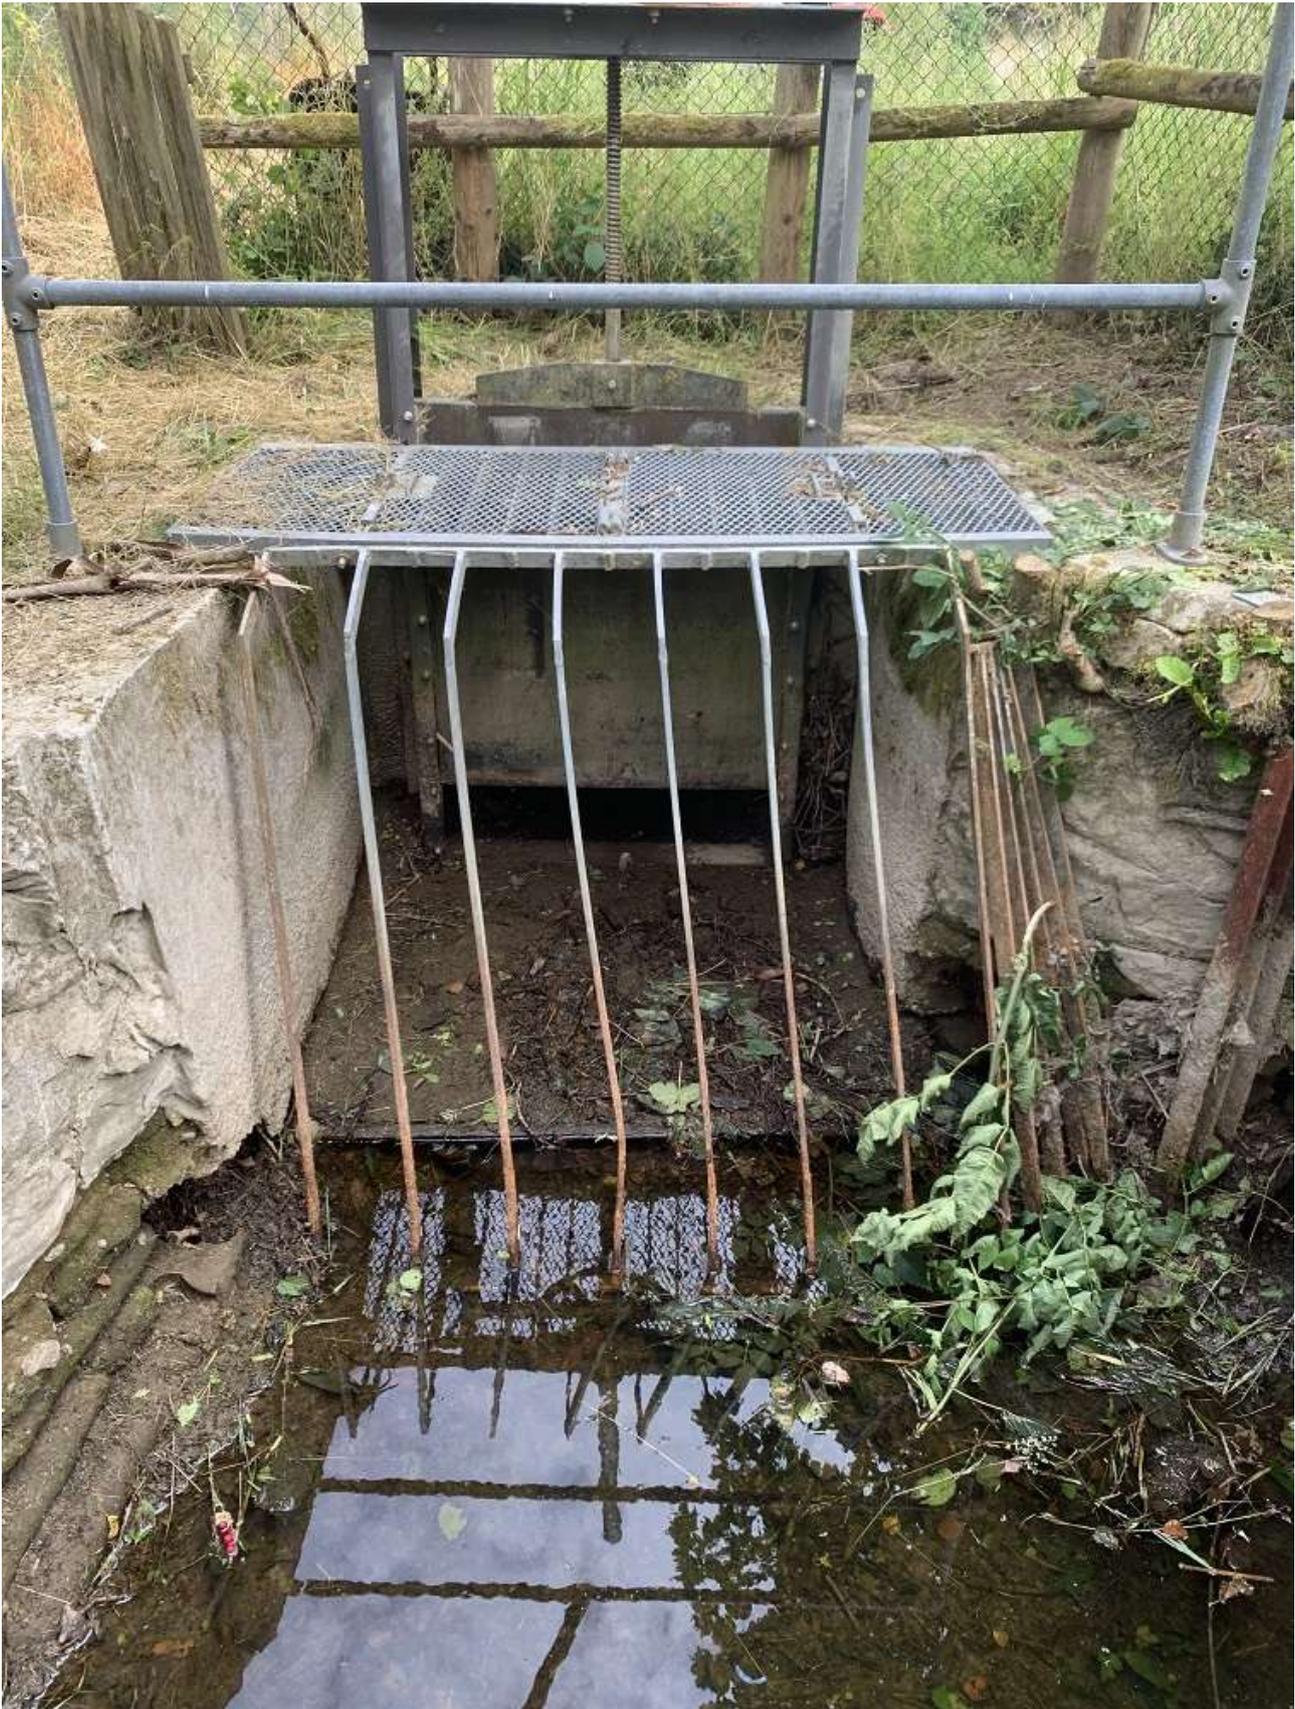
2d Leat channel: The channel running down to the sluice gate

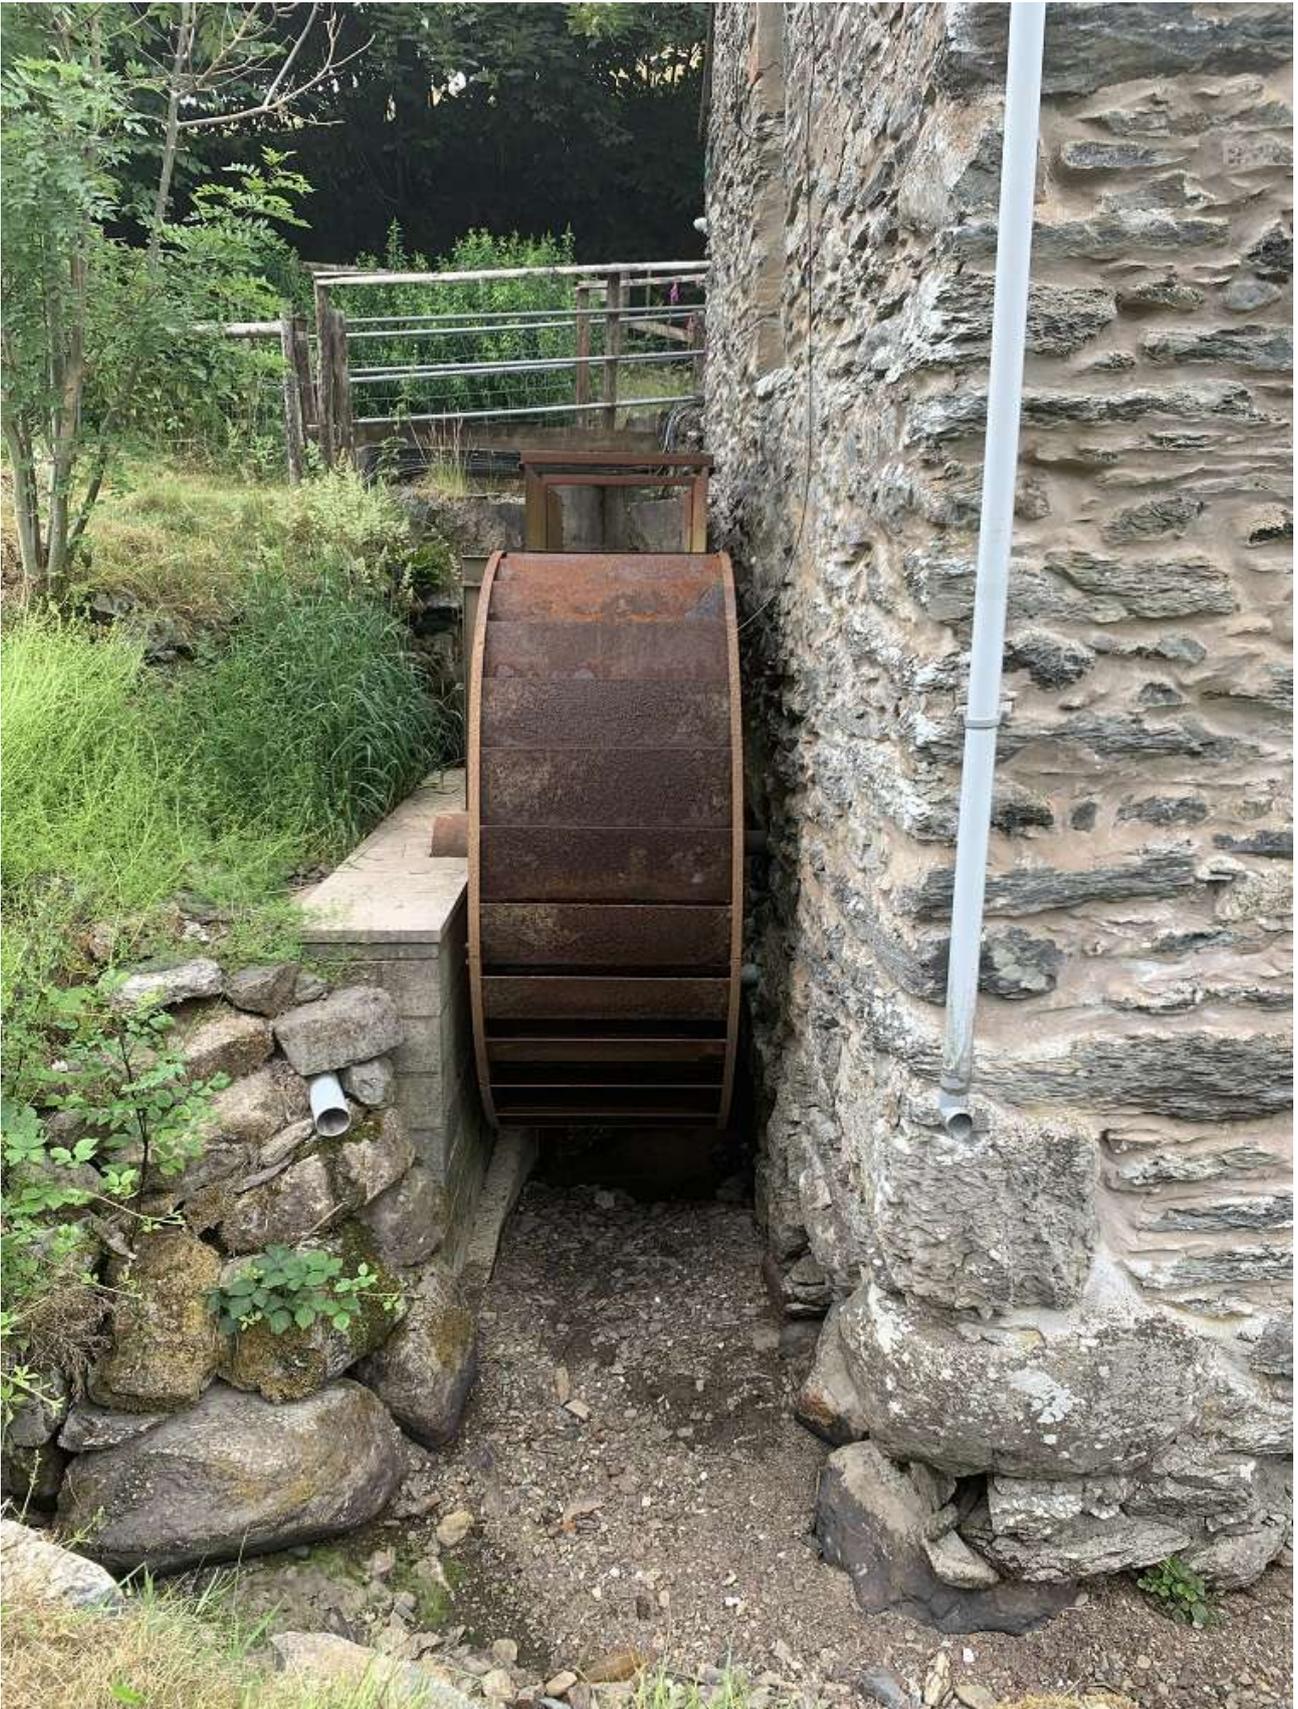
3a Tailrace: The discharge point back into the river

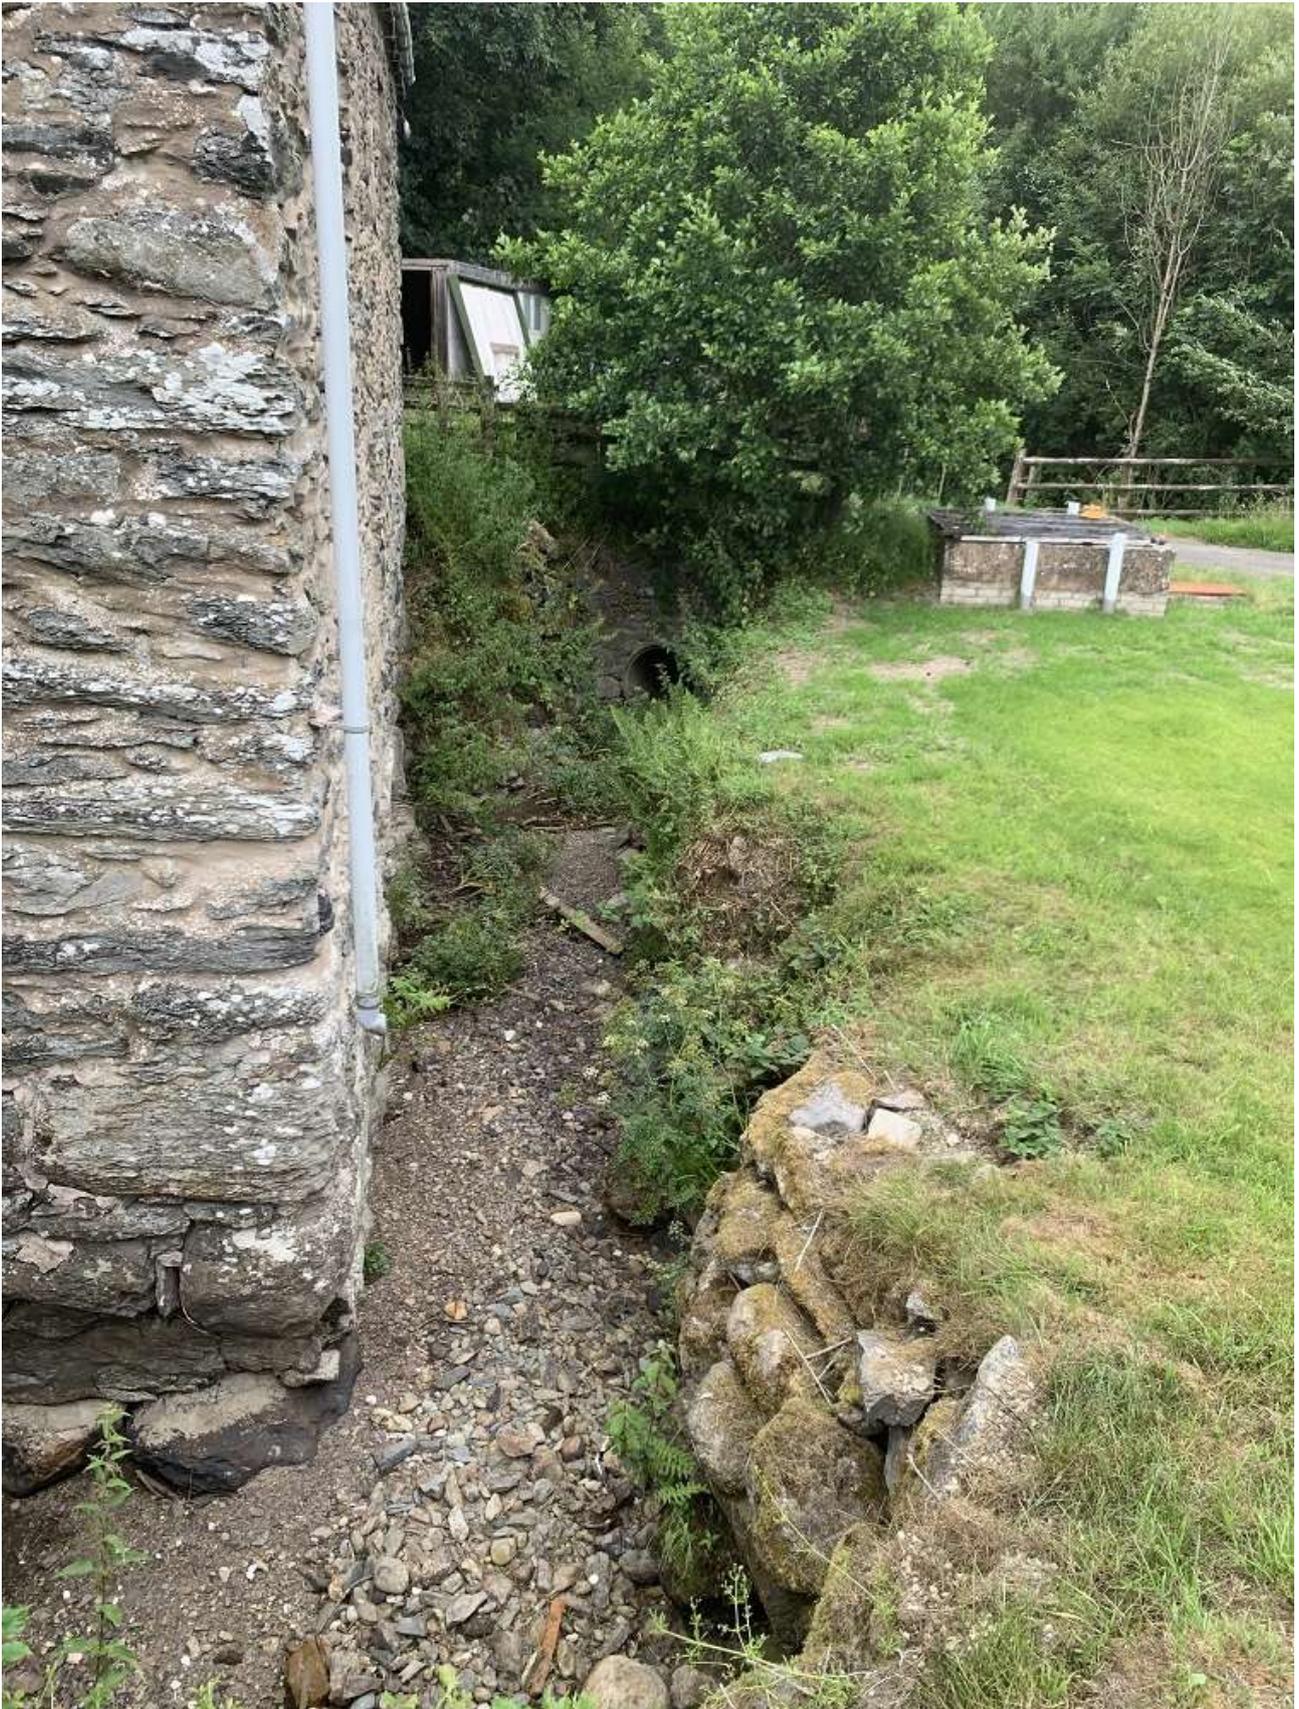
3b Tailrace: The discharge point back into the river

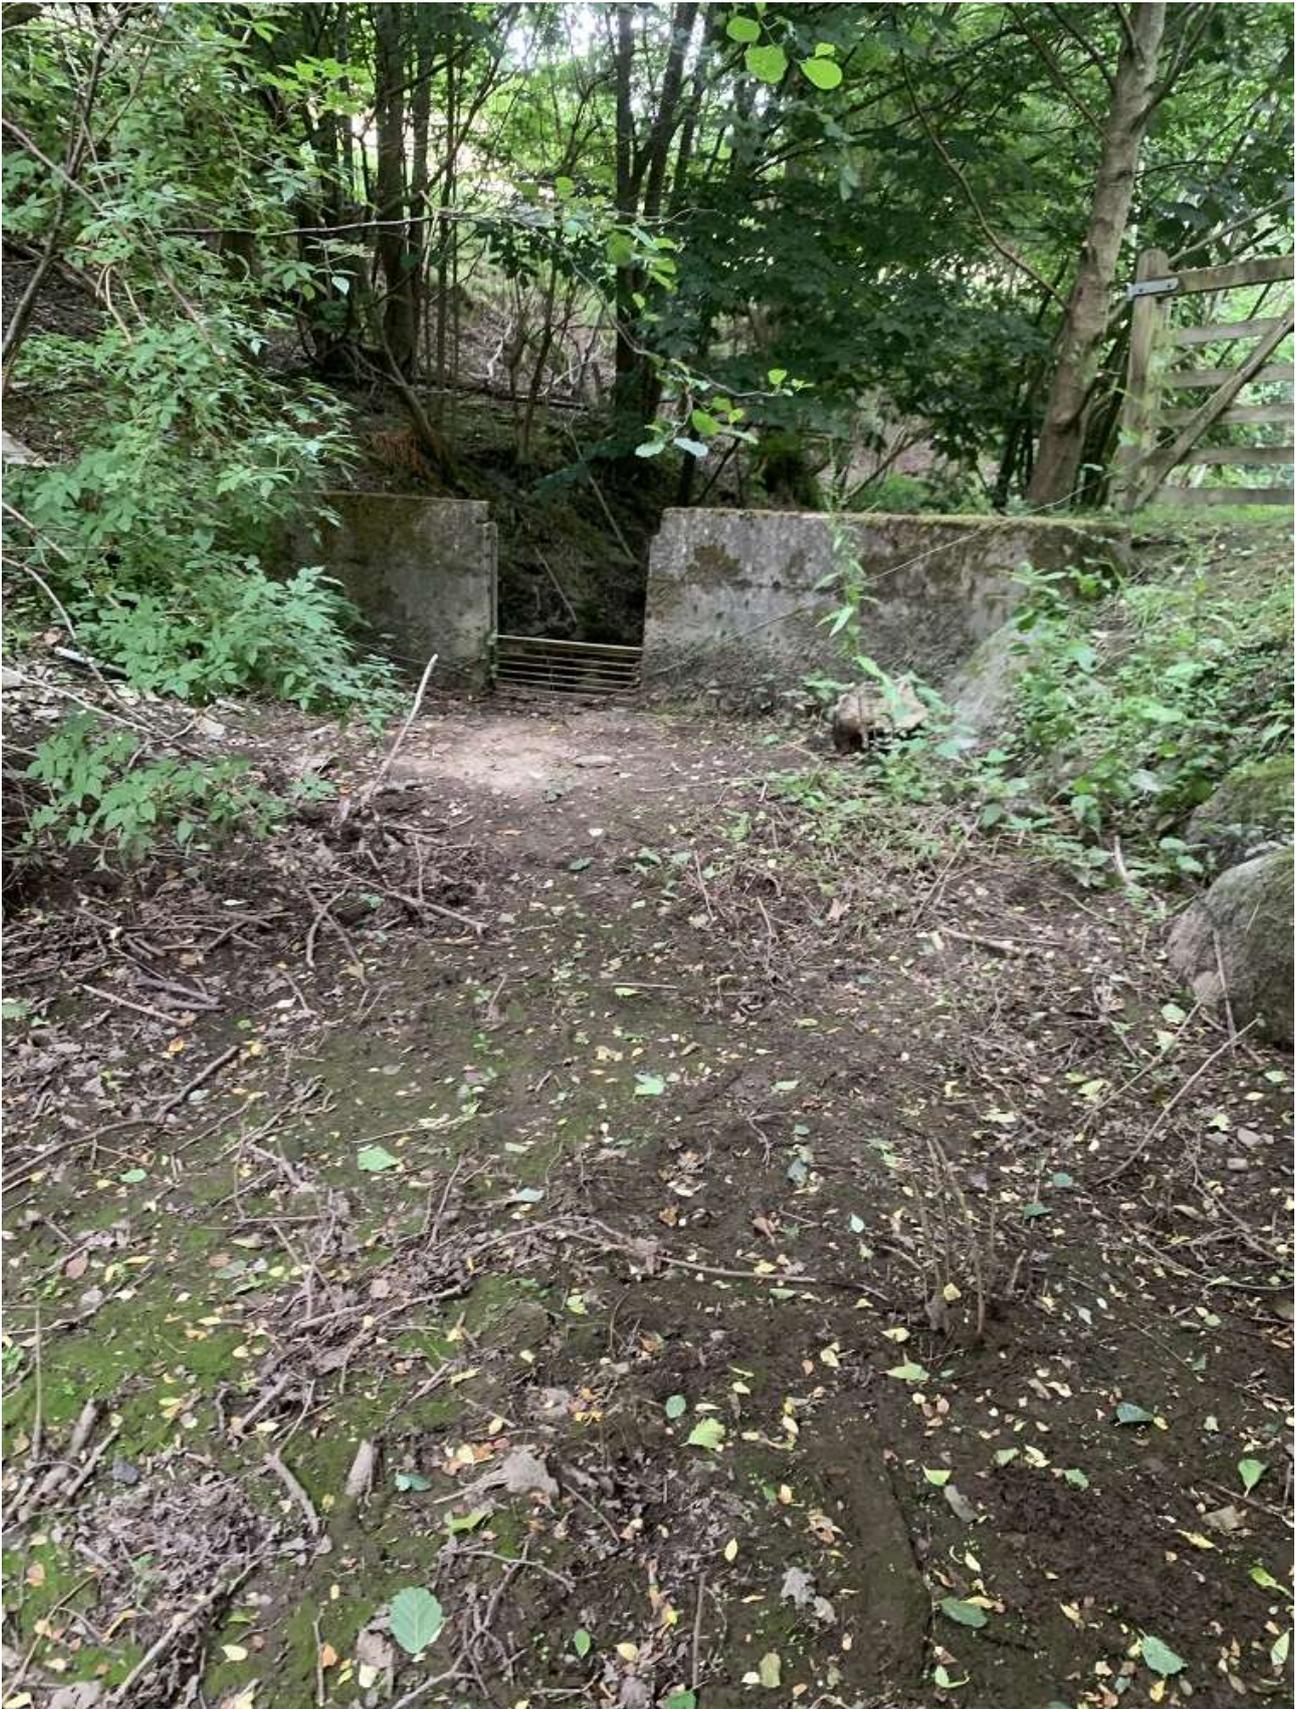
3c Tailrace: The discharge point back into the river

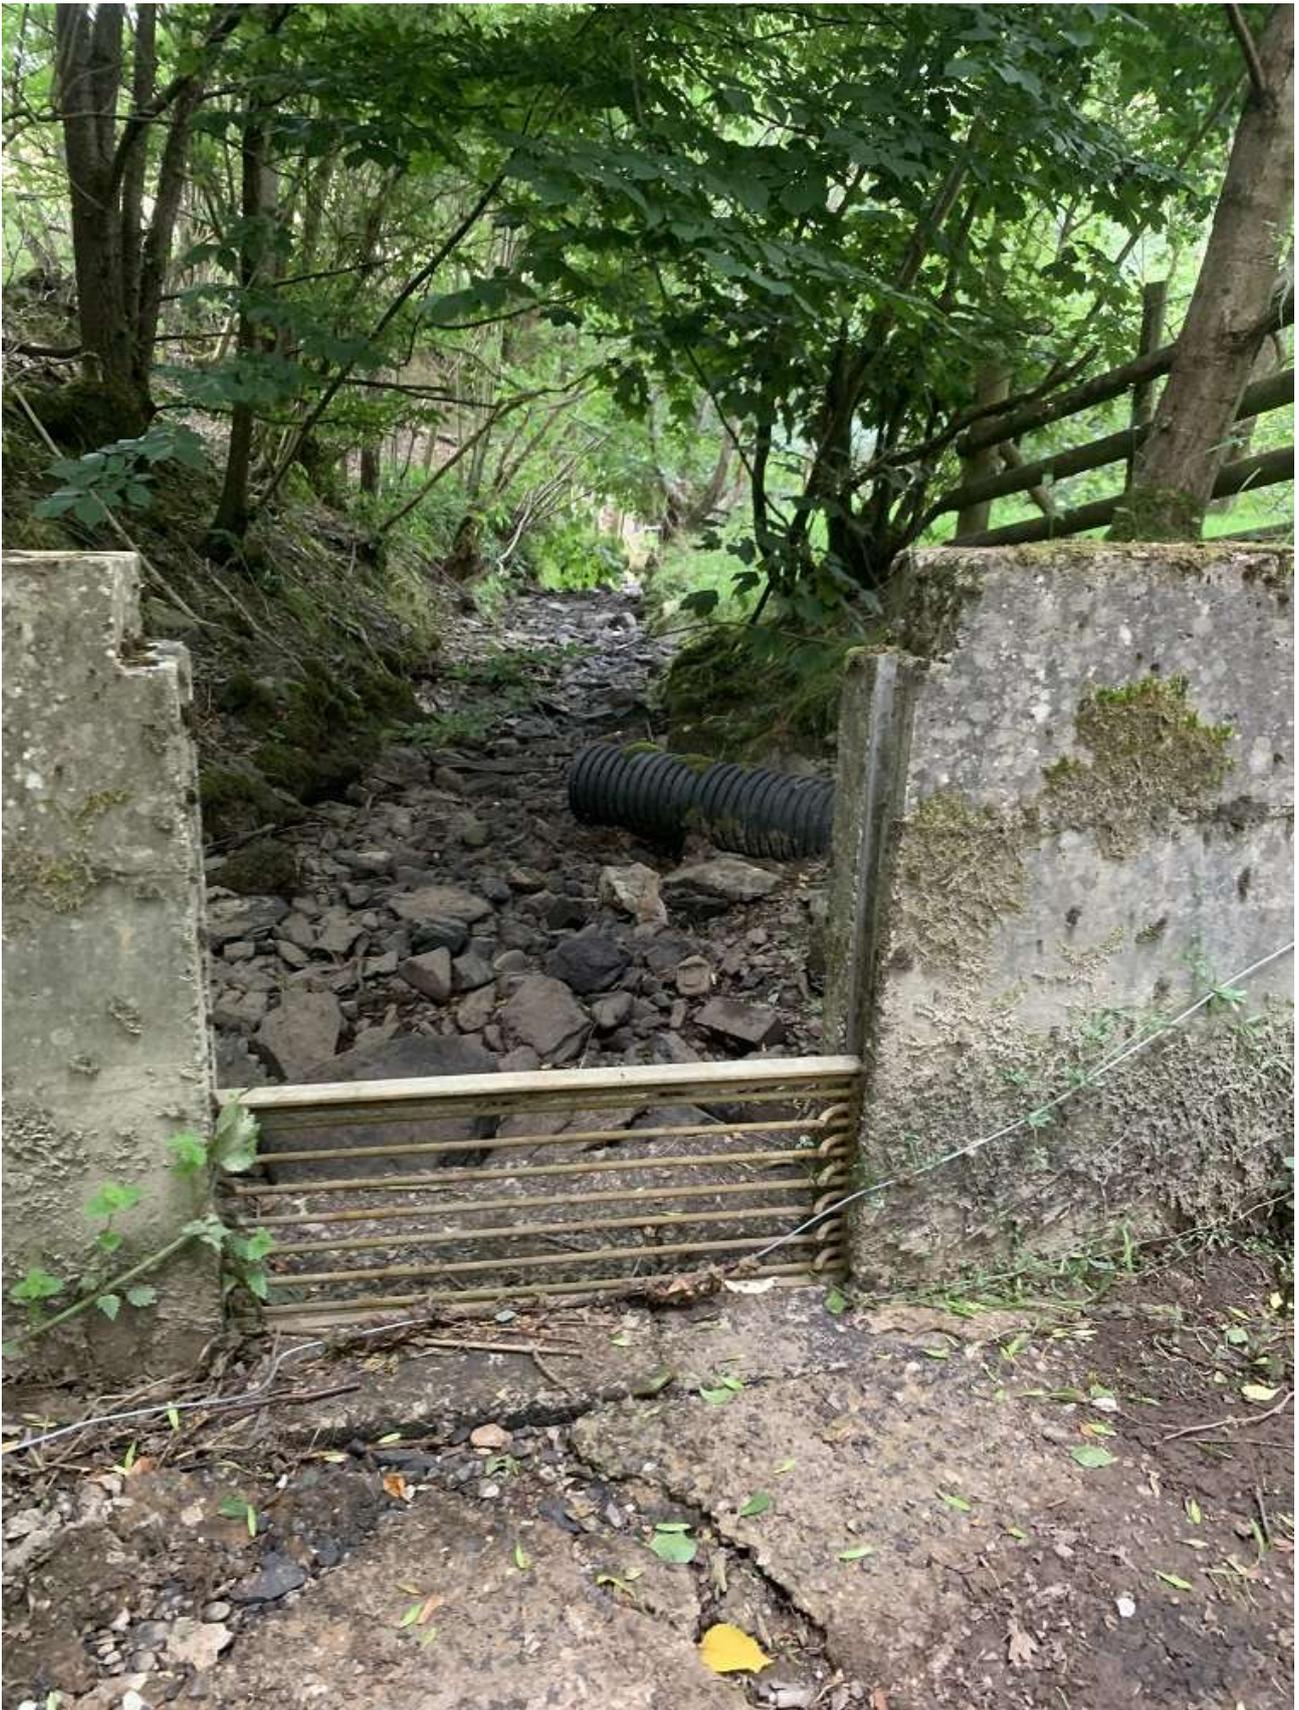
3d Tailrace: The discharge point back into the river
