**Site Photos**

Maerdy Mill, Corwen, LL21 0NR

Photographs taken 01/07/2023

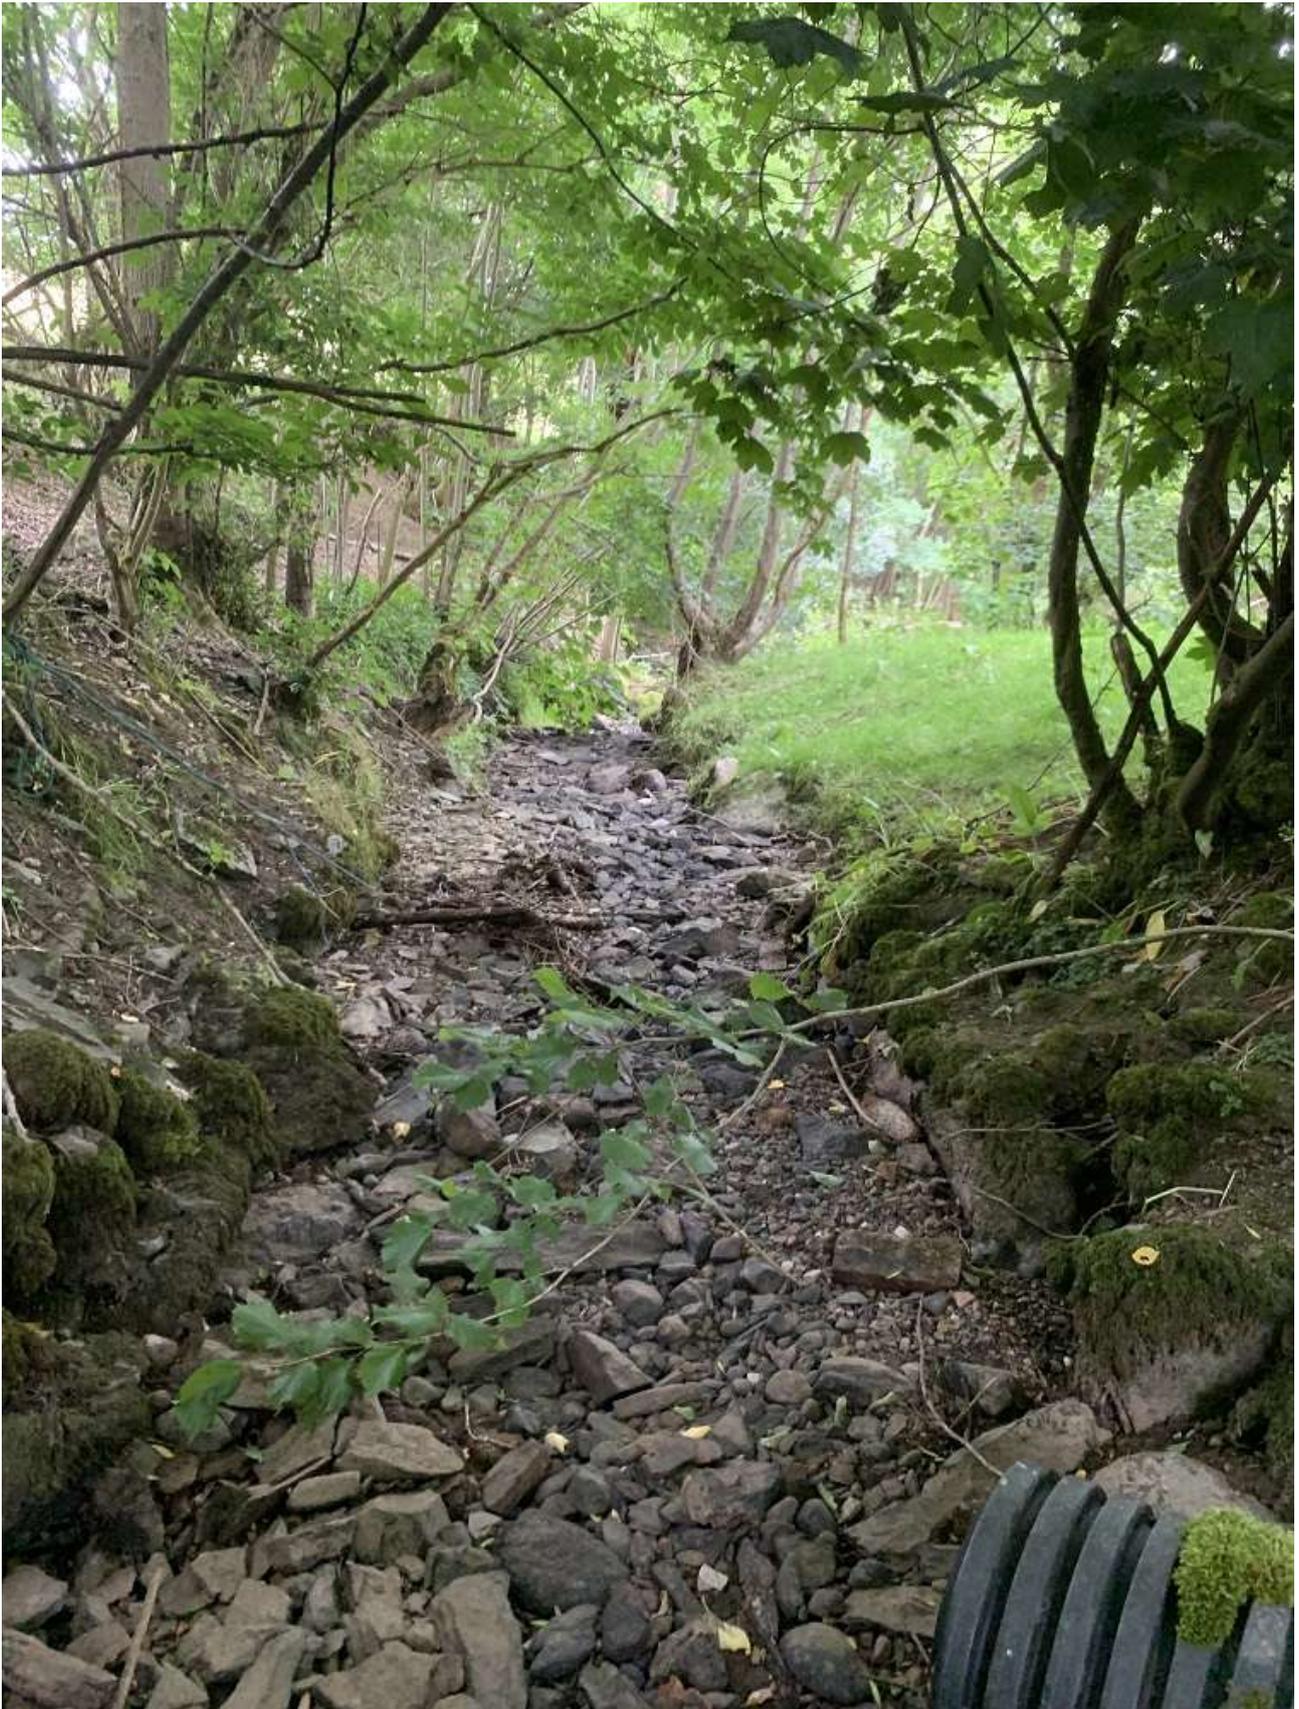
3e Tailrace: The discharge point back into the river

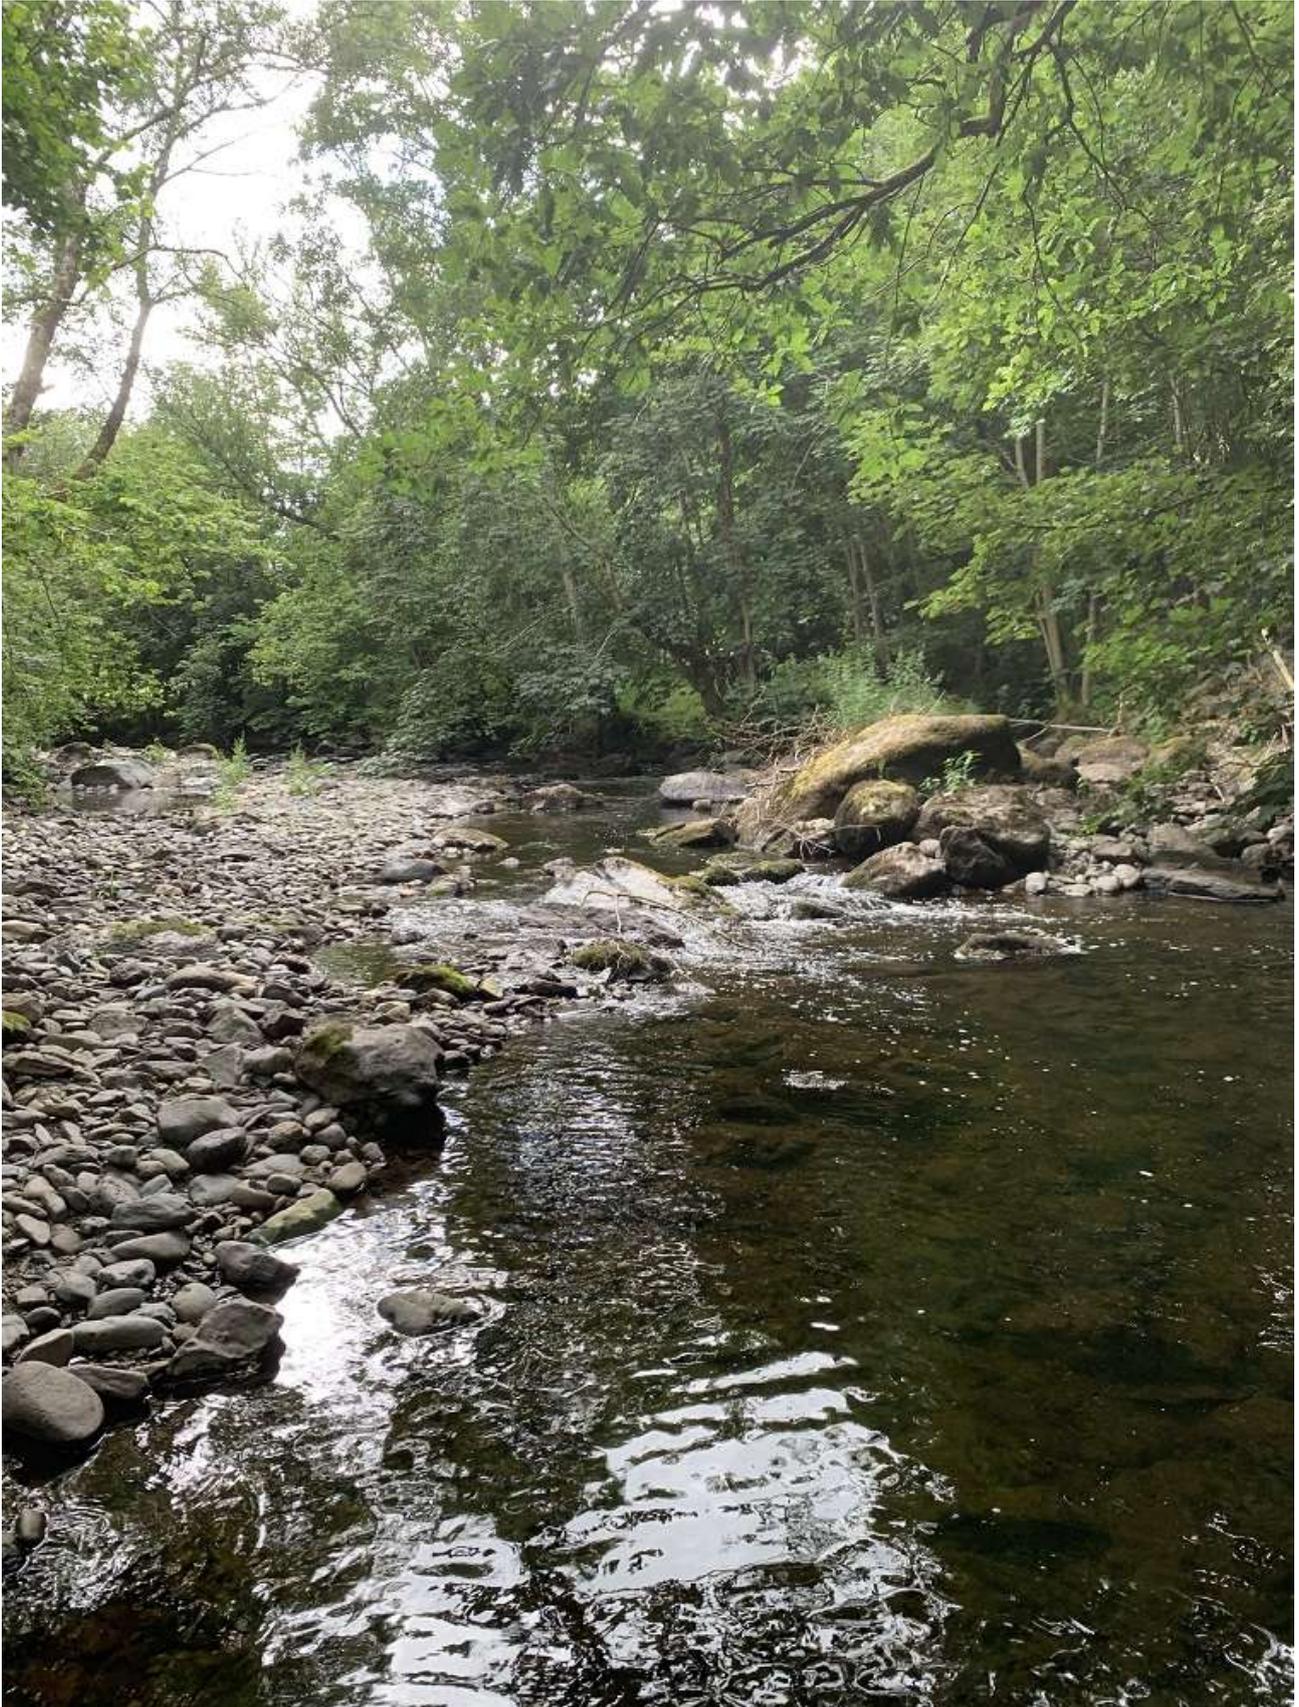
4a Depleted reach: The depleted reach from the weir to the tailrace confluence

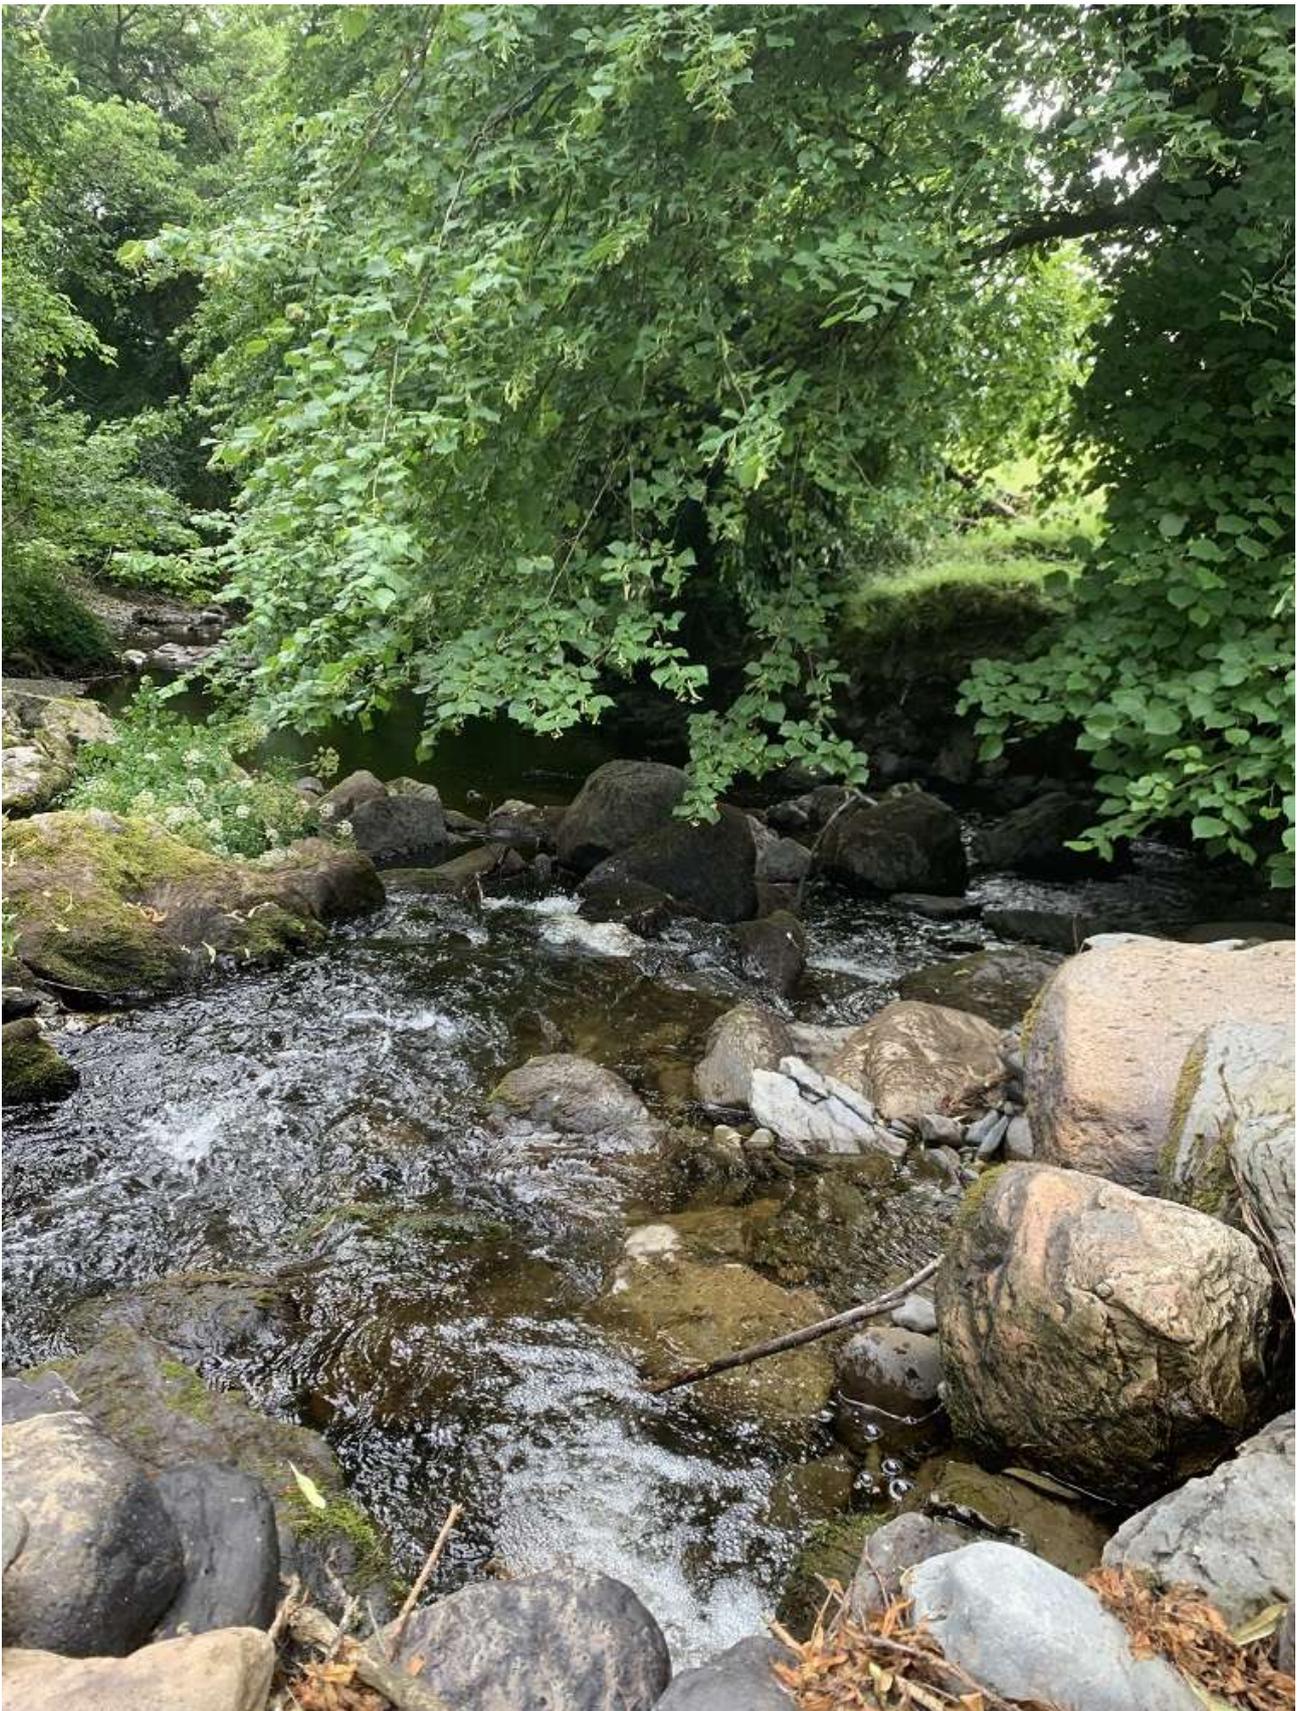
4b Depleted reach: The depleted reach from the weir to the tailrace confluence

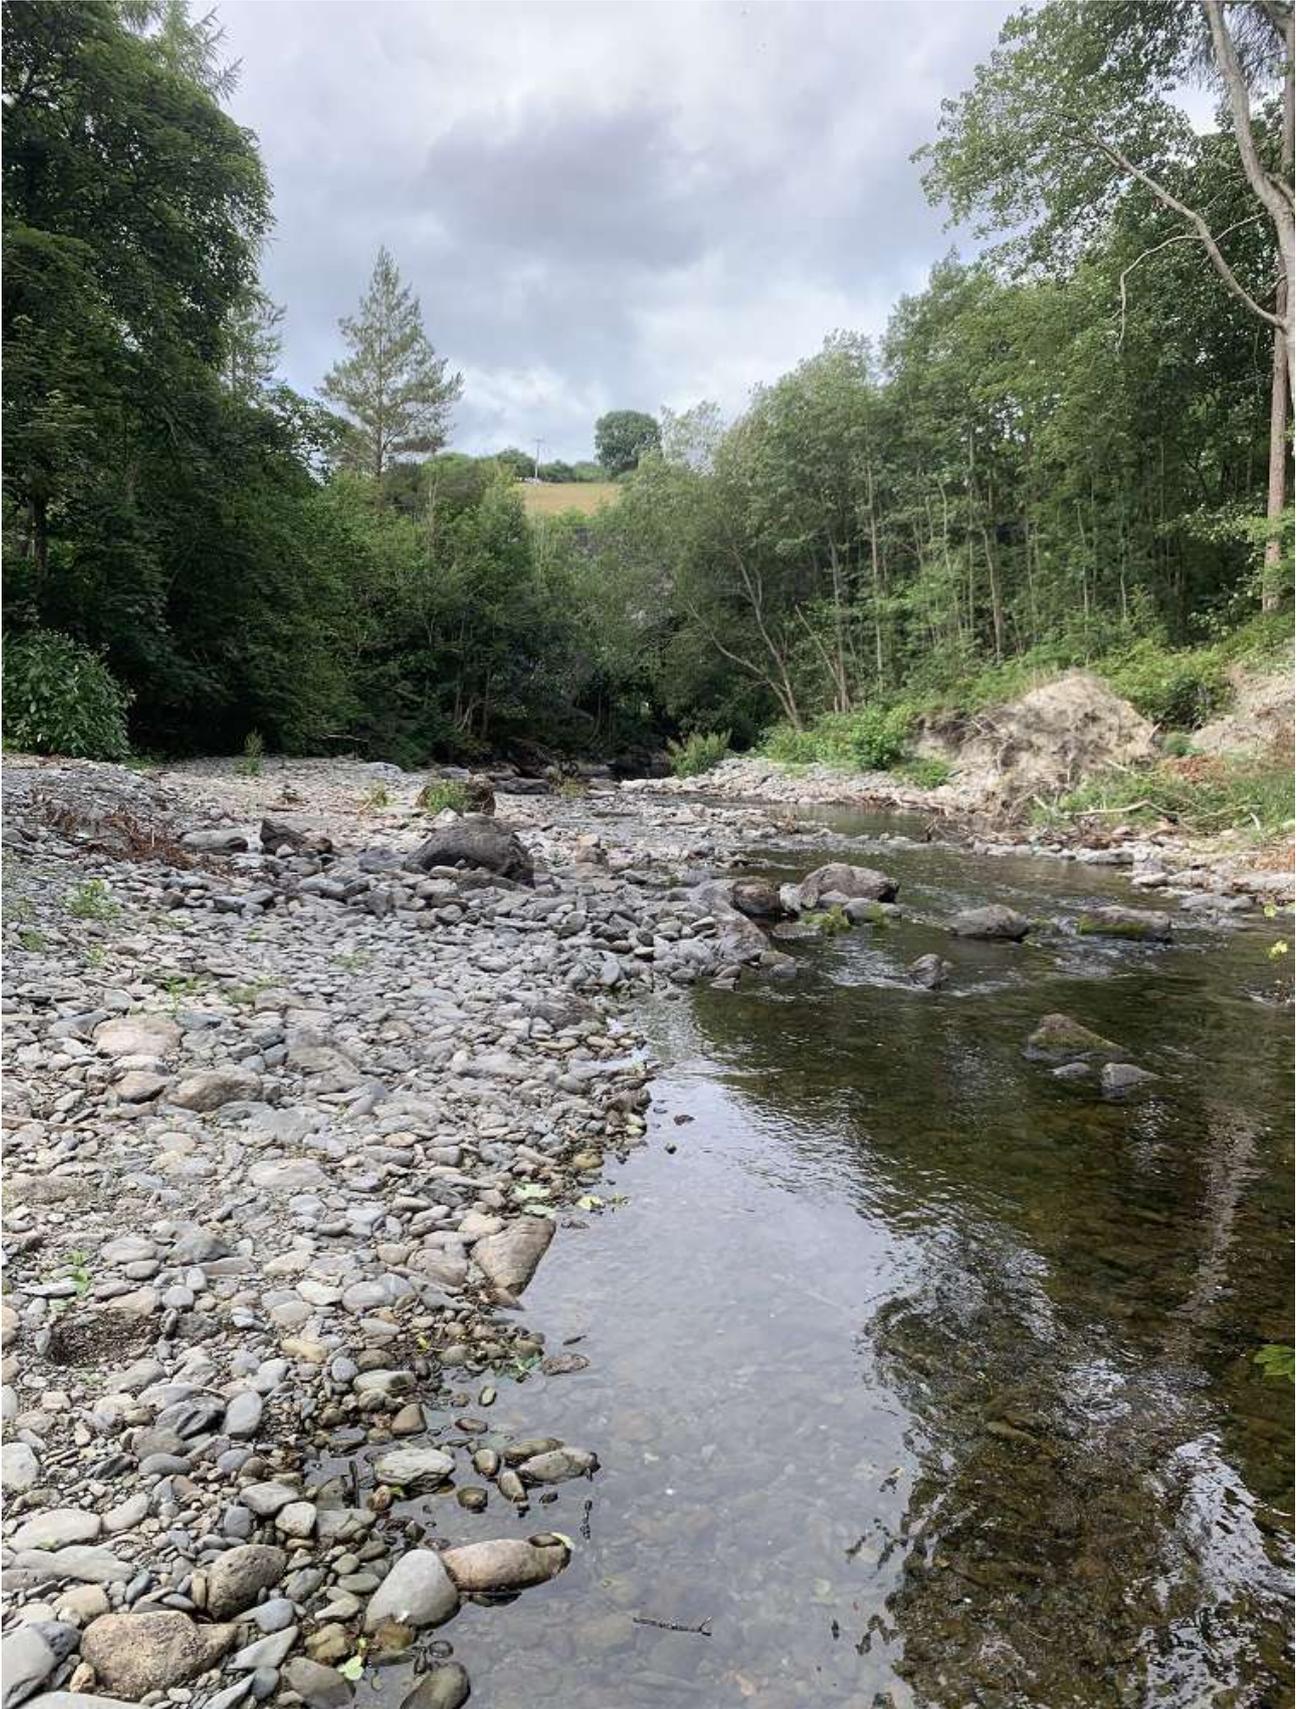
4c Depleted reach: The depleted reach from the weir to the tailrace confluence

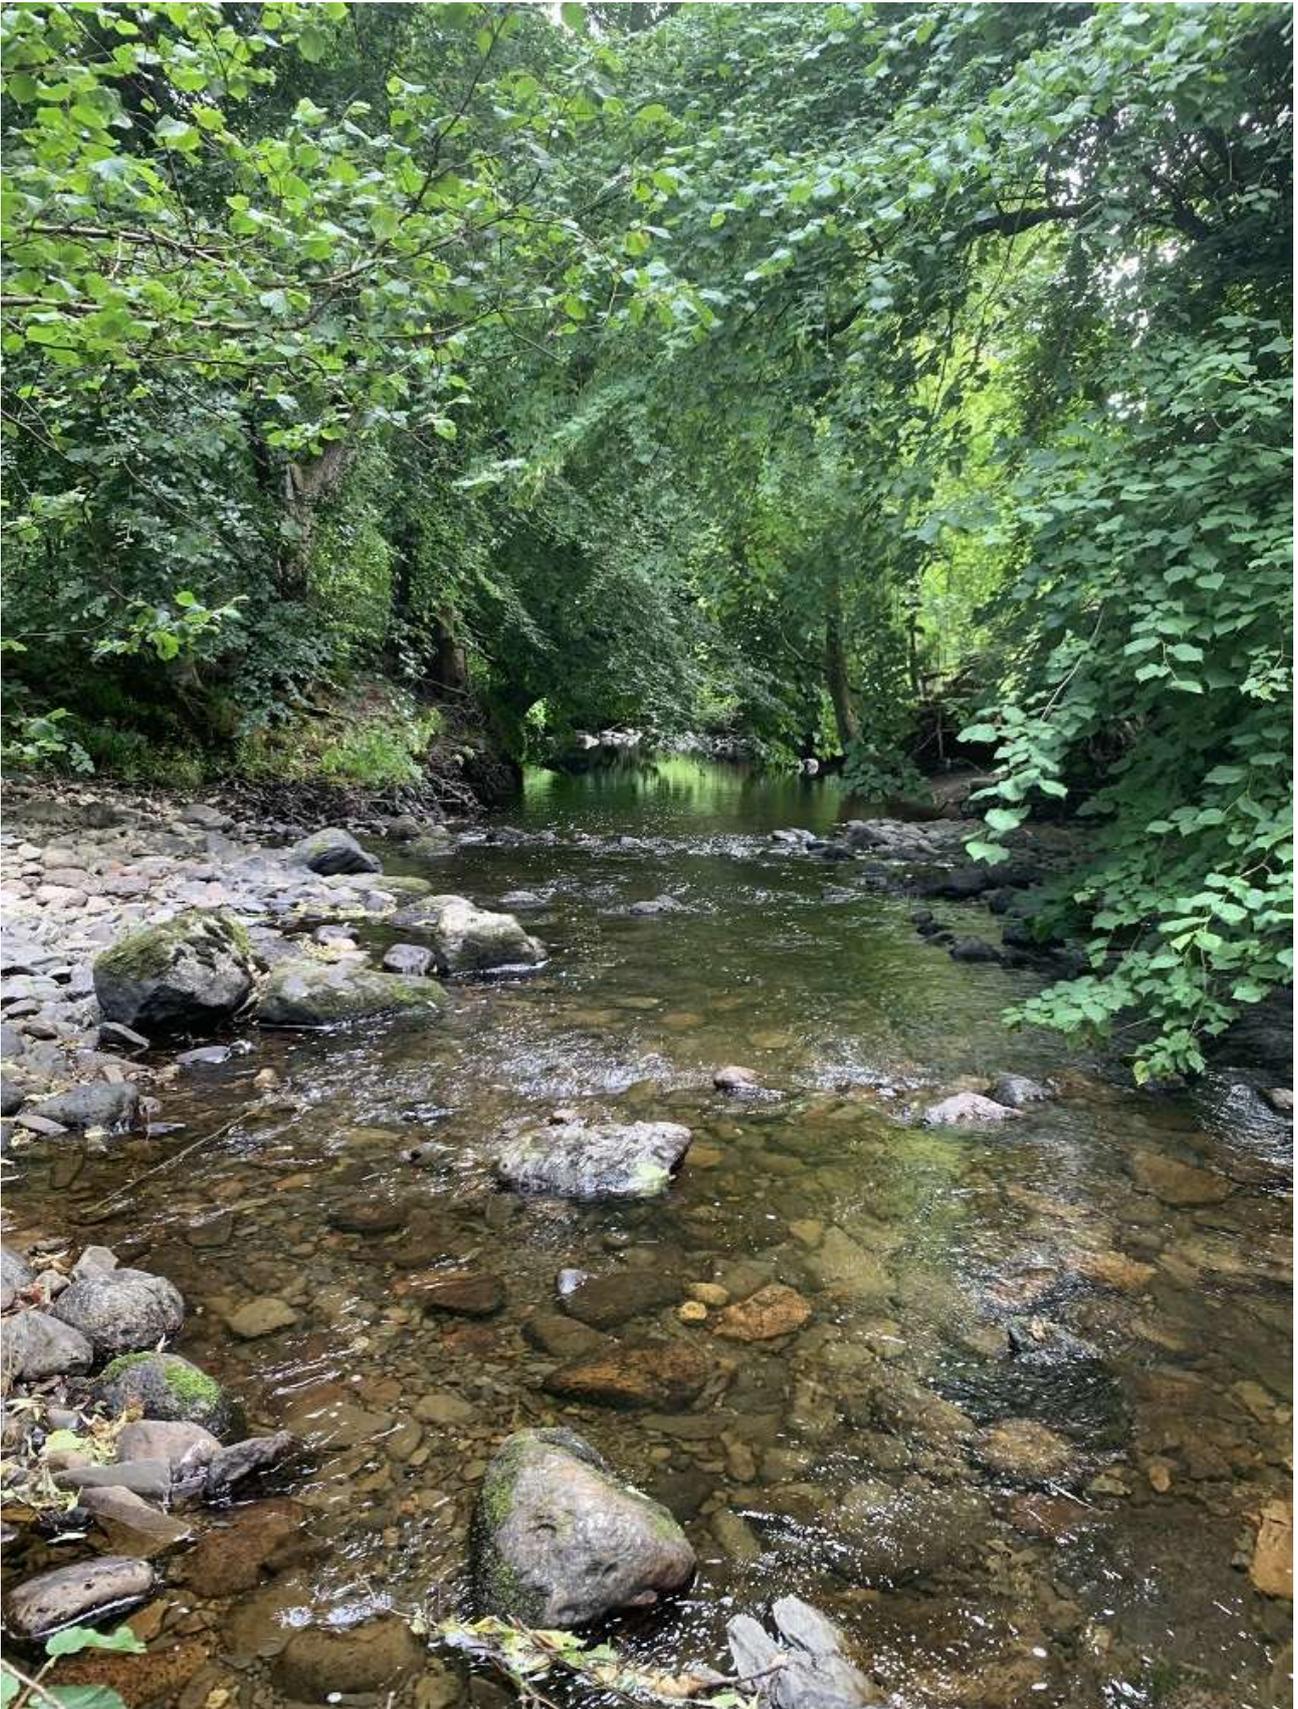
4d Depleted reach: The depleted reach from the weir to the tailrace confluence
