## Compliance Assessment Report CAR\_NRW0038774

**Permit being assessed:** ZB3593HH.

For: S L Recycling Ltd, held by S L Recycling Limited

**Type of assessment carried out:** Site Inspection, Reason: Incident Response (Incident number 2107332).

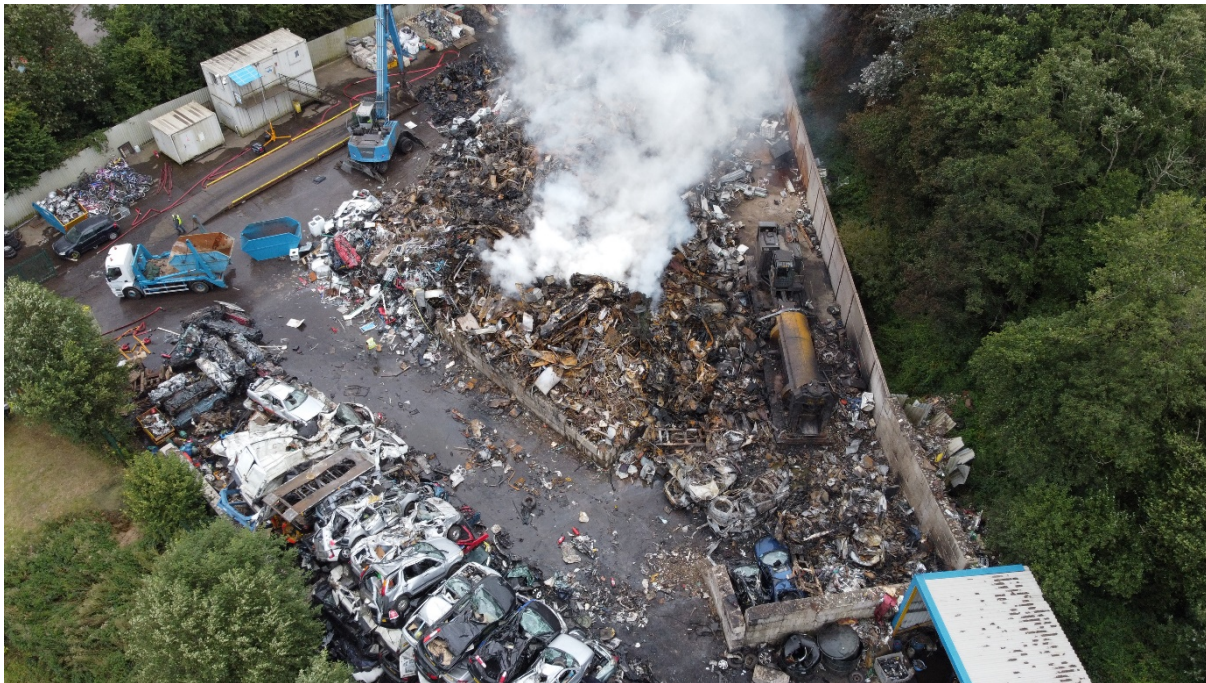
**Image 1 - Showing drone image of the waste stockpile on fire and smoking - taken by NRW drone pilot Chris BURGE around 12:02 on 2 September 2021**

SWFRS Incident Commander Mark KIFT informed NRW that, SL Recycling Limited site staff believed that the incident was started by a lithium ion battery, which exploded when a vehicle shell was being crushed. The fire then spread to the primary stockpile of scrap metal waste, which was excessively large, stored centrally within the yard. This posed problems for the SWFRS to manage effectively. It was stated that the height of this stockpile made it difficult for fire fighters to safely extinguish and segregate the hotspots within the stockpile. Also, due to the lack of space within the yard, this extended the time it took for fire personnel to isolate pockets of waste and reach the source of the flames.

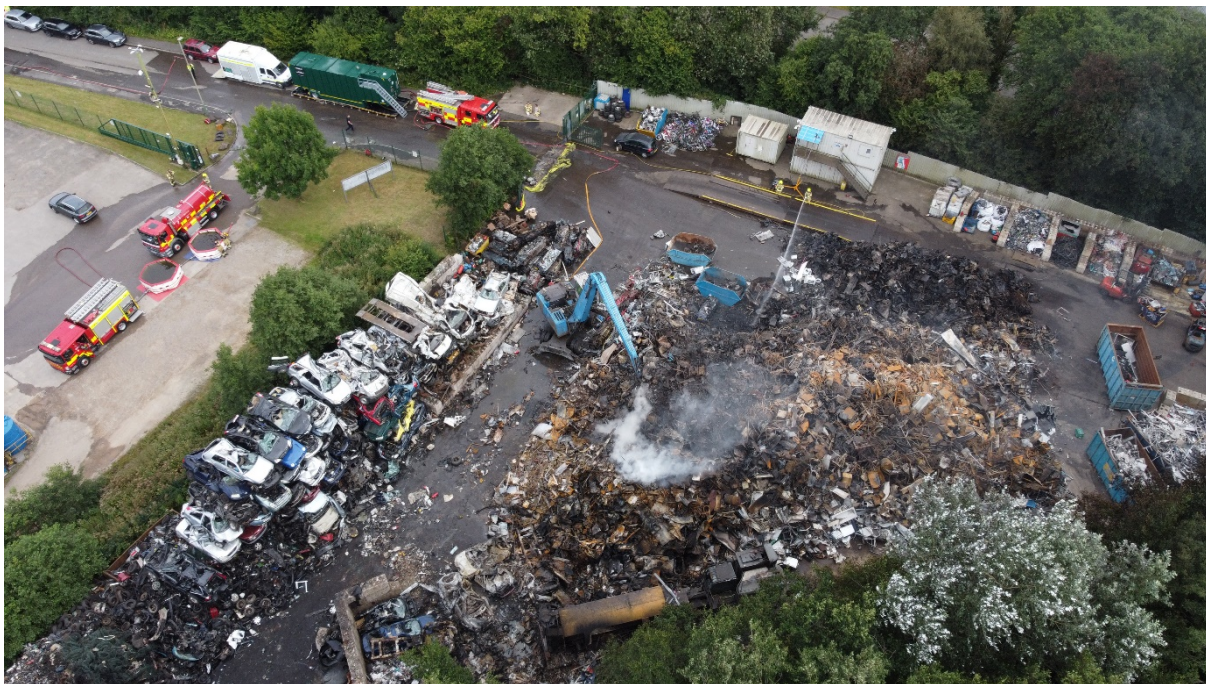
**Image 2 - Showing drone image of the waste stockpile with limited quarantine area to segregate waste - taken by NRW drone pilot Chris BURGE around 16:30 on 2 September 2021**

The operator has failed to: (i) appropriately manage its waste volumes, (ii) maintain a compliant stockpile size and (iii) keep an appropriate quarantine space on site, as per its FPMP. As a result, this made fire-fighting a lengthier and more dangerous task for the SWFRS. Greater emissions entered the local environments due to the increased time it took to extinguish the fire.

- Reduce all heights of stockpiled waste to **4m**. Do not allow waste stockpiles to exceed this height restriction in future.
- Review waste management strategy to ensure customer material is rejected if there is unsuitable capacity on site to compliantly accept more waste.

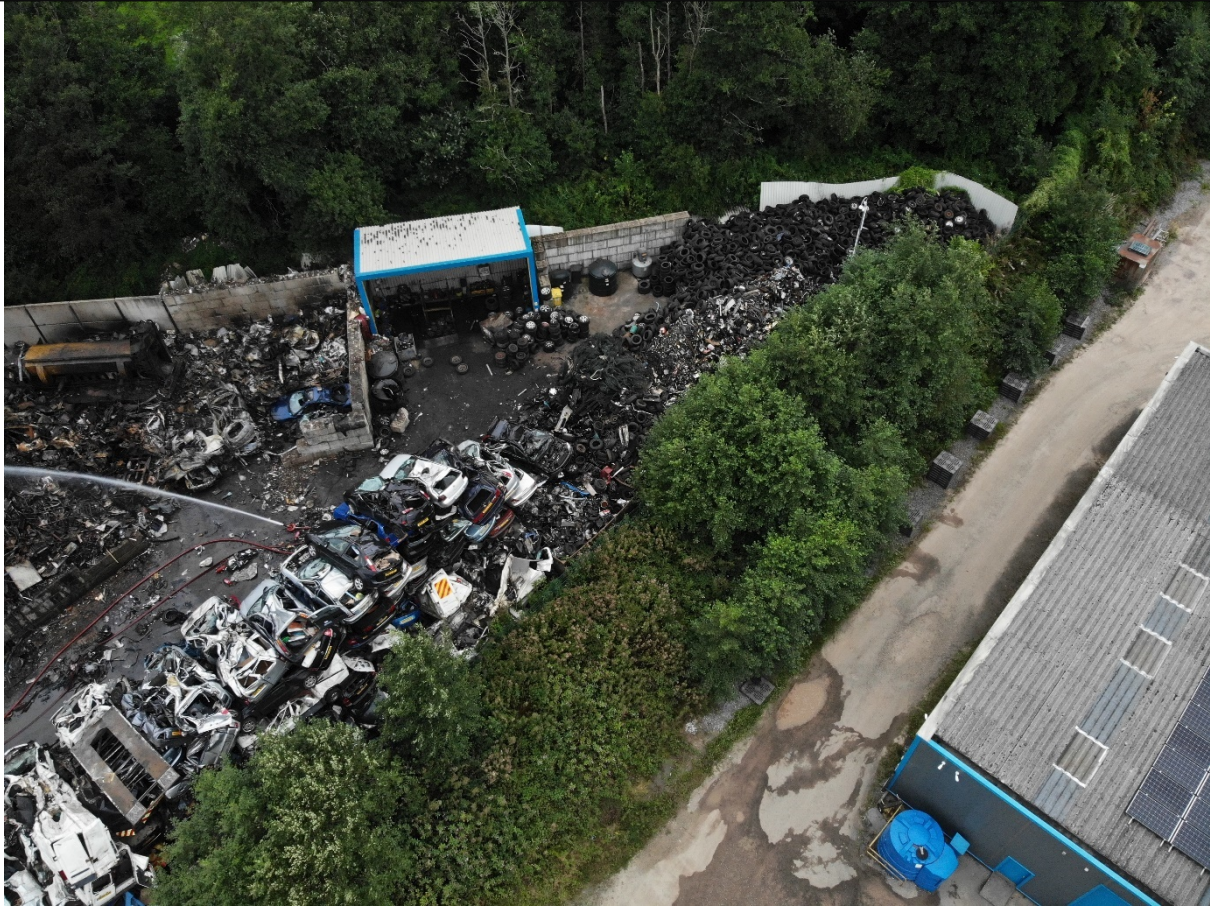
At the time of the incident, there were large amounts of tyres stored at the rear of the site that were unaffected by the fire, as seen in image 3. Although there was an established separation distance between the tyres and potential ignition sources, volumes should not be allowed to reach this level. The operator must reduce tyre volumes on site by: (i) sending a portion of the tyres to an appropriate contractor (as an initial response); and (ii) ensuring that the volume of tyres kept on site is better managed going forward.

***Image 3 - Showing drone image of large volume of waste tyres stored in the corner of the site - taken by NRW drone pilot Chris BURGE around 08:20 on 2 September 2021***

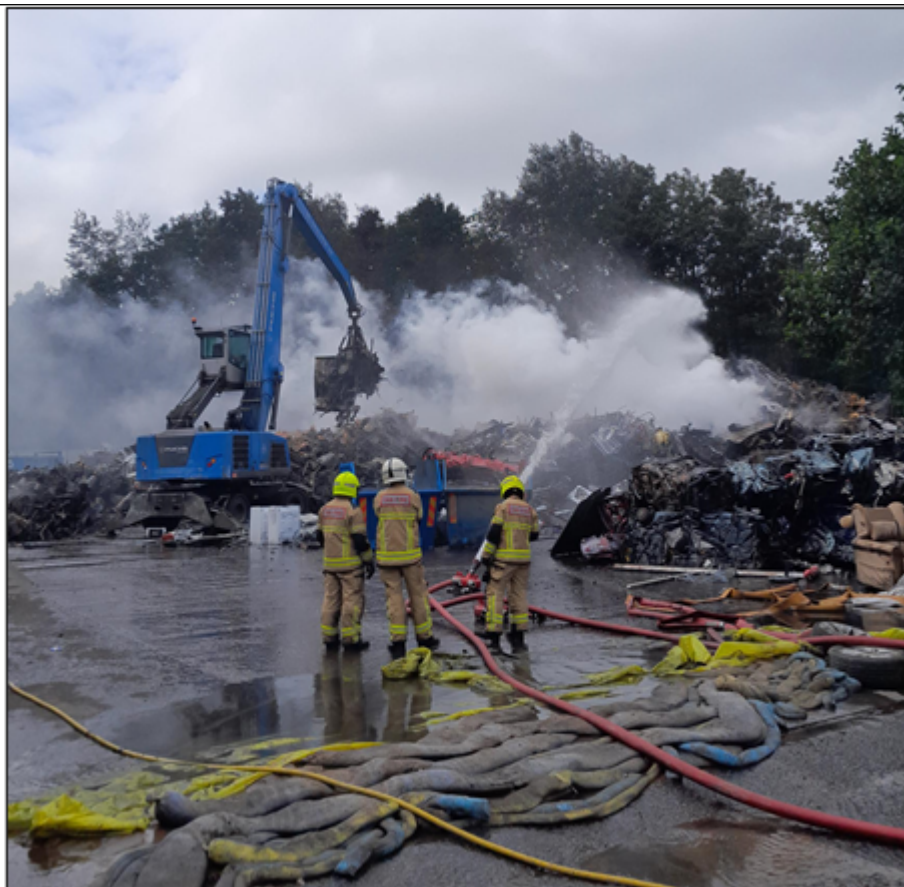
**Image 4 - showing fire fighters dowsing the waste stockpile - taken by Officer Alex BOWDER at 14:04 on 2 September 2021**

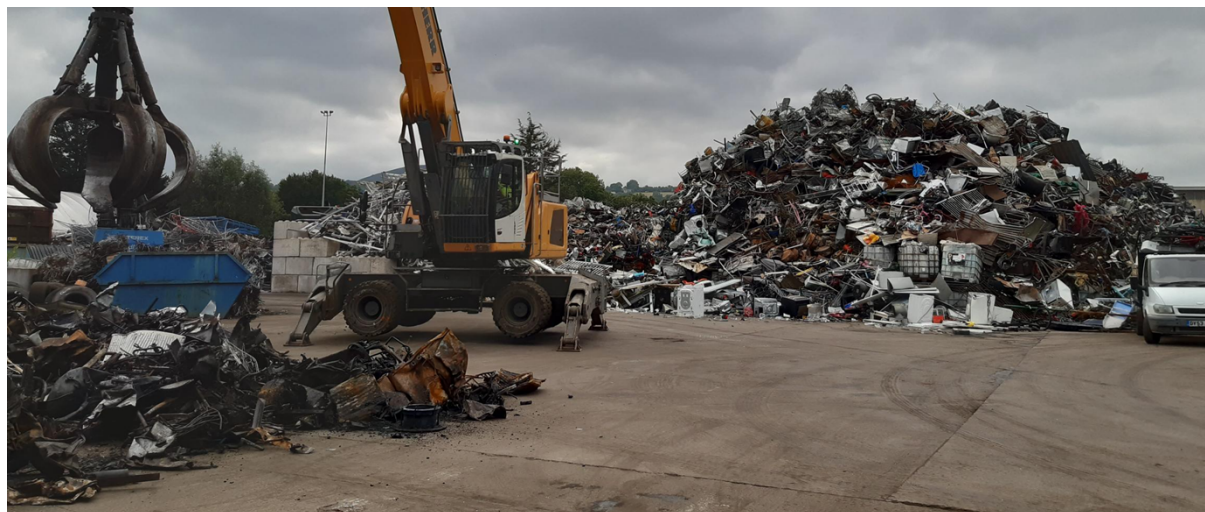
NRW Officers noted that, there were large and excessive stockpiles stored across the New Inn yard, despite the operator being told to reduce these on the last inspection of 18 August 2021 - detailed in compliance report *CAR\_NRW0038643*. The Operator was disinclined to

**Image 5 - showing the size of the stockpile at the New Inn yard - taken at 15:23 on 2 September 2021 by Officer Jak ROSE**

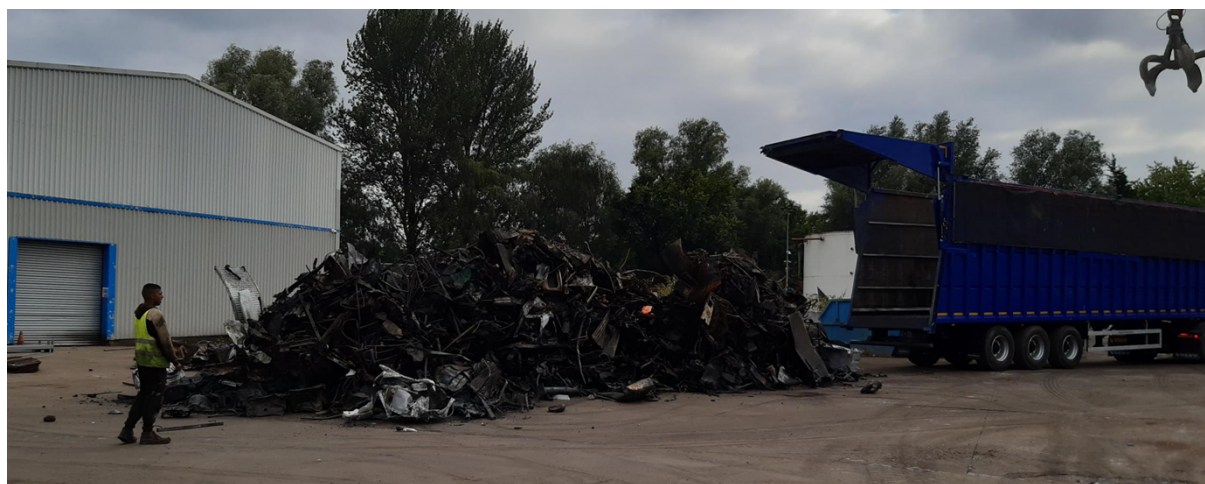
**Image 6 - showing the fire affected material being deposited at the New Inn yard - taken at 16:23 on 2 September 2021 by Officer Jak ROSE**

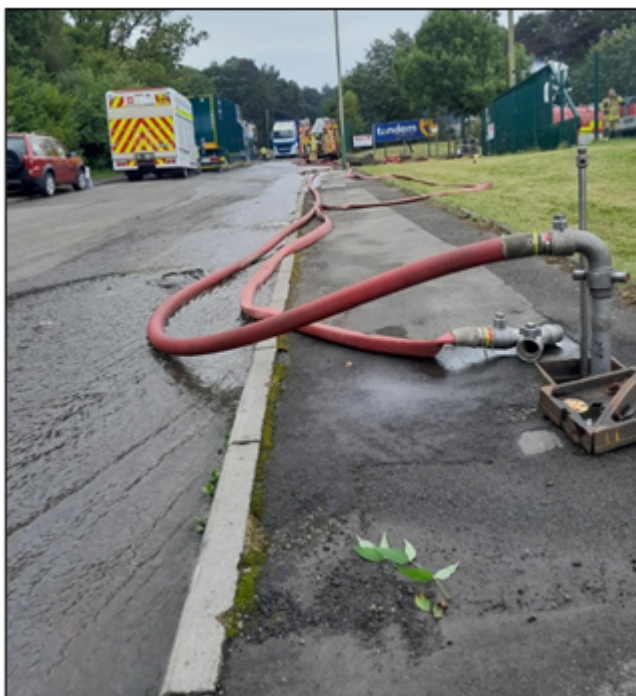
When NRW arrived on site, Officers informed the operator that it was their duty to manage and contain all surface water run-off as a priority to prevent further pollution to the watercourses. Accordingly, the operator contacted and instructed Spill Response Wales to contain the fire water run-off and prevent any further oils and fuels from entering the watercourse.

*Image 7 - showing fire water run-off flowing down the road from the SL premises - taken by Officer Alex BOWDER at 14:58 on 2 September 2021*

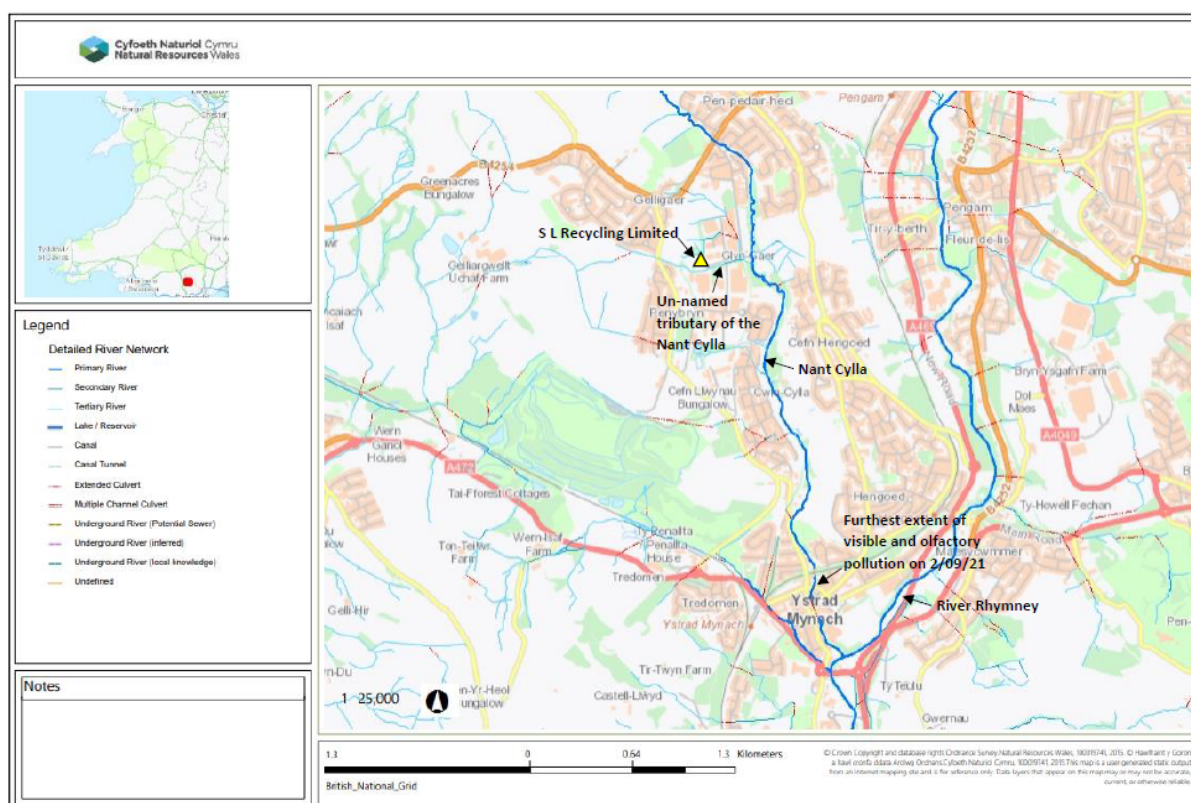
On the 2 September 2021, the effects of the pollution from the incident were seen and smelt in watercourses up to 2,600 metres from the site. The watercourses affected were an un-named tributary of the Nant Cylla, which runs parallel to the SL Recycling Limited site and the Nant Cylla which is a tributary of the River Rhymney (all shown on the below map).

**Image 8 - Map annotated with the site location and the affected watercourses**

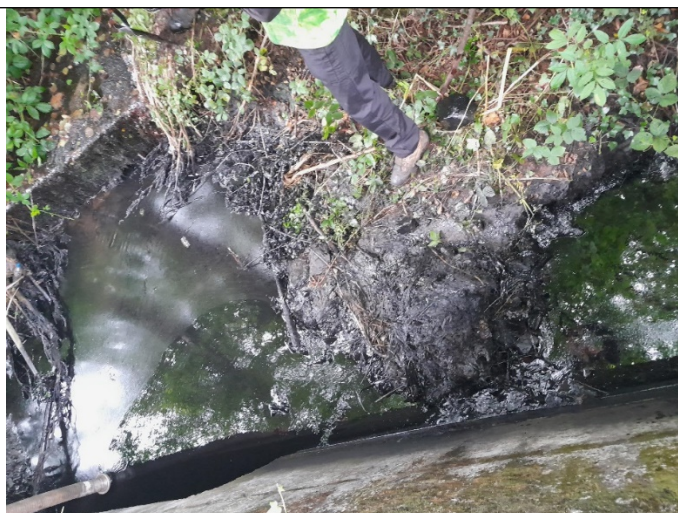
***Image 9 - showing large amounts of oils and fuels in the unnamed tributary of the Nant Cylla 70m downstream from the site - taken by Officer Alex BOWDER at 10:08 on 3 September 2021***

Large volumes of oils and fuels entered the watercourses due to the site's interceptor system being overwhelmed. This happened as a result of the volume of firewater required to extinguish the incident. It is considered that, had appropriate measures been in place i.e. compliant stockpile sizes, the fire would not have been as severe, nor would it have caused such a significant incident.

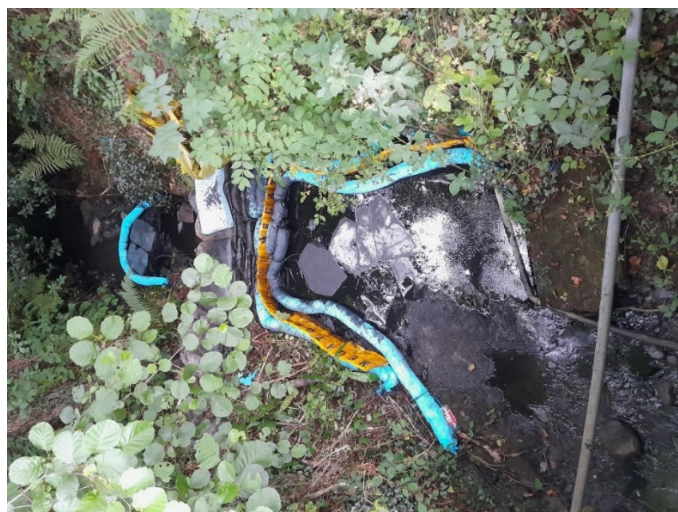
***Image 10 - showing containment measures capturing oils and fuels in the unnamed tributary of the Nant Cylla downstream from the site - taken by Officer Alex BOWDER at 10:07 on 3 September 2021***

Environmental protection measures such as bunding, boons and absorbent pads were put in place by NRW and Spill Response Wales to best capture any contaminants (oils and fuels) in the watercourse from flowing further downstream. Disappointingly, these measures were damaged and removed in the early hours of the Monday 6 September and again on Tuesday 7; NRW has no evidence of who carried out these actions. Security was employed by the operator on the evening of 8 September to see that this did not happen again.

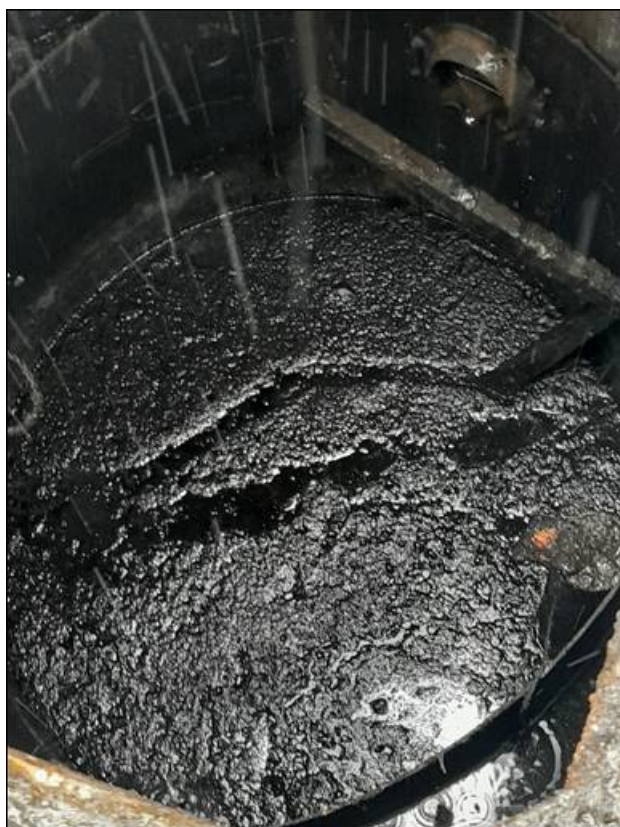
On Wednesday 8 September, the operator instructed Egan Waste Services to restore the interceptor and flush out the lines to ensure the system was fully functioning. However, the relevant drain (near the site) was left un-serviced and the interceptor was not fully recharged to manufacturer standards. This meant that the drainage system and surface

water lines still contained oils and fuels which would be washed through to the tributary.

***Image 11 - showing the contents of the operator's interceptor holding large volumes of oils and fuels - taken by Officer Chris BURGE at 12:01 on 9 September 2021***

In addition, if the interceptor system and associated drainage lines had been appropriately cleaned, recharged, and set to an appropriate standard immediately after the fire, this would have helped to prevent the secondary water pollution.

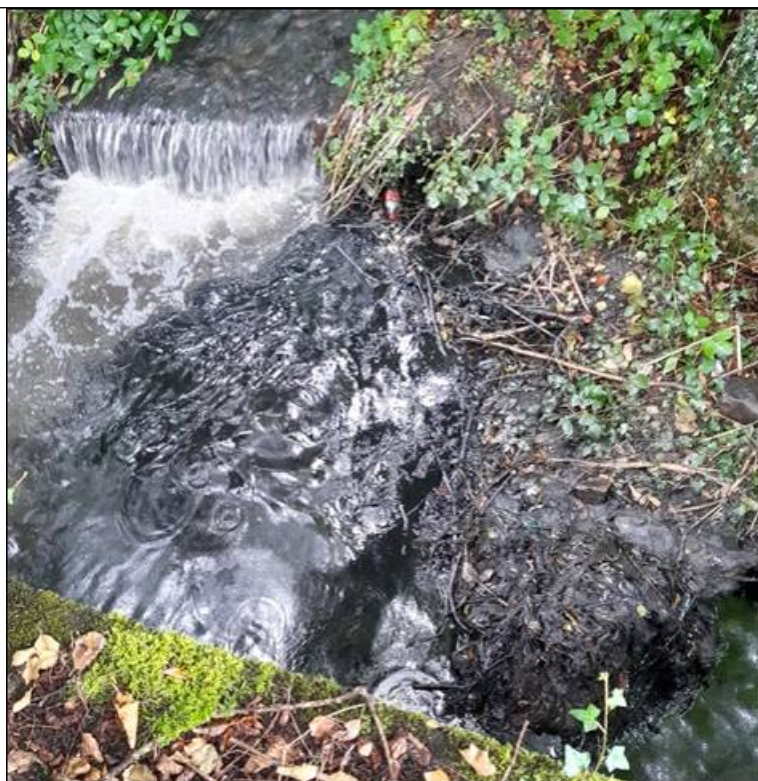
On the morning of Thursday 9 September, the area received its first heavy rainfall since the fire incident. As a result of the increased water flow, further oil entered the tributary from the drainage system causing a secondary pollution incident. Spill Response Wales and NRW Officers worked to contain this over the next few days. On 10 September, Arch Drainage Services bunged off the site's interceptor to prevent any further discharge from entering the watercourse. It was said that, this should have been actioned as soon as the fire had stopped, to ensure that the drainage system was fully emptied, recharged and inspected to see that all discharges from it were running clear.

**Image 12 - showing further oils and fuels washing into the unnamed tributary of the Nant Cylla downstream from the site - taken by Officer Chris BURGE at 09:43 on 9 September 2021**

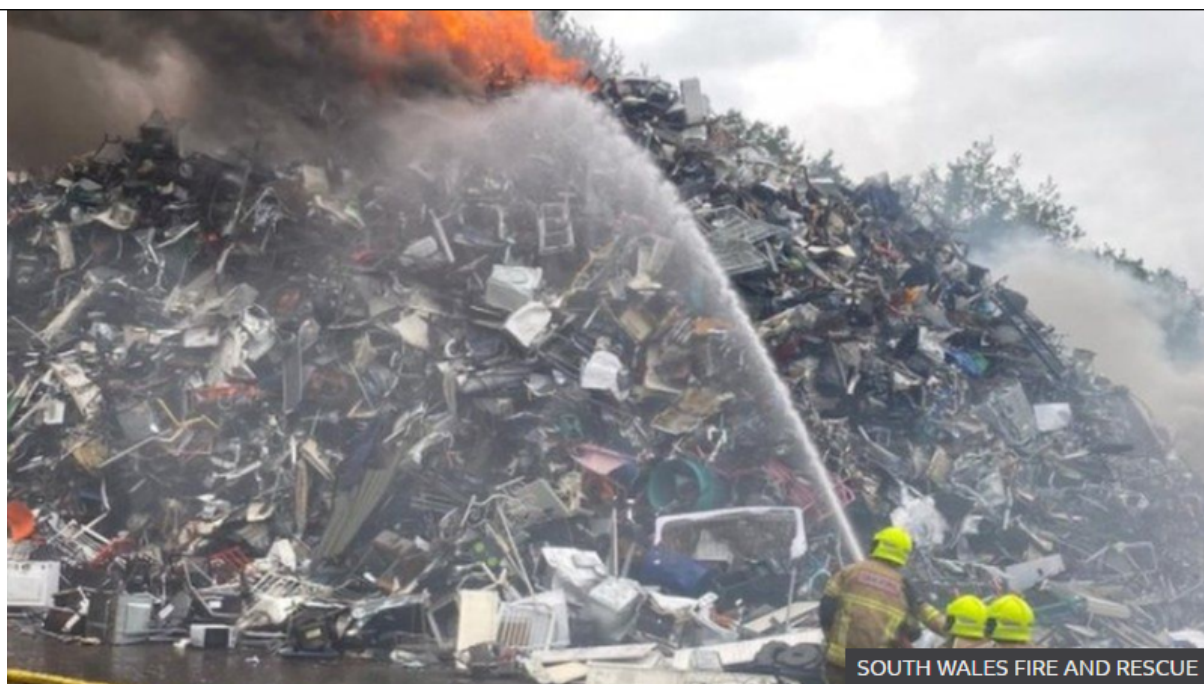
It has been previously emphasised to the operator that the Fire Prevention and Mitigation Plan (FPMP) guidance sets the maximum storage height of stockpiled waste to **four metres**. This height specification was determined by the Fire and Rescue Service for general good management practise and stability to enable fire fighters to tackle a fire on site, if an incident were to occur. The operator also did not contact NRW at the earliest stage to inform us that there was a fire incident on site. This is a direct requirement of the permit conditions and is stated within the Management System.

**Image 13 - illustrating the height of the metal waste stockpile in excess of 4 metres - lifted from the BBC News article on 2 September 2021**
