## Compliance Assessment Report CAR\_NRW0042009

**Permit being assessed:** XP3830UR.

**For:** Haverfordwest Creamery, **held by:** The First Milk Cheese Company Ltd

**Type of assessment:** Audit,

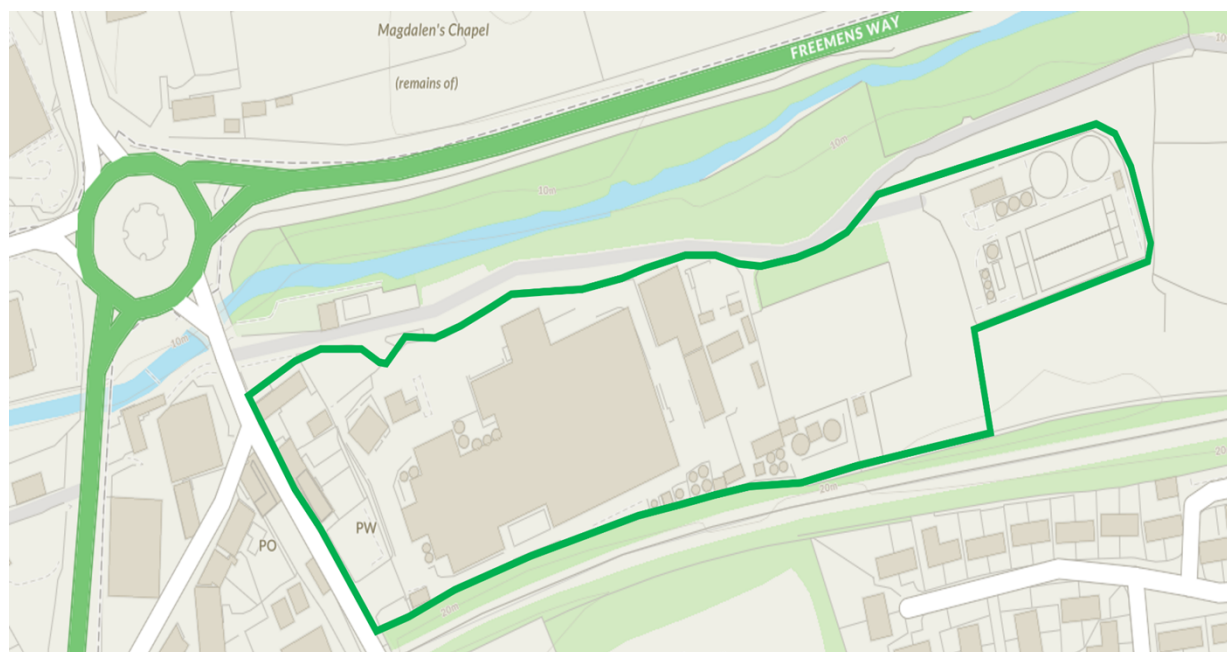
Figure 1. The Permitted Site Boundary

The First Milk Cheese Company had the potential to emit untreated effluent to sewer through an overflow pipe that is not included within the site permit boundary. The untreated effluent had the potential to cause a significant impact on the operation of the receiving Dwr Cymru wastewater treatment works and consequently on the Western Cleddau river.

Permit condition 2.2.1 states that the activities shall not extend beyond the site, being the land shown edged in green on the site plan at schedule 7. This has partially been replicated at figure 1 below.

**The unauthorised connection outside the permit boundary with significant potential is category 2 non-compliance with permit condition 2.2.1.**

The First Milk permit boundary is indicated by the darker green line. The unauthorised connection pipe was located inside the drain at the corner of the northernmost building in the centre of the map. It took untreated effluent out through the permit boundary into an adjacent Dwr Cymru sewer pipe under the road outside First Milk's permitted site.

**Action 2 – First Milk to provide proposals to NRW by 30 September 2023 for permanent abandonment of the pipeline connection between the First Milk internal effluent pipework system and the public sewer, including grouting of the full length of the connection and capping at both ends and periodic inspection of the capping.**

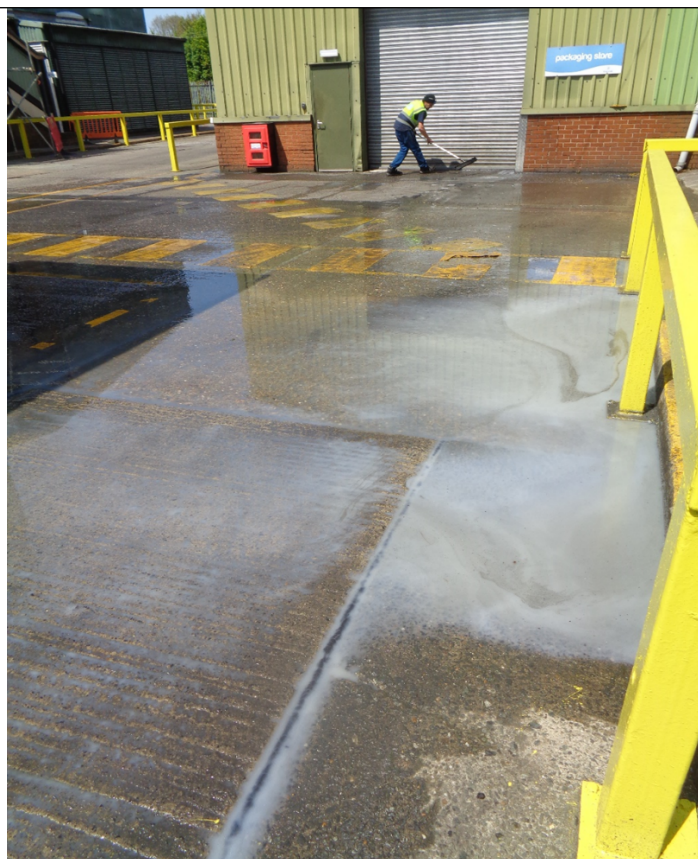
Fig 2 above. Taken on 22<sup>nd</sup> May 2023 by visiting EHO PCC food safety team. Shows milky effluent pooling in the First Milk yards. This acts as a possible source of high COD/BOD pollution if left to overflow off site.

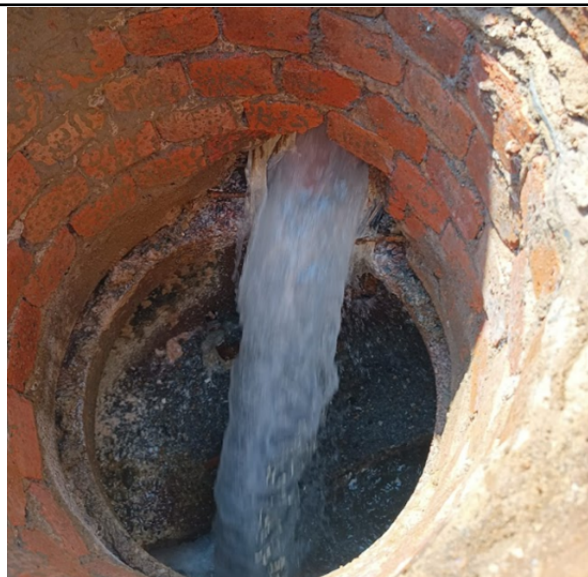
Fig 3 Dwr Cymru gravity fed drain SM94149502 taken by Dwr Cymru staff shows milky effluent entering their drain on 7th June through an unpermitted emission point inside First Milks site boundary.

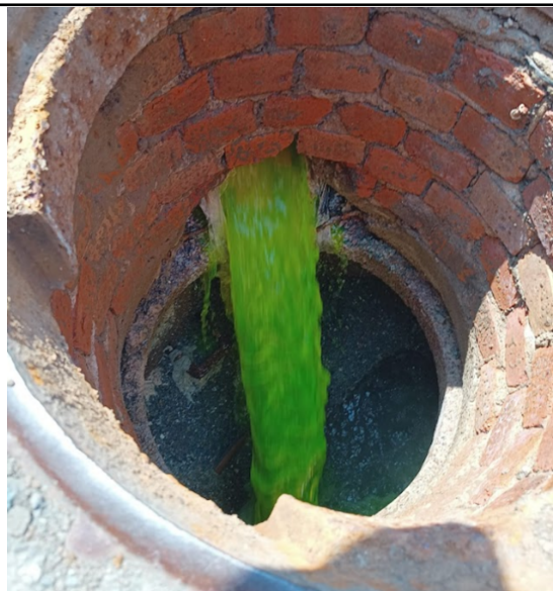
When the unauthorised connection pipe was identified through the investigation between May 26<sup>th</sup> and 7<sup>th</sup> June, it was not reported to NRW with immediate effect. First Milk failed to notify NRW of the nature of the pipe until 13<sup>th</sup> June at the NRW audit despite members of staff being present at the Dwr Cymru investigation and dye tracing exercise. (Pic 4 below).

Fig 4 Taken by Dwr Cymru shows the same drain during dye tracing on 7th June by Dwr Cymru in the presence of First Milk staff. This confirmed the existence of the overflow pipe which allowed untreated effluent to overflow from the First Milk site into the Dwr Cymru

drain which flowed to their treatment works at Merlin's Bridge.

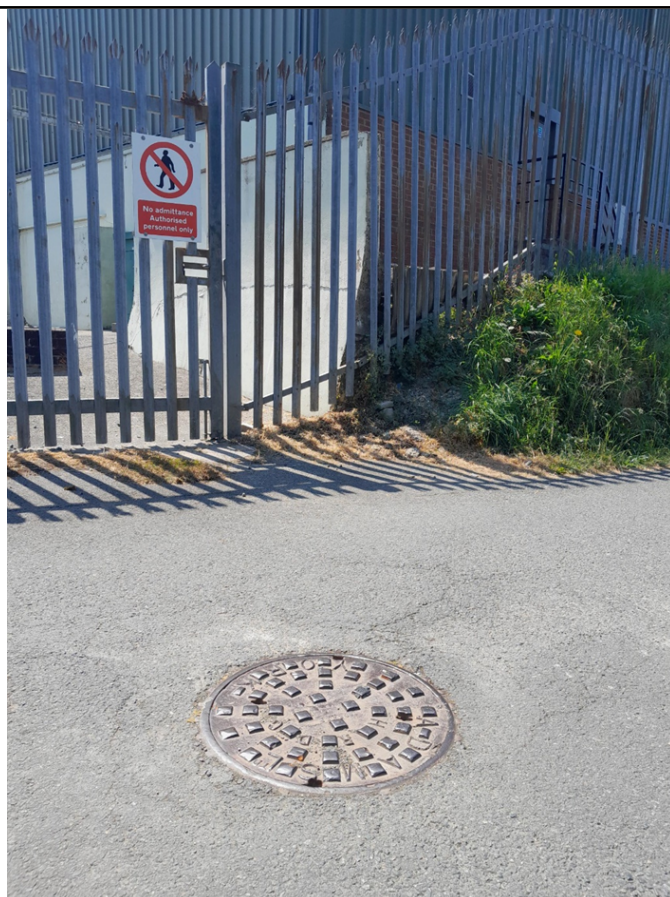
Fig 5 above. The same drain pictured outside the First Milk permitted fence line taken at the NRW inspection on 13<sup>th</sup> June 2023.

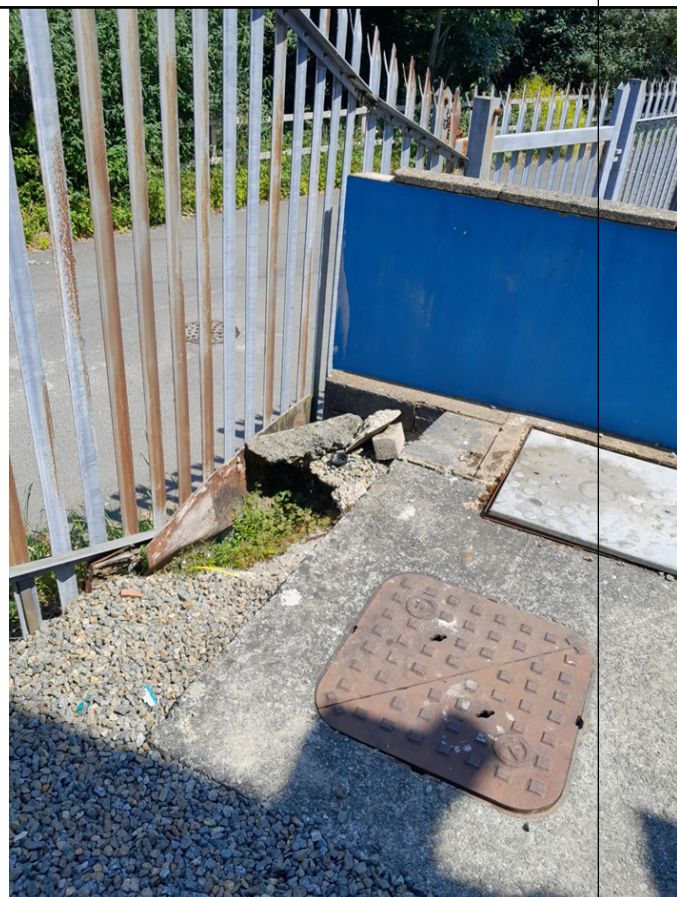
Fig 6 above. Shows the same drain in the road outside the fence with First Milk's overflow drain in the near ground. The overflow connected both drains. Concrete work has since blocked off the route from 7th June.

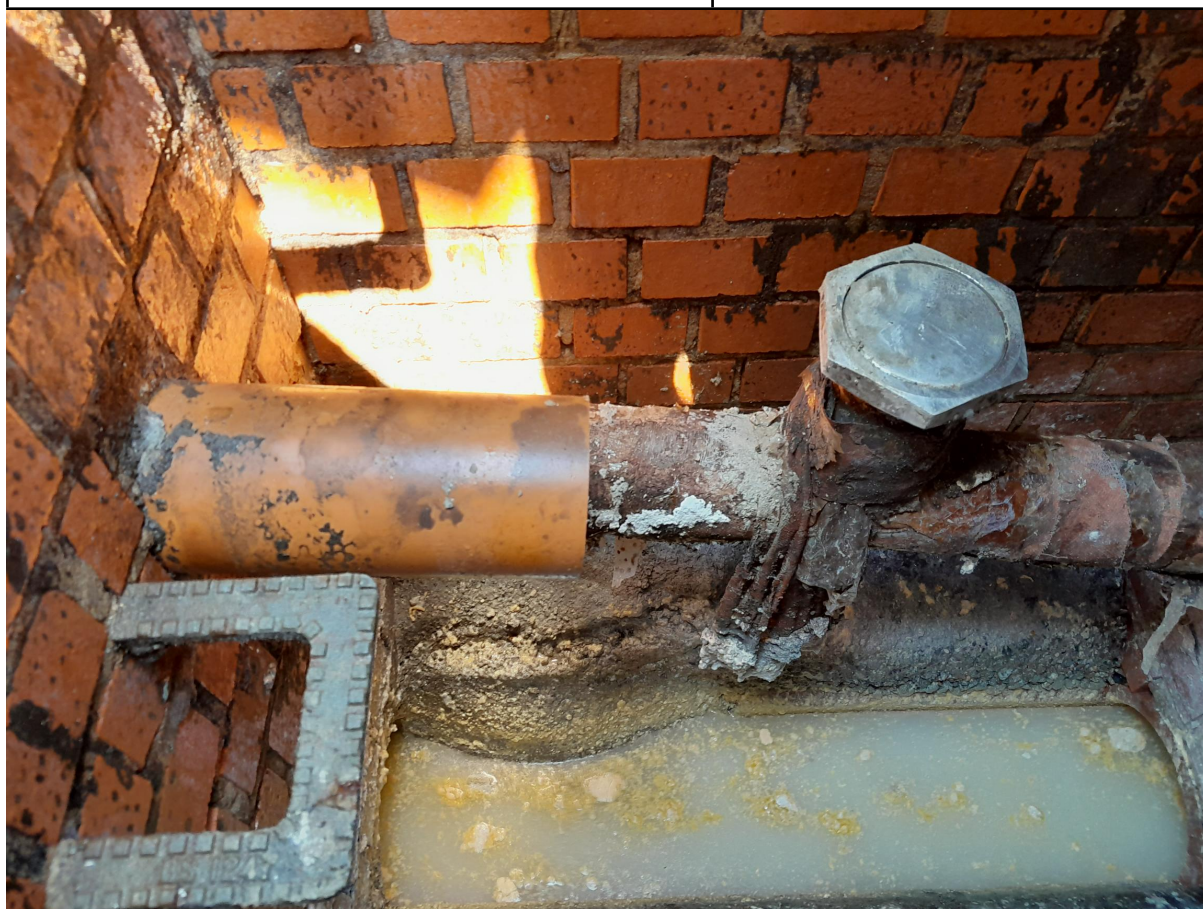
The overflow was blocked with a concrete plug inside the drain on 7<sup>th</sup> June 2023 (pic 7 below). This was visually inspected by NRW on 13<sup>th</sup> June. Up until this point, the unauthorised connection had been effectively operated by First Milk as an undeclared and unpermitted discharge point. This had the potential to release untreated effluent from First Milk's drain into a network sewer pipe owned by Dwr Cymru and fed into the Dwr Cymru sewage treatment works at Merlin's Bridge.

Fig 7 below – inside First Milk's drain (SM94149502) A new concrete plug has been placed inside the drain, between the upper orange sleeved condensation pipe and the lower milky effluent channel. It was seen to be shaped to allow effluent to flow past the blocked hole which is hidden behind the orange plastic pipe sleeve. Milky effluent was seen to be flowing left to right towards the First Milk effluent treatment plant and cannot get through the now blocked hole. The opposite end of the pipe in the drain pictured above was also seen to be dry after placing the concrete seals at either end of the pipe.

At the inspection, the repairs to block off the pipe flow with shaped concrete plugs was seen to be working. The repairs should have been carried out to BS EN 1504-9:2008 standards for repairing concrete structures and quality control. Periodic inspection and testing (dye testing) is required to ensure that the concrete is sound, and the seal is robust. This needs to be done at periodic intervals to be decided by First Milk and agreed with NRW. This will be subject to audit at future inspections.

The concrete needs to be periodically checked to ensure continuous integrity. An annual dye tracing exercise

| needs to be carried out to ensure the seal remains intact. | |

**Action 4 – First Milk to provide NRW with a copy of a written procedure to conduct a visual inspection on the concrete plug together with a dye tracing exercise to ensure the seal between the effluent system and the sewer is maintained until completion of Action 2 above. Inspections will be scheduled on a periodic basis to be agreed with NRW.**

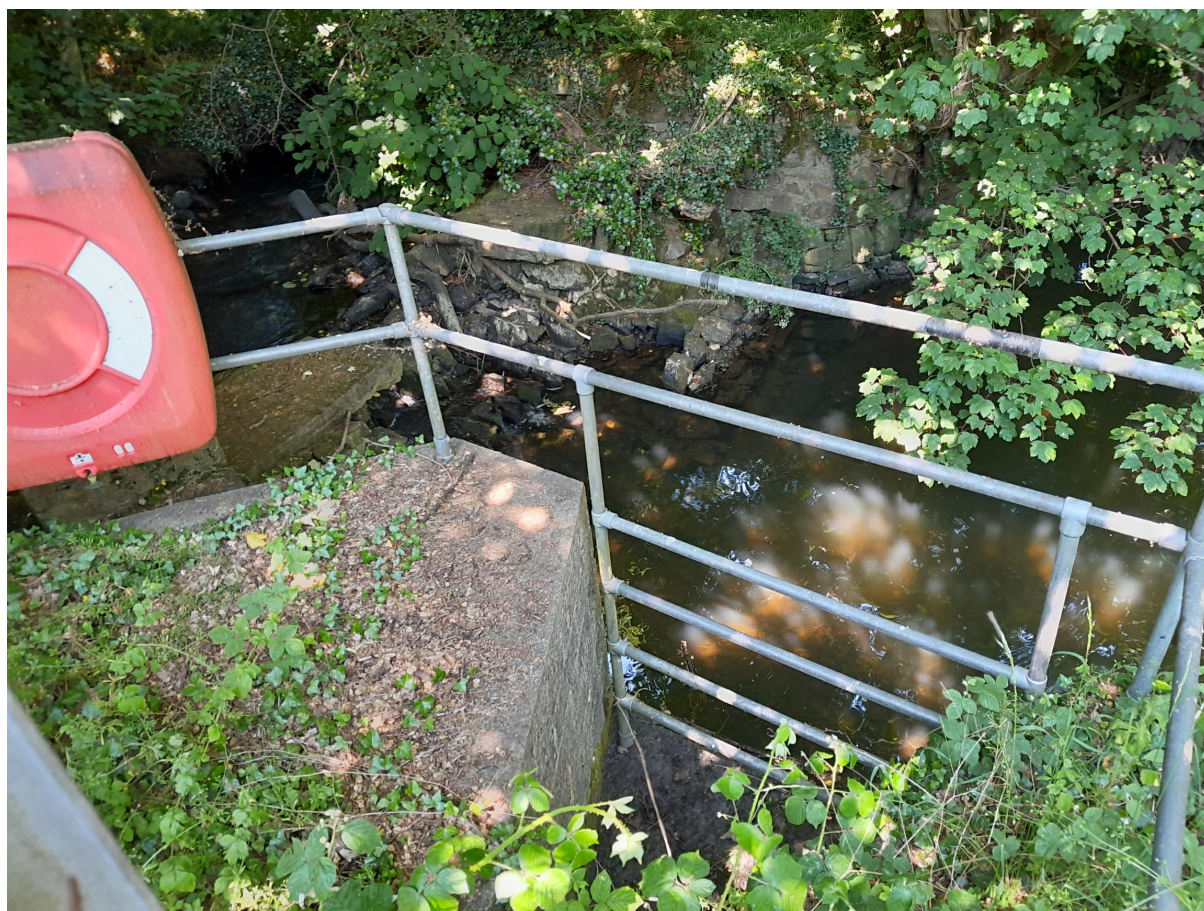
uncontaminated surface runoff away from site. The access was well maintained with evidence of recent brush clearing activity to maintain access. The outlet flows into a contributory brook which feeds the western Cleddau. The water was seen to be clear, with no signs of milky product or no odour. No invasive weeds were seen in the vicinity.

Fig 8. Shows First Milks W1 outlet for uncontaminated runoff. The access was well maintained with no evidence of pollutants or odour.
