## Schedule 1

### Notification of Unauthorised Release

| <b>Operator:</b> | Tata Steel UK Ltd | | |

- This Part B, SN5\_23\_52B is a follow-up to the Part A Notifications, SN5\_23\_52A, for a breach of permit conditions at Port Talbot W1 consent point.

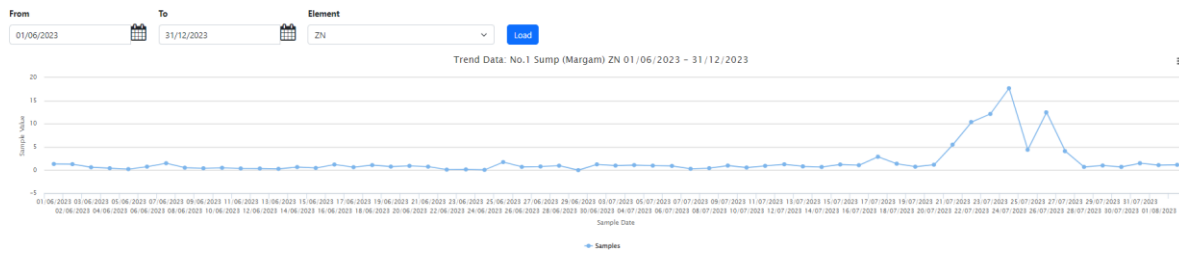
Trend Chart - No.1 Sump (Margam) Elements

- The cooling tower constantly overflows to sump 1 (to maintain conductivity and scale/corrosion prevention), so any exceeded analyte in the Gas Plant recirculating water will show in sump 1 and BETSI sump. (Highlighted in the graphs below)

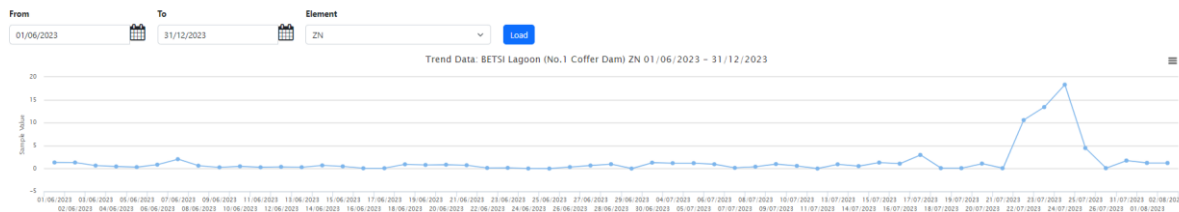
Trend Chart - BETSI Lagoon (No.1 Coffor Dam) Elements

- The sludge in the Dorr ponds gets pumped to BETSI lagoon and the water filters back to the BETSI corner, which on level control, gets pumped to sump no.1. Elevated Zn was seen at BETSI corner during this event.
