Location Plan:	<b>Afonwen Sea Wall</b> Assessment Date: 16/03/2022	
<p>Contains Ordnance Survey data © Crown copyright and database right 2015</p>	CARRS Exam ID:	<b>14468740</b>
	Exam Type:	<b>Detailed</b>
	Complete Survey:	Yes
	Network Rail ELR:	<b>DJP</b>
	Structure Reference:	<b>127 41</b>
	Mileage:	<b>127m 798yds 36chs</b>
	OS Ref:	245630 , 337300
	Operational Area:	Cambrian
NOTE: This document has been prepared as an Asset Condition Survey Report for Network Rail. JBA Consulting accepts no responsibility or liability for any use that is made of this document other than by the Client for the purposes for which it was originally commissioned and prepared.	Governing SMP2:	Coastal Snowdonia
	SMP2 Policy Unit:	12.24
	SMP2 Policy:	2025 = hold the line; 2055 = managed realignment; 2105 = managed realignment.

Afonwen Sea Wall is located between Afonwen and Llanystumdwy. The defence is split into two sections, Afonwen Sea Wall A and B, corresponding to a change in major element type at 245068, 337218 (between Sections A and B):

# COASTAL ASSET CONDITION SURVEY REPORT

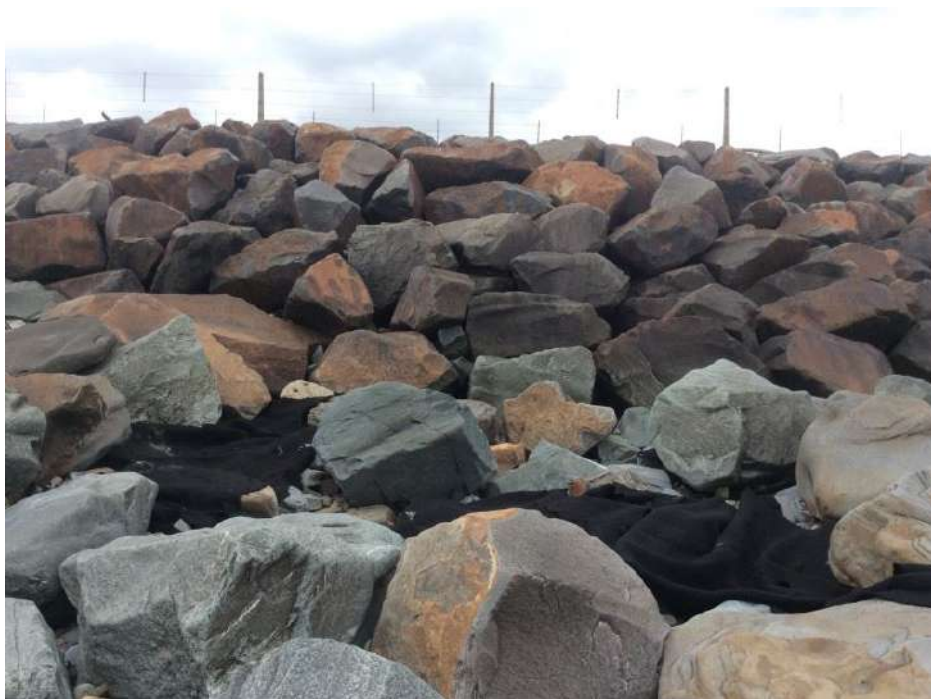
**Section A**  
**Embankment**  
**Armour**  
**Defect Ref: D3**  
**Description:**  
Exposed geotextile  
and loss of  
armourstone. No  
change between  
2021-2022  
examinations.  
**Photo number: 58**

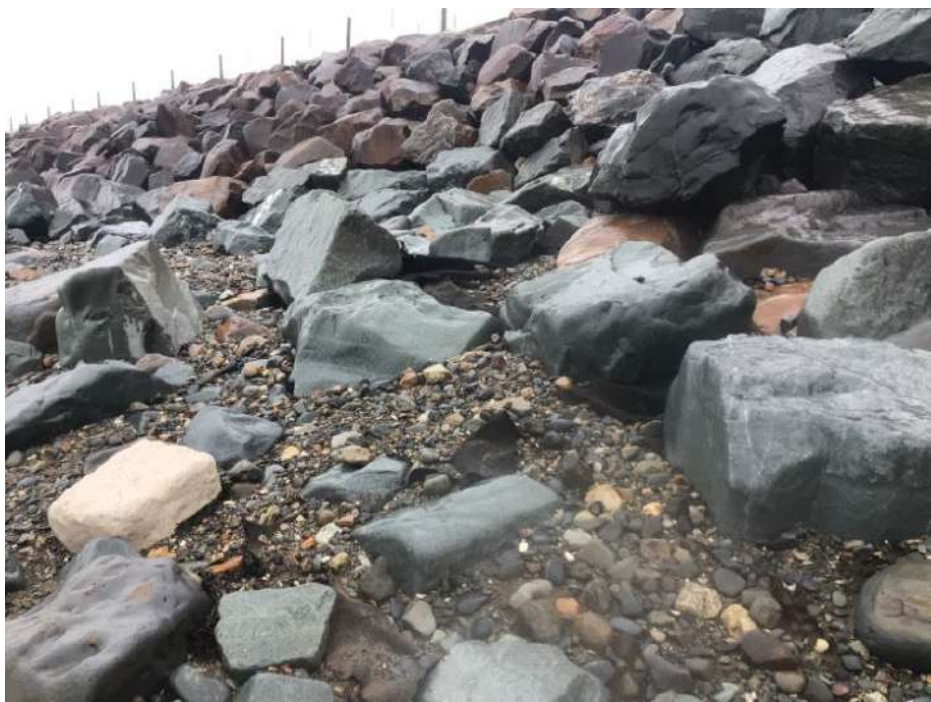
**Section A**  
**Embankment**  
**Armour**  
**Defect Ref: D3**  
**Description:**  
Exposed geotextile  
and loss of  
armourstone. No  
change between  
2021-2022  
examinations.  
**Photo number: 140**

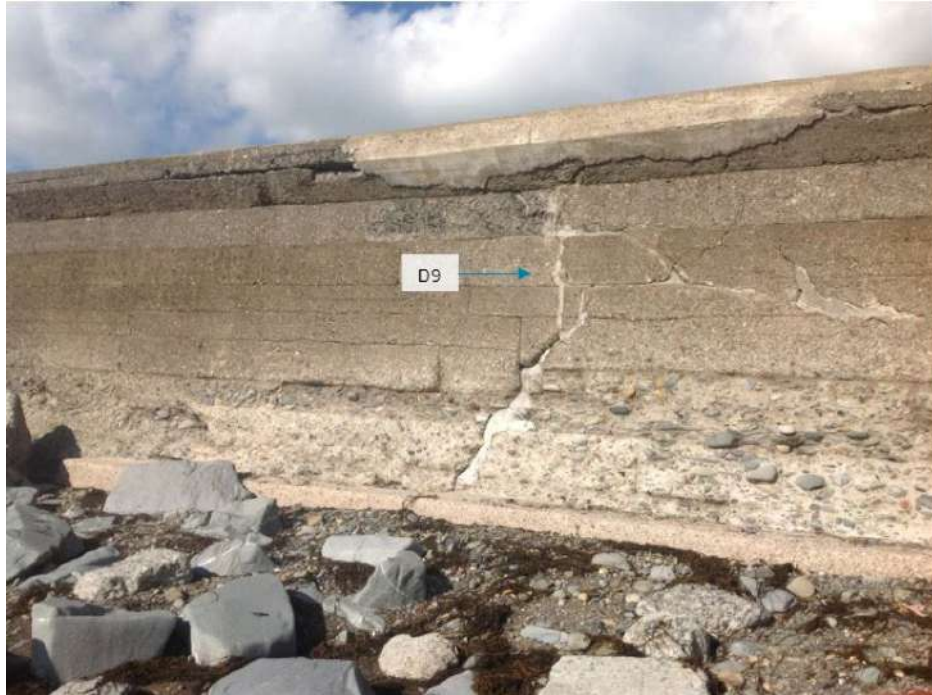
**Photo number: 24**

**Description:** Poor condition of wall section, longitudinal cracks and delaminating in the wall section and capping. Although the defect has previously been repaired, it is evident voids have been filled without breaking out the section and an adequate bond between new and existing material has not been ensured. Some cracks protrude through the thickness of the wall. There was no change between 2021-2022 examinations.

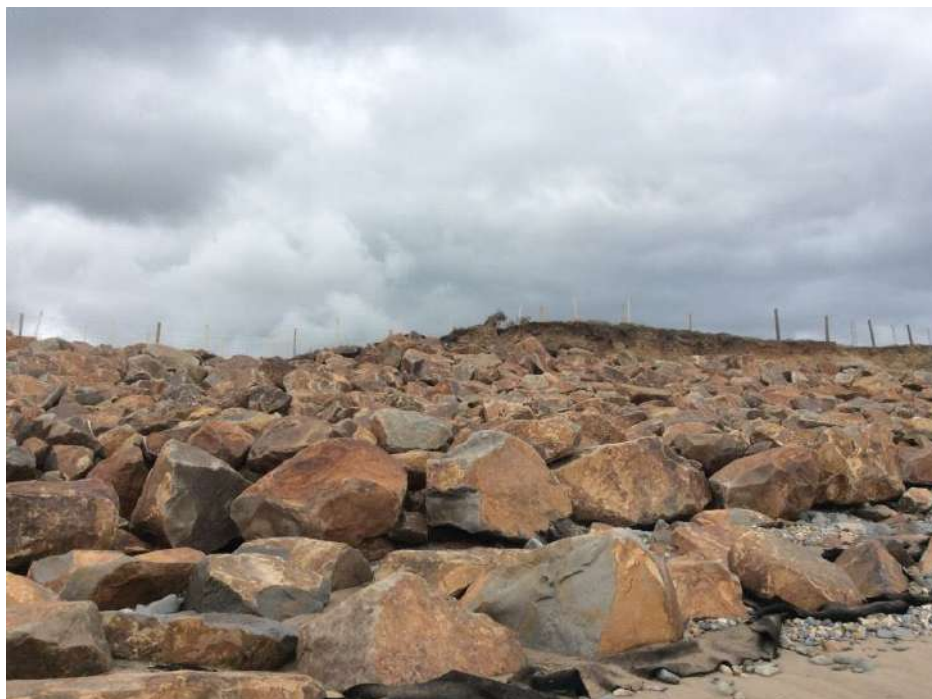
**Section A**  
**Embankment**  
**Armour**  
**Defect Ref: D26**  
**Description:** Lower rock crest with the exposed cliff. There was no change between the 2021-2022 examinations.  
**Photo number: 42**

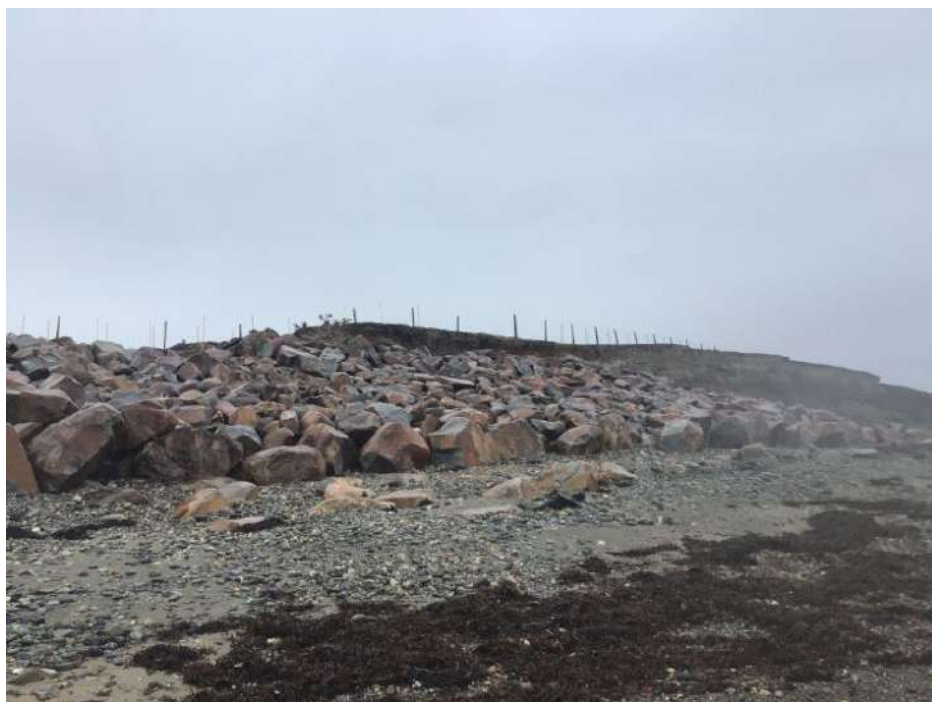
**Section A**  
**Embankment**  
**Armour**  
**Defect Ref: D26**  
**Description:** Lower rock crest with the exposed cliff. There was no change between the 2021-2022 examinations.  
**Photo number: 144**

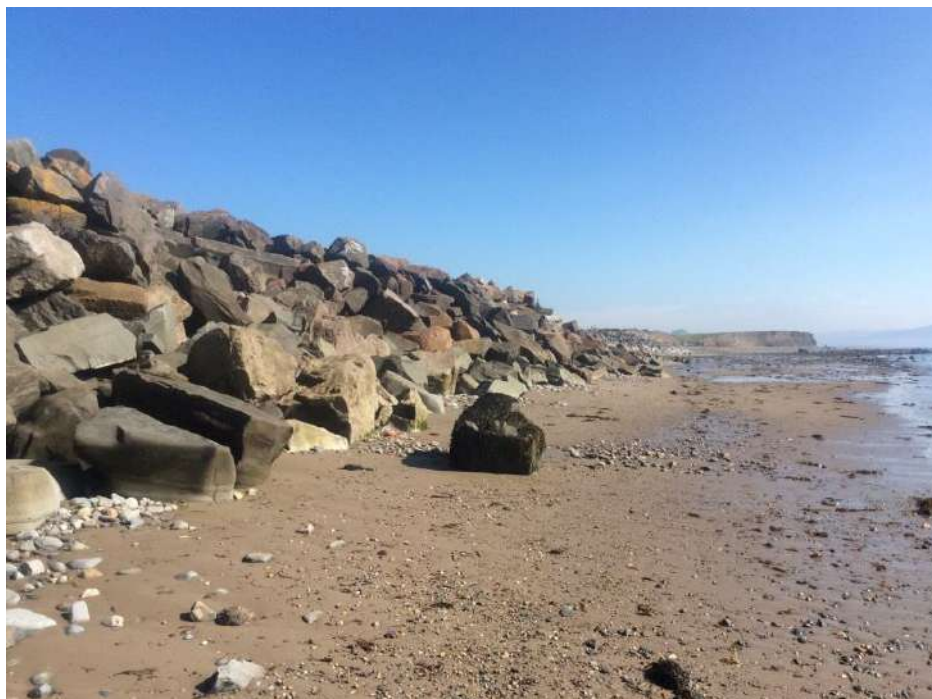
**Section A**  
**Embankment**  
**Armour**  
**Defect Ref: D27**  
**Description:** Overly steep rock profile with a poor interlock between the rock units. There was no change between 2021-2022 examinations.  
**Photo number: 27**

Defect Ref No.	Defect Location (NGR)	Major Element	Minor Element	Photo Ref	Severity	Probability	Risk Score	Below MHW	Defect Group	Defect Description	Recommendations	Defect Priority
D27	245358, 337260 DJP 127.115	Embankment	Embankment Armour	27, 53	3	2	6	False	Loss/damage of rock-armour	Overly steep rock profile with a poor interlock between the rock units. There was no change between 2021-2022 examinations.	Reprofile the embankment to an appropriate angle (1 in 2 slope) and place rock armour such that it has appropriate interlock between armour units.	17
D28	245170, 337233 DJP 127.136	Embankment	Embankment Armour	51, 132	5	2	10	False	Loss/damage of rock-armour	Single rocks are placed on top of the crest/wall with no interlocking. During extreme storm conditions, rocks may collapse resulting in a high safety hazard. There was no change between the 2021-2022 examinations.	Remove upper rocks that do not interlock and re-design the revetment to increase crest height or decrease face slope angle to reduce chance of wave overtopping.	4

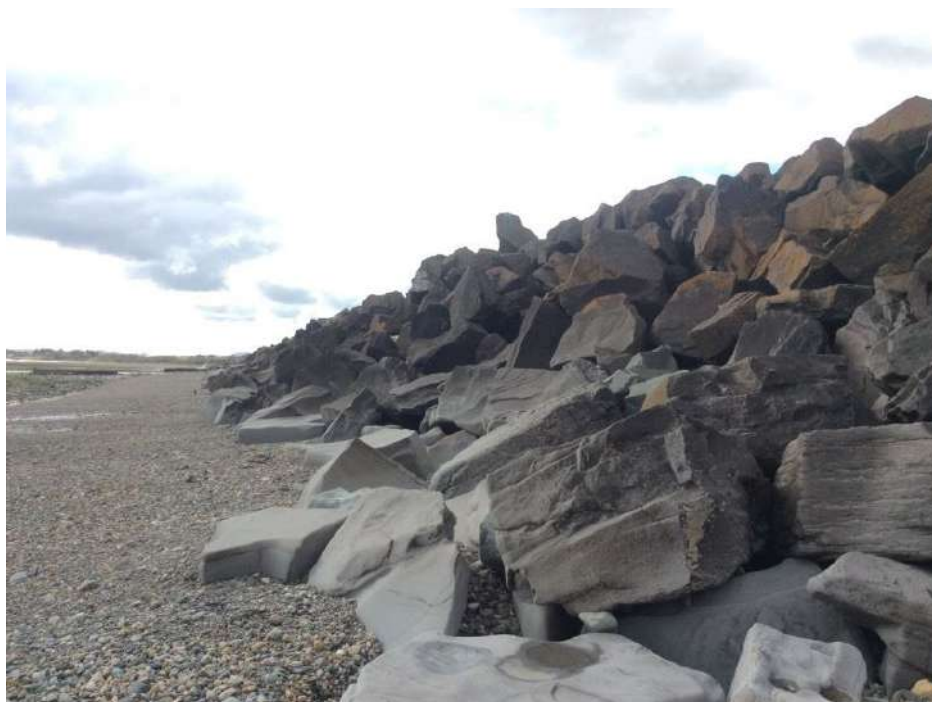
**Section A**  
**Embankment**  
**Armour**  
**Defect Ref: D27**  
**Description:** Overly steep rock profile with a poor interlock between the rock units. There was no change between 2021-2022 examinations.  
**Photo number: 53**

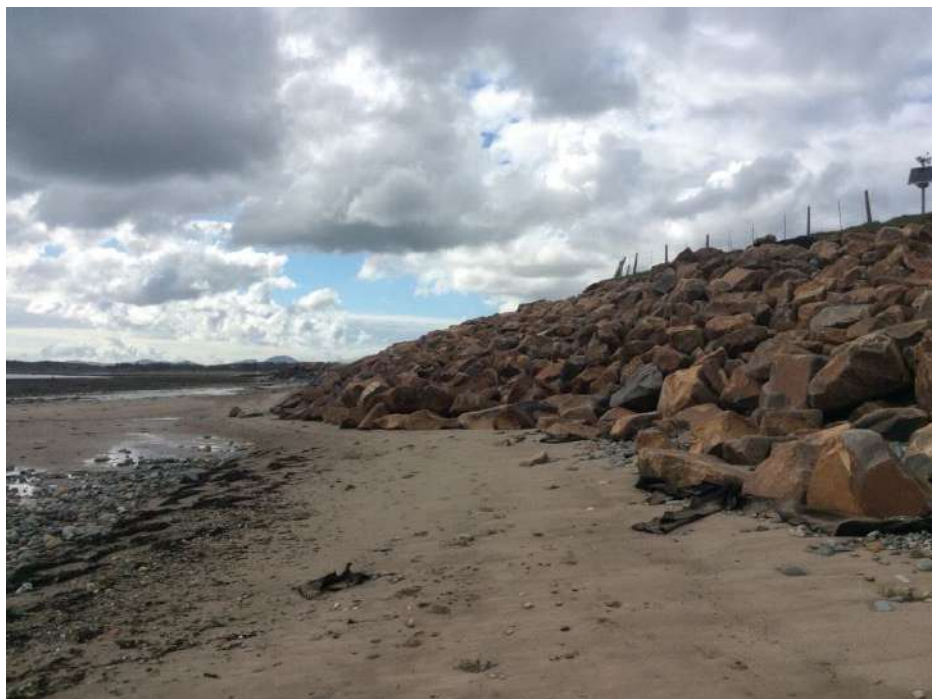
**Section A**  
**Embankment**  
**Armour**  
**Defect Ref: D35**  
**Description:**  
Remaining armour is  
steep and minimal.  
No change between  
2021 and 2022  
examinations.  
**Photo number: 41**

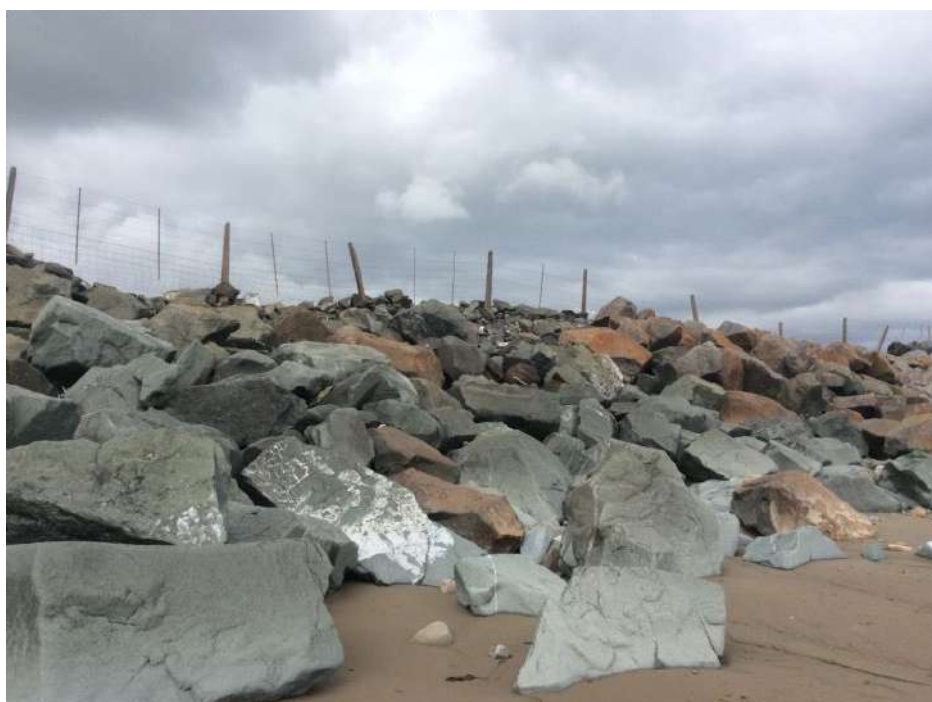
**Section A**  
**Embankment**  
**Armour**  
**Defect Ref: D36**  
**Description:** Crest is  
formed of poorly  
graded rock armour.  
There was no change  
between the 2021  
and 2022  
examinations.  
**Photo number: 45**

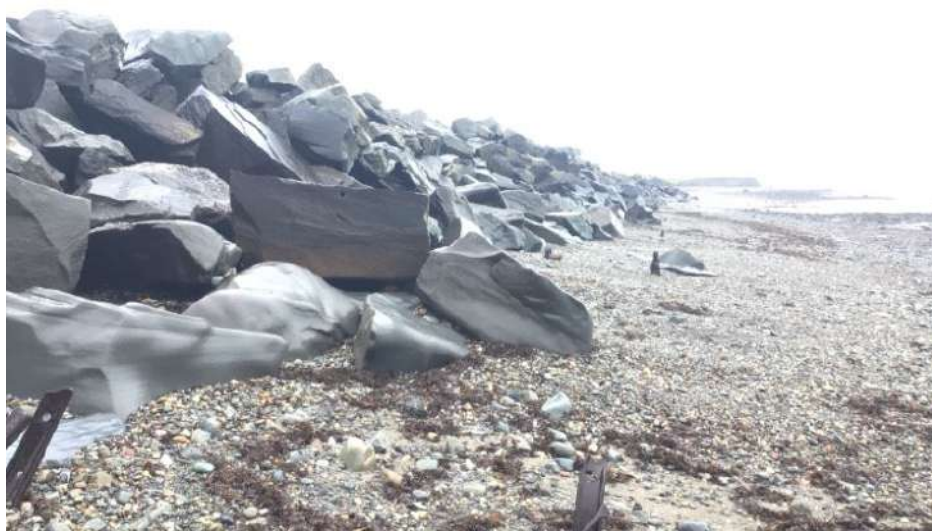
**Section B**  
**Parapet/Capping**  
**Defect Ref: D42**  
**Description:** Very steep rock armour. During the 2022 examination, areas of very steep rock armour were observed with potentially unstable units and other split units  
**Photo number: 128**

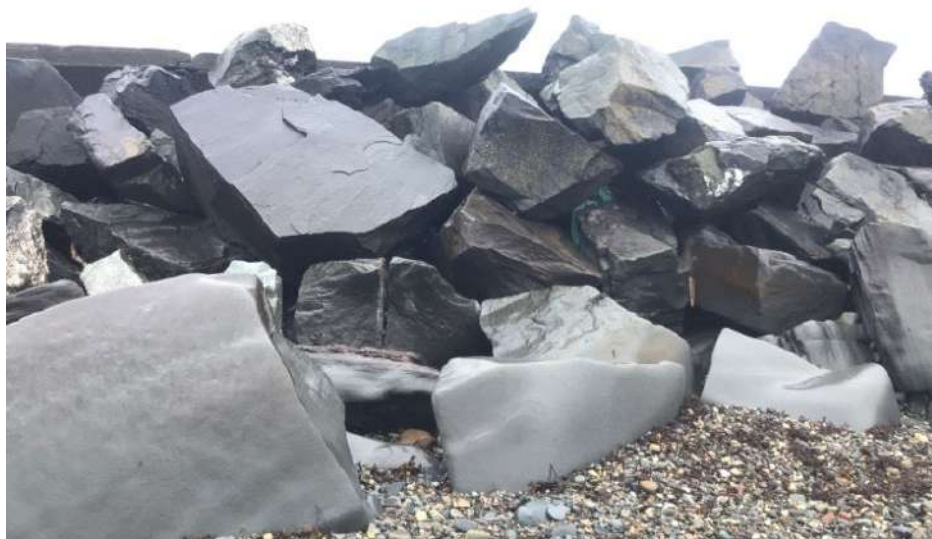
**Section B**  
**Parapet/Capping**  
**Defect Ref: D42**  
**Description:** Very steep rock armour. During the 2022 examination, areas of very steep rock armour were observed with potentially unstable units and other split units  
**Photo number: 130**

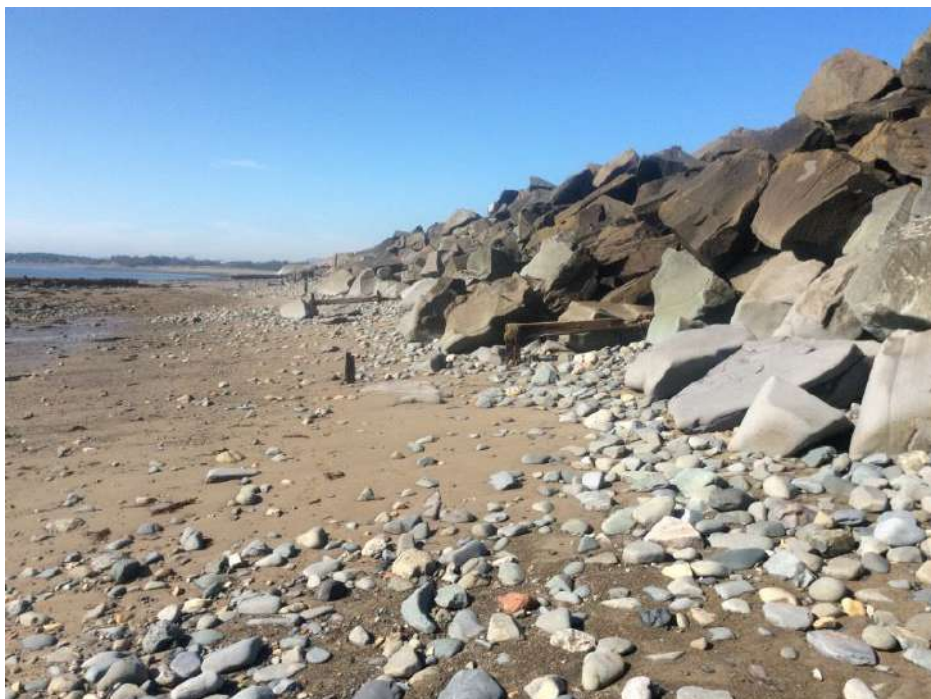
**Section B**  
**Parapet/Capping**  
**Defect Ref: D43**  
**Description:**  
Broken/failed  
groynes. There was  
no change between  
the 2021 and 2022  
examinations.  
**Photo number: 30**

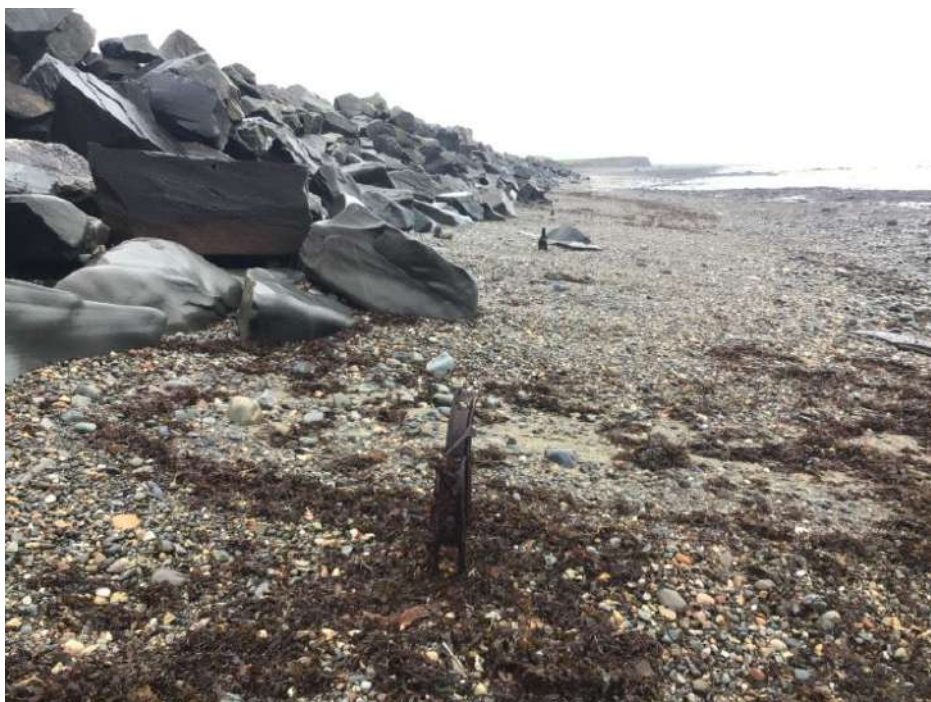
**Section B**  
**Parapet/Capping**  
**Defect Ref: D43**  
**Description:**  
Broken/failed  
groynes. There was  
no change between  
the 2021 and 2022  
examinations.  
**Photo number: 127**

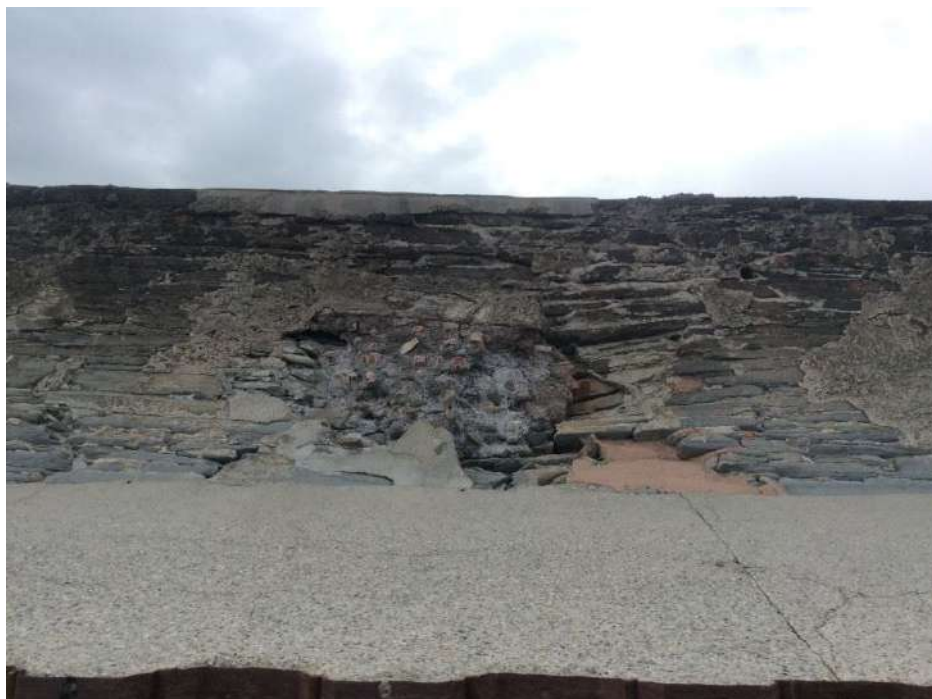
**Section B**  
**Parapet/Capping**  
**Defect Ref: D45**  
**Description:** Scour damage to poor repair on the face of the wall. During the 2022 examination, deterioration to the lower section of the patch repair was noted with visible loss of material.  
**Photo number: 76**

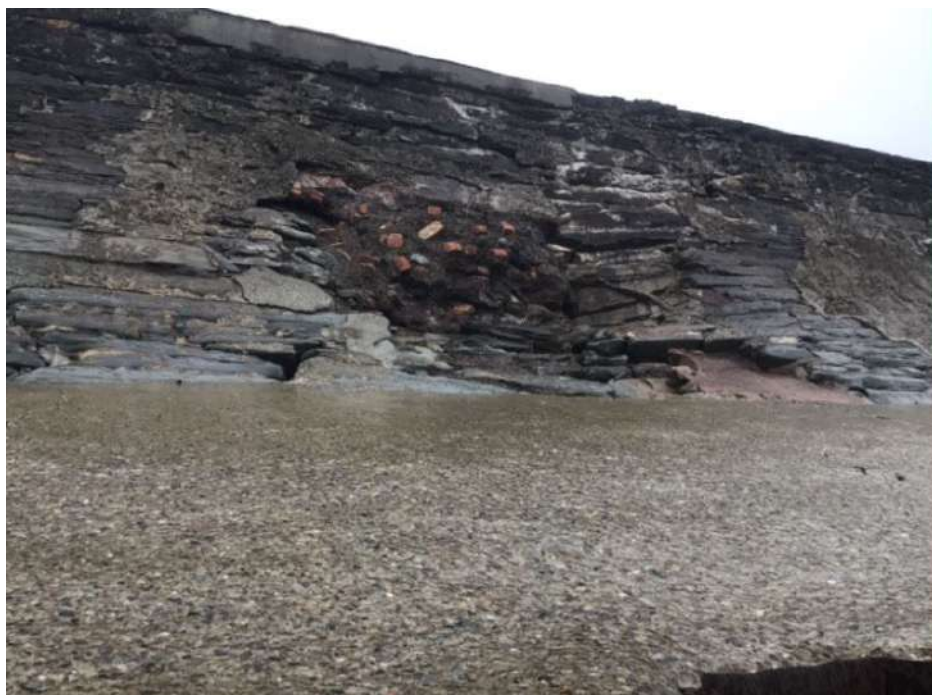
**Section B**  
**Parapet/Capping**  
**Defect Ref: D45**  
**Description:** Scour damage to poor repair on the face of the wall. During the 2022 examination, deterioration to the lower section of the patch repair was noted with visible loss of material.  
**Photo number: 148**

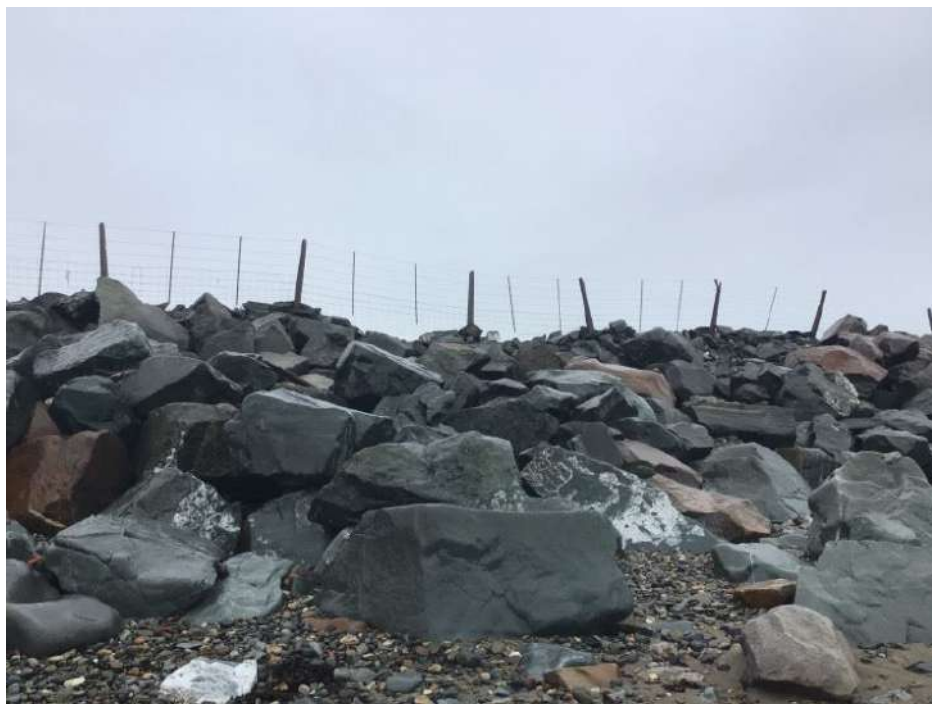
**Section A**  
**Embankment**  
**Armour**  
**Defect Ref: D49**  
**Description:** An unstable concrete fence post creating potential health and safety hazard should the post or fence fail. There has been no change between the 2021 and 2022 examinations.  
**Photo number: 142**

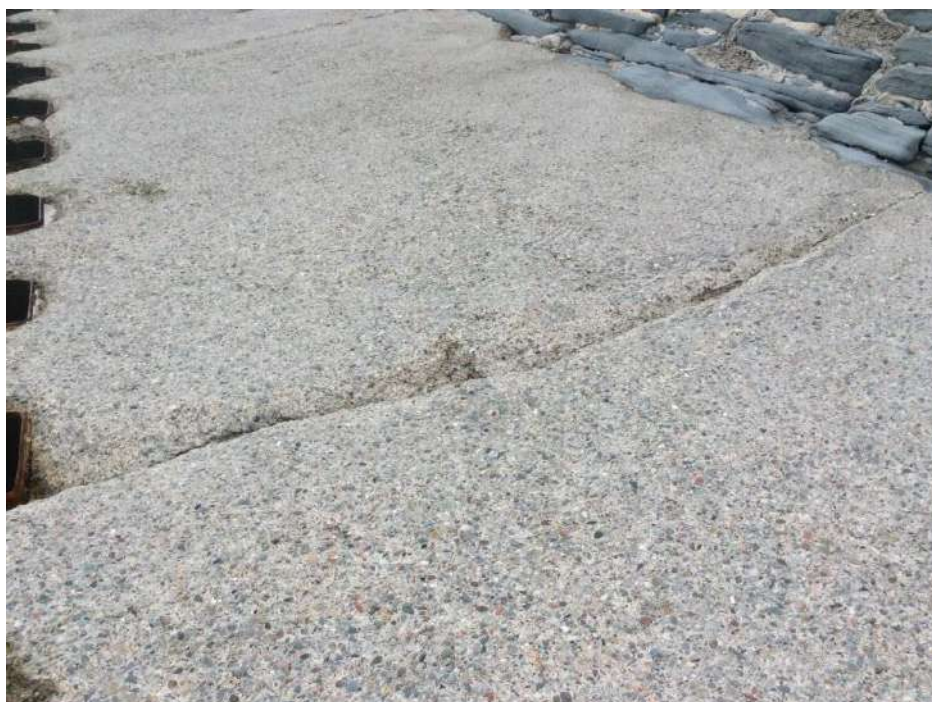
**Section B**  
**Wall Apron**  
**Defect Ref: D50**  
**Description:** Scour at the joints between apron units for approx. 40m. There was no change between the 2021 and 2022 examinations.  
**Photo number: 68**

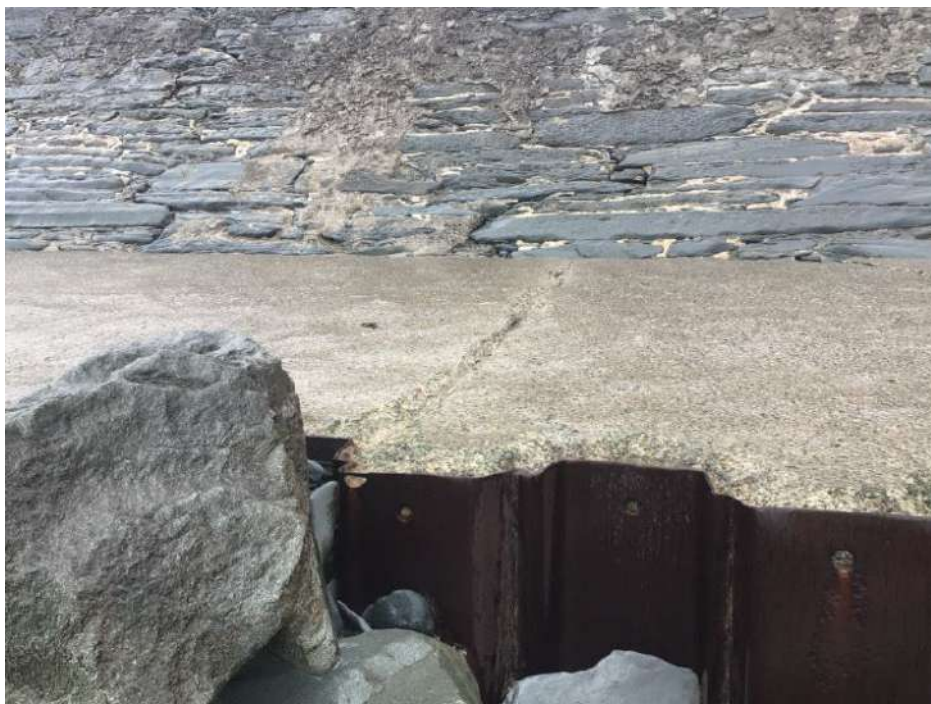
**Section B**  
**Wall Apron**  
**Defect Ref: D50**  
**Description:** Scour at the joints between apron units for approx. 40m. There was no change between the 2021 and 2022 examinations.  
**Photo number: 116**

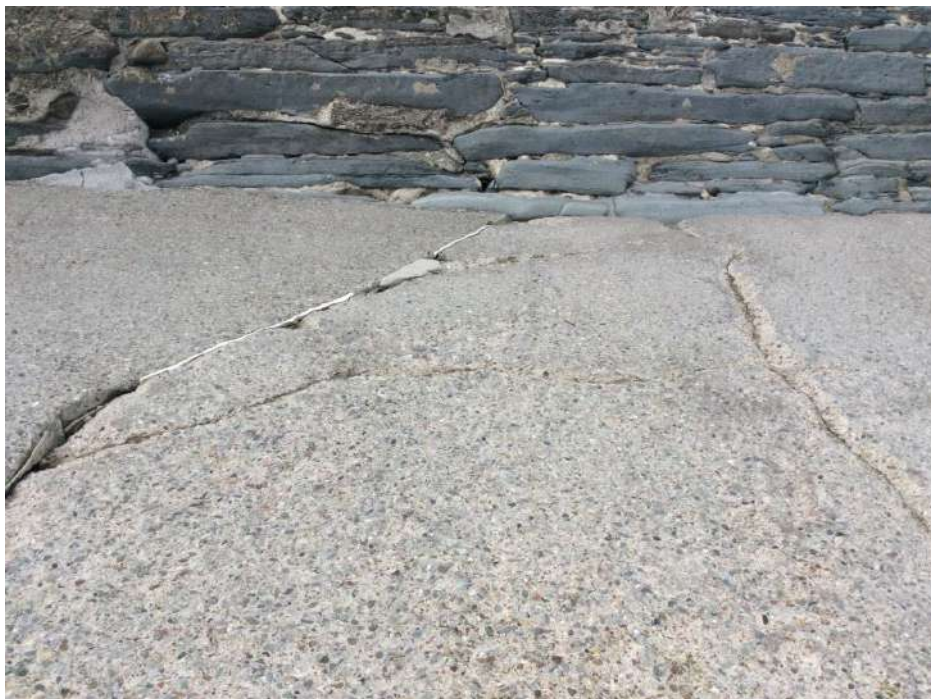
**Section B**  
**Wall Apron**  
**Defect Ref: D51**  
**Description:** Cracks in the concrete apron. During the 2022 examination, multiple large cracks and removed material creating voids were observed throughout the large concrete slabs.  
**Photo number: 69**

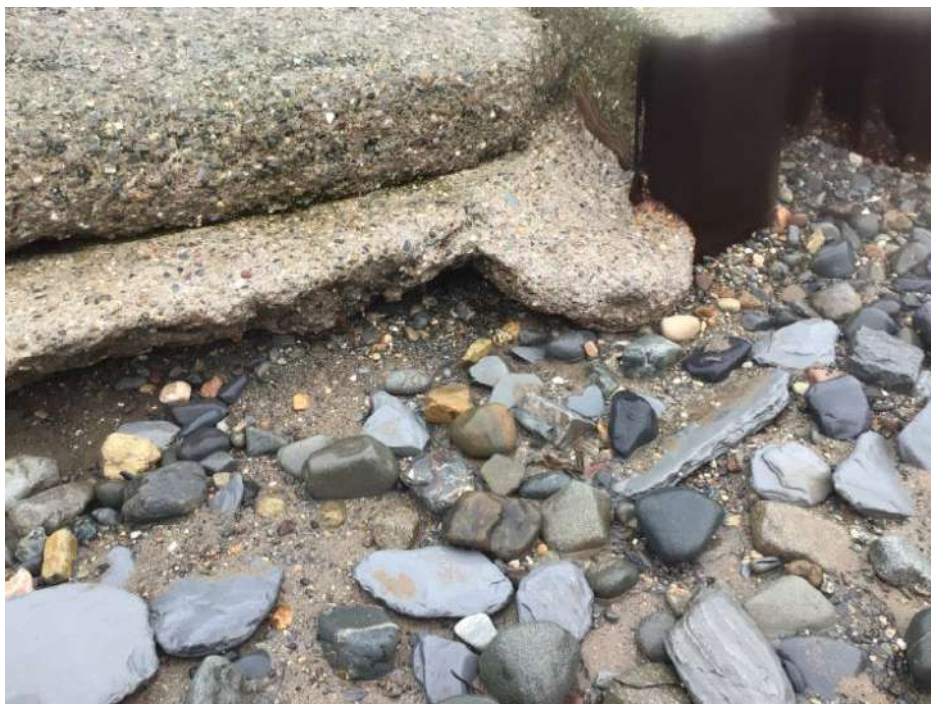
**Section B**  
**Wall Apron**  
**Defect Ref: D53**  
**Description:** Water seepage through the base of concrete apron.  
**Photo number: 93**

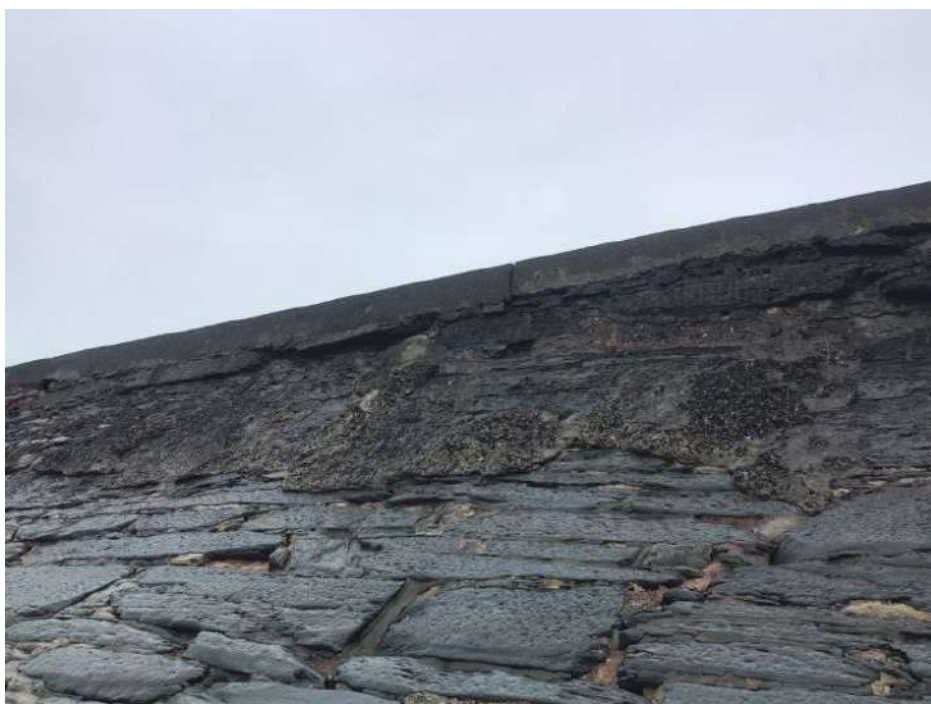
**Section B**  
**Parapet/Capping**  
**Defect Ref: D54**  
**Description:** Voiding between capping and the crest.  
**Photo number: 95**

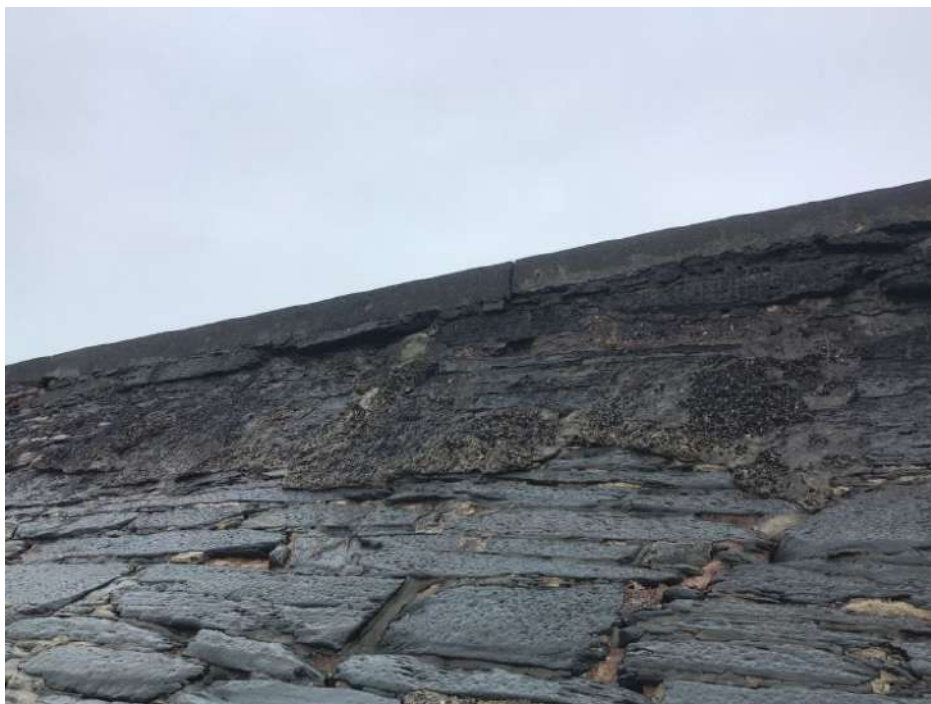
**Section B**  
**Parapet/Capping**  
**Defect Ref: D54**  
**Description:** Voiding  
between capping and  
the crest.  
**Photo number: 96**

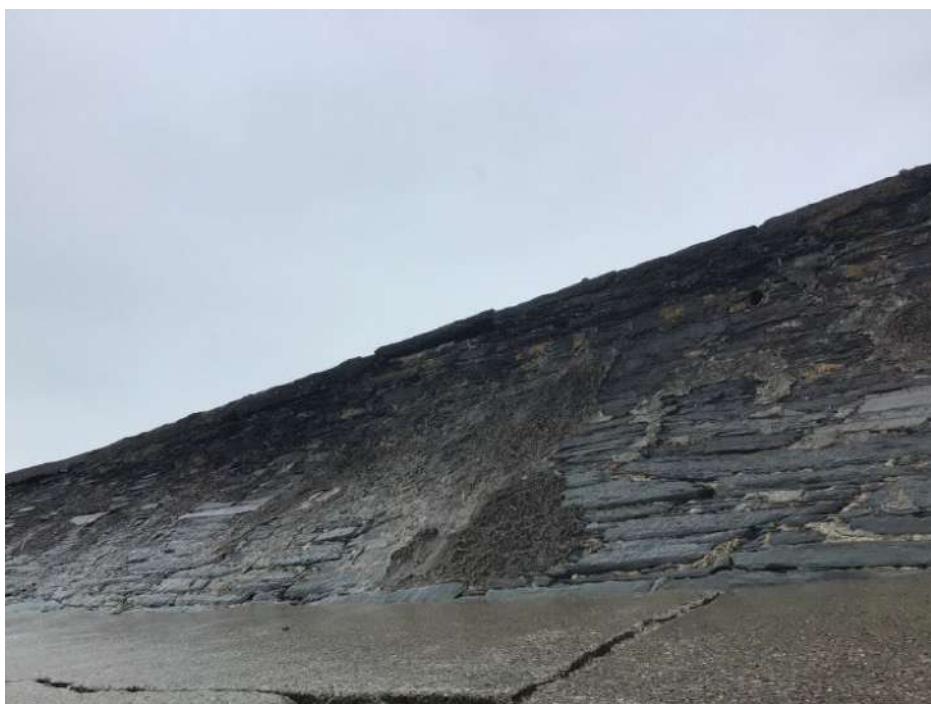
**Section B**  
**Parapet/Capping**  
**Defect Ref: D54**  
**Description:** Voiding  
between capping and  
the crest.  
**Photo number: 109**

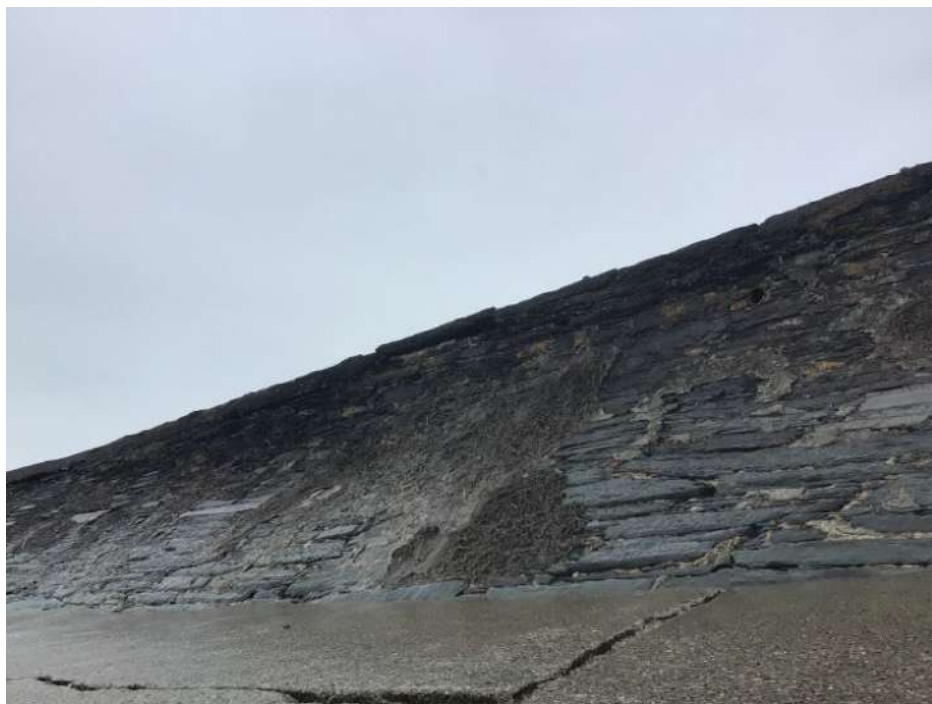
**Section B**  
**Parapet/Capping**  
**Defect Ref: D54**  
**Description:** Voiding  
between capping and  
the crest.  
**Photo number: 110**

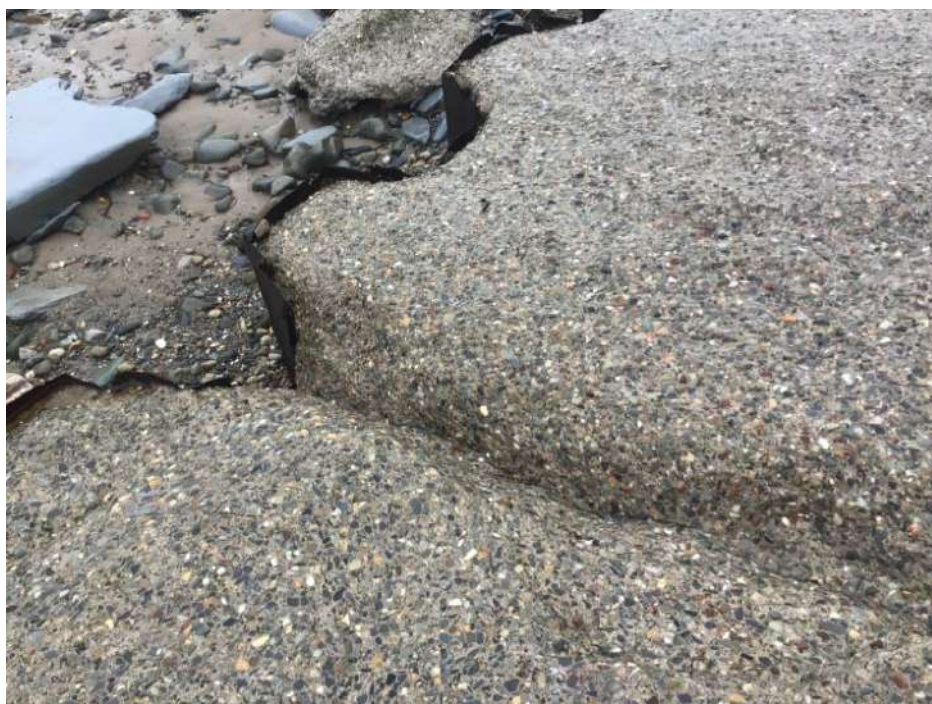
**Section B**  
**Wall Apron**  
**Defect Ref: D55**  
**Description:** Spalling  
to the concrete apron  
material.  
**Photo number: 99**

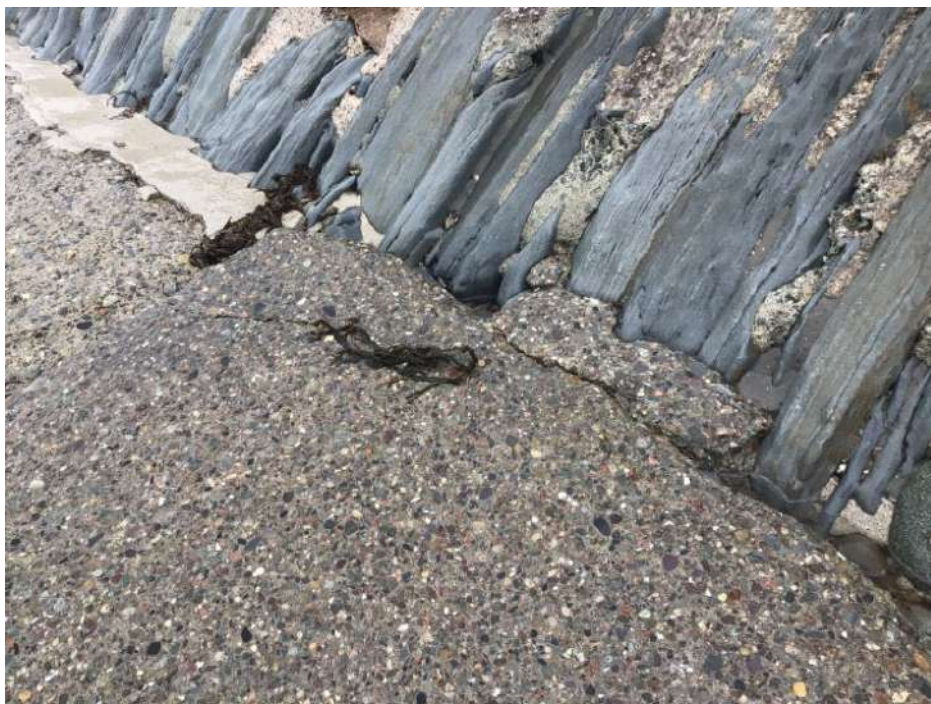
**Section B**  
**Wall Apron**  
**Defect Ref: D56**  
**Description:**  
Concrete void with  
crack in left hand  
corner of slab.  
**Photo number: 100**

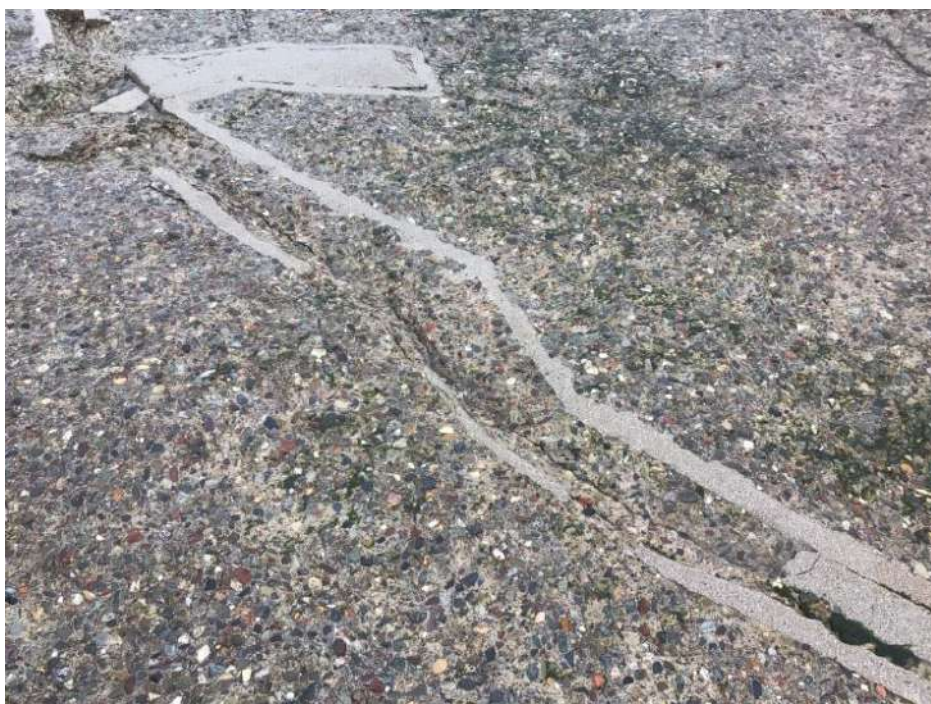
**Section B**  
**Wall Apron**  
**Defect Ref: D57**  
**Description:** Missing  
patch repair material  
with multiple cracks  
present.  
**Photo number: 101**
