DŴR CYMRU WELSH WATER

EVENT DURATION MONITORING

EDM TEN Initial Investigation Report – BP0237412
Sandfields SPS (CSO 121)

Asset ID No. 51148

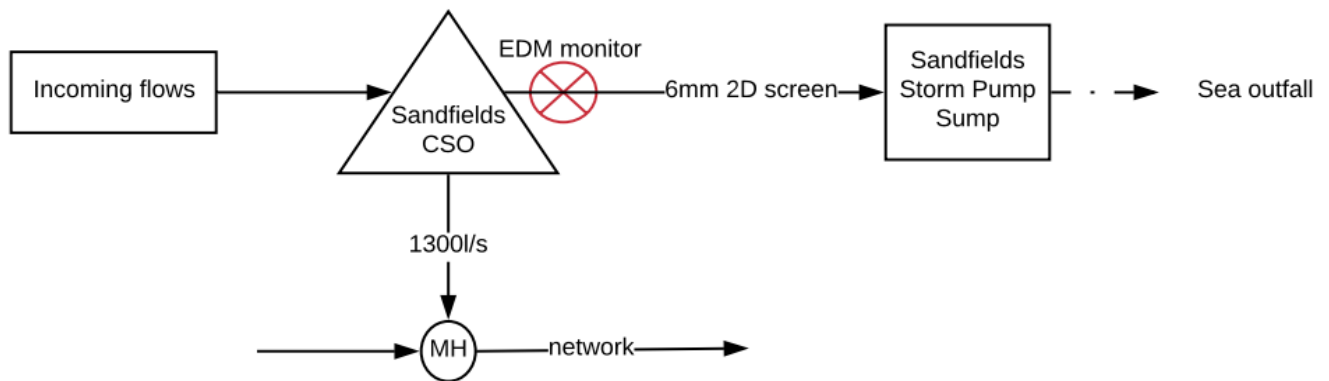
Figure 2: Sandfields SPS configuration

If the flow coming into the CSO exceeds the capacity of the downstream flow control, a spill occurs due to the downstream network surcharge. Spill flows pass up, through the screen and over the weir and gravitates to the discharge point via the long sea outfall. If there is a high tide and the outfall becomes hydraulically locked, flow enters the storm pump sump, and the pumps lift flows to create sufficient hydraulic head to pass flows down the outfall.

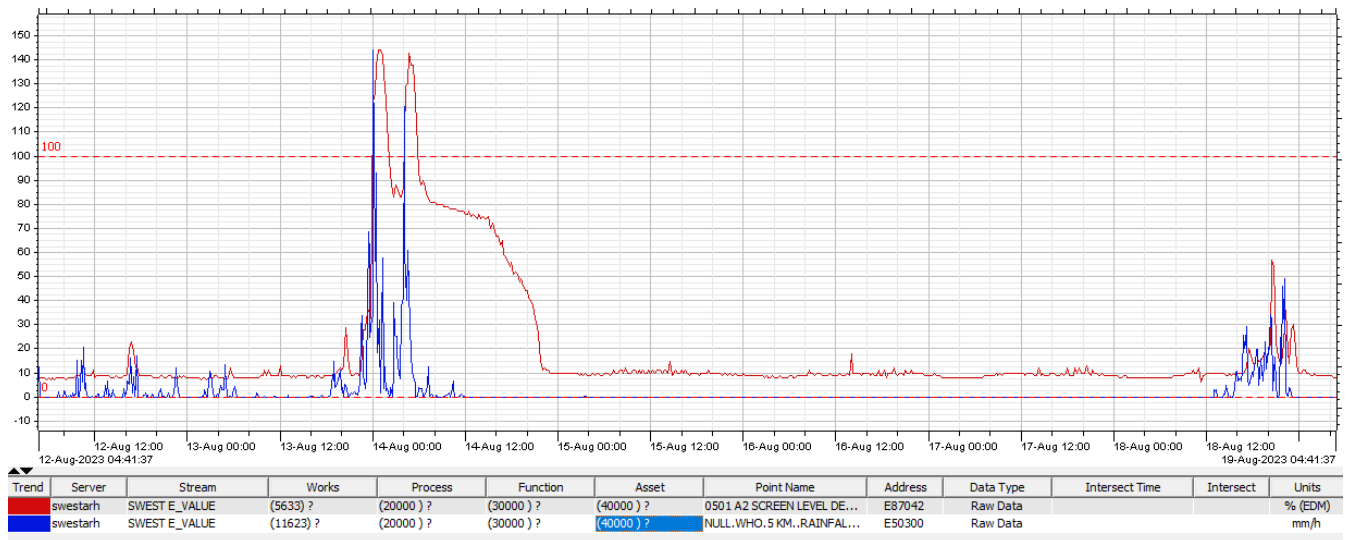
Previous investigations identified telemetry trends of the storm sump partially filling on a 12-hour cycle, suggesting there is tidal infiltration to the storm sump, and requires further investigation.

Figure 3: Red displays wet well level. Dotted red line indicates spill level. Blue displays rainfall. Data correlates to rainfall events and suggest hydraulic overload issues.
