EVENT DURATION MONITORING

November 2023

**EDM TEN Initial Investigation Report –
BW3206201
Penybont SWK**

Asset ID No. 50743

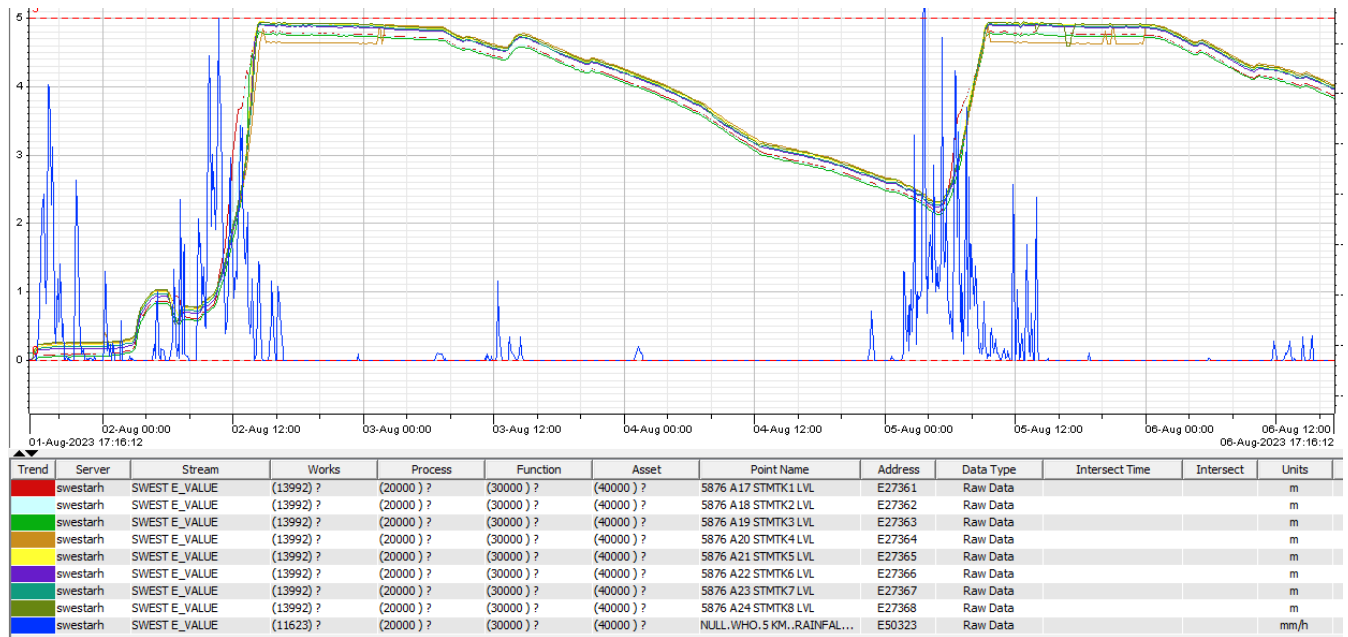
A review of the telemetry data has been carried out for the period of recorded spills across the 2023 bathing water season. Data sets for spills are consistent with response to rainfall events in the catchment and also other monitored assets in the surrounding area. All discharges occurred when the permit requirements were met i.e., inlet flows exceeded 1650l/s, and storm tanks were utilised to full capacity (21,896m³) prior to any spills taking place.

Figure 3 - Blue displays rainfall. All other colours represent the 8 storm tanks. Data indicates direct link to rainfall events and suggest hydraulic overload issues, leading to excess flows being passed to storm tanks.
