## SCHEDULE 5 Notification

### Part B

| Name of Operator: | Tata Steel UK Ltd |
| Location of Facility: | Port Talbot Works |

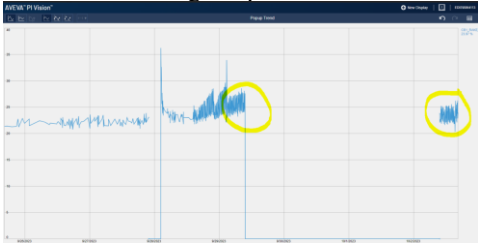
- Altrad, who operate the sludge removal from the DC clarifier systems for pressing, reported no issues during the period (verbally or in any shift reports).
- The torque on the DC clarifier rakes, which indicate if the DC clarifiers are too full (Torque increases and there then a risk of the suspended solids

| | <p>tipping the DC clarifiers affecting sump no.5) were reviewed and gaps were found during the period of week 40.</p> <ul style="list-style-type: none"> <li>• Additionally, if the concentrated sludge line from clarifier to holding tank/presses gets blocked, Altrad bubble back argon to release the blockage which raises the TSS in the clarifier (this reduces the rake torque significantly). This process disturbs the settled sludge, which can affect sump no. 5 TSS and Fe ppm. During an Argon bubbling event, Altrad must inform Tata, however, no such event or notification was conducted. After the investigation, all parties determined it would be good to also capture a procedure where BOS plant notify Environment of any Argon Bubbling, and diversion of effluent stream can be conducted to avoid elevated Fe at W1 LSO.</li> <li>• During the event, the BOS gas condensate line downpipe was being flushed by Energy on 23<sup>rd</sup>/24<sup>th</sup> Sept 2023. During this process, the water and Fe would have entered the groundwater system and eventually resided at the Gilly's, which on level, transfer to sump no.5. A sample of the contaminated water from the condensate line was analysed and found to be 287ppm total Fe and Energy confirmed the volume would have been less than 10m<sup>3</sup>, so at this concentration and volume we concluded this would not have caused 77.57ppm total Fe we saw at sump no.5 on the 2<sup>nd</sup> Oct 2023.</li> </ul> | |

| Measures taken, or intended to be taken, to prevent a recurrence of the incident | <ul style="list-style-type: none"> <li>• After the investigation, all parties determined it would be good to capture a procedure where BOS plant notify Environment of any Argon Bubbling. Following communication, sump no.5 can be diverted to Nautilus to drop out the TSS and avoid elevated Fe at W1 LSO.</li> <li>• DC water TSS are monitored daily to help understand the risk.</li> <li>• During period of elevated TSS in the DC water and sump no.5 the effluent can and was diverted to Nautilus to help drop out the TSS and reduce the risk of breaches of Fe.</li> </ul> | |
