**SOUTH SIDE  
QUEENSWAY WASTE  
MANAGEMENT SITE,  
LLANWERN STEELWORKS**

**2021 Annual Review of  
Environmental  
Monitoring**

*Report Number 2103r2v1d0122*

*Prepared by*  
Geotechnology Ltd  
Ty Coed  
Cefn-yr-Allt  
Aberdulaish  
SA10 8HE

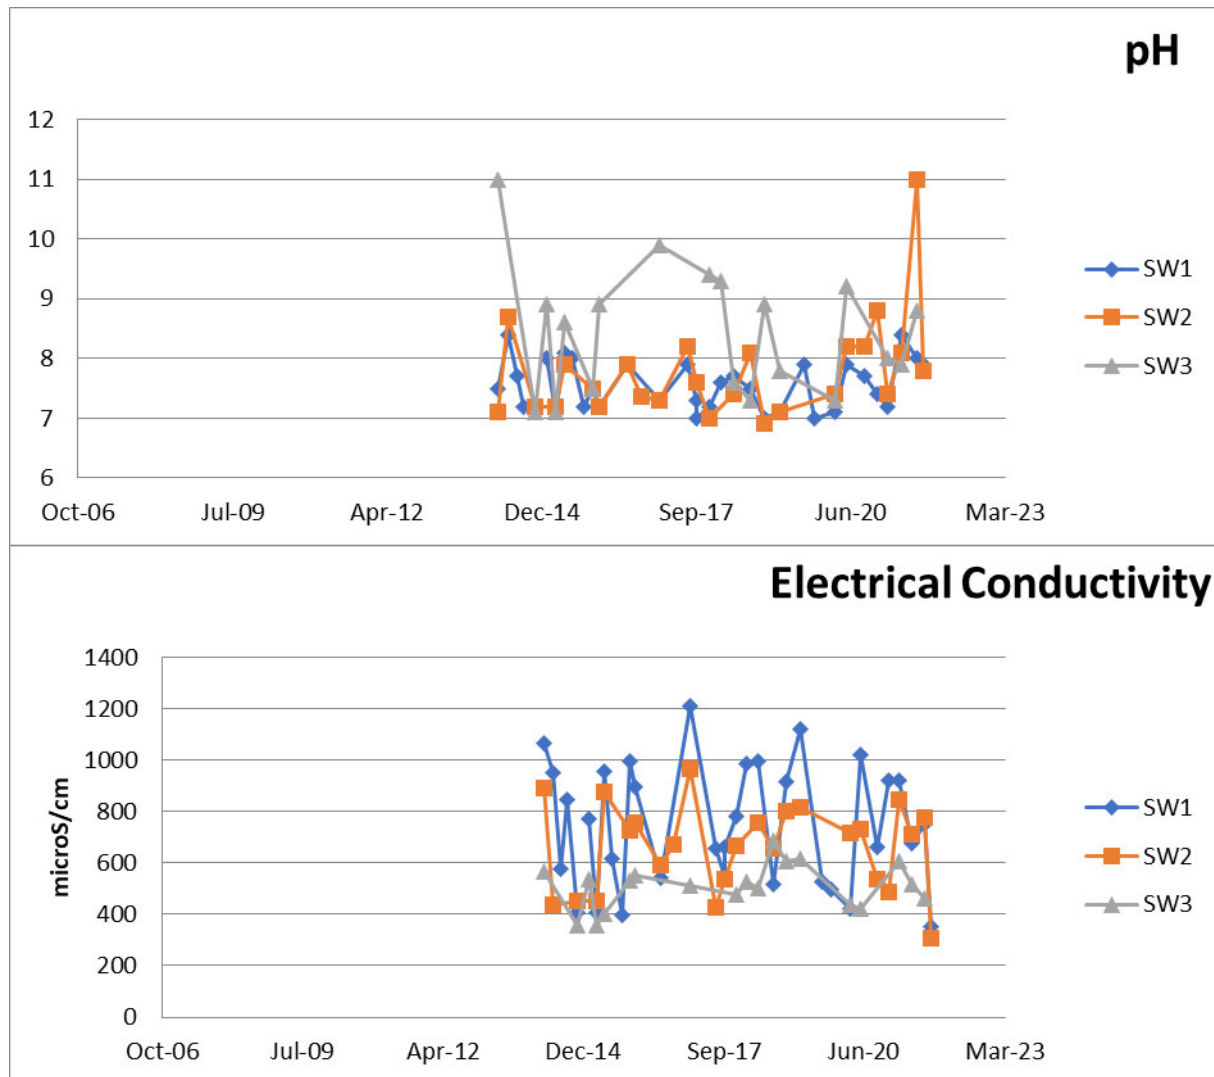
**Plate 6-1 Variations in surface water chemistry**

Surface water is typically circumneutral, moderately mineralised with low levels of non-hazardous and hazardous substances. There are sometimes short-term variations in trace metal concentrations but no persistent trends indicating deteriorating water quality. Some of the data trends may be influenced by the timing of sampling relative to ditch clearance and maintenance, as shown in Plate 6-2. During 2021, there were no breaches of the Annual Average EQS at any of the surface water monitoring points. In October 2021, some of the highest surface water levels observed were found at SW1 (compare Plates 6-2 and 6-3). This was due to significant rainfall in the preceding 24 hrs.
