**SOUTH SIDE  
QUEENSWAY WASTE  
MANAGEMENT SITE,  
LLANWERN STEELWORKS**

**2018 Annual Review of  
Environmental  
Monitoring**

*Report Number 1785r2v1d0219*

**February 2019**

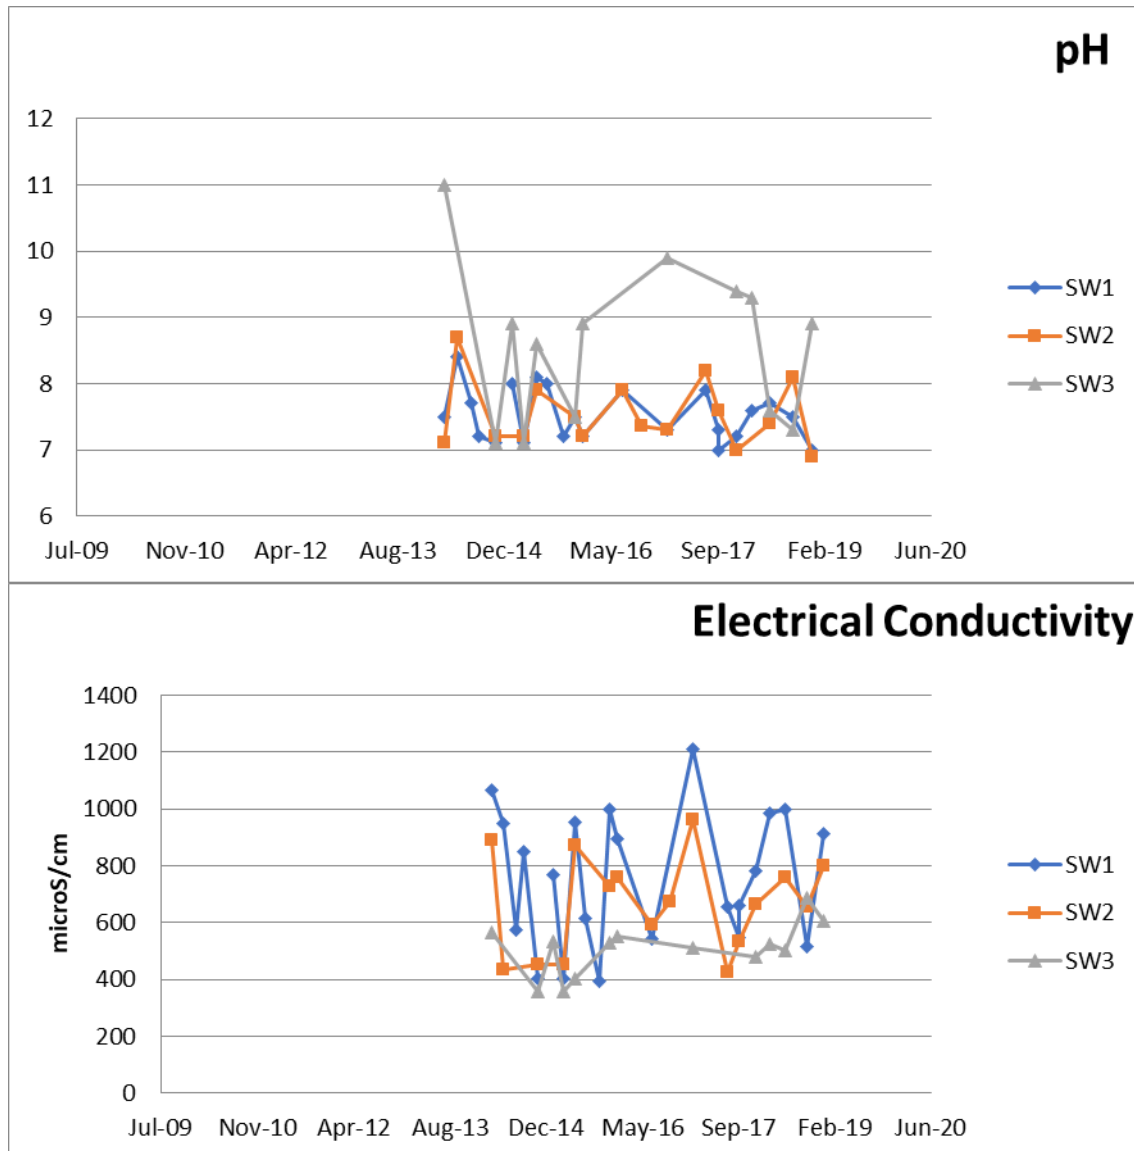
Surface water is circumneutral, moderately mineralised with low levels of non-hazardous substances. As surface water progress from east to west, the mineralisation decreases from ~ 800 microS/cm to less than 600 microS/cm. The main reason for this change is decreasing alkalinity although most parameters are lower downgradient of SW1. Apart from a few short-term breaches, all data is typically within Environmental Quality Standards. Phosphate was detected at increased concentrations in 2017. In 2018, concentrations were low / below detection limit for most of year apart from September when 27 mg/l was detected at SW3, 43 mg/l at SW2 and 77 mg/l at SW1. Phosphate was not detected in the made ground or peat and the source is unclear at this stage.

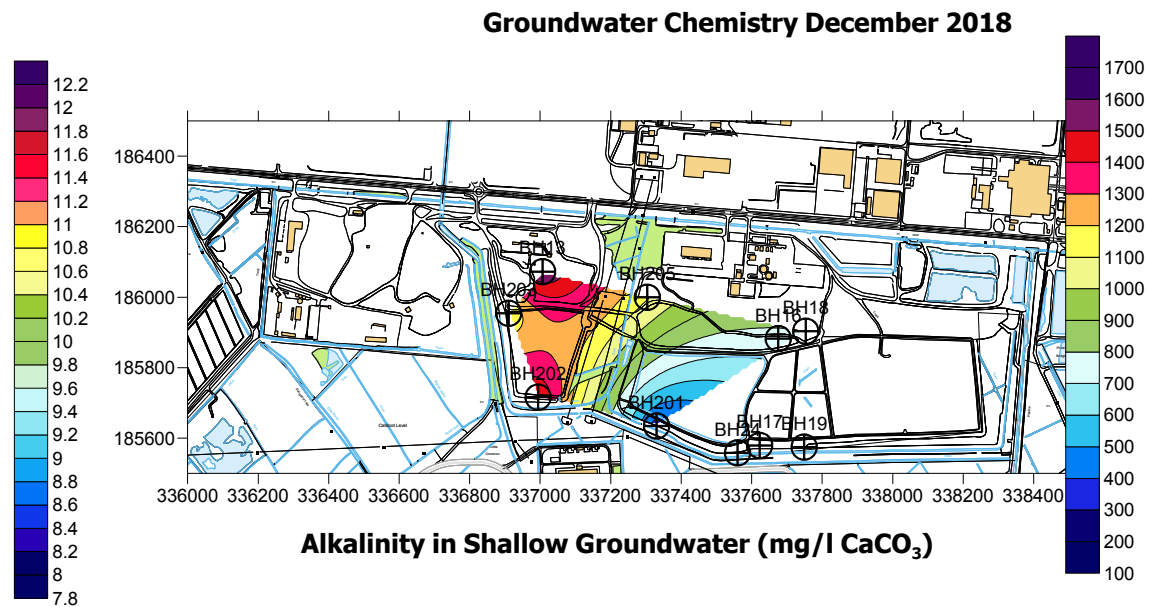
**pH in Shallow Groundwater**

The data indicate that groundwater within the shallow made ground is distinct and characterised by elevated pH (typically > pH 11). This is principally because the made ground comprises steel slag that leaches lime. In comparison, the groundwater in the peat is circumneutral (pH 6 – 8) although there is potential evidence of some interconnection between the made ground and peat at BH202, as the pH is elevated at this point. Groundwater chemistry tends to become more dilute from north to south.

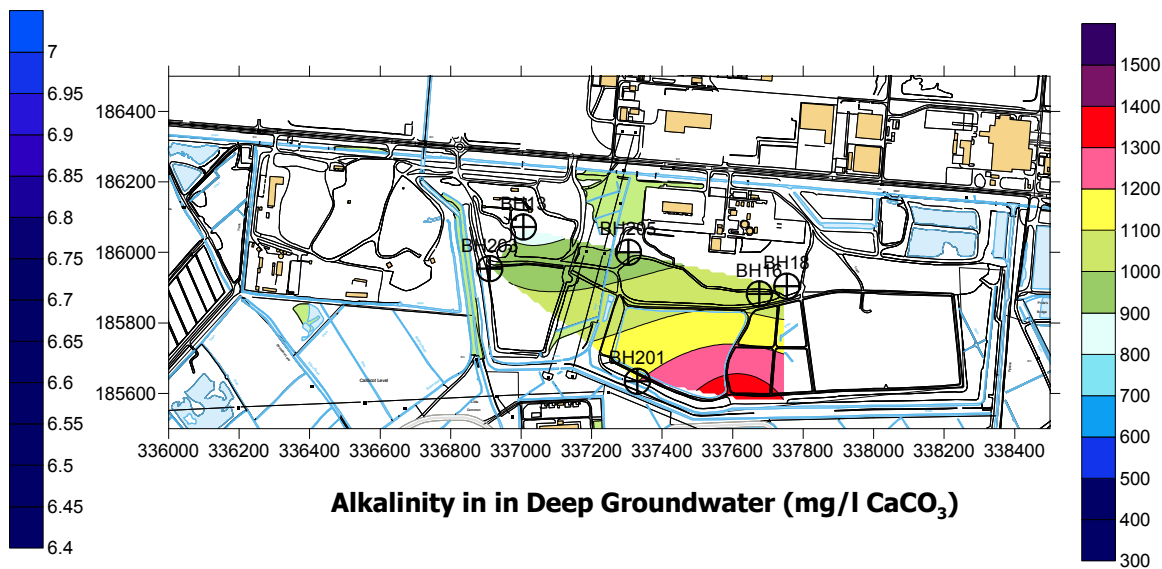
**pH in Deep Groundwater**

Groundwater in the Mercia mudstone is only monitored at BH24, to the south of Lagoon 25. Like the groundwater found in the peat, the groundwater in the bedrock has a circumneutral pH and elevated electrical conductivity (4000-6000 microS/cm in 2017). During 2017, the mineralisation was increasing due, in part, to sustained increases in chloride and ammonia. In 2018, mineralisation has been stable. The levels currently observed are similar to those observed previously. The precise cause of these variations is unclear.
