**CONSTRUCTION QUALITY ASSURANCE
2023 GEOCOMPOSITE DRAINAGE LAYER AND SOILS CAP
VALIDATION REPORT**

AT PWLLFAWATKIN LANDFILL SITE

CQA Validation Report Reference: WR7957/05/02
January 2024

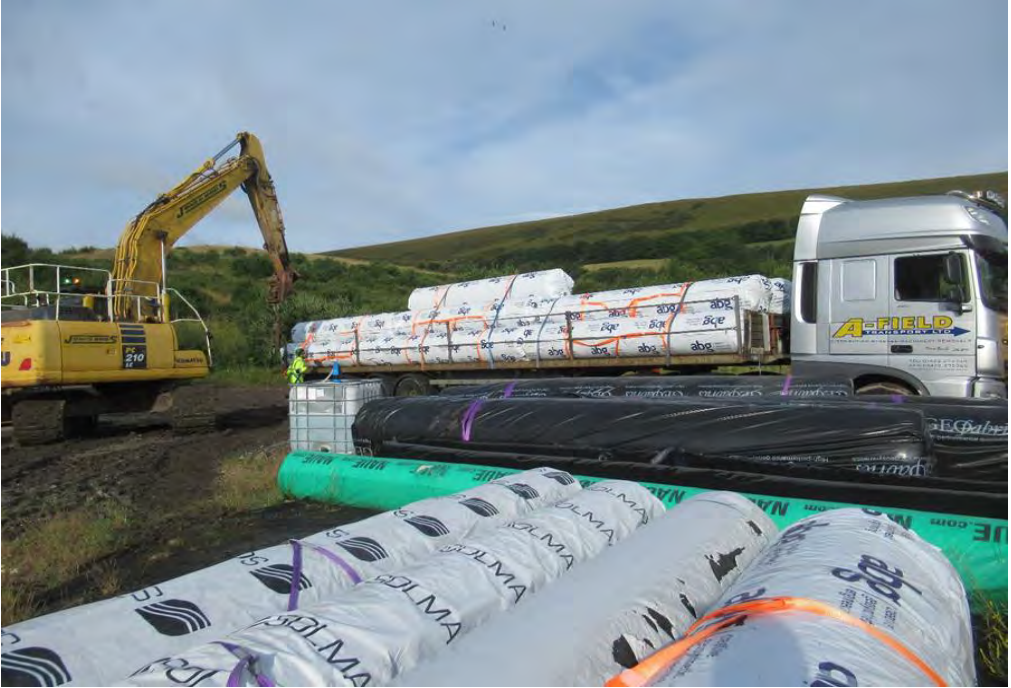
Plate:
1

Materials Received

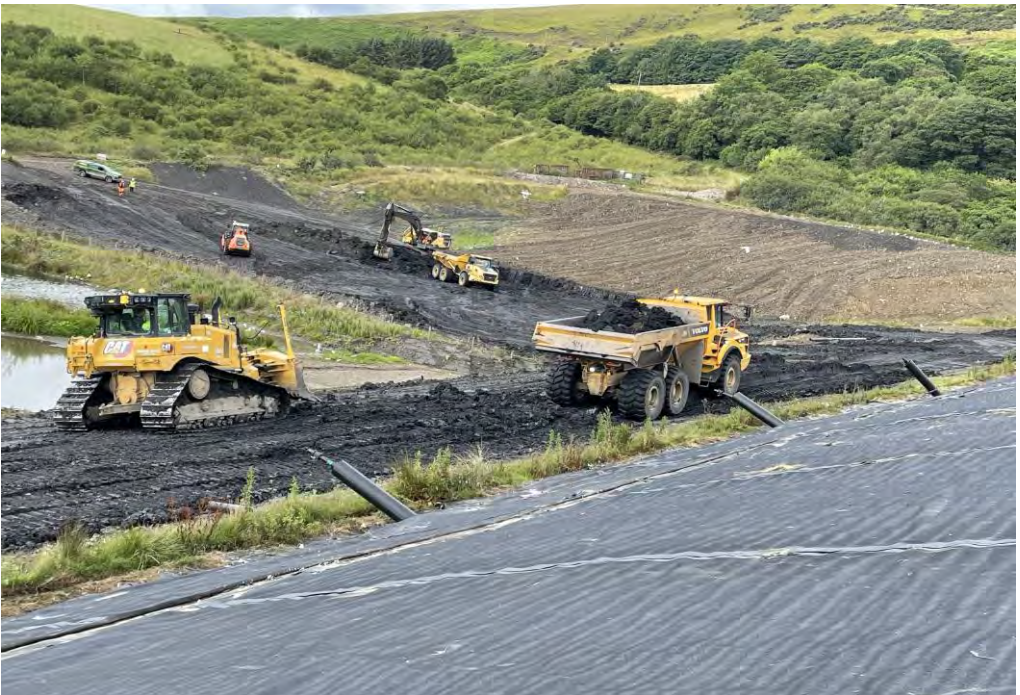
Plate:
2

Preparing Working Area

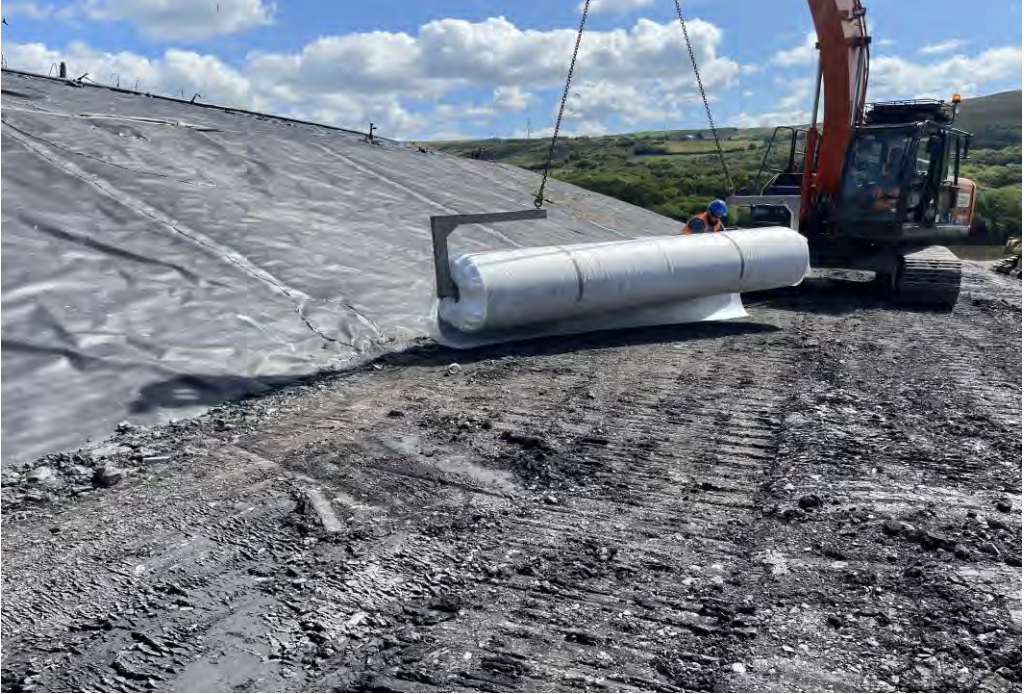
Plate:
3

Preparing to Deploy GDL

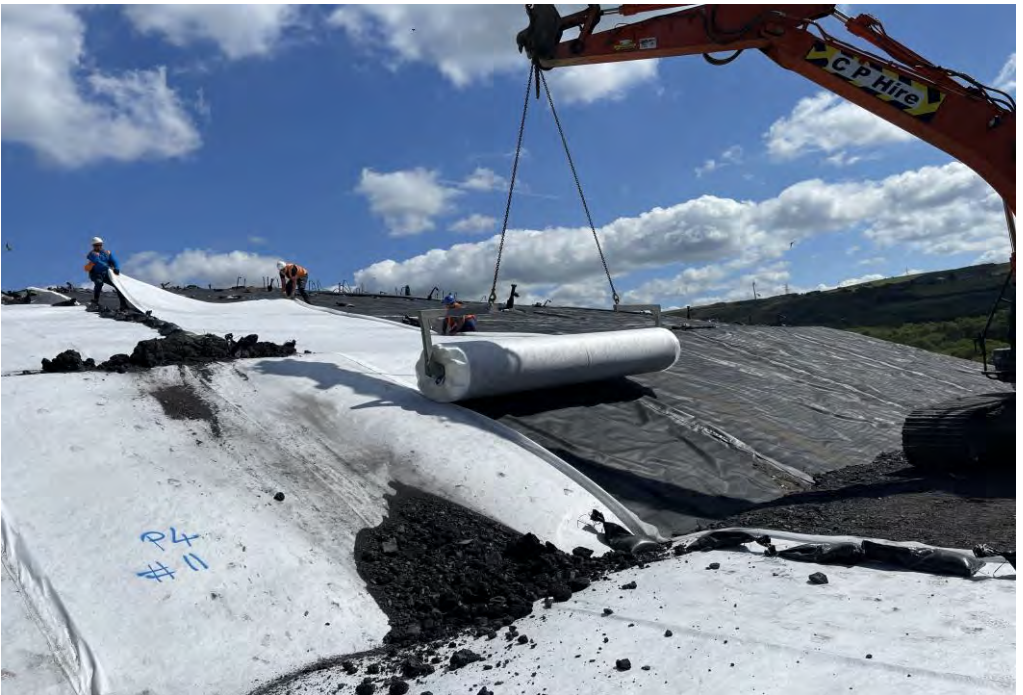
Plate:
4

GDL Deployment in Progress

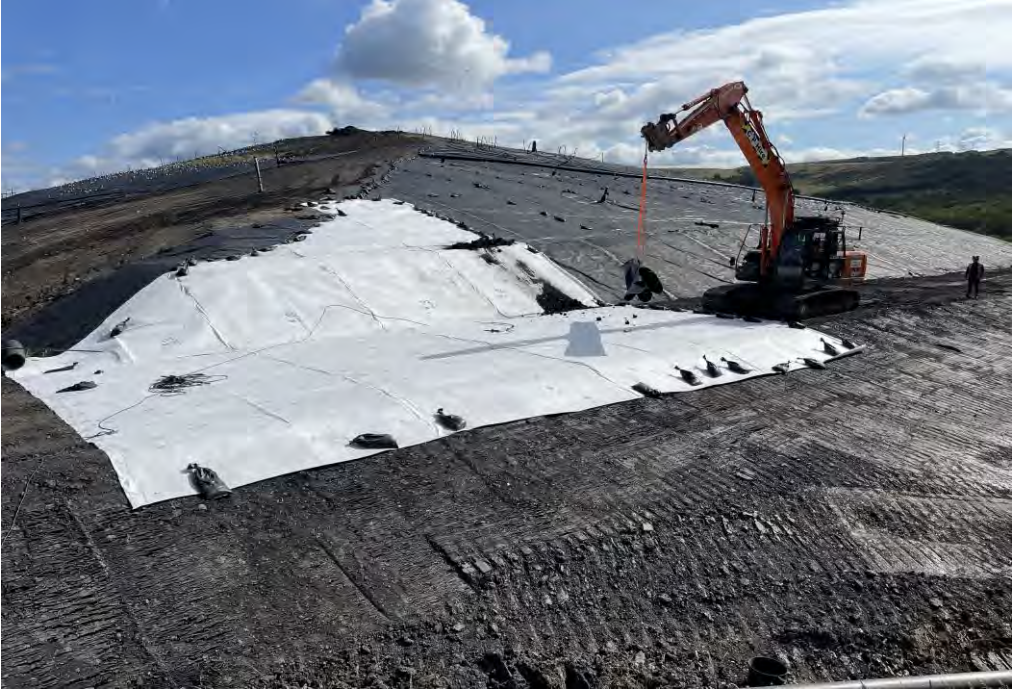
Plate:
5

Overview of Works

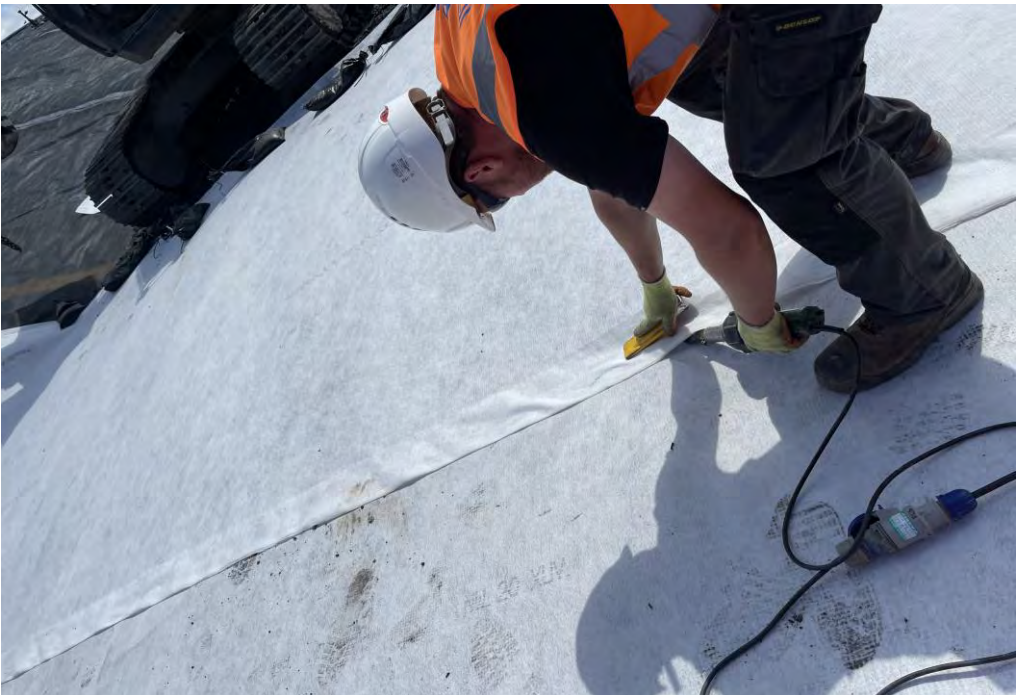
Plate:
6

Heat Bonding Material

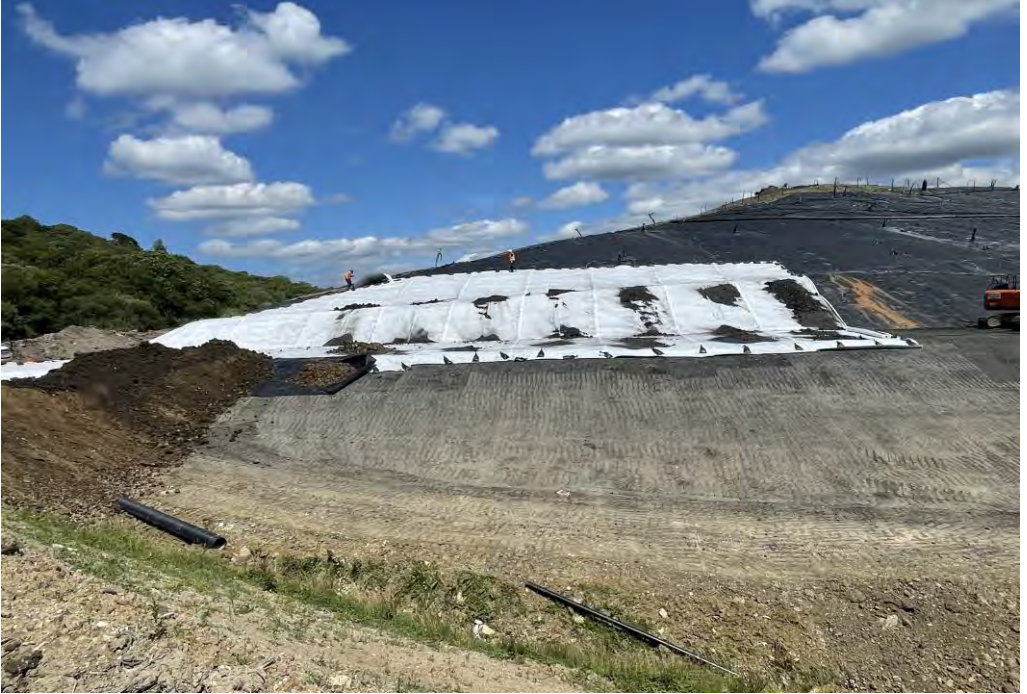
Plate:
7

Overview of Works

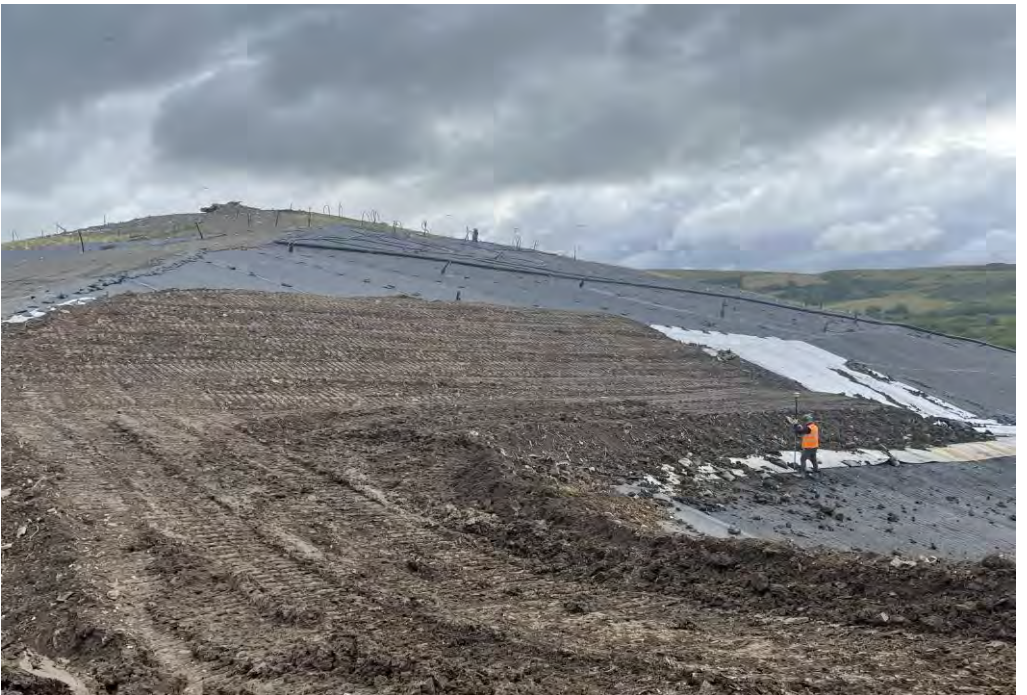
Plate:
8

Place Restoration Material

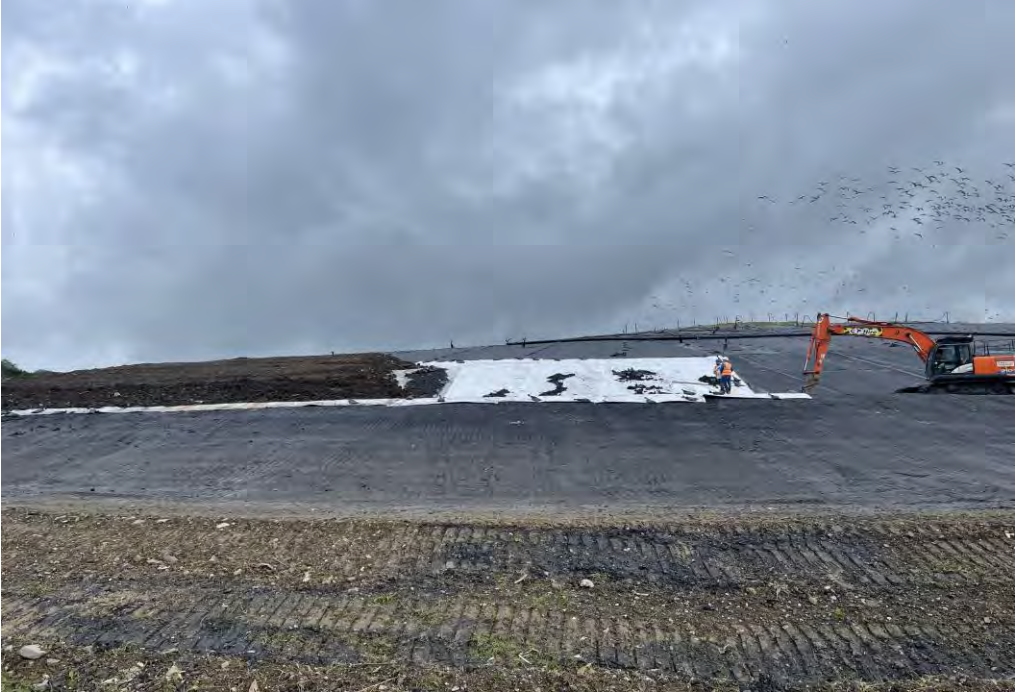
Plate:
9

Overview of Works

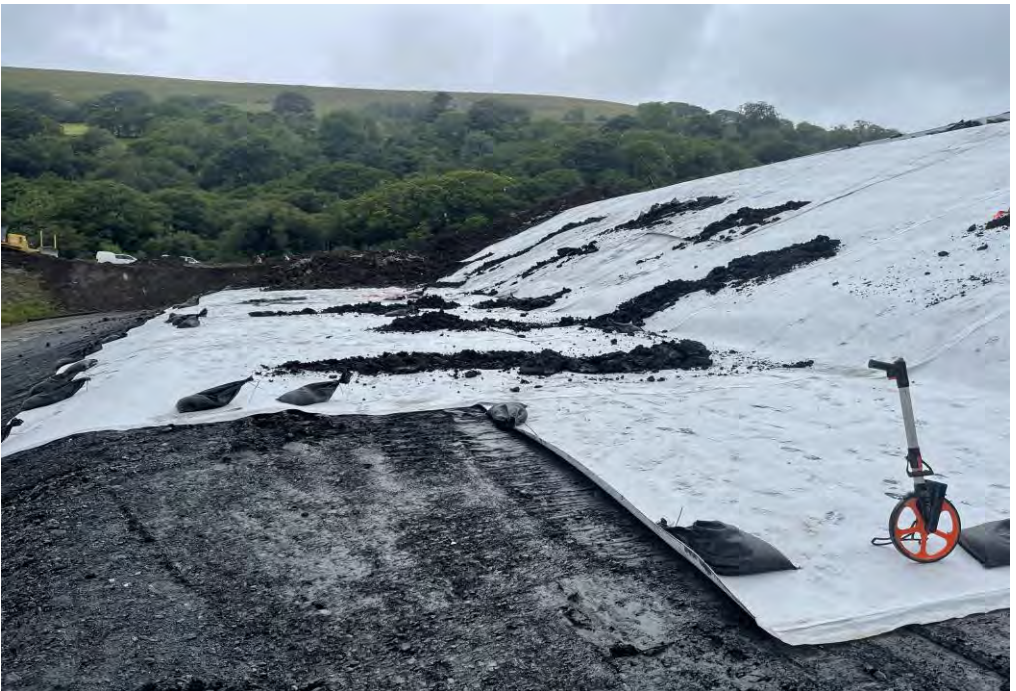
Plate:
10

Overview of Works

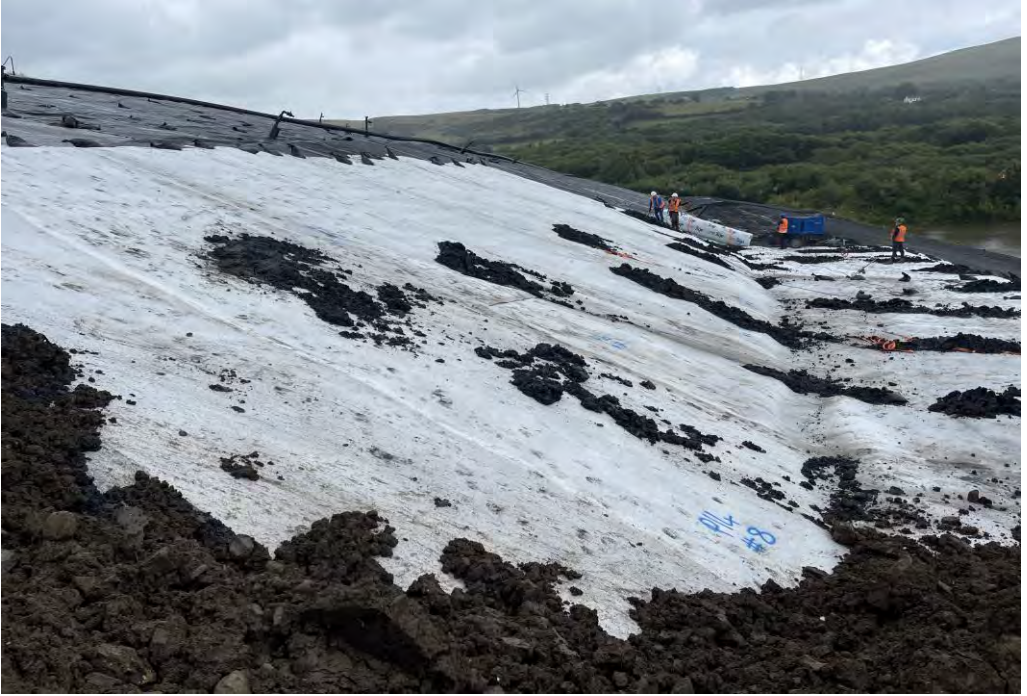
Plate:
11

Overview of Works

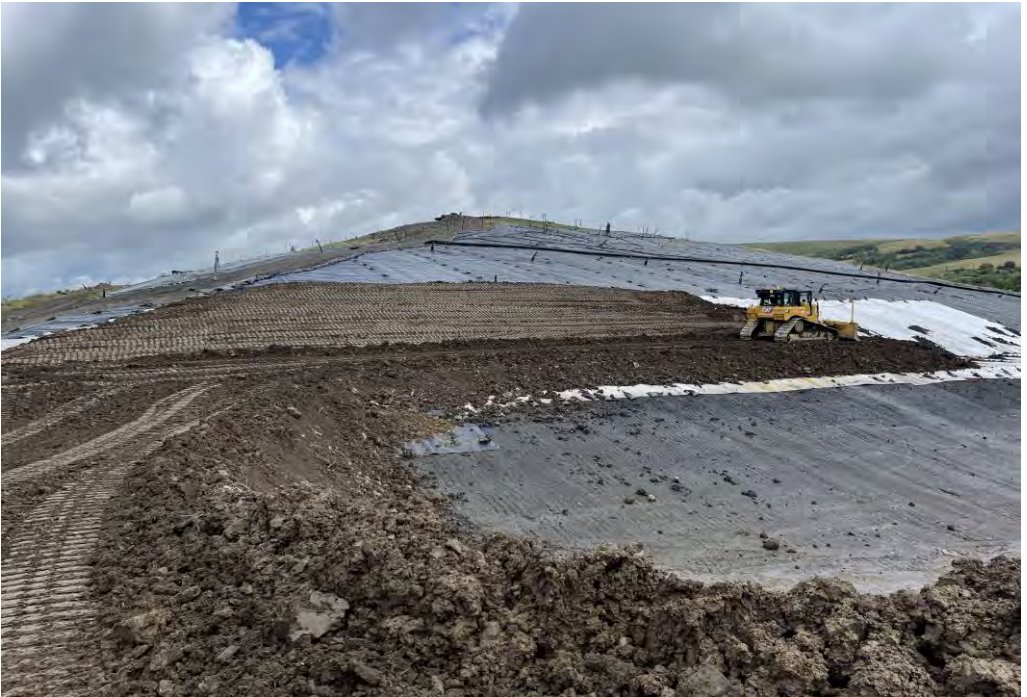
Plate:
12

Restoration in Progress

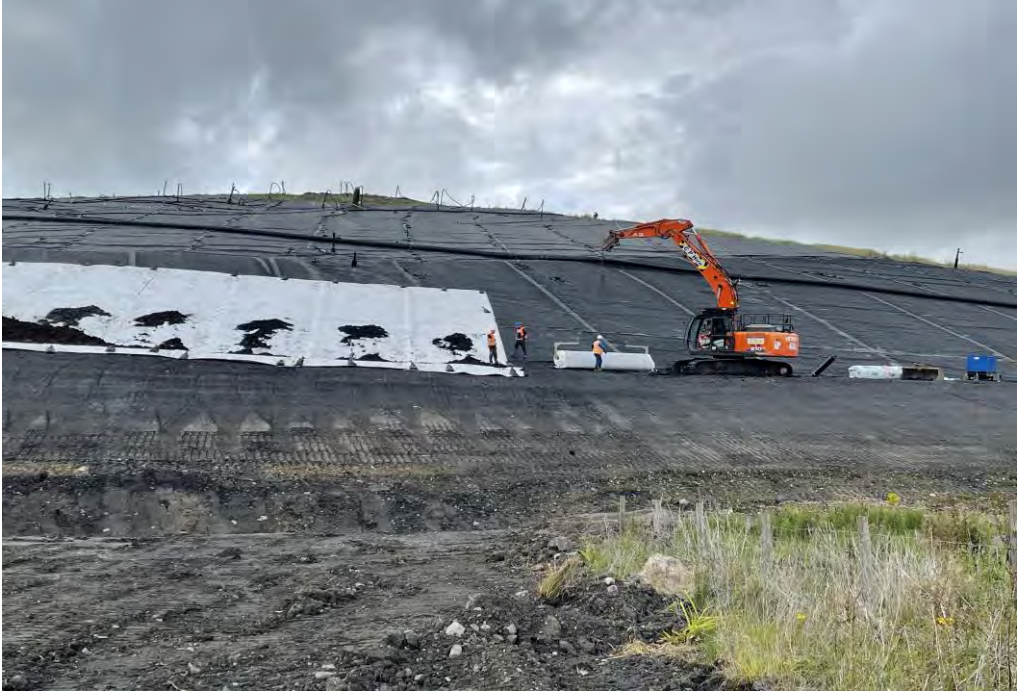
Plate:
13

Continued GDL Installation

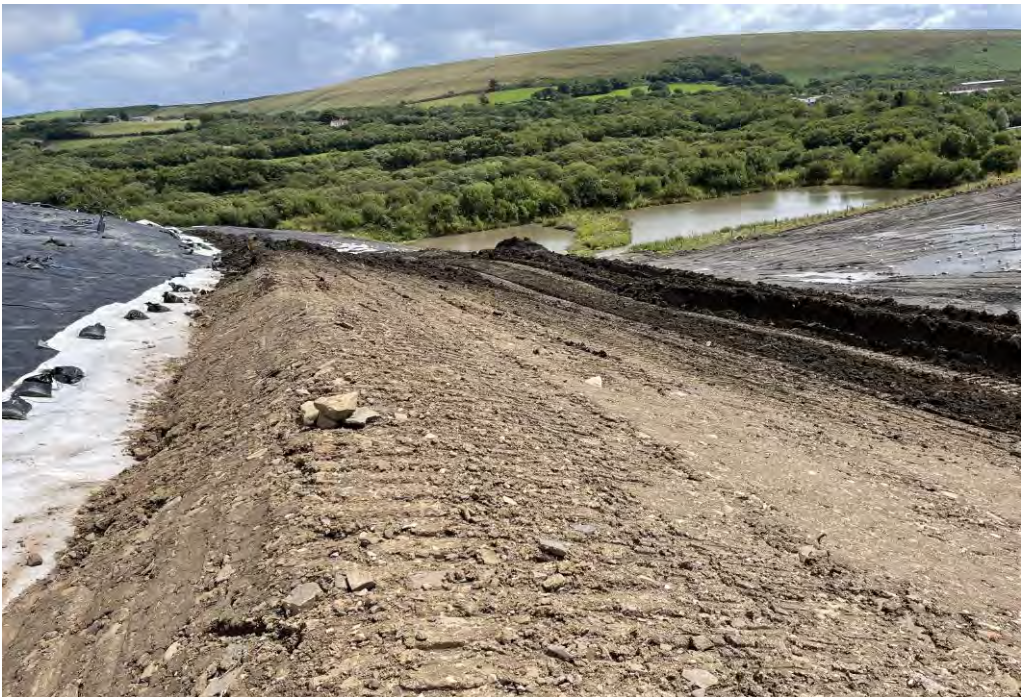
Plate:
14

Overview of Work

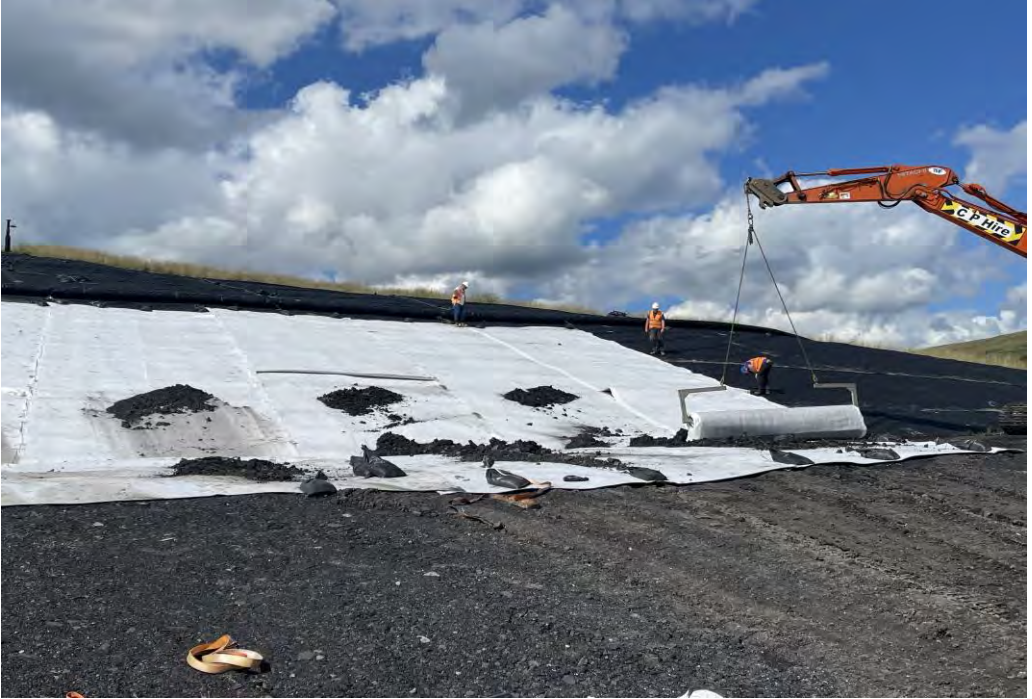
Plate:
15

Overview of Work

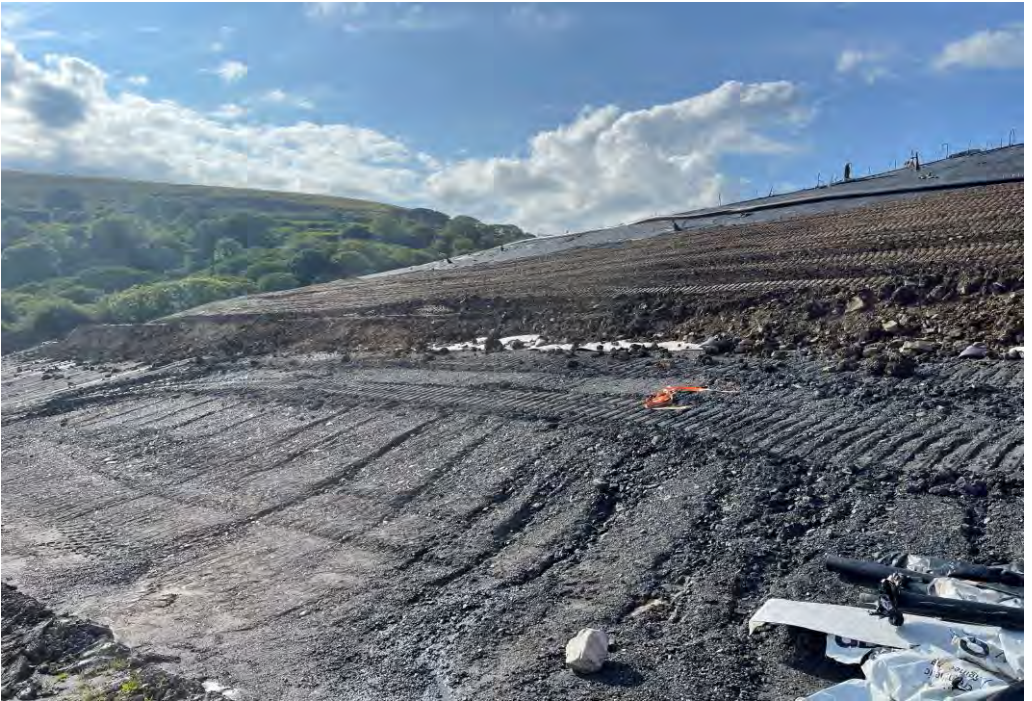
Plate:
16

Overview of Work

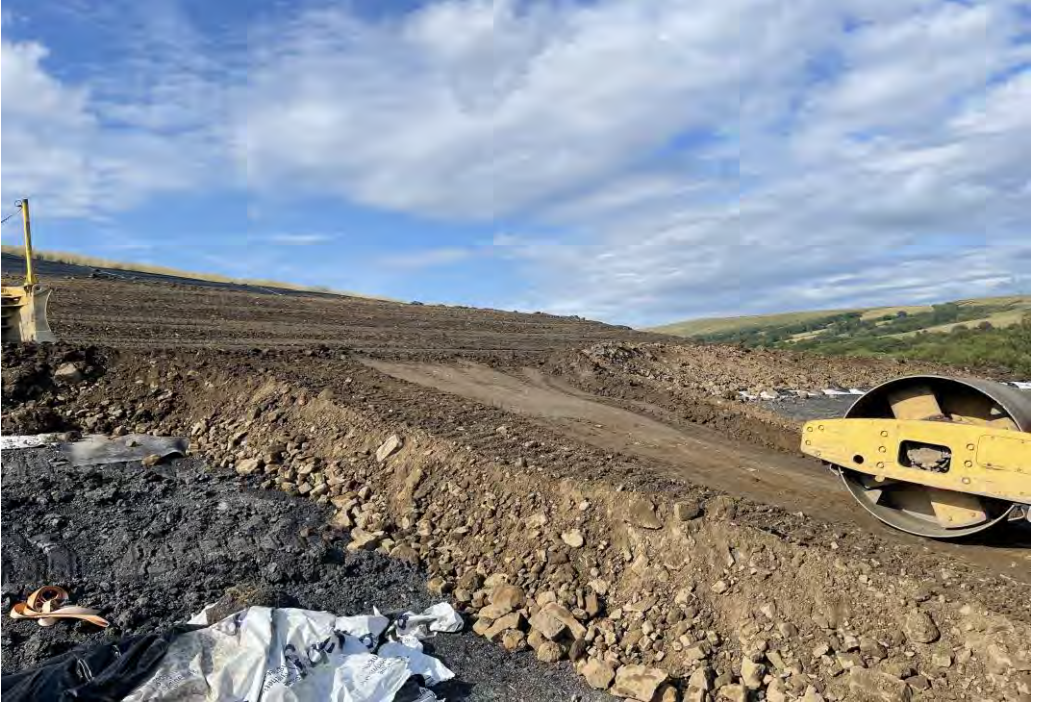
Plate:
17

Restoration Placement in Progress

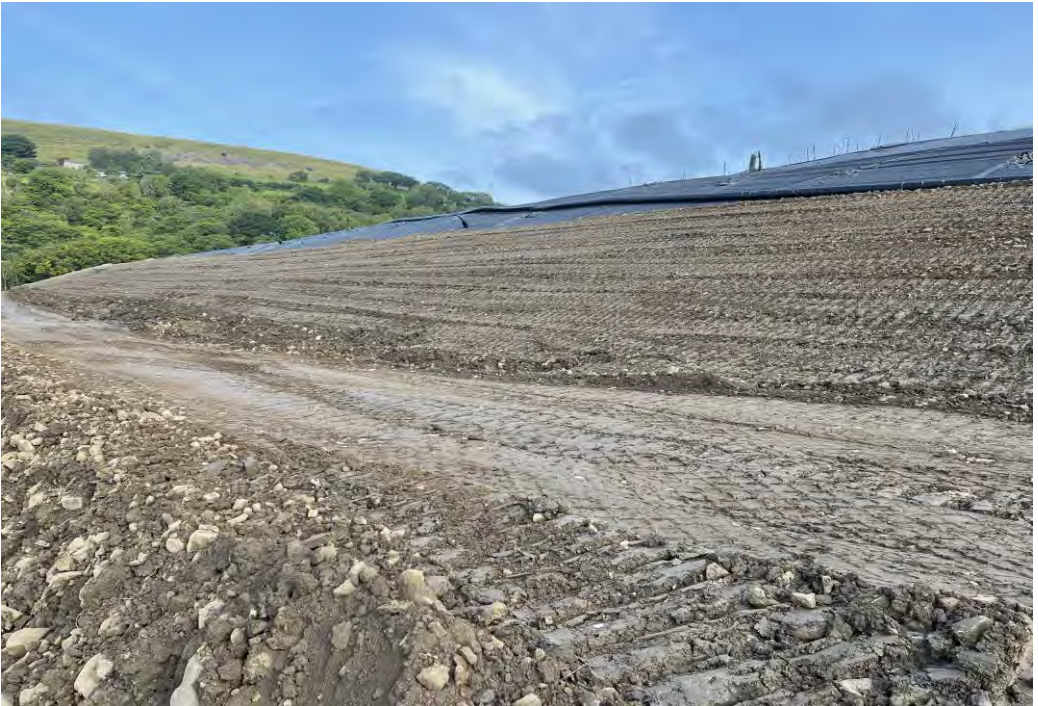
Plate:
18

Completed
