## Compliance Assessment Report CAR\_NRW0043324

For: Llanwrtyd Wells Wastewater Treatment Works, held by DWR CYMRU CYFYNGEDIG

**Type of assessment carried out:** Site Inspection, Reason: Routine.

On 30/01/2024, between 10:48 and 11:22.

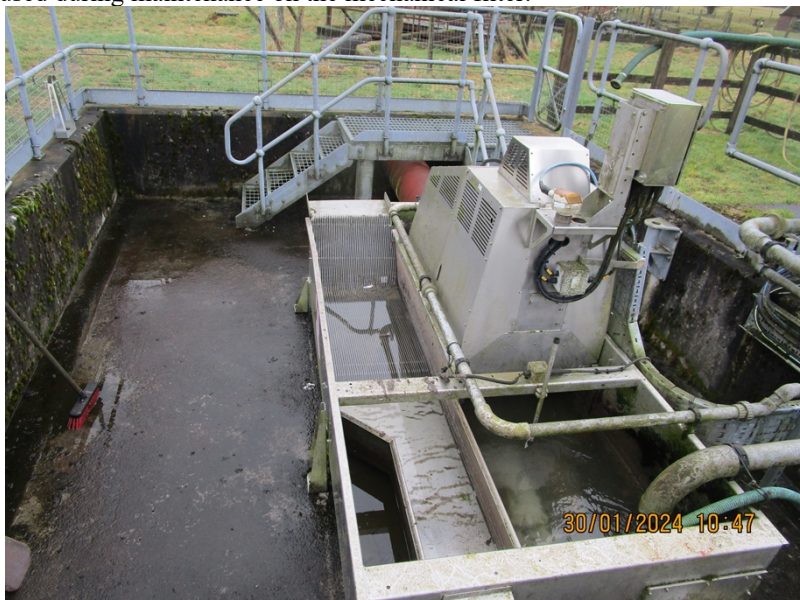
#### Inlet

The incoming flow to the site is via combined gravity sewer. Flows initially pass through a mechanical centrifuge filter which rotates to remove rag/ solids from the influent. The centrifuge filter is located within a self-contained inlet unit. The screen was clearly operation at the time of inspections and there were no signs of significant solids or rag passing through to the next stage of treatment. There is a bypass channel at the inlet with a hard-set bar screen, which can be used during maintenance on the mechanical filter.

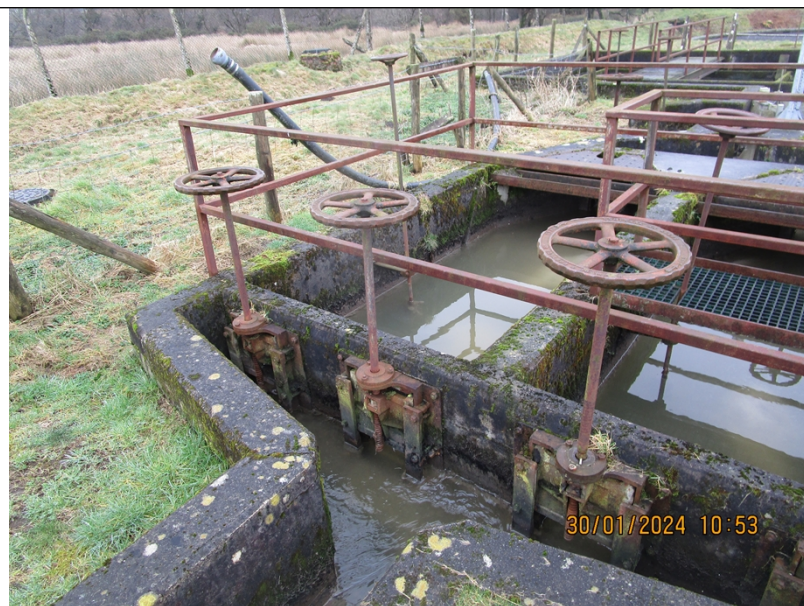
Flows from the inlet then pass through two parallel rectangular tanks, which appear to be operating as grit traps by slowing down the flow through the works. The tanks have manually operated penstocks on both ends which can be used to control flow into or out of each of the tanks. At the time of inspection all the penstocks were open, and flows were passing through freely.

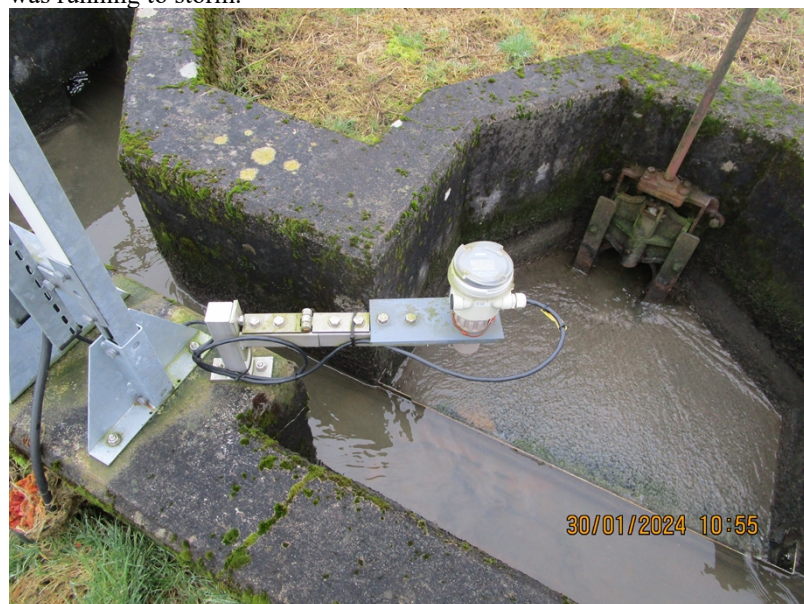
#### Storm Weir

The storm weir in place is a hard-set weir at the side of the channel, following from the grit traps. The storm discharge can only discharge when flows reach the level of the weir. The storm channel has no screening in place, as all flows pass through the mechanical screen at the inlet. There is Event Duration Monitoring spill meter in place to monitor storm discharges, which was clearly operational. At the time of inspection, flows were passing over the storm weir and the site was running to storm.

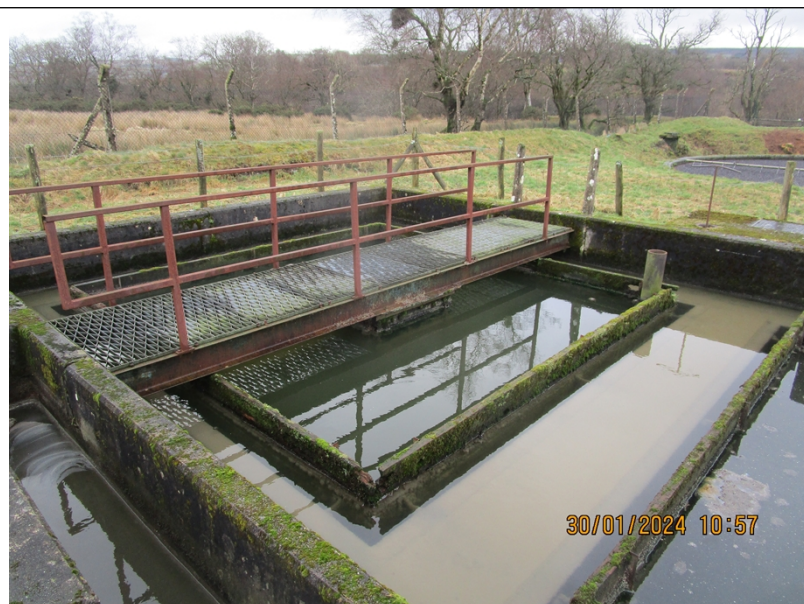
#### Primary Settlement and Overflow.

The primary settlement at the works are older square shaped tanks, with wooden scum boards for retaining solids. The two tanks are within a shared unit which flows into a joined outfall channel. Visually the settlement systems appear in need of maintenance or renewal. The scum retaining boards in several places appear to be rotten and crumbling away, specifically within the left settlement tank. This will eventually reduce their efficiency at retaining solids, so it is advisable that the wooden boards are replaced as soon as practicable.

| Criteria | Action needed | Complete by |
|---|---|---|
| WQ-A1 | Advisory Actions- 1- Repair/replace Primary settlement Retention Boards. 2- Investigate cause and solutions for Final Settlement tank overflowing retention boards. | 31/07/2024 |

1. The retention boards within the Primary settlement tanks appear in need of repair or replacement. This should be undertaken to prevent negative impacts on the treatment process
2. Investigations to identify potential improvements or changes which can be made, to prevent overtopping of the retention boards within the final settlement tanks. As this could result in ineffective final settlement during higher flow periods.

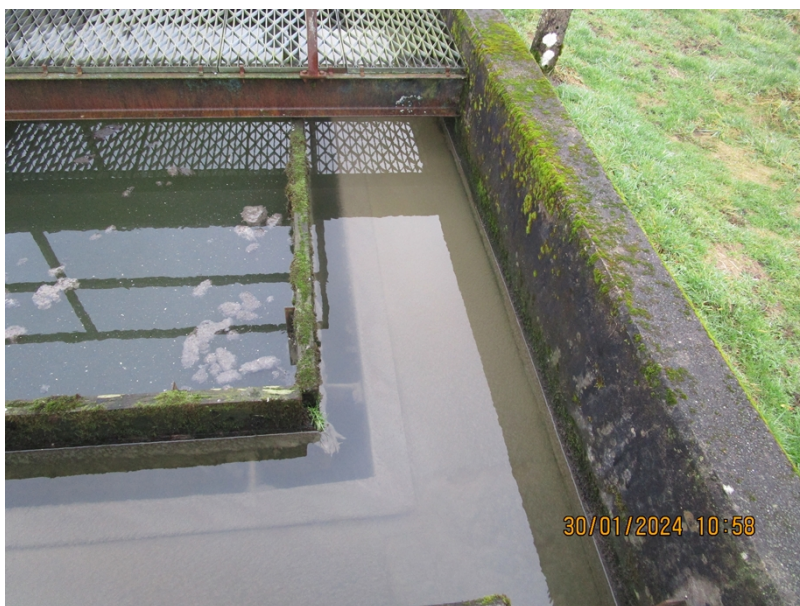
Overall, the settlement system appeared to be retaining solids at the time. There were no signs of significant solids entering the outfall channel. sewage fungus was present on the outside of the scum boards; additionally, the base of the channels within the settlement tank area, appeared to have a persistent coverage of sewage fungus, giving it a light colour. This should be monitored as it suggests a high nutrient content, however, is not a sign of noncompliance at this point.

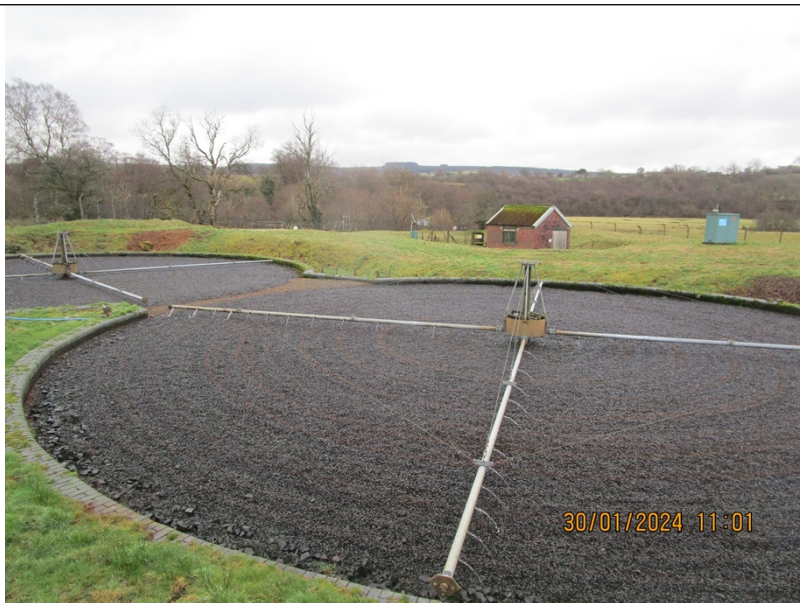
#### Filter Bed

The works contains two filter bed of stone media. The rotation arms were moving freely and unhindered. There Both rotating arms appeared to be distributing effectively during the inspection. There were no signs of ponding or dry patches across the filter beds. The filter beds appeared to be good working order and the outfall channel from the beds was flowing clear.

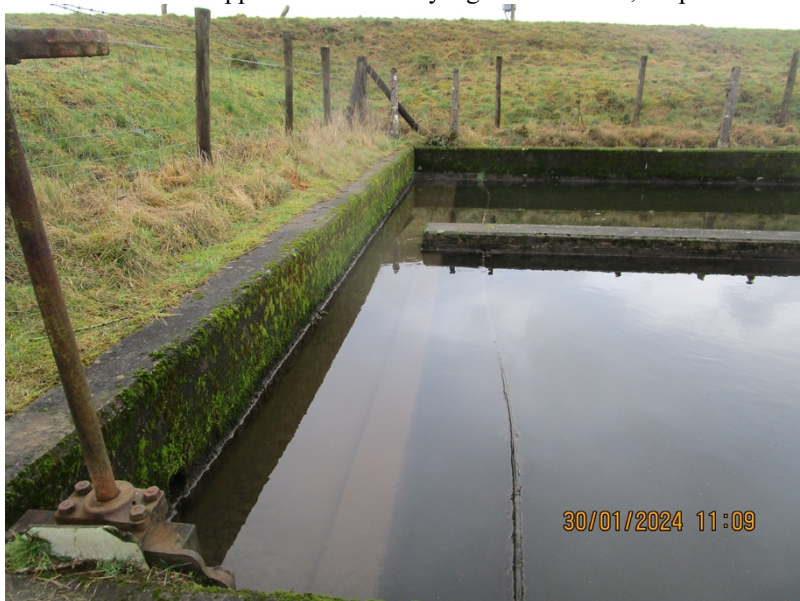
#### Humus Tanks

The site operates two rectangular final settlement tanks, with retention boards to hold back solids at both the inlet and outfall ends of the tanks. At the time of inspection, the levels within the tanks were high to the point where flows were above the level of the outfall retention boards. With flows passing over the top of the outfall retention boards the system cannot operate as designed, as there is nothing to hold back solids from the outfall. The outfall at the time of inspection showed signs of sewage fungus build up, which indicate that there is potentially a high ammonia content in the effluent. The outfall channel appeared clear of any significant solids, despite the overtopping of the retention boards.

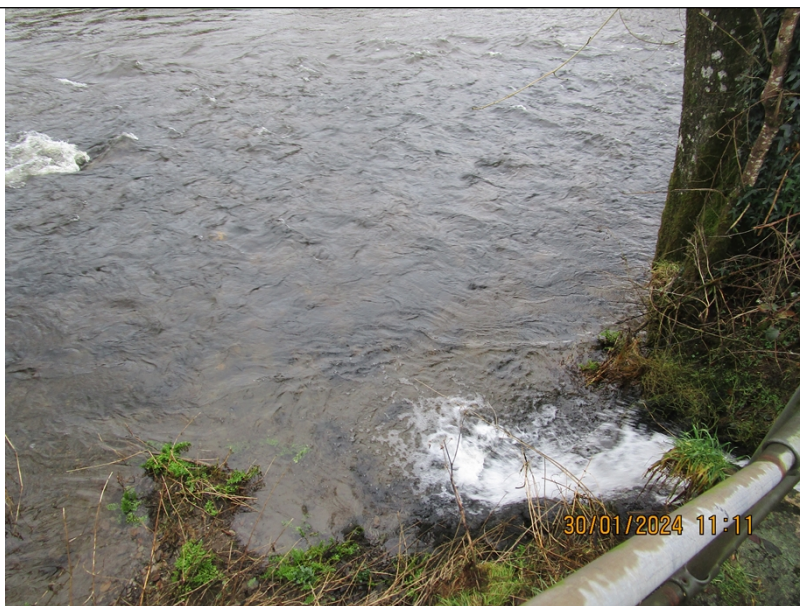
#### Outfall and Sampling point

The sample point is clearly marked with signage including the sample point number. There is an MCERTS flow monitoring meter in operation before the outfall. The outfall into the river was checked and there were no signs of impact or discolouration around the outfall pipe.

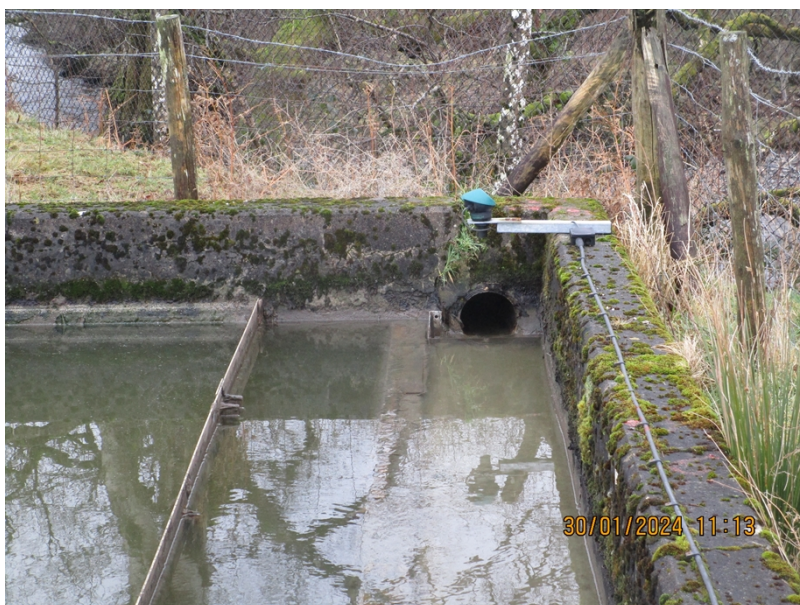
#### Storm Tank and Storm Outfall

The storm tank on site is a rectangular tank similar to a primary settlement tank. There are retention boards on the inlet and outfall ends of the tank. There is an EDM spill monitor in place on the storm outfall channel, which was clearly operation at the time. The outfall of the storm tank discharges to the consented storm outfall point. At the time of inspection, the storm tank was full to capacity, and a discharge was being made via the storm channel. With the works running to storm at the time of inspection, this is as expected and appears compliant. A data inspection will be undertaken at a later date, to check full compliance to the storm conditions has been observed.

The storm outfall was clearly discharging into the river during the inspection. There were not signs of any discolouration of the receiving watercourse. The watercourse was in full flow following recent rainfall.
