# LEACHATE TREATMENT REPORT JULY – DECEMBER 2023 NANTYCAWS LANDFILL

Prepared for: **Carmarthenshire County Council**

Date: **March 2024**

| <b>TITLE:</b> | Leachate Treatment Report – July to December 2023 |

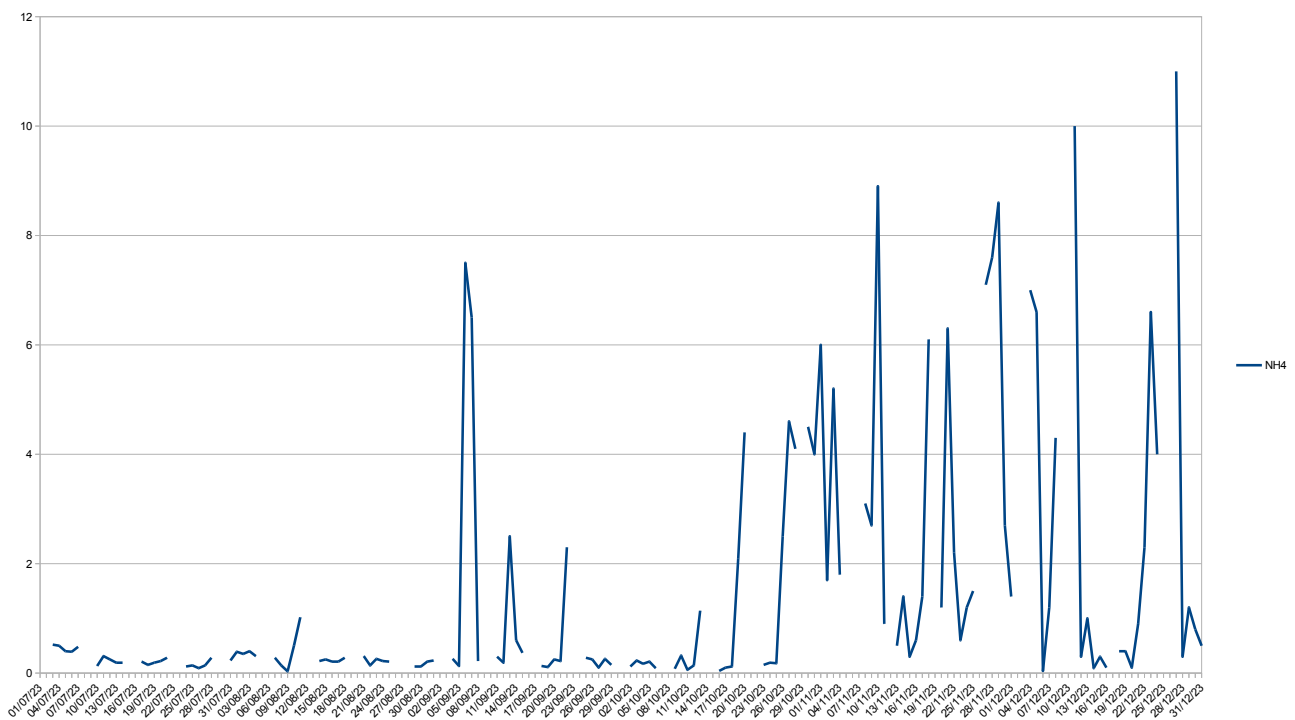
**Graph 1. Ammonia. Main plant (post)**

The main plant treats the water pumped over from the landfill. The landfill waters can be as high as 100 mg/L NH4 and during normal operating parameters the discharge to W1 can be under 1 mg/L NH4.

The first spike in ammonia was due to the plant being pushed hard as the pipe that feeds the lagoon to the SAF2 pumping well had become blocked and the lagoon had to be kept as low as possible.

The onset of autumn and winter brought a lot of problems on site with elevated water levels present in the well and months of intense rain. The plant parameters were changed almost daily in order to keep the lagoon levels as low as possible whilst processing the most amount of water whilst remaining in compliance. The plant continuously swung between extremely good performance to poor performance with an adequate performance very difficult to achieve. As of the New Year the plant has settled down.

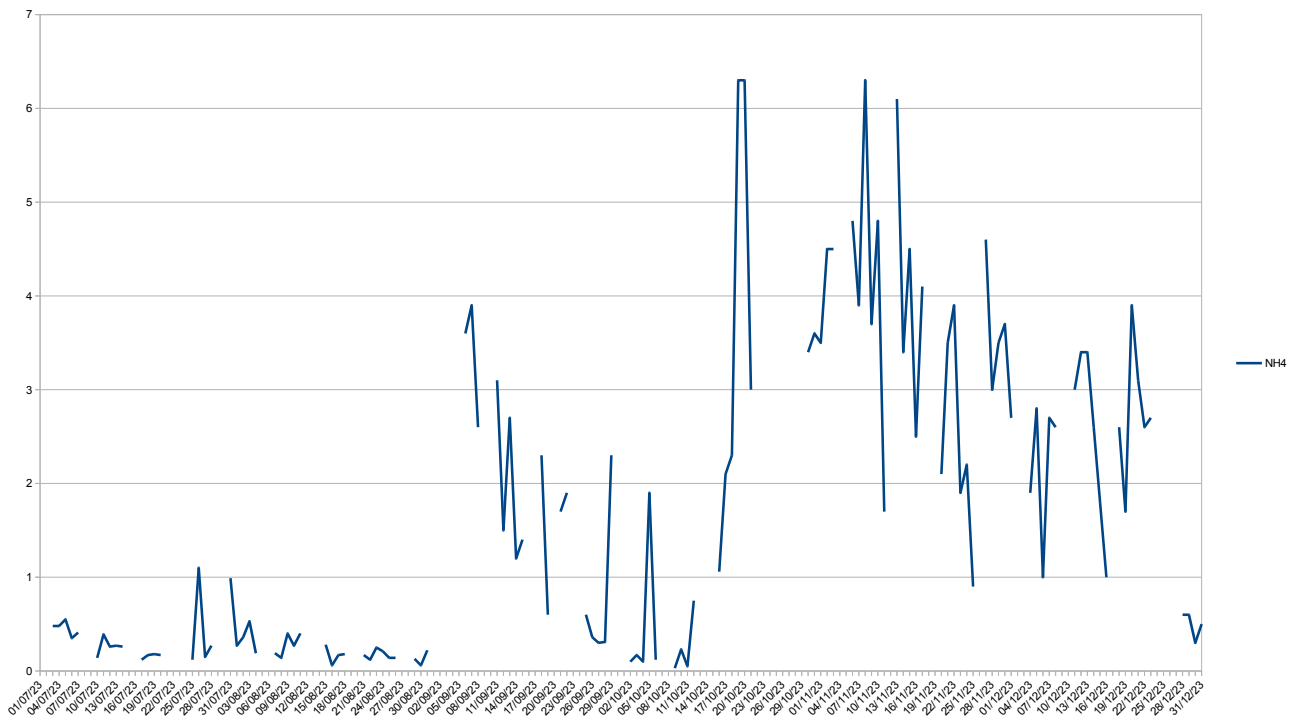
**Graph 2. Ammonia, Final Discharge to stream. W1**

The location of sampling is the final well or W1. It consists of both the main plant water and the SAF2 water after it has gone through the reed bed.

The main plant and SAF2 were pushed hard given the extreme weather of late 2023 with adjustments constantly being made in order to process sufficient water to avert a lagoon overflow event. The issue of breaches mainly arose from SAF2 and the lagoon. An acceptable balance would be achieved with SAF2 for example and then owing to the non-uniform nature of the ammonia concentration in the lagoon one would find the SAF2 unit unable to cope with a rich area of lagoon water.

The breaches are as follows in mg/L NH4: -

19<sup>th</sup> October = 6.3  
 20<sup>th</sup> October = 6.3  
 23<sup>rd</sup> October = 5.7  
 2<sup>nd</sup> November = 4.5  
 3<sup>rd</sup> November = 4.5  
 6<sup>th</sup> November = 4.6  
 8<sup>th</sup> November = 6.3  
 10<sup>th</sup> November = 4.8  
 13<sup>th</sup> November = 6.1  
 15<sup>th</sup> November = 4.5  
 17<sup>th</sup> November = 4.1  
 27<sup>th</sup> November = 4.6

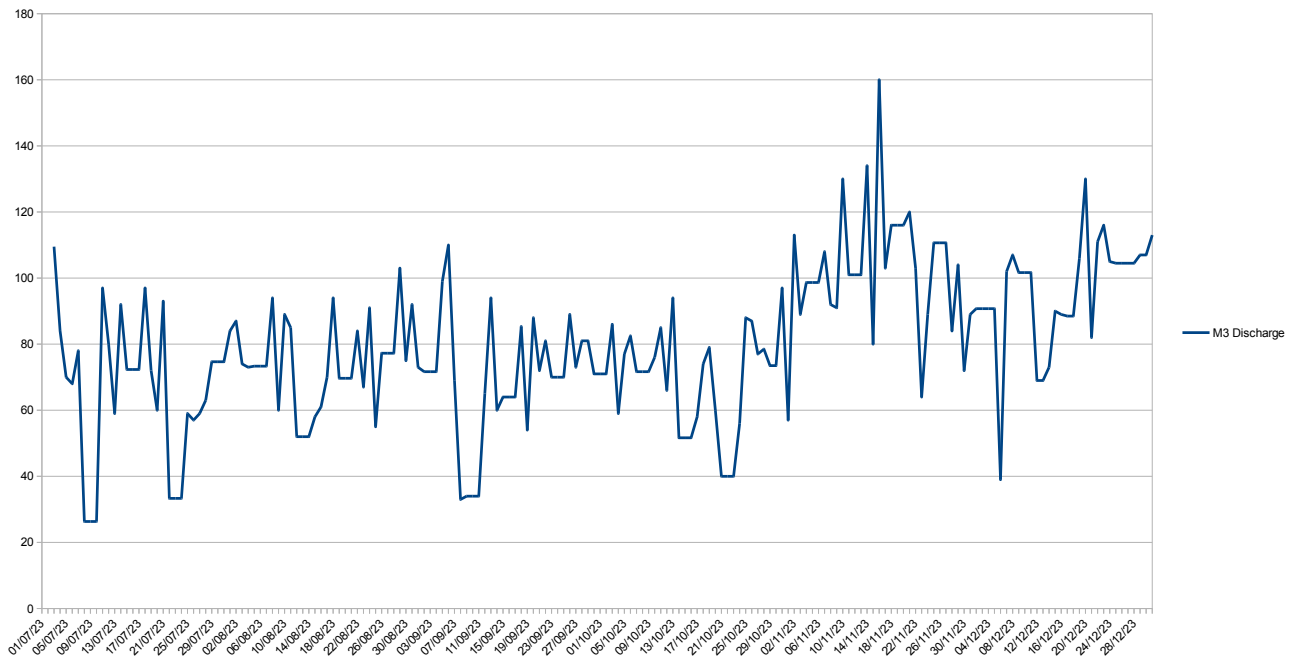
**Graph 3. Daily Flow, Final Discharge**

The total discharged water on the 1/7/2023 was 368,055m<sup>3</sup> and at the end of 2023 it was 382,633m<sup>3</sup> therefore a total of 14,578m<sup>3</sup> was processed by the main plant during this time. This is a lot more than the first half of the year at a recorded 9,061m<sup>3</sup>. This is owing to the increased influx into the system and a resultant need for more throughput.

SAF2 was discharging water to the reed bed and W1 for the second half of 2023. But the amount varied. The pump rate for SAF2 at a minimum is 0.2L/s. The maximum pump rate is 1.9L/s and currently the rate is set at 0.9L/s.

Therefore on average the pump rate can be considered to be 1L/s, equating to 86m<sup>3</sup> per day.  
184 days at 86m<sup>3</sup> = 15,824m<sup>3</sup>.

A minimum value for clarification would be 17.2m<sup>3</sup> and the maximum rate would be 164m<sup>3</sup>. It is worth noting that the pump has been changed since last year, where a figure of 200m<sup>3</sup> was calculated from the flow rates.

The total discharge is therefore 14,578m<sup>3</sup> + 15,824m<sup>3</sup> = 30,402m<sup>3</sup>.

The lagoon can hold roughly 2,752m<sup>3</sup> and at the end of 2023 was nearly full due to inclement weather.

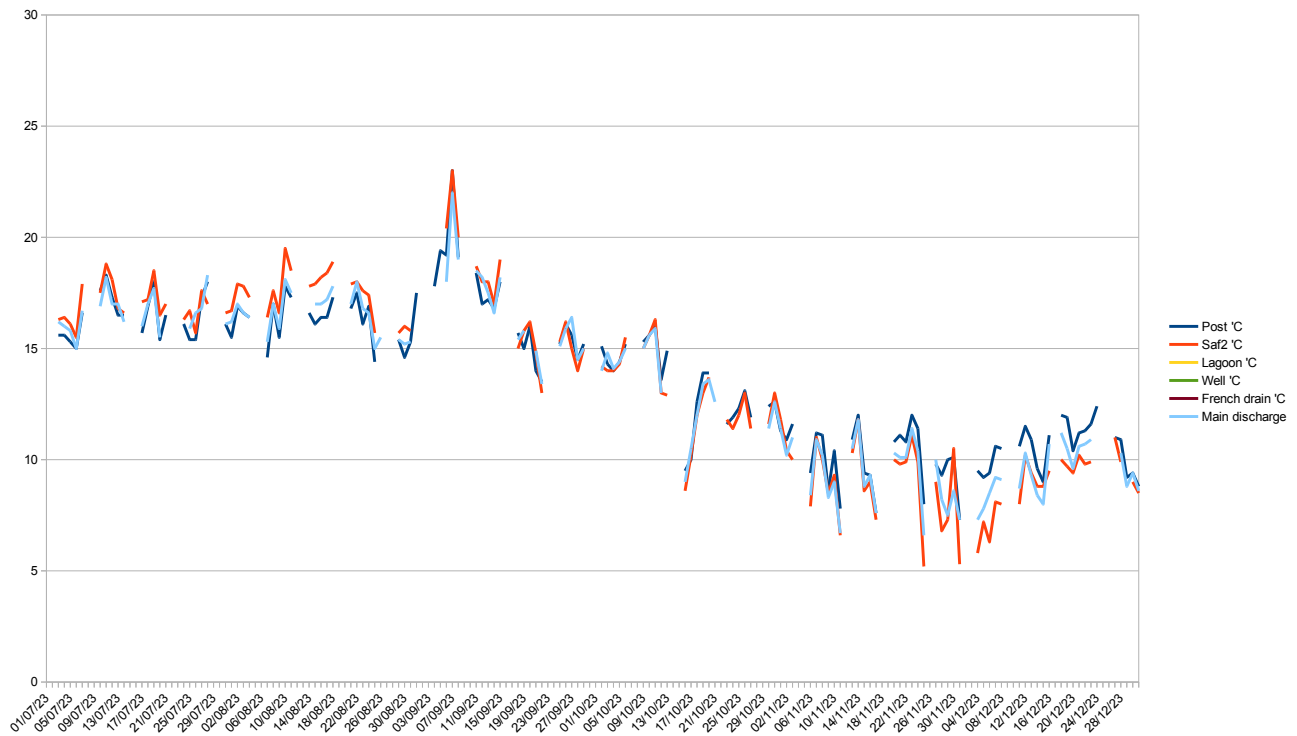
**Graph 4. Temperatures**

Temperature in all the recorded media depicts a trend that follows yearly variations. The highest temperature is observed in August and the decline in temperature, as westerly storm systems brought mild weather in autumn through to winter, can also be observed. There were a couple of sudden drops in temperature that proved troublesome for the plant.

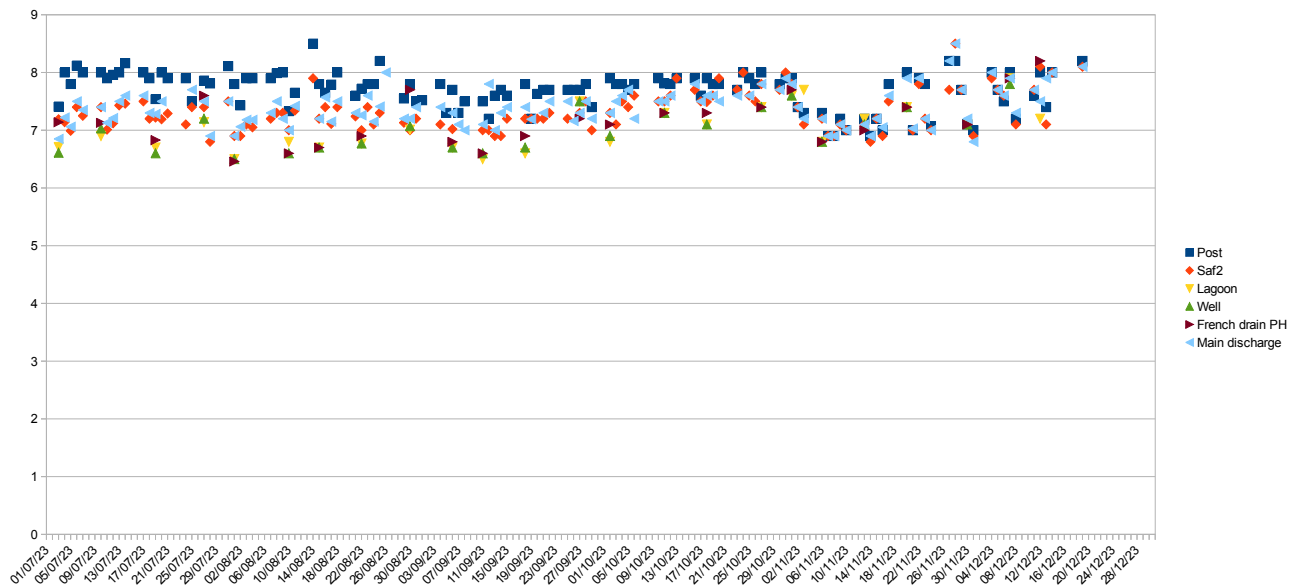
Graph 5. pH levels

The acidity and alkalinity levels or pH levels of the recorded media are in concert with each other with no serious deviations from the average. The consent levels for discharge are a range of 6 to 9 pH units. The probe failed toward the end of the year and a new one has been ordered.

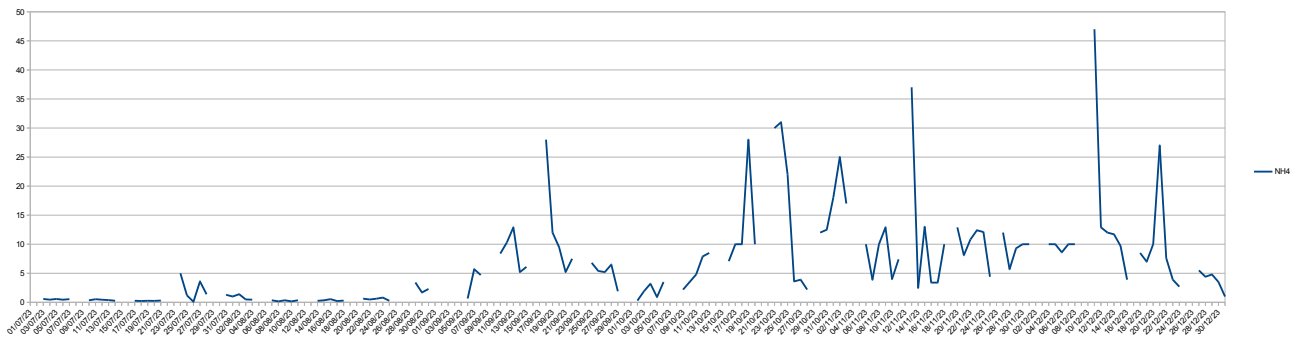
**Graph 6. SAF2 Ammonia Levels**

SAF2 treats the water from the holding lagoon and is normally discharged to the reed bed that feeds the stream via W1 when the ammonia levels are acceptable. The graph above shows spikes in ammonia. When these are detected the SAF2 is diverted to the lagoon. It is thought that waves of ammonia rich waters drift through the near still lagoon from the overflow pipe that feeds raw leachate to the plant from the well. The reed bed that receives the SAF2 water is able to reduce ammonia, but no exact figures have been recorded and its effectiveness is seen to reduce dramatically when winter sets in and the reeds drop their blades.

The spikes in ammonia seem alarming, but it must be noted that less than 10% of the SAF2 discharge was directed to W1. The old methodology saw the discharge of the SAF2 unit being split to the lagoon and reed bed and W1. The new methodology applied has a split manifold before the SAF2 inlet. One leg feeds the SAF2 unit and the second leg heads straight back to the lagoon. Both legs are controlled via a valve. This allows for a much finer and improved retention time to be applied to SAF2.

The elevated levels seen are due to the elevated influx of water into the system.

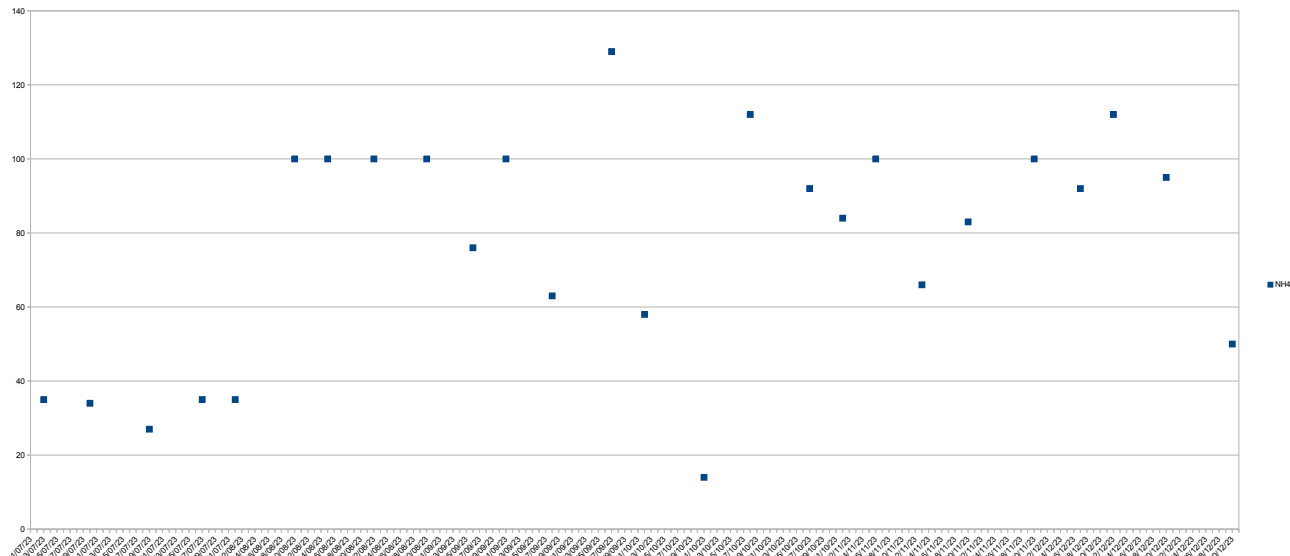
Graph 7. Well Ammonia Levels

The ammonia levels of the well vary and can be observed to be nearly 125 mg/L NH4 on occasion and sometimes as low as 20 mg/L NH4 and less. The low levels are due to the influx of SAF2 water from the diversion system that serves to dilute the well water. This diversion system was refined resulting in the influx of SAF2 water to the well being removed later in the year at around the end of November.

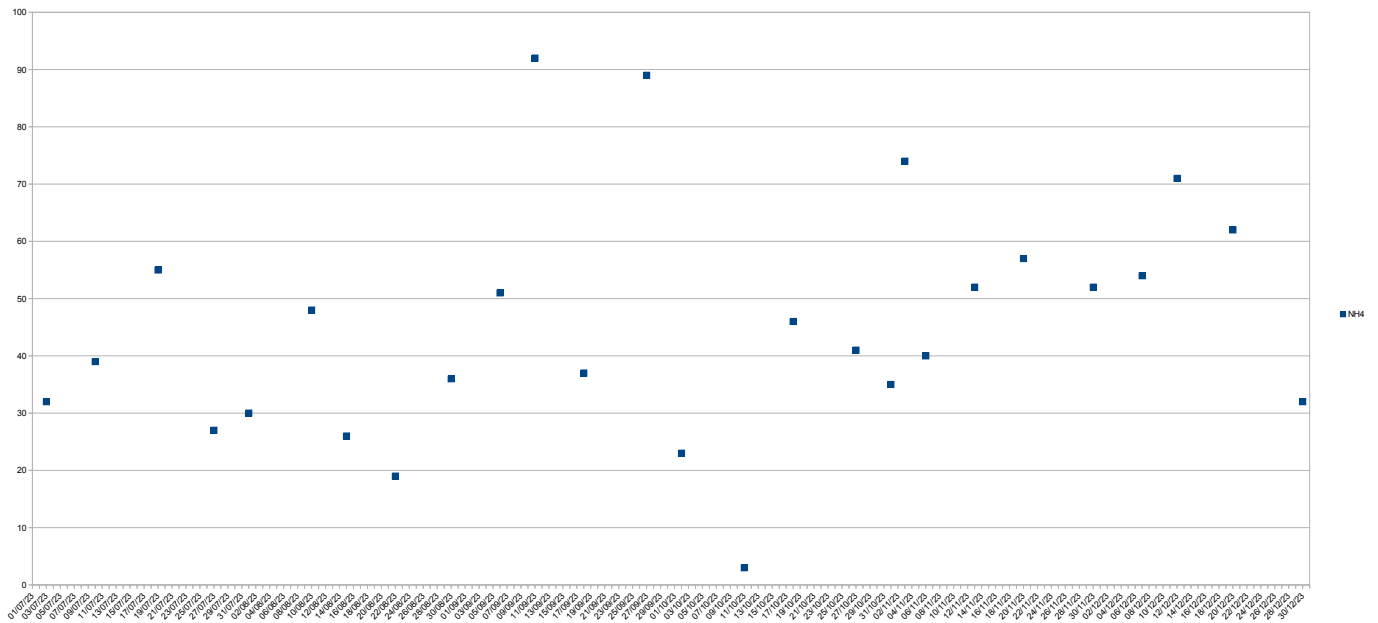
Graph 8. Lagoon Ammonia Levels

The lagoon is the overflow storage area for the landfill water. This water is treated by the SAF2 unit before discharge via W1 to the watercourse. The lagoon showed ammonia to be on the rise as the inclement weather persisted into autumn. The levels of ammonia recorded were around 30 mg/L NH4 with one sample found to be over 90 mg/L NH4.

It was also proven that ammonia levels do vary across the lagoon when sampled in various locations within the same time frame.

The samples were taken on the 27<sup>th</sup> of October. One was taken near the lagoon side by the main plant and was found to be 41mg/L NH4. The second sample was taken roughly 20m away off the pontoon and was found to be 13mg/L NH4 and the third sample was taken near the SAF2 plant and it was found to be 14mg/L NH4.

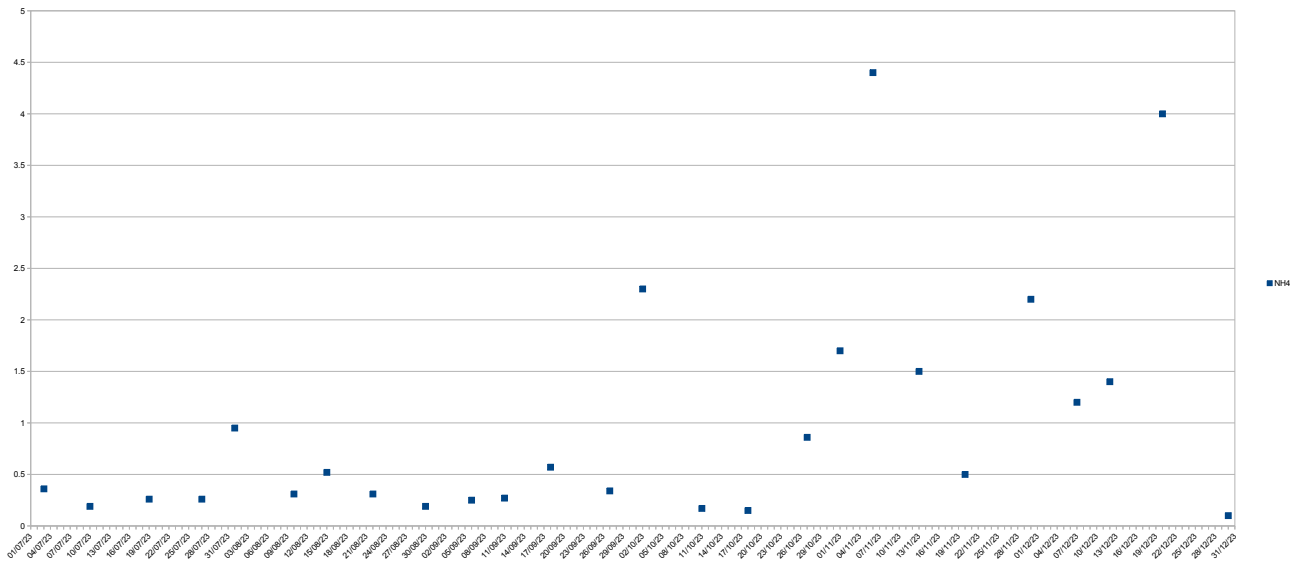
**Graph 9. French Drain Ammonia Levels**

The French drain captures surface water from the low portion of the capped landfill and is monitored weekly for any elevated ammonia discharge.

During storm events the French drain is shown to have elevated ammonia levels.

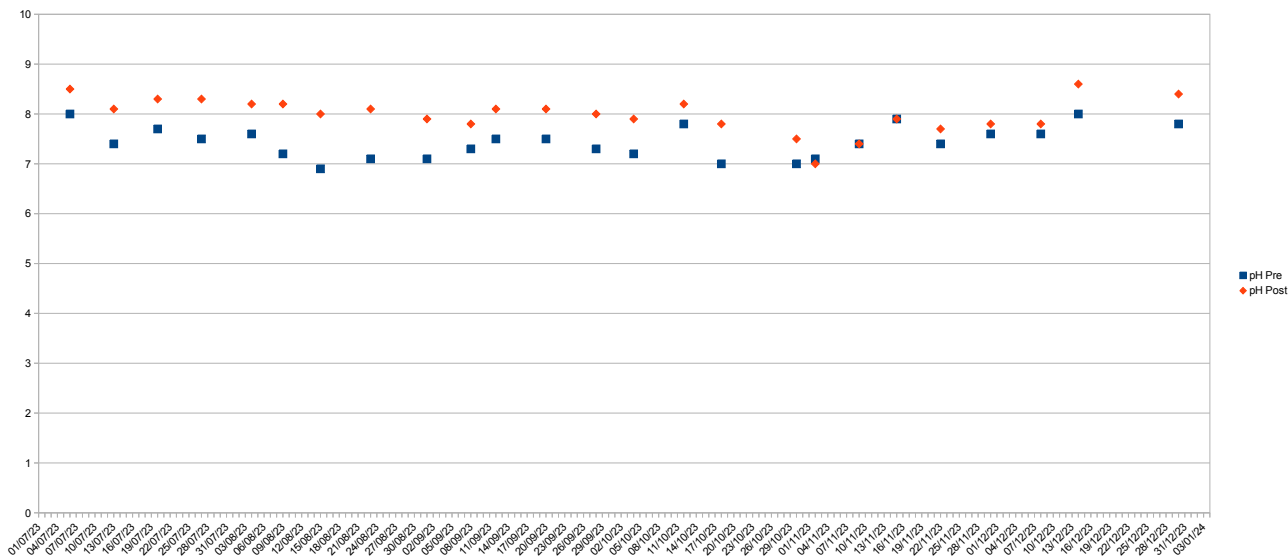
Graph 10. pH Pre and Post Treatment Comparison

The results remained consistent through the second half of the year with a slight rise and fall throughout.

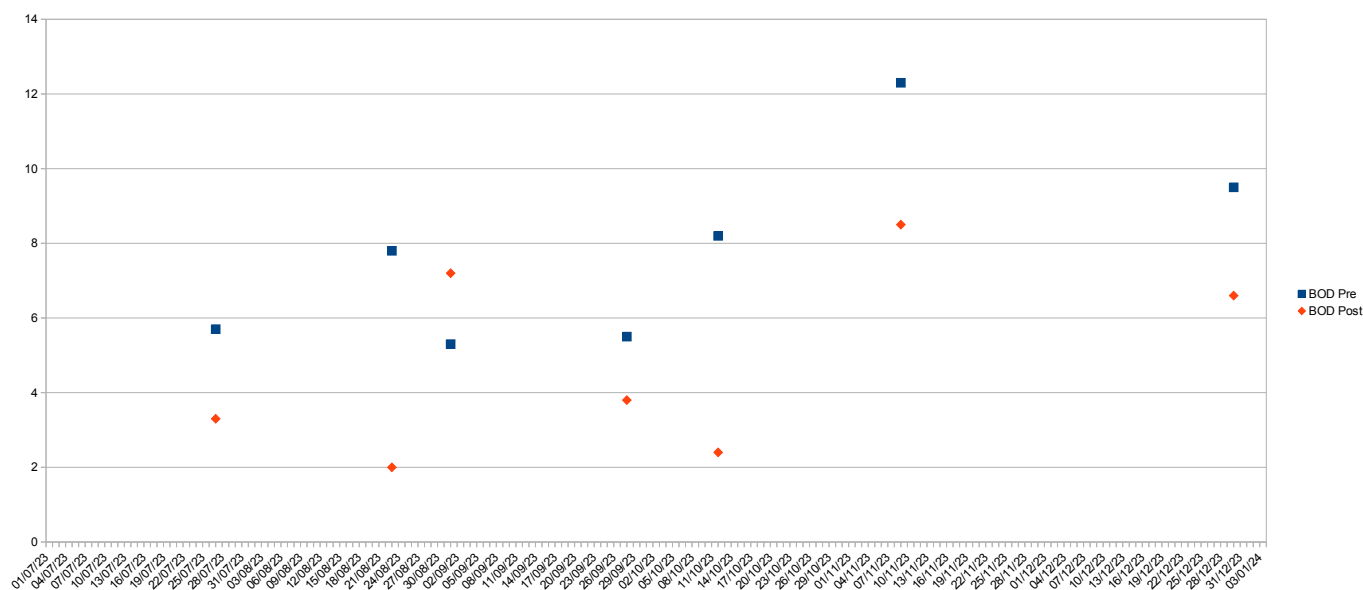
Graph 11. BOD Pre and Post Comparison

The BOD (biological oxygen demand) levels on the discharge did not breach the consent levels of 20 mg/L throughout the year.

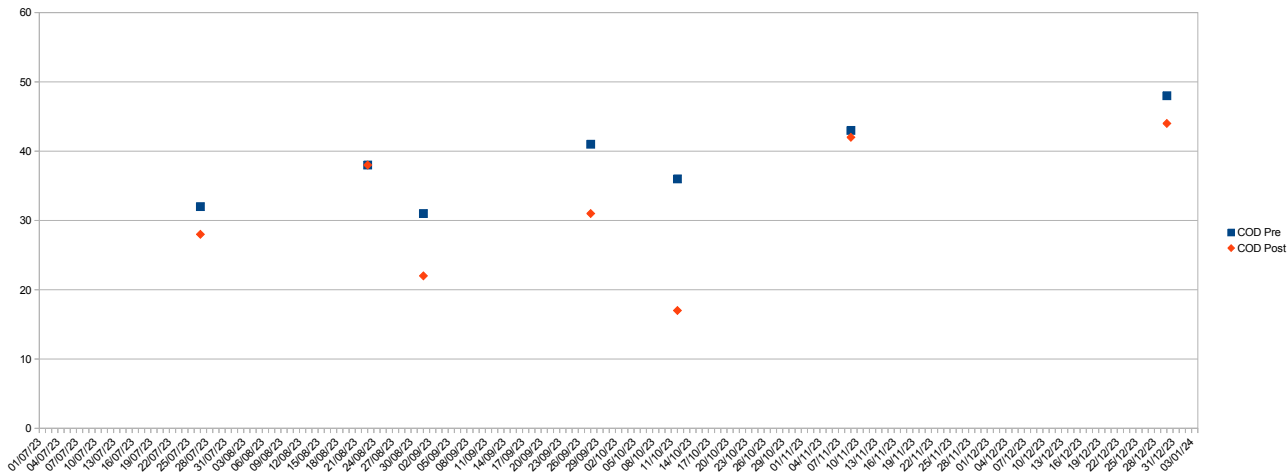
Graph 12. COD Pre and Post Comparison

The chemical oxygen demand (COD) levels remained consistent through the second half of the year with discharge levels varying between 15 to under 50 mg/LO2.

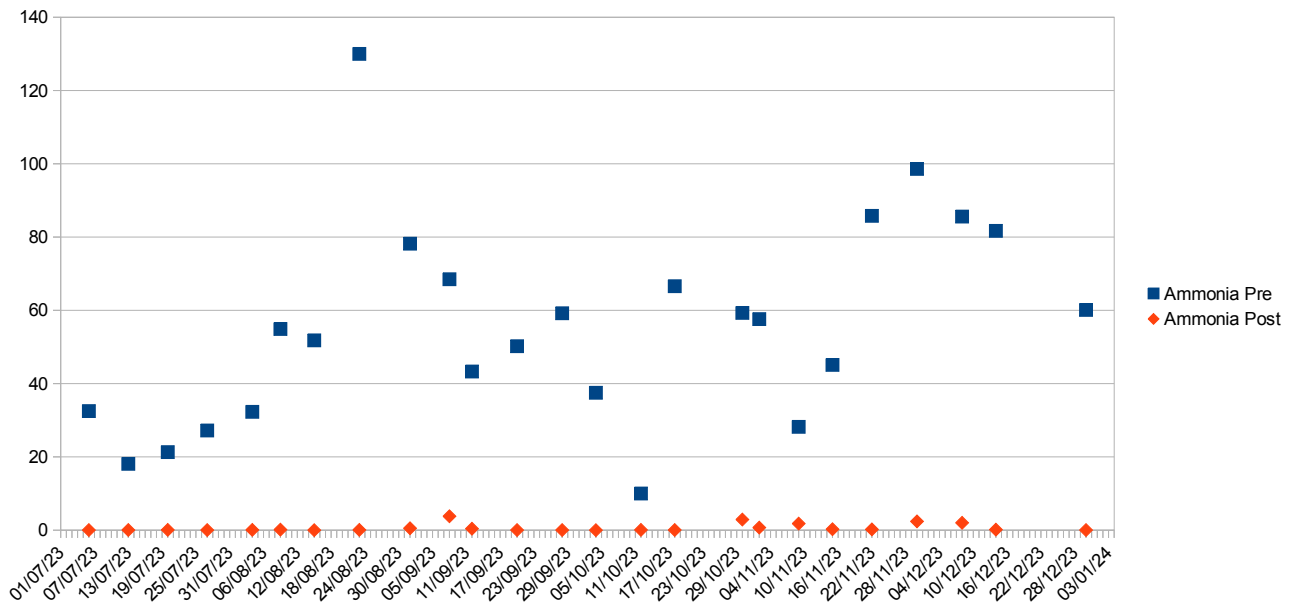
**Graph 13. Ammonia Pre and Post Comparison**

There were no sampled breaches in ammonia in the laboratory samples. The water from the landfill (pre) is seen to fluctuate between roughly 10 to over 120 mg/L NH4. The low levels of ammonia seen in the pre samples are due to the influx of semi treated SAF2 waters that were diverted to the well in an attempt to maximise treatment. The diversion was later refined as discussed above in relation to graph 6.

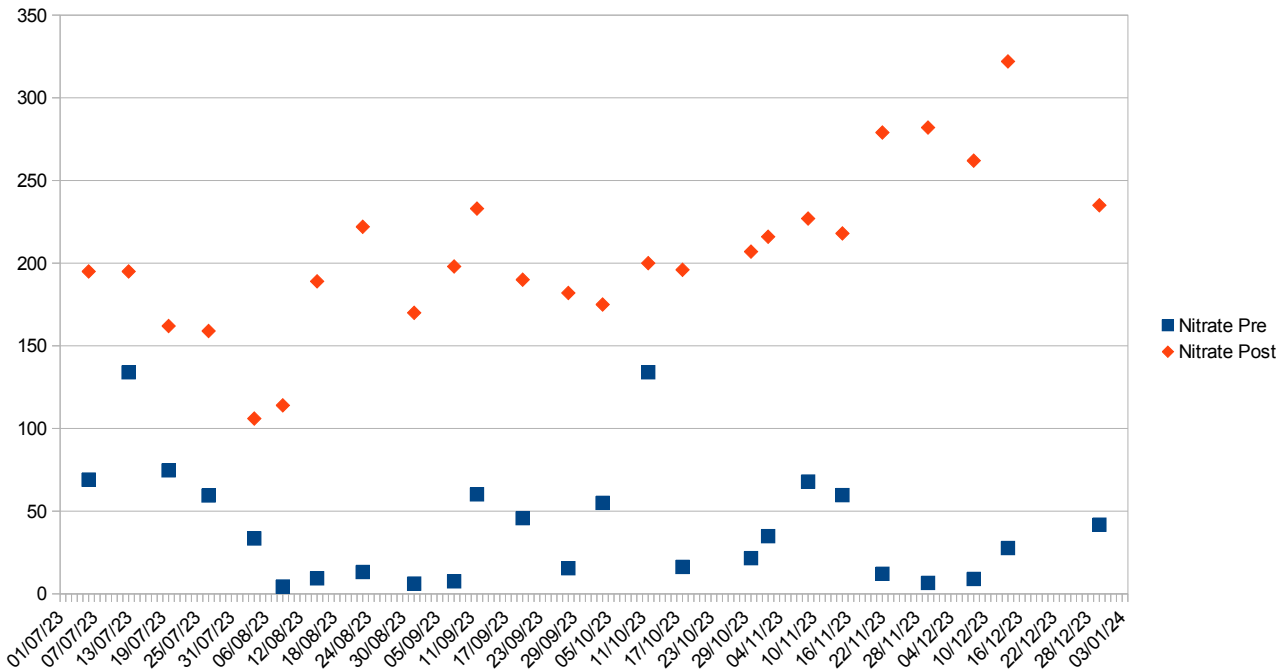
Graph 14. Nitrate Pre and Post Comparison

The Nitrate levels are expected to be quite low coming from the landfill as shown in the pre samples. There are some elevated Nitrate levels seen from July onwards. This is due to SAF2 waters being passed to the main well. The SAF2 waters have already undergone treatment, but due to the cold and wet weather the ammonia levels were too high in ammonia for full discharge to W1.

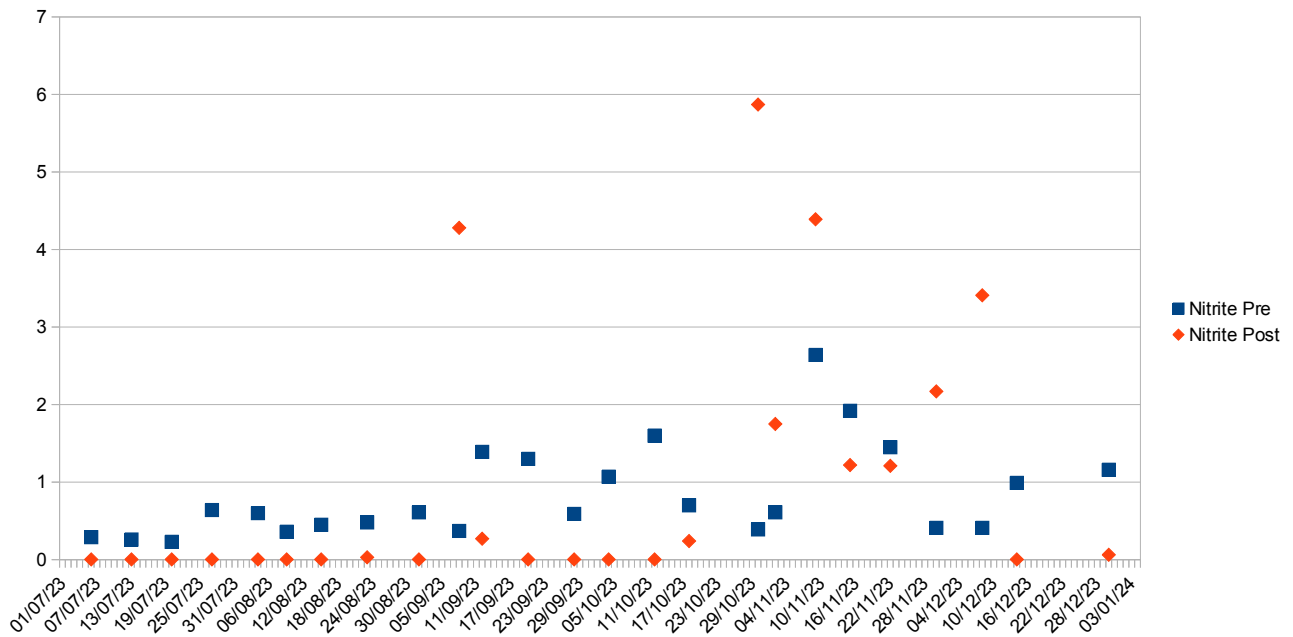
**Graph 15. Nitrite Pre and Post Comparison**

The intermediate stage sees bacteria oxidise the ammonia to nitrite that will be finally converted to nitrate. Therefore, the successful treatment of ammonia rich effluent should show close to zero nitrite as shown above.

A couple of anomalies stand out, but the range is very very small, but clearly the tumultuous treatment issues due to the weather can be seen toward the end of the year. In the final discharge nitrite should be low, nitrate high and ammonia low.

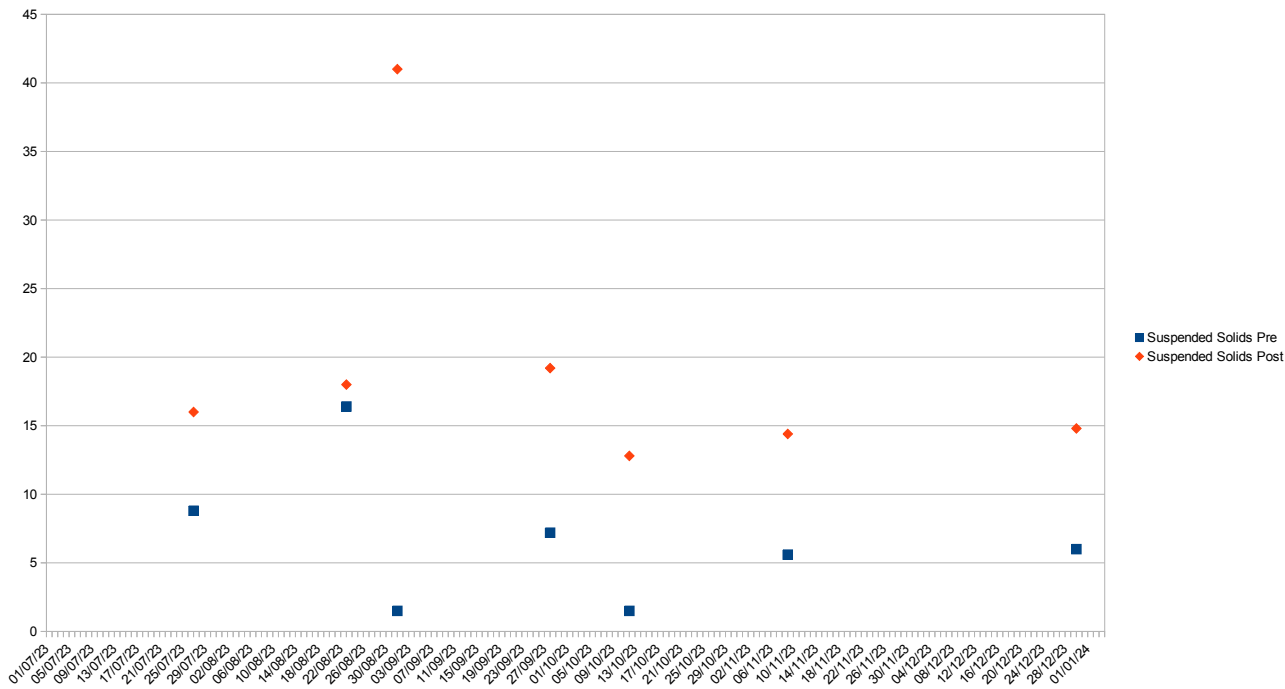
Graph 16. Suspended Solids Pre and Post Comparison

There was one instance of the 30 mg/L of suspended solids permitted level being breached. The average being around 15 mg/L.

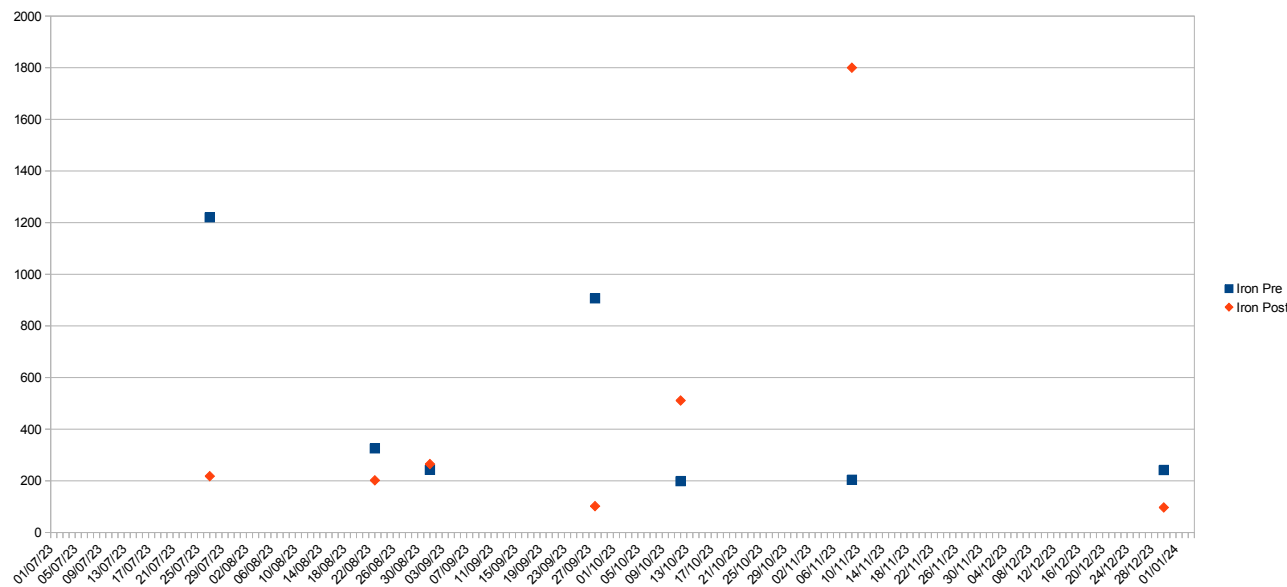
Graph 17. Iron Pre and Post Comparison

Discharge levels of iron are seen to be low in the last half of 2023, staying under 600 ug/L except for one instance in November where the iron level was seen to be 1800 ug/L. The leachate from the landfill is seen to fluctuate in iron content from 200 ug/L to as high as nearly 1300 ug/L.

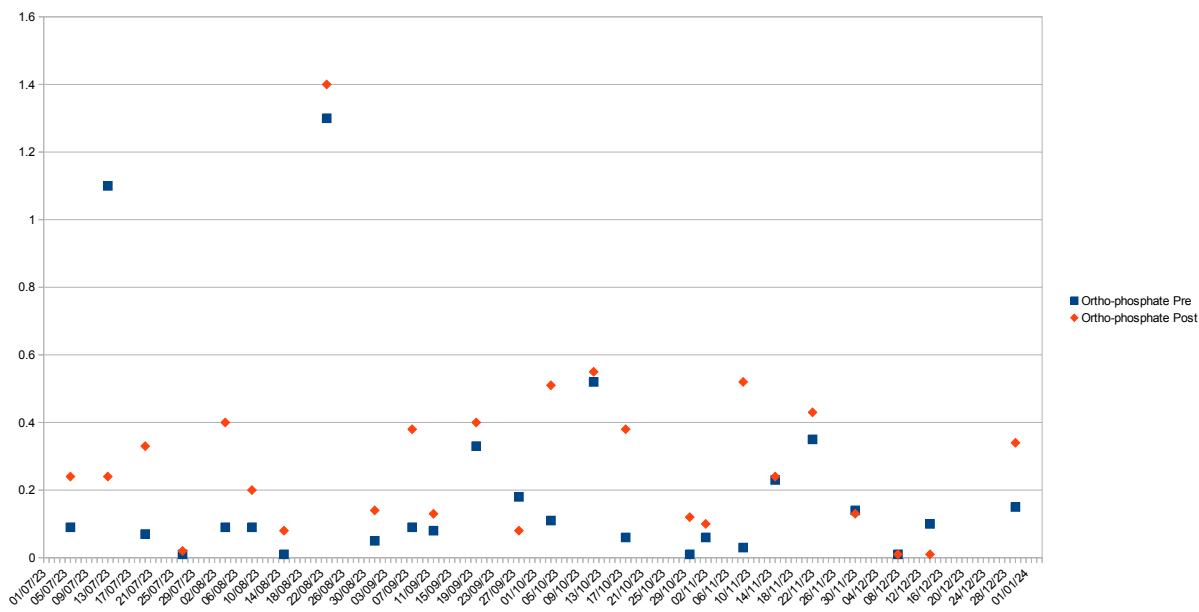
Graph 18. Orthophosphate

The orthophosphate levels remained constant through the year except for spikes in levels in July and August.

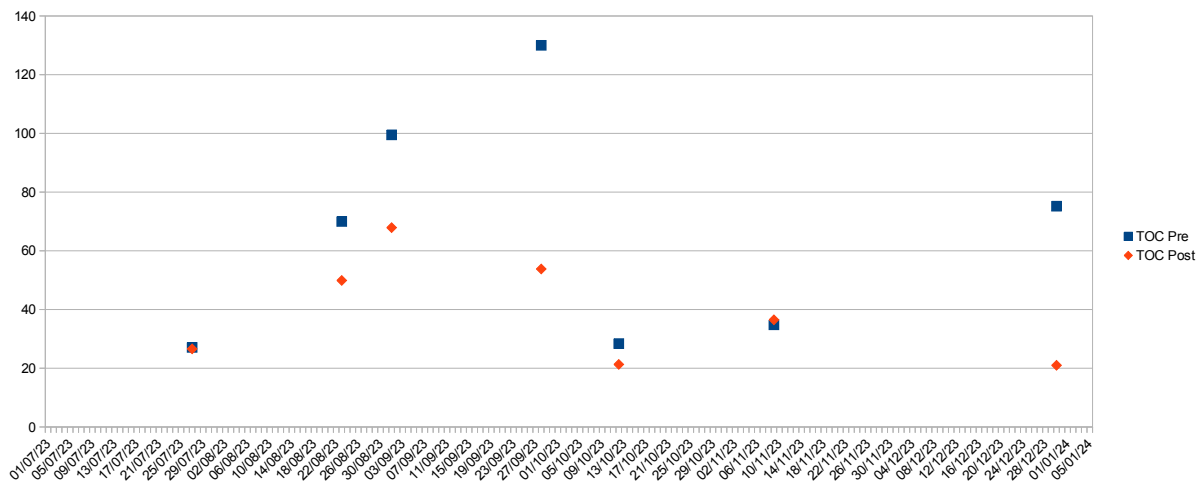
Graph 19. TOC, Total Organic Carbon

The total organic carbon (TOC) measurement is a measure of the organic carbon in the water pre and post treatment. The levels detected are consistent through the year with no major deviations from the mean observed except for elevated levels in the pre waters in September and October.
