Compliance Assessment Report CAR_NRW0042097

Permit being assessed: AW1005201

For: RHAYADER STW RHAYADER, held by DWR CYMRU CYFYNGEDIG

Type of assessment carried out: Site Inspection, Reason: Routine.

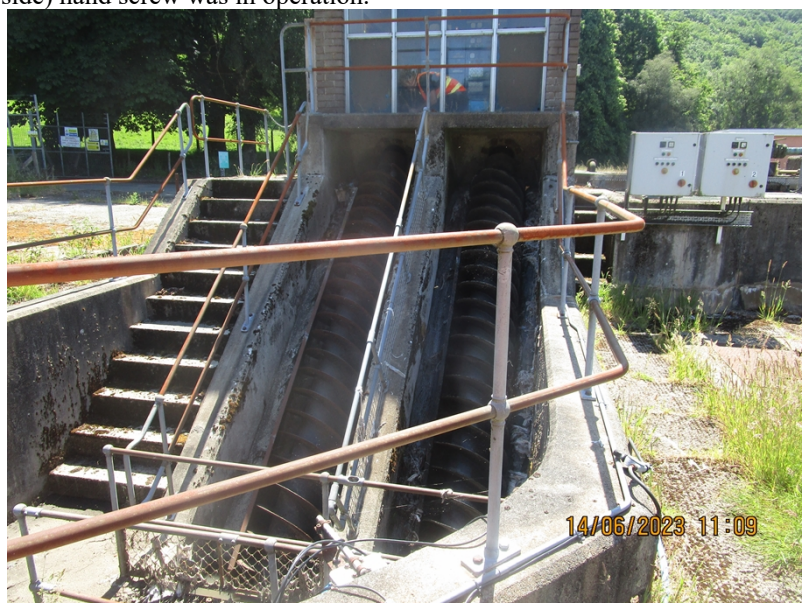
Inlet

The incoming flow to the site is raised to the head of the works by two powered Archimedes screws. One of the screws runs constantly during normal dry weather flows. The second screw is brought online automatically when flows into the works rise, this is measured by flow level telemetry equipment. At the time of the inspection only a single (Right Hand side) hand screw was in operation.

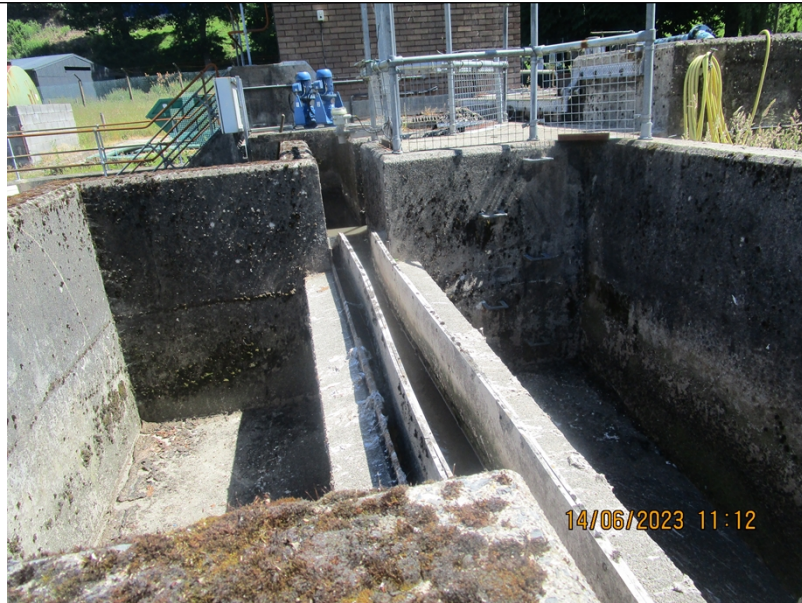
Once at the head of the works, all flows pass through a macerator. There are two macerators on site., There were clearly operational at the time of inspection and no significant signs of solids/rag were seen passing forward. Additionally, there is a bypass channel with a hard-set bar screen, which can be manually controlled using penstocks. The bypass channel and screens are in place for use when required for maintenance of the macerators. The bypass channel was not in use at the time of the inspection.

The storm weir on site is a semi-hard-set weir setting within the flow channel following maceration. It is controlled by a flotation within the inlet channel. As the flows into the works increase, the level in the flotation chamber rises, which in turn causes the gate to close. The gate closing raises the water level within the storm weir channel/chamber, once this reaches the set height, flow will begin flowing over the weir into the storm system. When the flow then drop, the level in the chamber will lower to the point where the gate is opened and all flow will then be sent for full treatment. At the time of inspection, the gate was not closed and there was no flows entering the storm system. There was evidence that there had been recent discharges into the storm channel, as rag was visible on and around the storm weir. The storm channel does not have additional screening as all flows into the site, pass through a macerator before the storm weir.

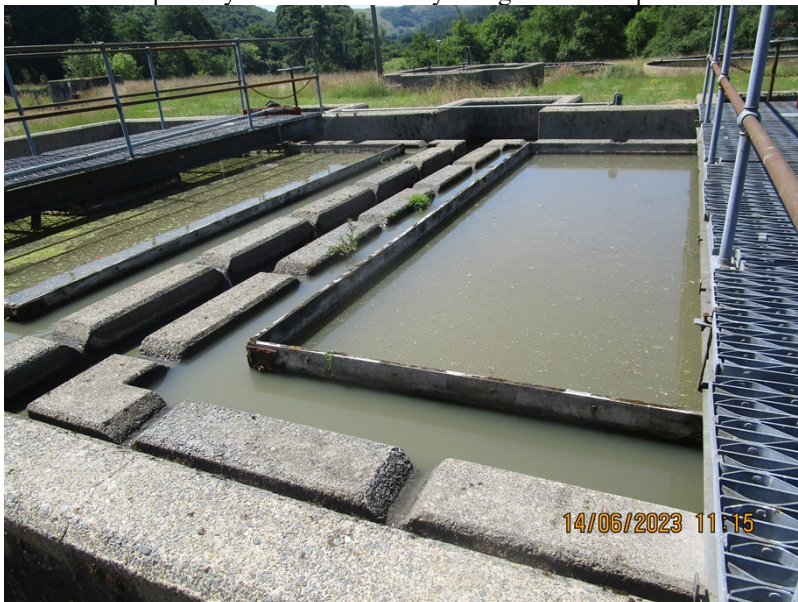
Primary Settlement

There are 2 rectangular primary settlement tanks on site, with set scum boards for retaining solid. The outfall channels are manually brushed by site operatives as required. The settlement tanks both appeared to be operating effectively and solids were being retained within the boards. There were no signs of significant solids passing through to the outfall channels. The primary tanks are manually deluged when required.

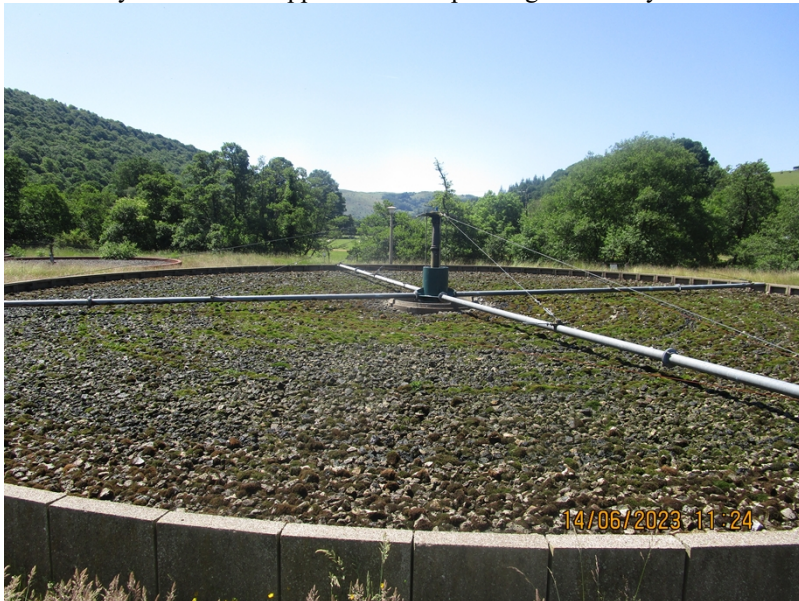
Filter Beds

The works contains a 2 circular filter beds containing stone media. The rotation arms on each were moving free and unhindered at the time of inspection. There were no signs of ponding or dry patches across the filter beds and no excessive vegetation growth. The filter housings are of concrete panel construction and appeared in good condition. The filter bed systems on site appeared to be operating effectively.

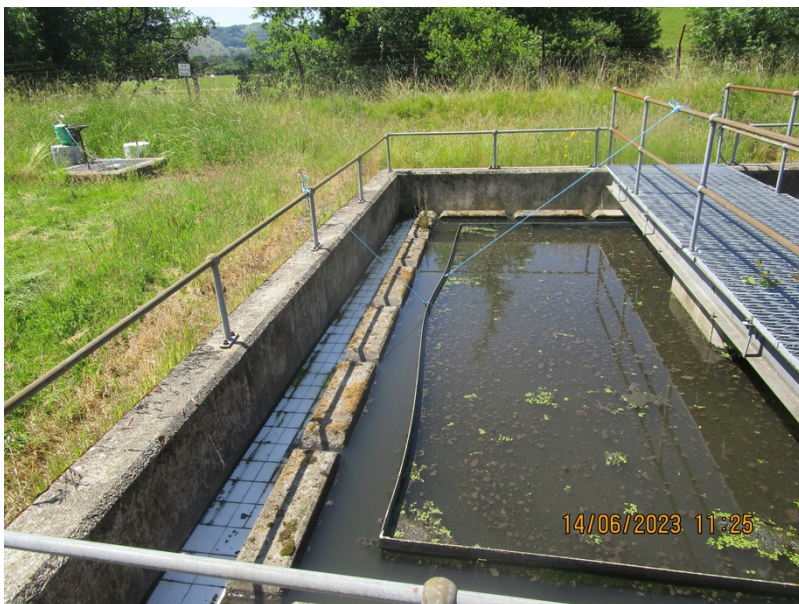
Final Settlement Tanks

There are 2 rectangular final settlement tanks on site, with set scum boards for retaining solids. The outfall channels are manually brushed by site operatives as required. The retaining boards on the left-hand settlement tank appeared to be being held in place by ropes. I asked if these are planned for repair and why this is in place. I was told the scum retaining boards contain asbestos so there are health and safety concerns when planning the repairs. Even with this in place the board appeared to be operating as designed.

Overall, the settlement system appeared to be operating effectively in preventing significant solids passing through to the outfall. There were small amounts of fungal growth present within the outfall channels. This may suggest that there is still a higher ammonia content within the effluent, however at this time it does not suggest any noncompliance with the permitted conditions.

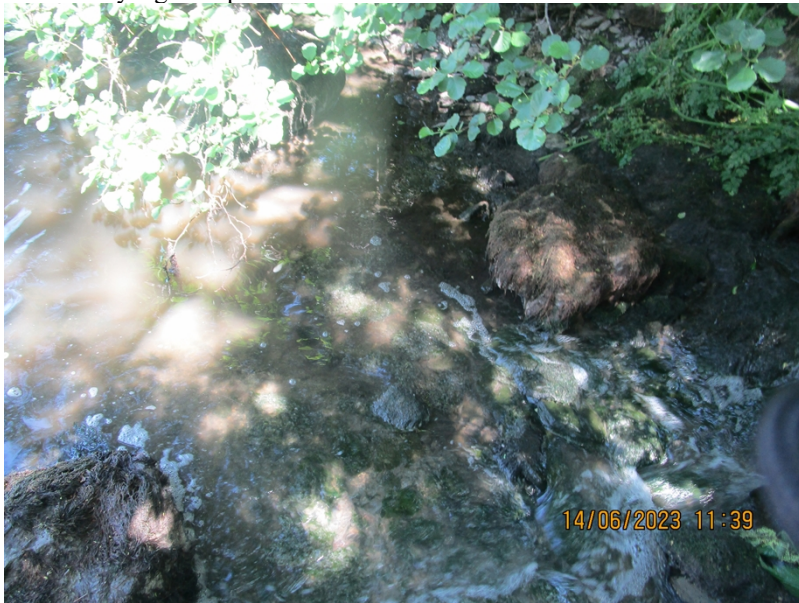
The outfall appeared to be flowing clearly and there were no signs of problems within the effluent. We walked to the outfall location in the river Wye. The outfall is located close to the bank of the river wye and is located in a way where effluent gets slightly held back by the flow of the river. There were small amounts of localised sewage fungus grown close to the outfall, nothing observed further downstream, this may potentially be attributed to the pooling effect and lower flows within the Wye in this instance. It was discussed that it would be beneficial if the outfall pipe was slightly further out to prevent effluent pooling in the area and to allow the river flow to better disperse the effluent, this will be investigated by DCWW to see if there are any solutions available. Downstream of the outfall the watercourse appeared clear of any signs of pollution.

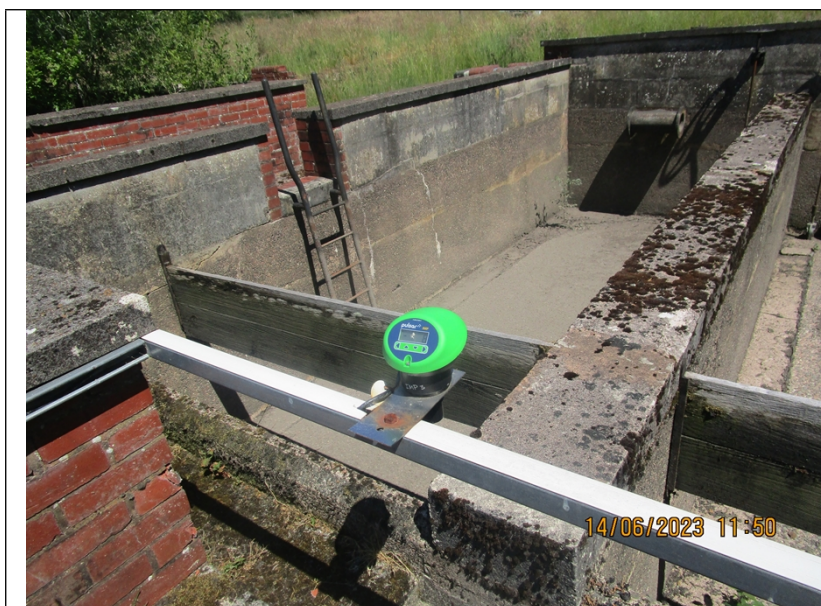
Storm Tanks

There are 6 in-line open rectangular storm tanks on site, which have a joint outlets channel on the downward side of the tanks. The storm tanks are manually returned to the head of the works when required.

The storm tanks all contained water but was well below the level where it would discharge via the storm channel. There had been persistent rainfall in the preceding days, so this was to be expected. There is EDM equipment present to monitor spilling from the storm system on site. At the time of inspections, the storm tanks were empty and there were no signs of any discharge occurring.
