**EAST WASTE  
MANAGEMENT SITE,  
LLANWERN STEELWORKS**

**PERMIT EAWML/30003**

**2019 Annual Review of  
Environmental  
Monitoring**

*Report Number 1895r1v1d1219*

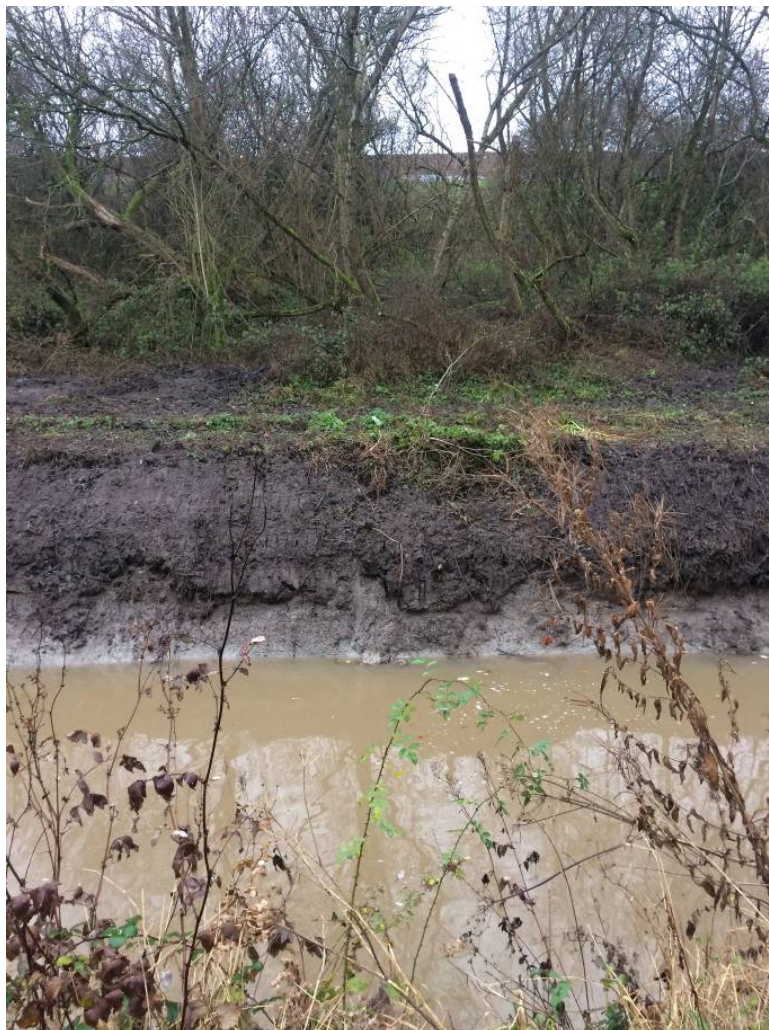
The latest monitoring data continues to indicate that upgradient and downgradient surface water chemistry is generally very similar. However, there are times when there are abrupt changes in several parameters including pH and alkalinity. Subtle differences in the concentration of sodium, potassium, chloride, sulphate and alkalinity (and other parameters) are sometimes apparent and as leachate has been observed along this flank and as the waste in the landfill is being exposed during the restoration works, this aspect of the monitoring programme should continue to be closely scrutinised. Recent inspection of the adjacent reen indicates that the reen is cut into low permeability deposits and that there are no obvious visual signs of staining indicative of leachate (see Plate 2). At this stage, there is no clear evidence that the reen quality is being impacted by the landfill.

**Plate 9-1 Reen flowing from right to left along eastern side of site. Landfill can be seen in background beyond tree.**
