**EAST WASTE
MANAGEMENT SITE,
LLANWERN STEELWORKS**

**2023 Annual Review of
Environmental
Monitoring**

Report Number 2299r1v1d0124

Prepared by
Geotechnology Ltd
Ty Coed
Cefn-yr-Allt
Aberdulais
SA10 8HE

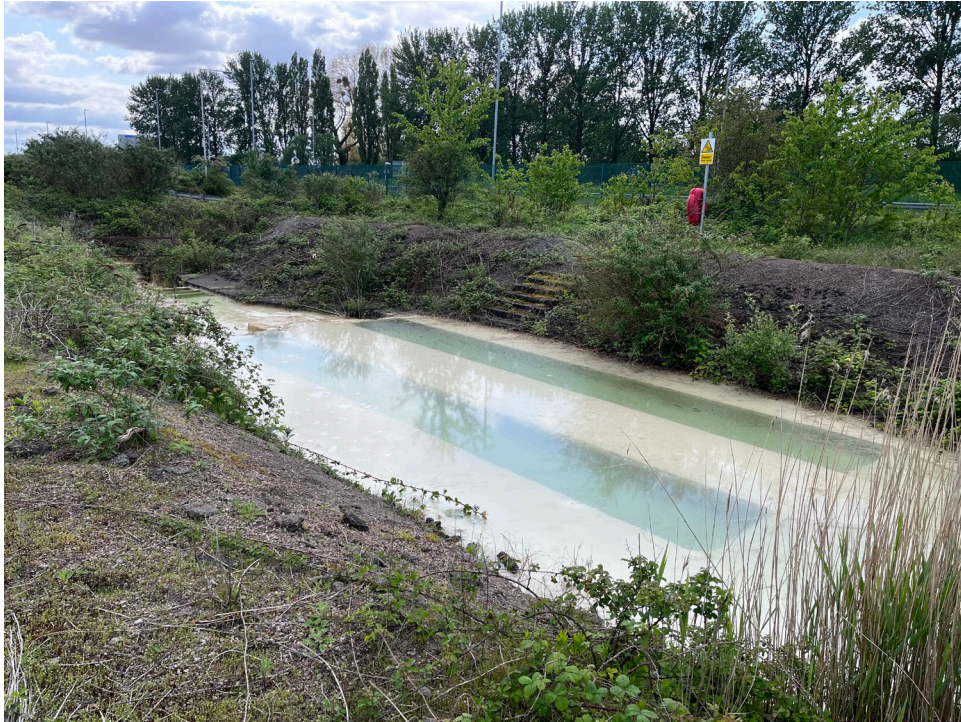
Plate 7-1 Surface water above concrete plinth (May 2023)

The ditch is culverted past BH5 as it drains to the on-site works treatment facility. During sampling in late 2022, the ditch was found to be spilling over the concrete containment structure and weir adjacent to BH5. When the levels are this high there is a possibility of the concentrated seepage infiltrating to land and groundwater as the construction of the concrete weir and surrounding structure is unknown. Such levels were observed in 2023, as shown in Plate 7-1.

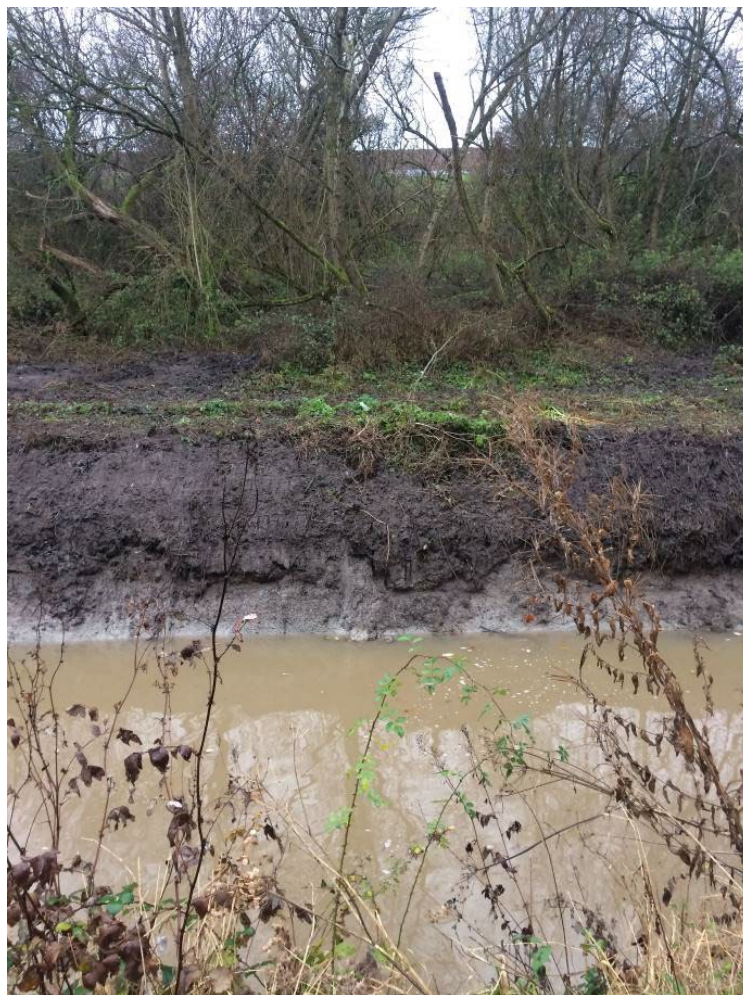
Plate 9-1 Reen flowing from right to left along eastern side of site. Landfill can be seen in background beyond tree.

The latest monitoring data continues to indicate that upgradient and downgradient surface water chemistry is generally very similar. However, there are times when there are abrupt changes in several parameters including pH and alkalinity. Subtle differences in the concentration of sodium, potassium, chloride, sulphate and alkalinity (and other parameters) are also sometimes apparent and as leachate has been observed along this flank and as the waste in the landfill is being exposed during the restoration works, this aspect of the monitoring programme should continue to be closely scrutinised. Recent inspection of the adjacent reen indicates that the reen is cut into low permeability deposits and that there are no obvious visual signs of staining indicative of leachate (see Plate 9-1). At this stage, there is no clear evidence that the reen quality is being impacted by the landfill.

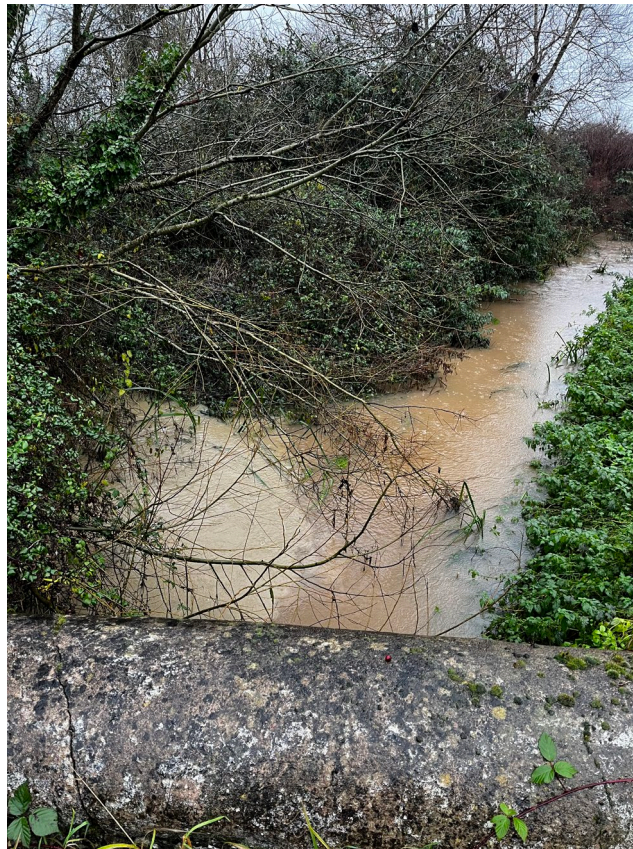
Plate 9-2 Suspended solids in surface water upstream of site (December 2023)

Continued scrutiny of upstream influences is also required as observations on several occasions, as shown in Plate 9-2, suggests that there are upstream sources of suspended solids and other potential pollutants like ammonia. These also influence water chemistry downstream of the landfill.
