**EAST WASTE  
MANAGEMENT SITE,  
LLANWERN STEELWORKS**

**PERMIT EAWML / 30003**

**2017 Annual Review of  
Environmental  
Monitoring**

*Report Number 1680r1v1d0218*

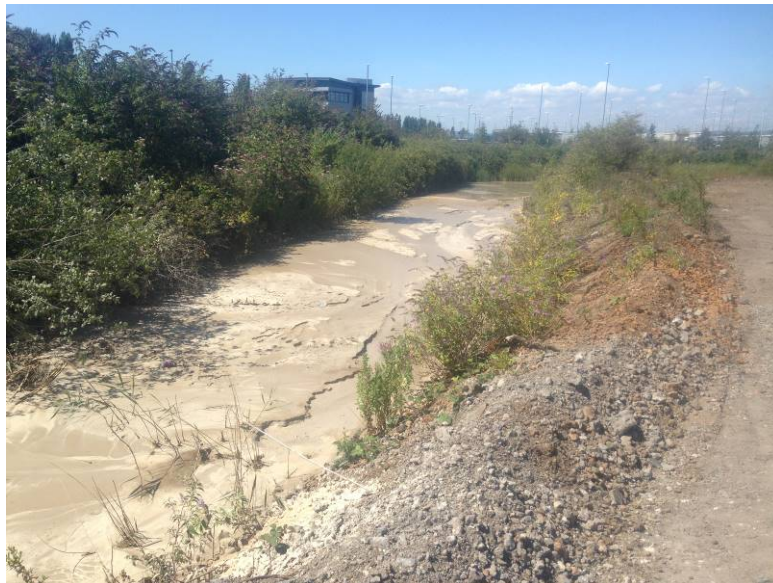
As anticipated, the monitoring reveals that surface water running in the leachate collection ditch is dominated by leaching of slag wastes and is characterised by high pH, alkalinity and calcium and low metals. The mobility of many metals will be reduced under the strongly alkaline conditions. In 2017, pH was persistently over 12 and EC typically over 4000 microS/cm. Ammonia and phosphate were frequently elevated. In August 2017, 0.08 mg/l cadmium was reported by the laboratory but less than 0.0001 mg/l was found on all other monitoring occasions.

Plate 1. Leachate Collection Ditch at southwest corner of site

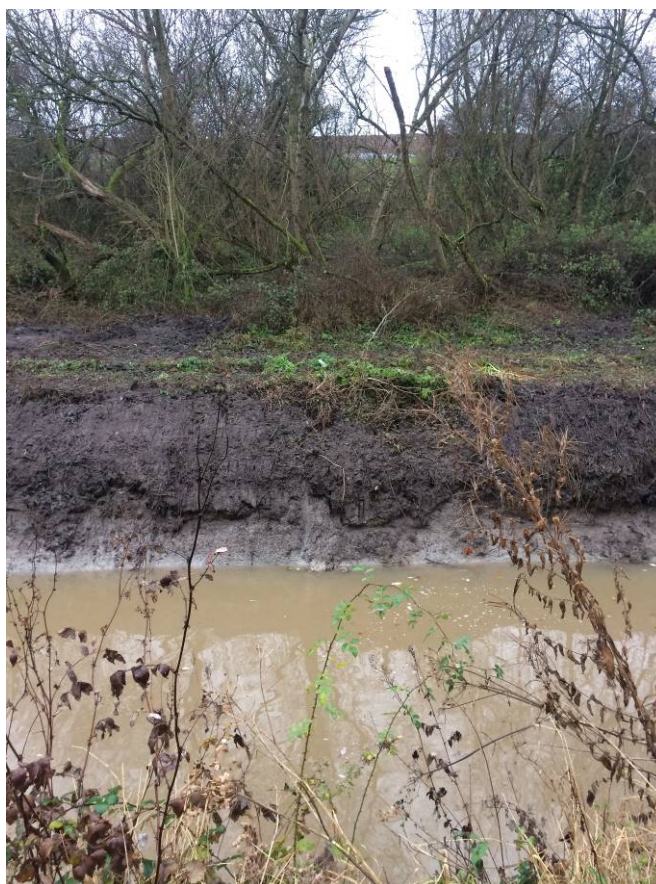
The latest monitoring data continues to indicate that upgradient and downgradient surface water chemistry is generally very similar. However, there are times when there are abrupt changes in several parameters including pH and alkalinity. Subtle differences in the concentration of sodium, potassium, chloride, sulphate and alkalinity are also apparent and as leachate has been observed along this flank and as the waste in the landfill is being exposed during the restoration works, this aspect of the monitoring programme should continue to be closely scrutinised. Recent inspection of the adjacent reen indicates that the reen is cut into low permeability deposits and that there are no obvious visual signs of staining indicative of leachate (see Plate 2). At this stage, there is no clear evidence that the reen quality is being impacted by the landfill.

Plate 2. Reen flowing from right to left along eastern side of site.  
Landfill can be seen in background beyond tree.

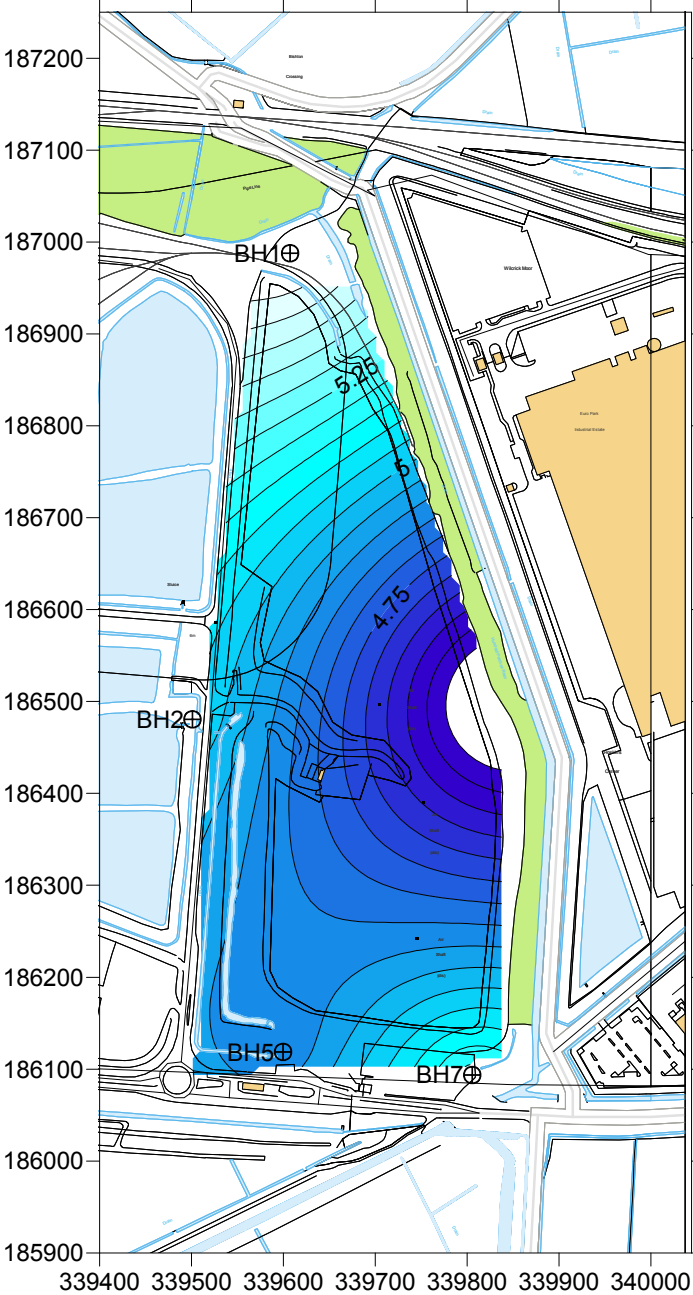
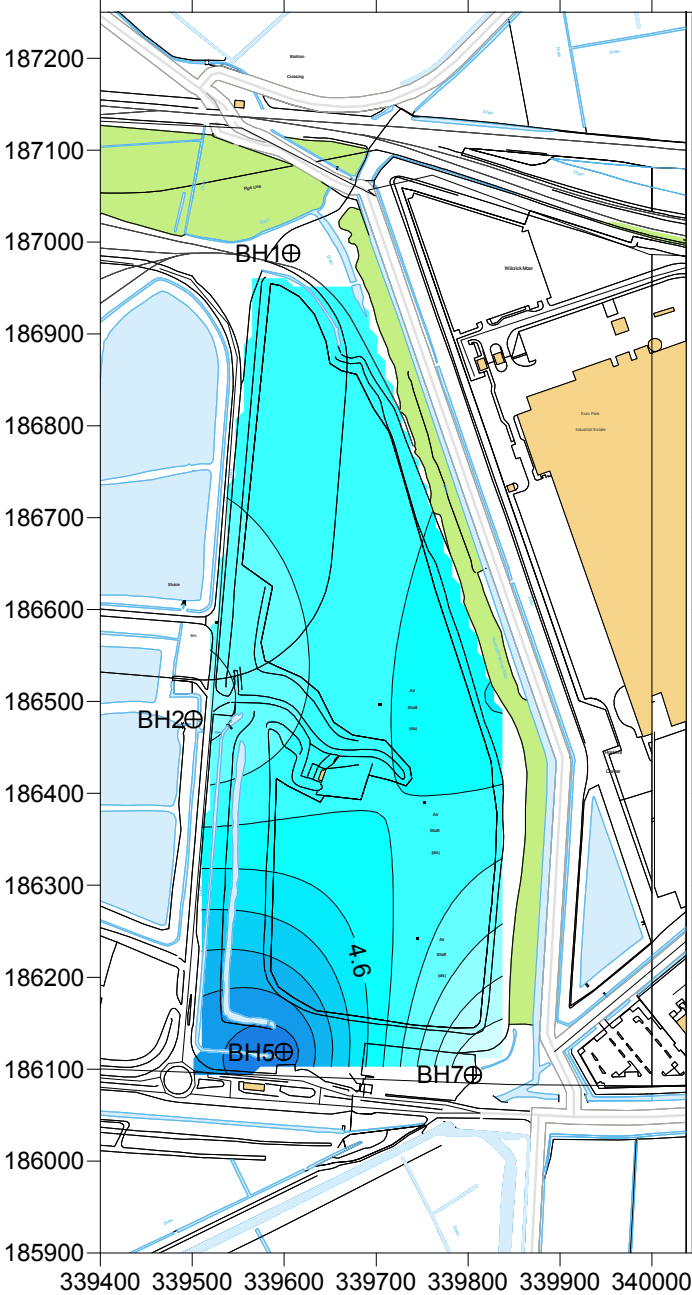
Figure 10. Groundwater Levels September 2017 (mAOD)

Based on available monitoring data from the last few years it would appear that the hydraulic gradients are shallow and sometimes lowest in the east at BH3 in both the shallow and deep aquifers (see Figures 9 and 10). Interestingly, in September 2017, the reverse was true in the deep aquifer. An outbreak of leachate has been observed on the eastern side of the site (just south of BH3) and this would appear to be coincident with the low point in the system. Tata is closely monitoring this position and has already informed NRW (who has also visited the site). A temporary bund to protect the adjacent reed has been constructed.
