**SOUTH SIDE  
QUEENSWAY WASTE  
MANAGEMENT SITE,  
LLANWERN STEELWORKS**

**2019 Annual Review of  
Environmental  
Monitoring**

*Report Number 1895r2v1d1219*

**December 2019**

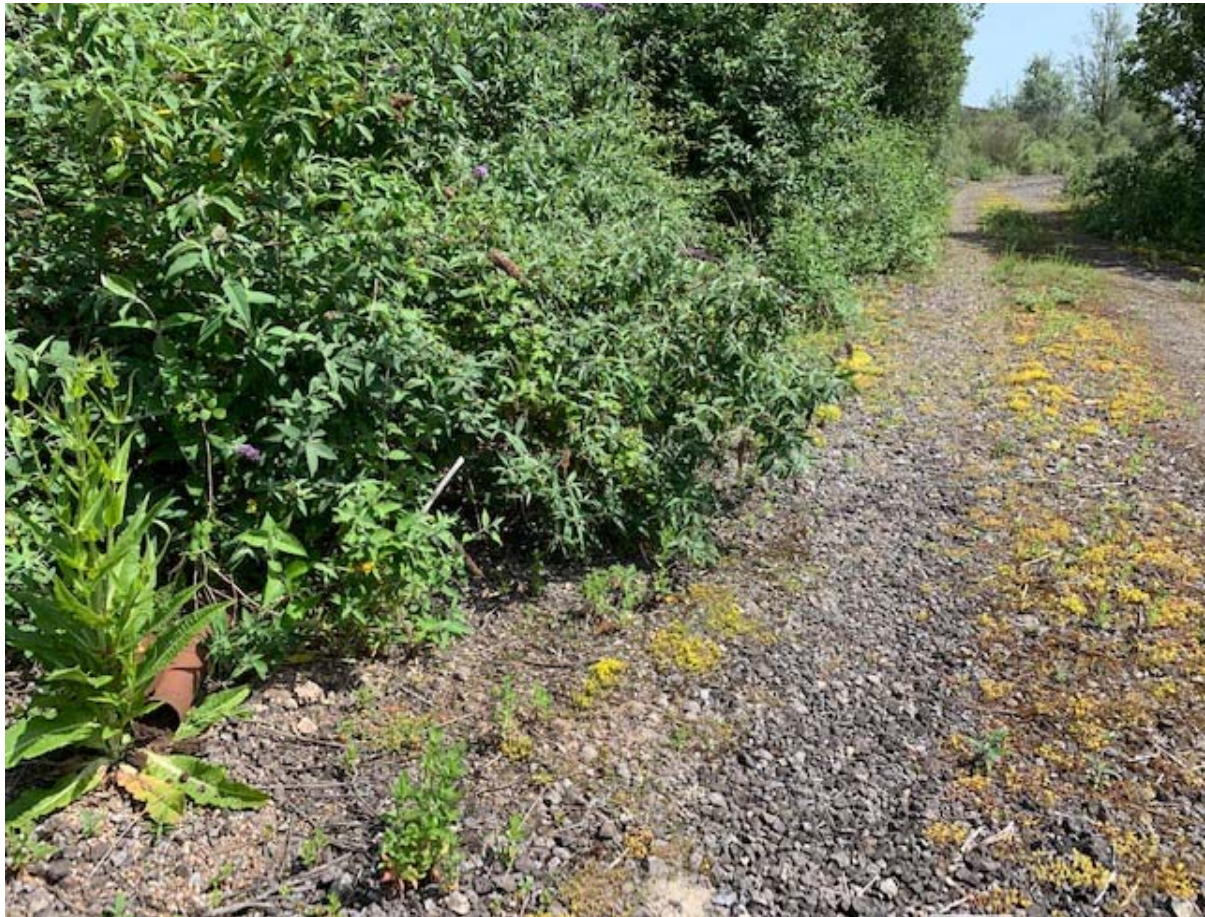
- 
- Samples cannot always be collected from the surface water sample monitoring locations due to dense vegetation growth. This was a particular problem during 2019 at SW2 and SW3 and requires routine action to ensure safe access.
  - Buddleia growth along the southern boundary sometimes limits access and monitoring, particularly during the summer months.
  - BH24 was not sampled during 2019 as the headworks appear to have been destroyed (see Plate 4-1).

**Plate 4-1 Overgrown buddleia at BH24**  
**Note headworks on ground in left of picture**

Groundwater in the Mercia mudstone is only monitored at BH24, to the south of Lagoon 25. Like the groundwater found in the peat, the groundwater in the bedrock has a circumneutral pH and elevated electrical conductivity (4000-6000 microS/cm in 2017). During 2017, the mineralisation was increasing due, in part, to sustained increases in chloride and ammonia. In 2018, mineralisation was stable. This position was not sampled in 2019 due to damage to the headworks.

- Safe access to the surface water sampling points needs to be improved. Given that vegetation growth is inevitable, routine maintenance and signage would be beneficial. Alternate sample positions could be considered and agreed with NRW, if necessary.
- The headworks at monitoring positions BH16 and BH18 should be excavated and inspected as the area was flattened during site clearance works in 2017.
- Buddleia growth along the southern boundary is limiting access and monitoring. The vehicular access route and monitoring positions should be routinely maintained.
- Investigate damage to BH24

- Check integrity of the site boundary to ensure members of the public cannot gain access.
- Conduct six monthly walkovers around embankments of Lagoons 12 and 25 to check for leachate breakout.
- Conduct annual walk-over each springtime to look for evidence of shallow translational slips along the embankment of Lagoon 12.
- Improve year-round access to the surface water monitoring positions.
- Locate and expose BH16 and BH18 to assess condition of headworks.
- Manage buddleia growth along the southern boundary as it is limiting access and monitoring.
- Investigate damage to BH24 and take appropriate actions

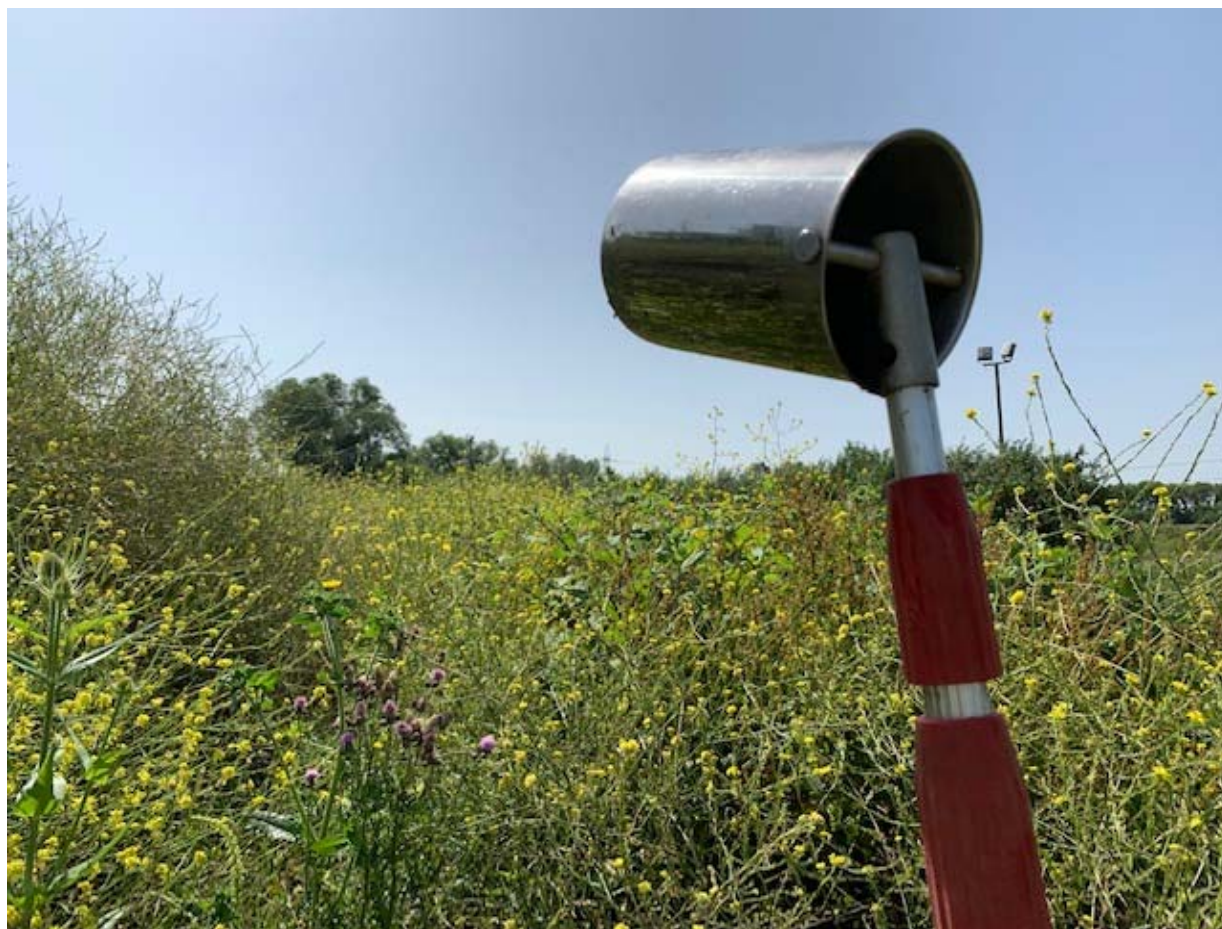
As shown in Plate 6-1, sample positions SW2 and SW3 were not always accessible in 2019 due to dense vegetation growth. This should be routinely cleared or new sample points established for 2020.

**Plate 6-1 Example of dense vegetation approximately 2m high along access route to SW3**
