**SOUTH SIDE  
QUEENSWAY WASTE  
MANAGEMENT SITE,  
LLANWERN STEELWORKS**

**2023 Annual Review of  
Environmental  
Monitoring**

*Report Number 2299r2v1d0124*

**January 2024**

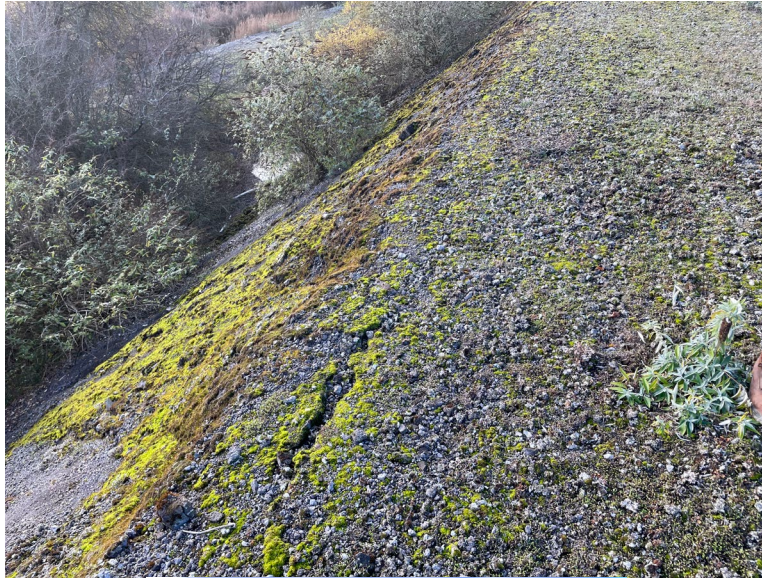
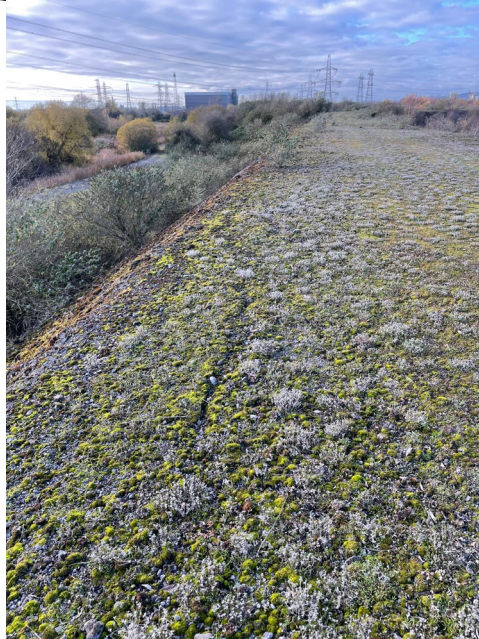
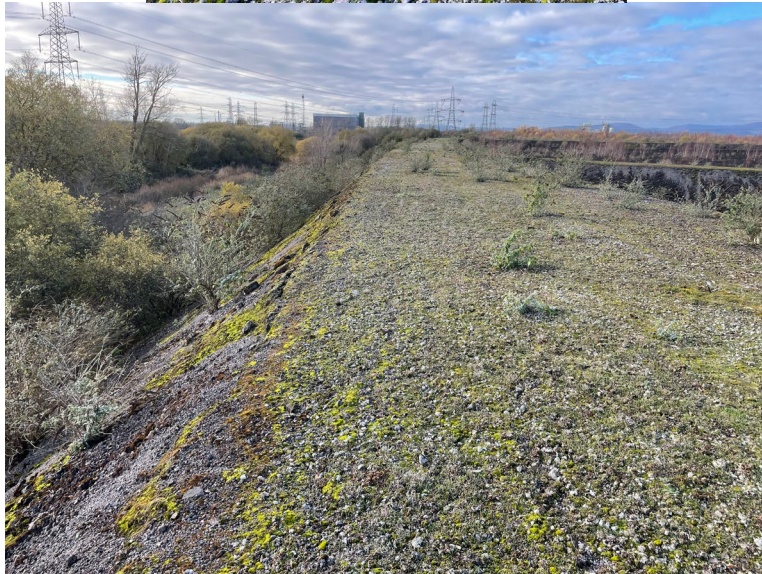
**Plate 4-1 Tension Cracks on Surface of Embankment of Lagoon 27**

During the 2022 walkover, tension cracks on the upper surface of the embankment of Lagoon 27 were observed, as shown in Plate 4-1. These have not notably changed during 2023.

The lagoon embankments should also be closely inspected as tension cracks were observed on the surface of the southern embankment of Lagoon 27.

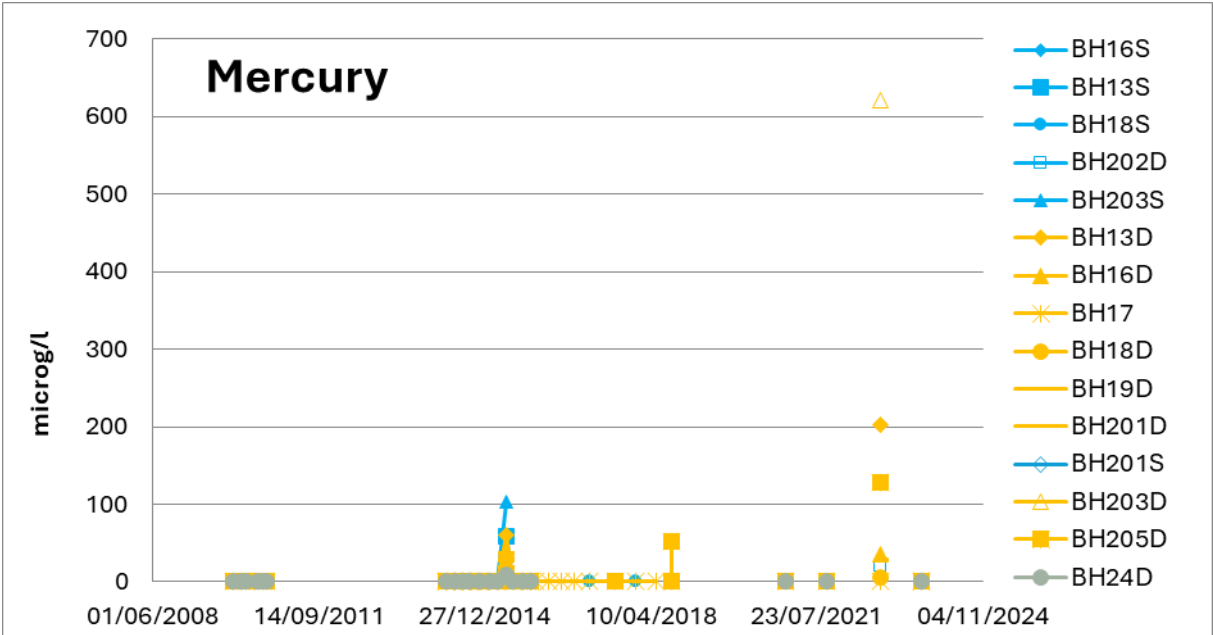
**Plate 5-1 Mercury concentrations in groundwater**

Because of the highly alkaline pH, many non-hazardous and hazardous substances are sometimes below detection limits or at low concentrations in the groundwater recovered from the made ground. In recent years, hazardous substance cadmium has been detected on several occasions, and sometimes at elevated concentration. During 2022 and 2023, cadmium was not found above the analytical detection limit. Surprisingly, significantly elevated concentrations of mercury were, however, detected in 2022 with 0.621 mg/l reported at BH203D. Elevated concentrations were also detected at BH13D and BH205D, as shown in Plate 5-1. Mercury was also found at elevated concentration in surface water, with the highest concentration at QSW1, downstream of the lagoons. Mercury was not, however, detectable in groundwater during 2023. Nickel and lead were detected at several positions in 2022 and 2023 but at lower concentrations than observed previously.

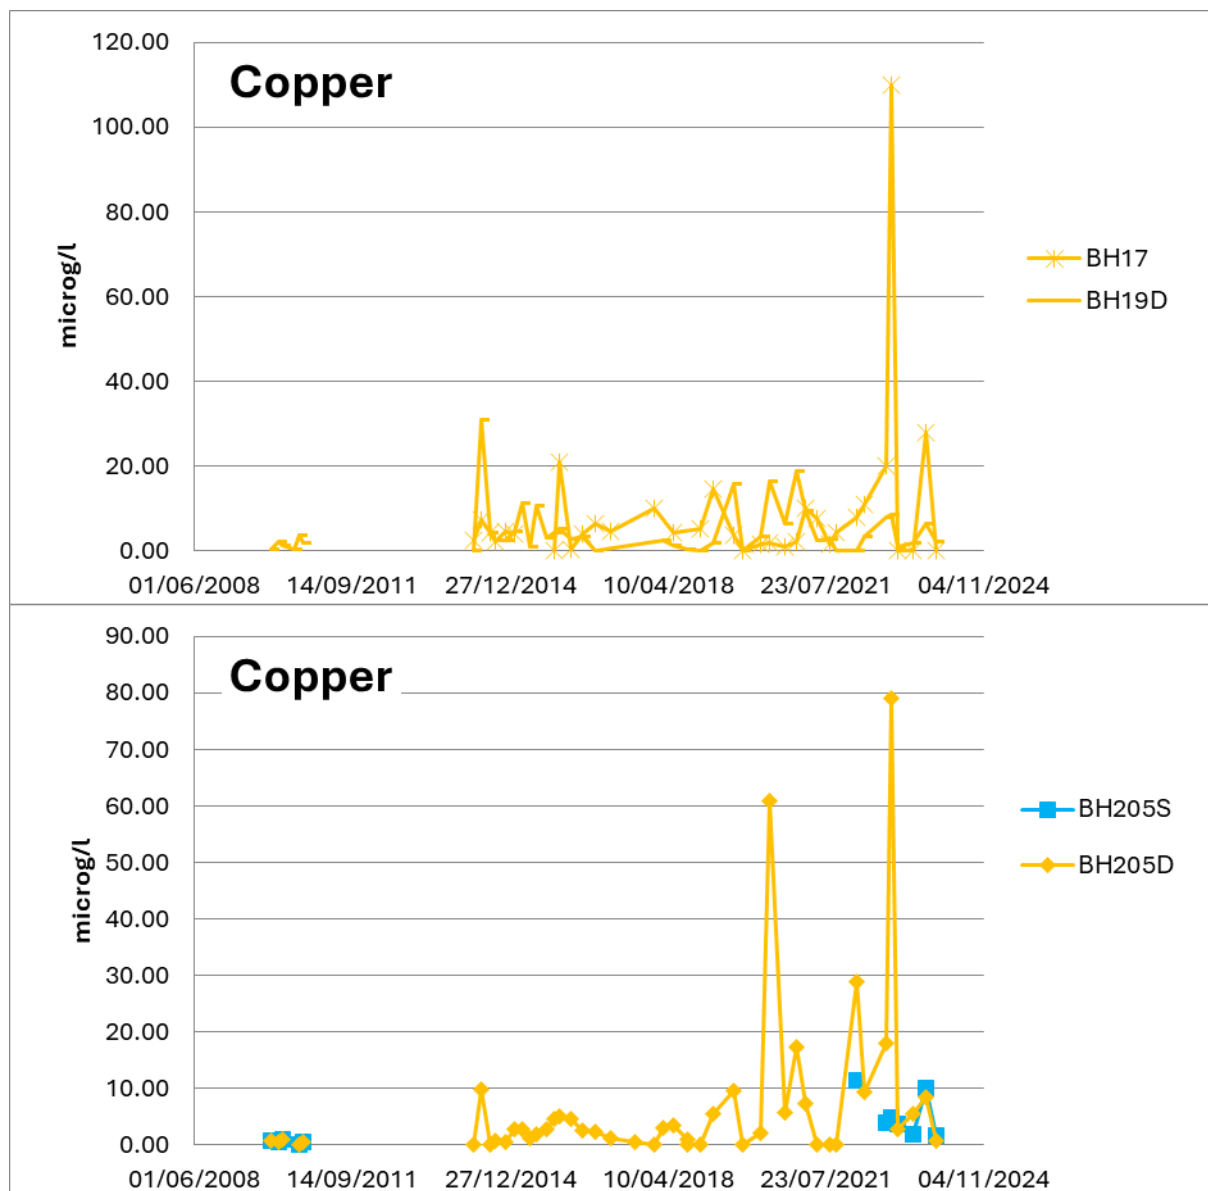
**Plate 5-2 Copper concentrations at BH205**

Chromium, copper, lead (and other metals) have also been found above their freshwater Environmental Quality Standards (EQS) from time to time, although there is no general upward trend. Exceptions do however occur, with copper detected at its highest concentration at BH17 in December 2022 and copper increasing at BH205D during 2022. As shown in Plate 5-2, such trends have not, however, persisted in 2023. This position is upstream of the lagoons and has also shown increasing concentrations of chloride, phosphate and ammonia in recent years.

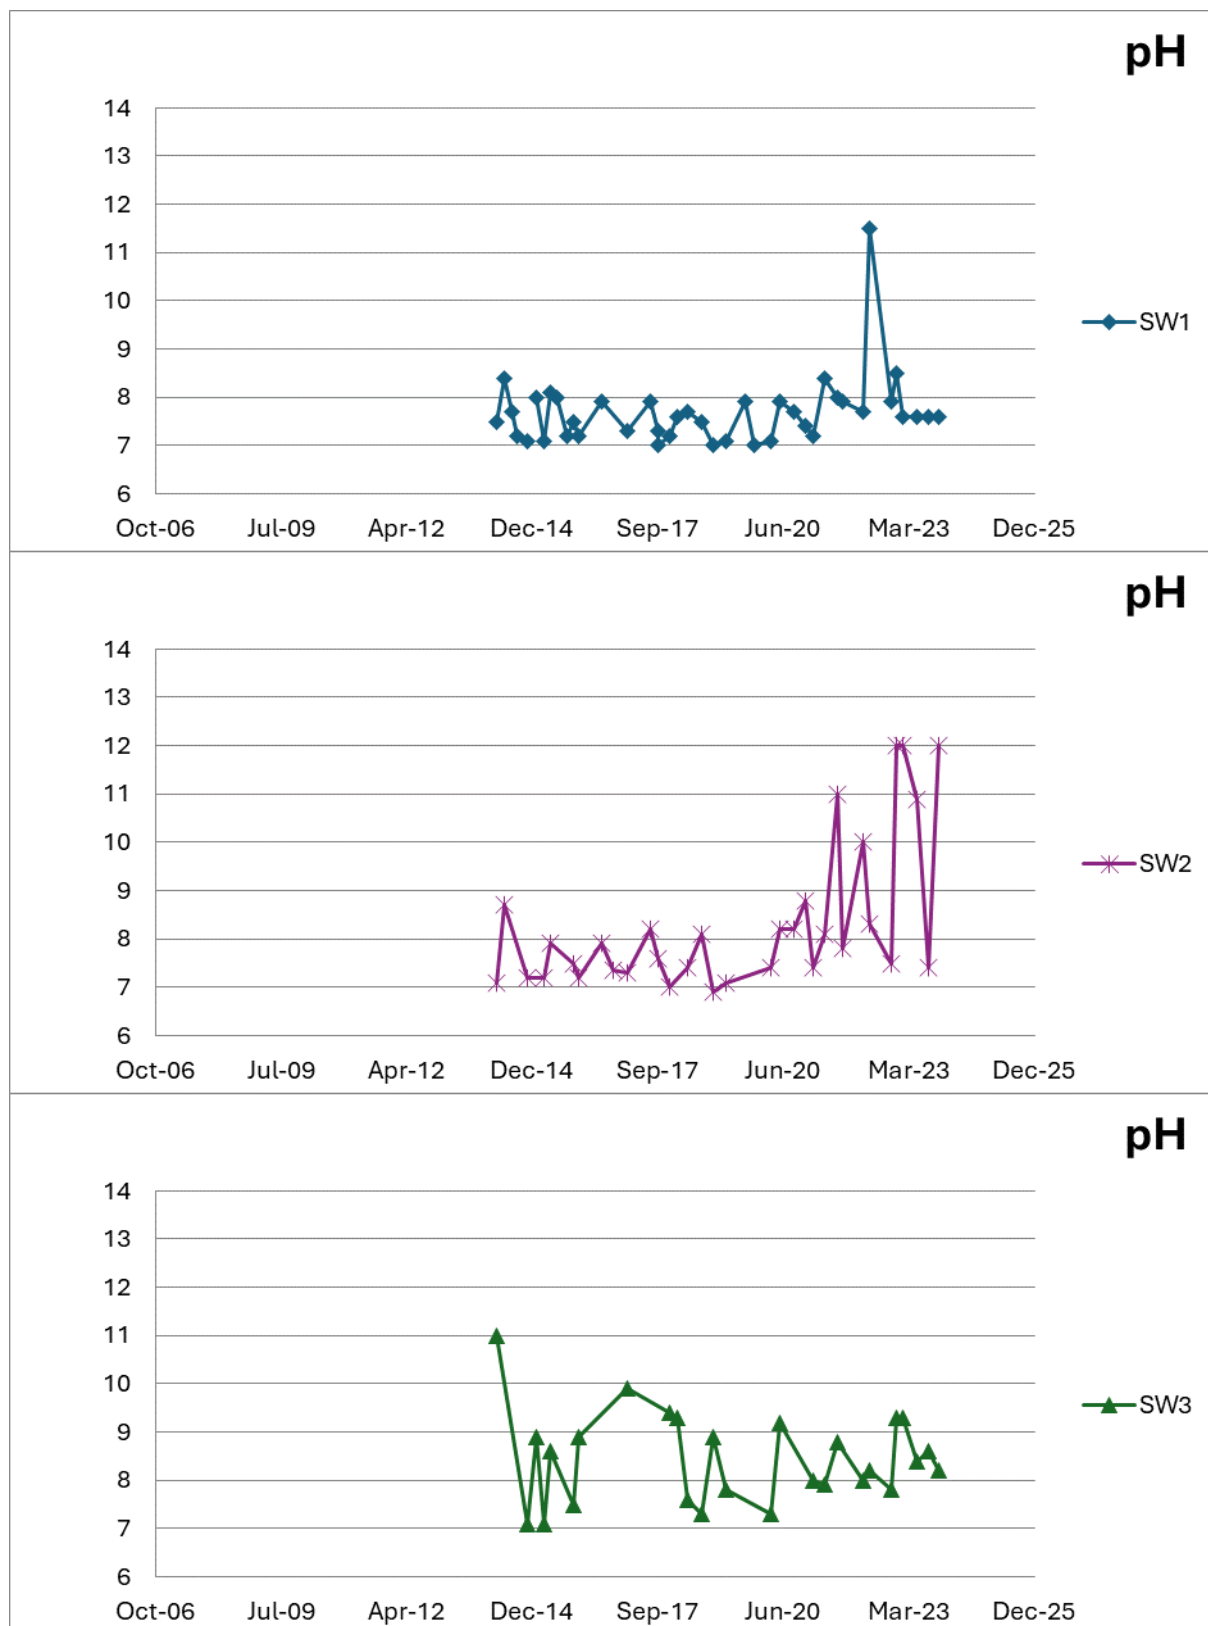
**Plate 6-2 Changes in pH at SW1, SW2 and SW3**

The data gathered during the past 12 months continues to suggest that surface water is becoming increasingly alkaline. This is based on the upwards inflection of the pH observed at all sample points over the past 24 months. It appears that there is a long-term underlying upwards trend in surface water pH with short-term spikes in pH, particularly at SW2. This is clearly shown in Plates 6-1 and 6-2. Sample position SW2 is downstream of SW3 and upstream of SW1, adjacent to powerline alley.

Such changes in surface water levels would be expected to alter water quality and could explain the variations observed. Consideration should also be given to other sources and the ditch should be inspected to ensure that all potential on-site and off-site run-off sources are understood.

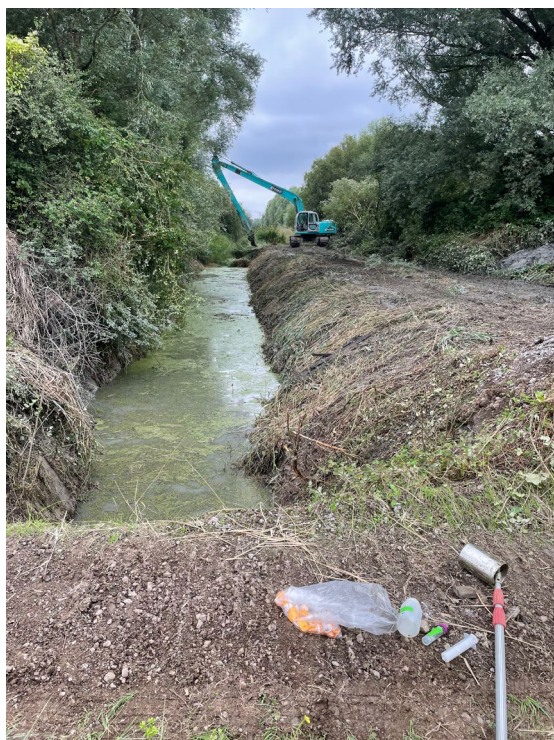
**Plate 6-4 Ditch maintenance during August 2021 sampling upstream of sample point SW1**

Some of the data trends may be influenced by the timing of sampling relative to ditch clearance and maintenance, as shown in Plate 6-4. In October 2021, some of the highest surface water levels observed were found at SW1 (compare Plates 6-4 and 6-5). This was due to significant rainfall in the preceding 24 hrs.
