## Compliance Assessment Report CAR\_NRW0043598

**Permit being assessed:** AW1005301

For: Talgarth Wastewater Treatment Works, held by DWR CYMRU CYFYNGEDIG  
At: Track Off Bronllys Road (A479), Talgarth, Brecon, LD3 0HH.

**Type of assessment carried out:** Site Inspection, Reason: Routine.

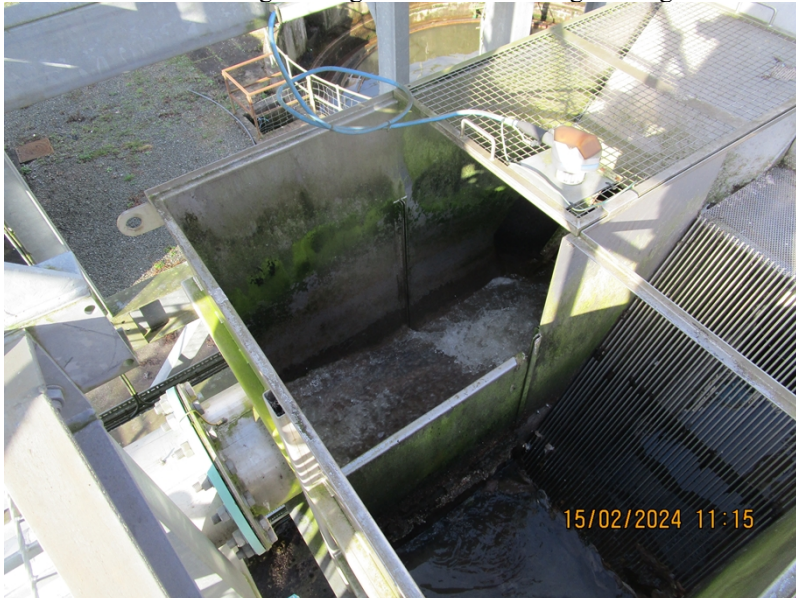
At the head of the works an Archimedes screw screen removes rag and large solids, this is also surrounded by a 6mm mesh screen. This was clearly operation and clear of blockages. There is a bypass screen (to the right) which is approximately inch in aperture, this issued when maintenance is required on the mechanical screen or in the event of a failure. There were no signs of significant solids or rag flowing to the next stage of treatment.

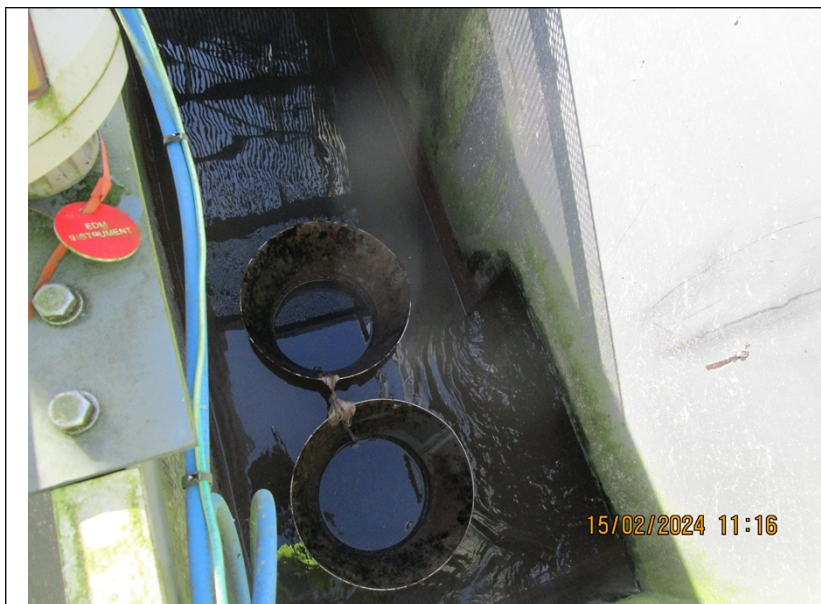
The storm weir at the works is via two cones in the chamber following inlet screening. The weirs are at a set level and will only discharge once the inlet flows reach the specified level. The flows into the works at the time were below the storm discharge level and the site was not running to storm. There was some rag present on the storm weir which suggests that there had been a recent discharge into the storm channel. There is EDM equipment in place to monitor flows, which appeared in working order and was clearly marked and visible.

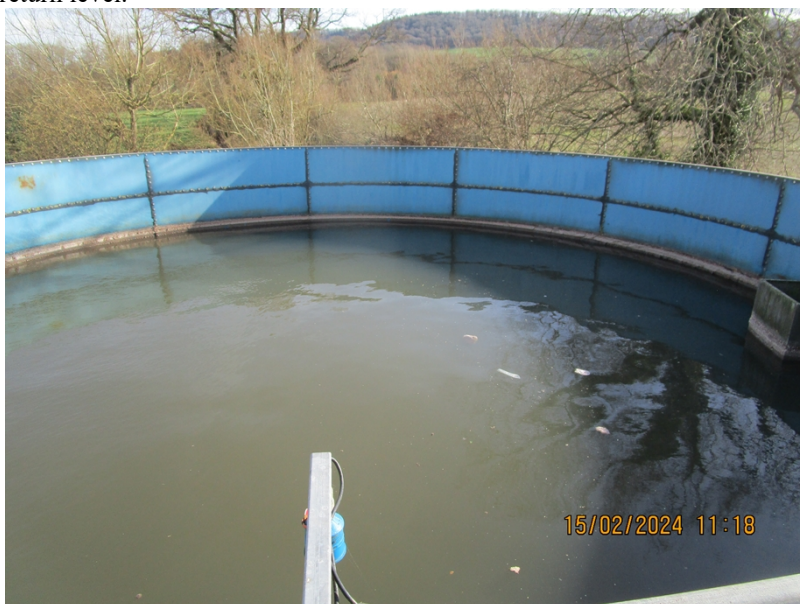
There is a single storm tank, which was nearly full at the time of inspection. The storm tank has an automatic return to the head of the works. The automatic return operated when the incoming flows to the works fall below the specified level. There had been heavy rainfall in the preceding days so it is likely flows would have remained above the automatic return level.

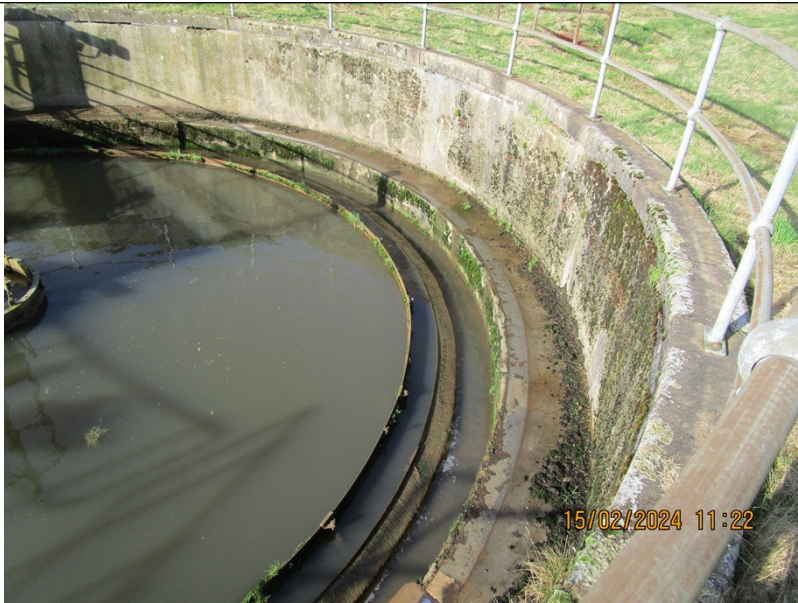
The primary settlement consists of two cylindrical settlement tanks, with rotating sludge scrapers. Both tanks appeared in good working order and there were no signs of significant solids carrying over from either. Each settlement tank has individual monitoring in place.

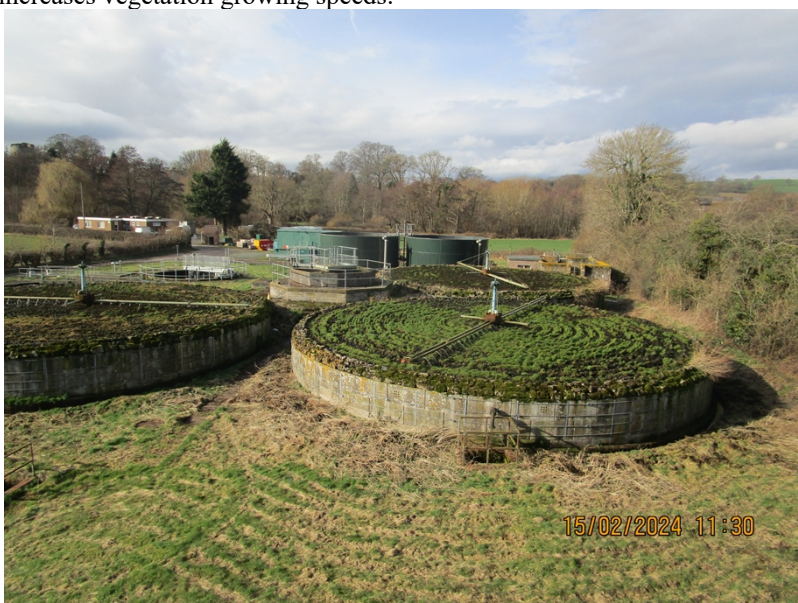
The three smaller filter beds had higher levels of vegetation build up on top of the filter media. I questioned about the vegetation management, and was advised that they are periodically cleared, there is a health and safety concerns with doing so. This is because the filter beds are raised and there is no guard rail. The vegetation does not appear to be hindering the operation of the filter beds currently, however this should be monitored and managed as it could lead to problem within the treatment process. It would be advisable to reduce the vegetation coverage before warmer weather increases vegetation growing speeds.

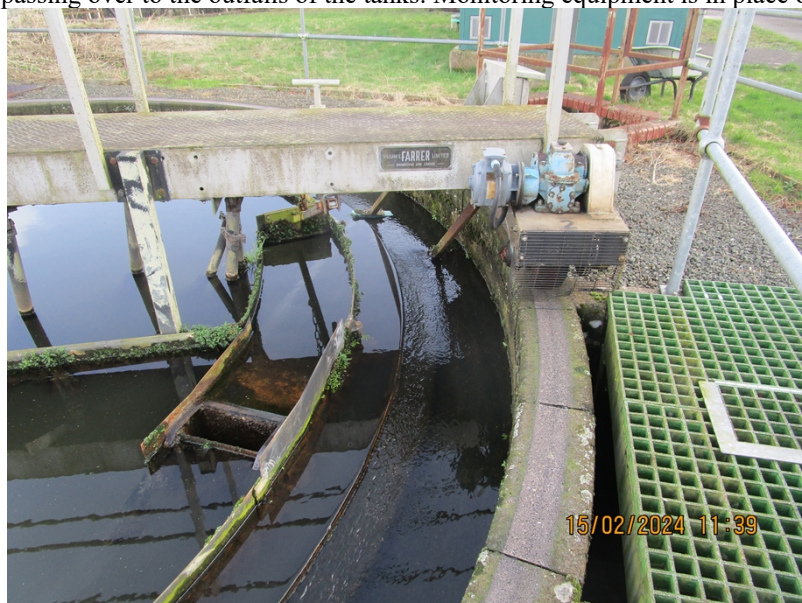
The works has three round humus tanks with rotating scum scrapers (Brush). There were no signs of solids passing over from the settlement tanks. The rotating brushes were clearly operational. There were no signs of significant solids passing over to the outfalls of the tanks. Monitoring equipment is in place on the humus tanks in case of any issues.

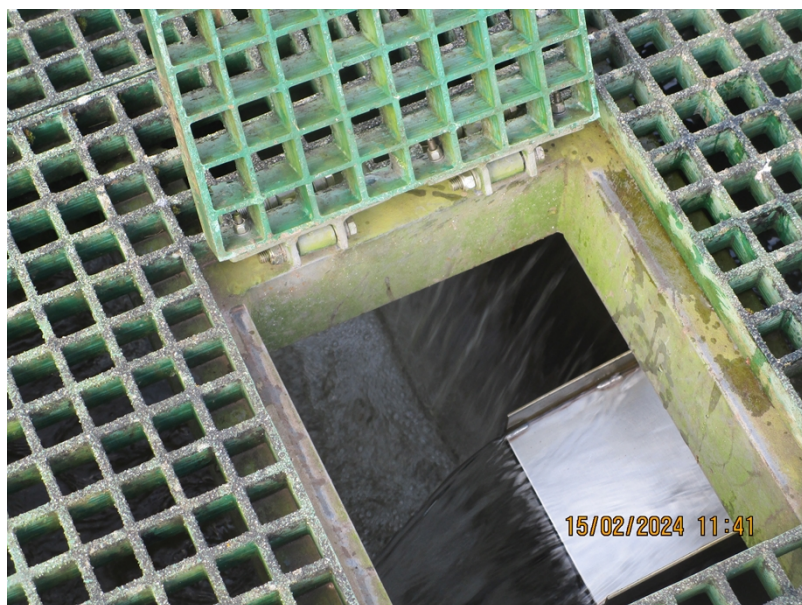
The final effluent from the humus tanks passes through a Magflow flow meter, which appeared to be operating as required and accessible for inspection. The sample point is clearly marked with appropriate signage including the sample point number. The effluent within the inspection point appeared clear of any solids or signs of polluting matter.

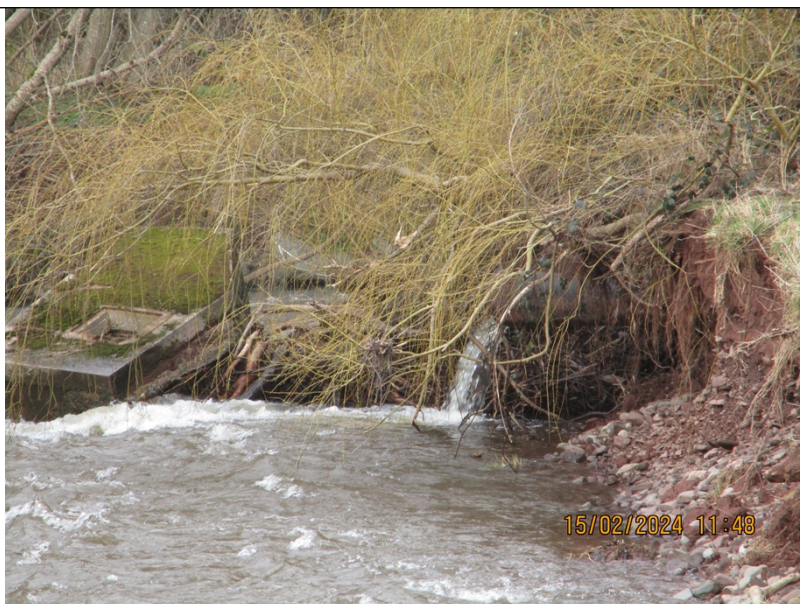
The outfall into the river has previously been damaged by a storm even. The banking behind the outfall chamber collapsed and washed away during storm Dennis (February 2020). The concrete housing for the outfall was also damaged and swept downstream. As such the site is not currently discharging via the location stated on the permit. This has been raised within a previous compliance report. Since the previous inspection there appears to have been further erosion of the banks around the outfall location. DCWW are looking into solutions to prevent erosion and to repair the outfall chamber.
