# DŴR CYMRU WELSH WATER

## EVENT DURATION MONITORING

**EDM TEN Investigation Initial Report – BW4102301  
Furzeland Drive CSO, Sketty, Swansea**

**Asset ID No. 72736**

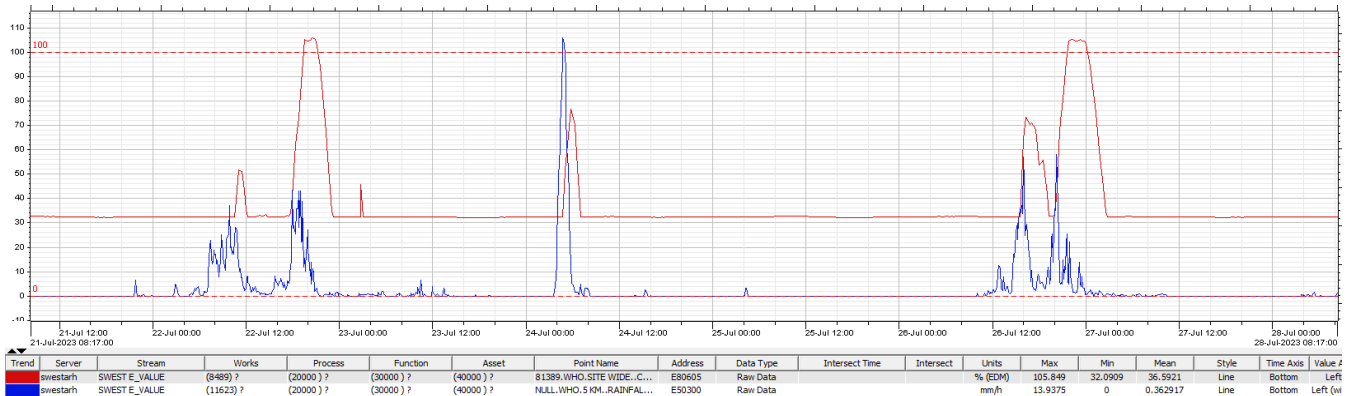
Figure 2: Red (solid line) trend displays wet well level. Red dotted line indicates spill level. Blue (solid line) trend displays rainfall. Data indicates direct link to rainfall events and suggest hydraulic overload issues.

The root cause of CSO spill frequency cannot be established at this time but is likely to be attributed to hydraulic overload of the sewerage system. Significant further investigation work will be required to confirm root cause.

Of the 6 spill this summer, 4 were attributed to prolonged rainfall between 6 to 8 mm/hr. 2 of these spills lasted for only 1 hour each. There were 2 longer duration spills where rainfall was prolonged between 14 to 18 mm/ hr. Yellow weather warnings were issued for the region during 4 of spills, this included Storm Antoni and Storm Betty.

Further investigation works will be released by DCWW for hydraulic modelling, to understand the return periods of storms and to see if the asset spilled as expected, this will include:

- Detailed investigation of current operating mode.
- Installation of additional level monitors within the asset.
- Flow modelling of the incoming and outgoing network.
