DŴR CYMRU WELSH WATER

EVENT DURATION MONITORING

**EDM TEN Investigation Initial Report – BP0315201
Ben Hughes Foundry CSO, Loughor, Swansea**

Asset ID No. 52307

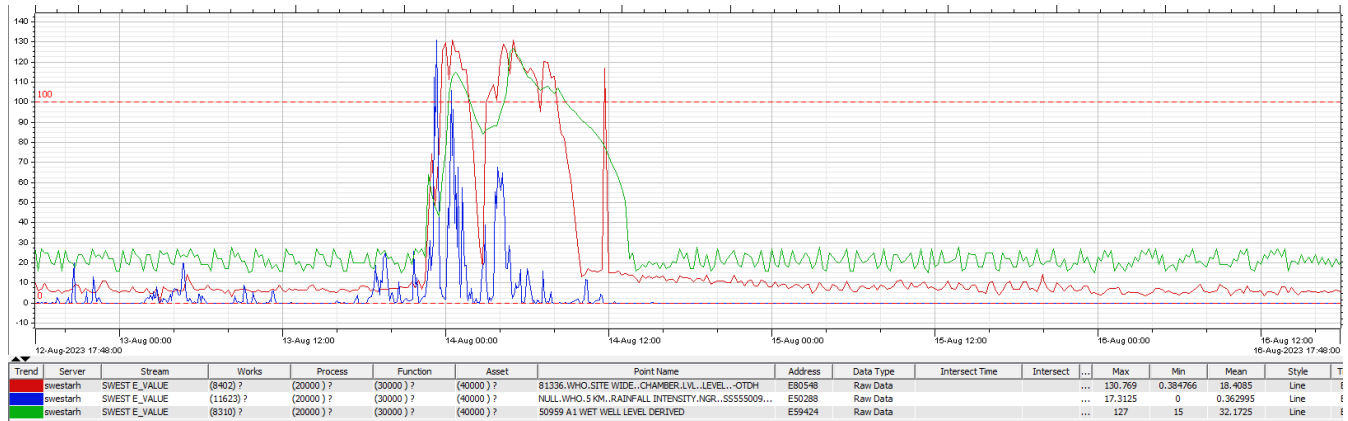
A review of the telemetry data has been carried out for the period of recorded spills in 2023. Data sets for spills are consistent with response to rainfall events in the catchment: pumps operating at Gwynne Road SPS and other monitored assets in the surrounding area.

Figure 2 – Red (solid line) trend displays the CSO flow level. Red dotted line indicates the CSO spill level. Blue trend displays the recorded rainfall. Green trend displays the wet well level at Gwynne Road SPS.
