Geomorphology survey

River Clywedog – Felin Puleston Weir removal

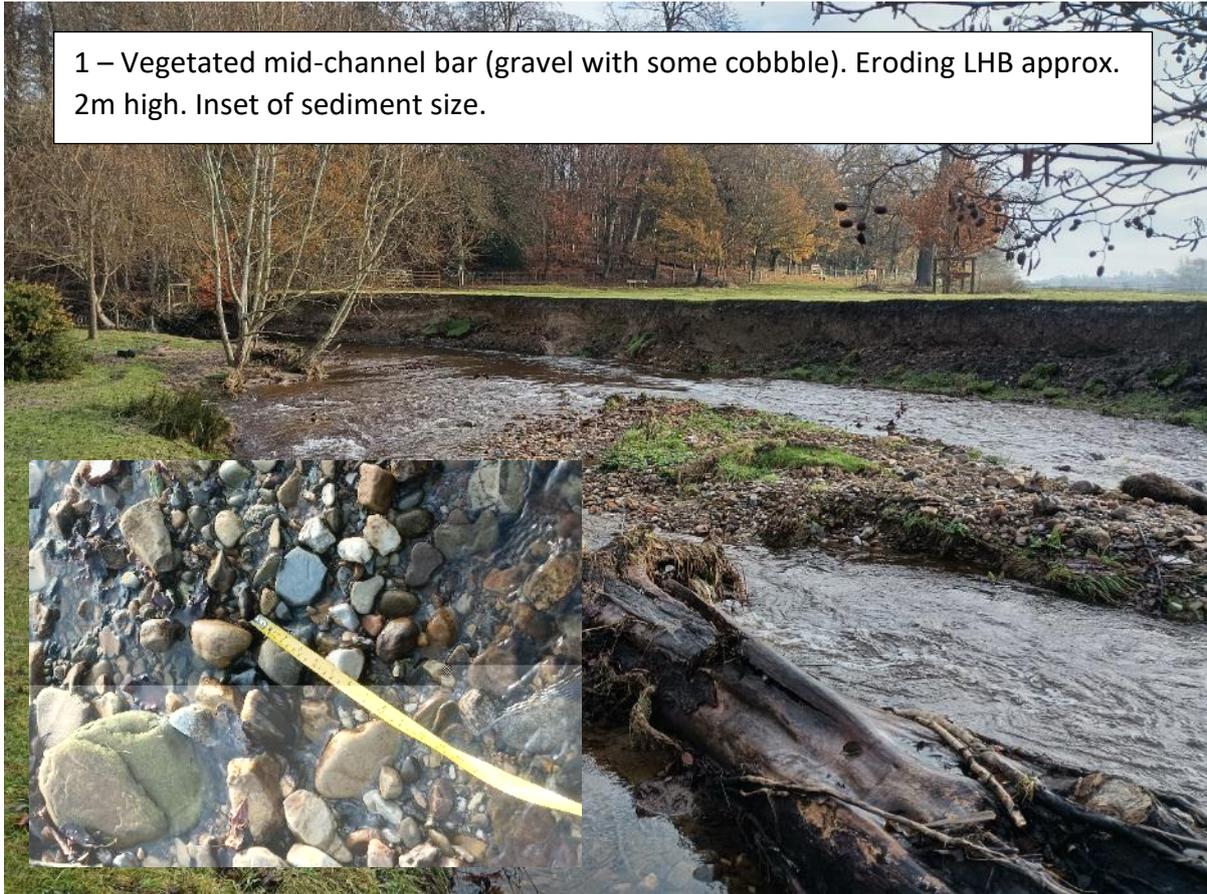
1 – Vegetated mid-channel bar (gravel with some cobble). Eroding LHB approx. 2m high. Inset of sediment size.

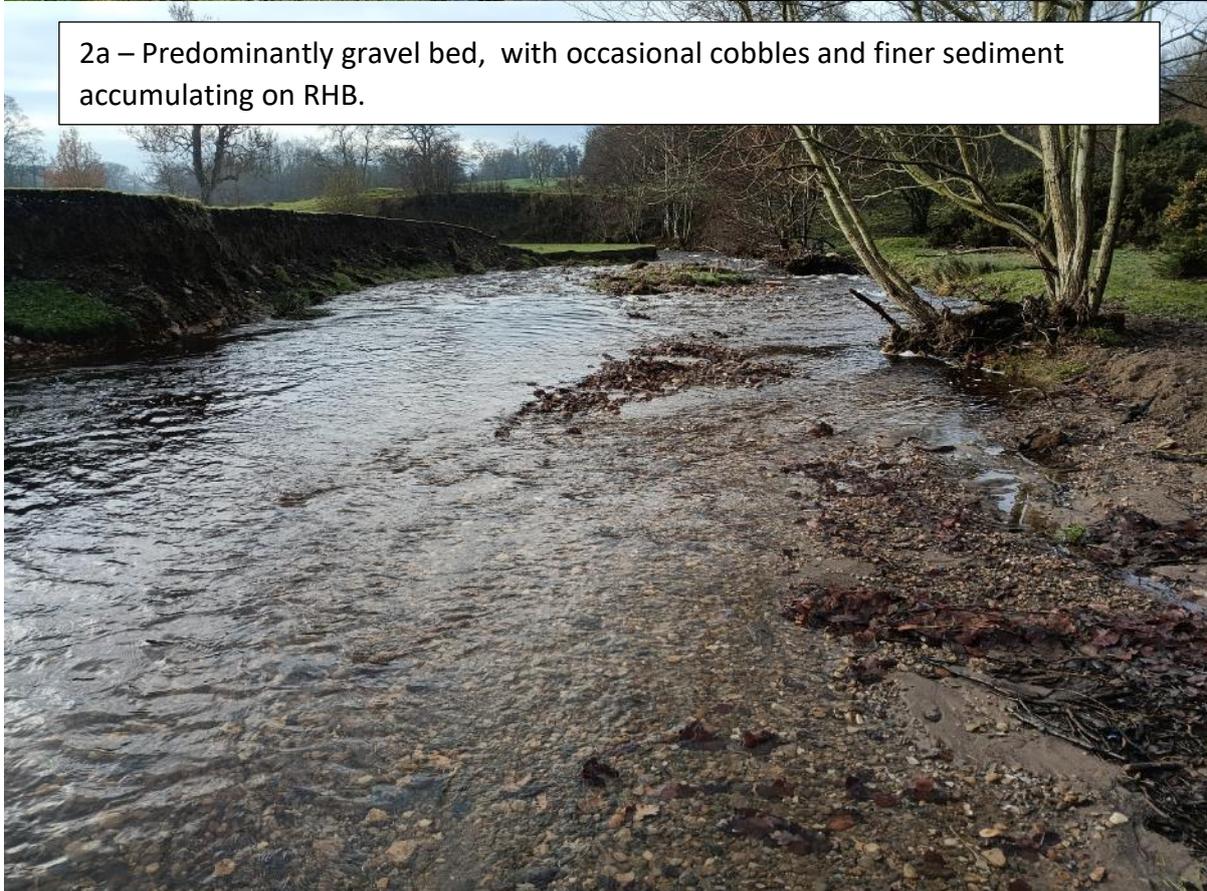
2a – Predominantly gravel bed, with occasional cobbles and finer sediment accumulating on RHB.

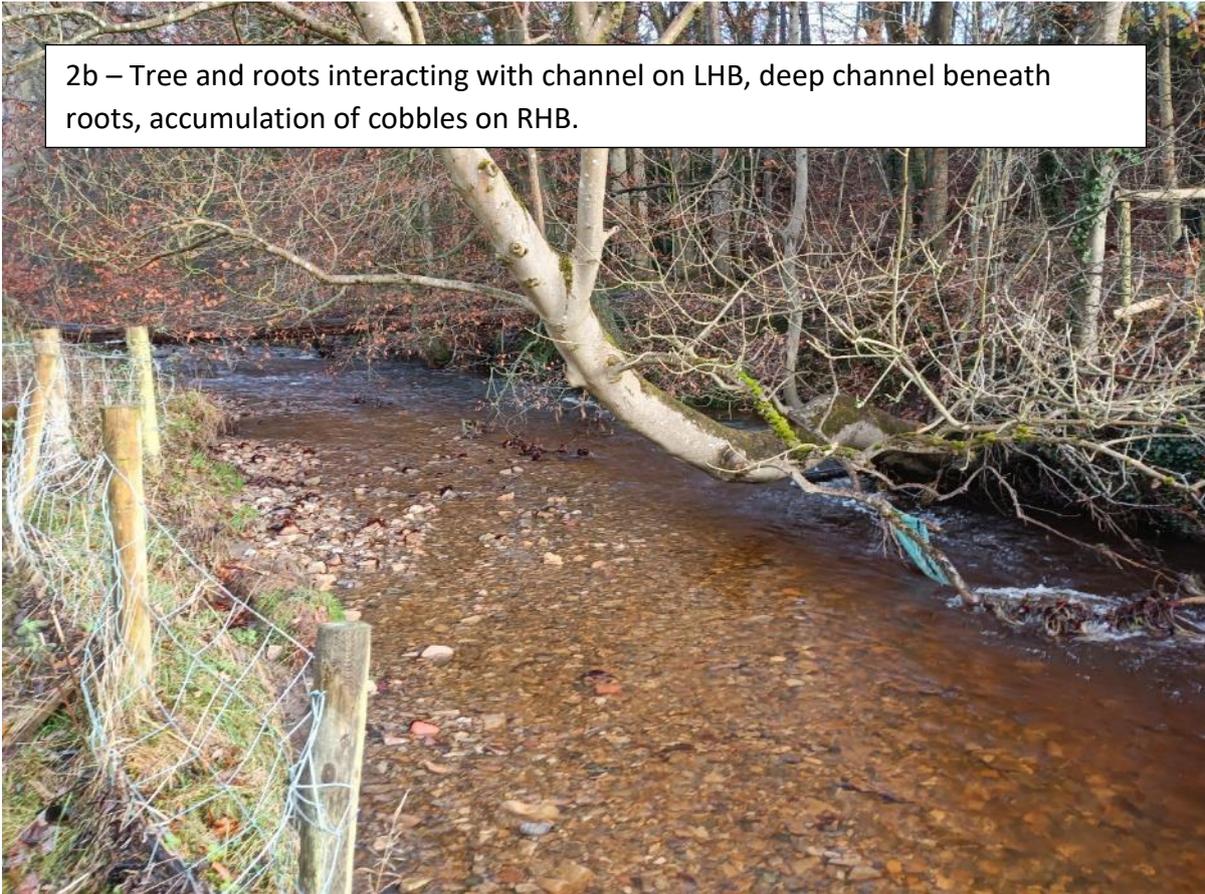
2b – Tree and roots interacting with channel on LHB, deep channel beneath roots, accumulation of cobbles on RHB.

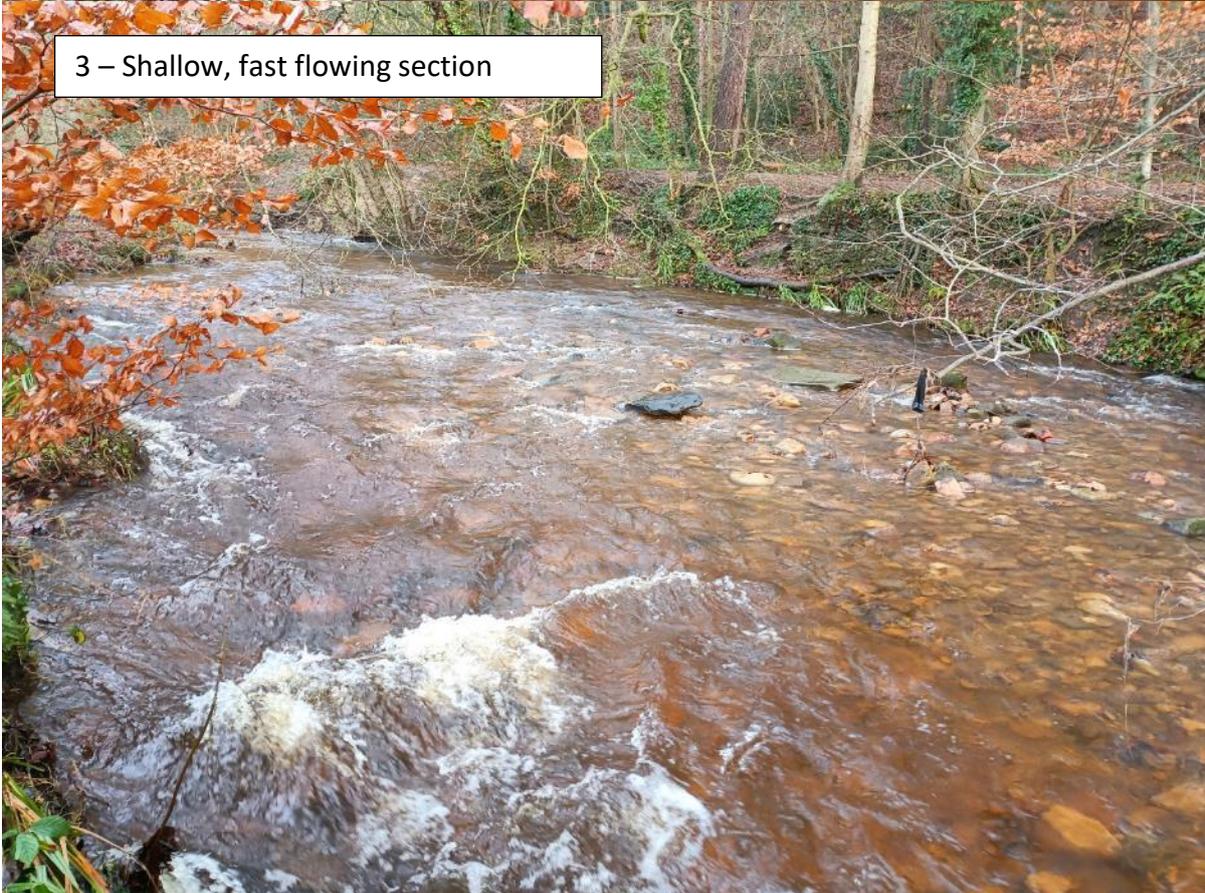
3 – Shallow, fast flowing section

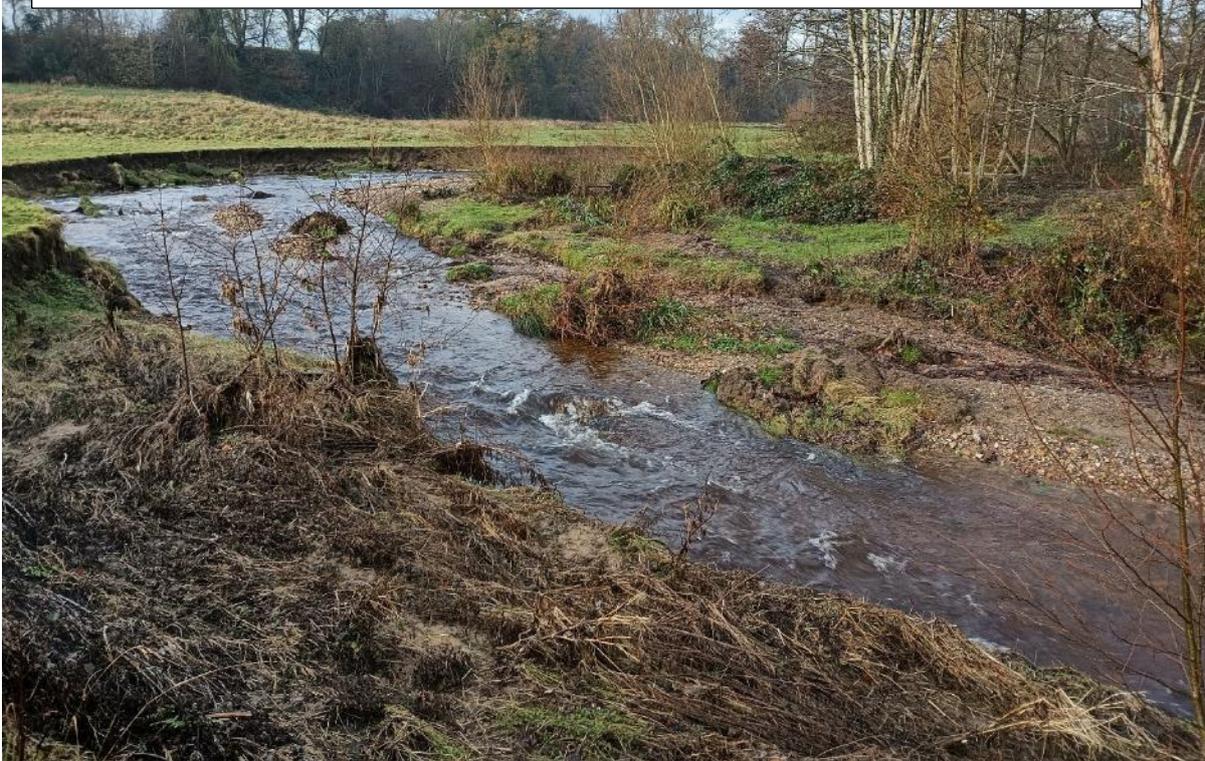
4 – Clear evidence of flood flows interacting with historic channel. Gravel and sand bar formed on LHB

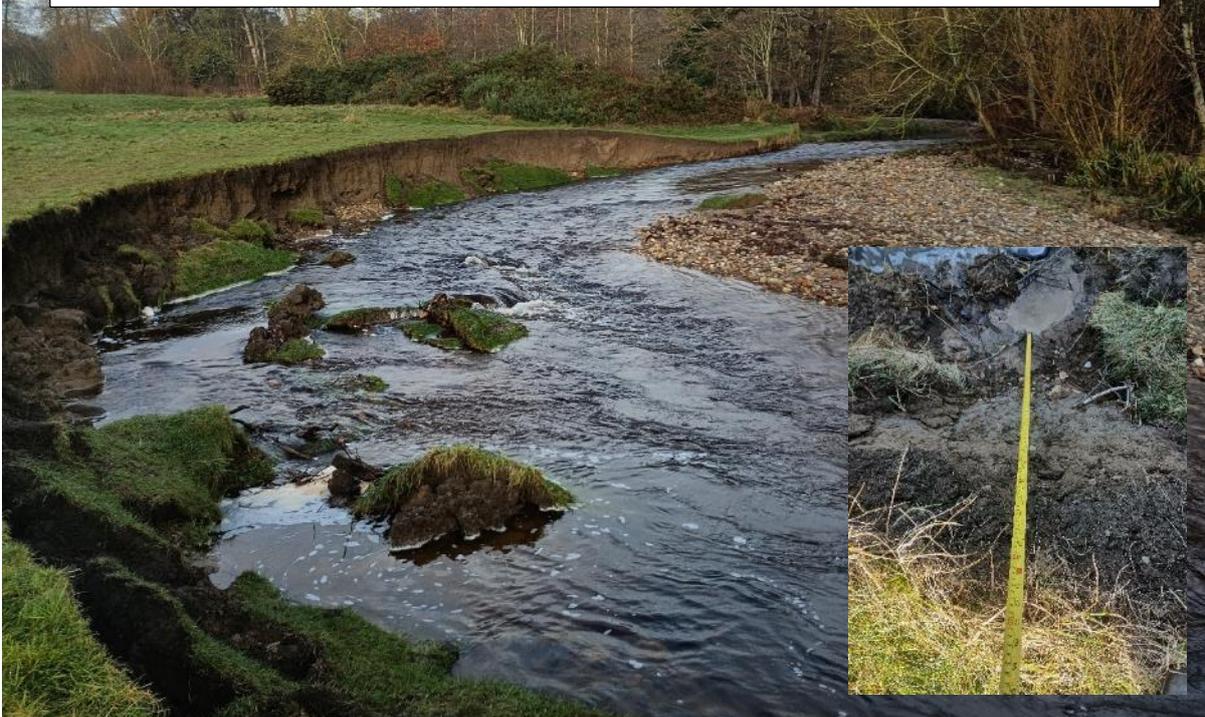
5 – Severe active erosion on RHB. Bank majority earth leads to rapid collapse in high flows. Turfs remain in channel and large gravel bar on LHB. Inset RHB 1.6m high.

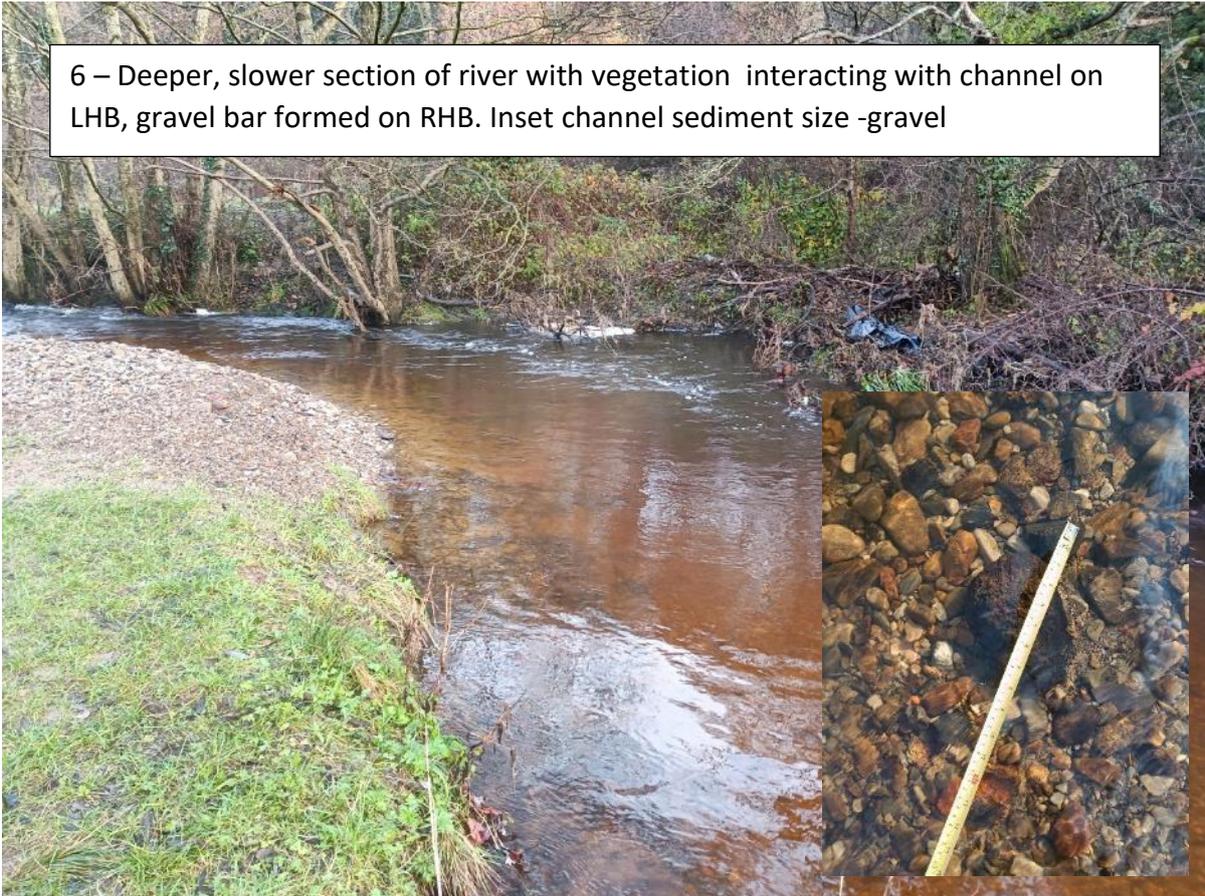
6 – Deeper, slower section of river with vegetation interacting with channel on LHB, gravel bar formed on RHB. Inset channel sediment size -gravel

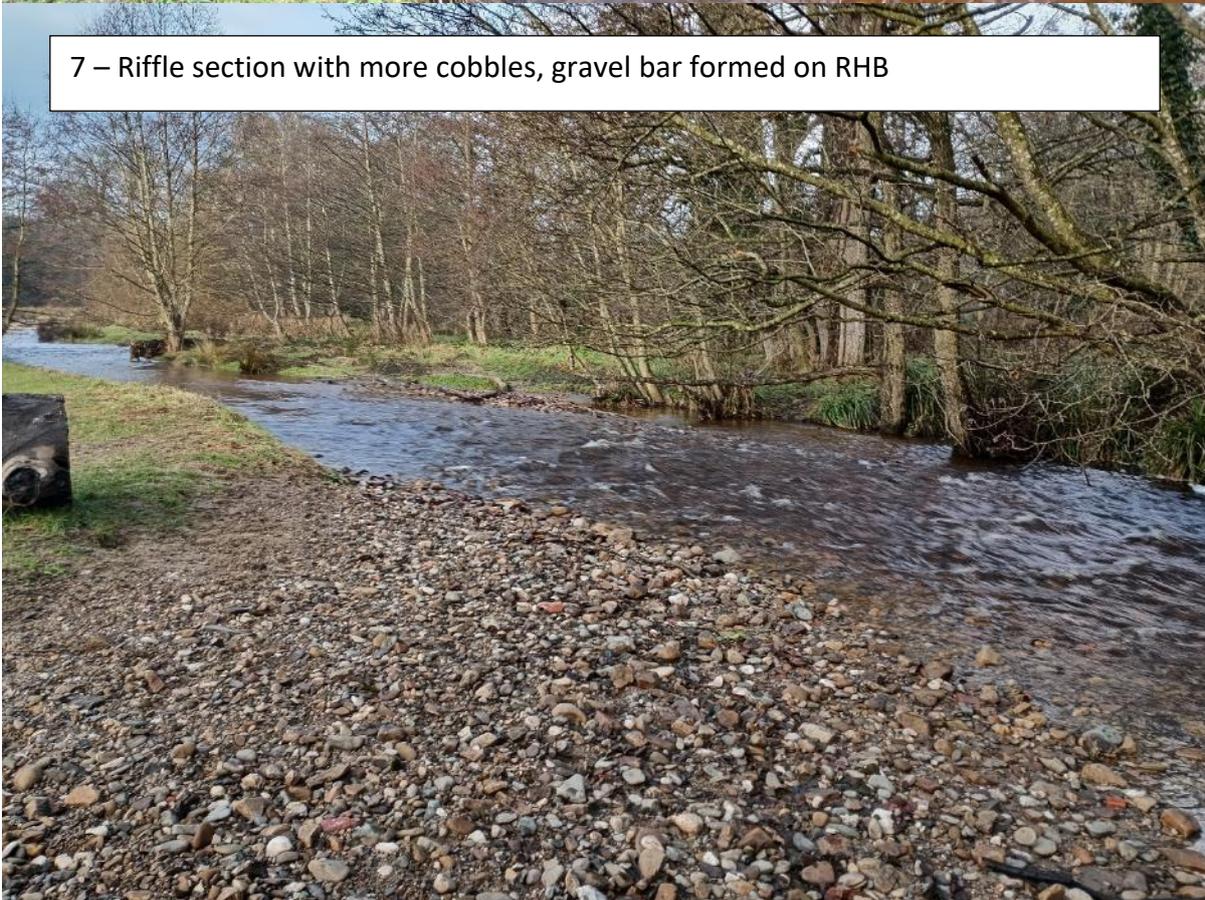
7 – Riffle section with more cobbles, gravel bar formed on RHB

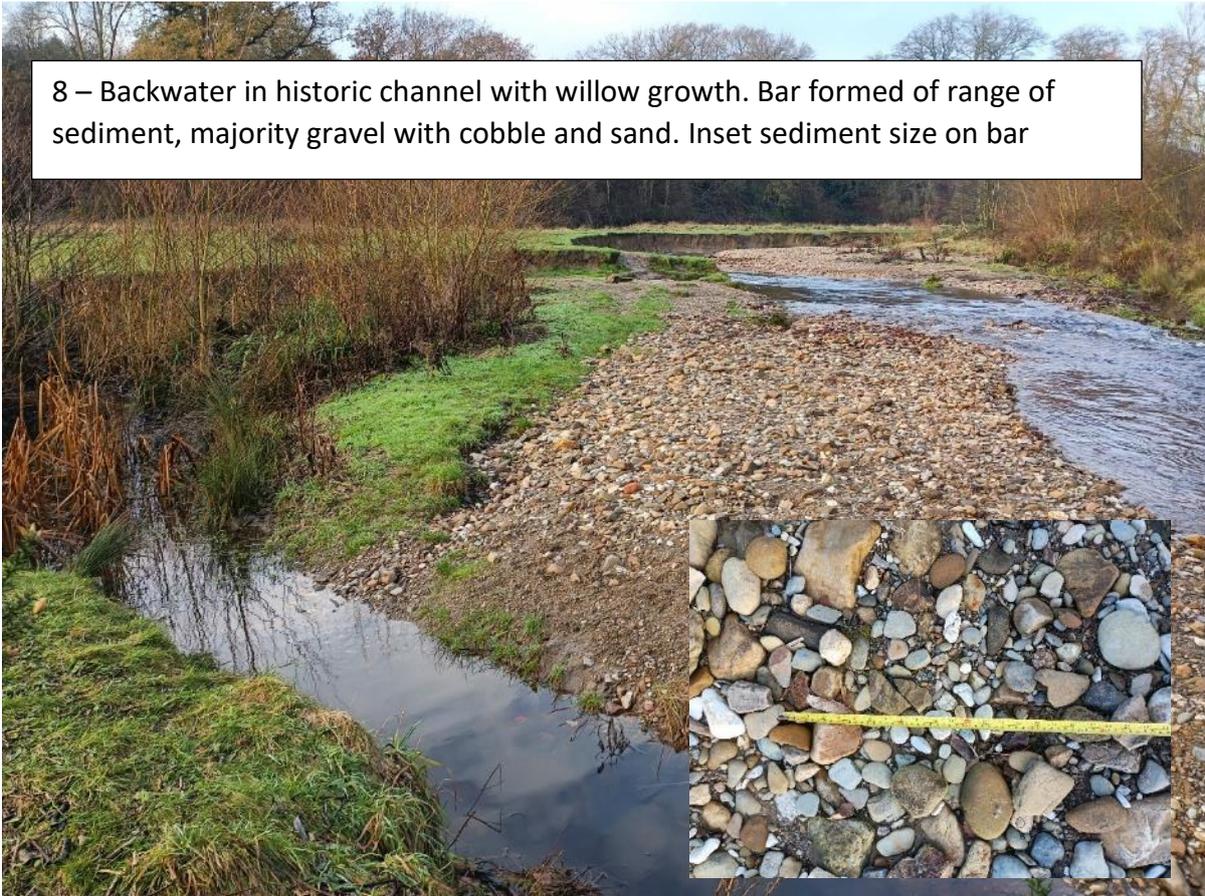
8 – Backwater in historic channel with willow growth. Bar formed of range of sediment, majority gravel with cobble and sand. Inset sediment size on bar

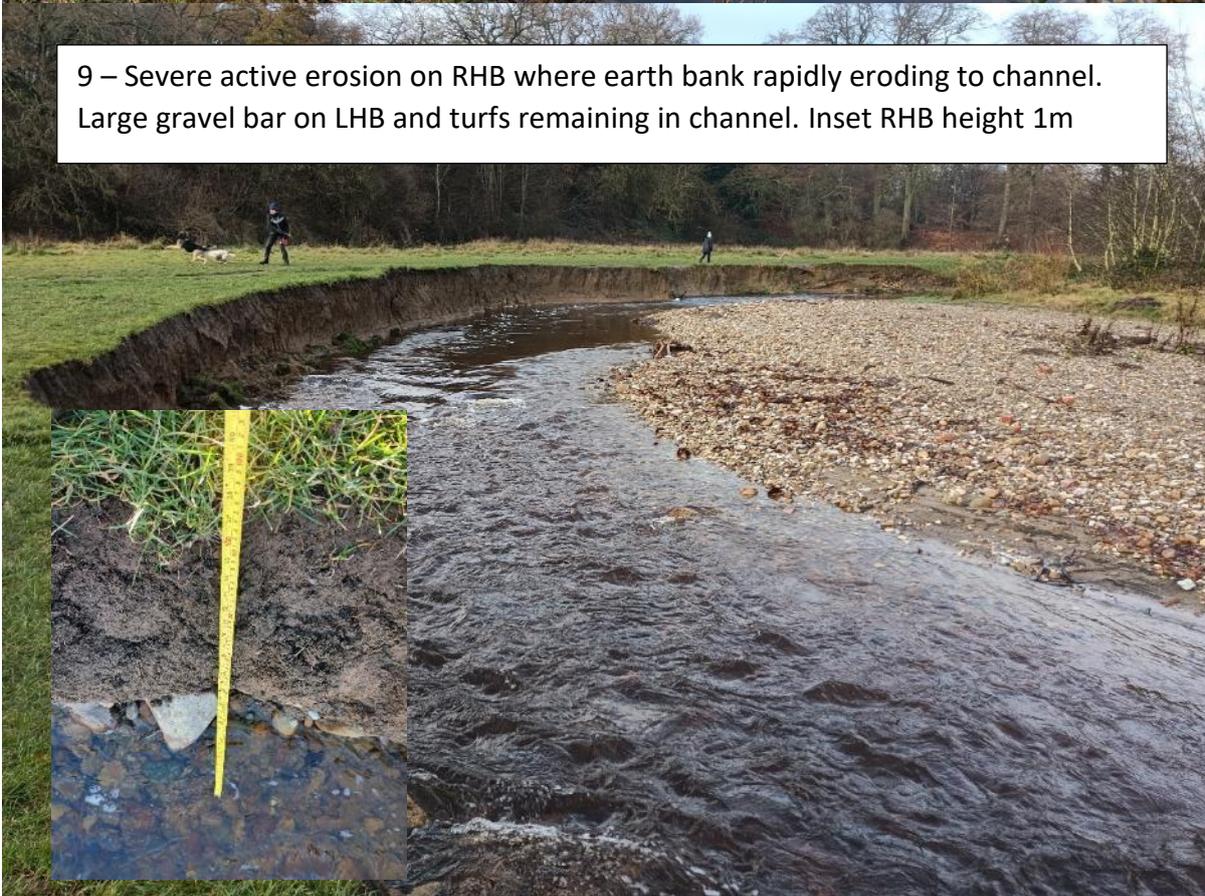
9 – Severe active erosion on RHB where earth bank rapidly eroding to channel. Large gravel bar on LHB and turfs remaining in channel. Inset RHB height 1m

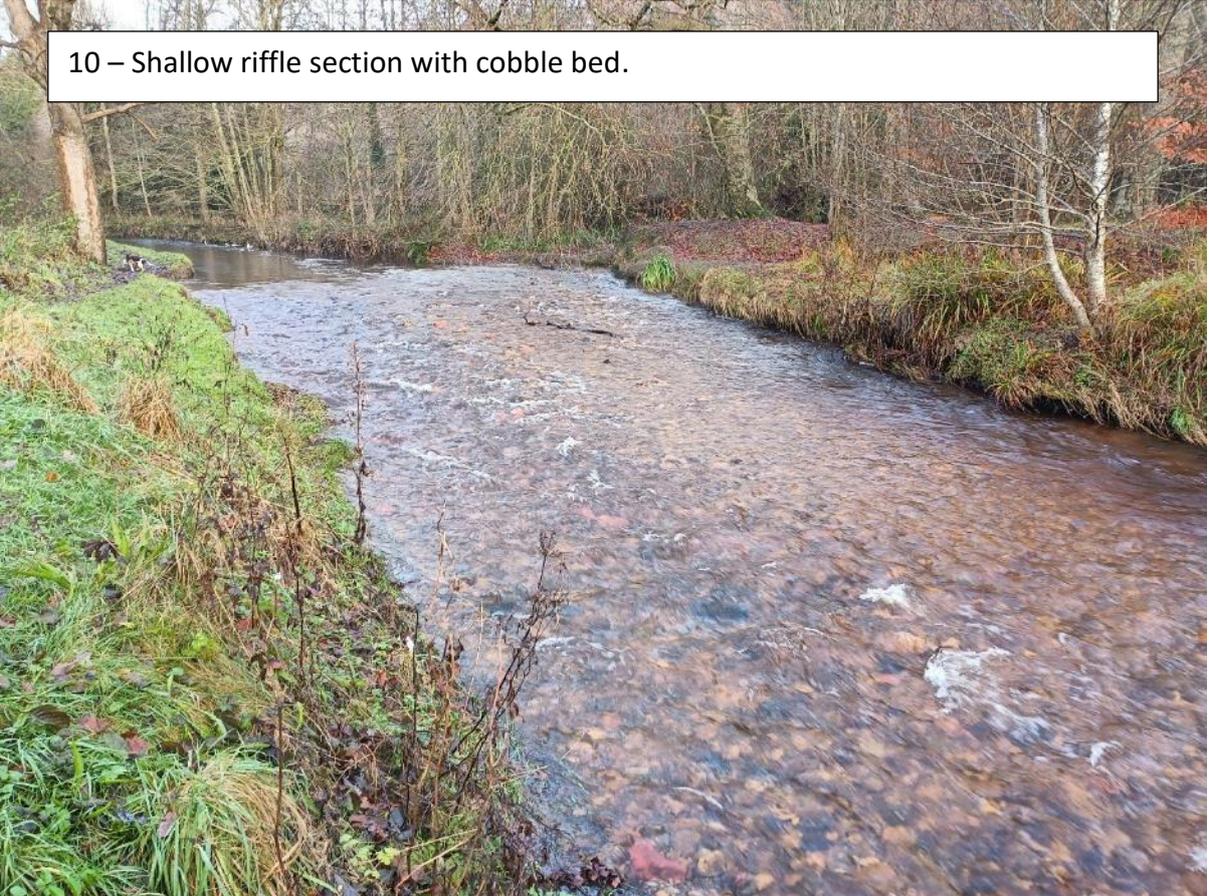
10 – Shallow riffle section with cobble bed.

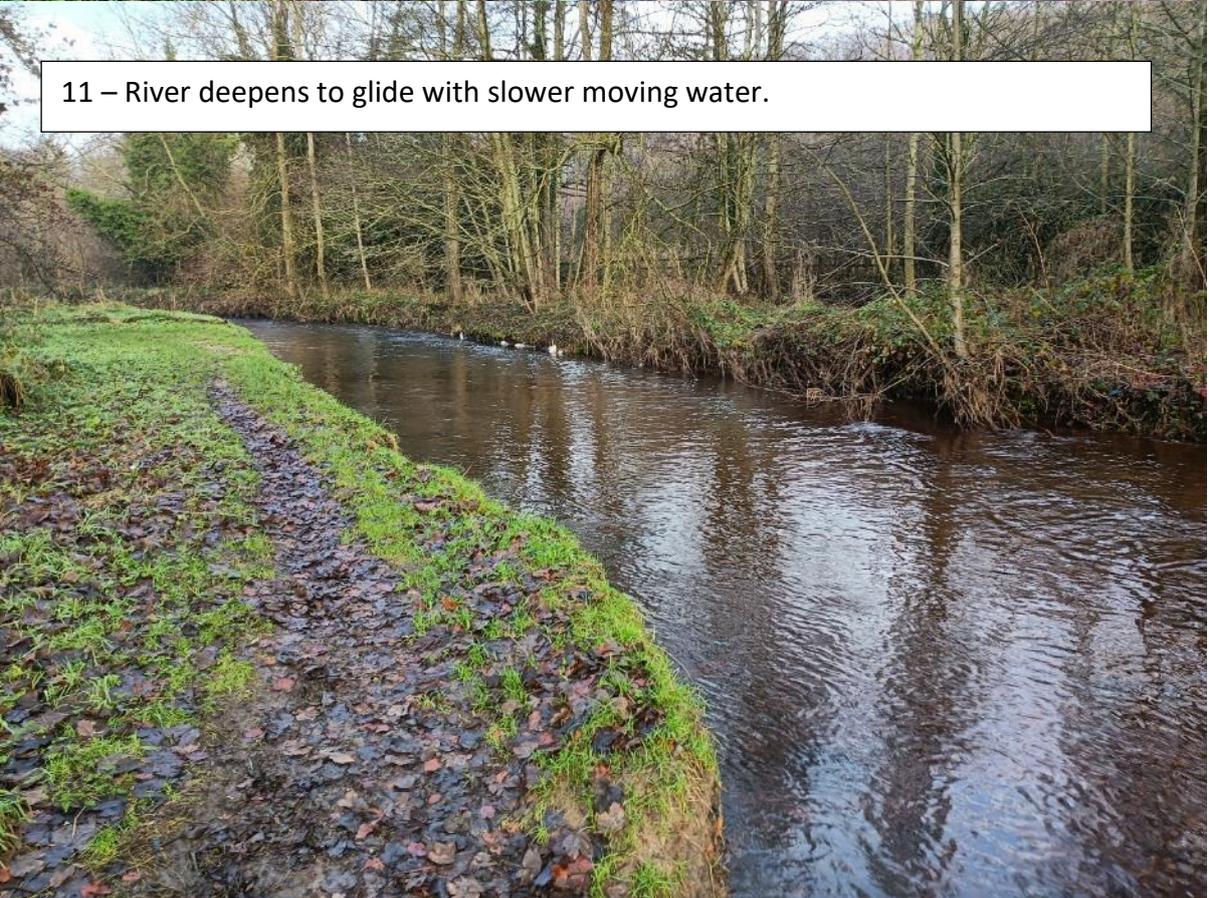
11 – River deepens to glide with slower moving water.

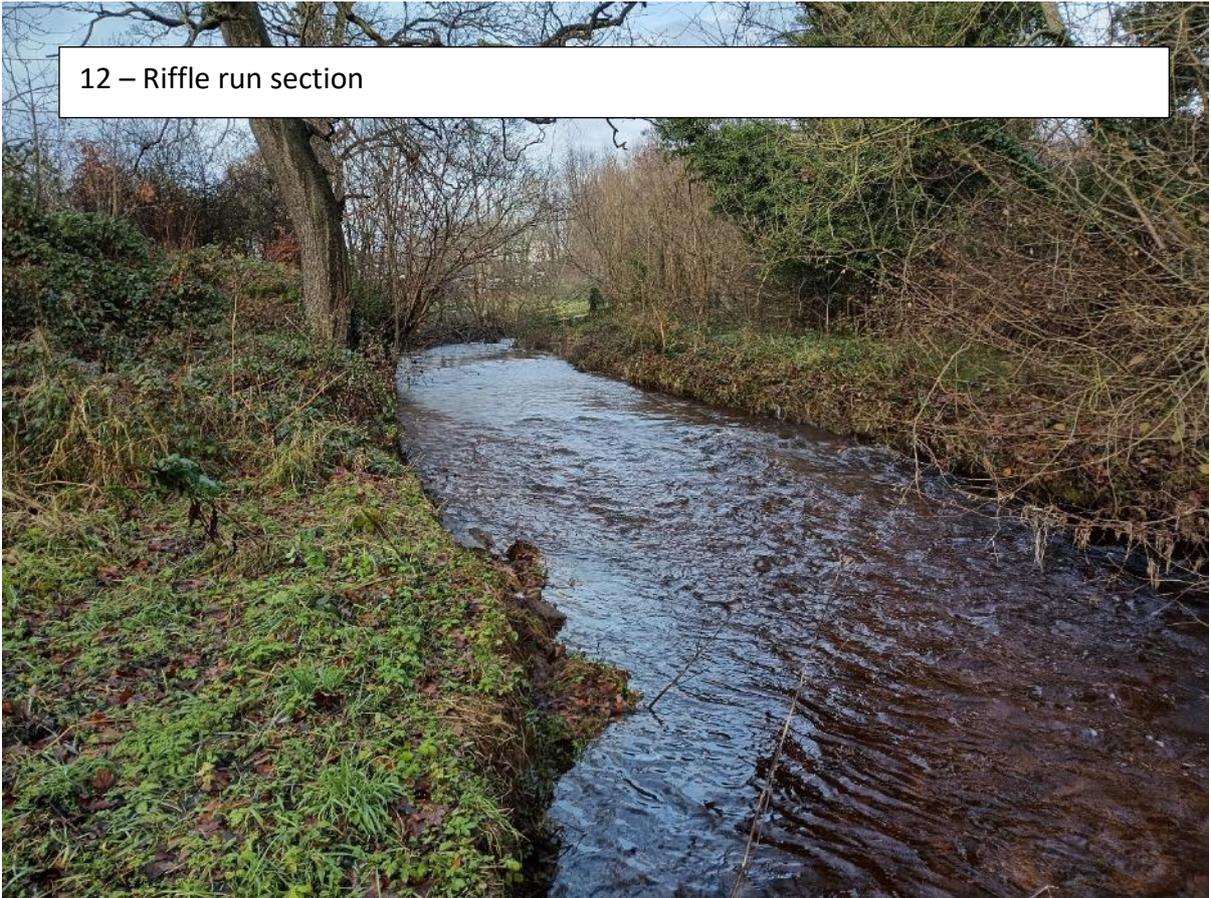
12 – Riffle run section

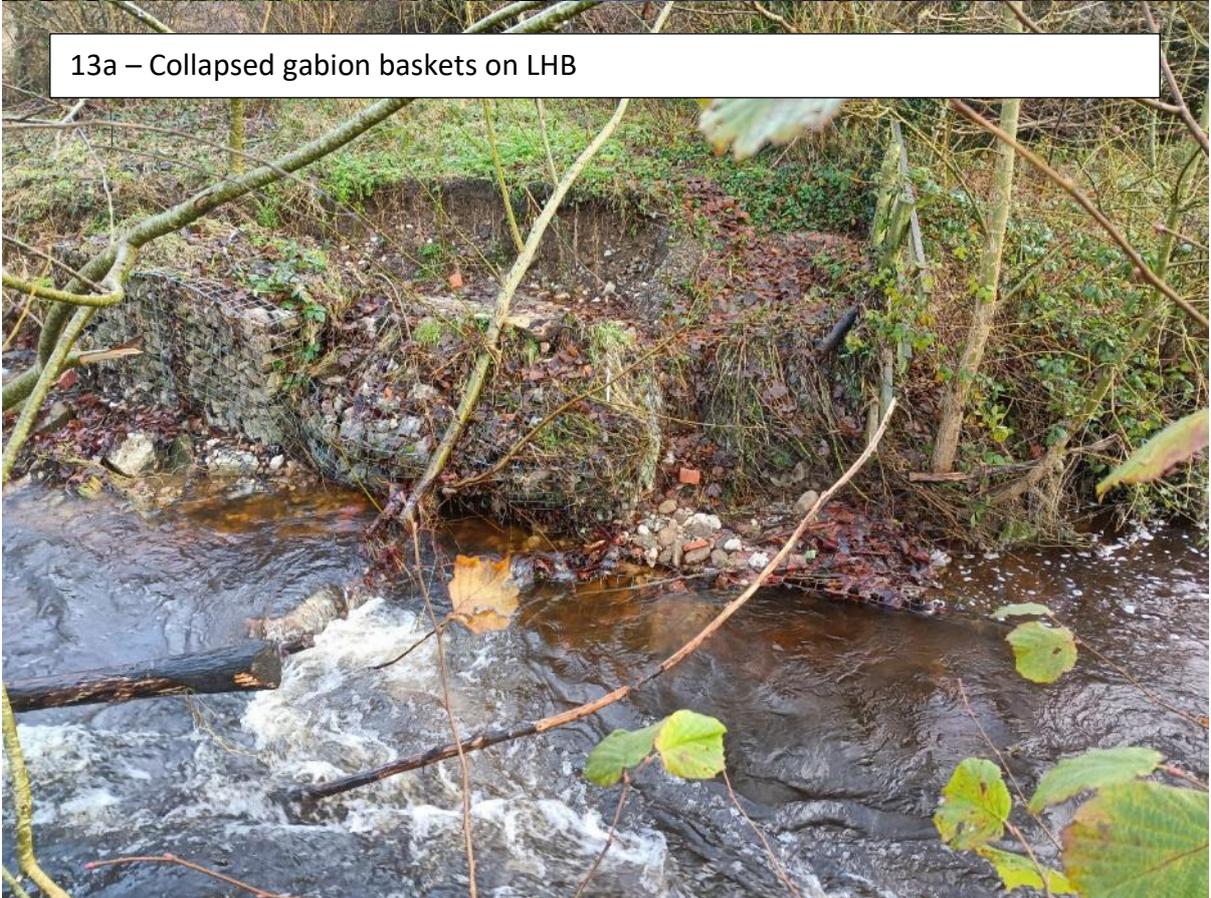
13a – Collapsed gabion baskets on LHB

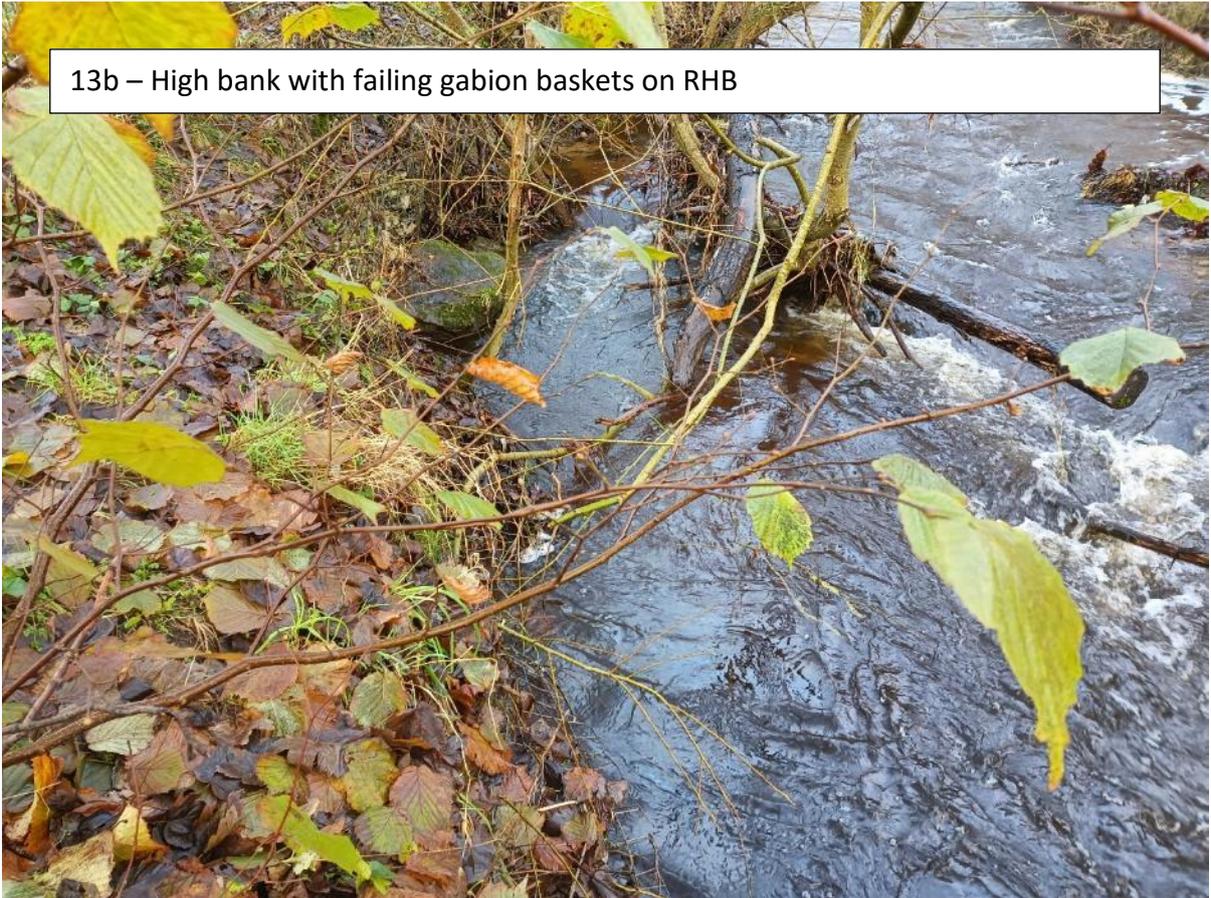
13b – High bank with failing gabion baskets on RHB

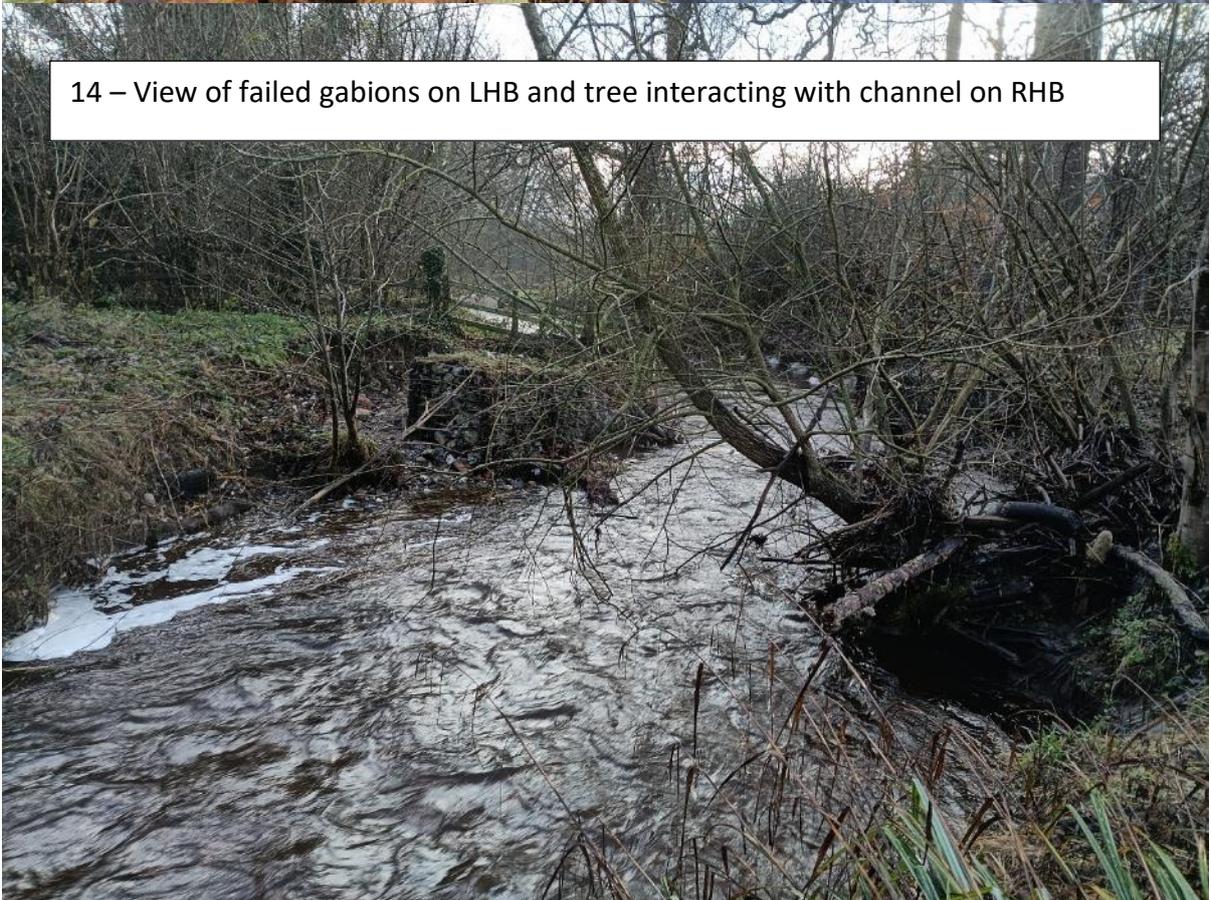
14 – View of failed gabions on LHB and tree interacting with channel on RHB

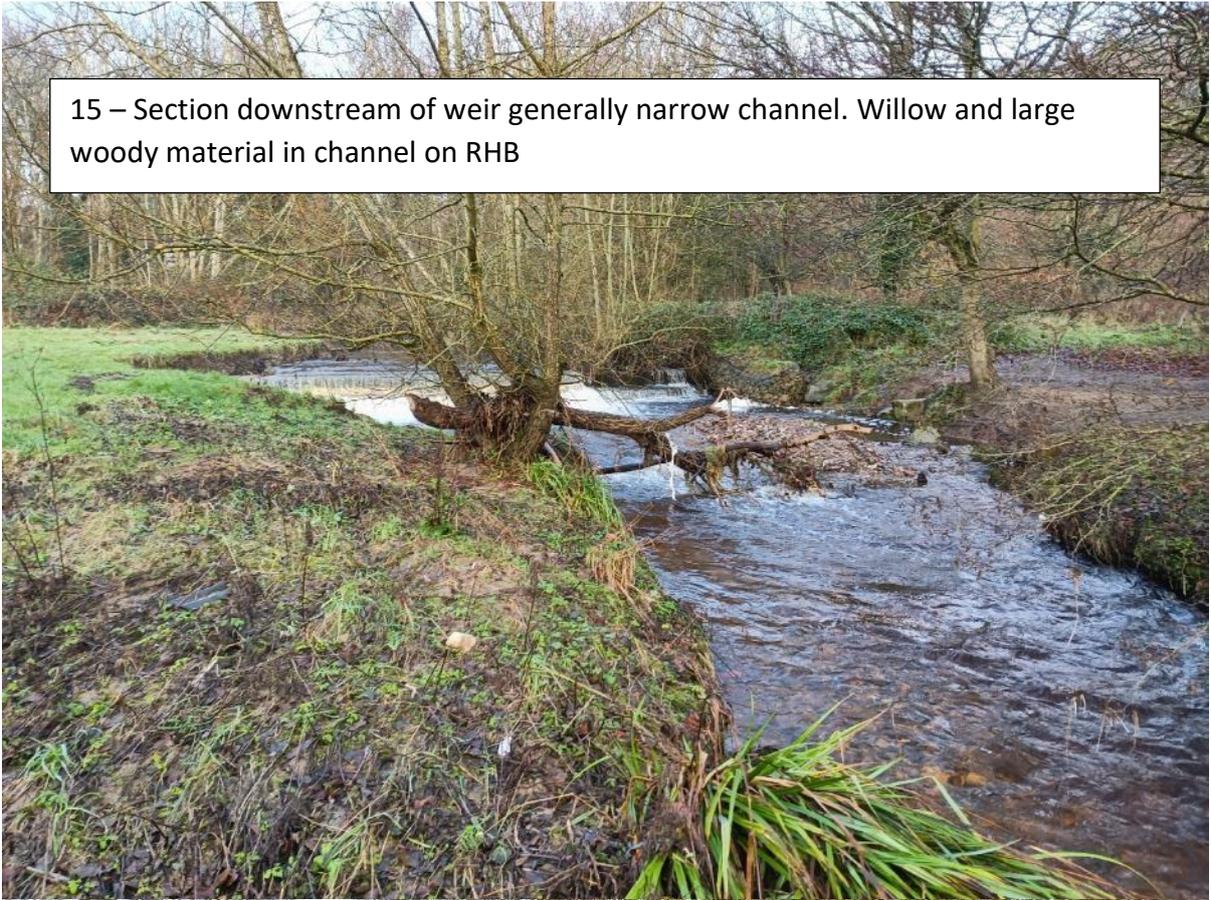
15 – Section downstream of weir generally narrow channel. Willow and large woody material in channel on RHB

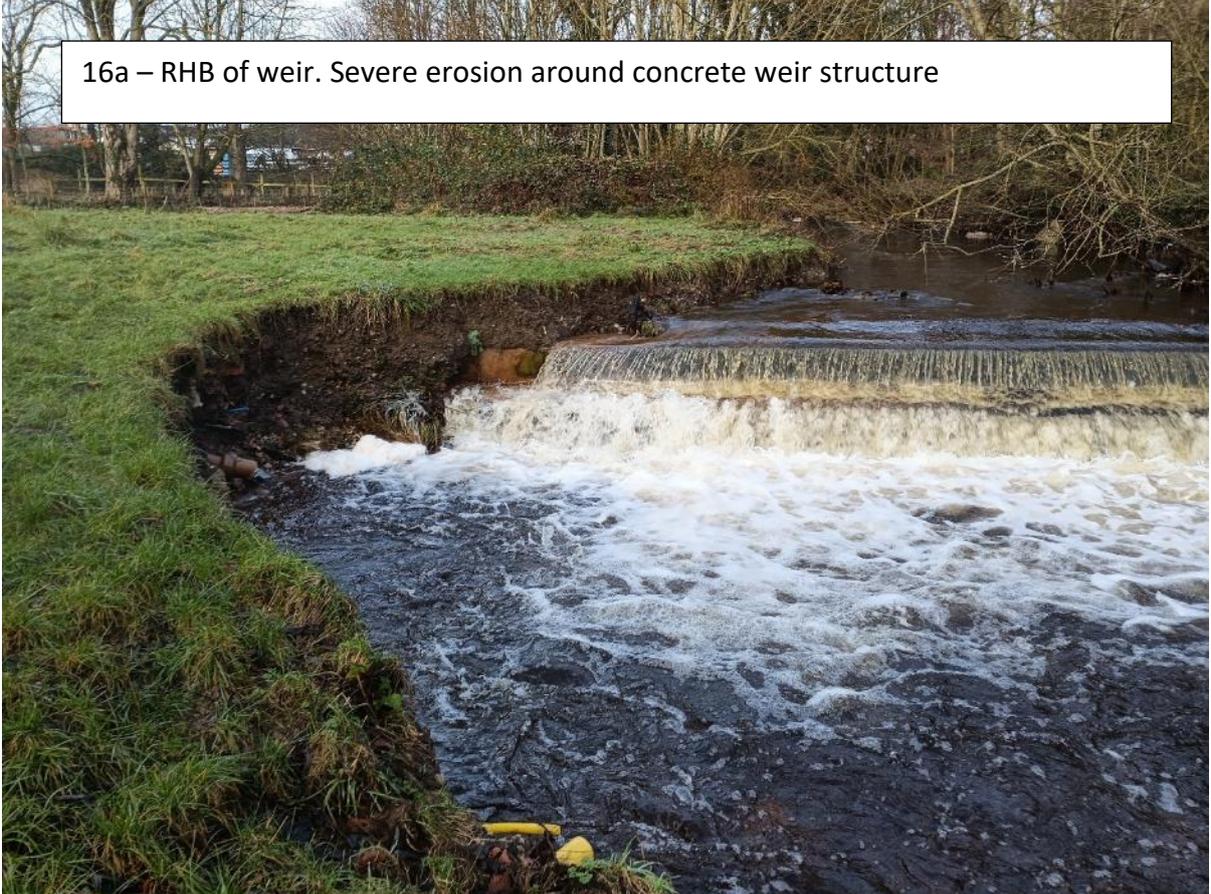
16a – RHB of weir. Severe erosion around concrete weir structure

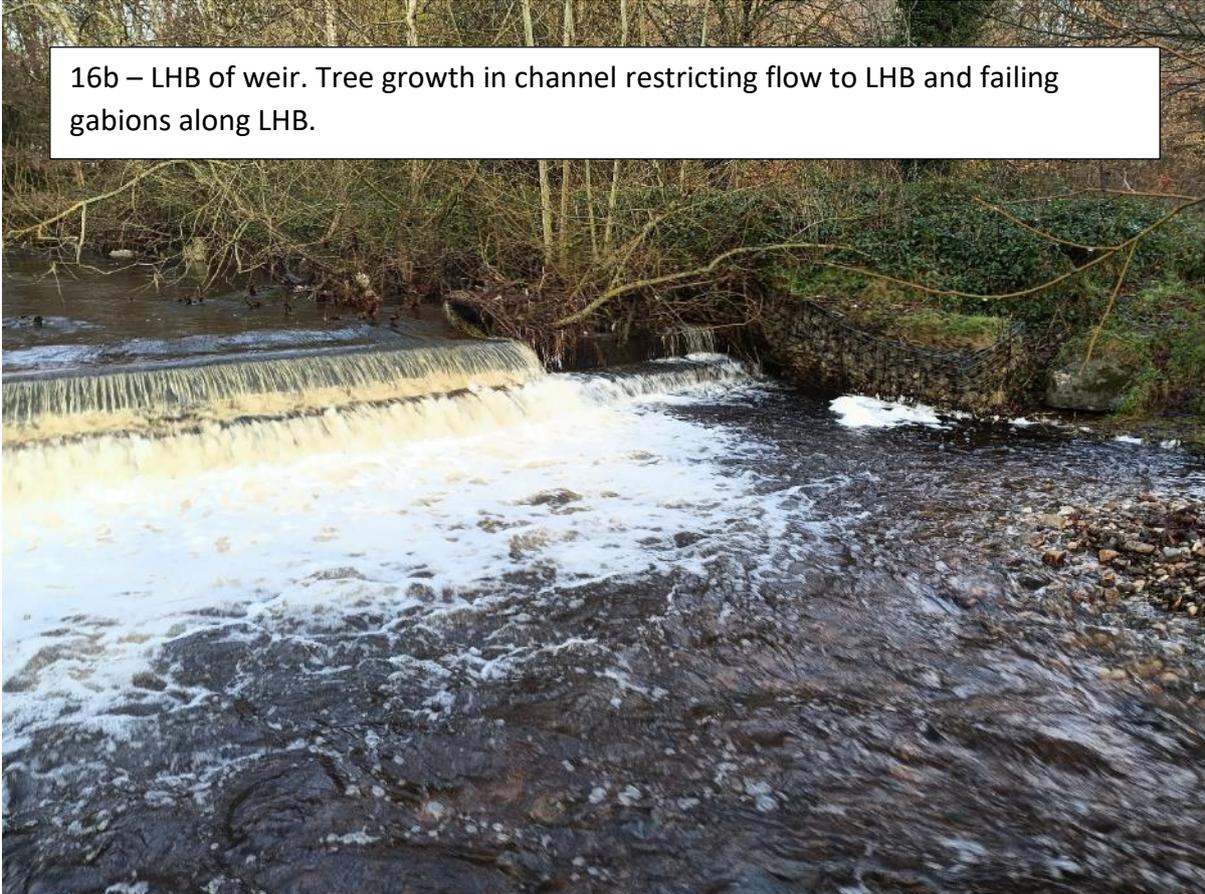
16b – LHB of weir. Tree growth in channel restricting flow to LHB and failing gabions along LHB.

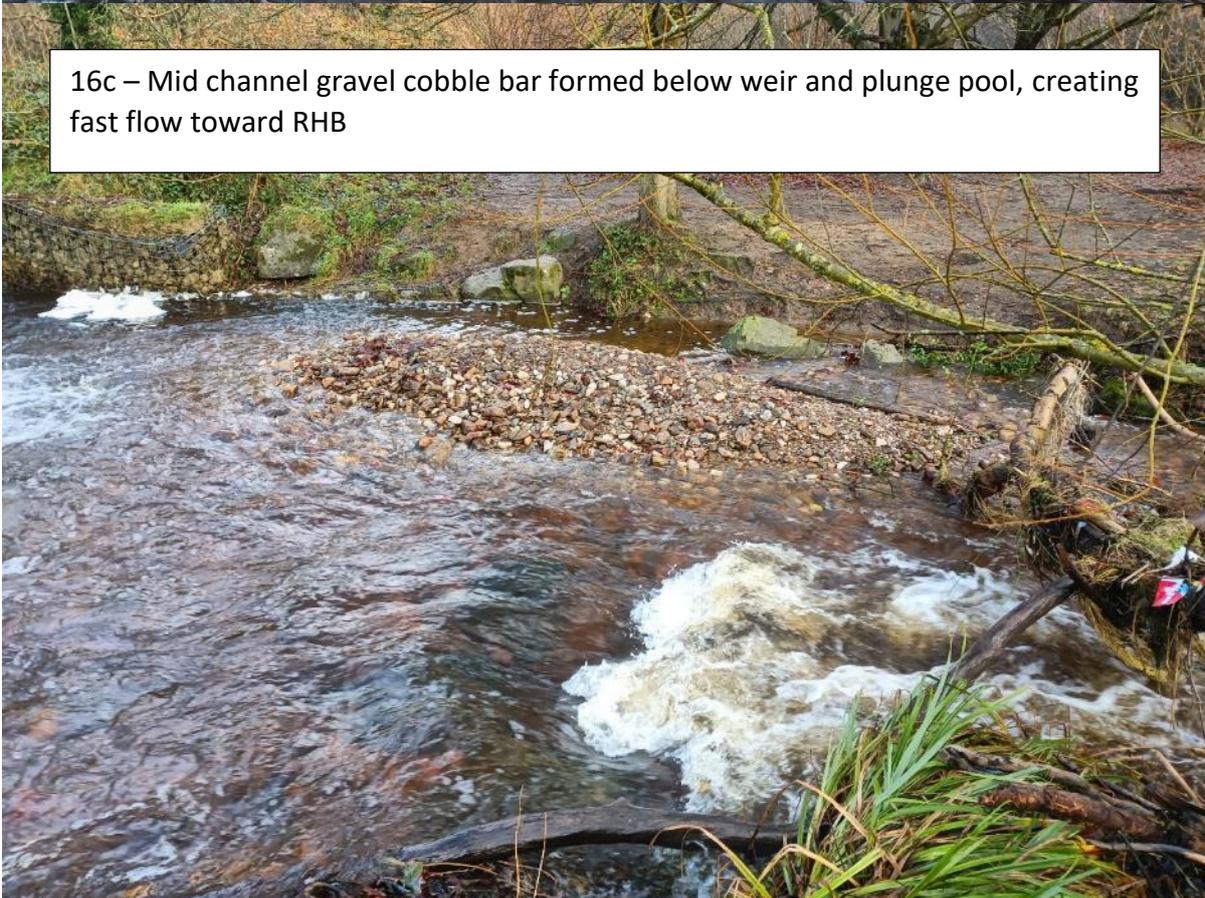
16c – Mid channel gravel cobble bar formed below weir and plunge pool, creating fast flow toward RHB

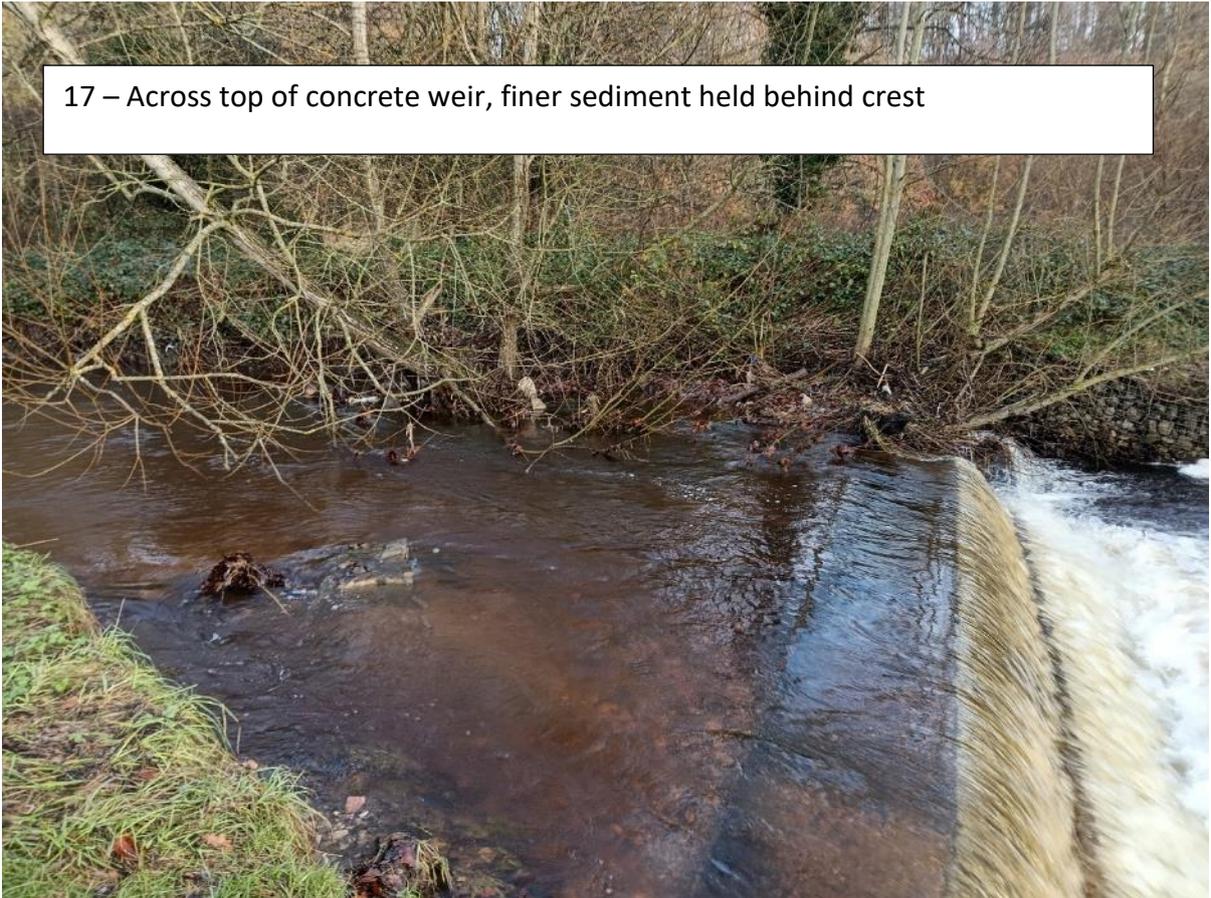
17 – Across top of concrete weir, finer sediment held behind crest
