Geomorphology survey

River Clywedog – Felin Puleston Weir removal

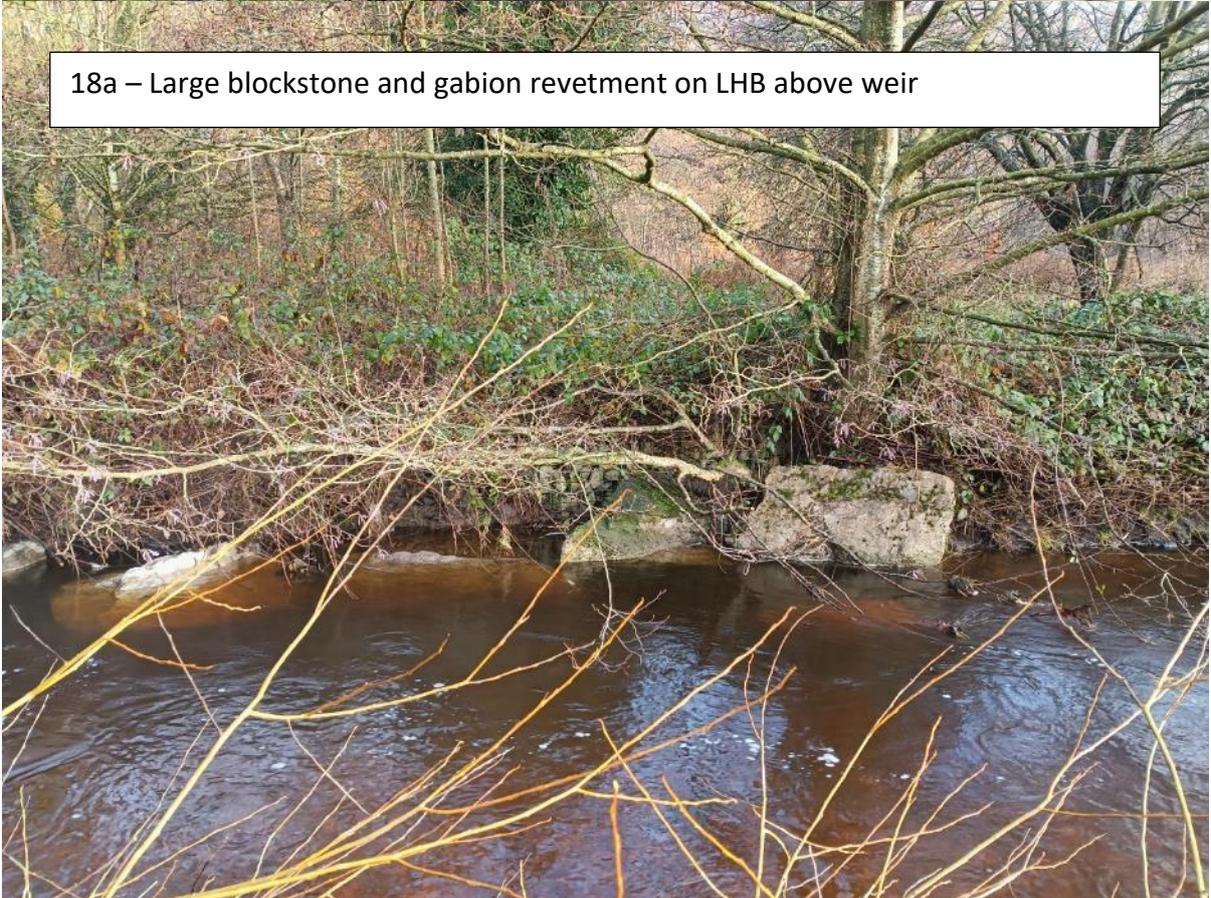
18a – Large blockstone and gabion revetment on LHB above weir

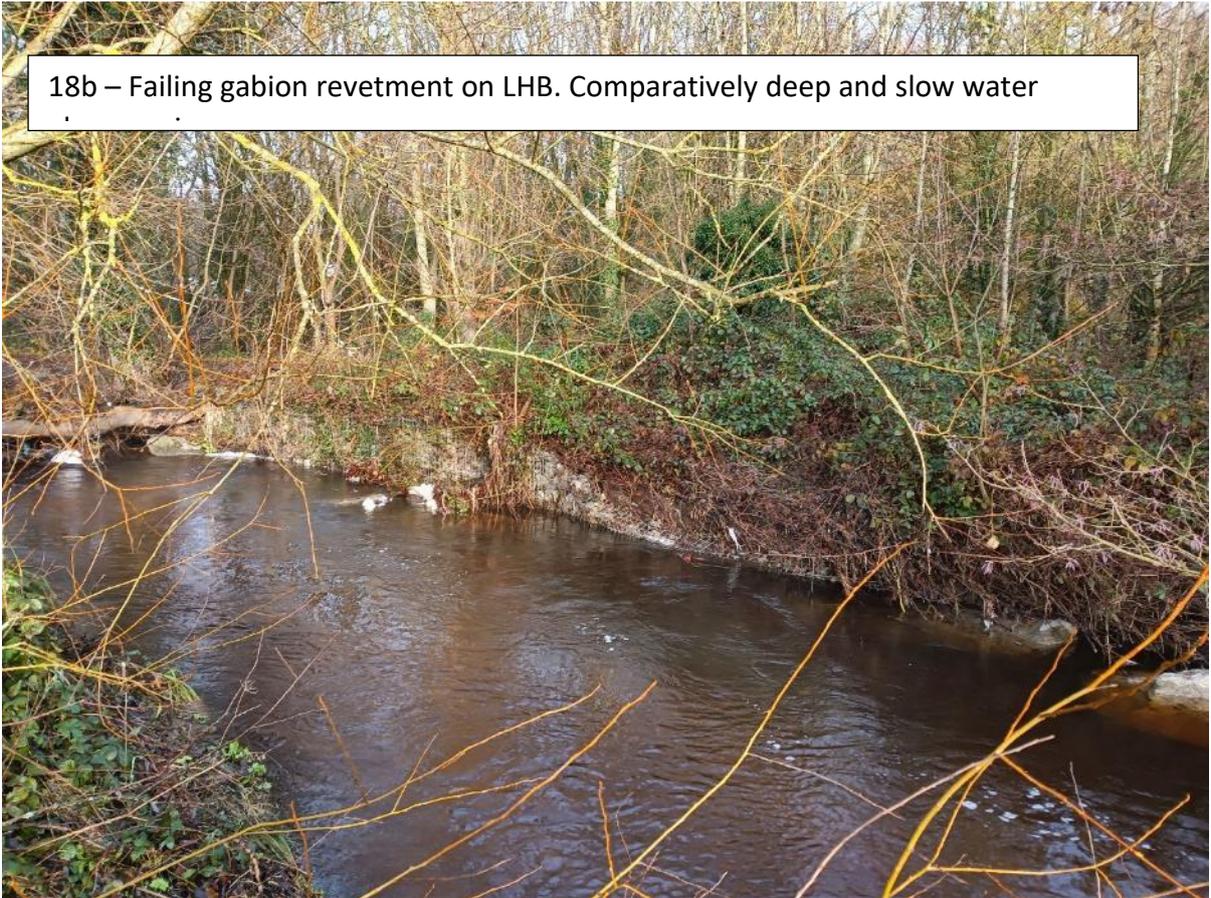
18b – Failing gabion revetment on LHB. Comparatively deep and slow water

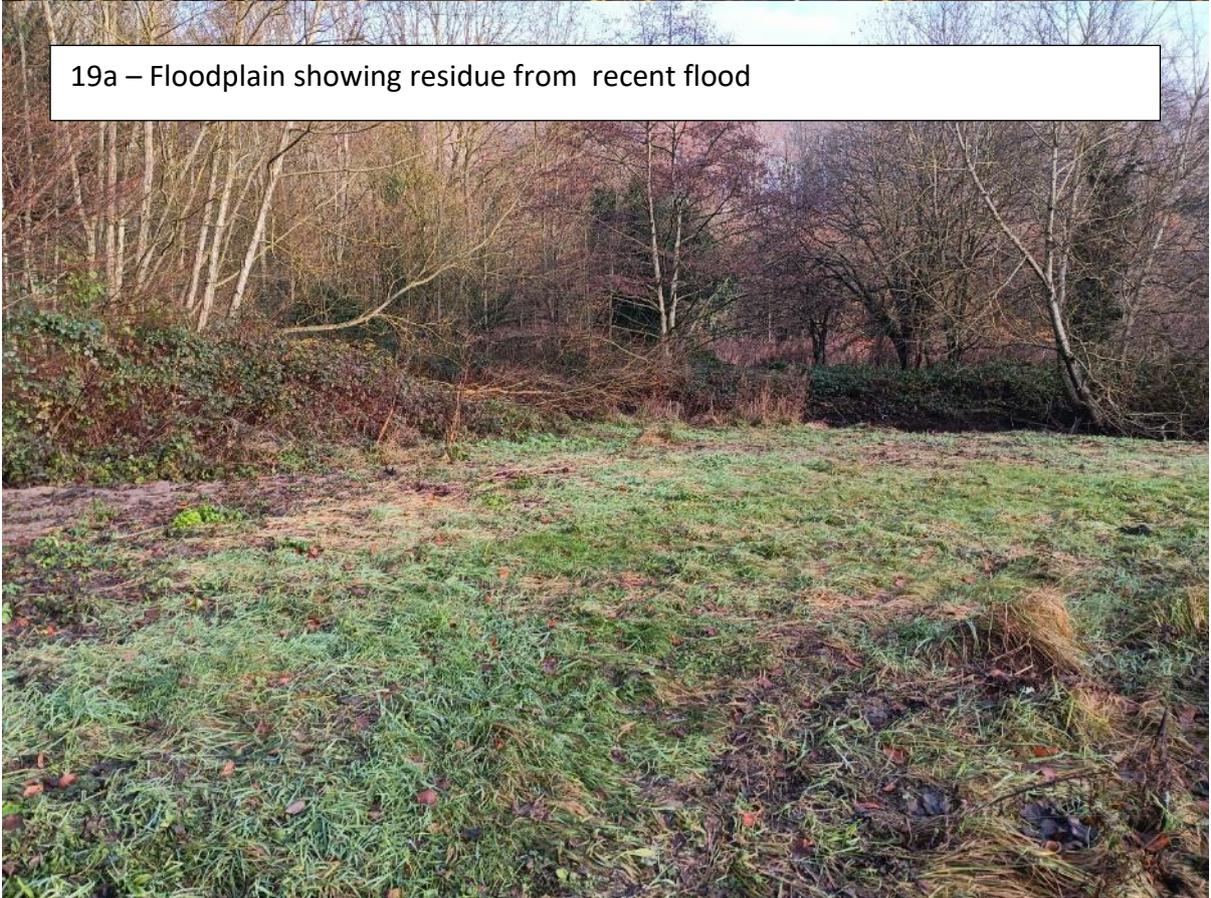
19a – Floodplain showing residue from recent flood

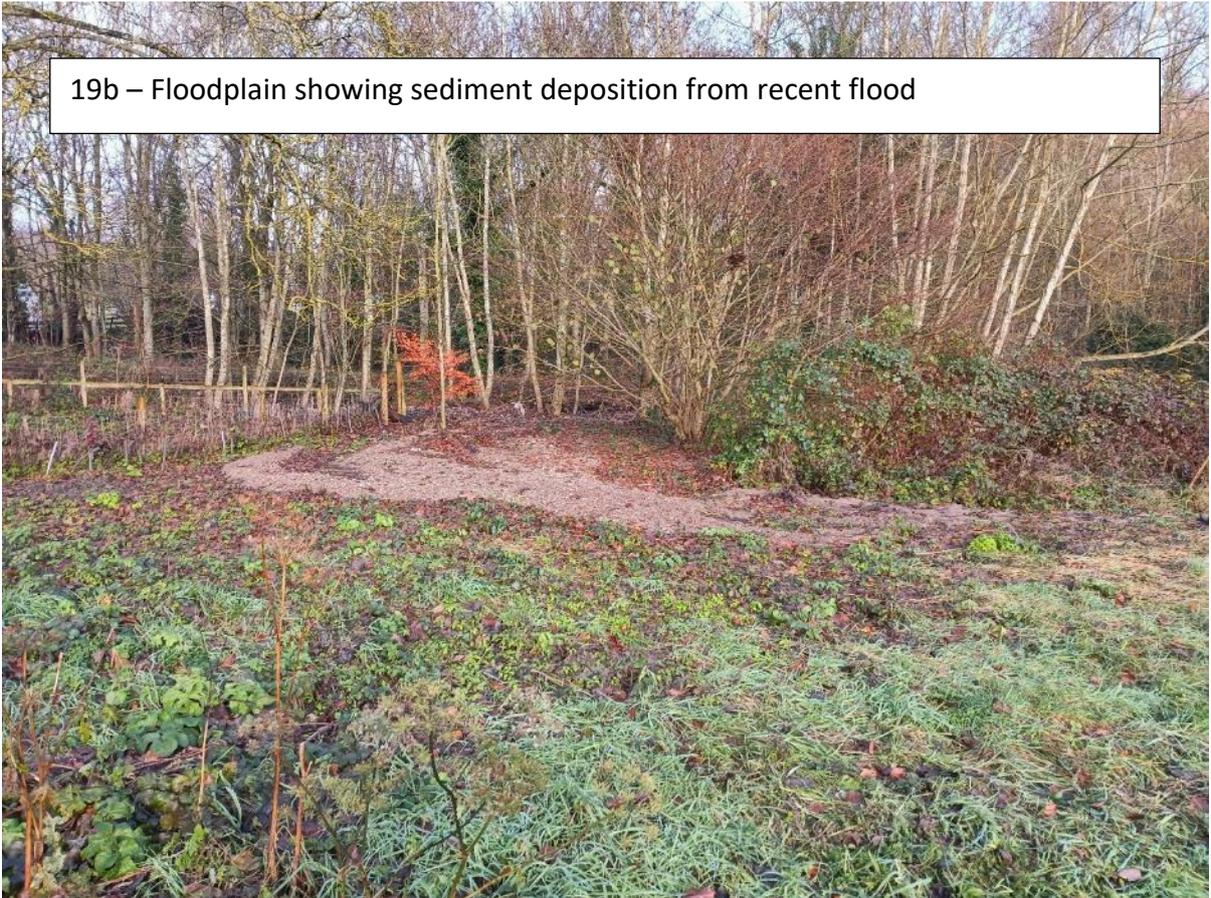
19b – Floodplain showing sediment deposition from recent flood

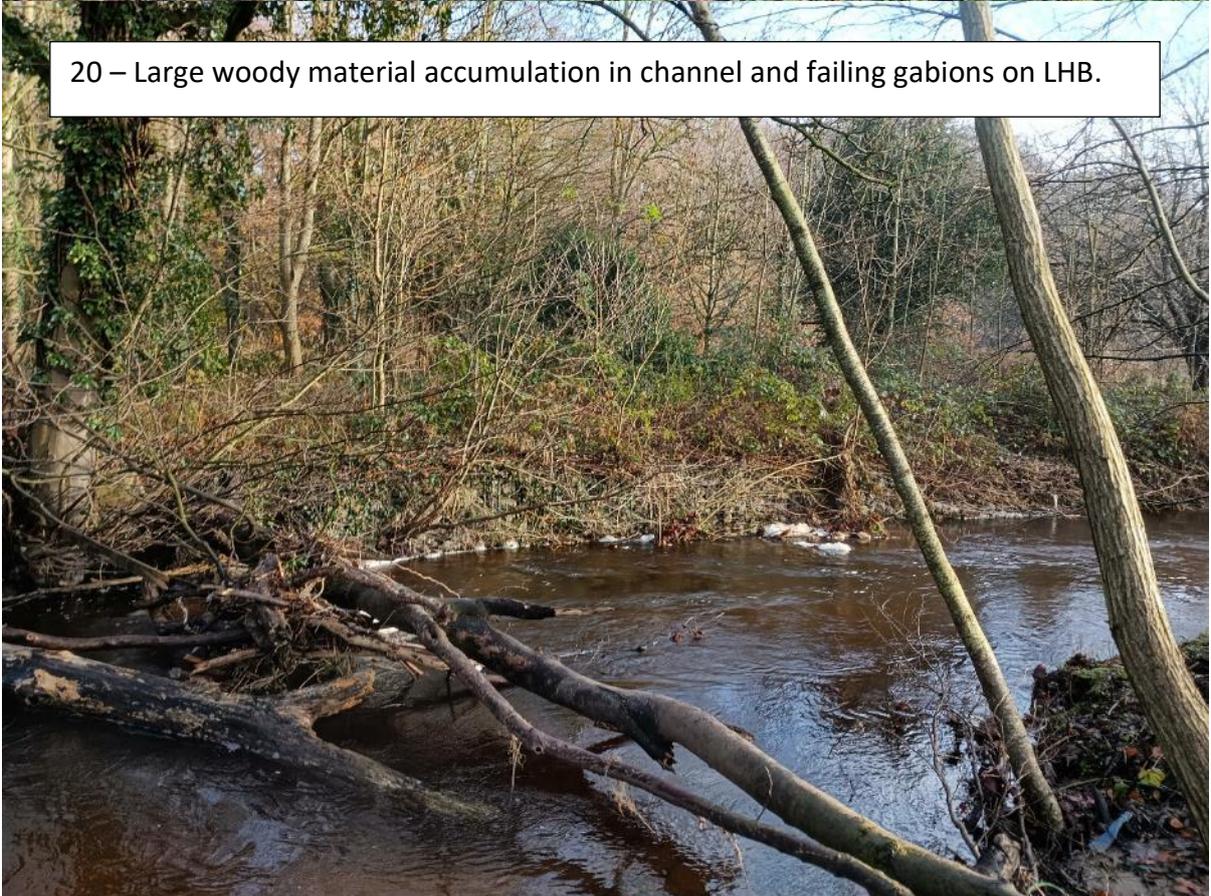
20 – Large woody material accumulation in channel and failing gabions on LHB.

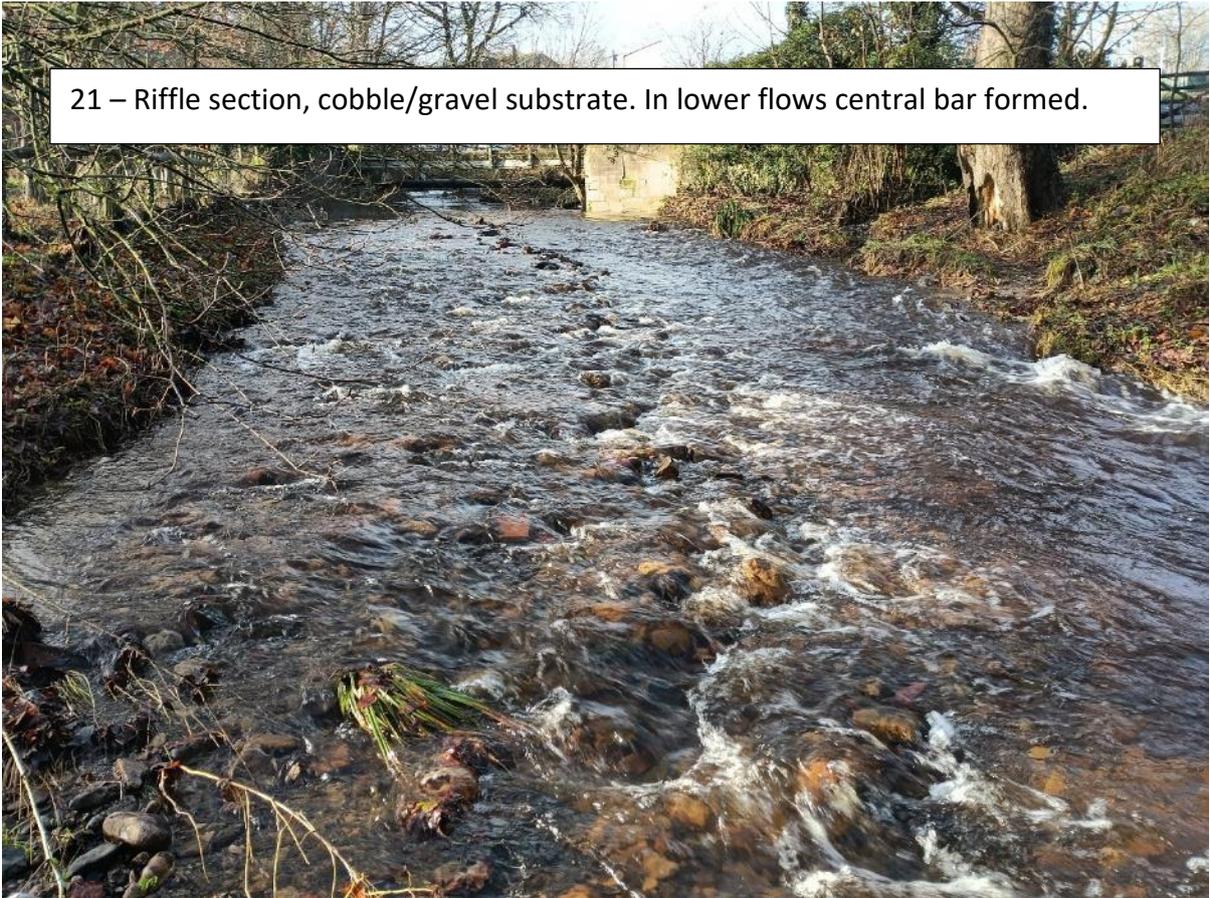
21 – Riffle section, cobble/gravel substrate. In lower flows central bar formed.

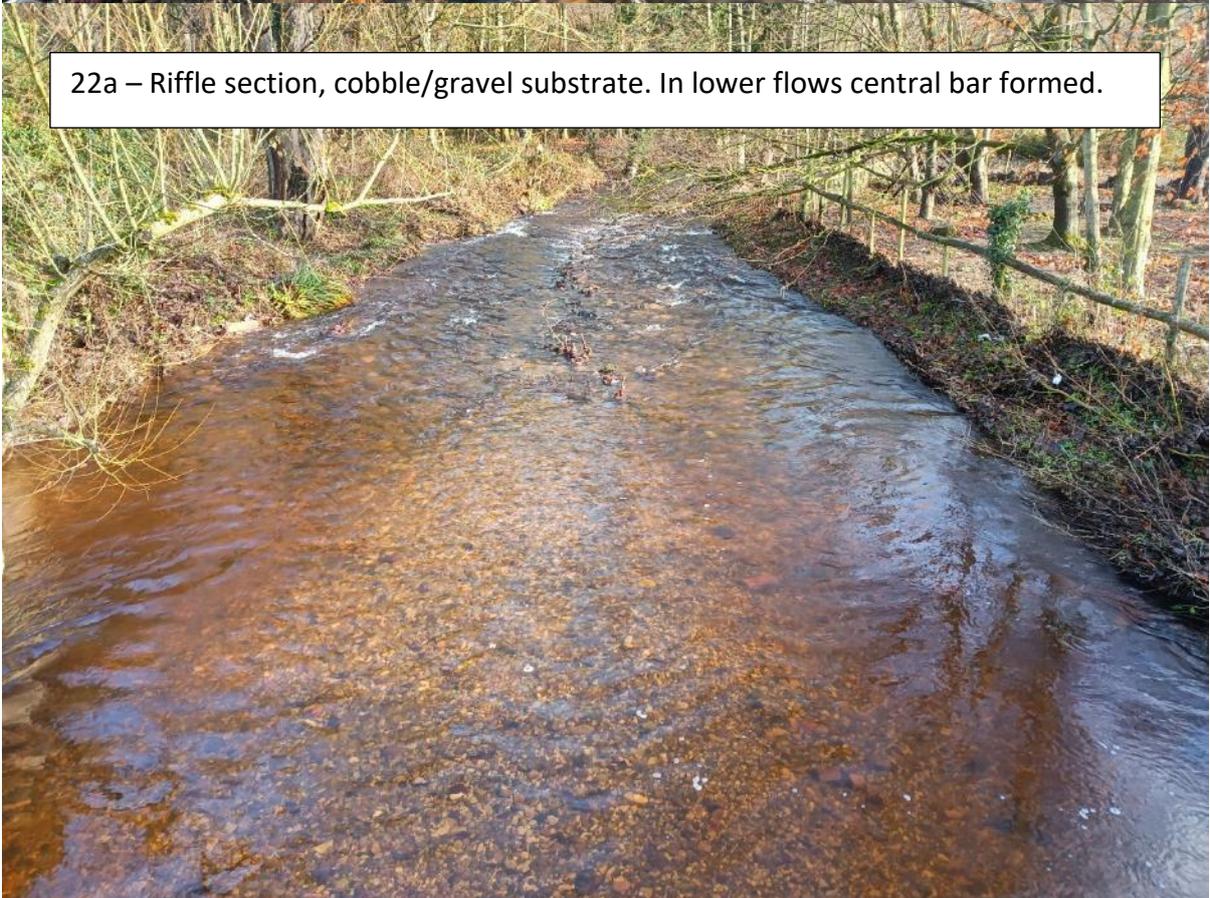
22a – Riffle section, cobble/gravel substrate. In lower flows central bar formed.

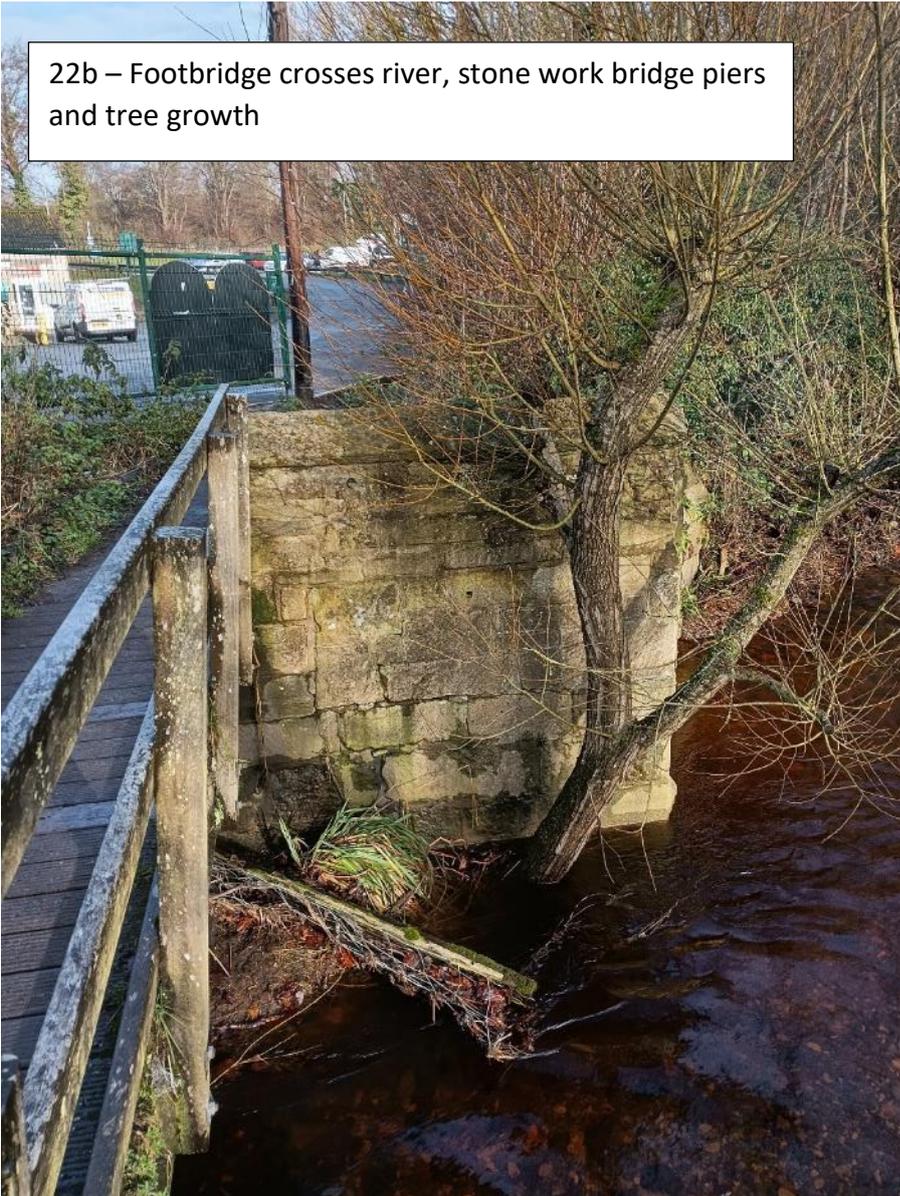
22b – Footbridge crosses river, stone work bridge piers and tree growth

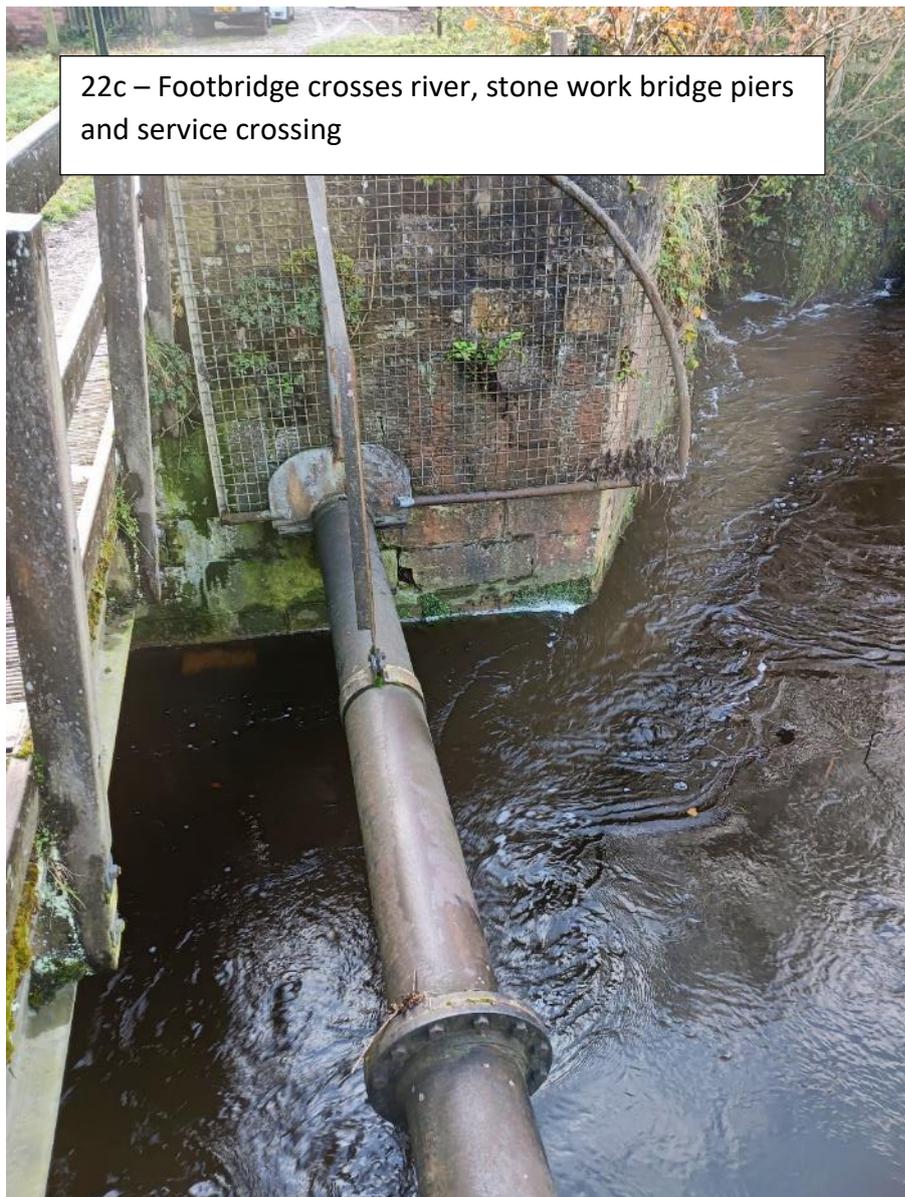
22c – Footbridge crosses river, stone work bridge piers and service crossing

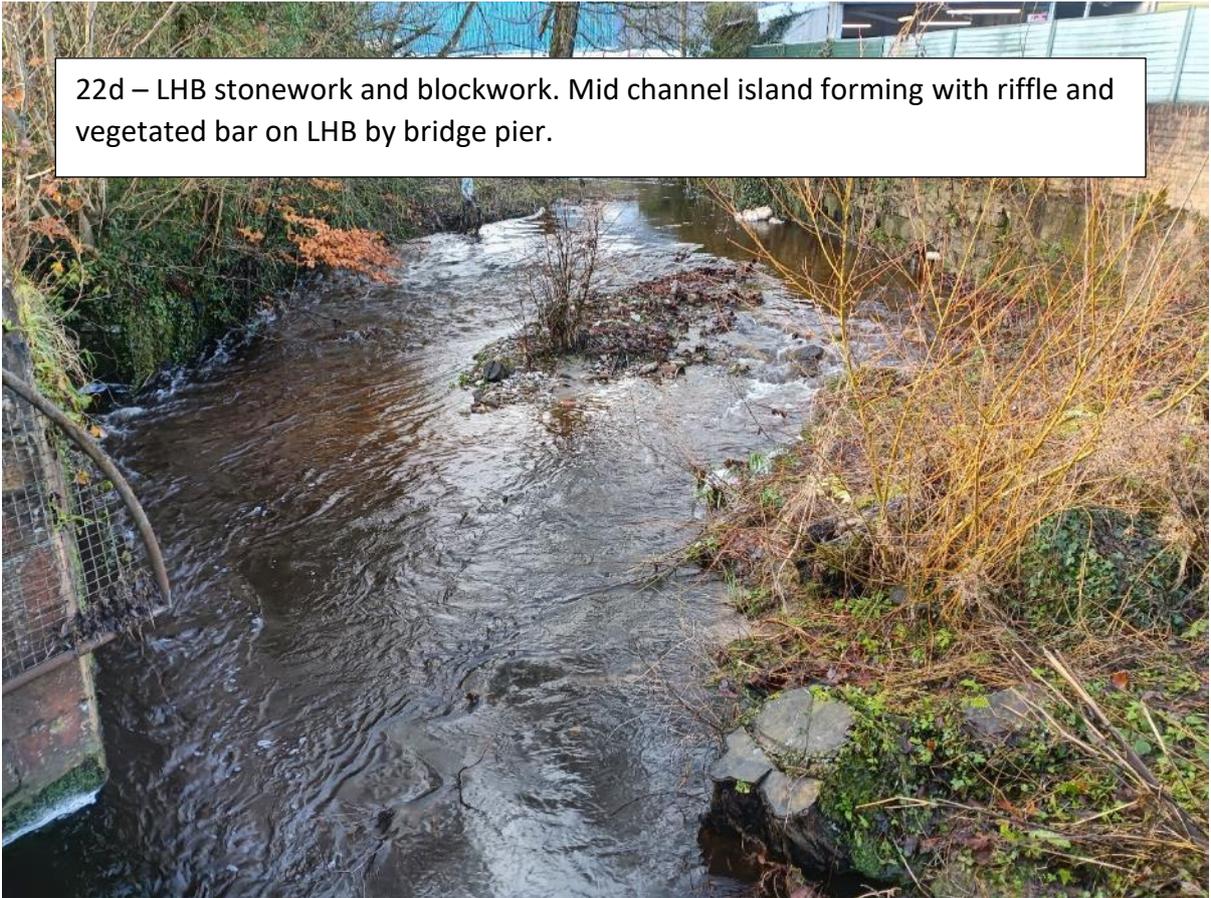
22d – LHB stonework and blockwork. Mid channel island forming with riffle and vegetated bar on LHB by bridge pier.

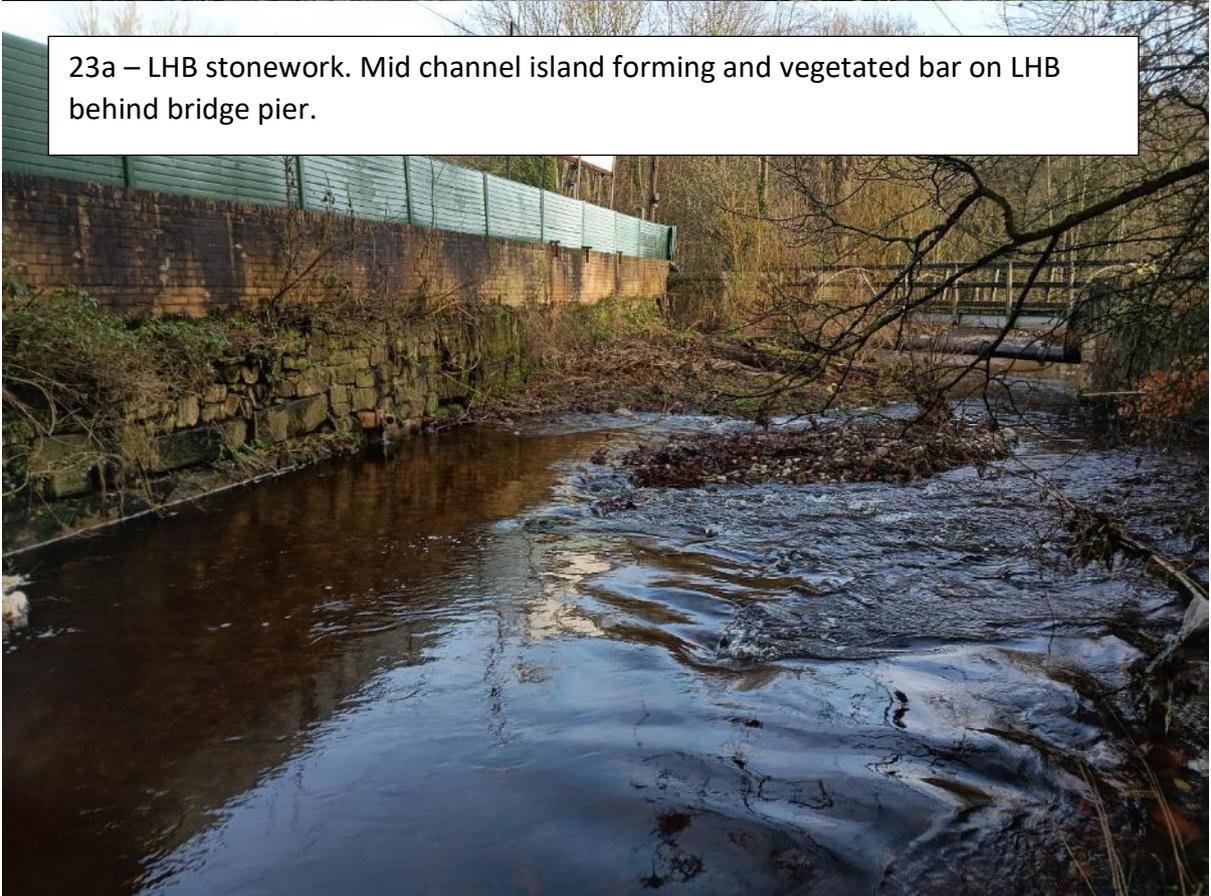
23a – LHB stonework. Mid channel island forming and vegetated bar on LHB behind bridge pier.

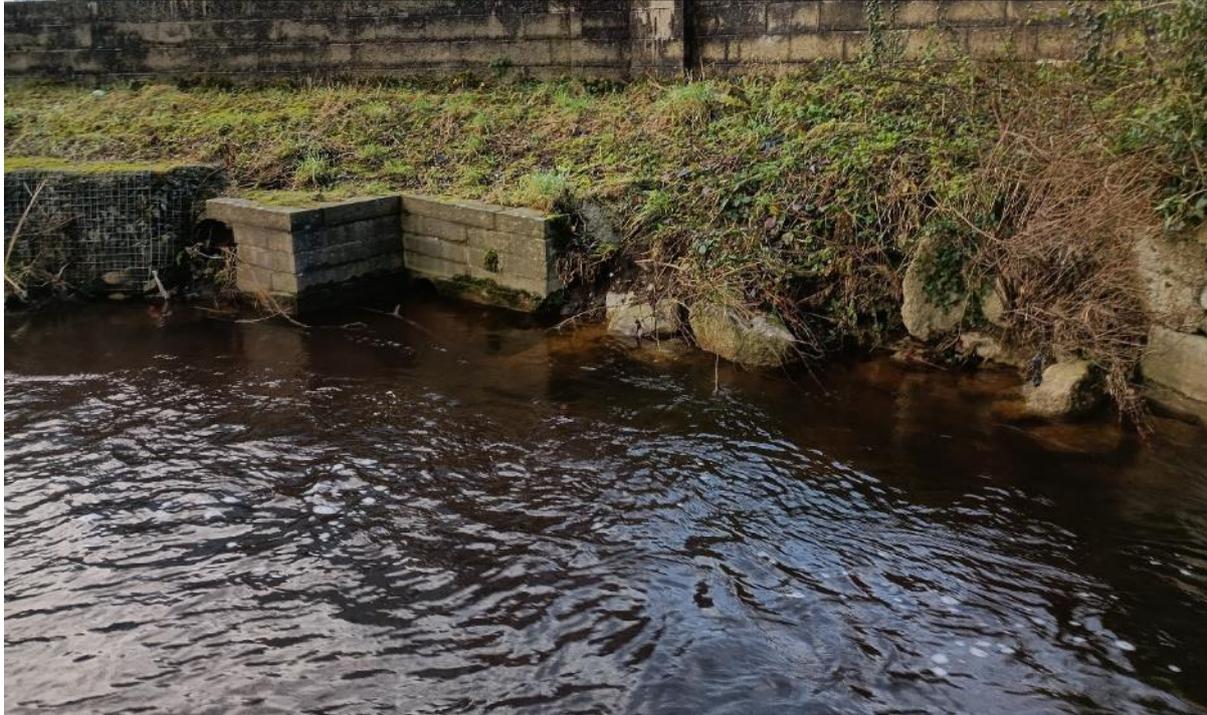
23b – LHB brickwork and failed stonework and gabions protecting industrial estate. River fairly deep and slow

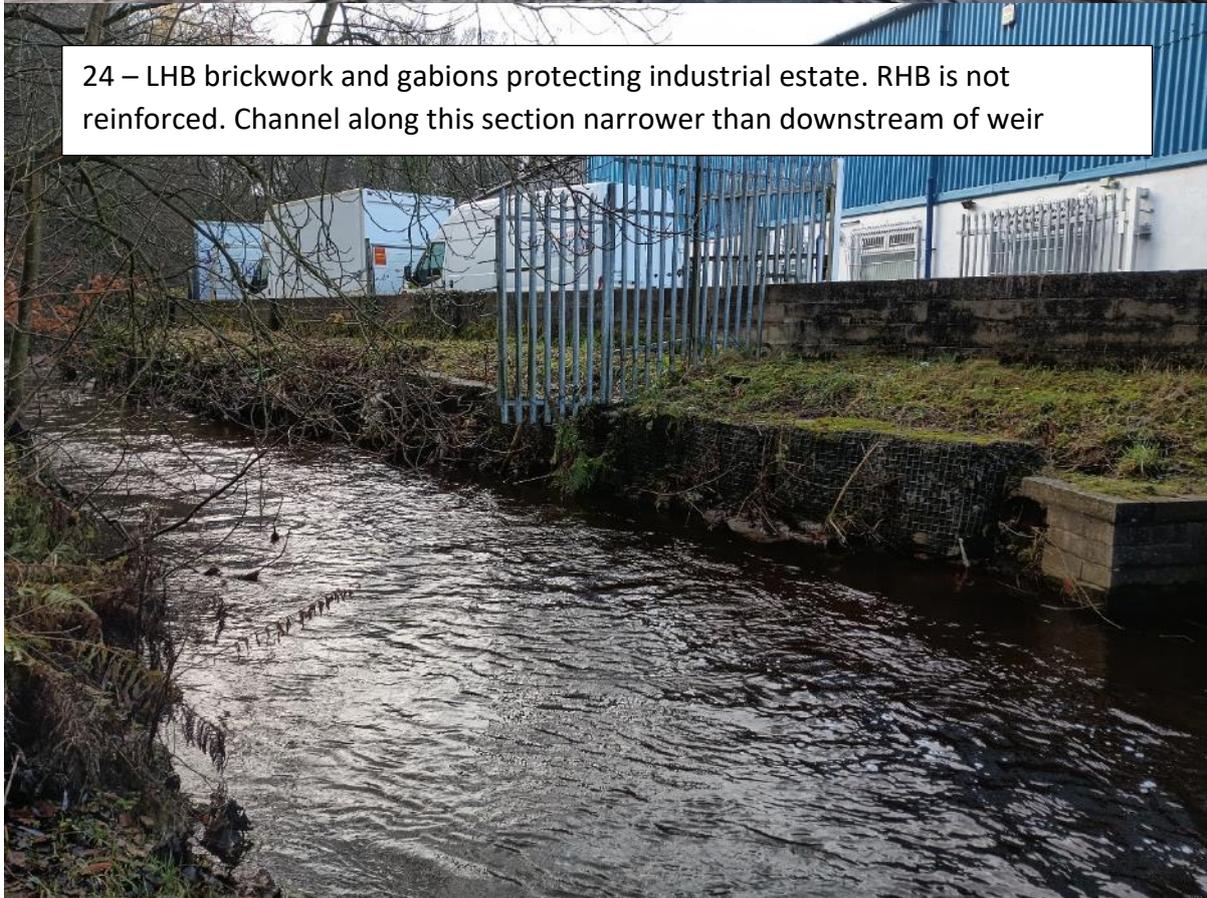
24 – LHB brickwork and gabions protecting industrial estate. RHB is not reinforced. Channel along this section narrower than downstream of weir

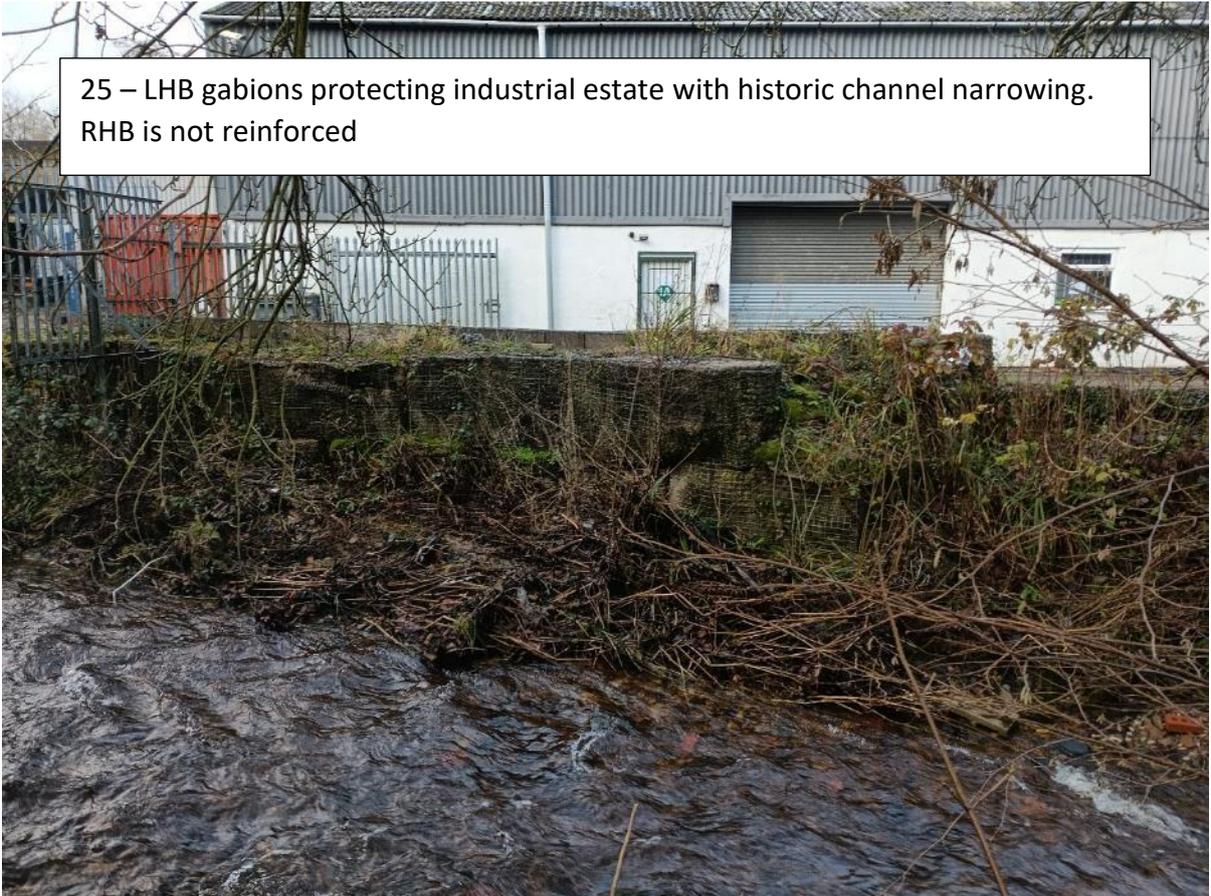
25 – LHB gabions protecting industrial estate with historic channel narrowing.
RHB is not reinforced

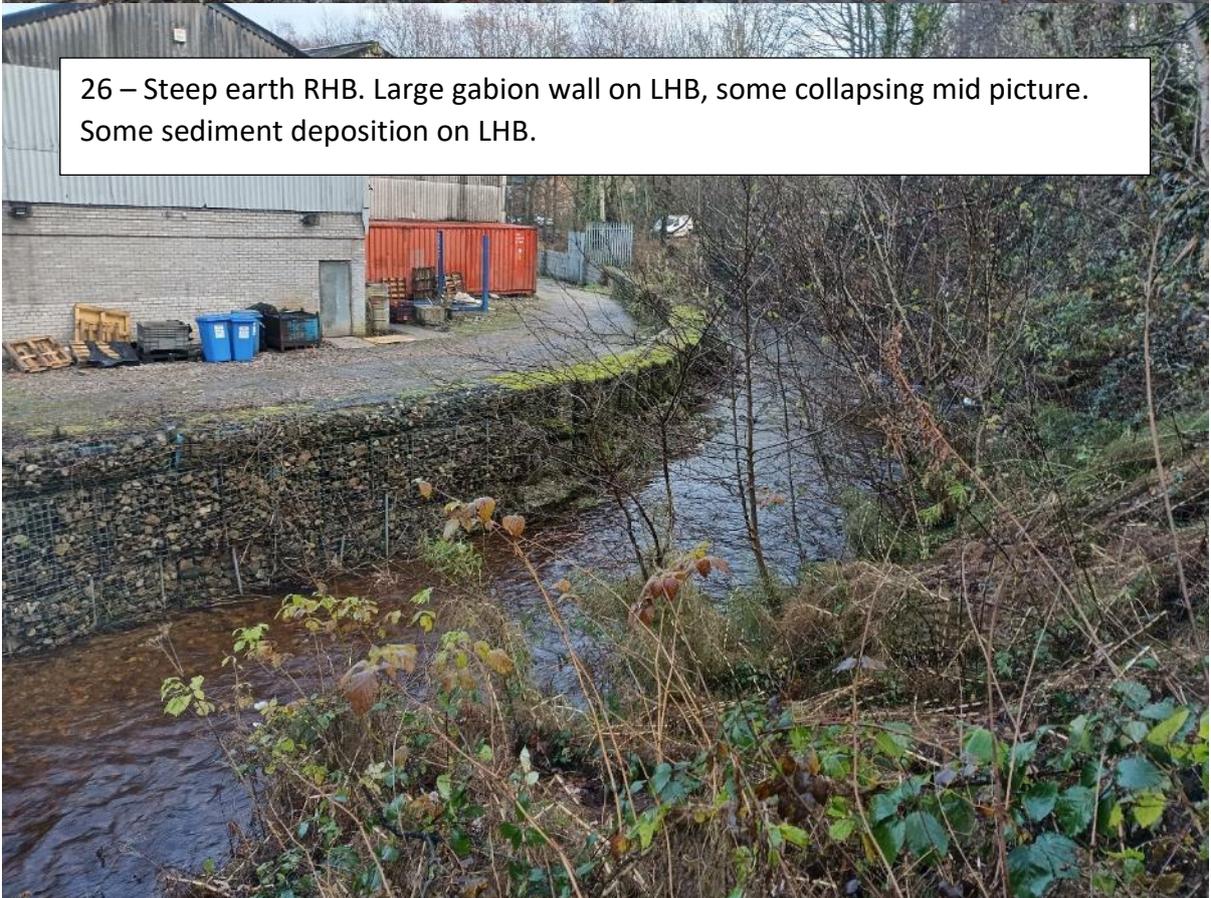
26 – Steep earth RHB. Large gabion wall on LHB, some collapsing mid picture.
Some sediment deposition on LHB.

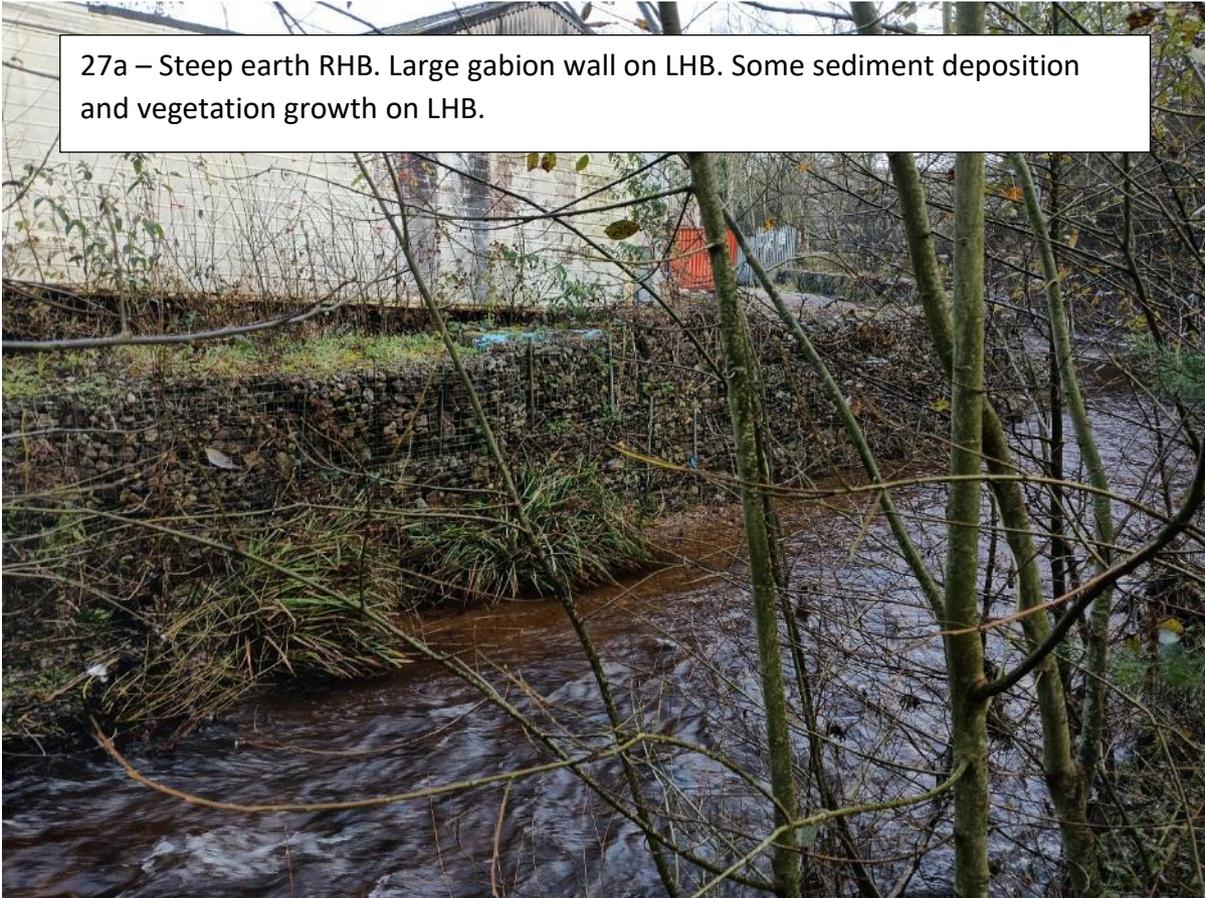
27a – Steep earth RHB. Large gabion wall on LHB. Some sediment deposition and vegetation growth on LHB.

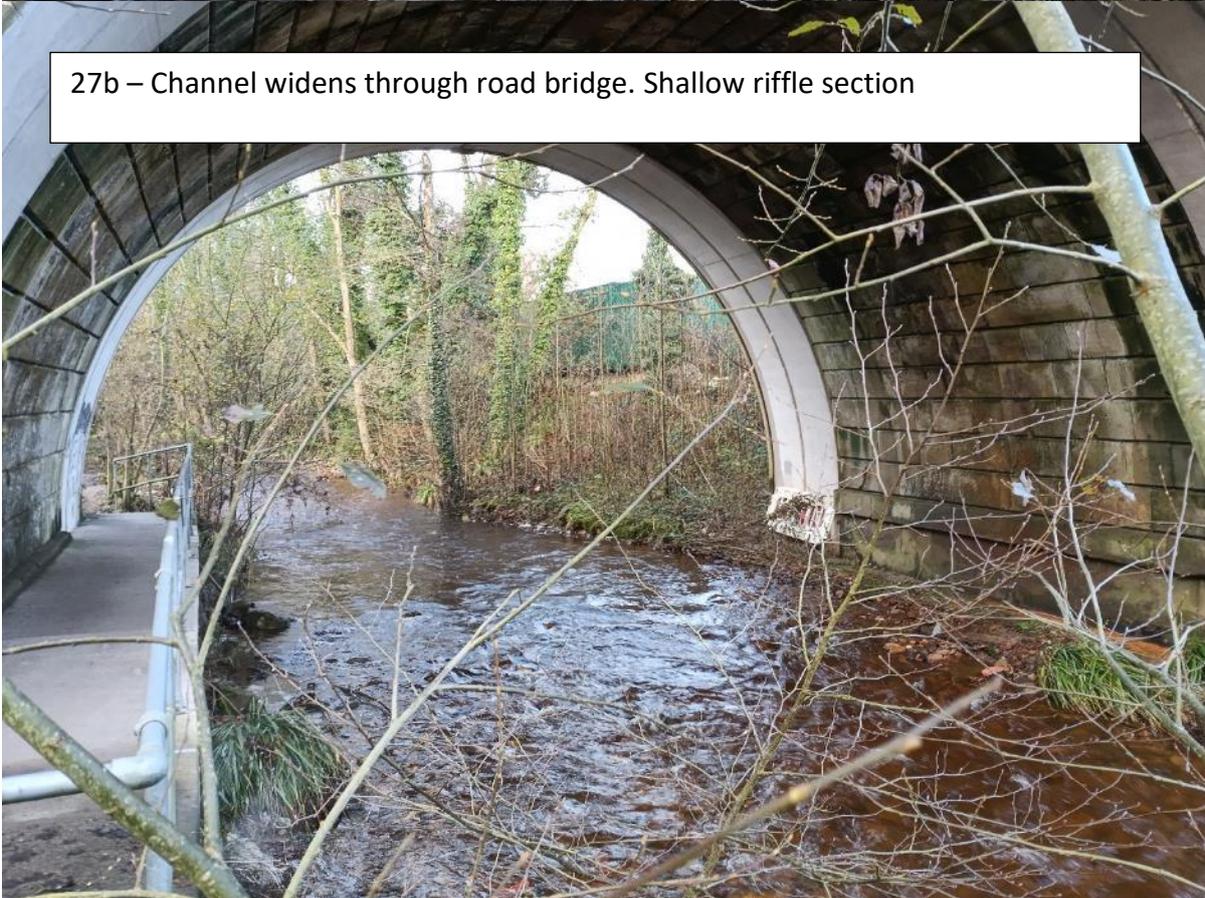
27b – Channel widens through road bridge. Shallow riffle section

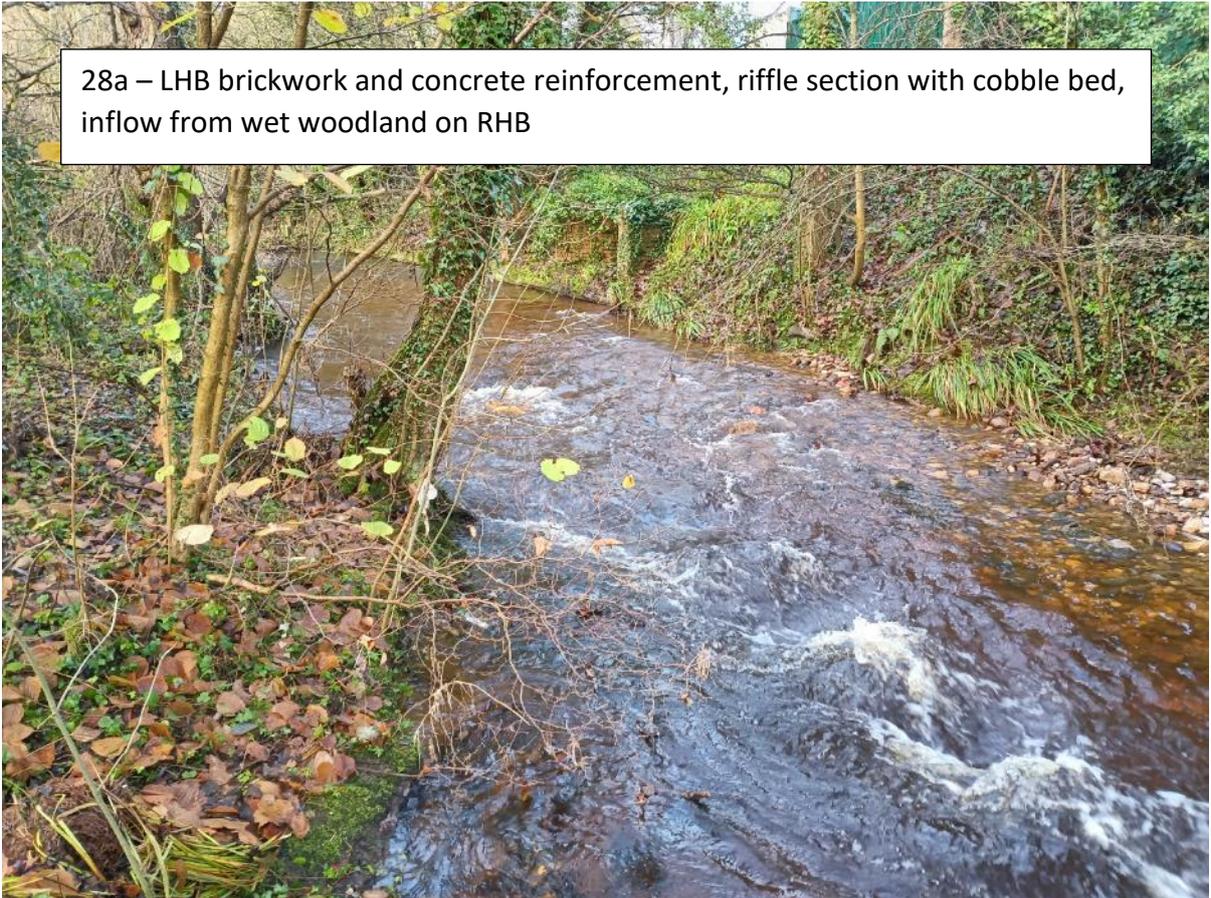
28a – LHB brickwork and concrete reinforcement, riffle section with cobble bed, inflow from wet woodland on RHB

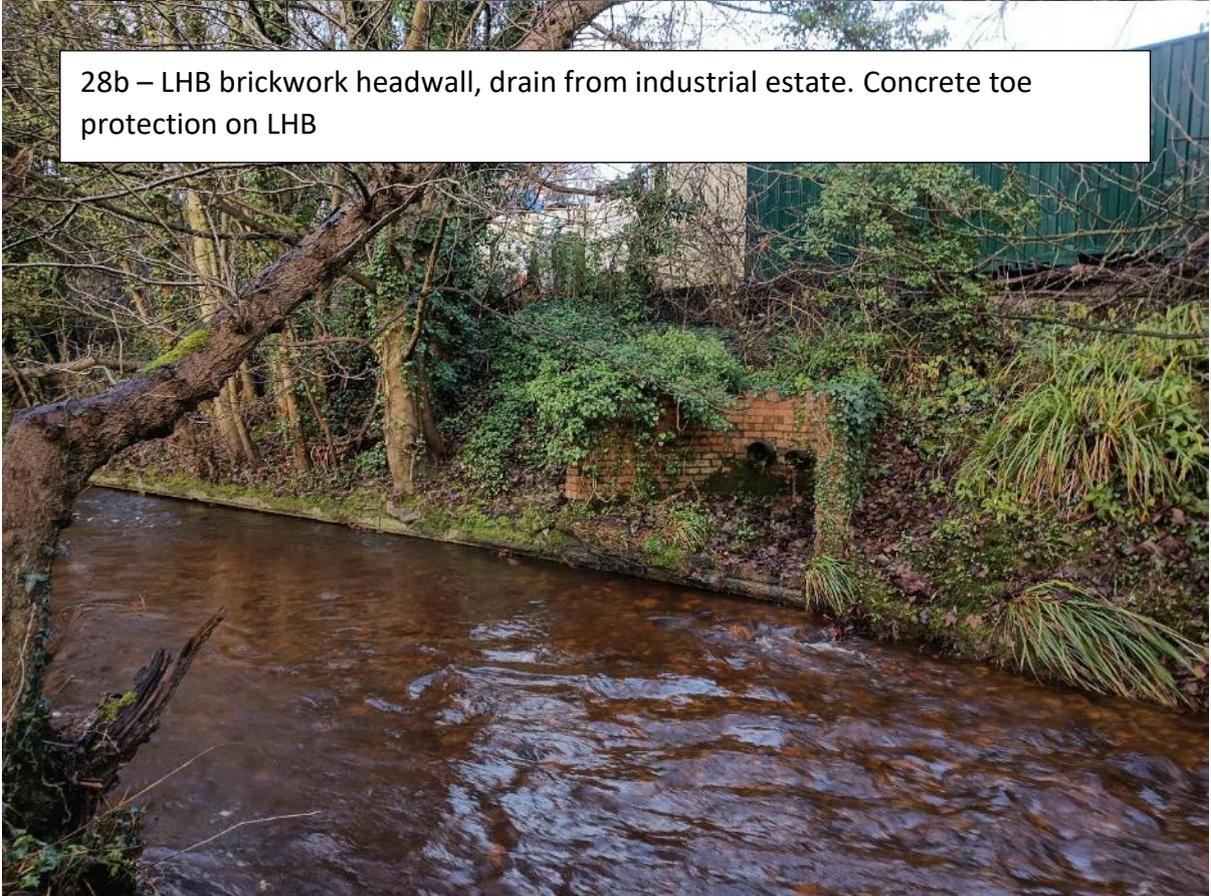
28b – LHB brickwork headwall, drain from industrial estate. Concrete toe protection on LHB

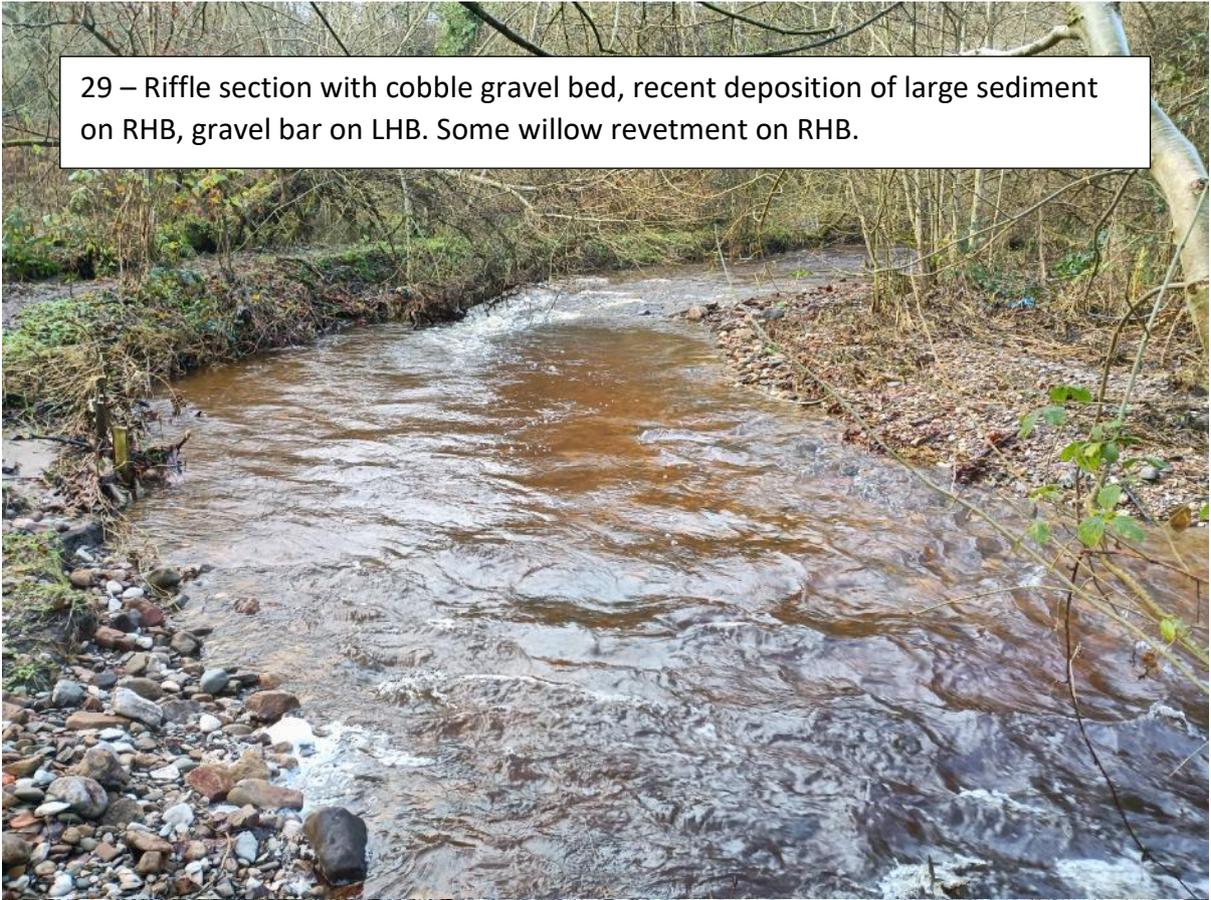
29 – Riffle section with cobble gravel bed, recent deposition of large sediment on RHB, gravel bar on LHB. Some willow revetment on RHB.

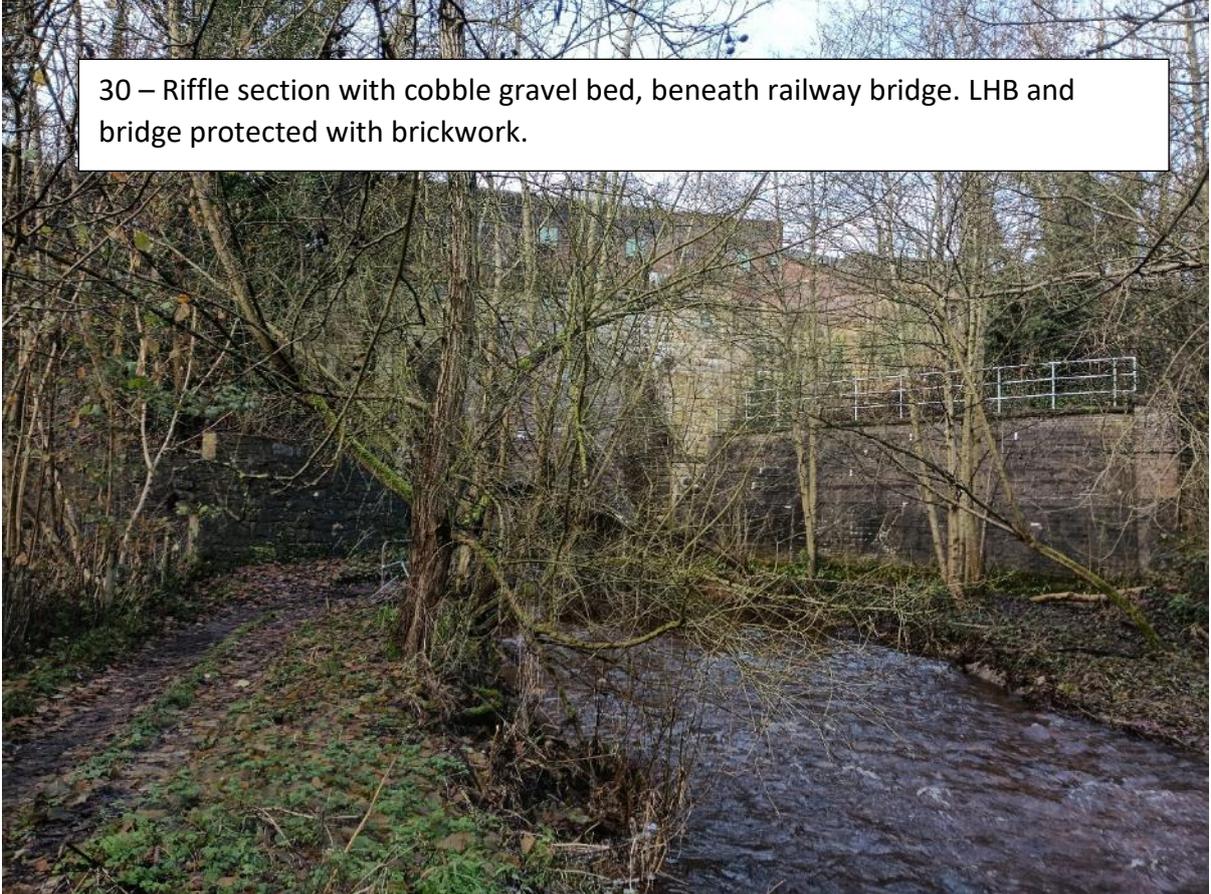
30 – Riffle section with cobble gravel bed, beneath railway bridge. LHB and bridge protected with brickwork.
