Geomorphology survey

River Clywedog – Felin Puleston Weir removal

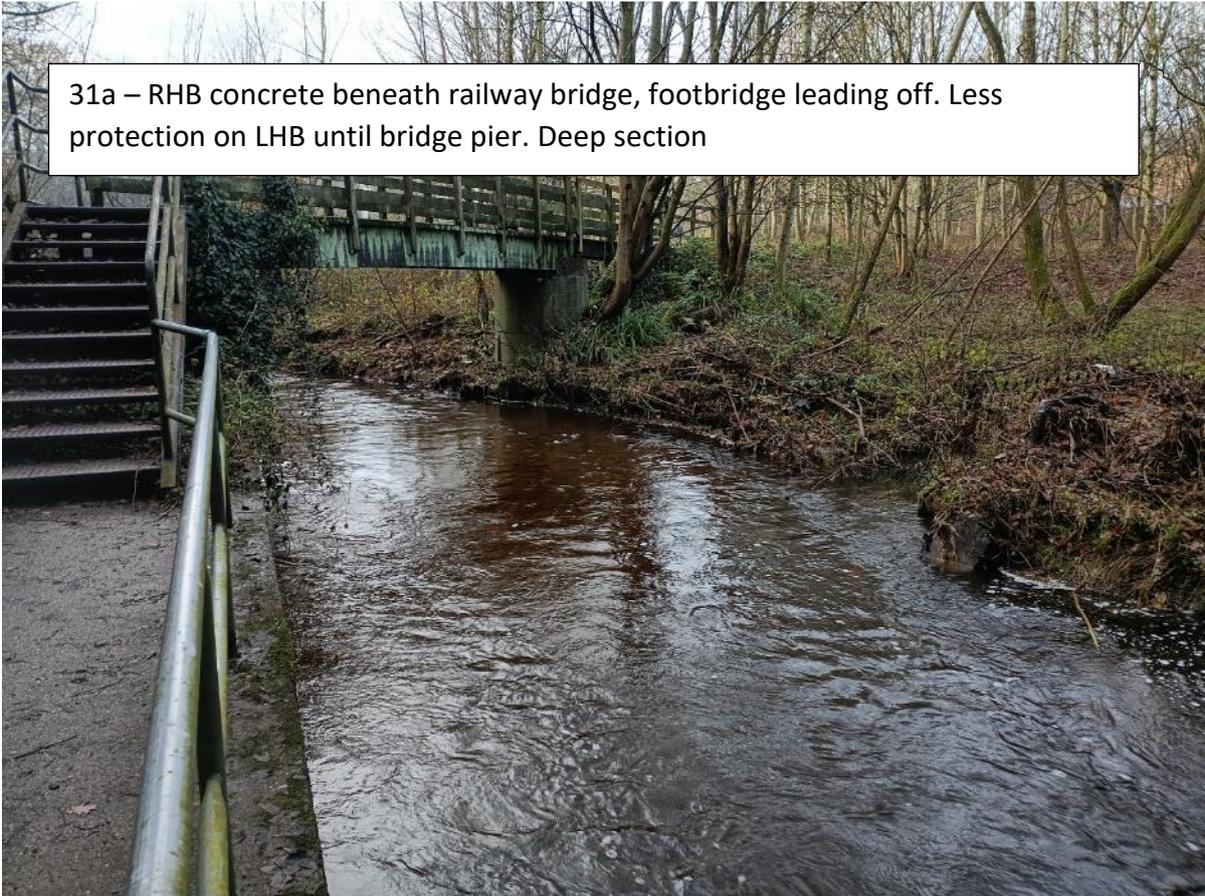
31a – RHB concrete beneath railway bridge, footbridge leading off. Less protection on LHB until bridge pier. Deep section

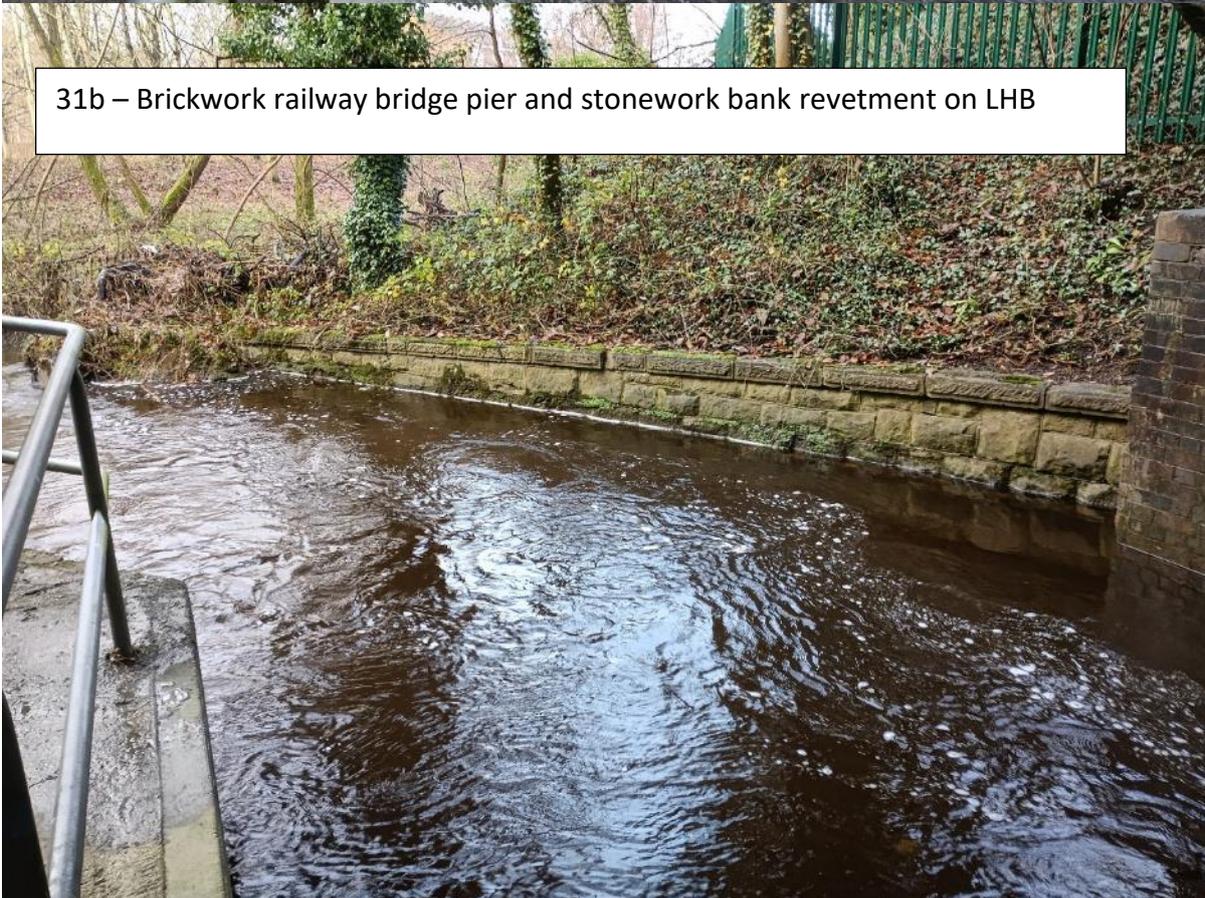
31b – Brickwork railway bridge pier and stonework bank revetment on LHB

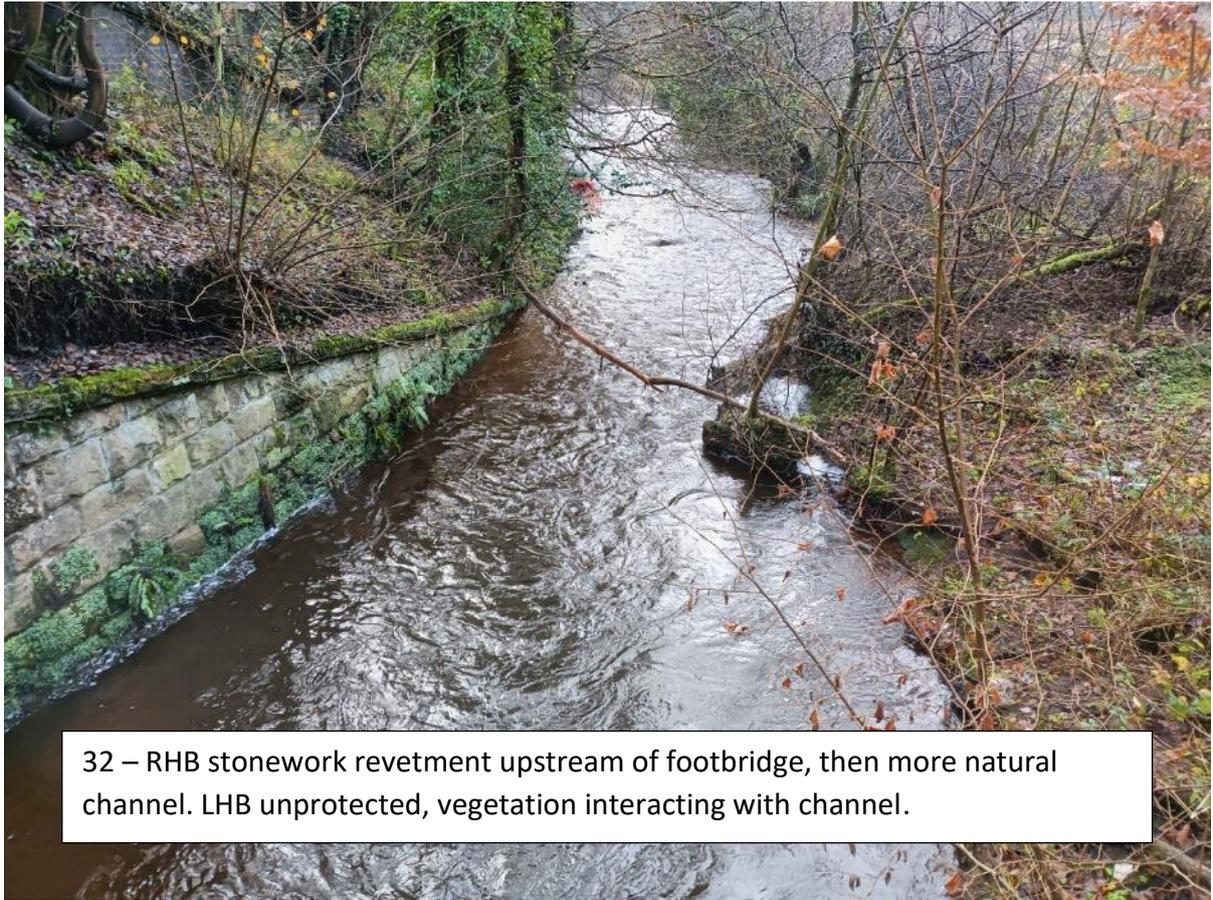
32 – RHB stonework revetment upstream of footbridge, then more natural channel. LHB unprotected, vegetation interacting with channel.
