Geomorphology survey

River Clywedog – Felin Puleston Weir removal

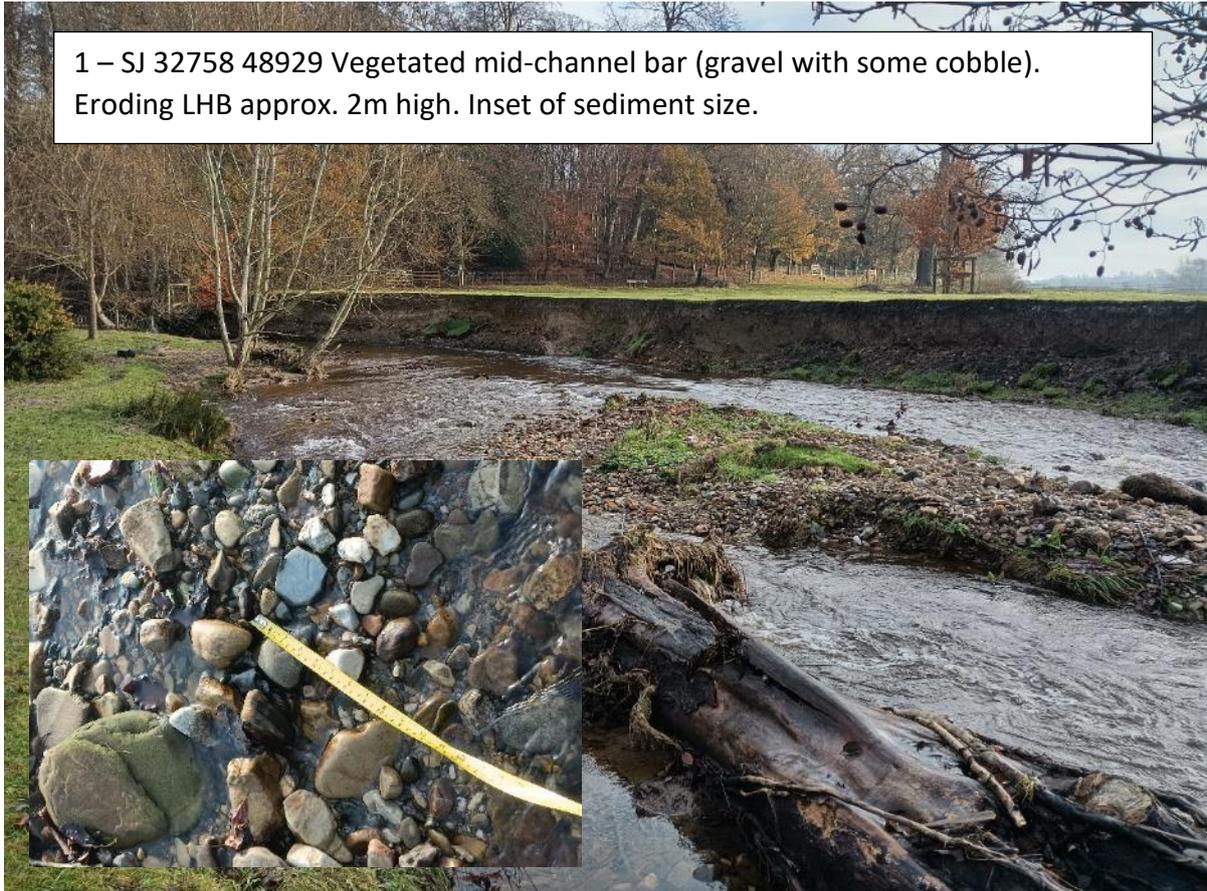
1 – SJ 32758 48929 Vegetated mid-channel bar (gravel with some cobble). Eroding LHB approx. 2m high. Inset of sediment size.

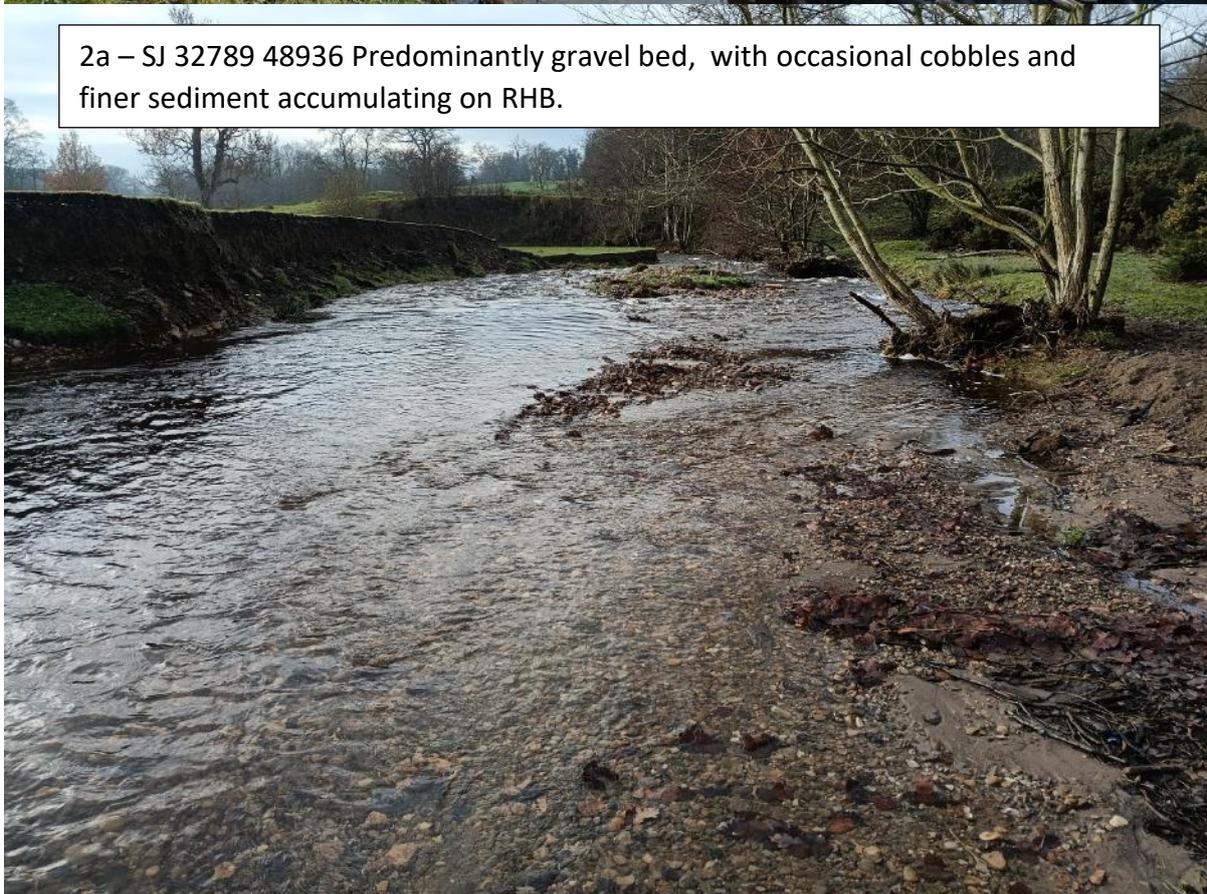
2a – SJ 32789 48936 Predominantly gravel bed, with occasional cobbles and finer sediment accumulating on RHB.

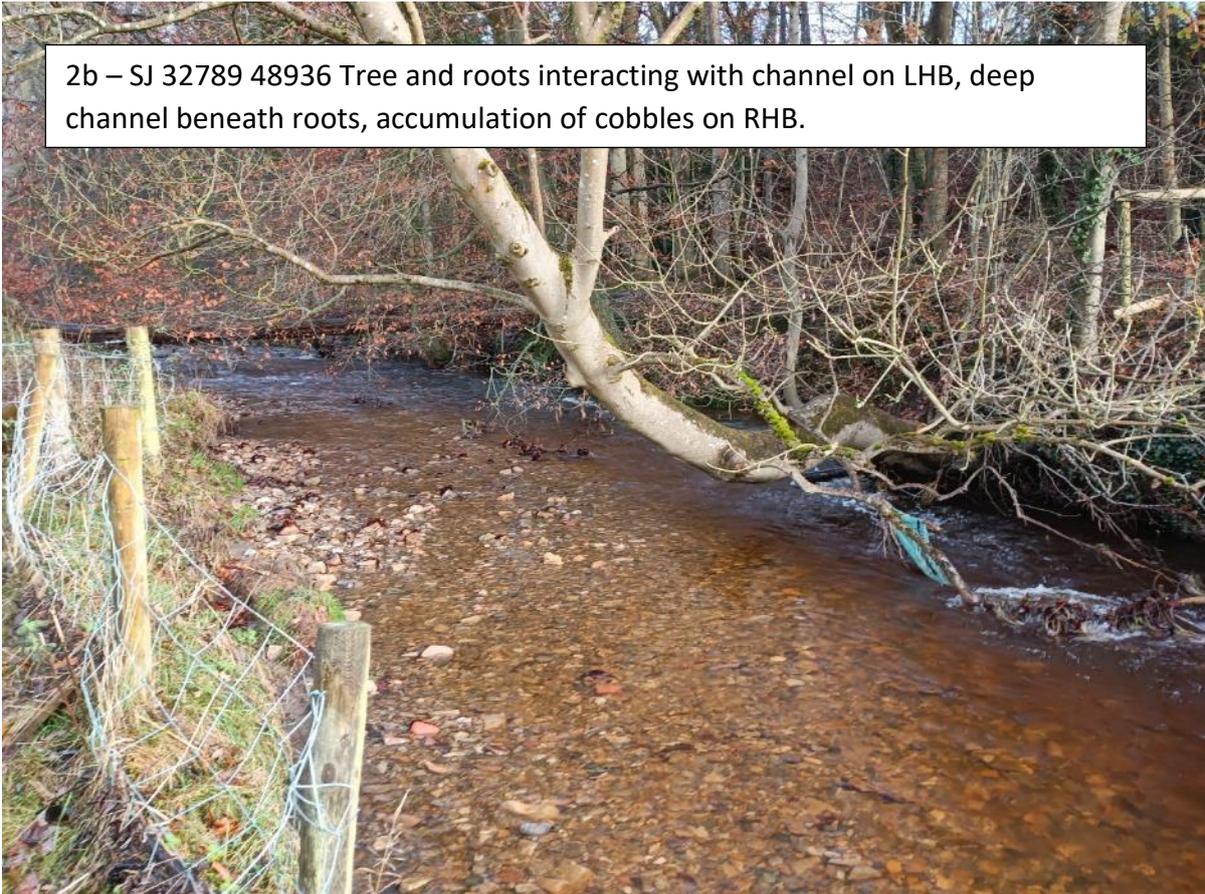
2b – SJ 32789 48936 Tree and roots interacting with channel on LHB, deep channel beneath roots, accumulation of cobbles on RHB.

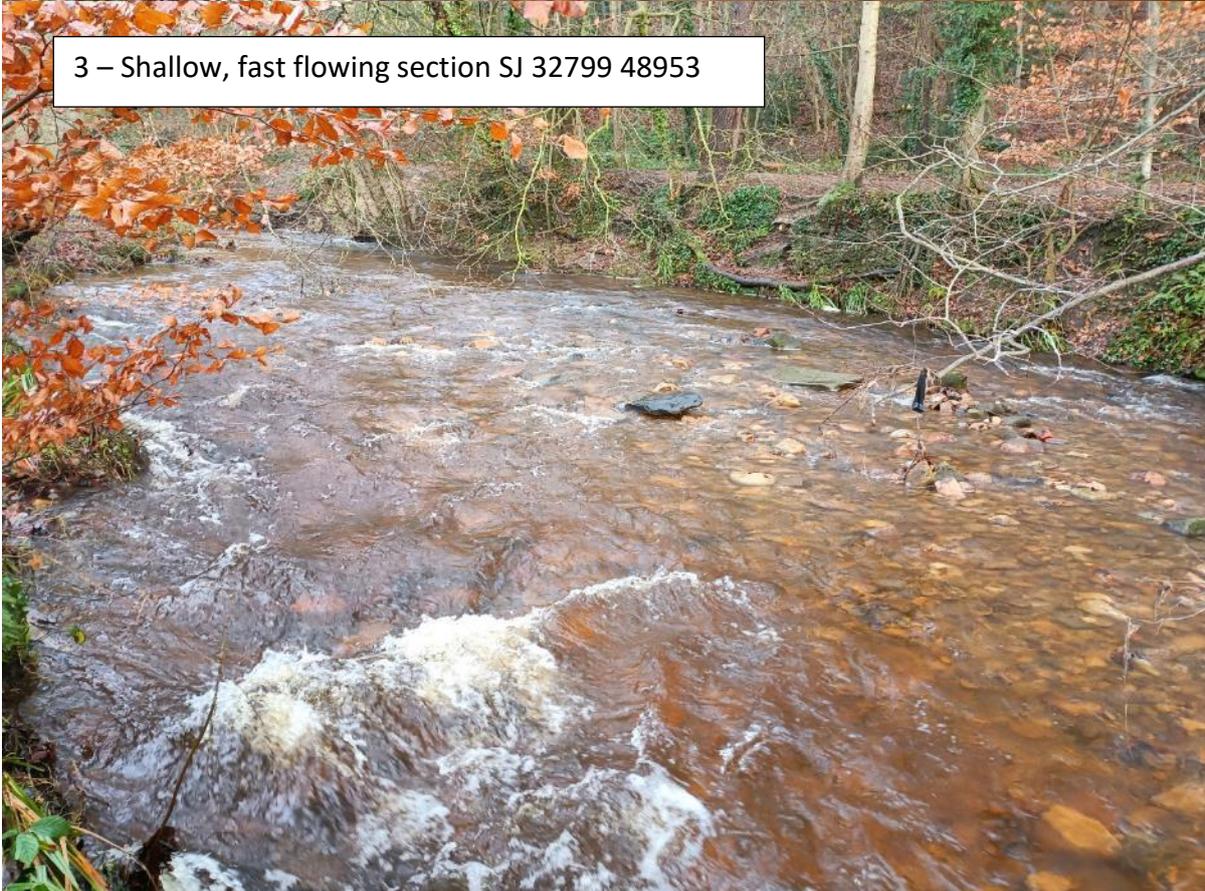
3 – Shallow, fast flowing section SJ 32799 48953

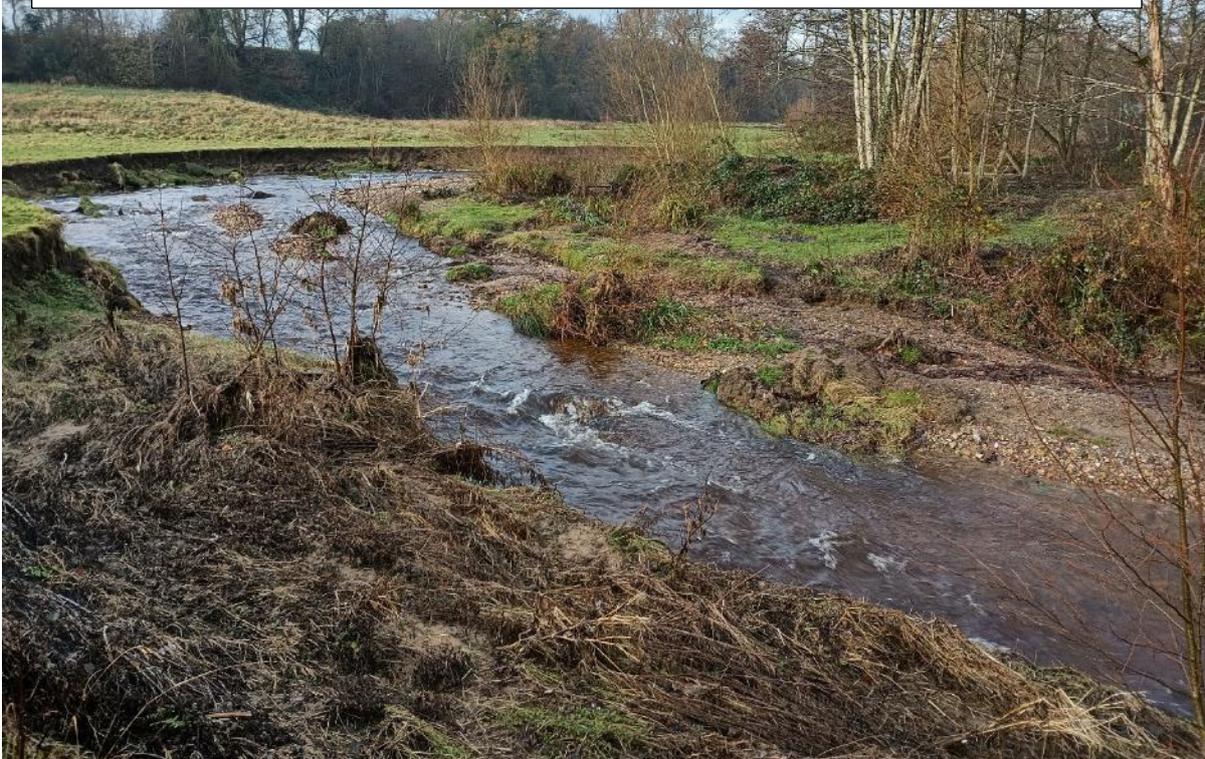
4 – SJ 32809 49006 Clear evidence of flood flows interacting with historic channel. Gravel and sand bar formed on LHB

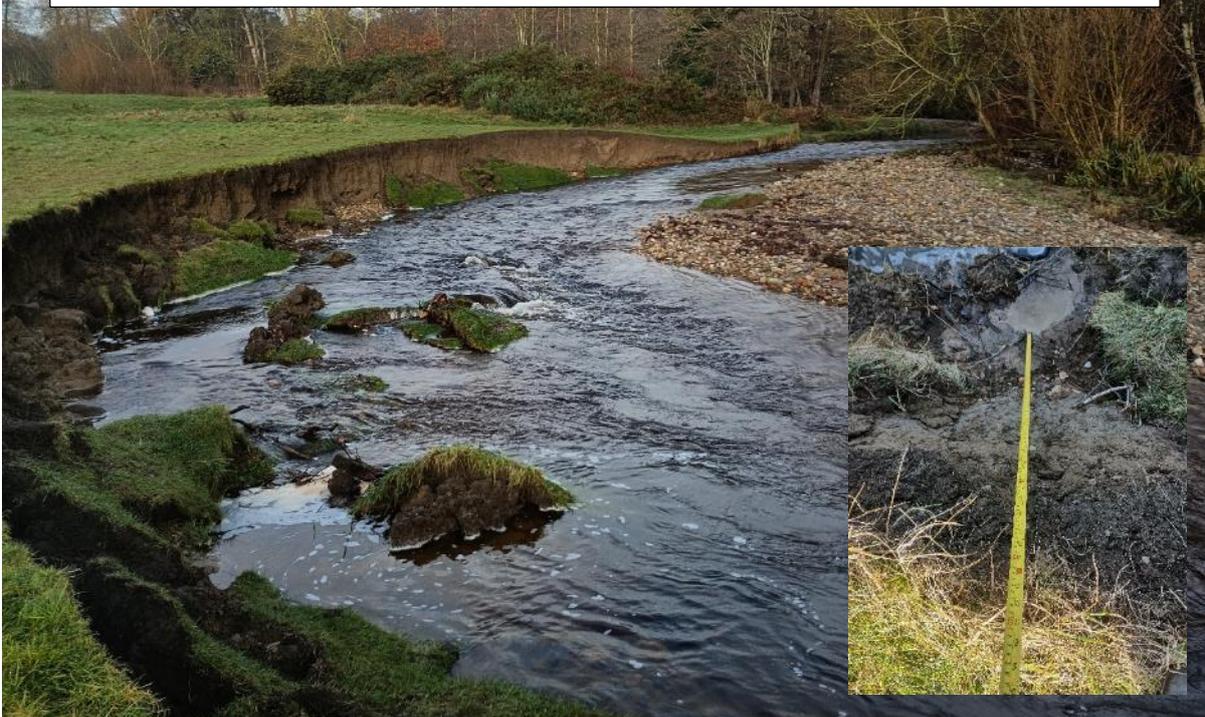
5 – SJ 32750 49005 Severe active erosion on RHB. Bank majority earth leads to rapid collapse in high flows. Turfs remain in channel and large gravel bar on LHB. Inset RHB 1.6m high.

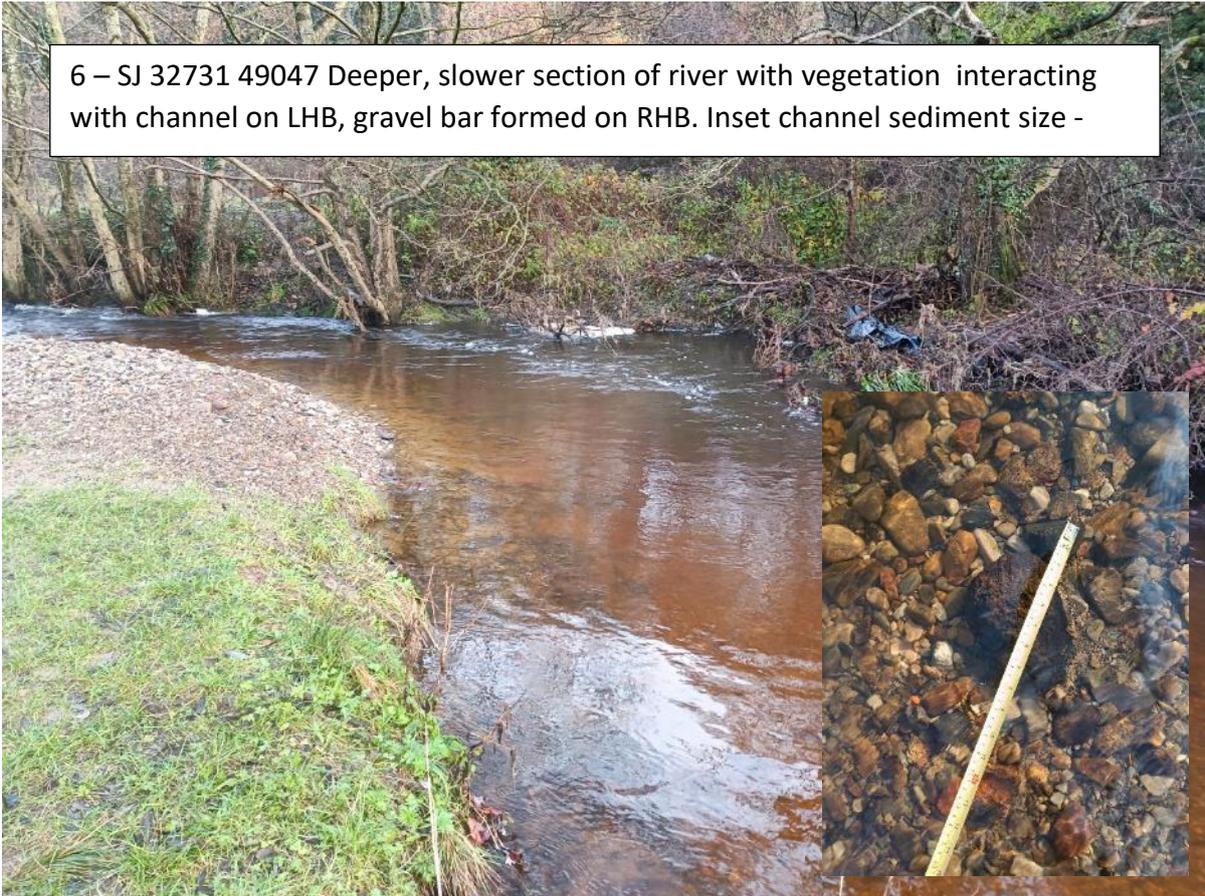
6 – SJ 32731 49047 Deeper, slower section of river with vegetation interacting with channel on LHB, gravel bar formed on RHB. Inset channel sediment size -

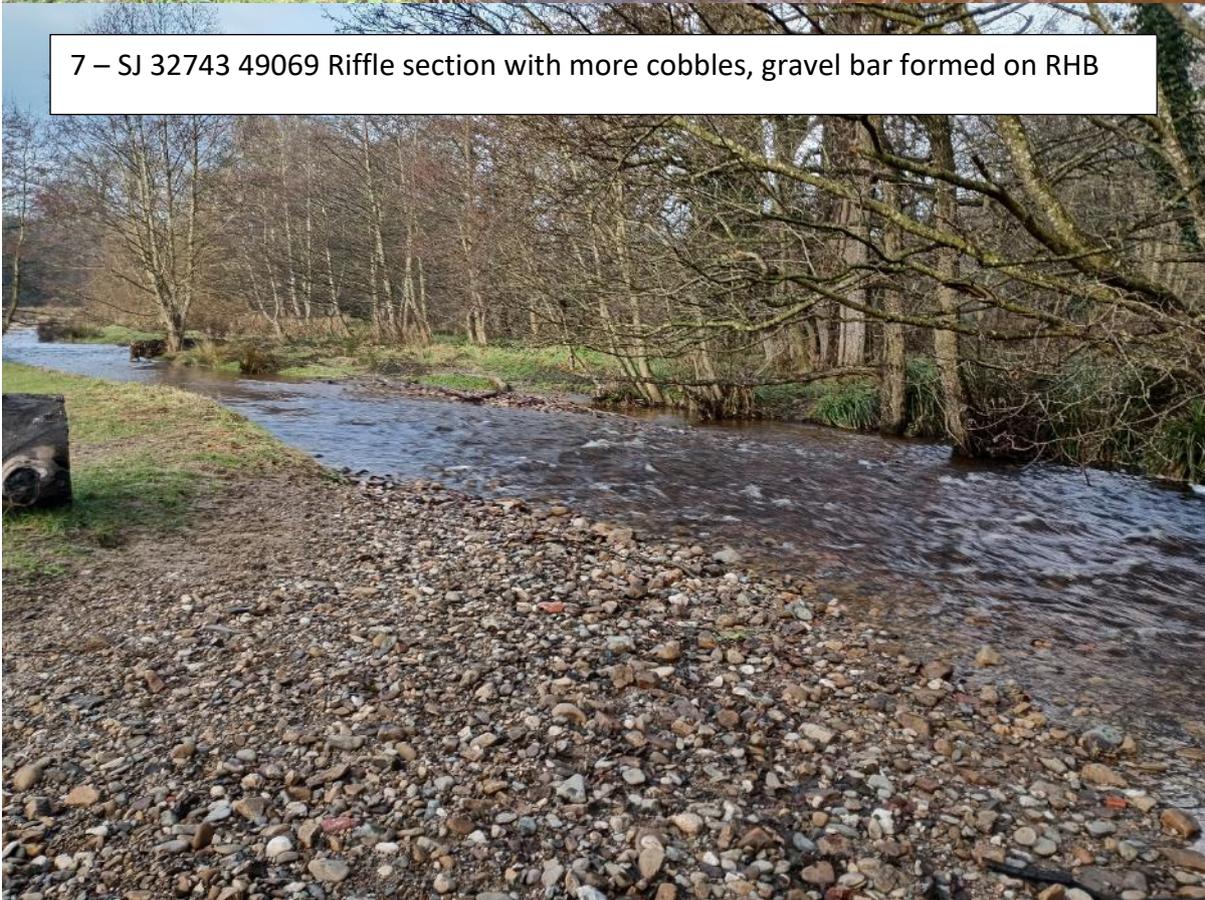
7 – SJ 32743 49069 Riffle section with more cobbles, gravel bar formed on RHB

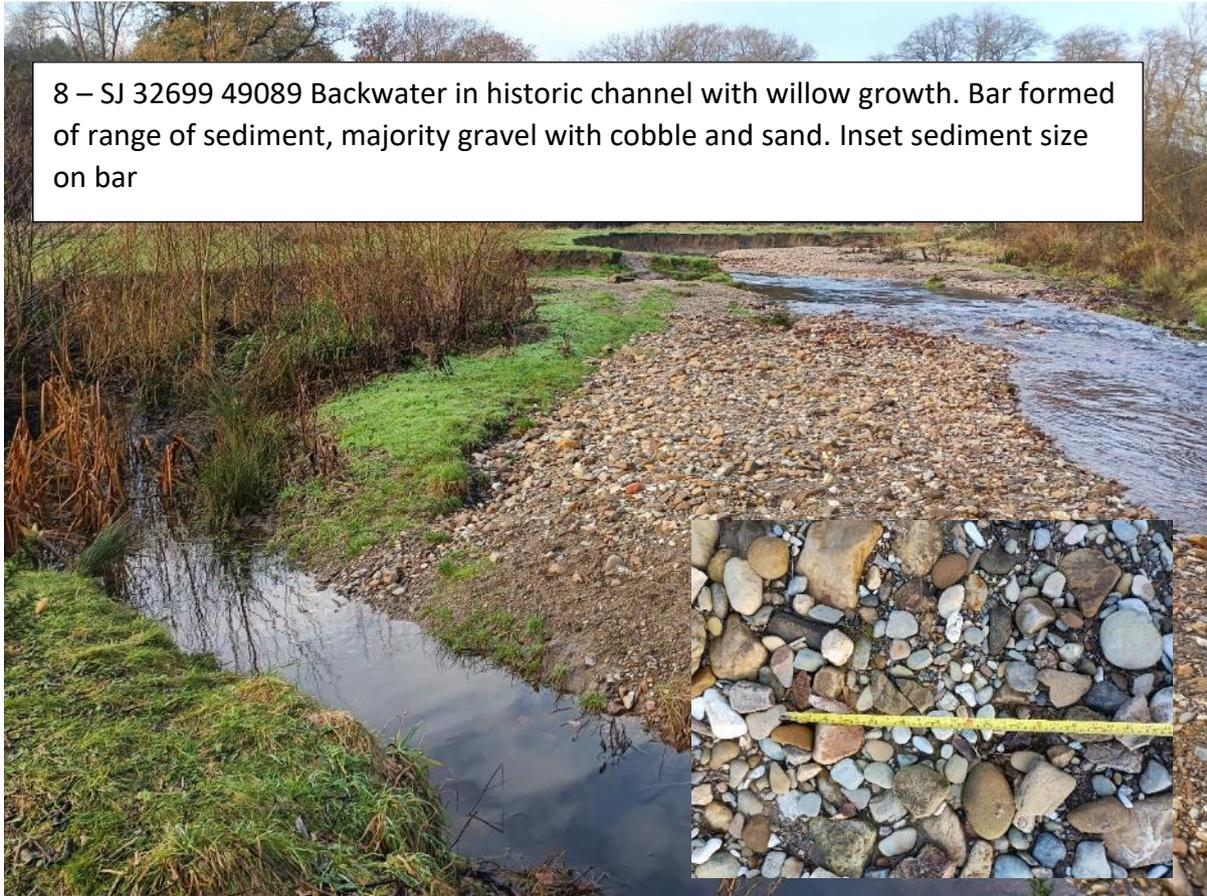
8 – SJ 32699 49089 Backwater in historic channel with willow growth. Bar formed of range of sediment, majority gravel with cobble and sand. Inset sediment size on bar

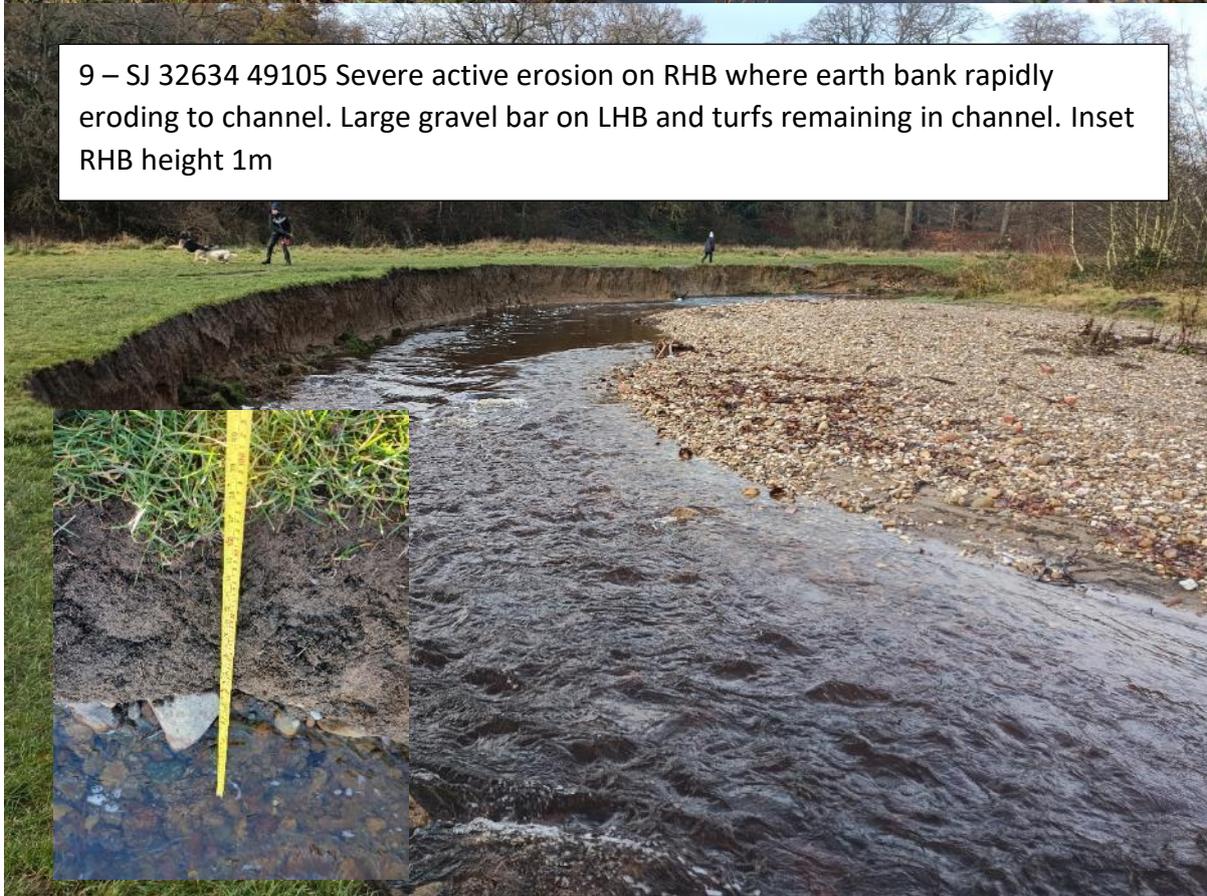
9 – SJ 32634 49105 Severe active erosion on RHB where earth bank rapidly eroding to channel. Large gravel bar on LHB and turfs remaining in channel. Inset RHB height 1m

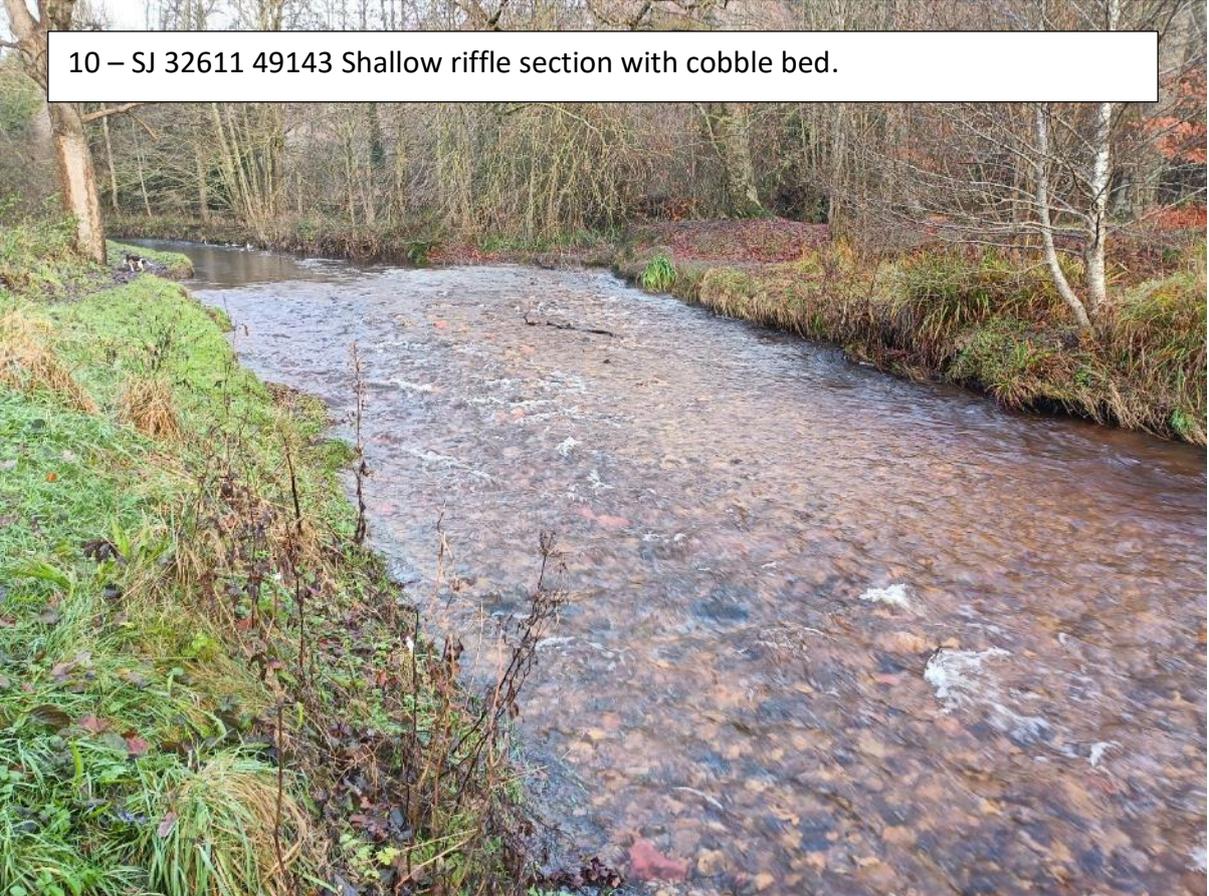
10 – SJ 32611 49143 Shallow riffle section with cobble bed.

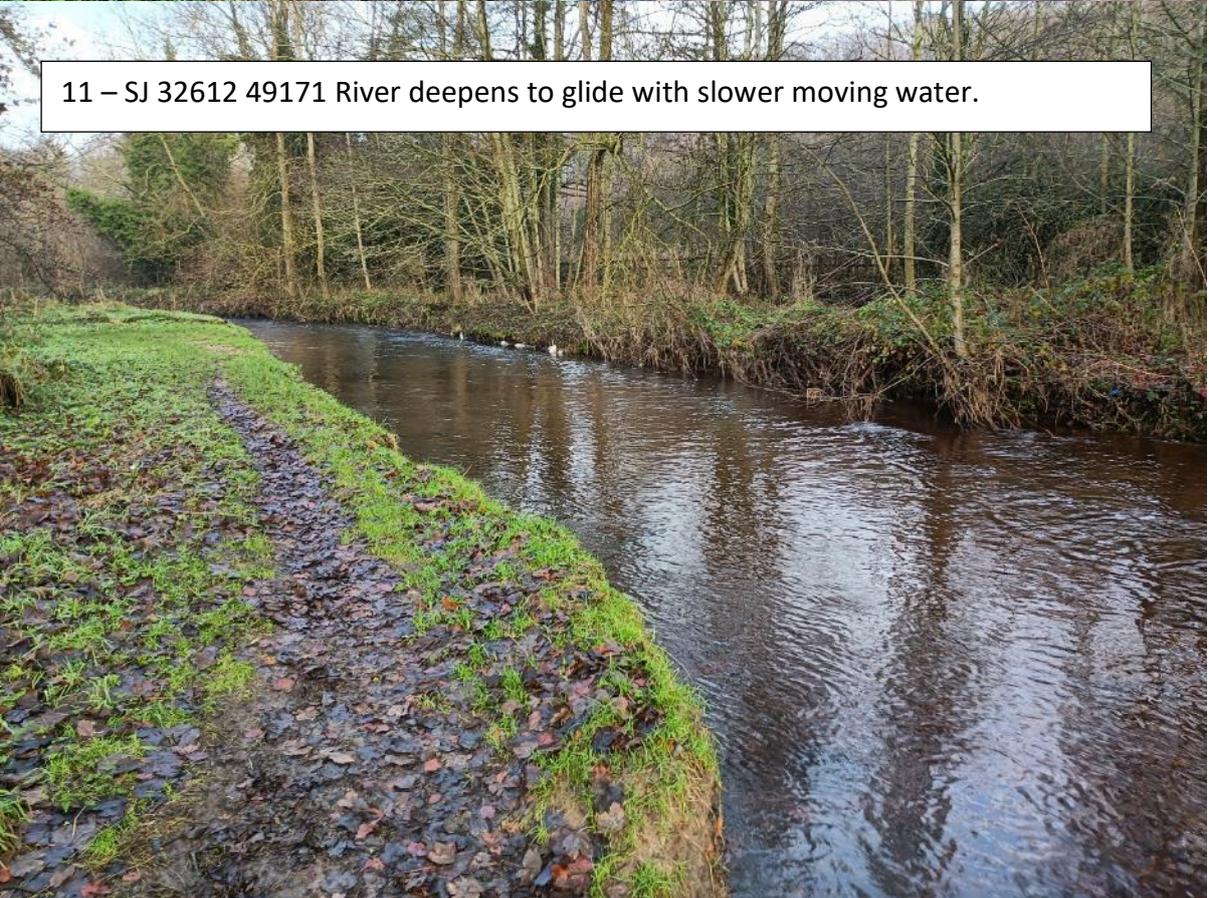
11 – SJ 32612 49171 River deepens to glide with slower moving water.

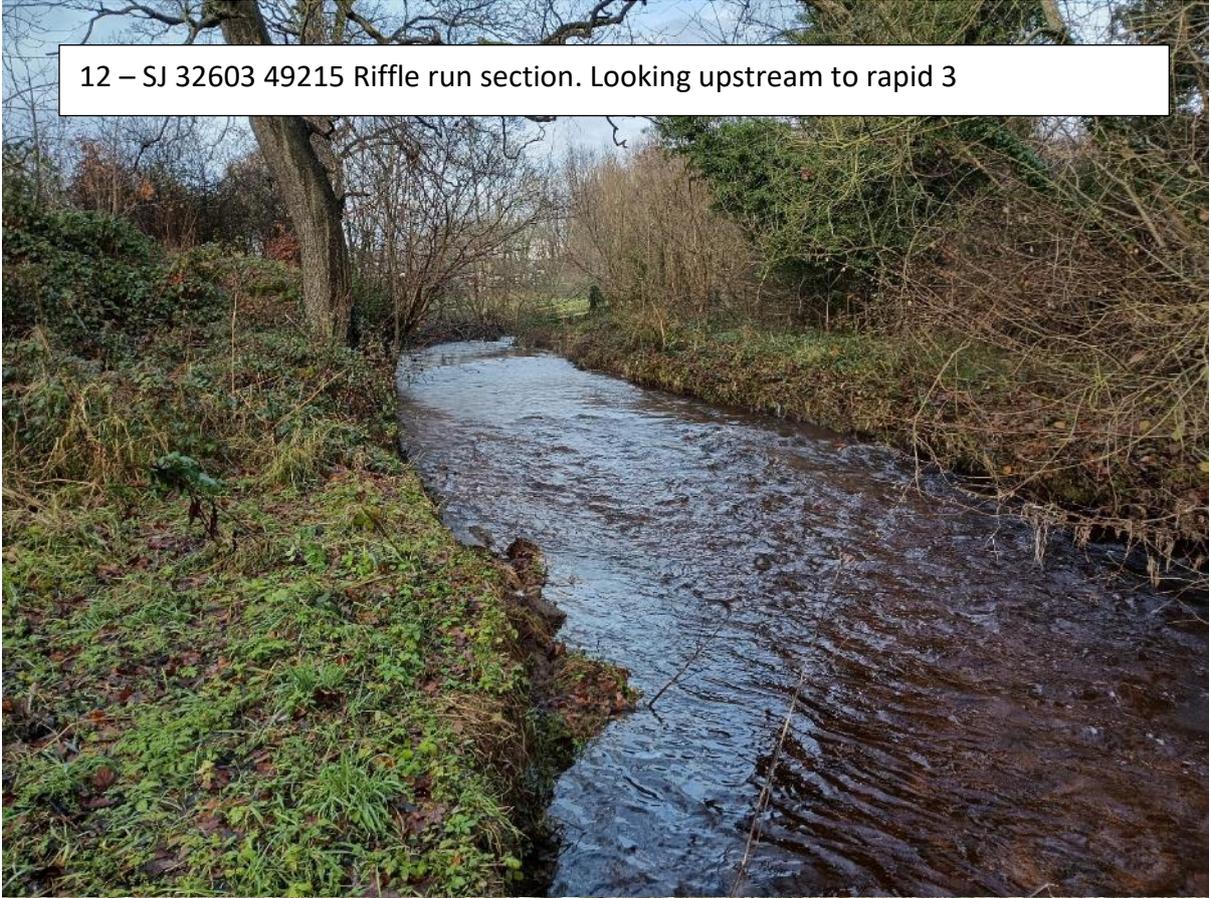
12 – SJ 32603 49215 Riffle run section. Looking upstream to rapid 3

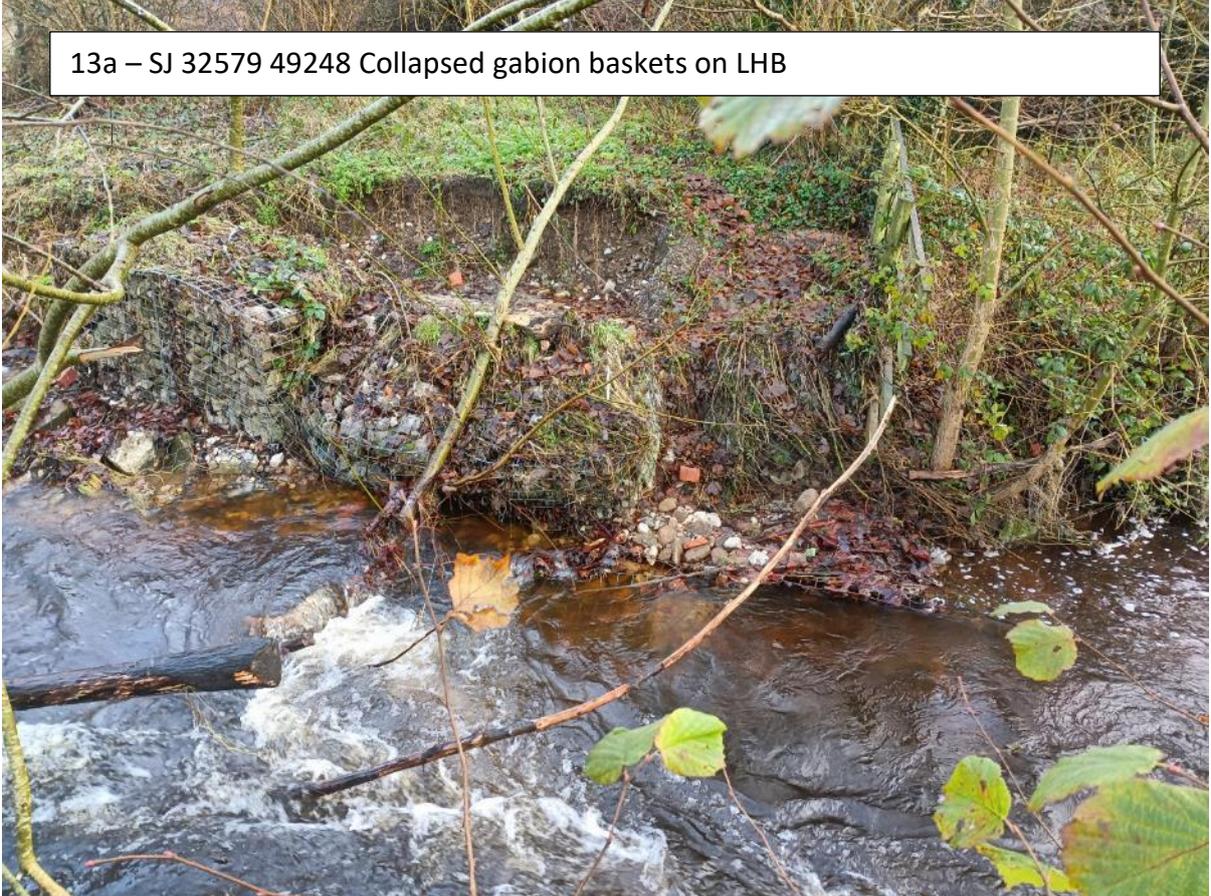
13a – SJ 32579 49248 Collapsed gabion baskets on LHB

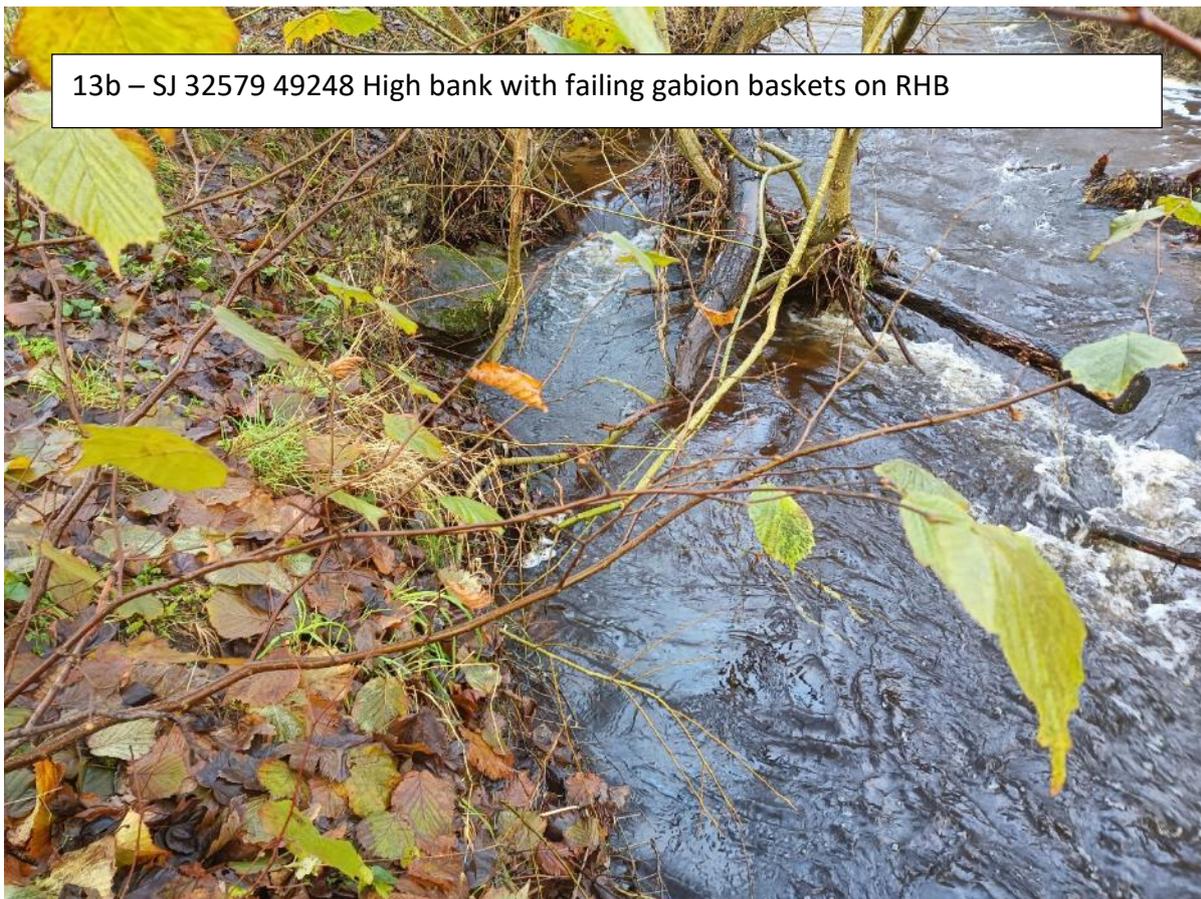
13b – SJ 32579 49248 High bank with failing gabion baskets on RHB

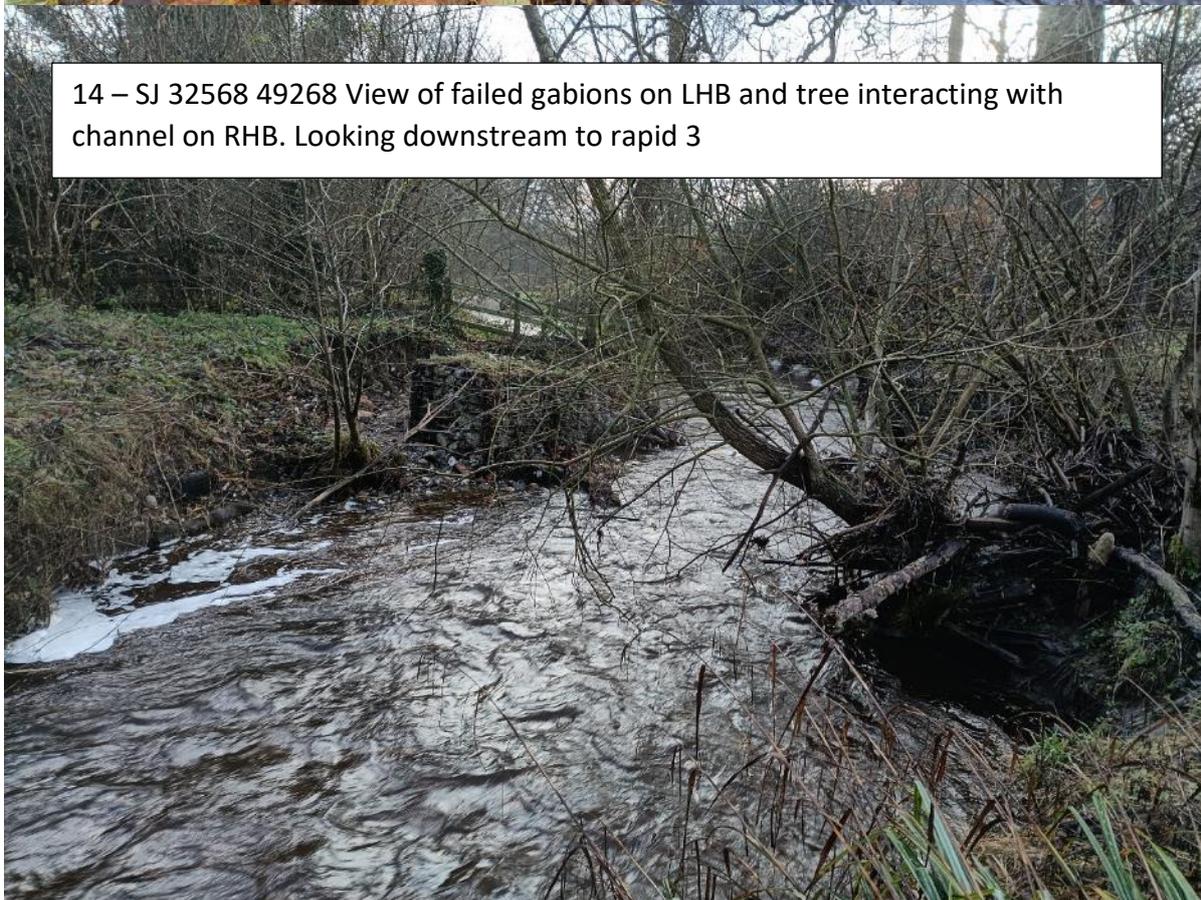
14 – SJ 32568 49268 View of failed gabions on LHB and tree interacting with channel on RHB. Looking downstream to rapid 3

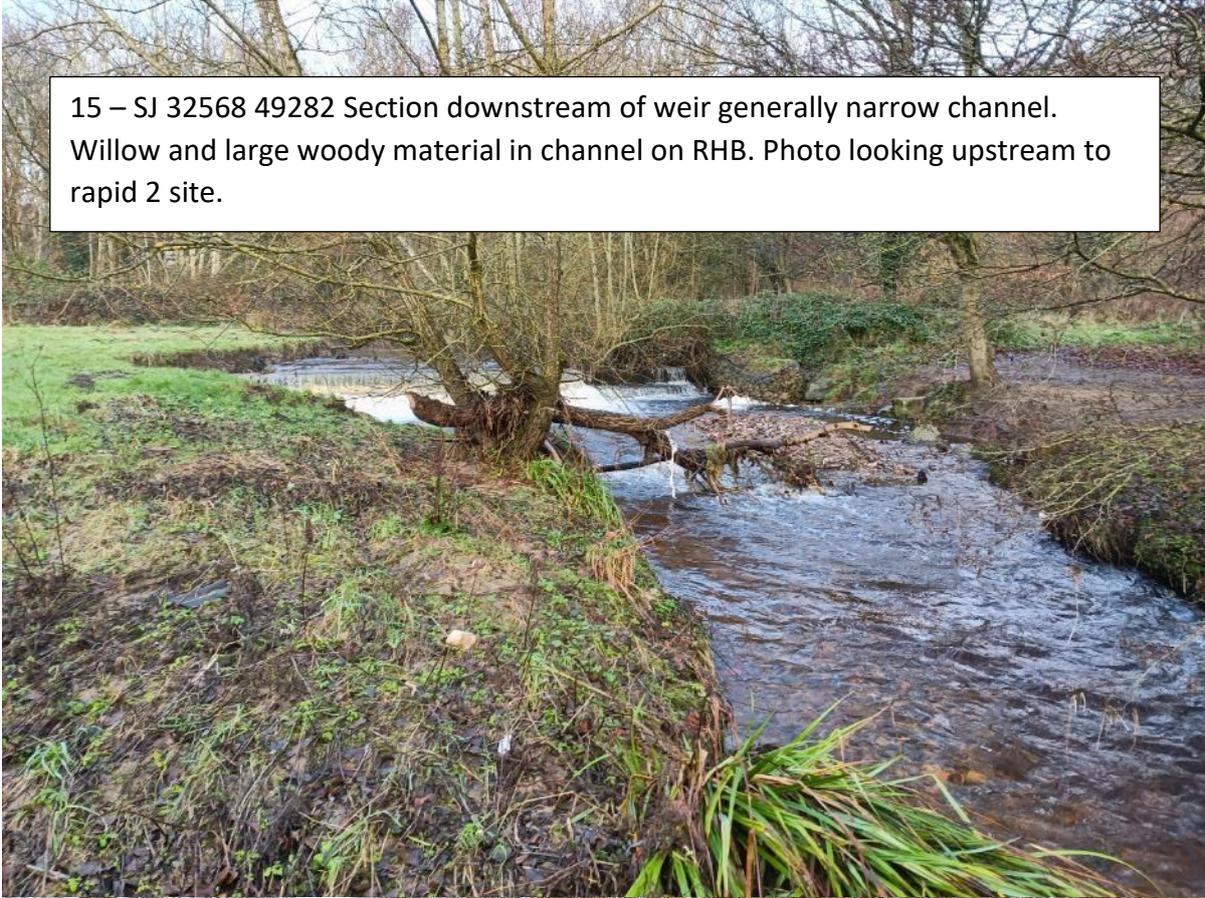
15 – SJ 32568 49282 Section downstream of weir generally narrow channel. Willow and large woody material in channel on RHB. Photo looking upstream to rapid 2 site.

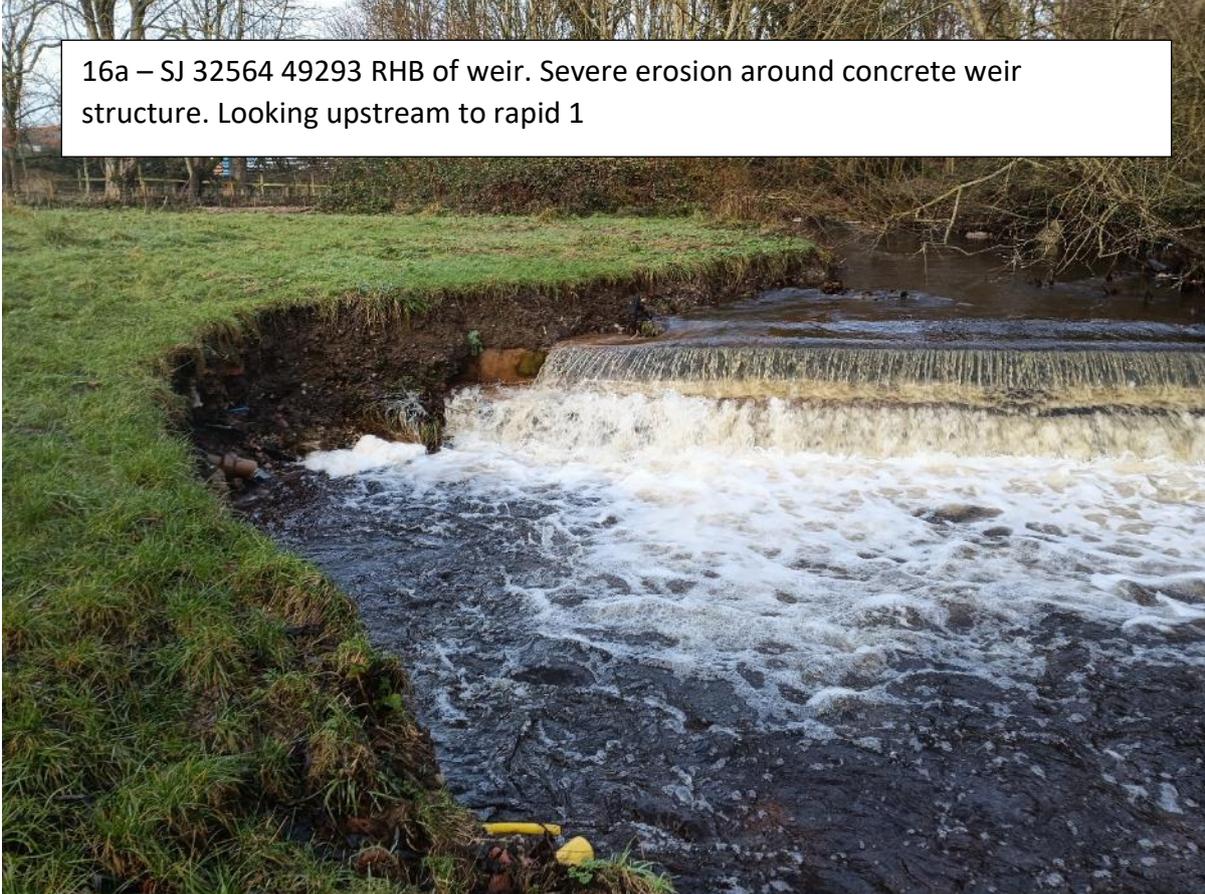
16a – SJ 32564 49293 RHB of weir. Severe erosion around concrete weir structure. Looking upstream to rapid 1

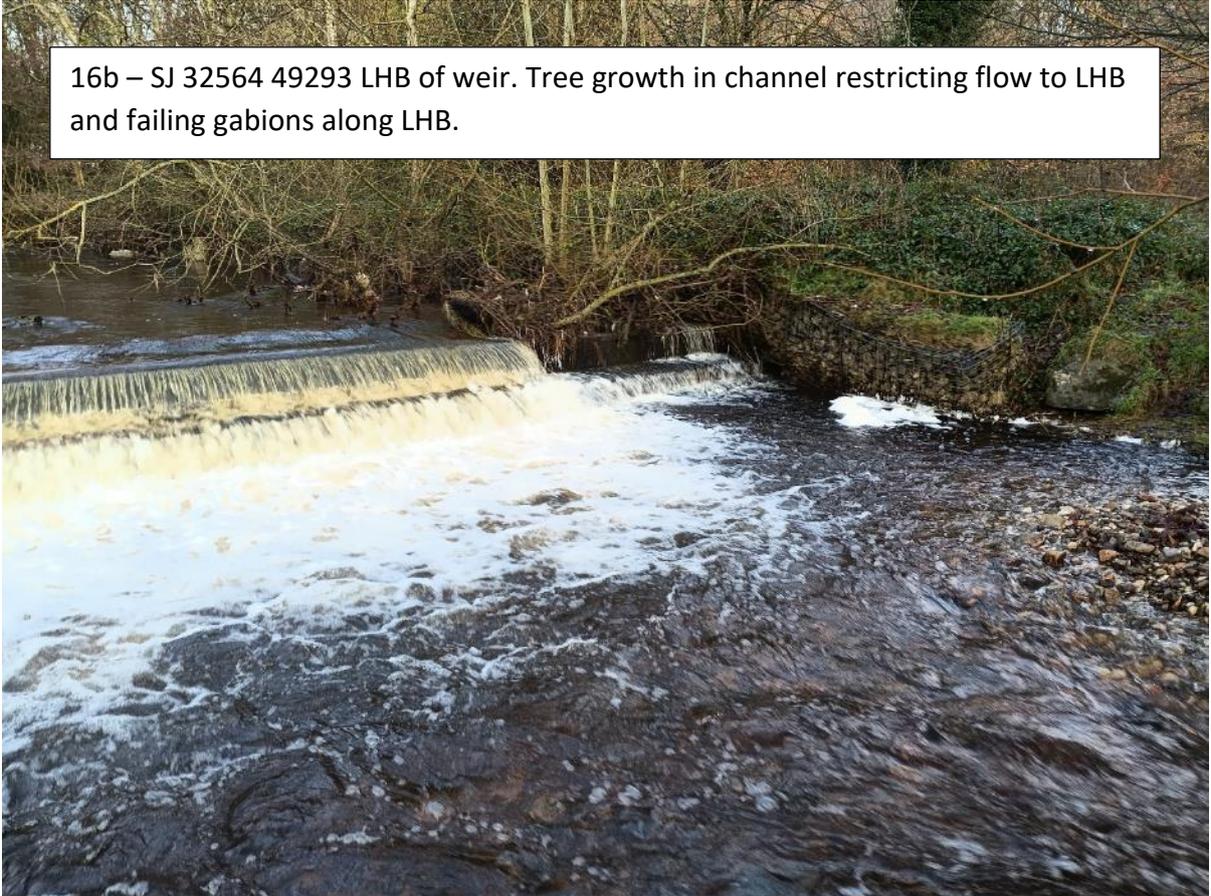
16b – SJ 32564 49293 LHB of weir. Tree growth in channel restricting flow to LHB and failing gabions along LHB.

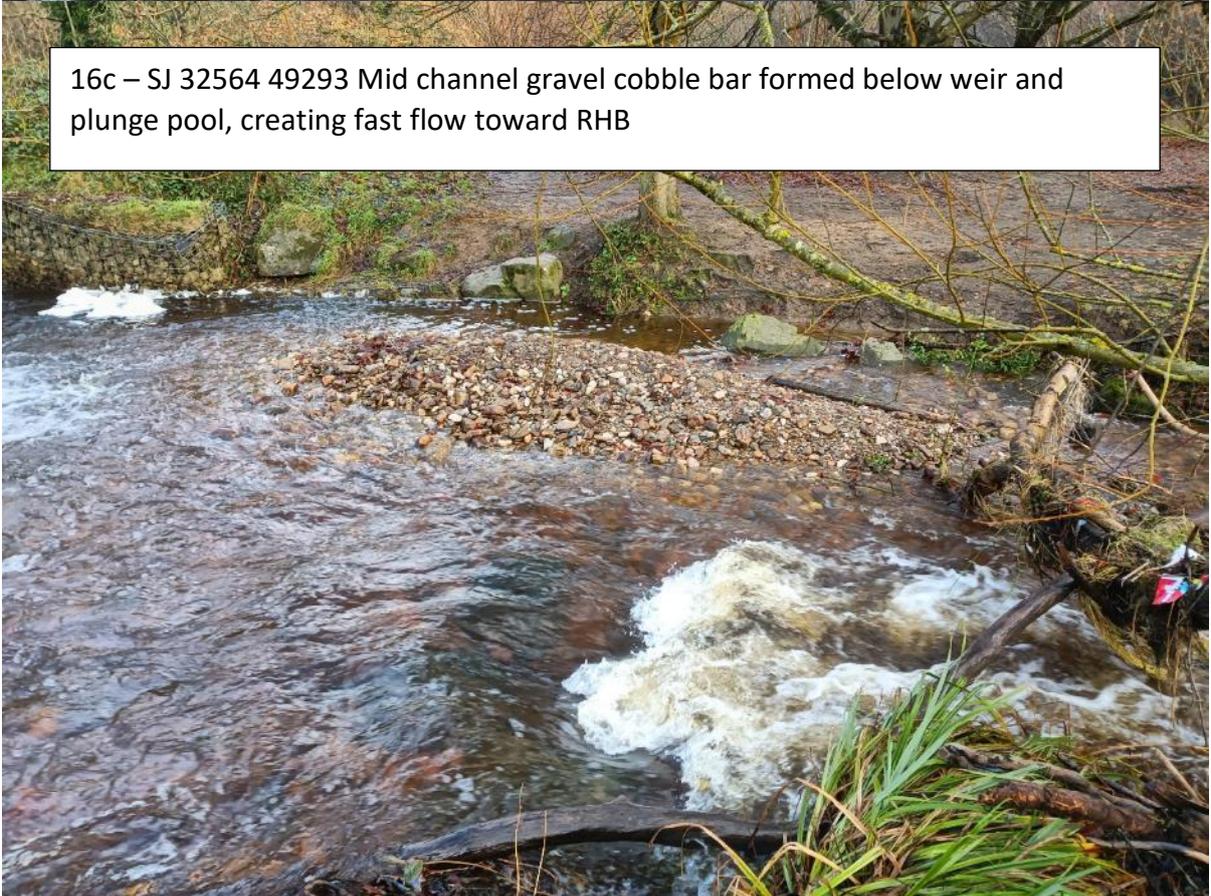
16c – SJ 32564 49293 Mid channel gravel cobble bar formed below weir and plunge pool, creating fast flow toward RHB

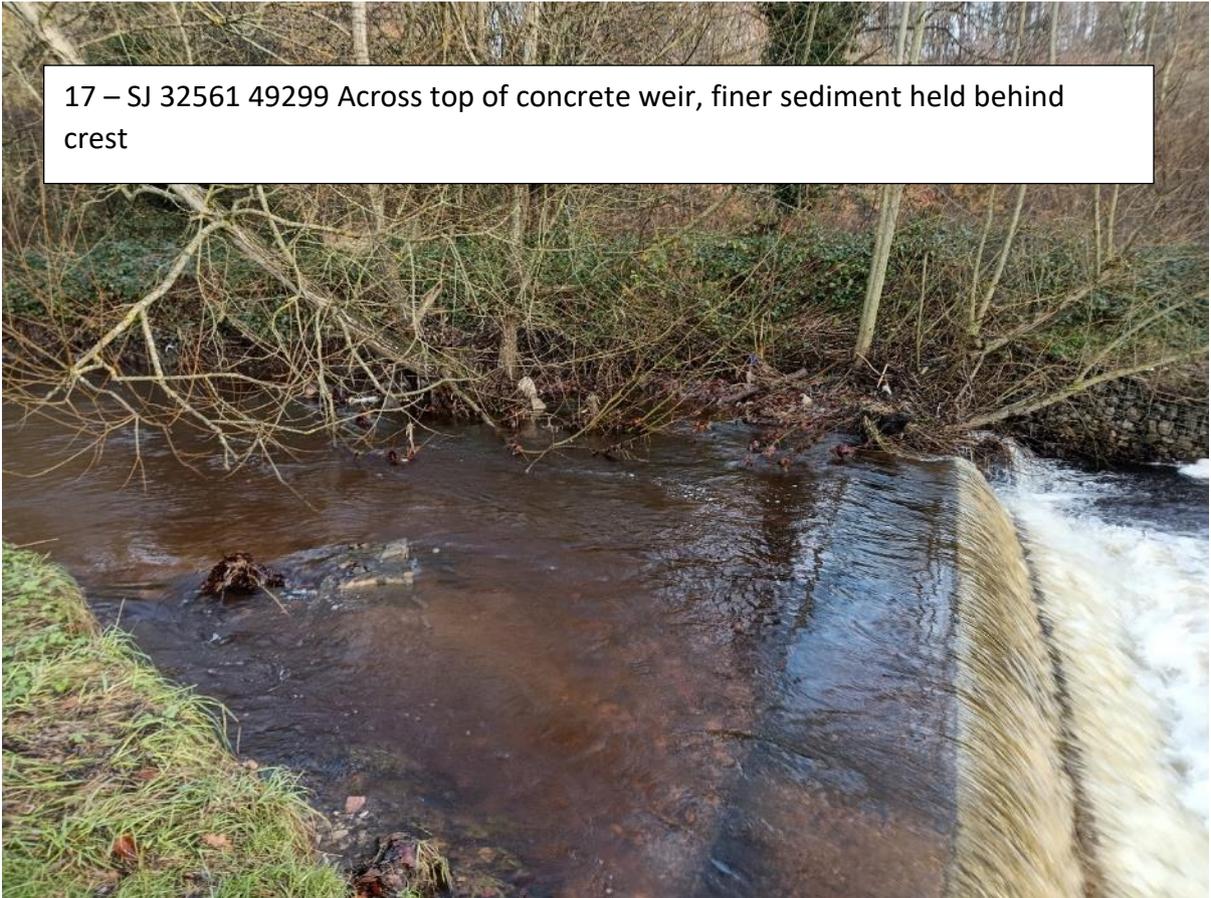
17 – SJ 32561 49299 Across top of concrete weir, finer sediment held behind crest
