Geomorphology survey

River Clywedog – Felin Puleston Weir removal

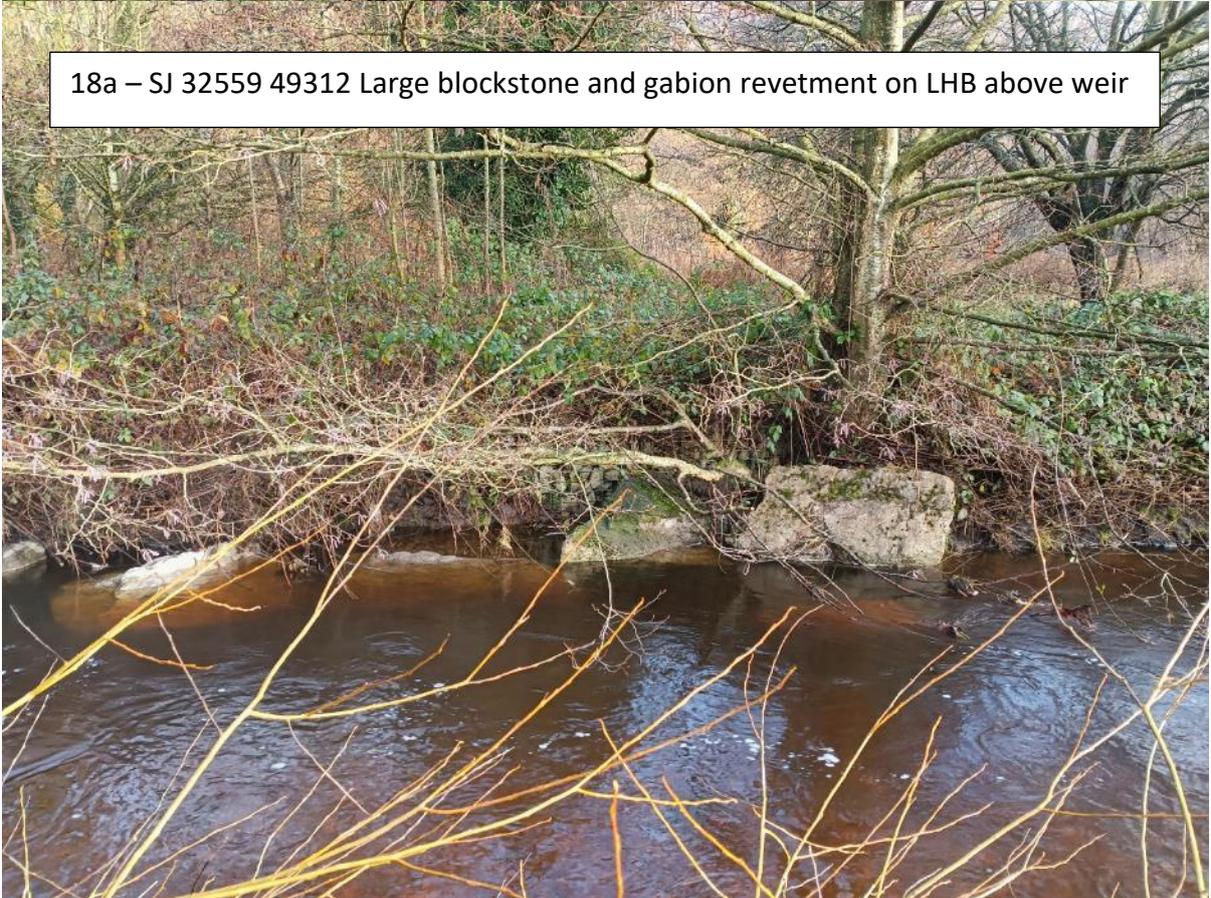
18a – SJ 32559 49312 Large blockstone and gabion revetment on LHB above weir

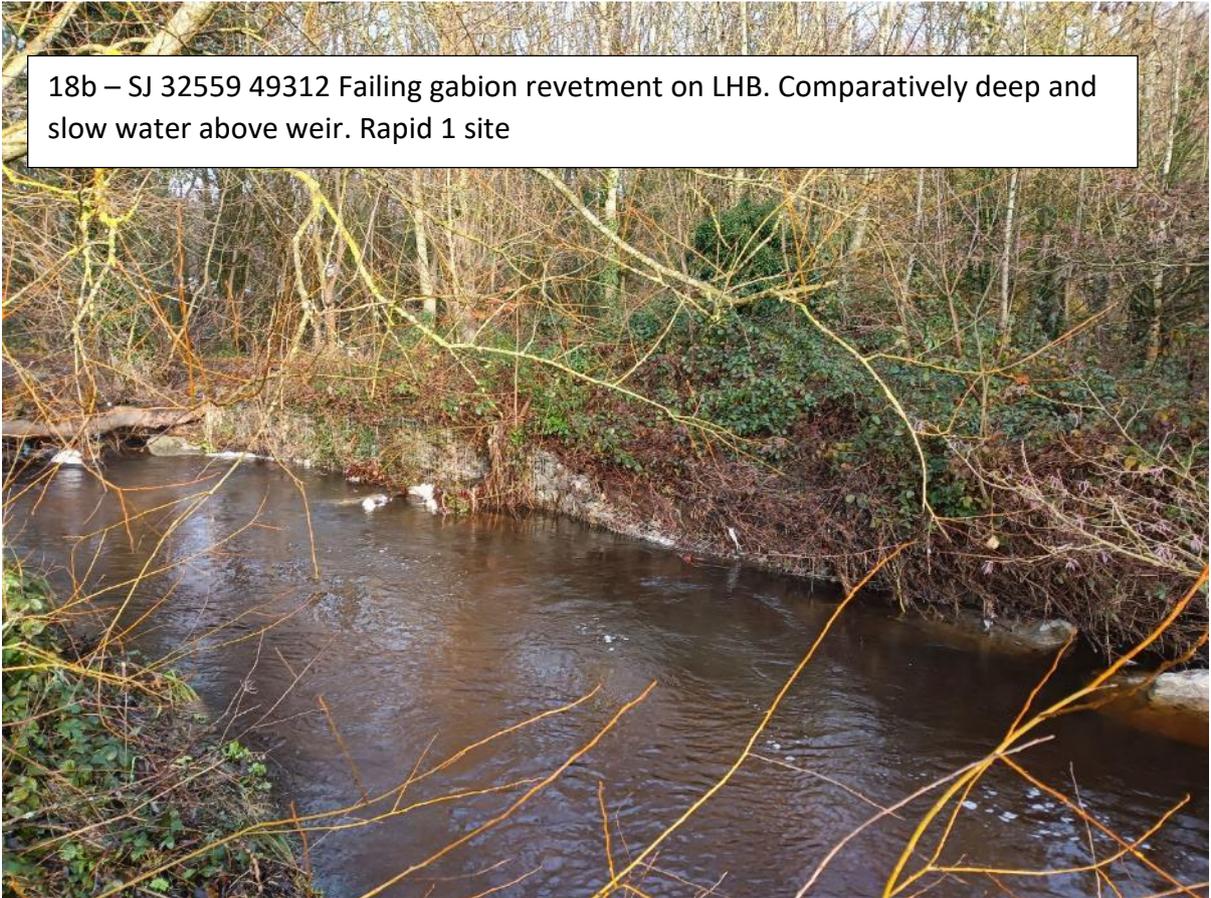
18b – SJ 32559 49312 Failing gabion revetment on LHB. Comparatively deep and slow water above weir. Rapid 1 site

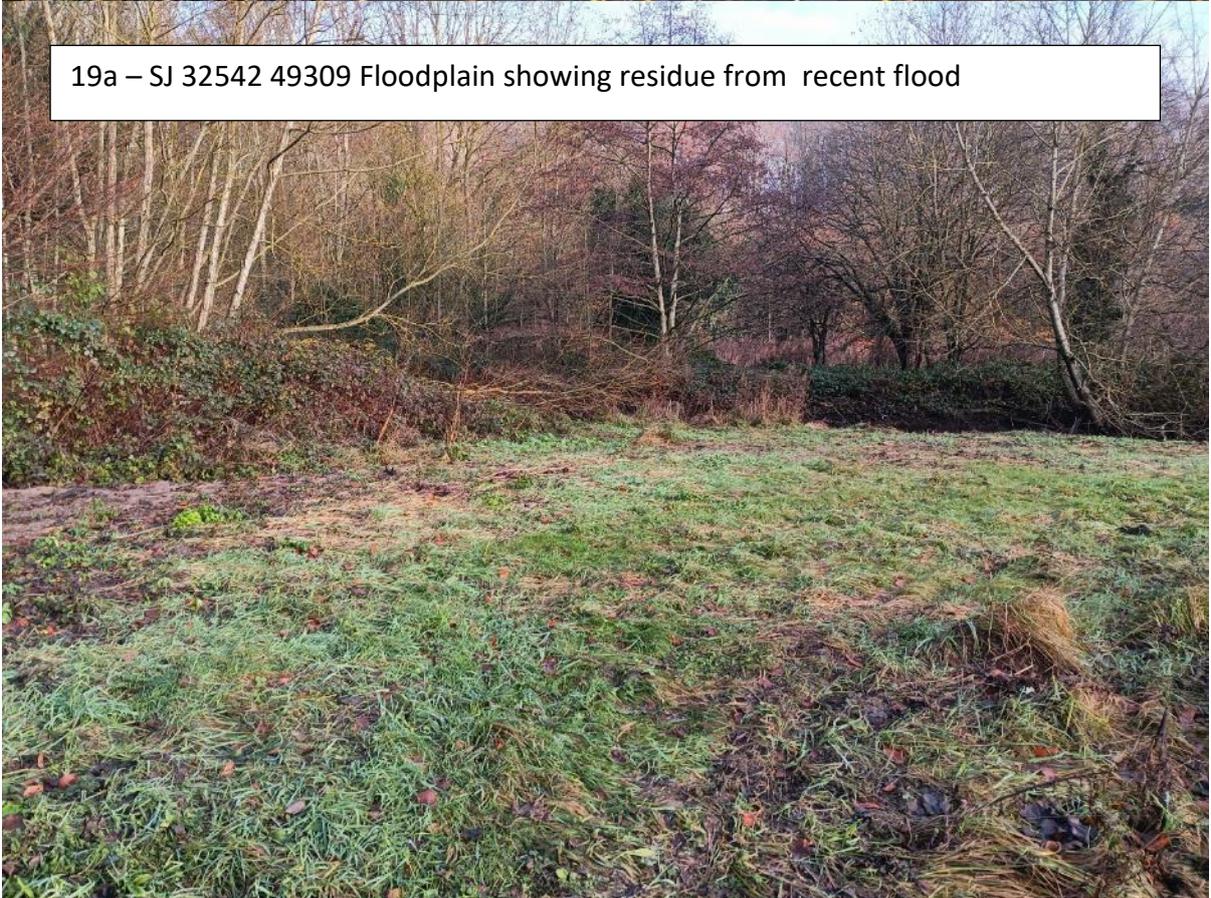
19a – SJ 32542 49309 Floodplain showing residue from recent flood

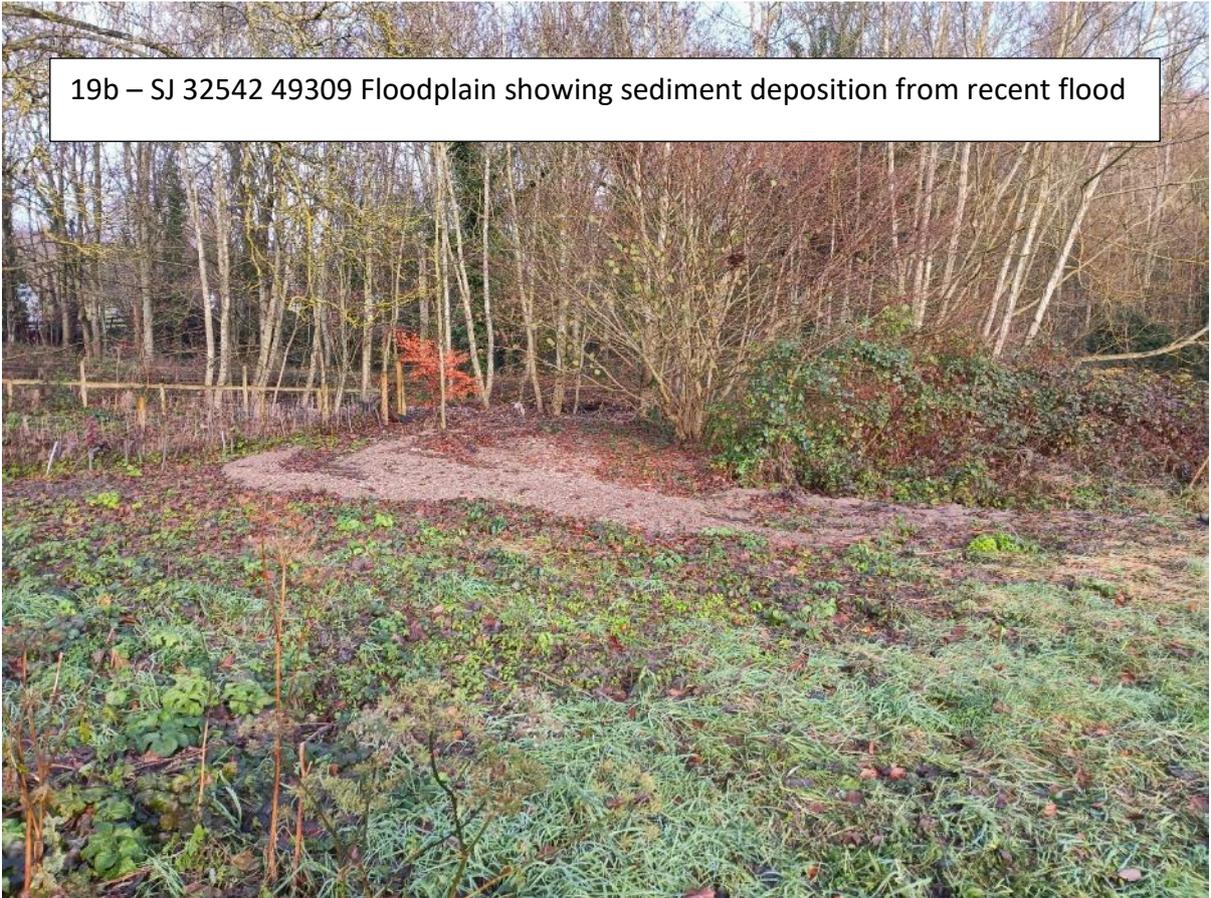
19b – SJ 32542 49309 Floodplain showing sediment deposition from recent flood

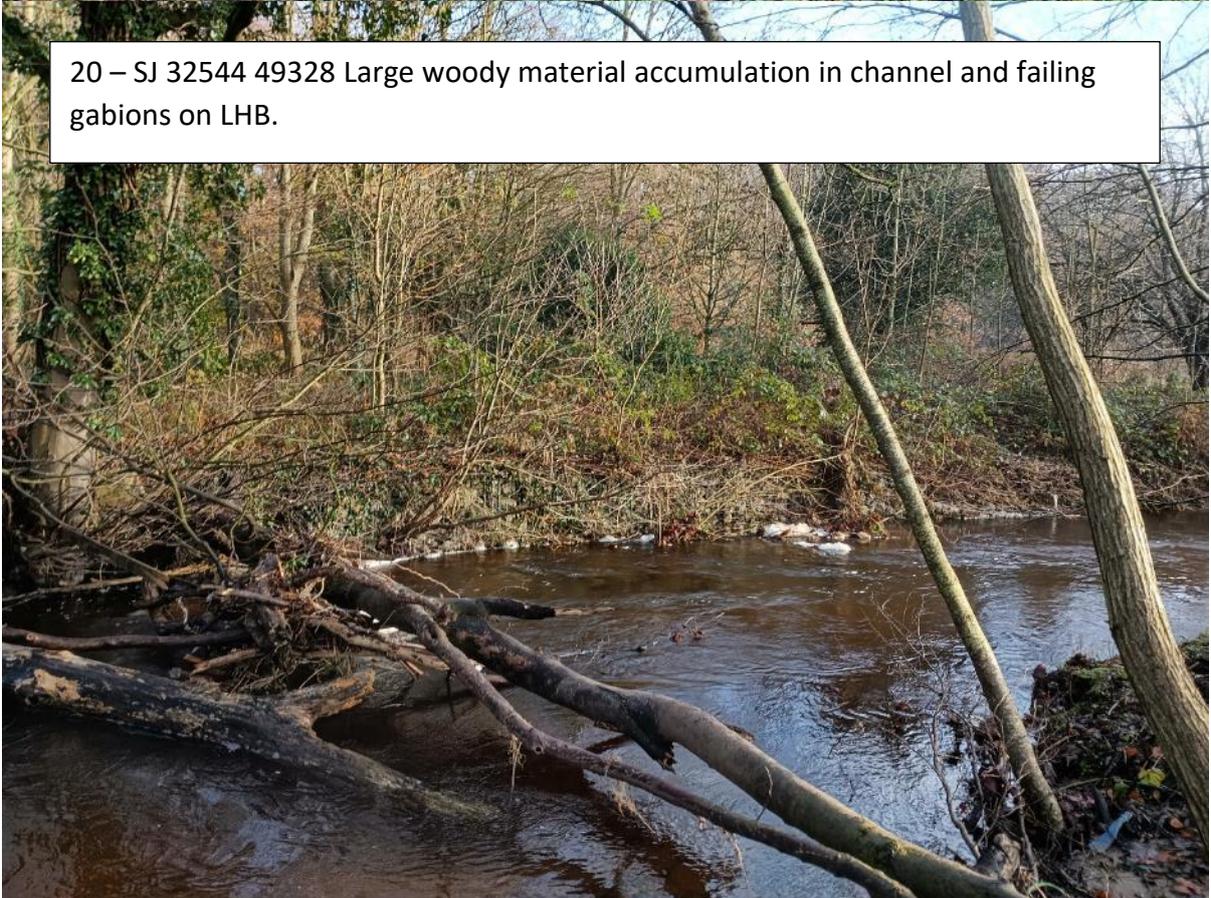
20 – SJ 32544 49328 Large woody material accumulation in channel and failing gabions on LHB.

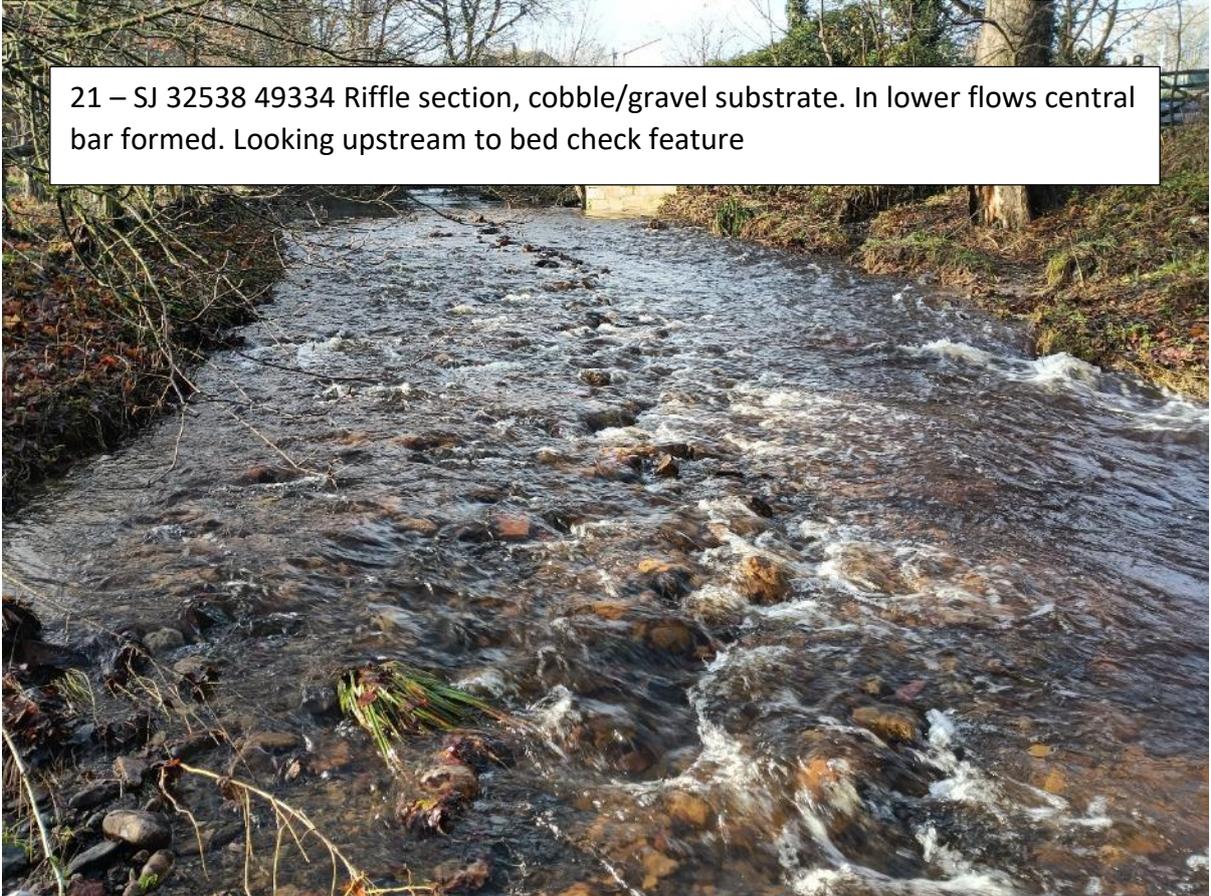
21 – SJ 32538 49334 Riffle section, cobble/gravel substrate. In lower flows central bar formed. Looking upstream to bed check feature

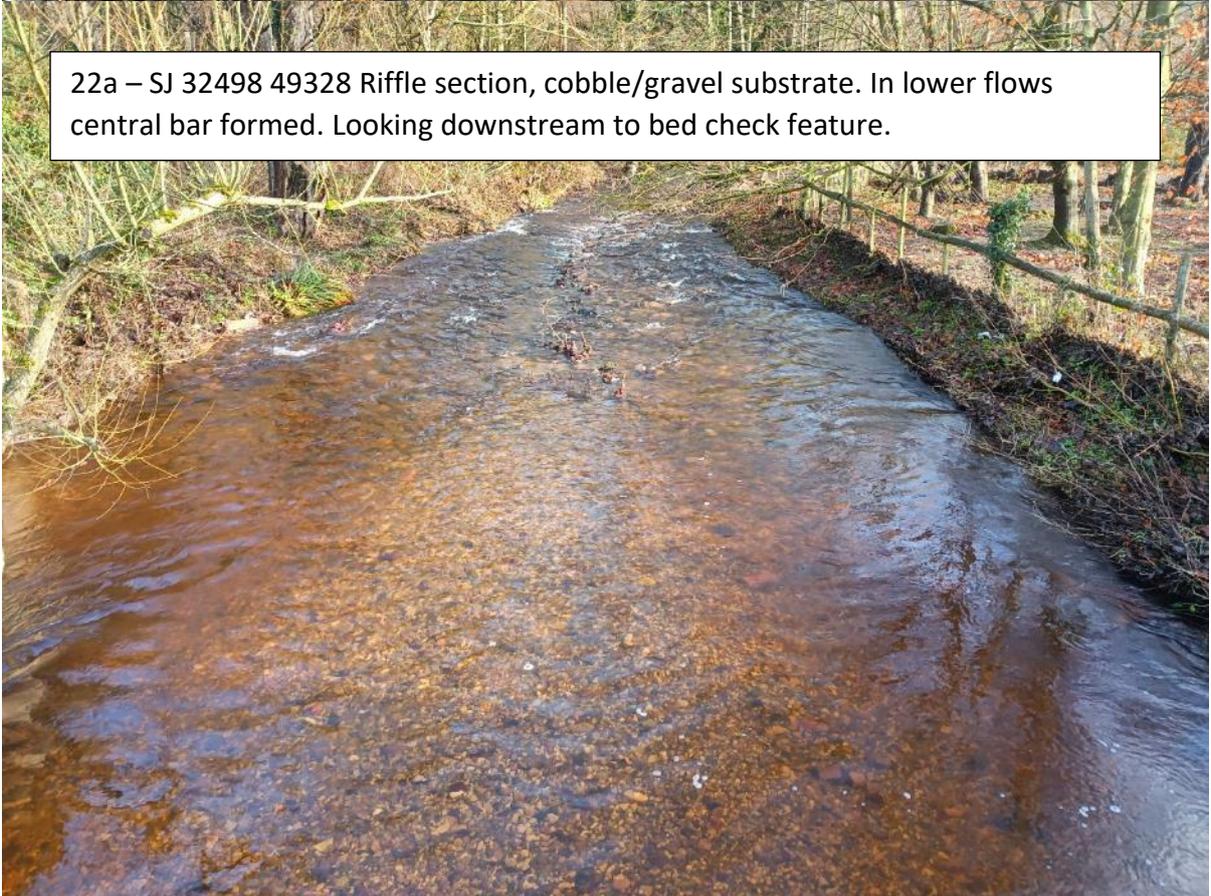
22a – SJ 32498 49328 Riffle section, cobble/gravel substrate. In lower flows central bar formed. Looking downstream to bed check feature.

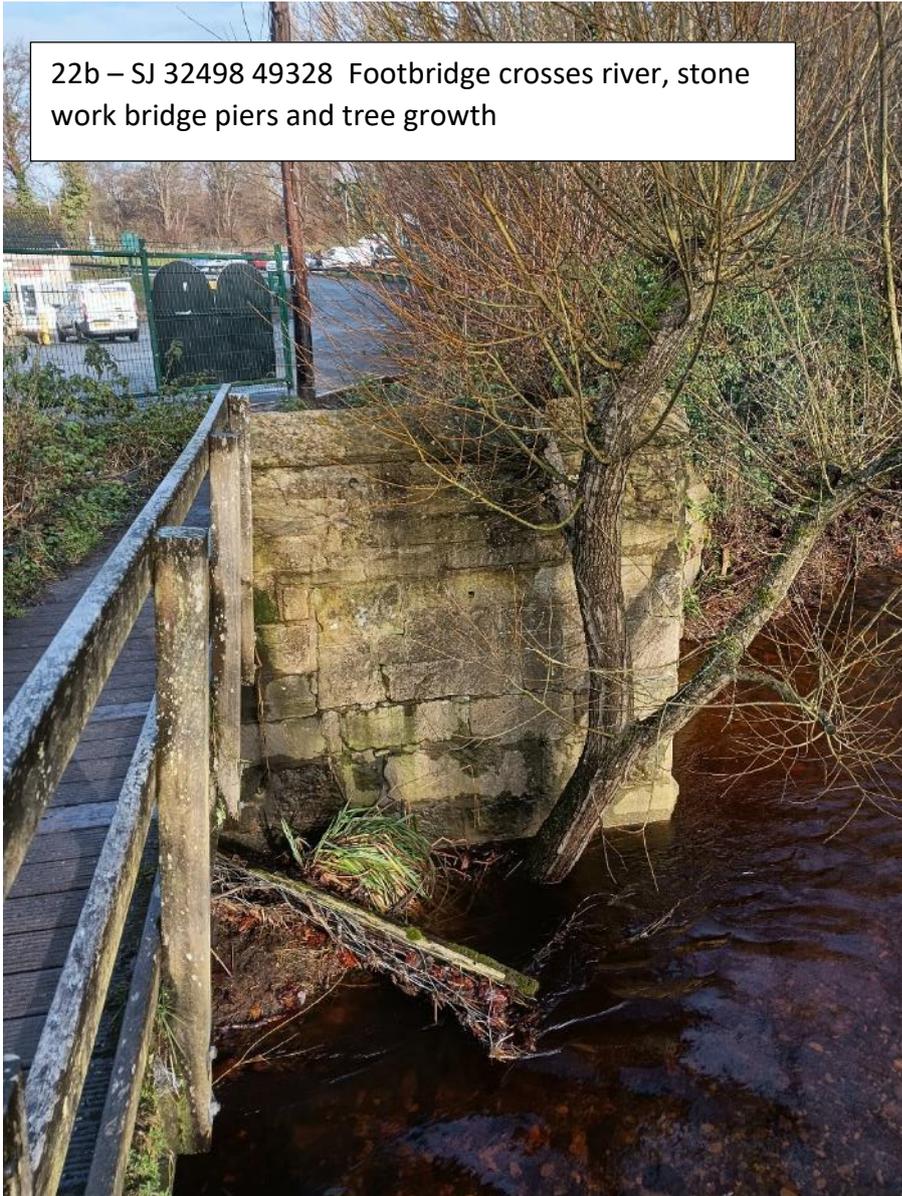
22b – SJ 32498 49328 Footbridge crosses river, stone work bridge piers and tree growth

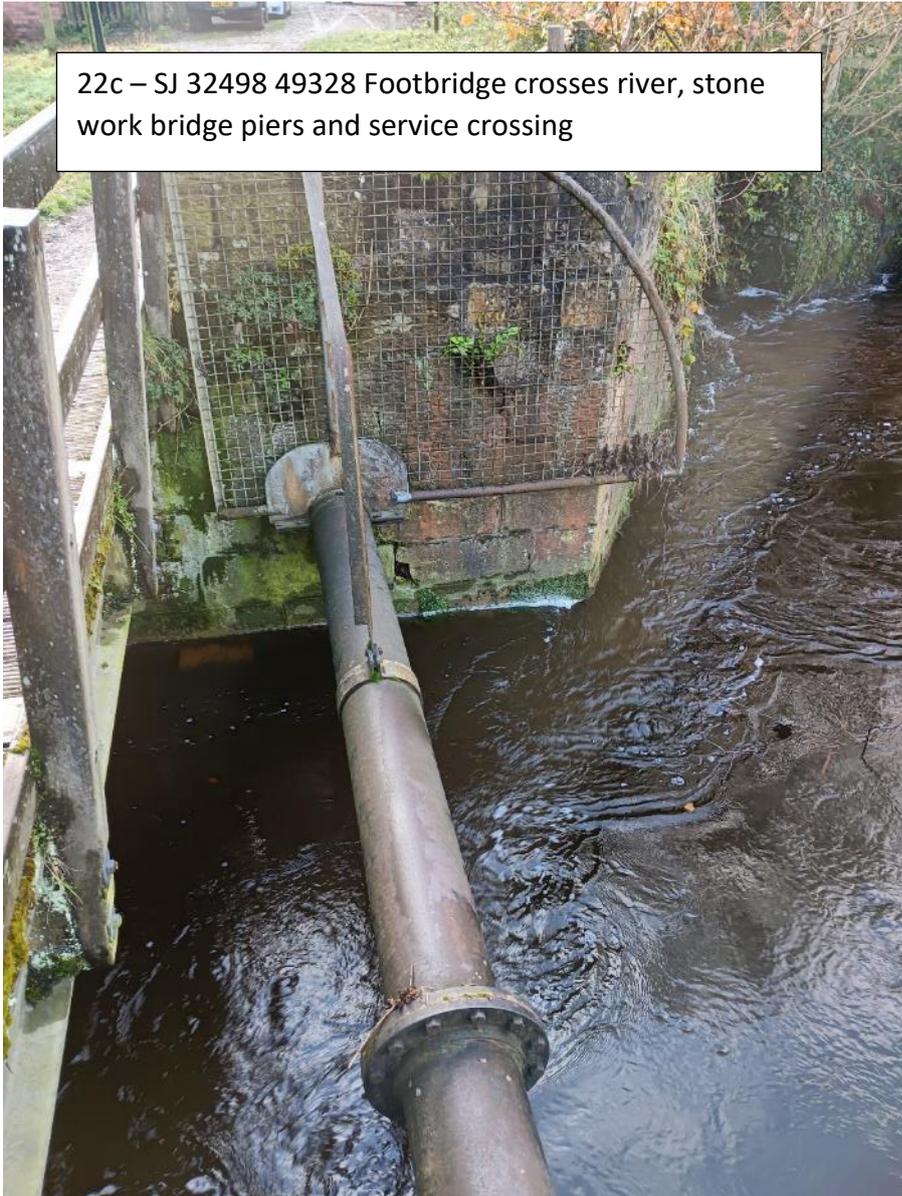
22c – SJ 32498 49328 Footbridge crosses river, stone work bridge piers and service crossing

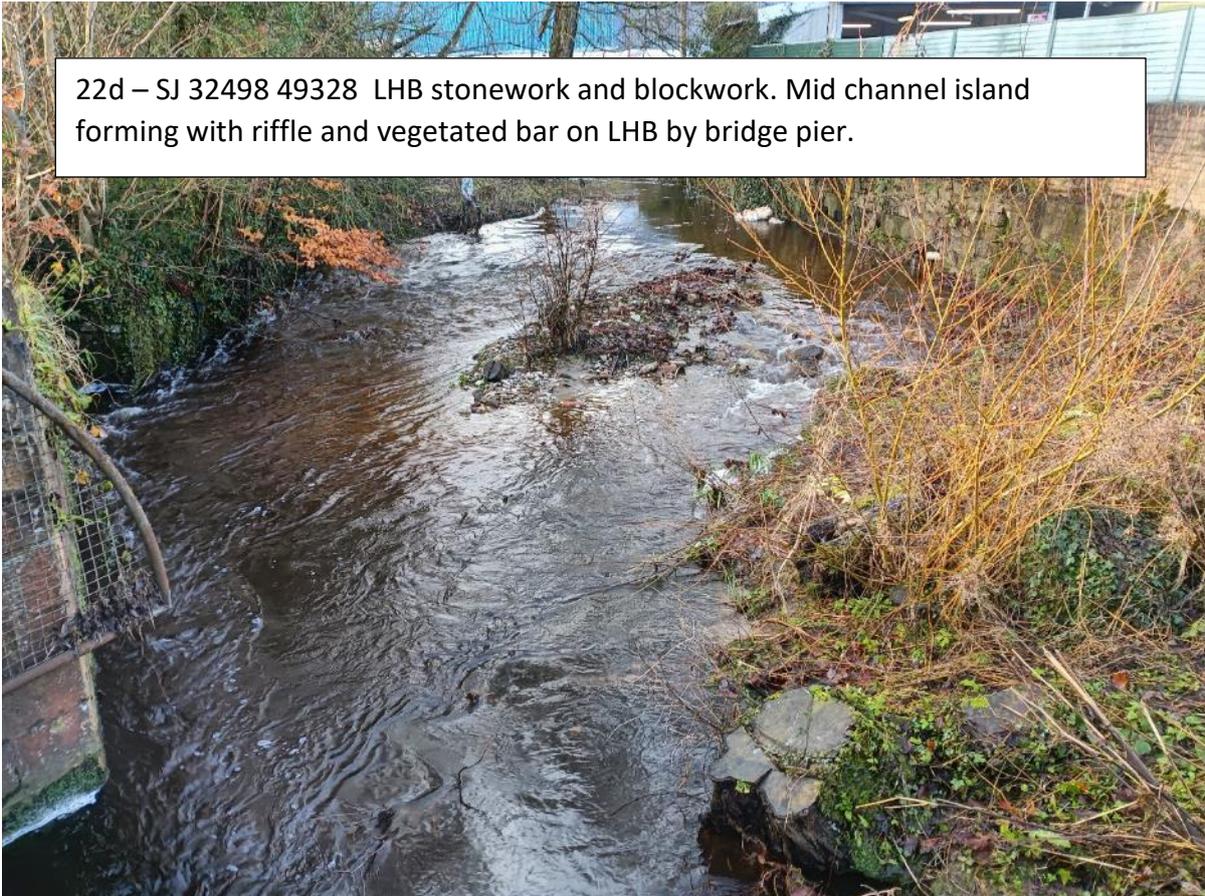
22d – SJ 32498 49328 LHB stonework and blockwork. Mid channel island forming with riffle and vegetated bar on LHB by bridge pier.

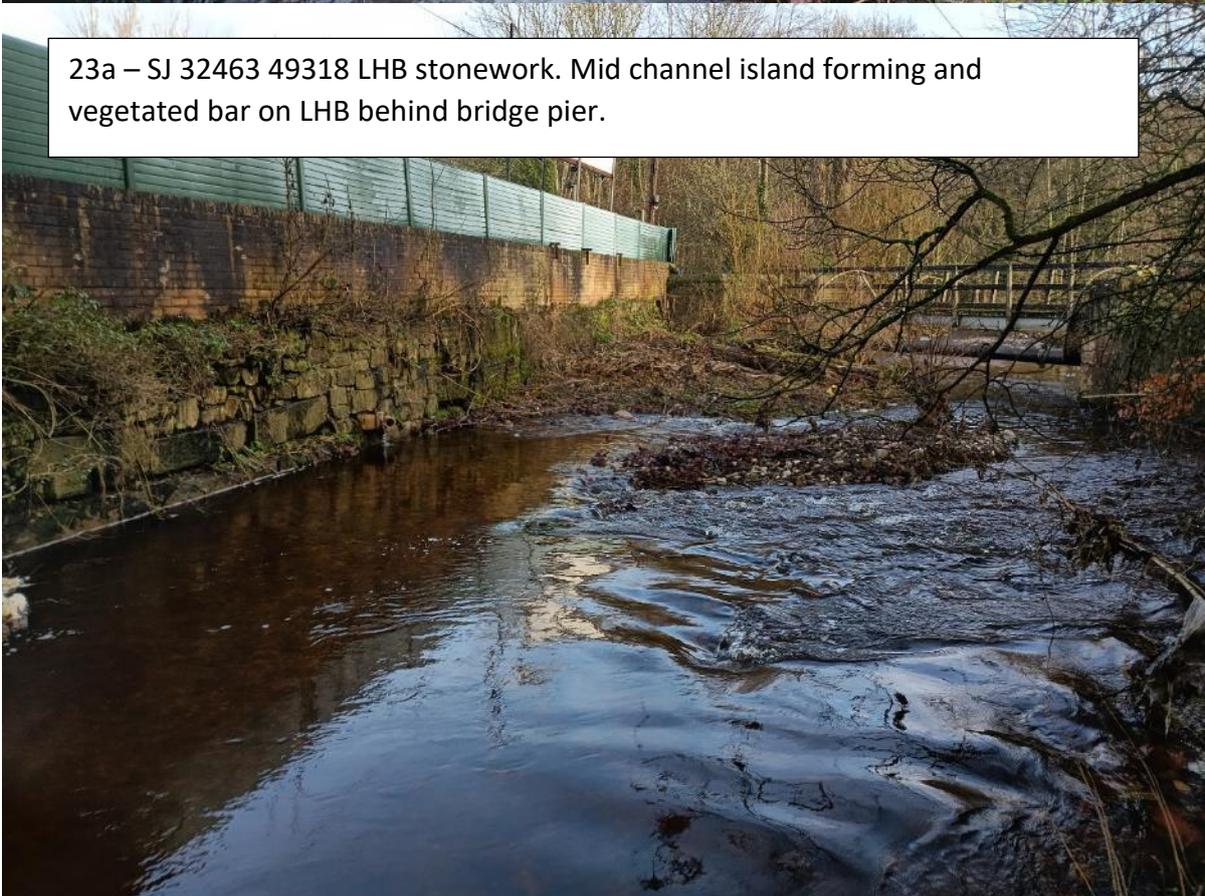
23a – SJ 32463 49318 LHB stonework. Mid channel island forming and vegetated bar on LHB behind bridge pier.

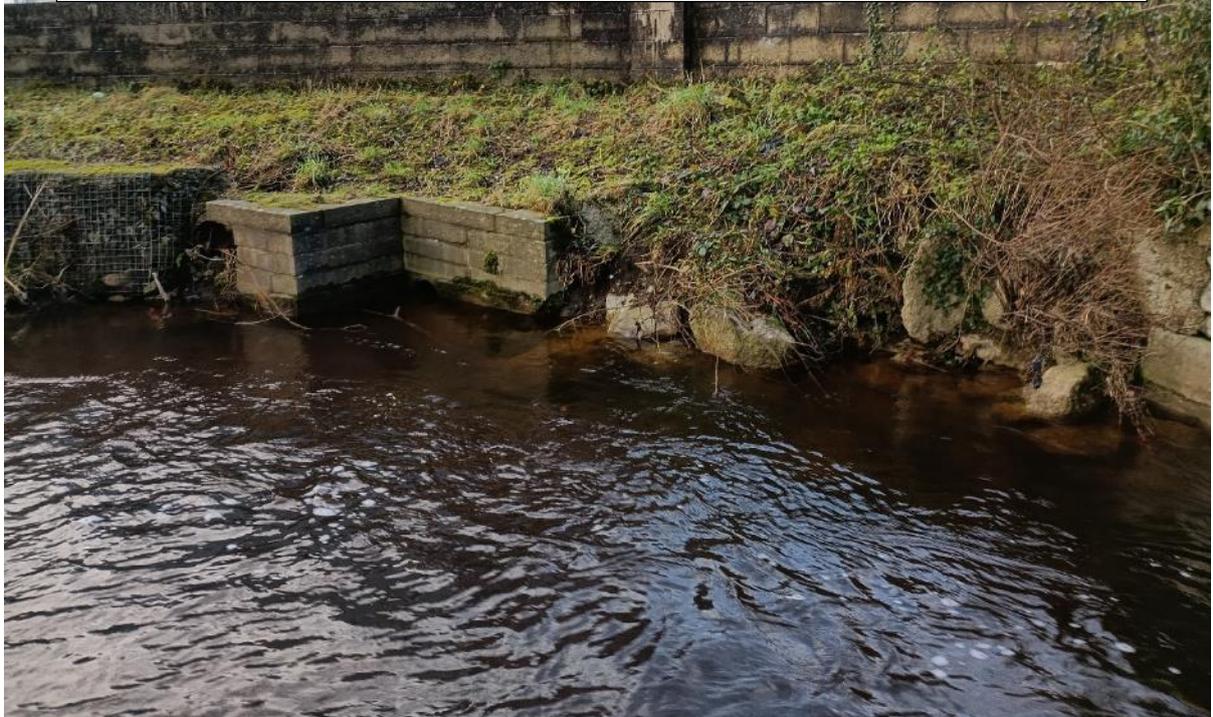
23b – SJ 32463 49318 LHB brickwork and failed stonework and gabions protecting industrial estate. River fairly deep and slow

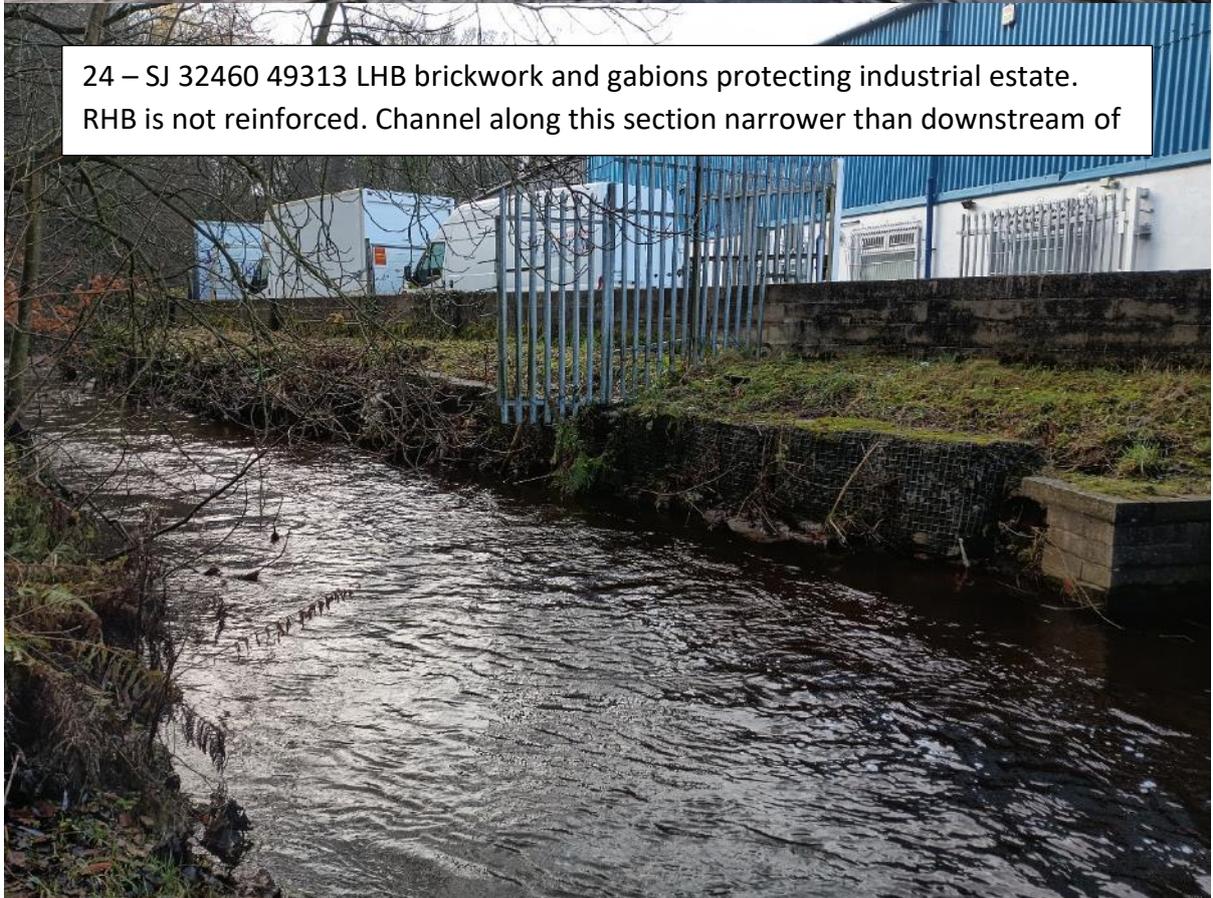
24 – SJ 32460 49313 LHB brickwork and gabions protecting industrial estate. RHB is not reinforced. Channel along this section narrower than downstream of

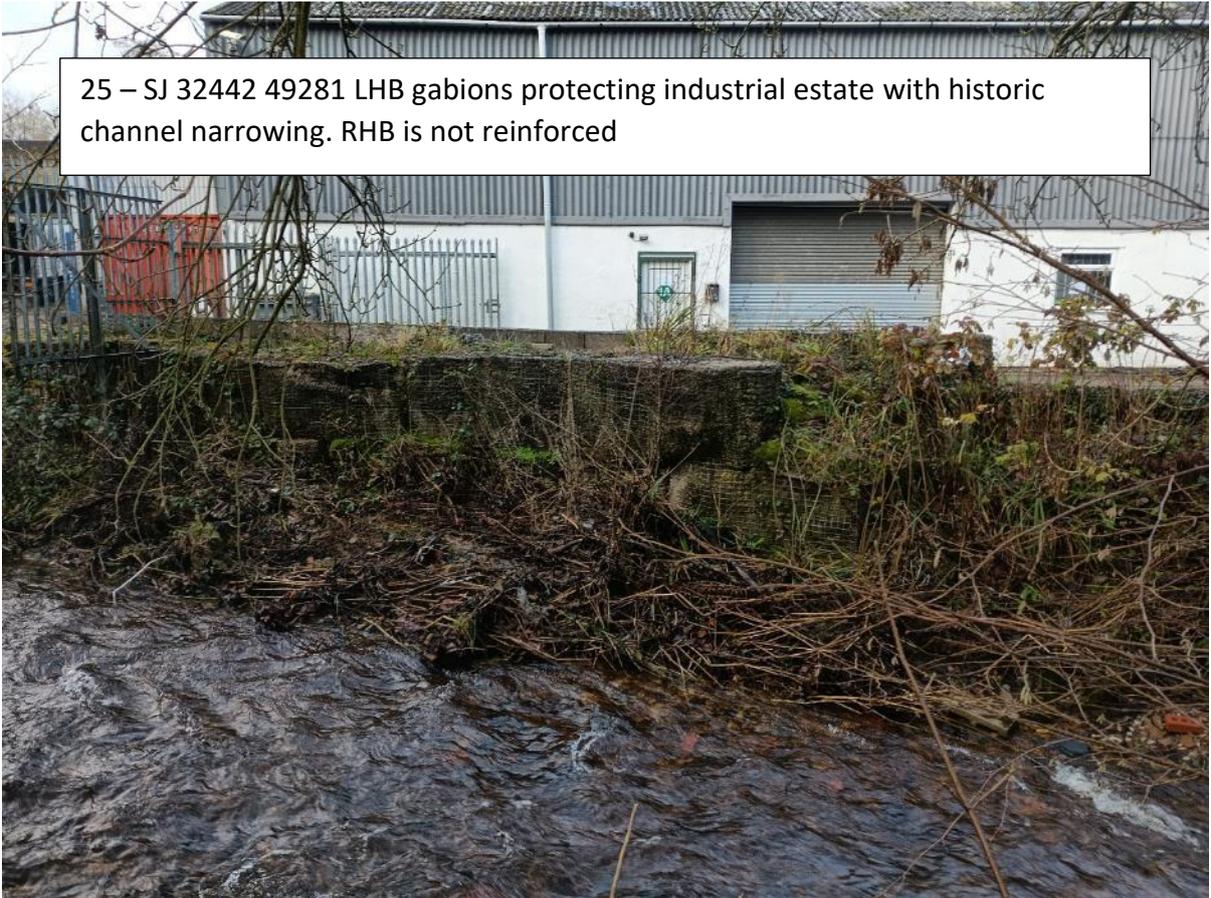
25 – SJ 32442 49281 LHB gabions protecting industrial estate with historic channel narrowing. RHB is not reinforced

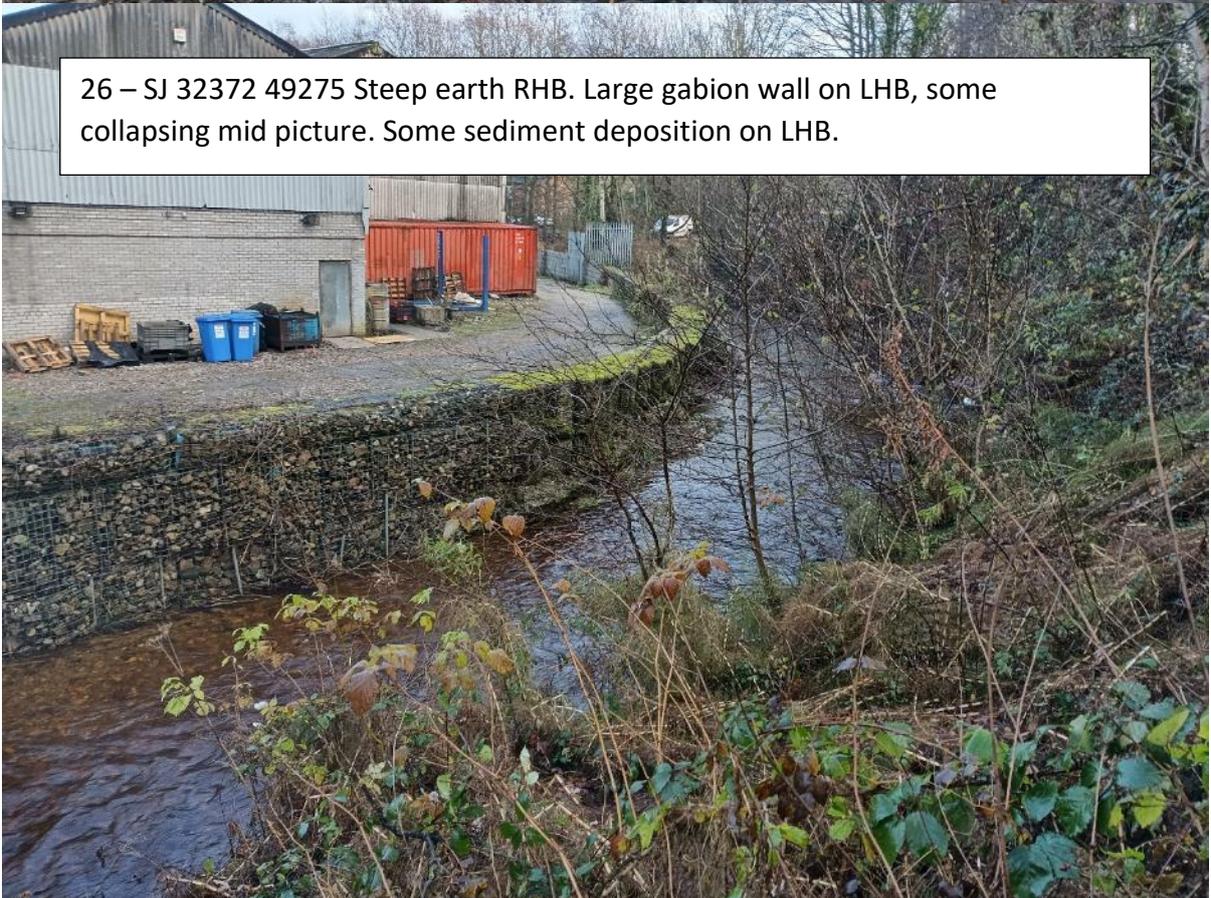
26 – SJ 32372 49275 Steep earth RHB. Large gabion wall on LHB, some collapsing mid picture. Some sediment deposition on LHB.

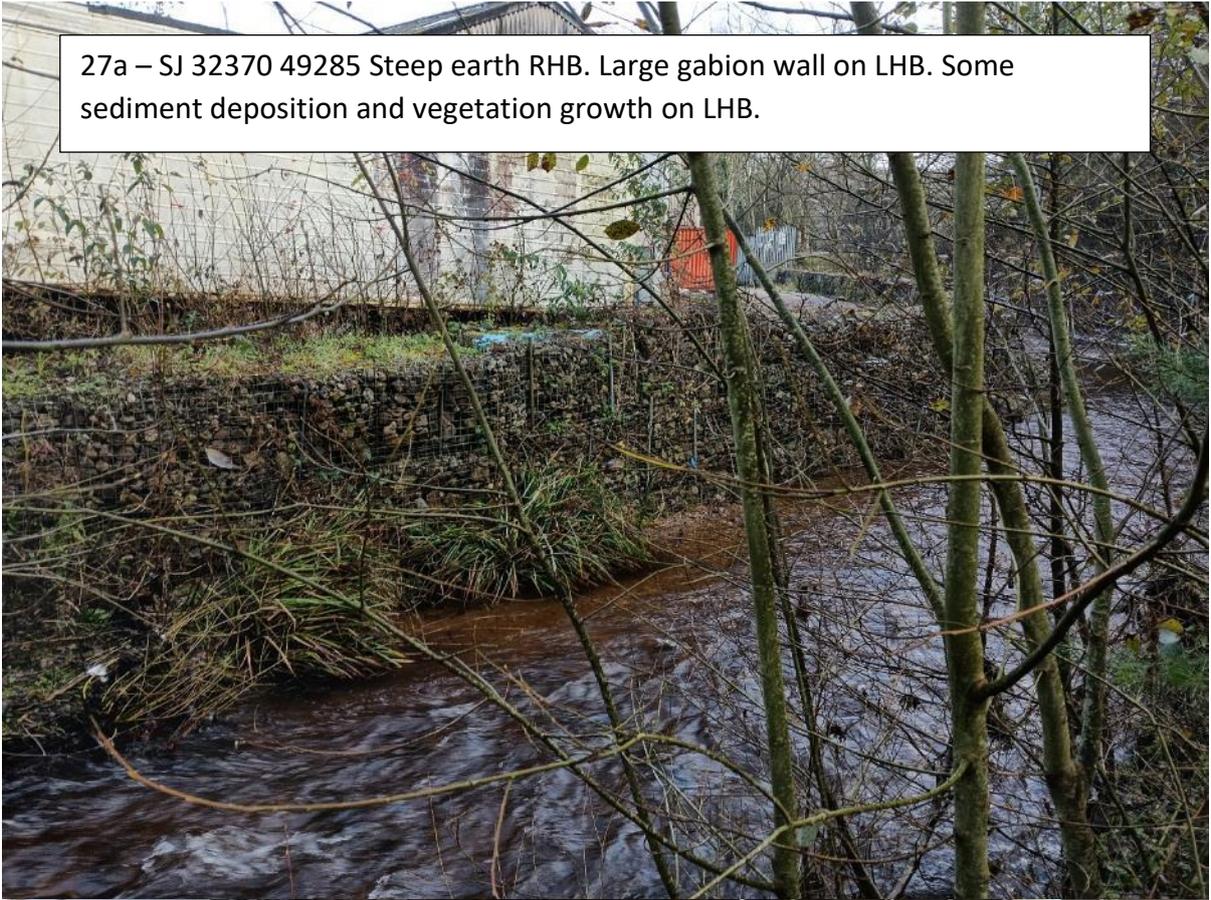
27a – SJ 32370 49285 Steep earth RHB. Large gabion wall on LHB. Some sediment deposition and vegetation growth on LHB.

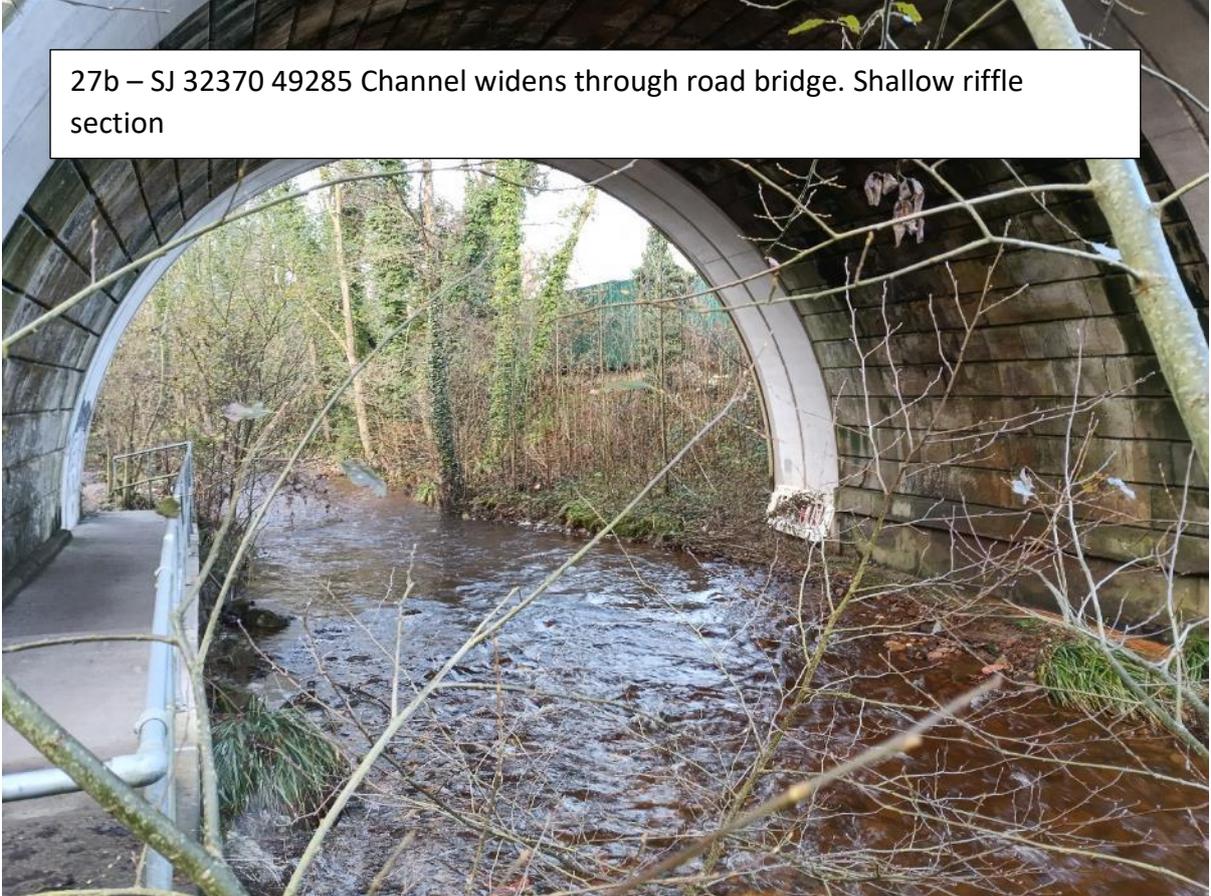
27b – SJ 32370 49285 Channel widens through road bridge. Shallow riffle section

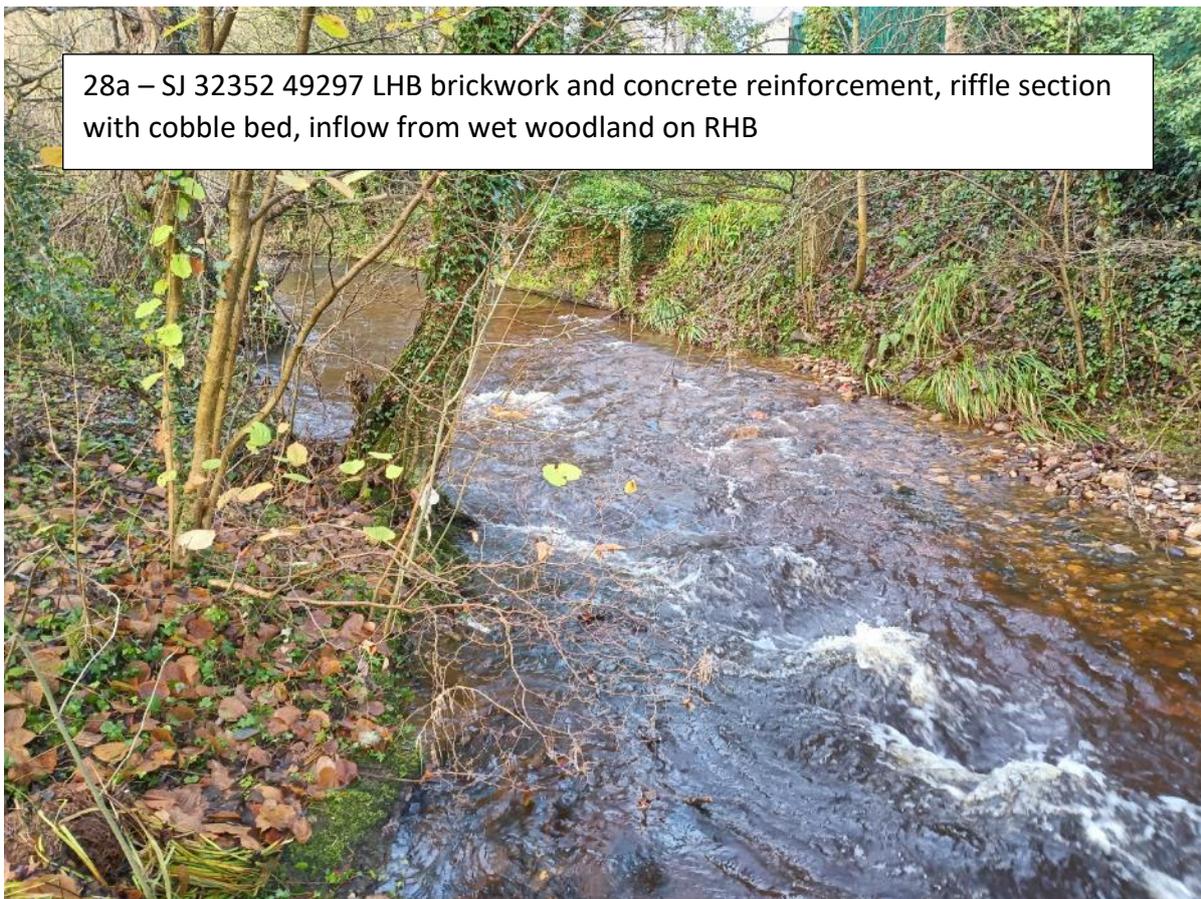
28a – SJ 32352 49297 LHB brickwork and concrete reinforcement, riffle section with cobble bed, inflow from wet woodland on RHB

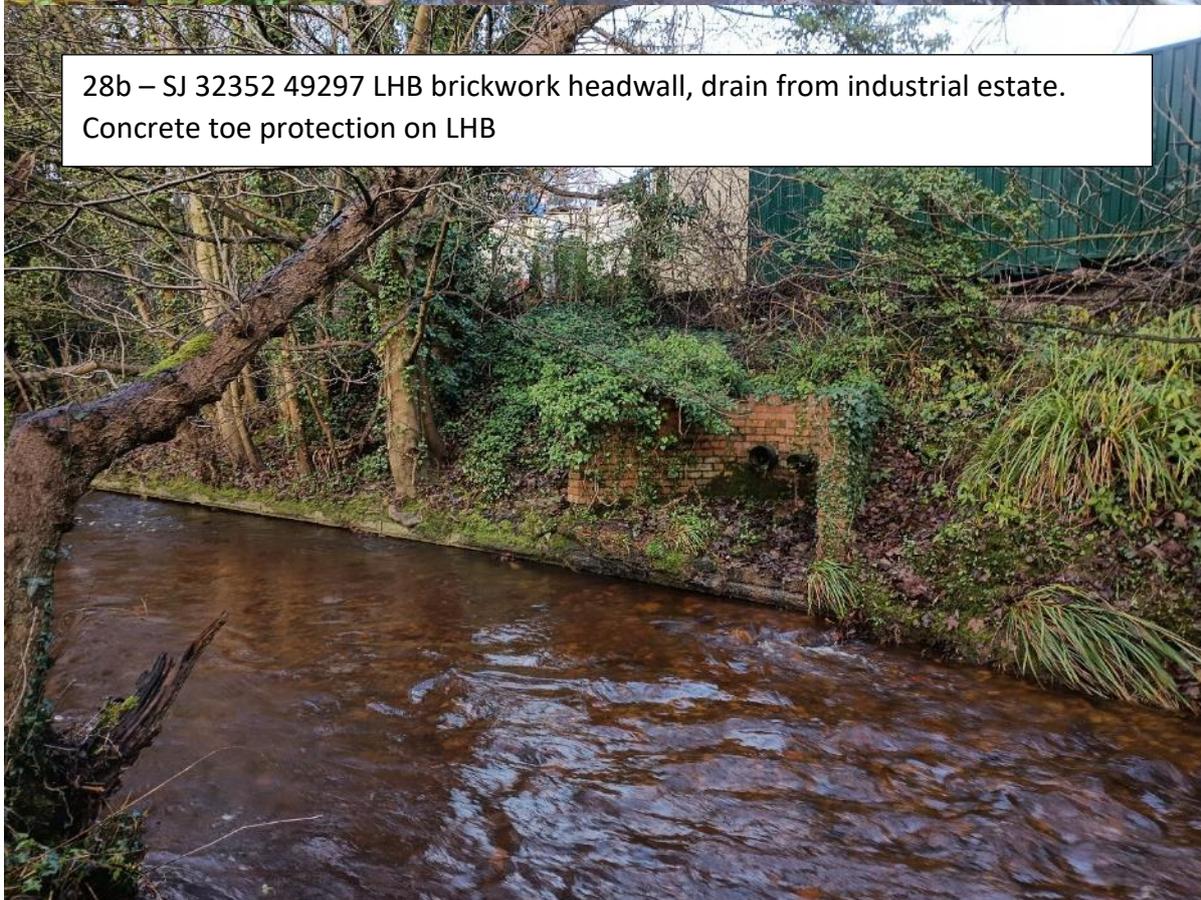
28b – SJ 32352 49297 LHB brickwork headwall, drain from industrial estate. Concrete toe protection on LHB

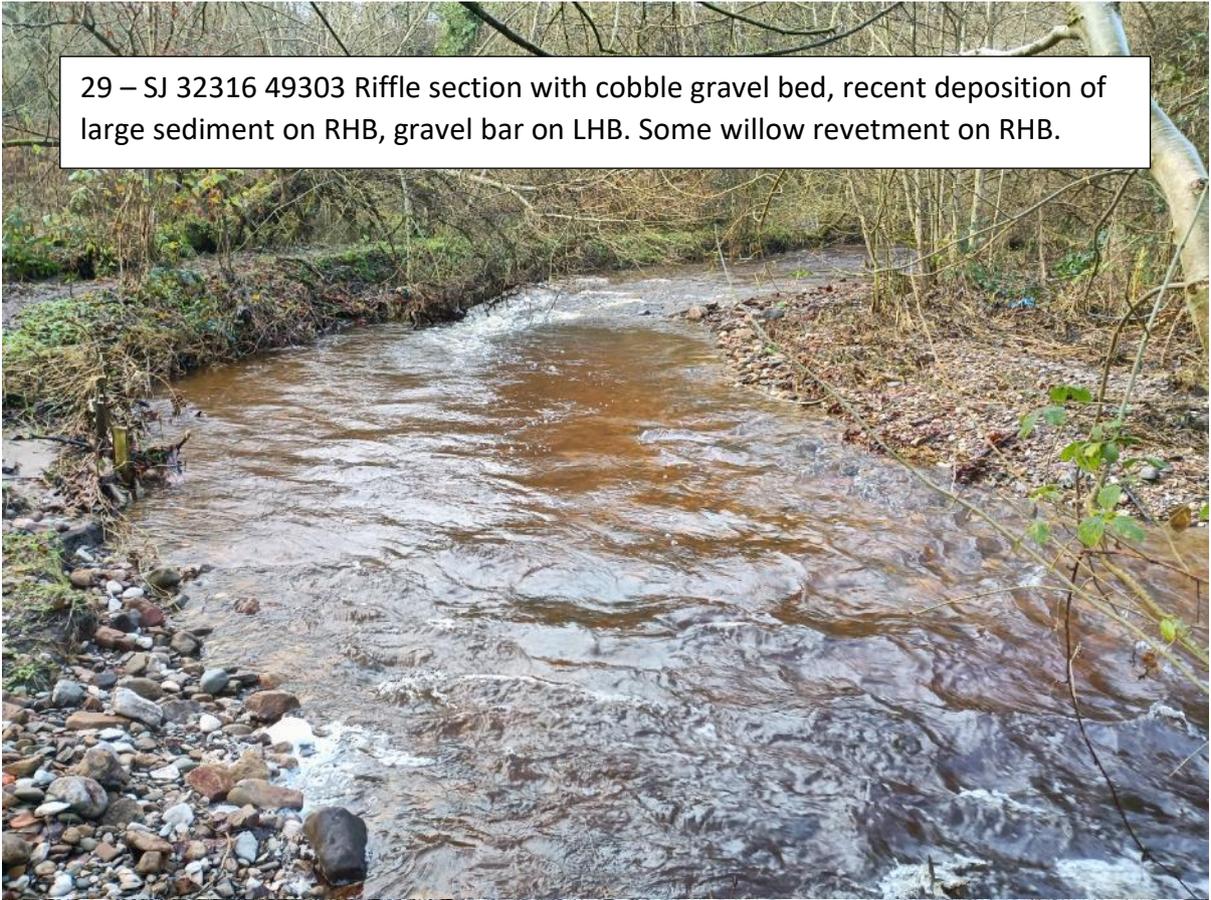
29 – SJ 32316 49303 Riffle section with cobble gravel bed, recent deposition of large sediment on RHB, gravel bar on LHB. Some willow revetment on RHB.

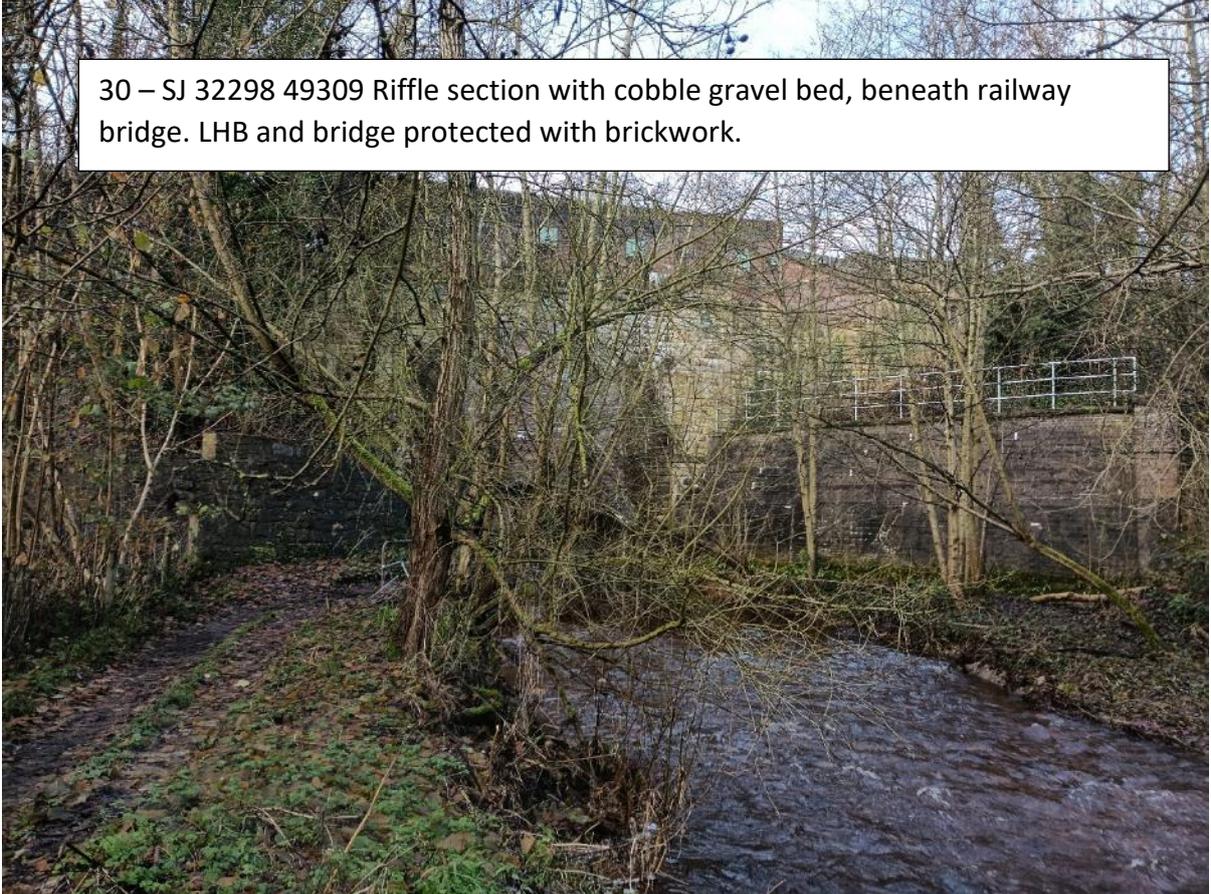
30 – SJ 32298 49309 Riffle section with cobble gravel bed, beneath railway bridge. LHB and bridge protected with brickwork.
