Geomorphology survey

River Clywedog – Felin Puleston Weir removal

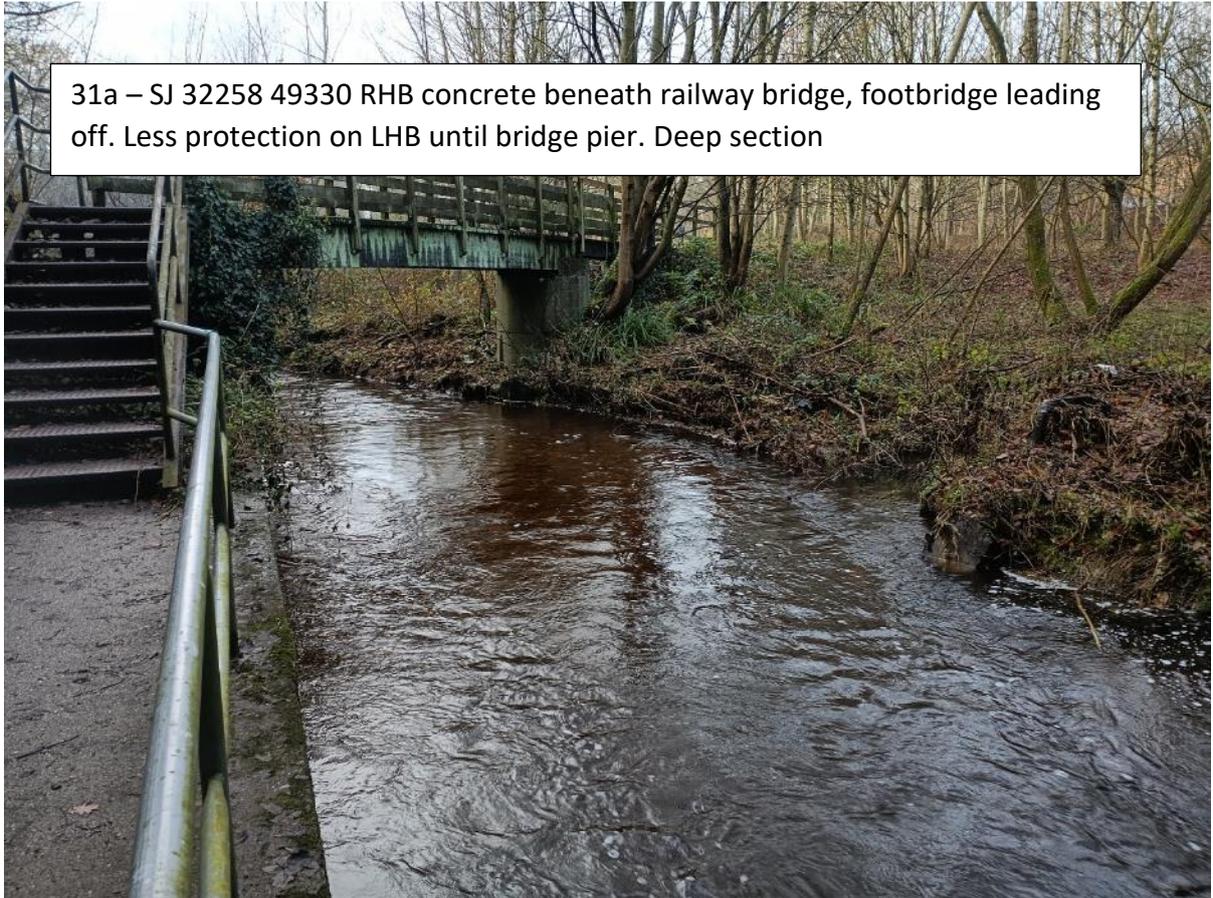
31a – SJ 32258 49330 RHB concrete beneath railway bridge, footbridge leading off. Less protection on LHB until bridge pier. Deep section

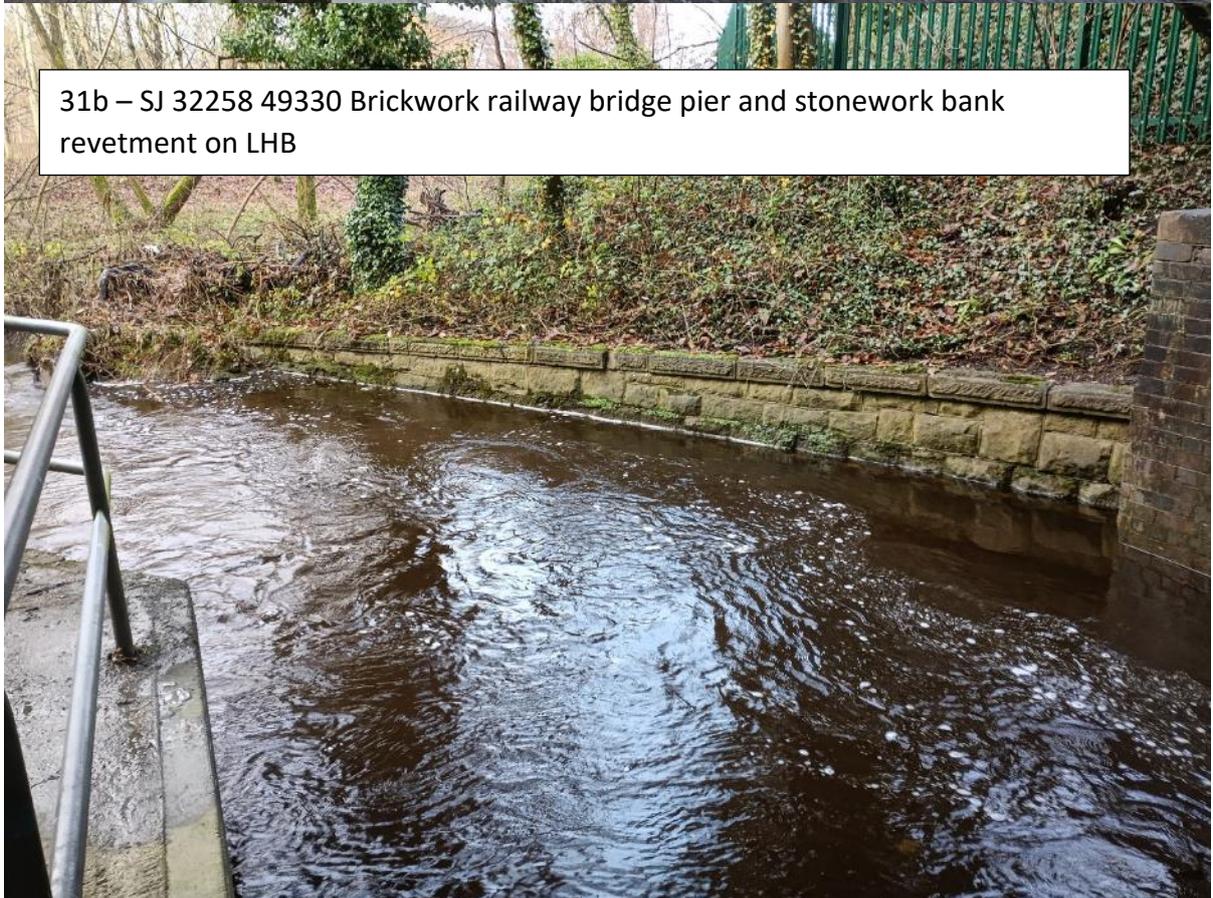
31b – SJ 32258 49330 Brickwork railway bridge pier and stonework bank revetment on LHB

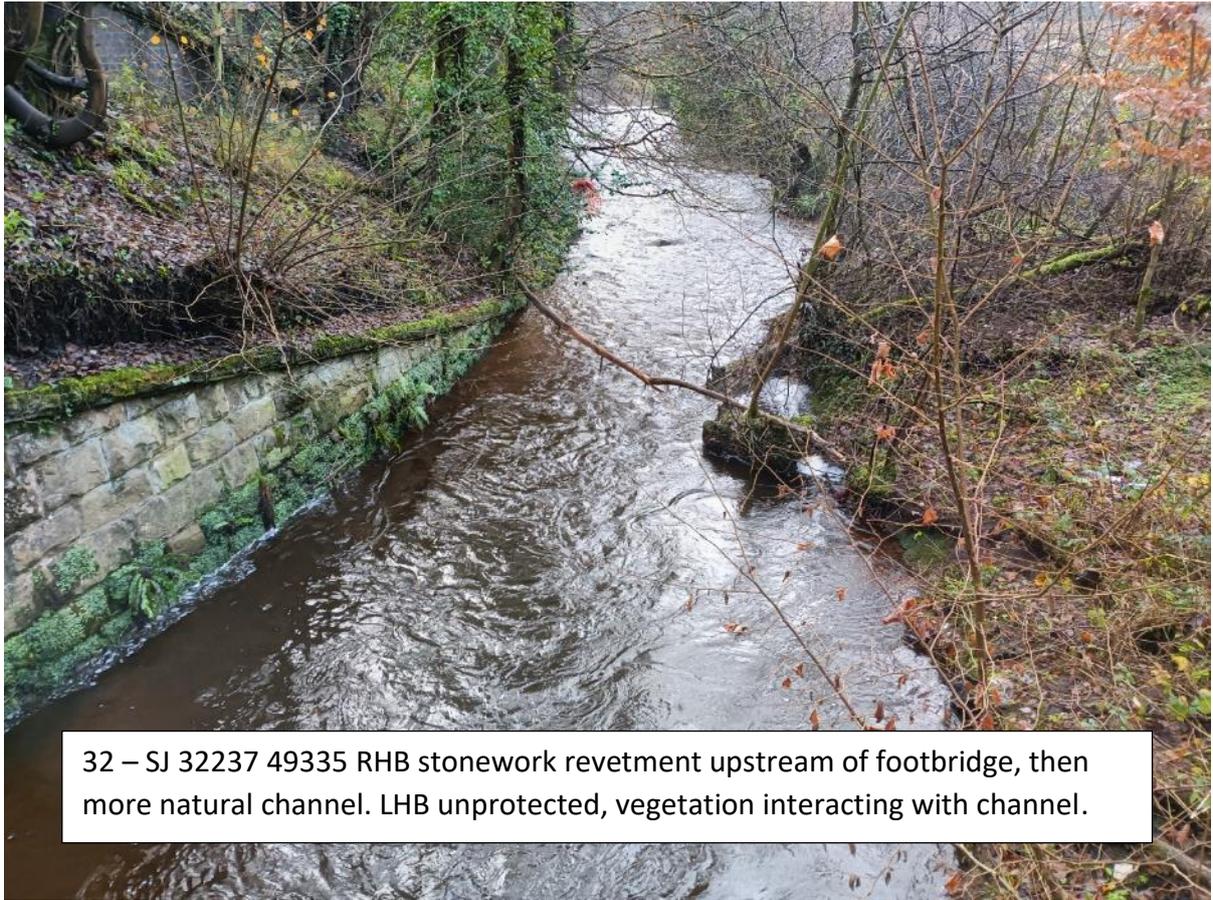
32 – SJ 32237 49335 RHB stonework revetment upstream of footbridge, then more natural channel. LHB unprotected, vegetation interacting with channel.
