**Whitehall Landfill**

CQA Validation Report Northern  
Sidewall Barrier – fourth lift

CQA VAL007

Issue | 21 August 2019

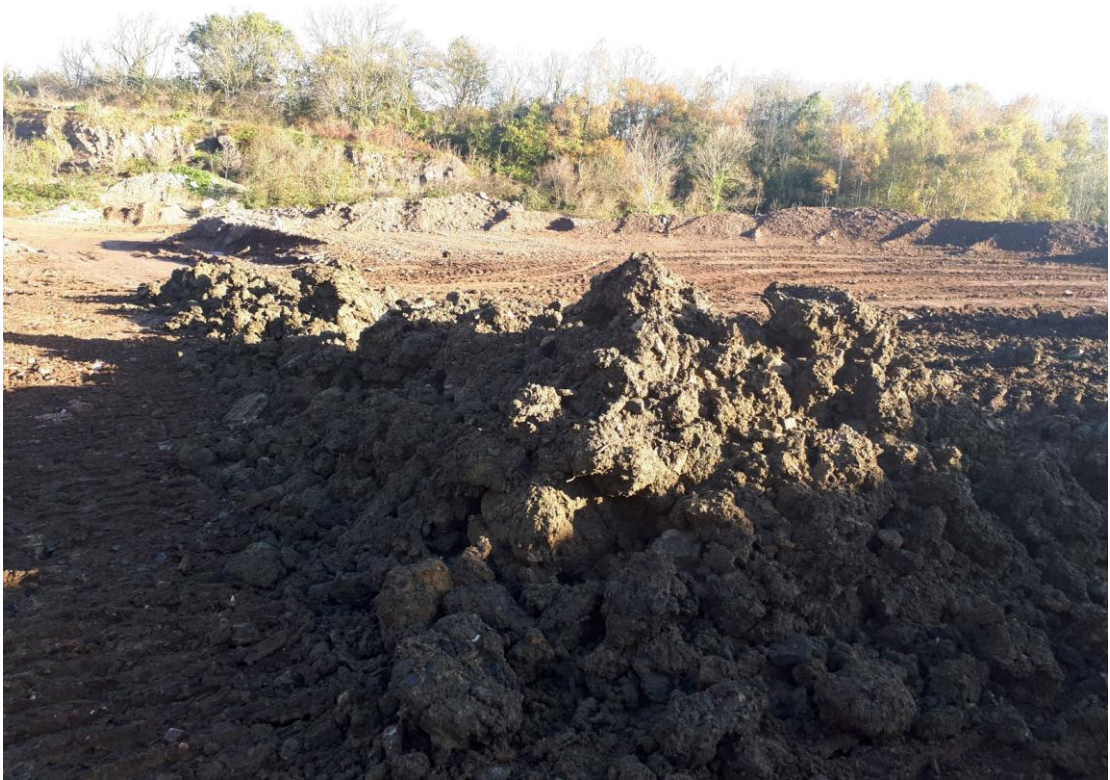
| Materials<br><br>Barrier material from existing stock pile on site from WIF WHL0104 (this material was previously inspected in June 2017).<br><br>Material noted to be a firm clay, predominantly orangey brown, locally brown to grey clay (see Photo 1) | | |

**Photograph 1- Stockpiled firm, locally stiff, clayey materials from St Fagan's**

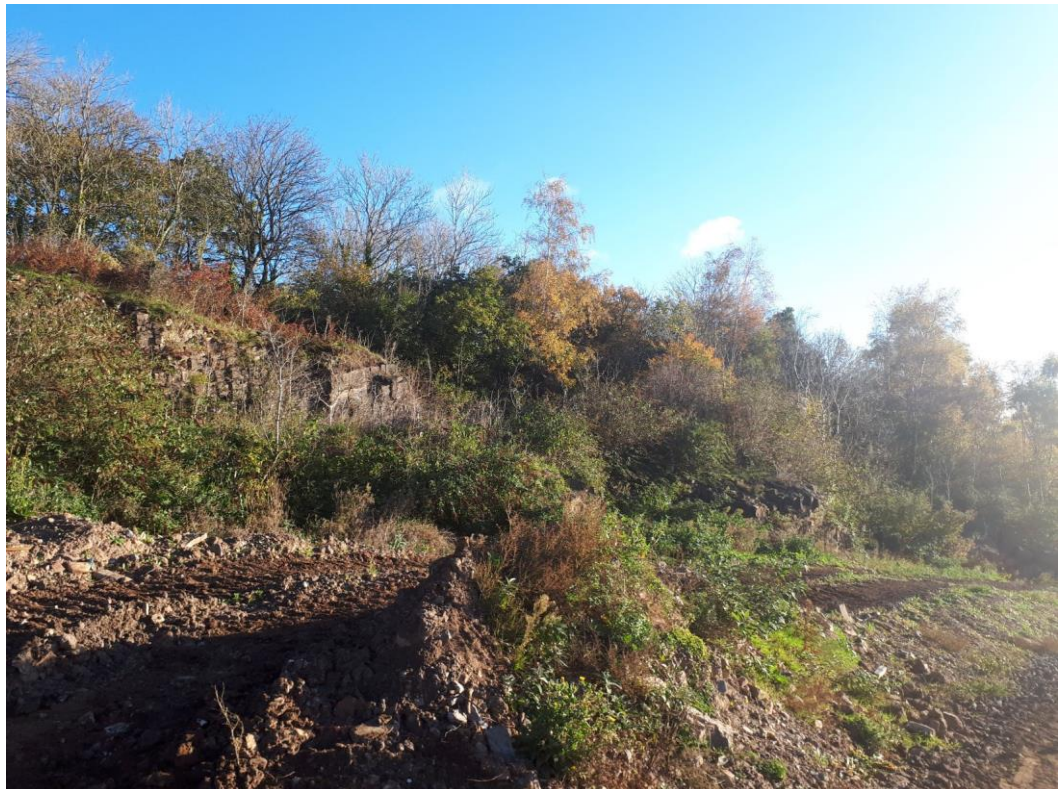
**Photograph 2 – Northern sidewall showing formation for Lift 4 (surface of Lift 3) – looking east. Vegetation to be removed prior to barrier construction**

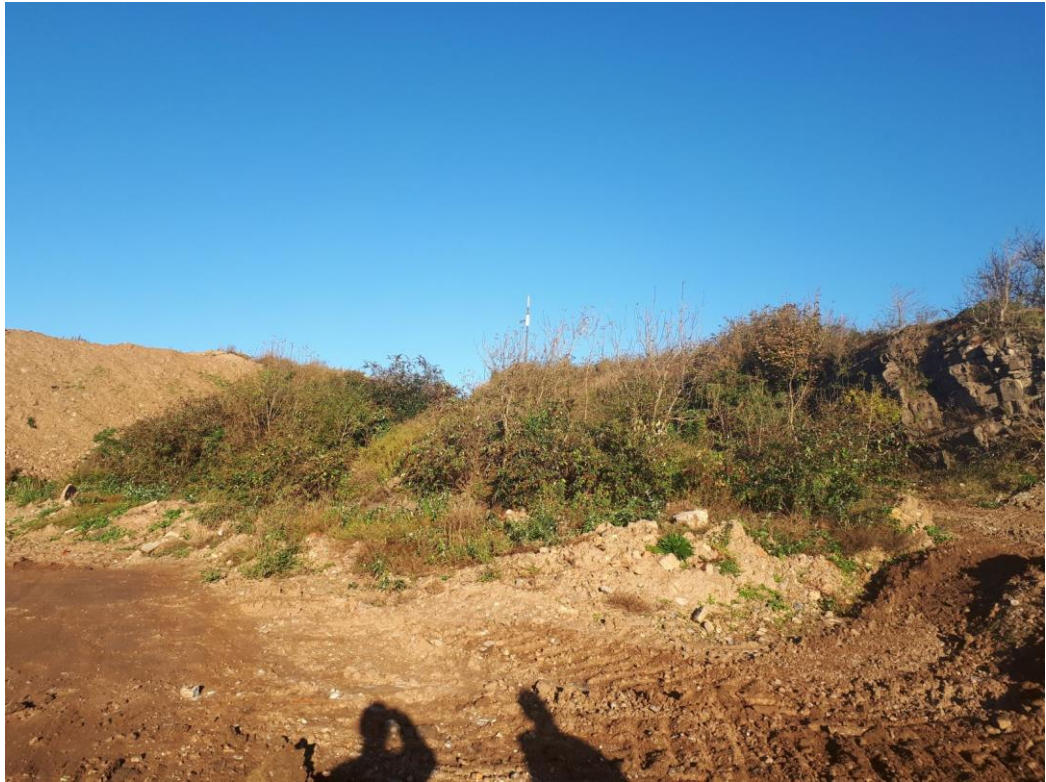
**Photograph 3 – Northern sidewall showing formation for Lift 4 (surface of Lift 3) – looking west**

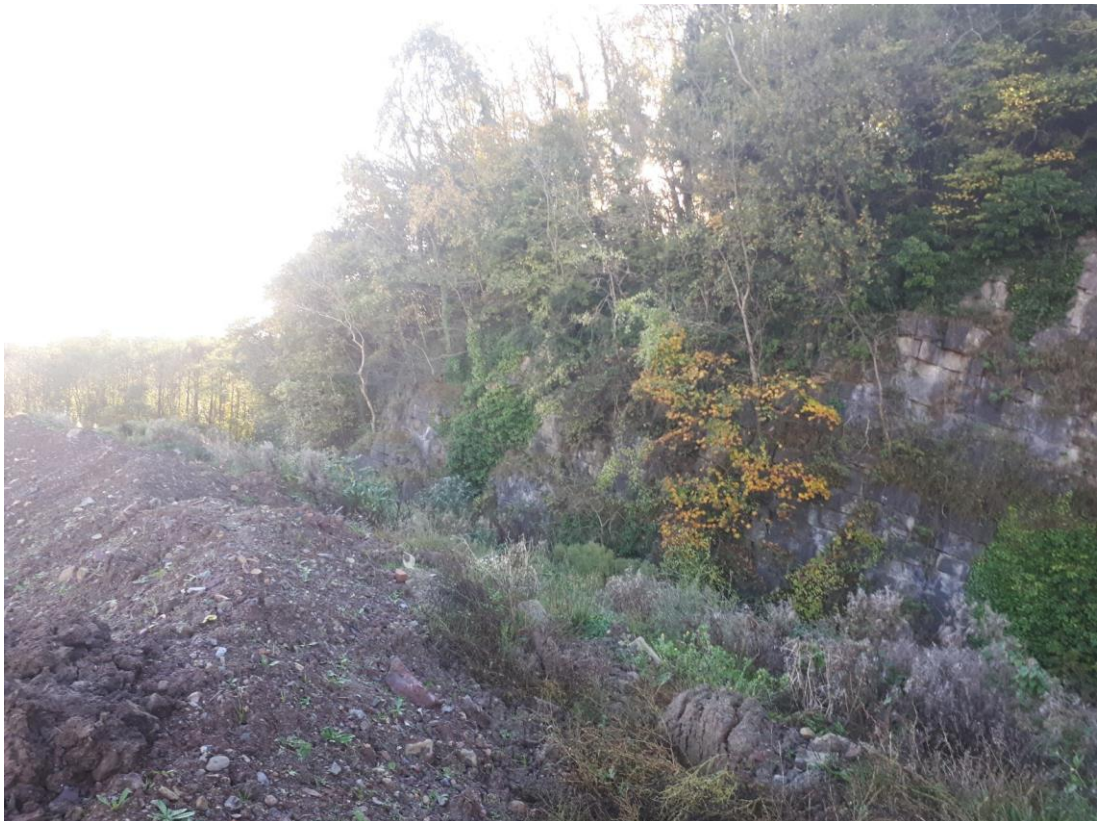
| <b>ELEMENT</b> | <b>DETAILS OF INSPECTION</b> | <b>LOCATION</b> | <b>PASS/FAIL</b> | <b>COMMENTS</b> |
|---|---|---|---|---|
| Geological barrier | Walkover inspection | Southern sidewall | | No apparent changes since previous inspection (see photo 4) |

**Photograph 4 – Southern sidewall showing no changes to sidewall construction – looking east**

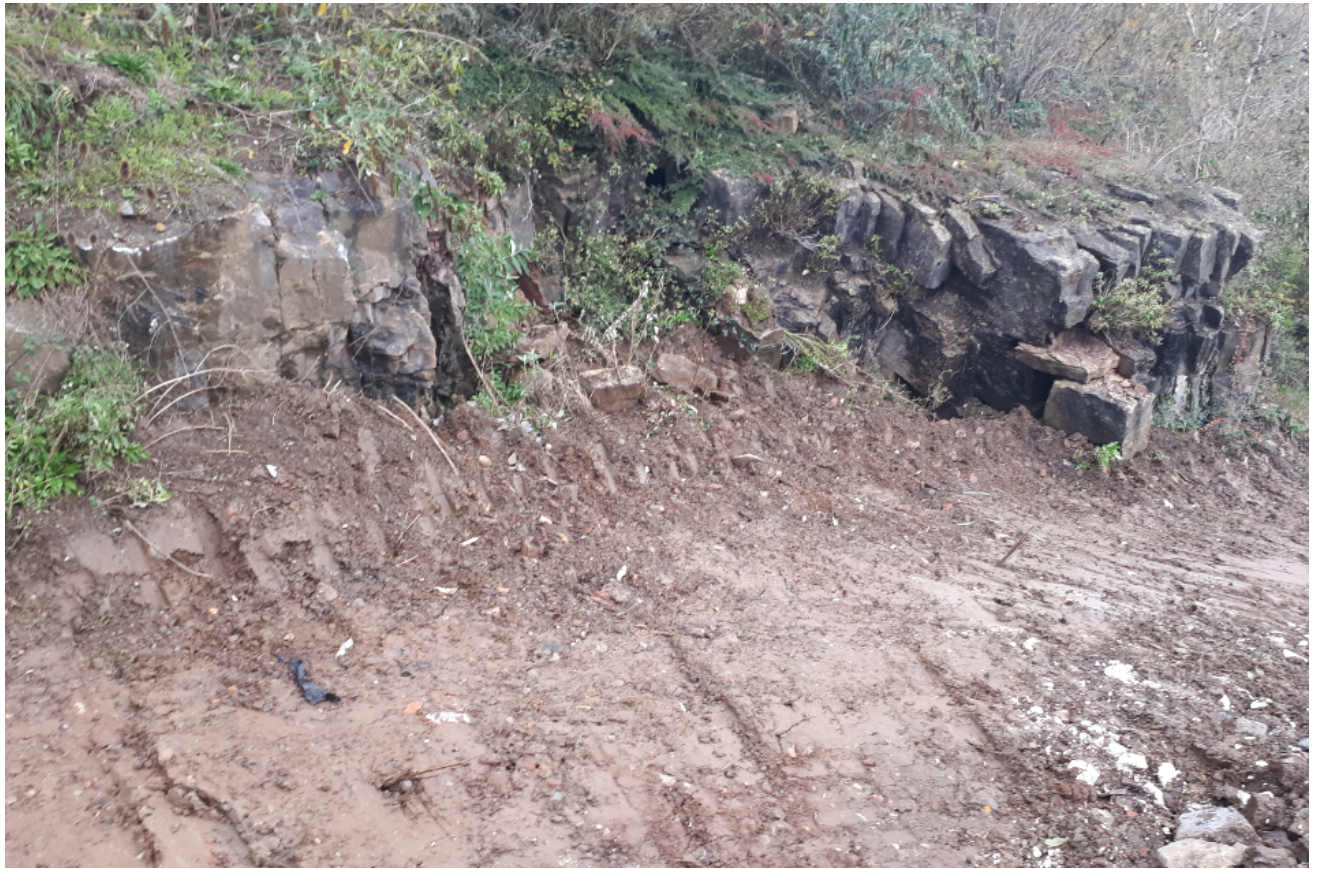
**Photograph 1- Formation level of Lift 4 prior to placement of material (eastern section)**

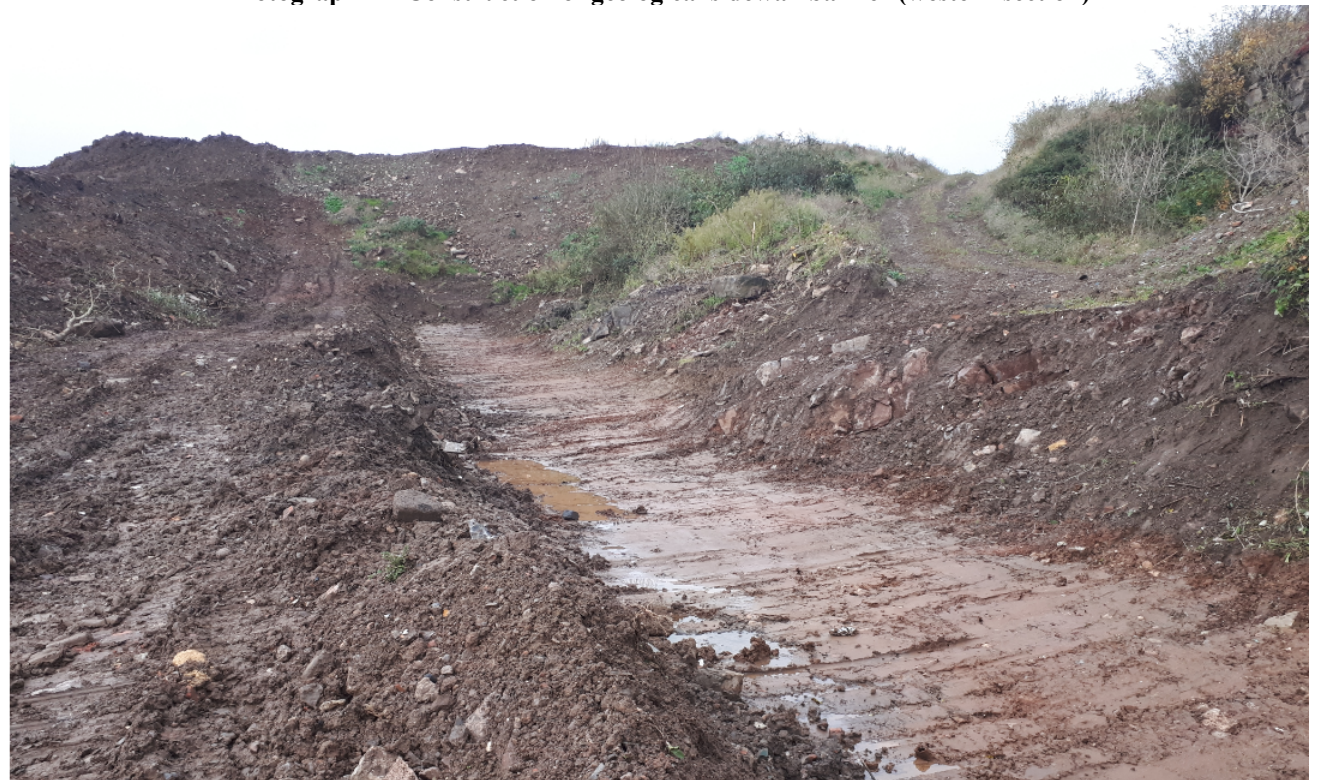
**Photograph 2 – Construction of geological sidewall barrier (western section)**

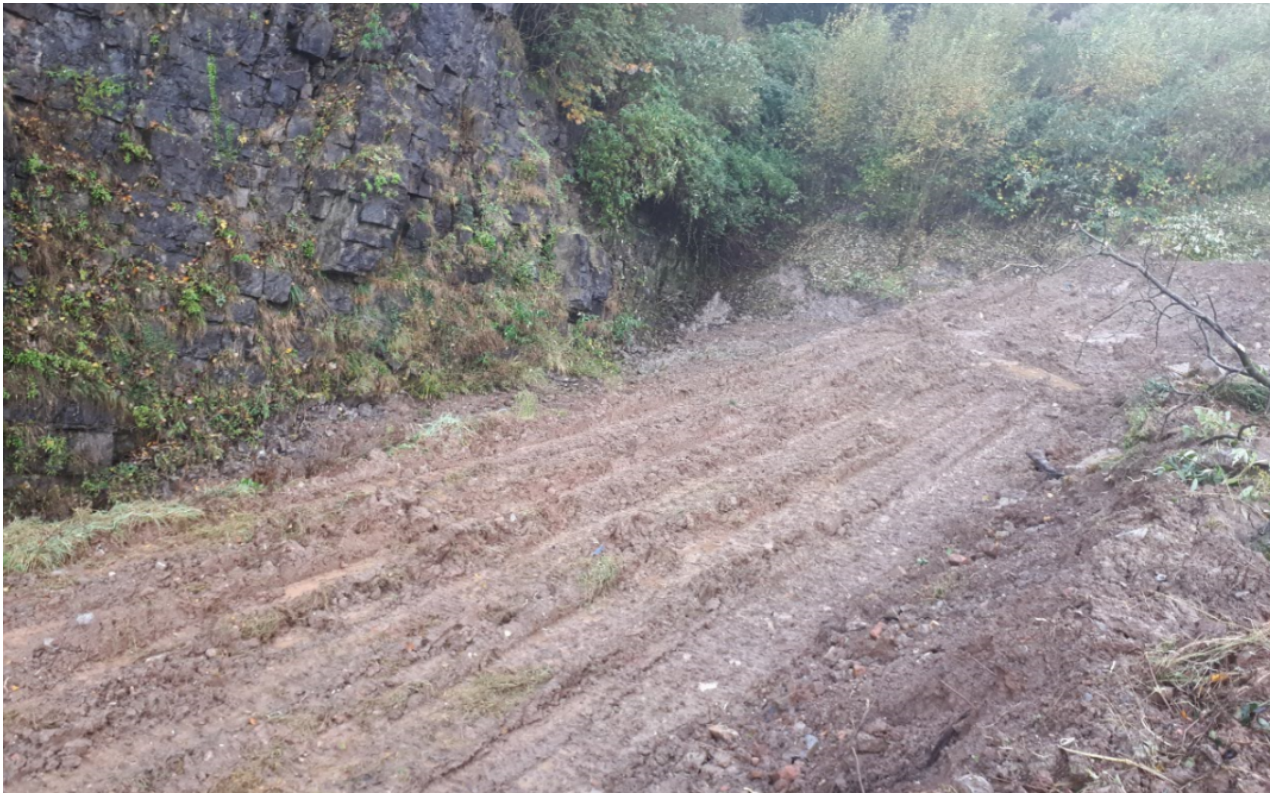
| <b>ELEMENT</b> | <b>DETAILS OF INSPECTION</b> | <b>LOCATION</b> | <b>PASS/<br/>FAIL</b> | <b>COMMENTS</b> |
|---|---|---|---|---|
| Geological barrier | Formation inspect of Southern Sidewall | Southern Sidewall | Pass | <p>Vegetation has been cleared from the top surface of the sidewall (following the previous works in 2016). Some vegetation noted on the side of the rockface, which will be removed prior to placement of materials.</p> <p>Formation surface shown in Photographs 1 and 2.</p> |

**Photograph 1- Formation surface of Southern Sidewall (west)**

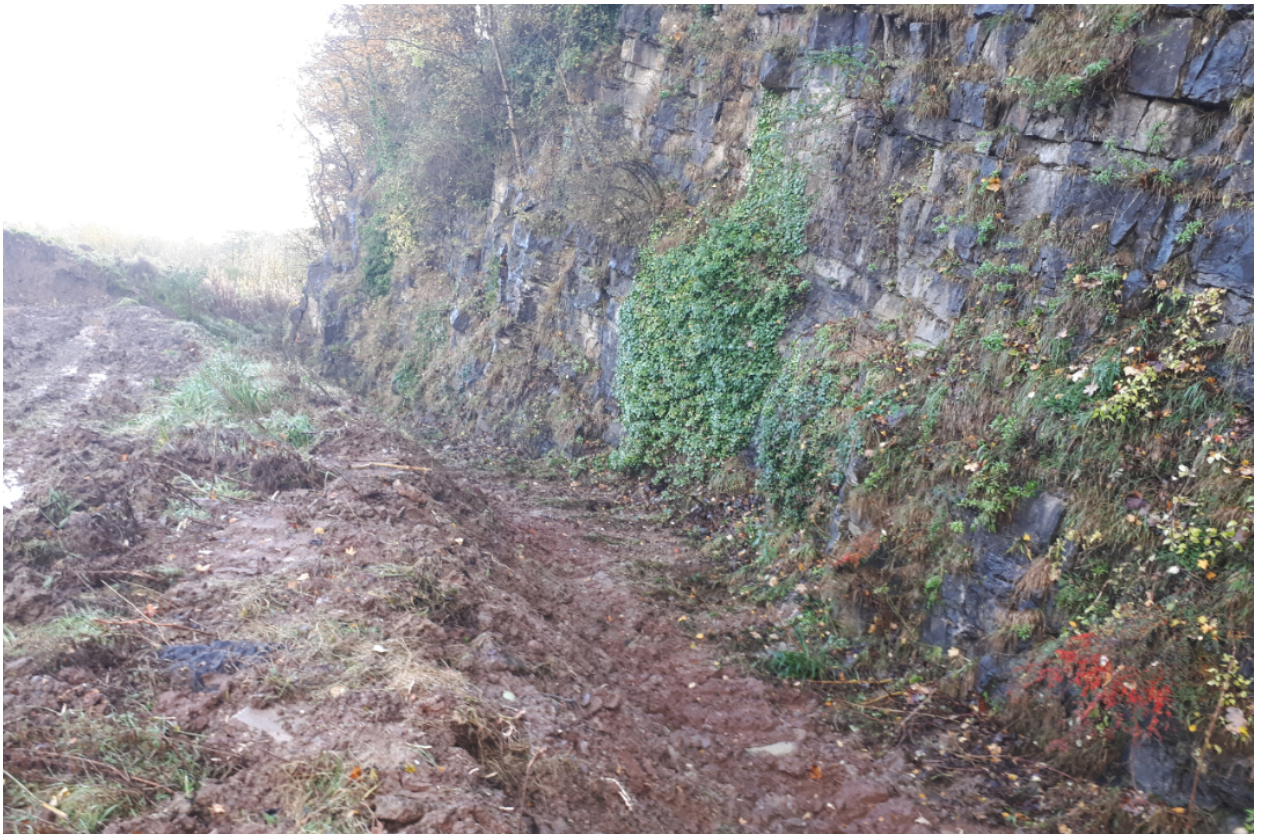
**Photograph 2 – Formation surface of Southern Sidewall (east)**

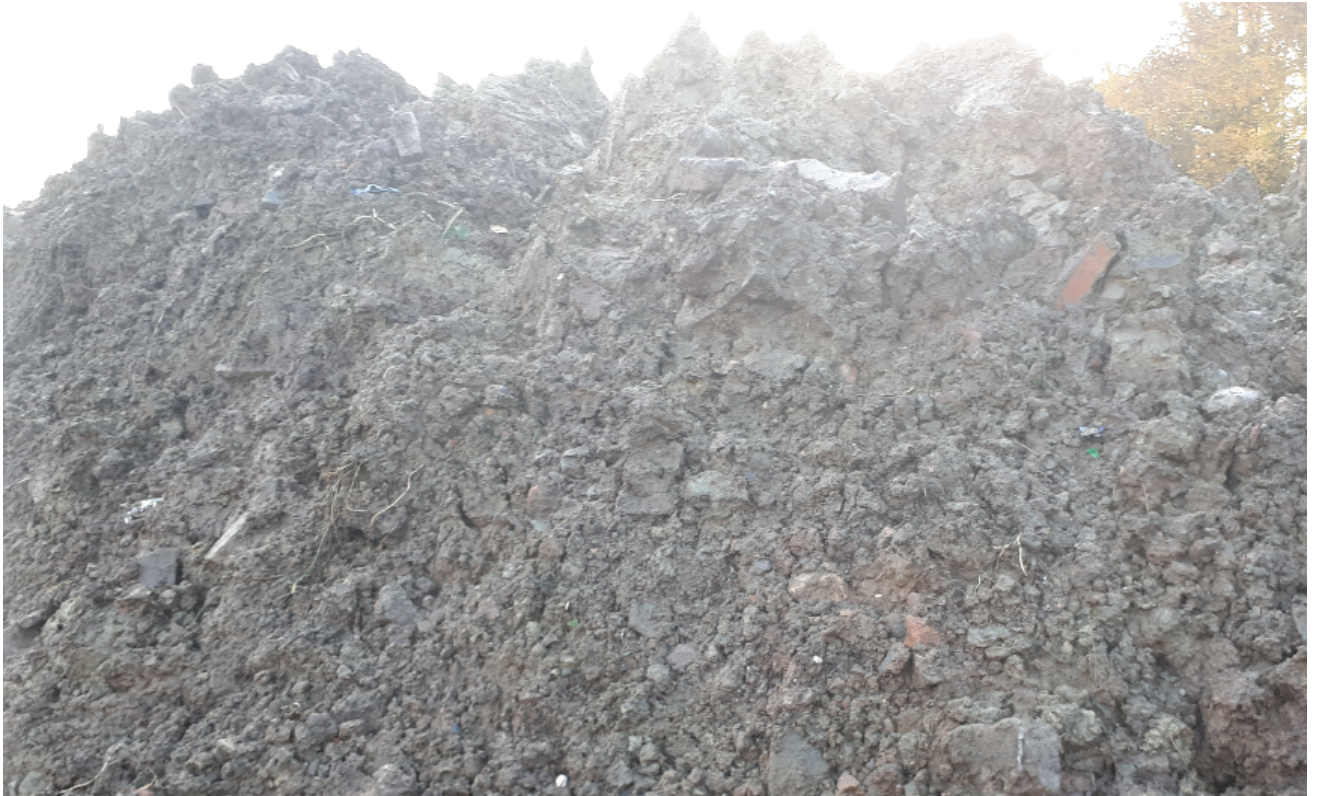
| <b>ELEMENT</b> | <b>DETAILS OF INSPECTION</b> | <b>LOCATION</b> | <b>PASS/<br/>FAIL</b> | <b>COMMENTS</b> |
|---|---|---|---|---|
| Sidewall material | Visual inspection | Stockpiled next to Southern Sidewall | | <p>Material to be used in sidewall construction stockpiled adjacent to works. Material is generally firm to stiff grey clay, with some gravels and larger items. Discussed with Martyn Hearn that the larger inclusions would require removal prior to placement.</p> <p>See Photograph 3 for details of material.</p> |

**Photograph 3 – Stockpiled materials for placement**
