# Mostyn Sea Wall

## OPTION SELECTION REPORT

Structure ID: W1990286

**DOCUMENT REFERENCE:** 23013W-REP-001 A01 – Mostyn Sea Wall

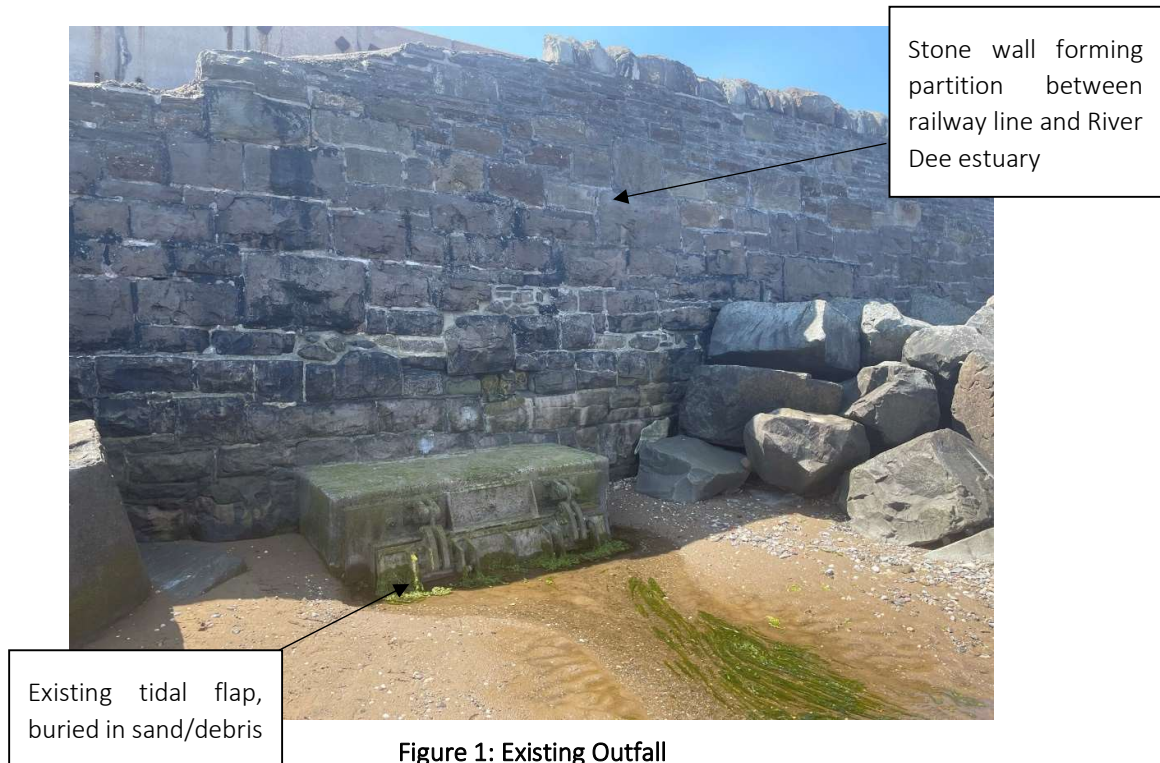
Figure 1: Existing Outfall

The existing outfall is headed by a top hinged tidal flap. The tidal flap is bolted to a concrete surround which protrudes approx. 0.8m from the stone masonry sea wall. The tidal flap is currently wedged slightly open by beach material and therefore not functioning as designed. Behind the sea wall the CNH3 railway line runs above the outfall.

A 1.05 x 0.9m culvert carries the storm water under the railway line to the outfall. At the upstream side of the culvert is a natural attention area, which is >1.5m below adjacent road and track levels.

**Preferred Option(s)** – Option 2 or 3 would be the most preferred. Option 1 would have a higher risk of failure as explored above and Option 4 would be effective but result in a larger scale operation. Option 2 would be preferable if it could be future proofed to allow quick installation of a duckbill valve in the event that the tidal flap becomes blocked and redundant. If the possibility of future works is to be avoided as a priority, Option 3 would be the most suitable. The short-term additional cost of the duckbill valve would be tolerated in order to have a much lower likelihood of encountering future issues.

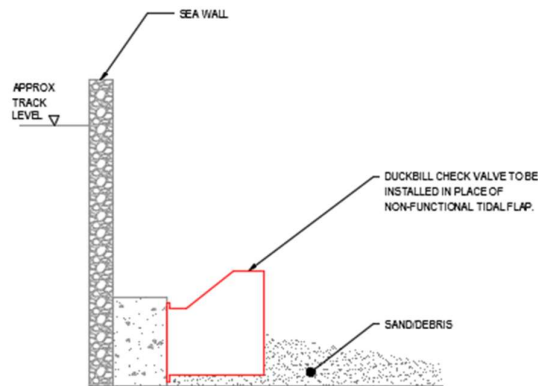
Figure 3: Sketch Option 1

This option involves the removal of sand/debris buildup in front of the tidal flap. The existing tidal flap will then be removed and replaced with a duckbill check valve of appropriate size to suit the discharge requirement.

**Option 1** – This is both the quickest and simplest option. However, the fact that the existing outfall is so deeply embedded in beach material is of concern when considering this solution. If this option was selected and the duckbill valve had limited functionality this could result in failure of the attempted remediation, which is undesirable for all concerned.

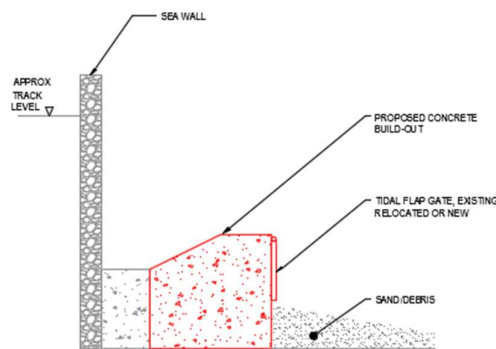
Figure 4: Option 2 Sketch

This option involves the forming of a concrete extension to the outfall which enables a higher soffit level at point of discharge. Existing tidal flap may be able to be reused or if not a new tidal flap with the same discharge capacity will be installed.

**Option 2** – This option is attractive as, although there is considerable time/financial/labour investment in the concrete build-out there is a large saving in reusing tidal flap or installing a new tidal flap as opposed to acquiring a duckbill check valve. The major drawback is the risk of further sand/sediment build-up and the repositioned tidal flap becoming blocked. If the installation was carried out to enable a duckbill check valve to be speedily installed if required in future, this would make this option more appealing.

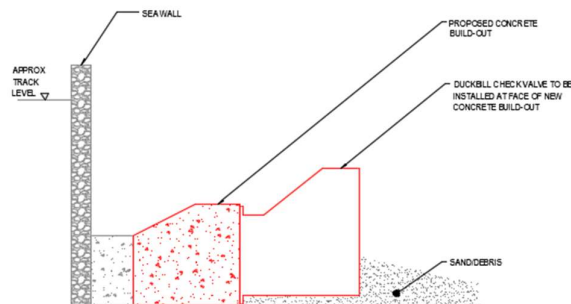
Figure 5: Option 3 Sketch

This option involves the forming of a concrete extension to the outfall which enables a higher soffit level at point of discharge. New duckbill check valve to be installed.

**Option 3** – This option is similar to Option 2 and therefore shares many of the advantages and disadvantages. It would be more expensive with the high cost of the duckbill check valve but there would be greater confidence that a robust and solution had been installed with more longevity.

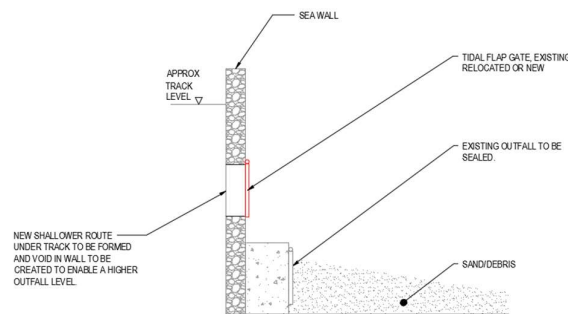
Figure 6: Option 4 Sketch

Initially, an investigation will need to be carried out to ascertain the difference in levels between outfall and upstream side of culvert to determine gradient and viability of decreasing it. This will need to include checking the minimum depth requirement is maintained under track level.

**Option 4** – If achievable, this option would be the most robust solution with the highest outfall level being achieved. It would also be the option causing the most disturbance and the most complex for design, logistics and construction. More significant site investigation would also need to be carried out. This would also be the most expensive option of the four considered.
