**SOUTH SIDE  
QUEENSWAY WASTE  
MANAGEMENT SITE,  
LLANWERN STEELWORKS**

**2022 Annual Review of  
Environmental  
Monitoring**

*Report Number 2215r2v1d0123*

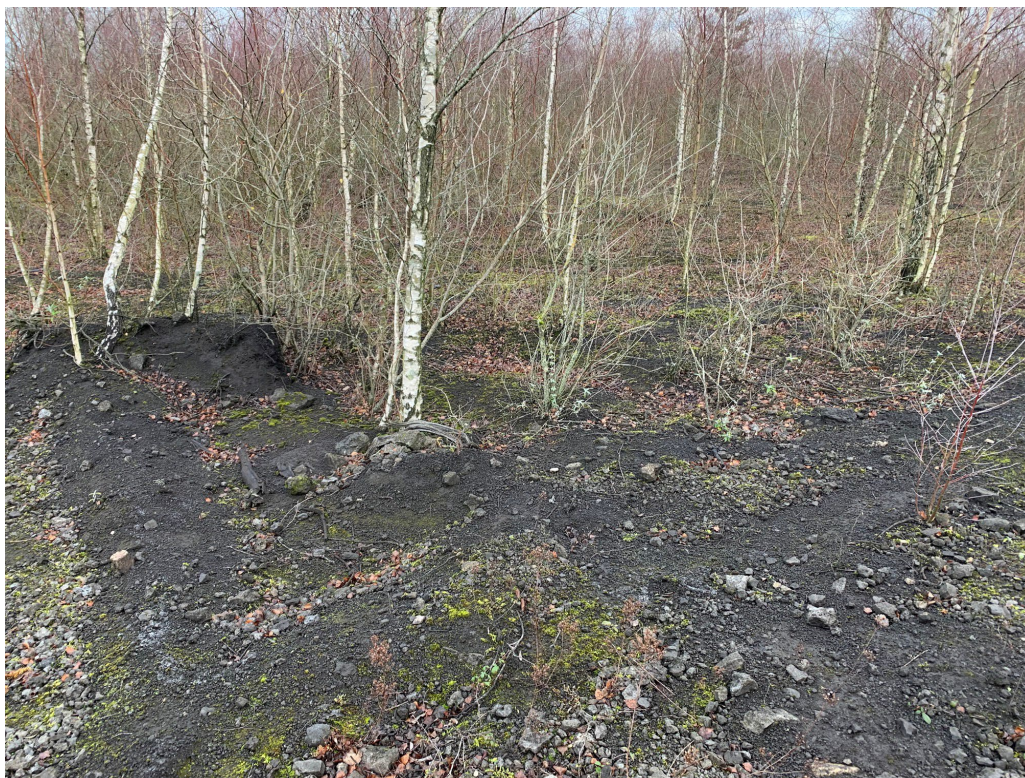
**Plate 3-1 Surface of Lagoon 12**

Lagoons 12 and 25 are very similar in terms of their site position, construction and deposit. Lagoon 12, however, is approximately 20 years old whilst Lagoon 25 is 10 years old. The typical surface condition of the lagoons is shown in Plates 3-1 and 3-2.

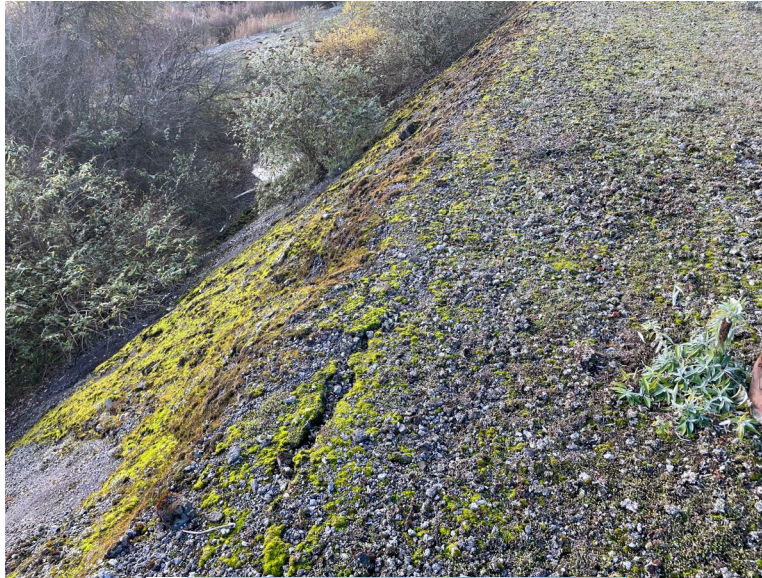
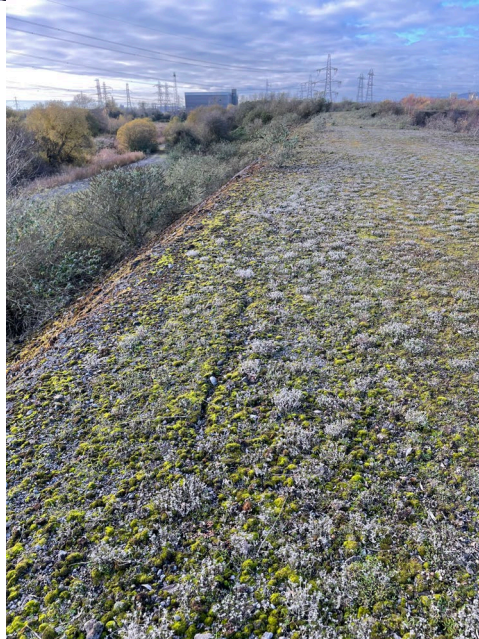
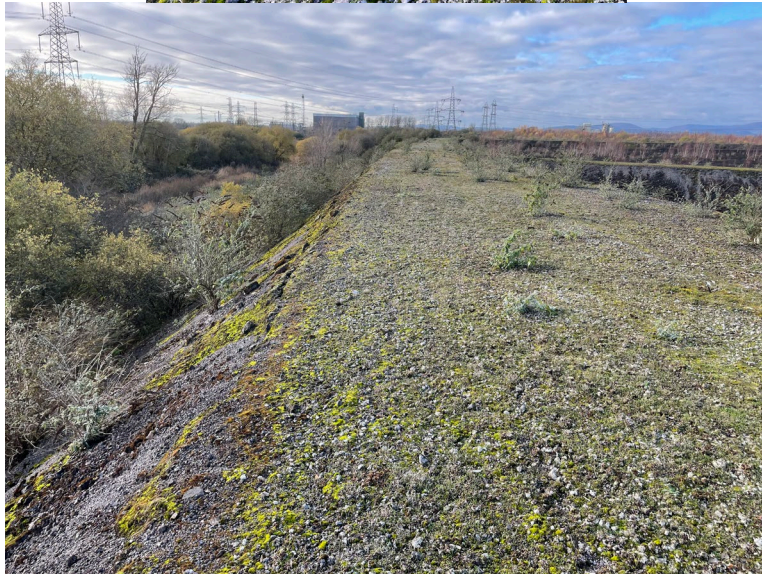
**Plate 4-1 Tension Cracks on Surface of Embankment of Lagoon 27**

The lagoon embankments should also be closely inspected as tension cracks were observed on the surface of the southern embankment of Lagoon 27.

During the December 2022 walkover, tension cracks on the upper surface of the embankment of Lagoon 27 were observed, as shown in Plate 4-1. This should be inspected further and reviewed in Q1 2023.

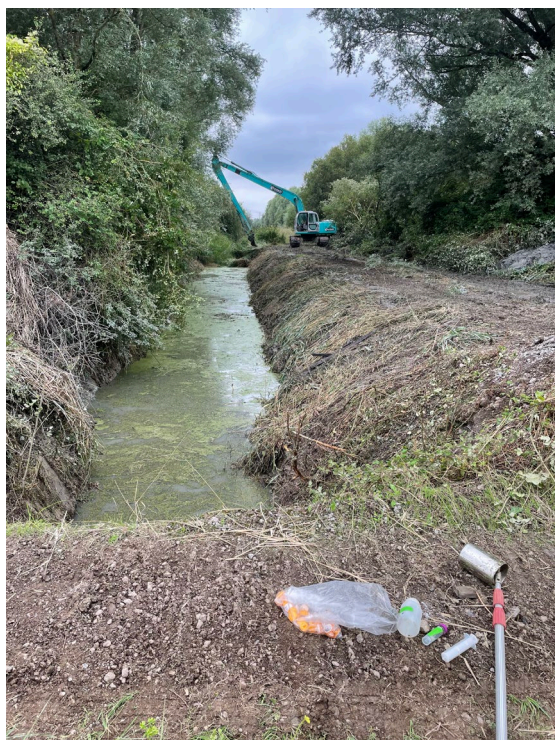
**Plate 6-4 Ditch maintenance during August 2021 sampling upstream of sample point SW1**

Some of the data trends may be influenced by the timing of sampling relative to ditch clearance and maintenance, as shown in Plate 6-4. In October 2021, some of the highest surface water levels observed were found at SW1 (compare Plates 6-4 and 6-5). This was due to significant rainfall in the preceding 24 hrs.

Such changes in surface water levels would be expected to alter water quality and could explain the variations observed. Consideration should also be given to other sources and the ditch should be inspected to ensure that all potential on-site and off-site run-off sources are understood.
