**Report Title:**                    **Structural Condition Report On  
Redundant ETP Slab**

**Address:**                        **The Creamery, Newcastle Emlyn**

**Client:**                         **Dairy Partners**

**Our Reference:**            **HCE-1498-STR-REP-001**

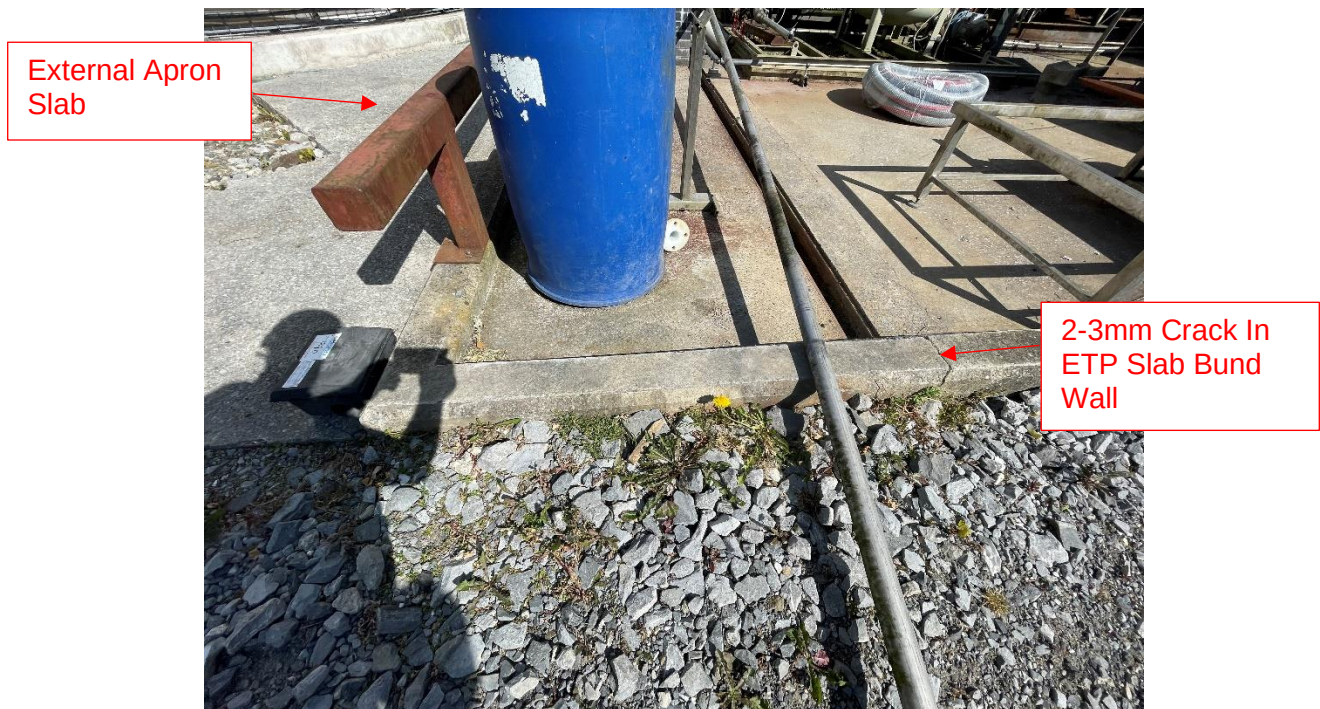
**Photograph 6: Crack In Bund Wall**

A 2-3mm wide crack observed in east bund wall as shown in Photograph 6.

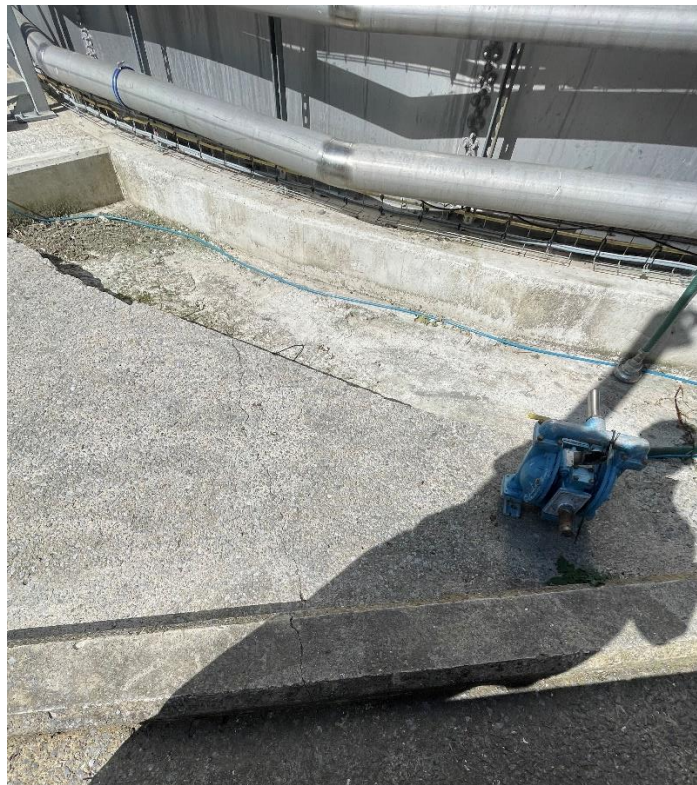
**Photograph 7: 1-2mm Crack In External Apron Slab View 1**

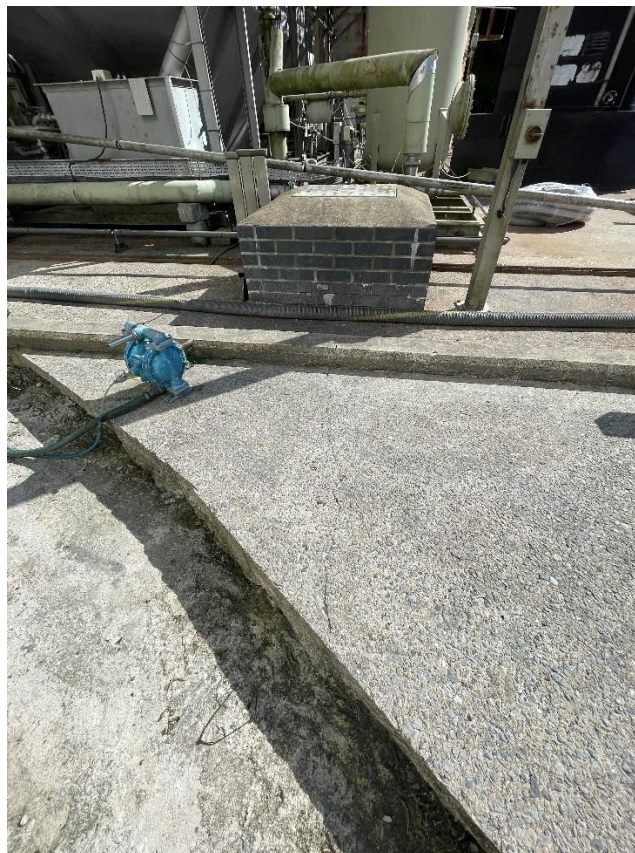
**Photograph 8: 1-2mm Crack In External Apron Slab View 2**

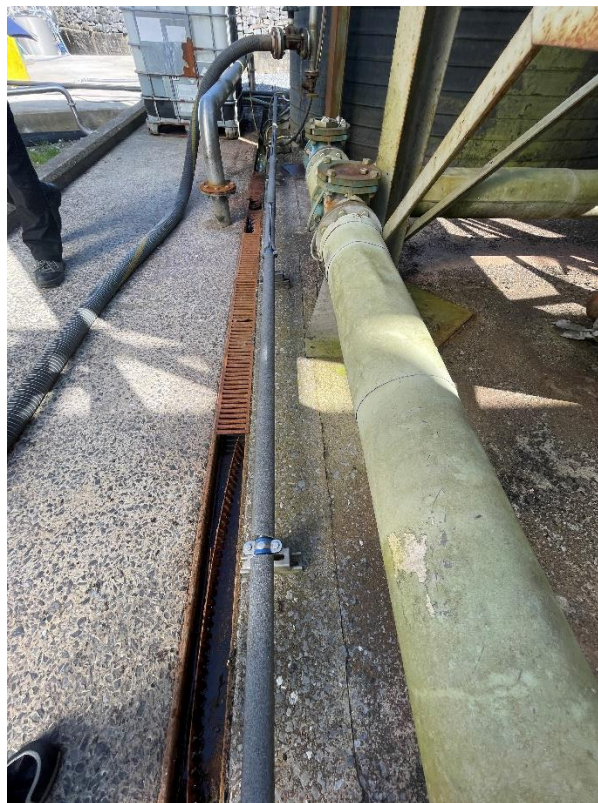
**Photograph 10: Surface Water Drainage Along West Side**

A crack measuring 1-2mm in width was observed running north-south adjacent to the ACO channel as shown in Photograph 10. This is likely to be a construction joint and likely to propagate full depth.

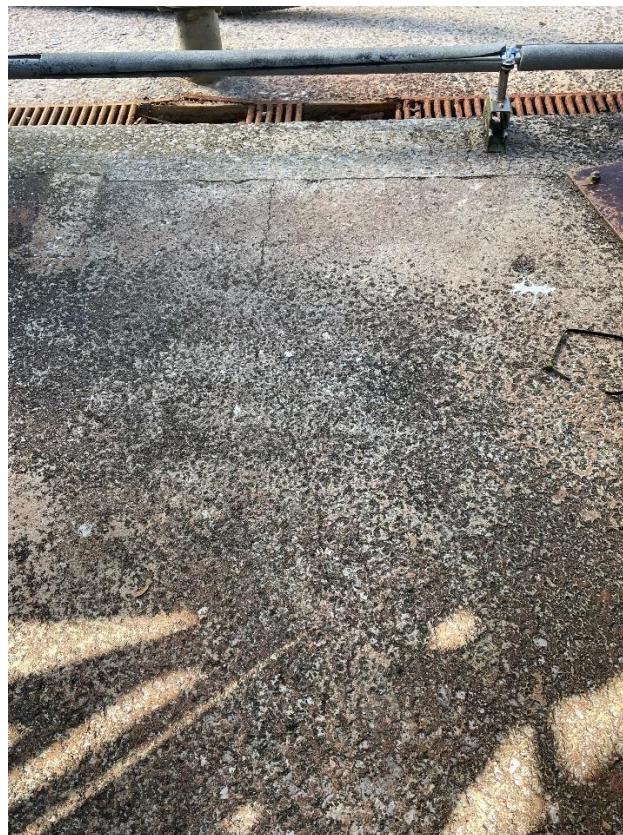
**Photograph 12: 2-3mm Crack In Slab Adjacent To South Drainage Channel**

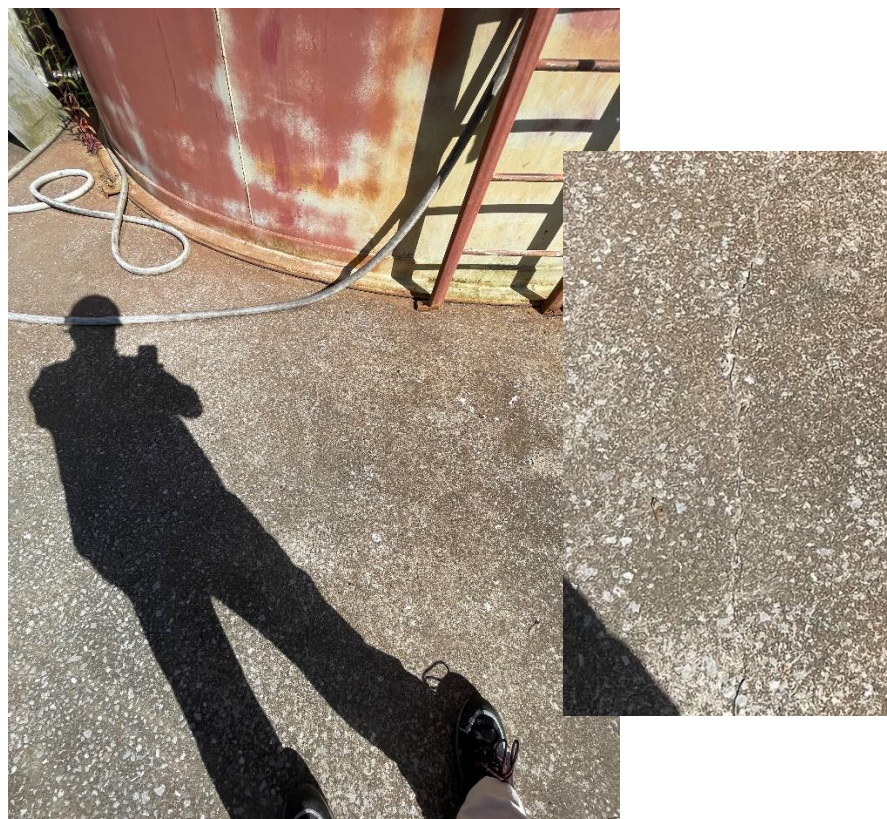
Photograph 18: 1-2mm Crack Propagating From East Side Under Tank

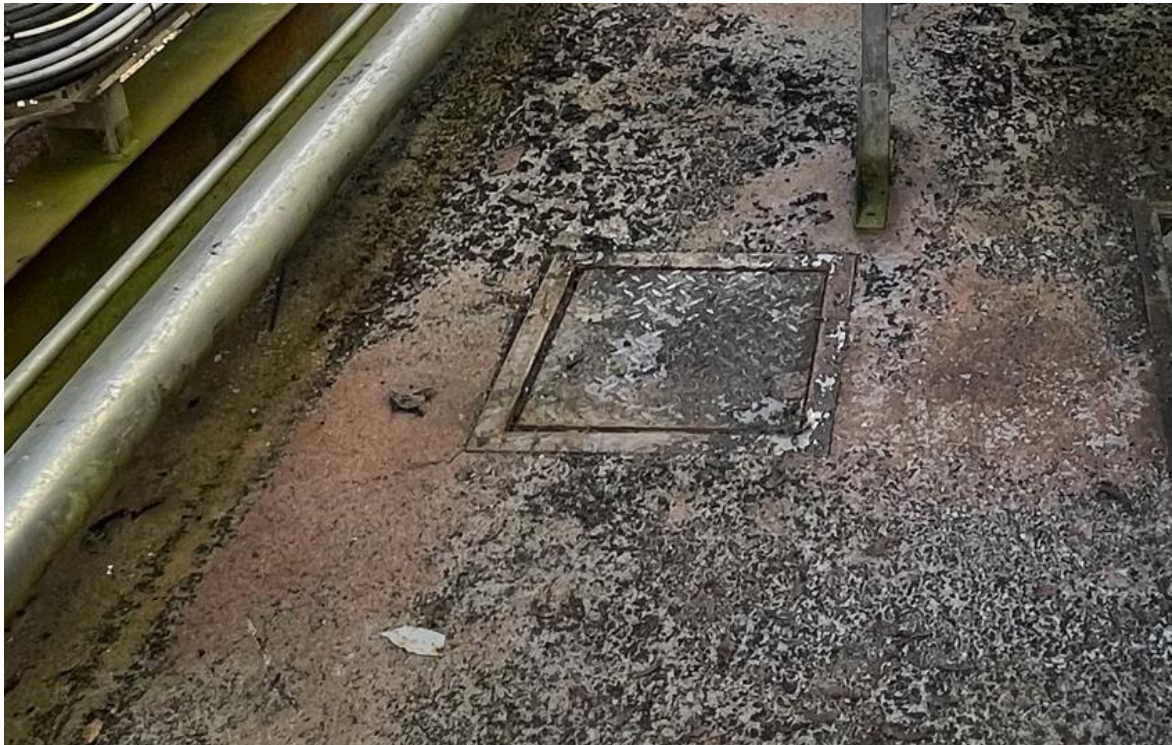
**Photograph 19: 2mm Crack Propagating From Corner of Valve Chamber**

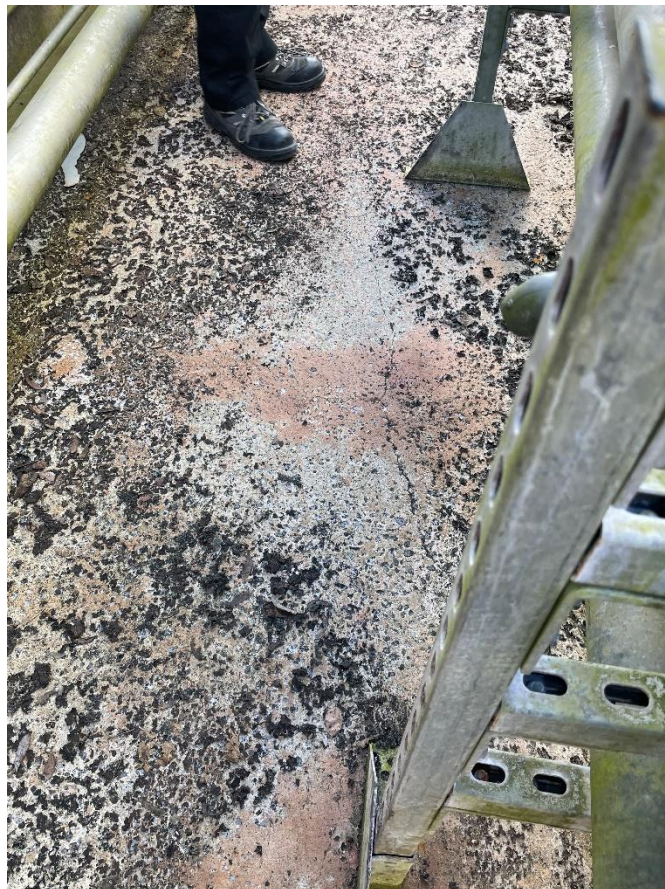
**Photograph 20: 2-3mm Crack Propagating In Centre Of Main Slab**

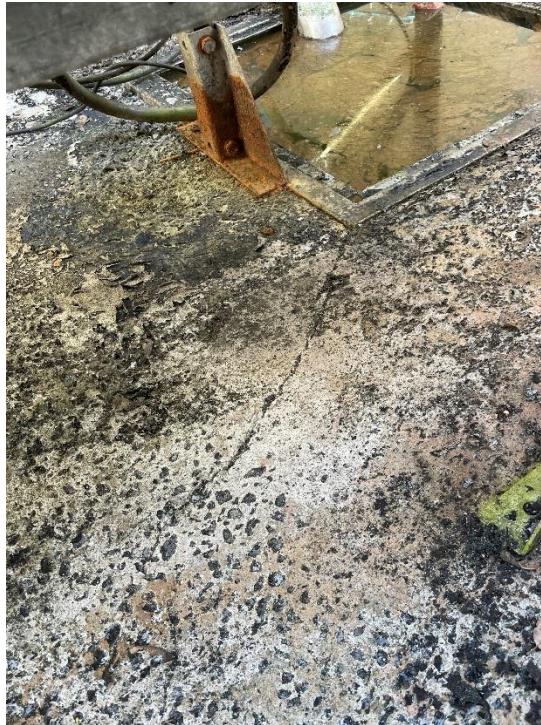
**Photograph 21: 2-3mm Crack Propagating From Recessed Cover**

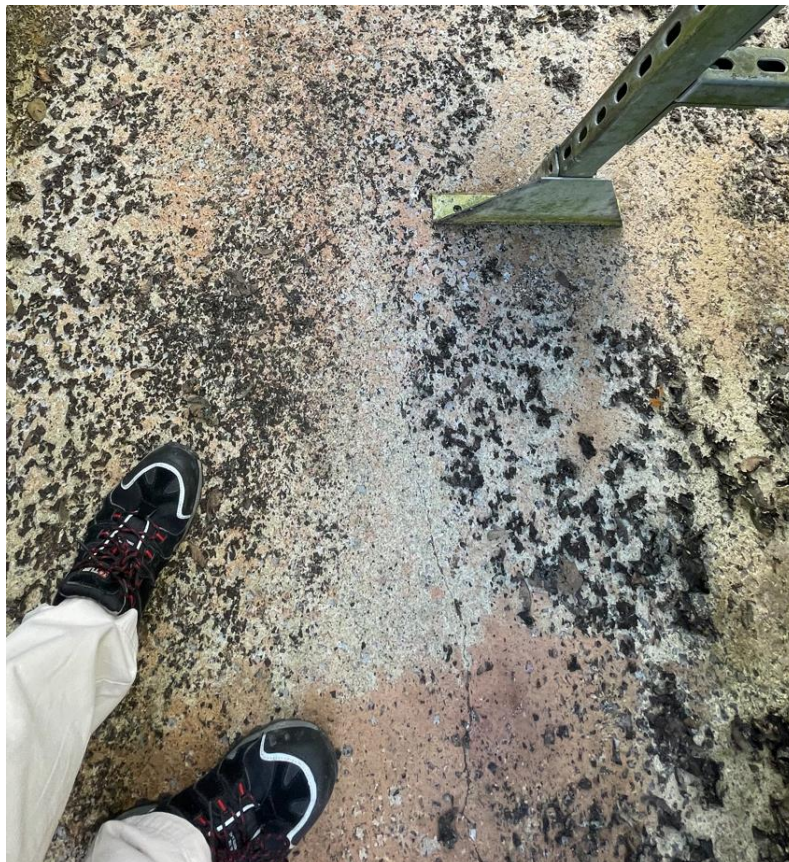
**Photograph 22: 2-3mm Crack Propagating In Main Slab Between Equipment Supports**
