## FF08 Structure Minor Works PPM Scoping Document

| Structure ID | 99 41.5 |
| Local Name/Structure Name & Location | BARMOUTH VIADUCT -913yd.No.40 - timber viaduct |
| Structure Type | Viaduct |

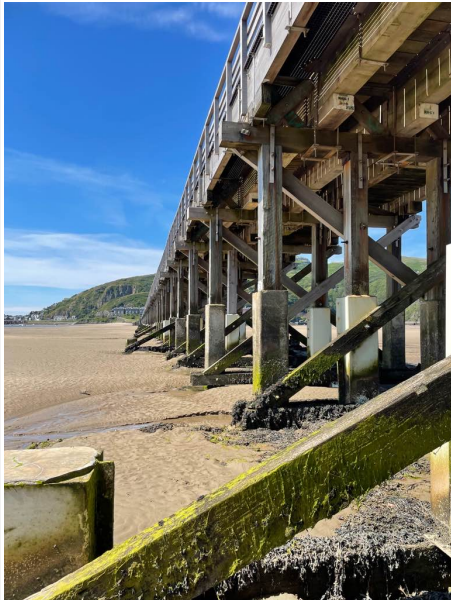
| | View from low milage access end | View from high milage end |

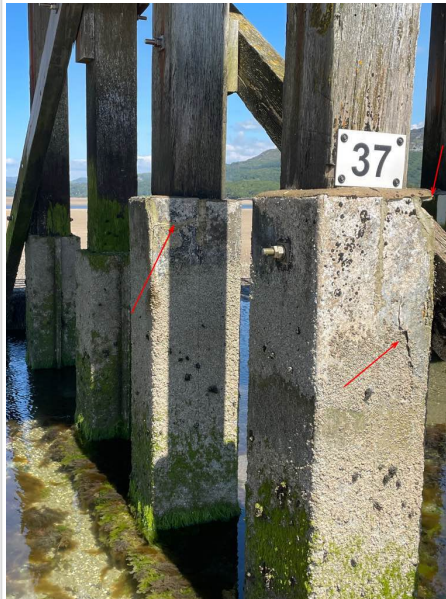
Various spilled concrete

| Additional Comments/Notes | <p>Parking at Morfa mawddach station.<br/>Can also drive down the lane to viaduct.</p> <p>Repair damaged pile casings throughout, the spilled Casings will need to be broken out and squared off and then repaired with marine friendly concrete repair material. Approx 10 repairs in total.</p> <p>Power wheelbarrow will be needed to transport plant and materials to site and all works to be done on low tide.</p> <p>Mph team<br/>Handtools<br/>Grinder<br/>Breaker<br/>Power wheelbarrows<br/>Marine friendly concrete repair approx 10 bags</p> |

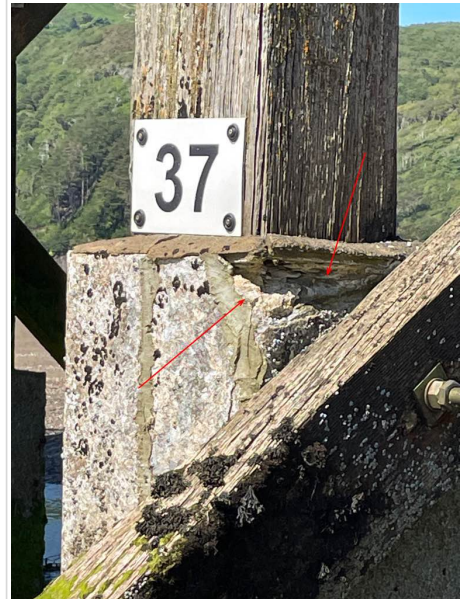
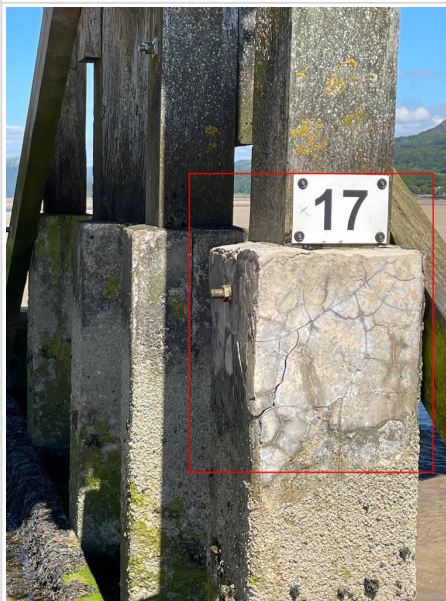
Repairs at span 17

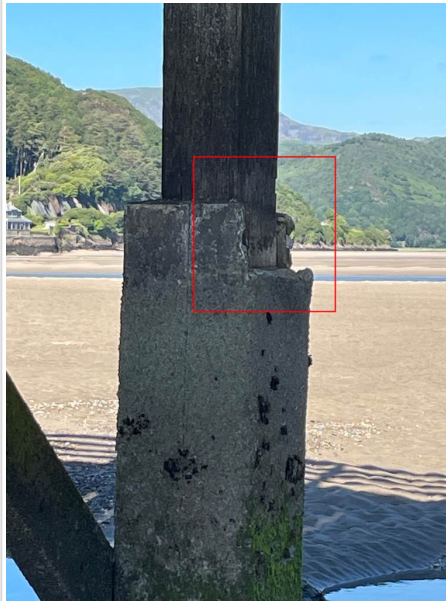
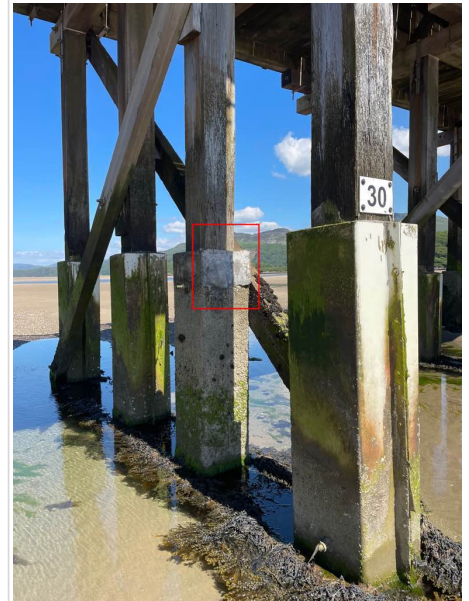
Repairs at span 30

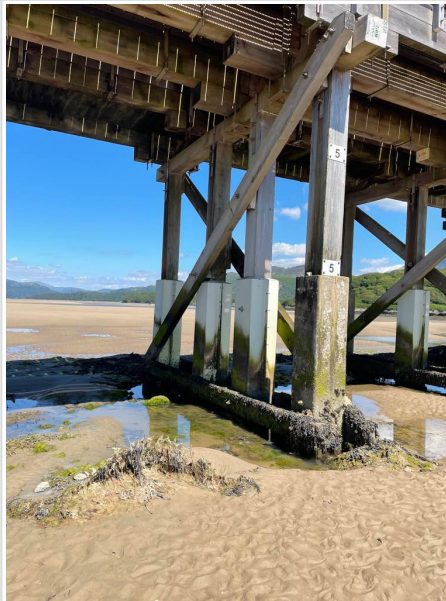
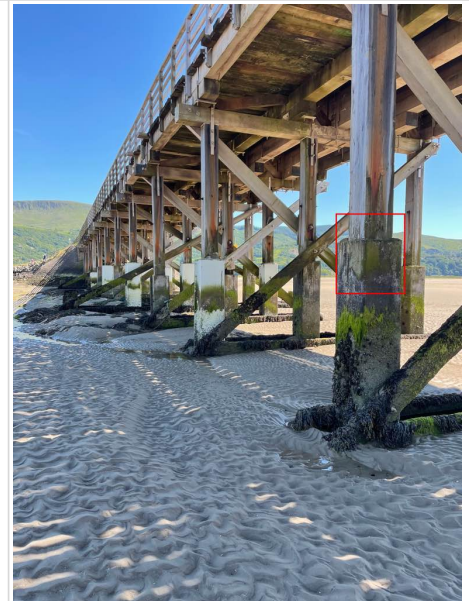
Areas of new timbers and repairs

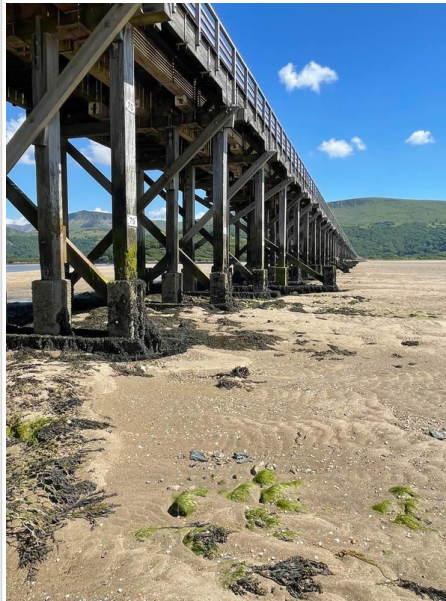
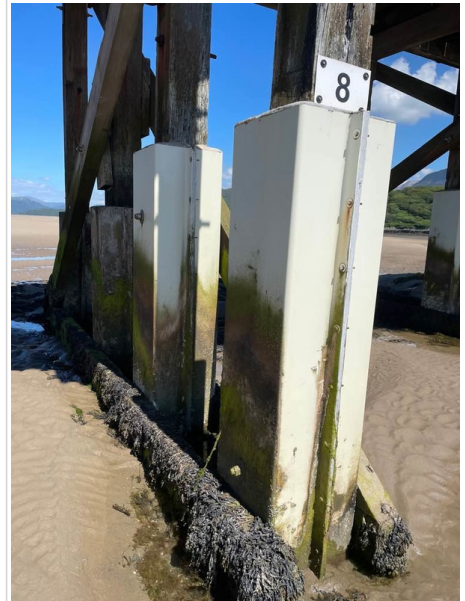
New pile casings
