| | | <p align="center"><b>NETWORK RAIL</b></p> <p align="center"><b>Underwater Examination Report</b></p> | | | | | | | |
| Examination Type: Underwater | | NR ID: | | | Exam Date: 18/04/2023 | | | | |
| Structure Name: Barmouth Viaduct (Timber) | | | | Type: | BV | | Exam ID: | 15614452 | |

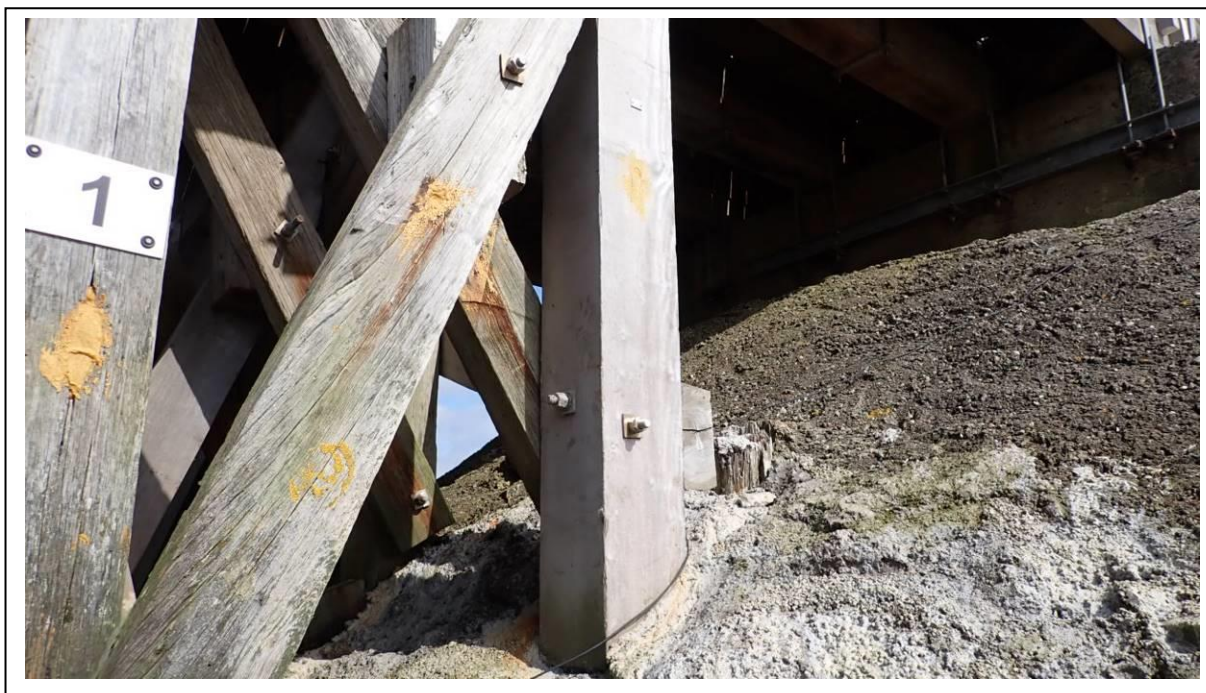
**Photo 3**      **Pile 1 - New**

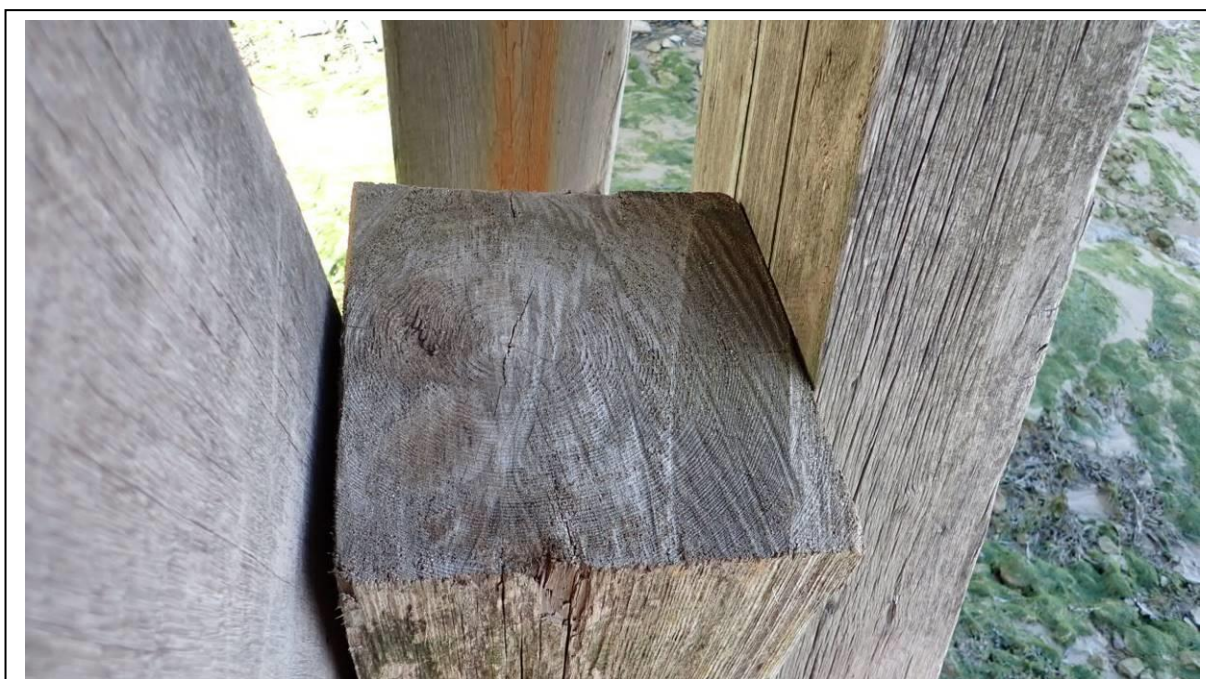
**Photo 4**      **New wedge between piles 4 and 5**

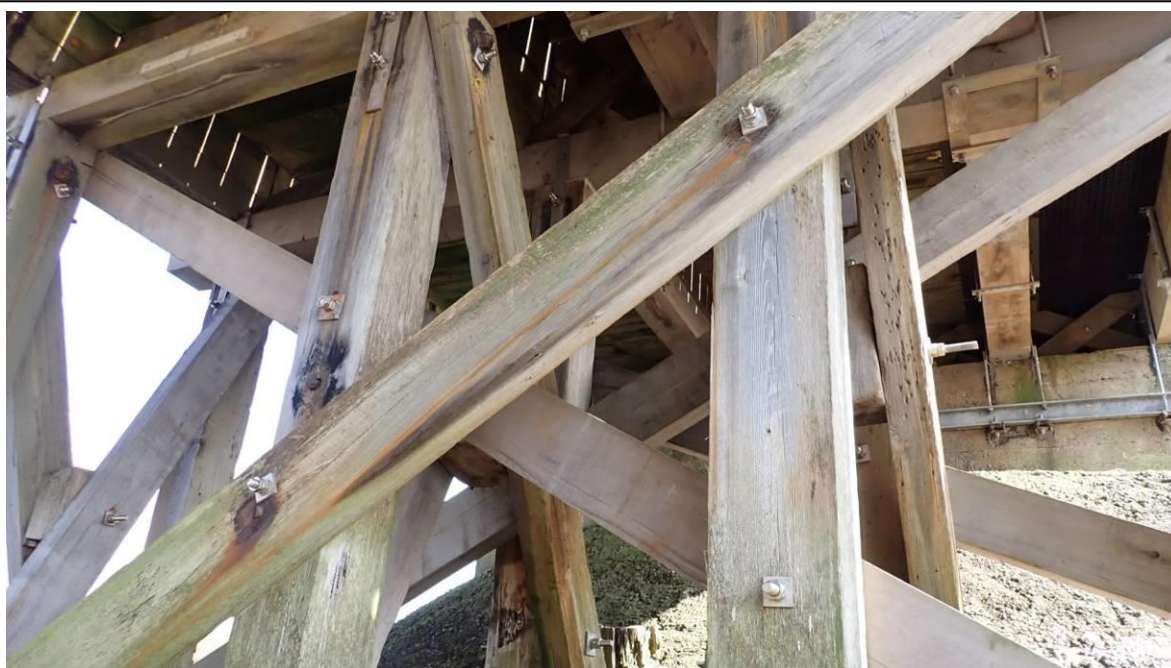
Photo 5 All steel fixing, have been replaced

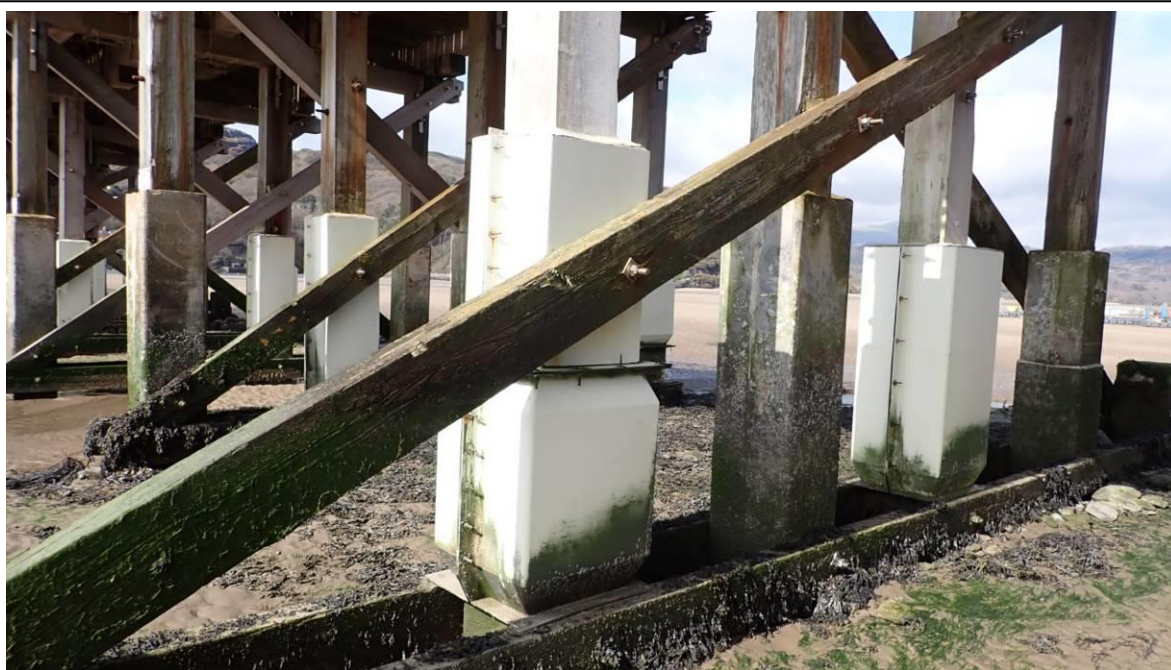
Photo 7 Trestle 2 - Pile 1, new encasement

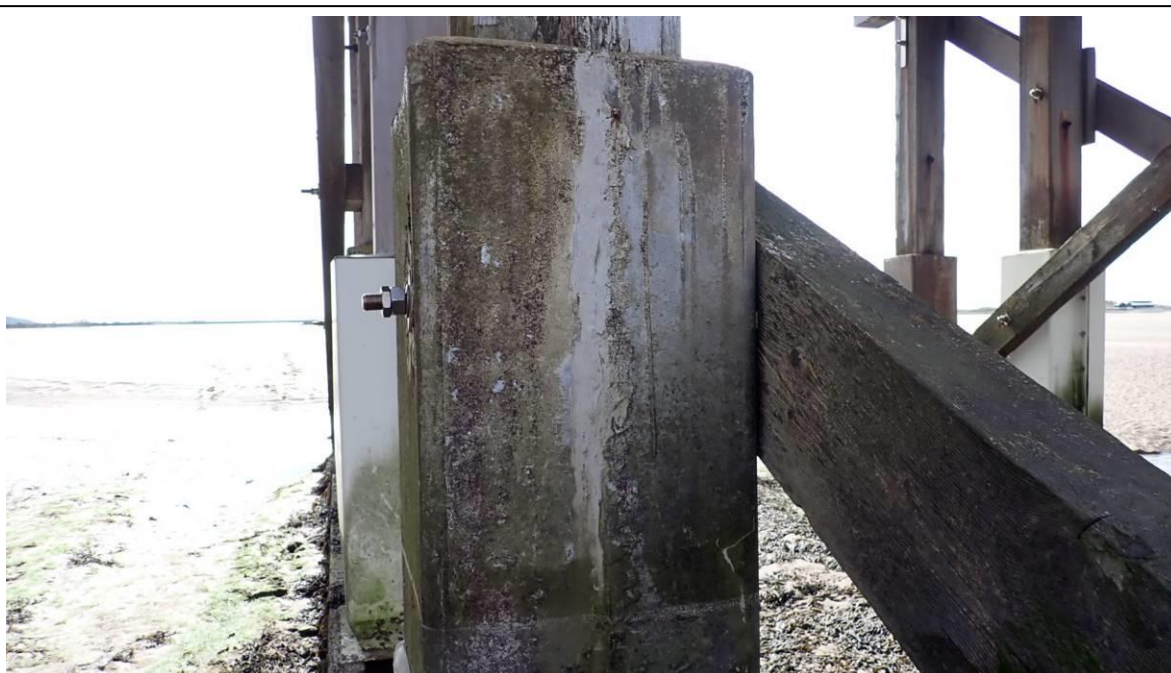
Photo 8 Trestle 2 – Pile 4, area of repair

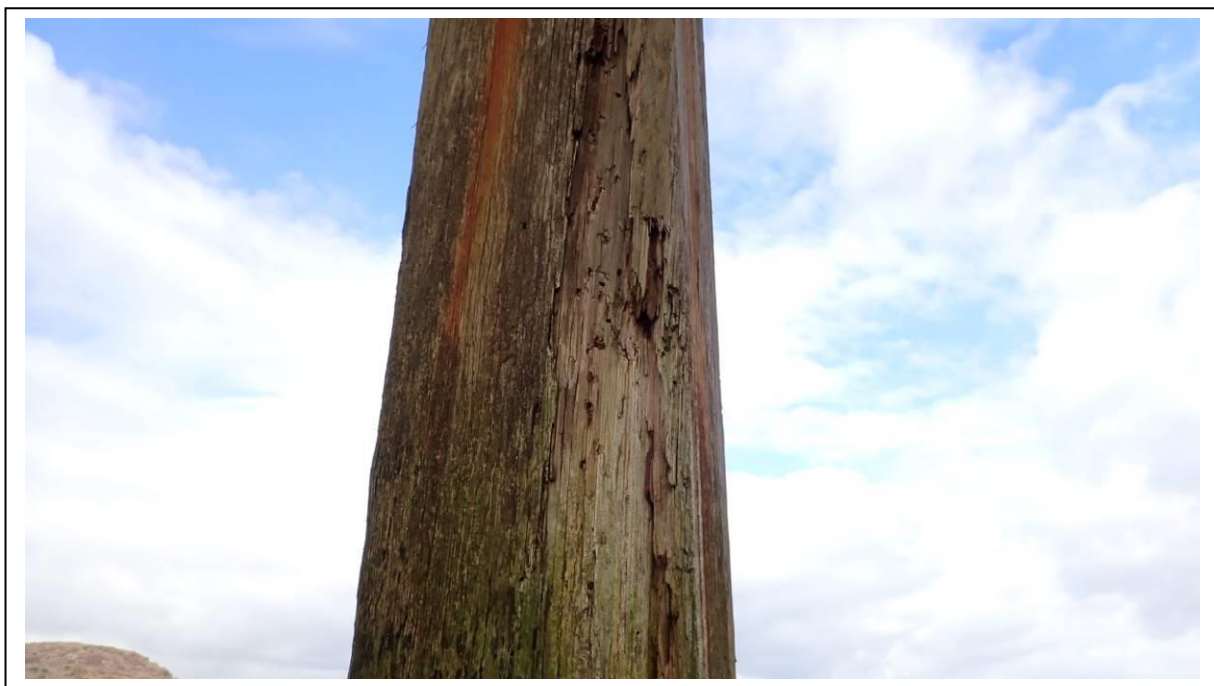
Photo 9      Trestle 2 – Pile 4, decay

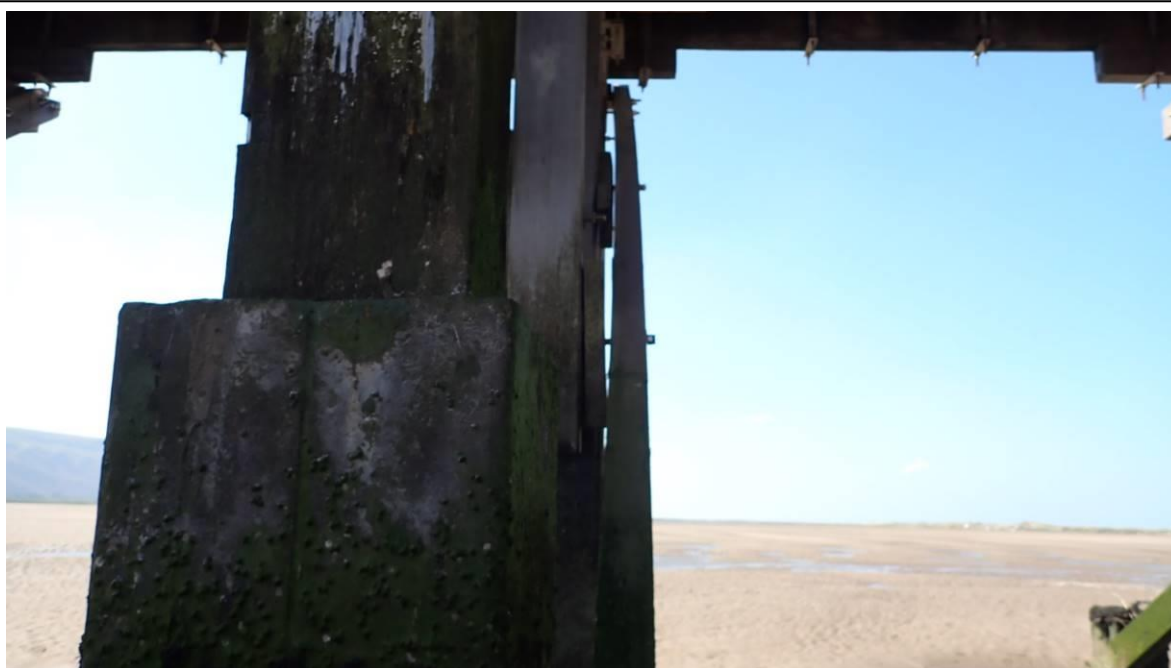
**Photo 15** Trestle 16 – New HM diagonal brace is bowed.

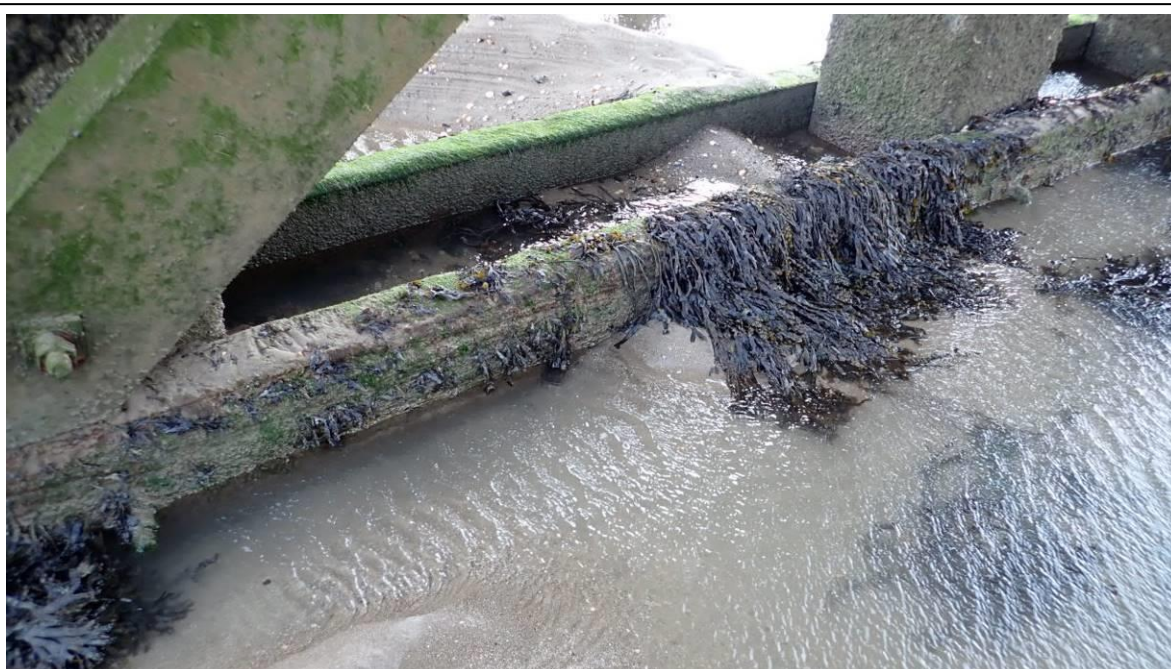
**Photo 16** Trestle 16 – HM horizontal brace, splits and minor decay

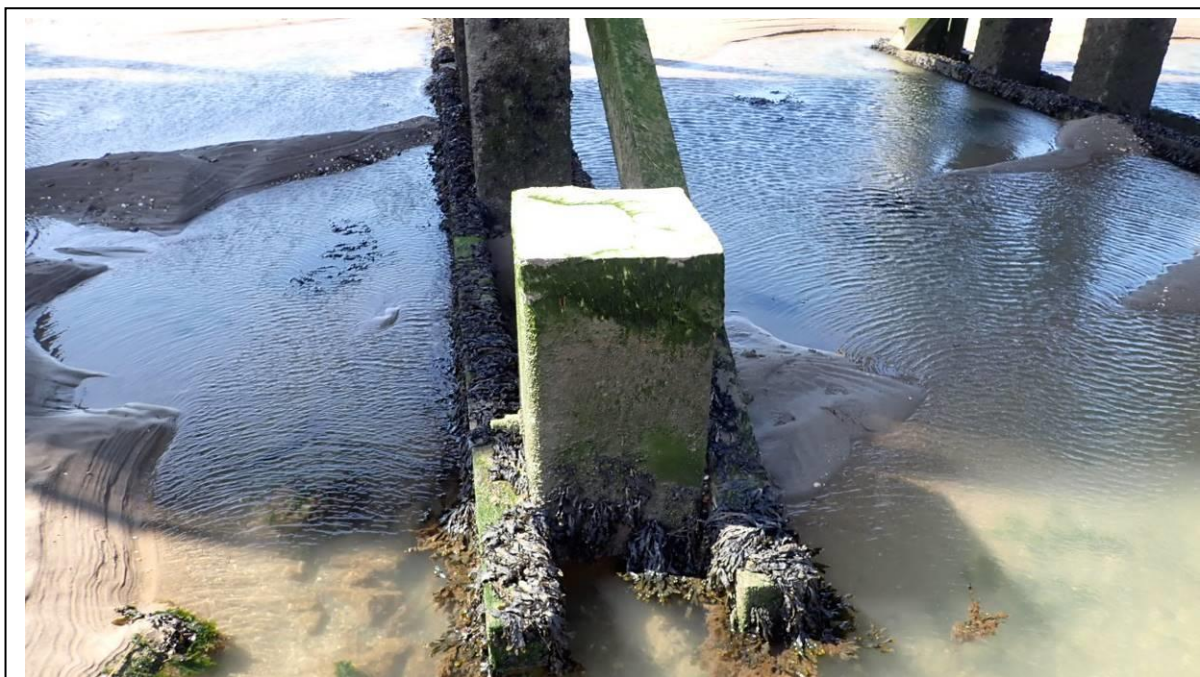
Photo 17 Trestle 17 – Upside outrigger repaired

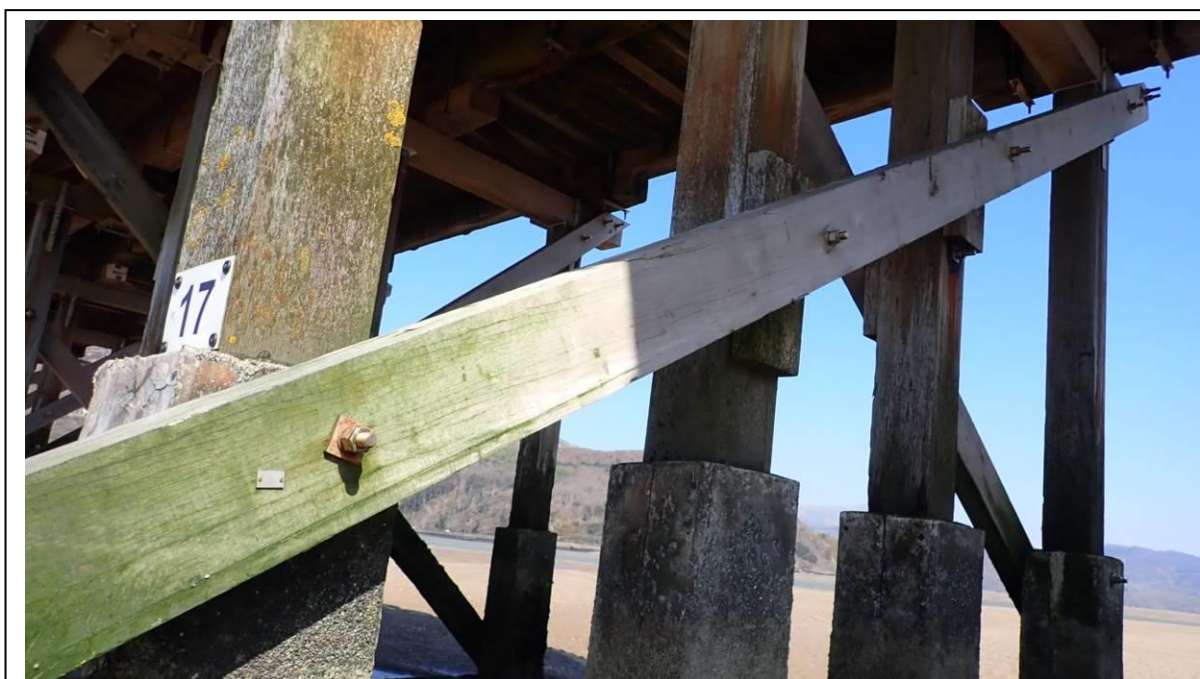
Photo 18 Trestle 17 – LM diagonal brace replaced 10/21

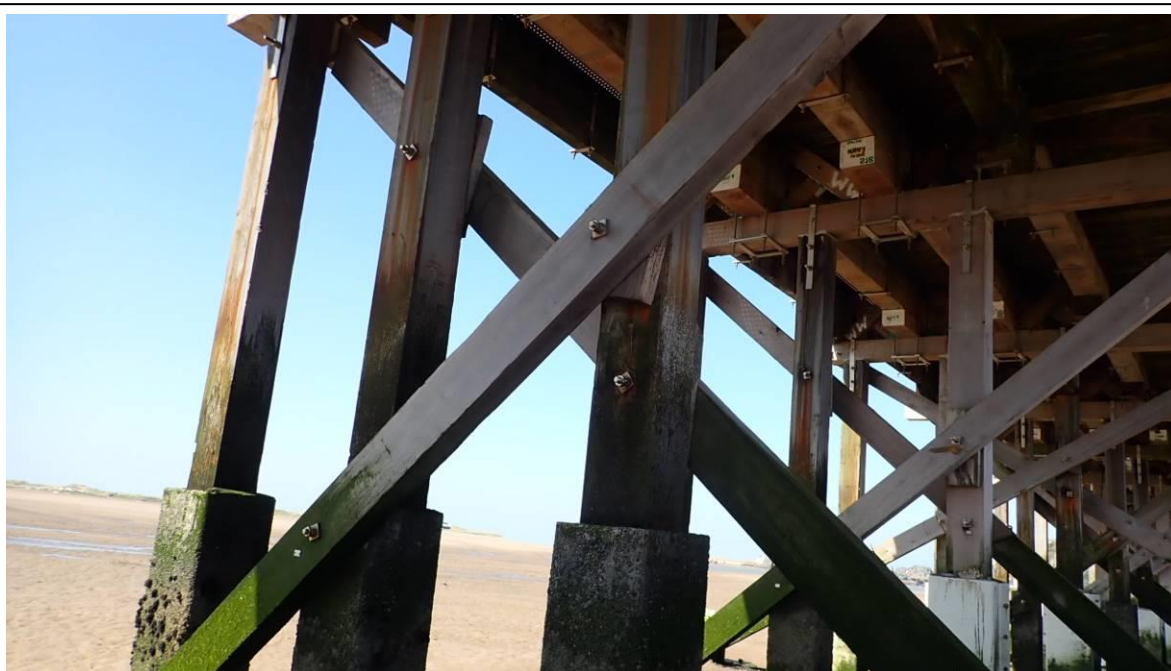
Photo 20 Trestle 20 – New timber to LM diagonal brace, plus new packer

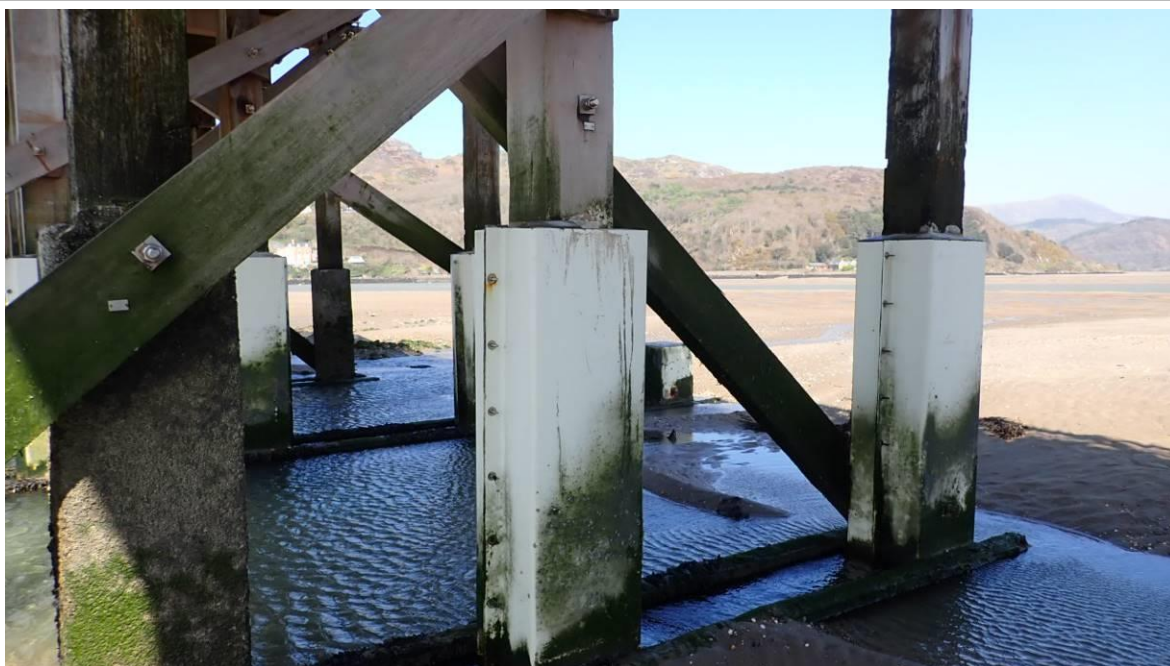
Photo 21 Trestle 21 – Pile 2 – Encasement in fair condition

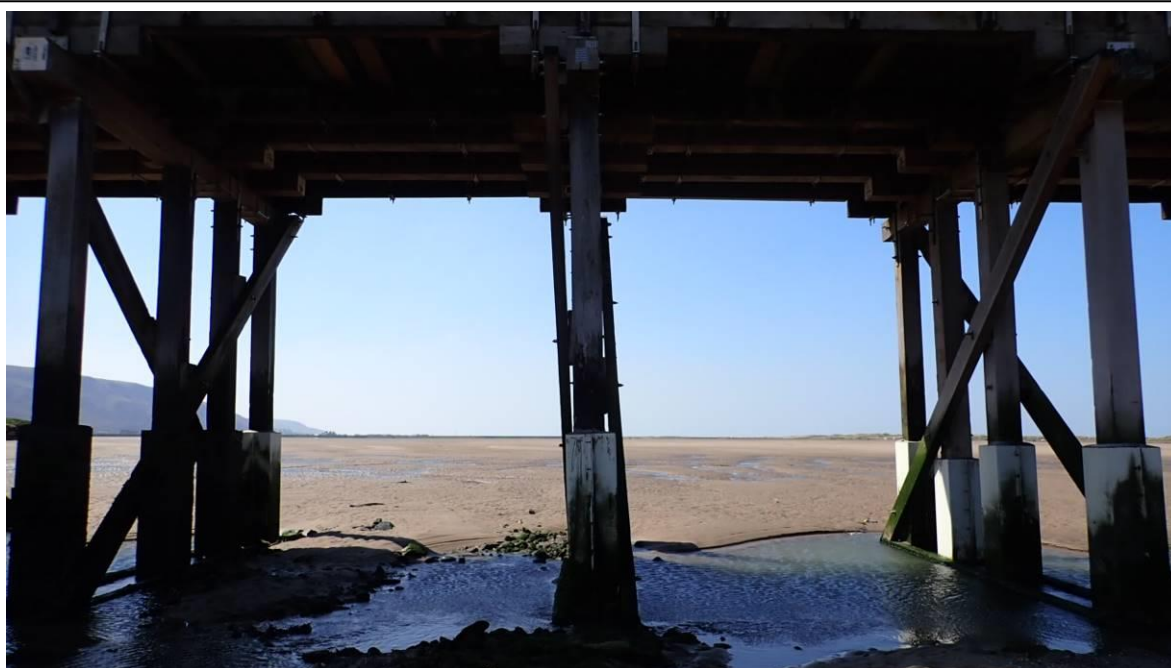
Photo 23 Trestle 24 – All piles appear to be out of plumb 10 degrees.

| | degrees out of plumb. Arrange for a competent person to visit site to determine the probable cause of the leaning and the lean is likely to worsen. Set up two sets of brass / stainless steel plumb bob monitoring points for use at future exams. | | | | | | | | | | | |

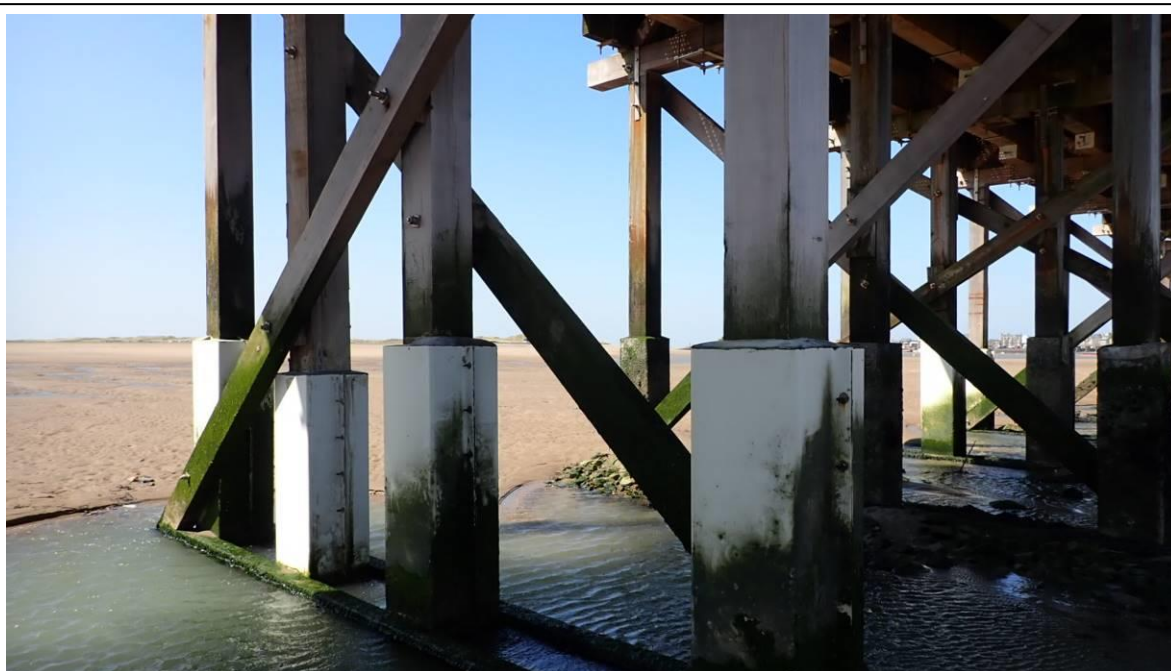
Photo 24 Trestle 25 – Repairs

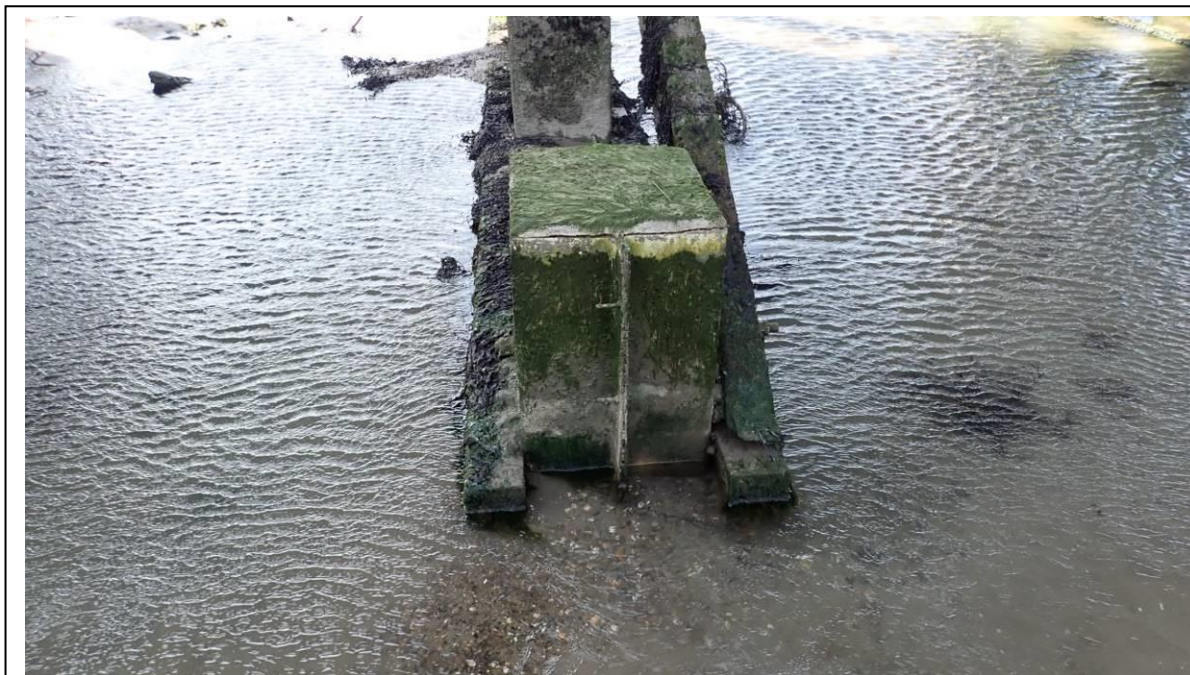
**Photo 27** Trestle 27 – Upside outrigger has been repaired

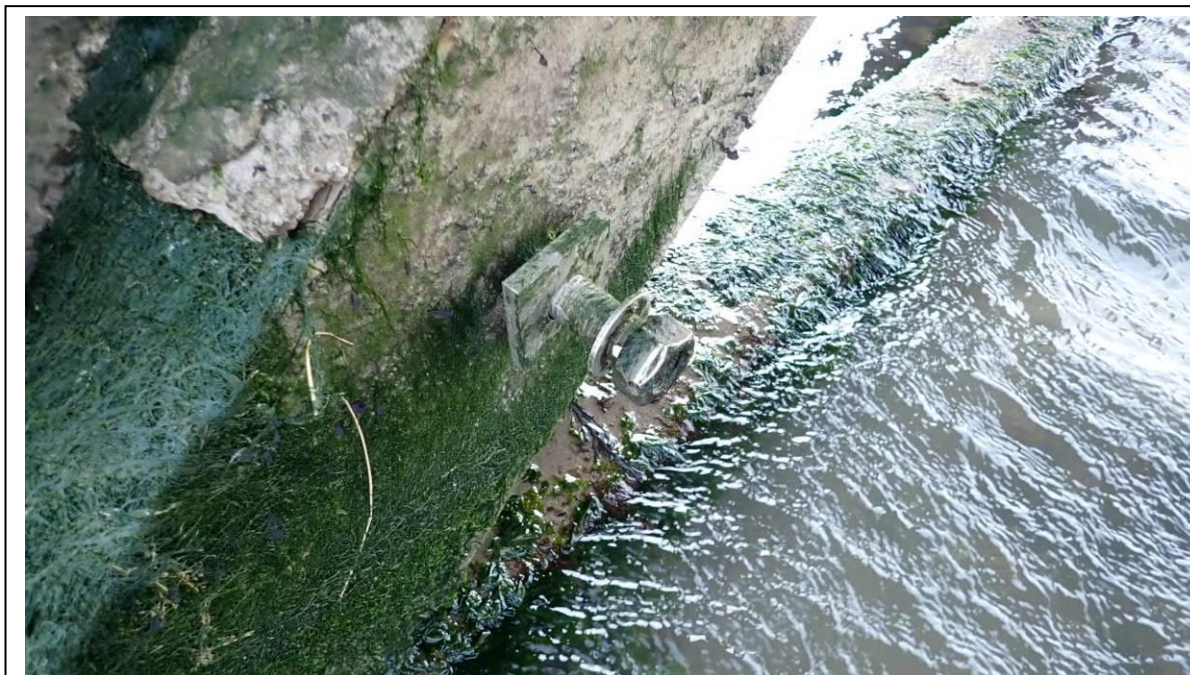
**Photo 28** Trestle 30 – Pile 4, HM side loose bolt

| | | <p align="center"><b>NETWORK RAIL</b></p> <p align="center"><b>Underwater Examination Report</b></p> | | | | | | | |
|---|---|---|---|---|---|---|---|---|---|
| 4 | Repair metallic clamp / bolt and / or timber pack | T25/P2<br>T30/P4<br>T48/P3 / Dgn | 2.5K | 26weeks | 3unit | 3 | 3 | S9 | Timber Deck Repair/Renewal |

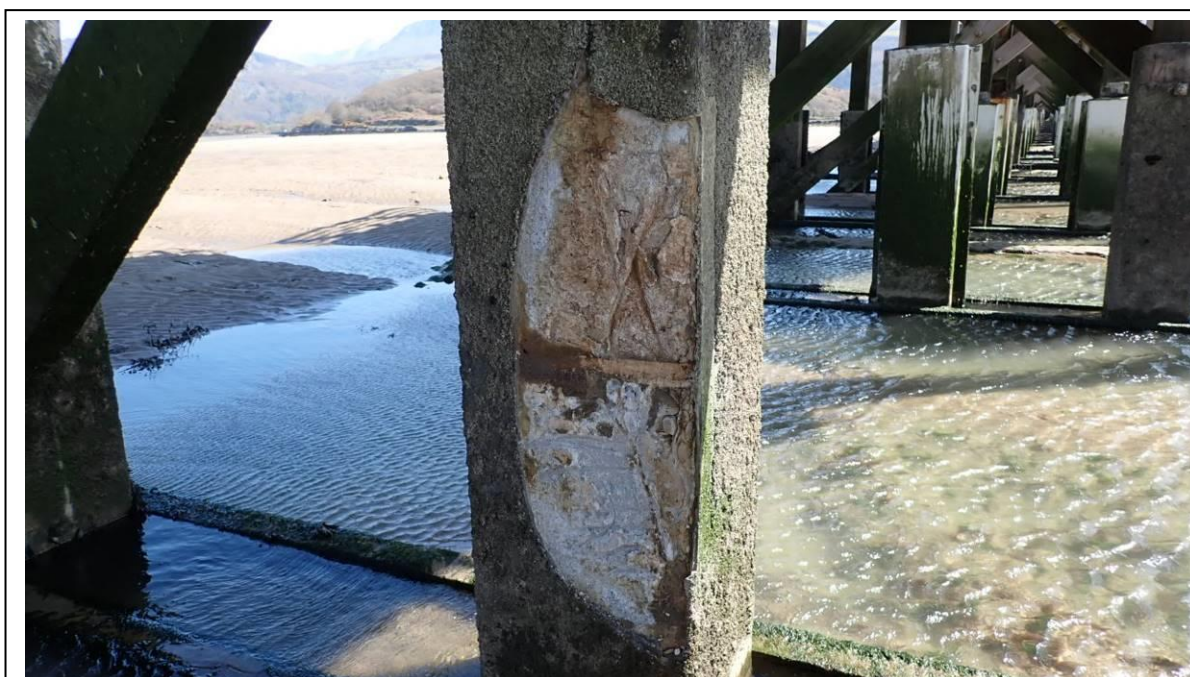
Photo 30 Trestle 31 – Pile 3, NEW area of spalling to encasement.

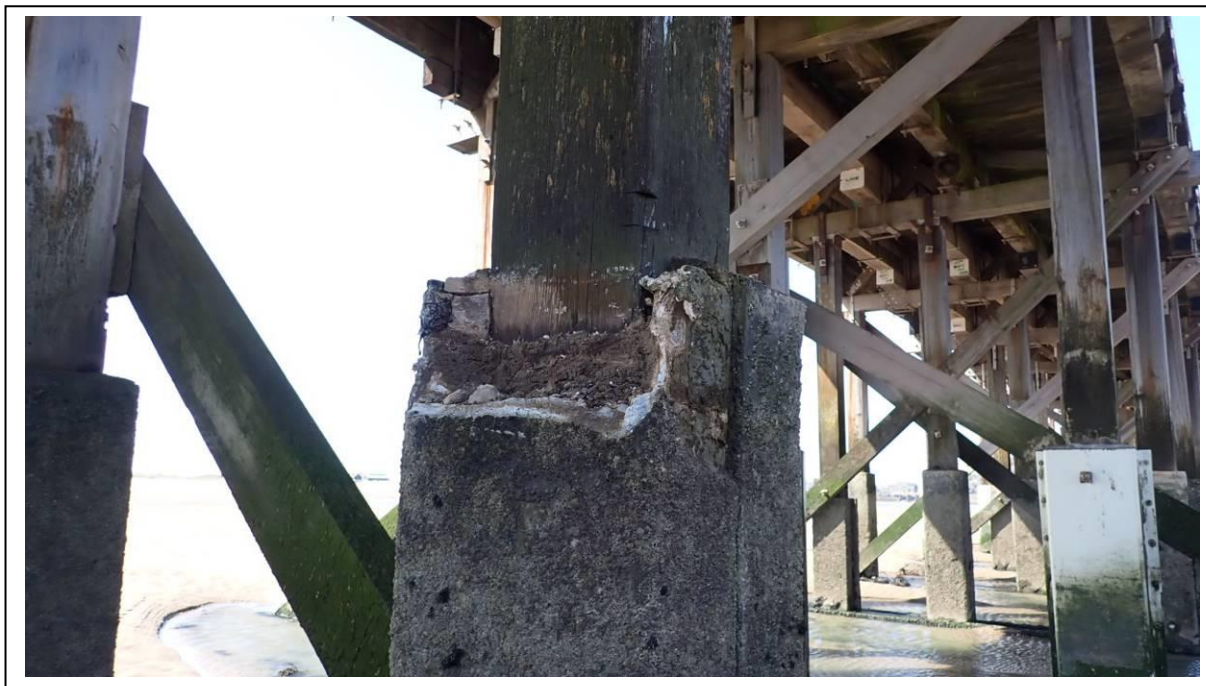
**Photo 31** Trestle 31 – Pile 4, loss of casement at top, LM face [NEW]

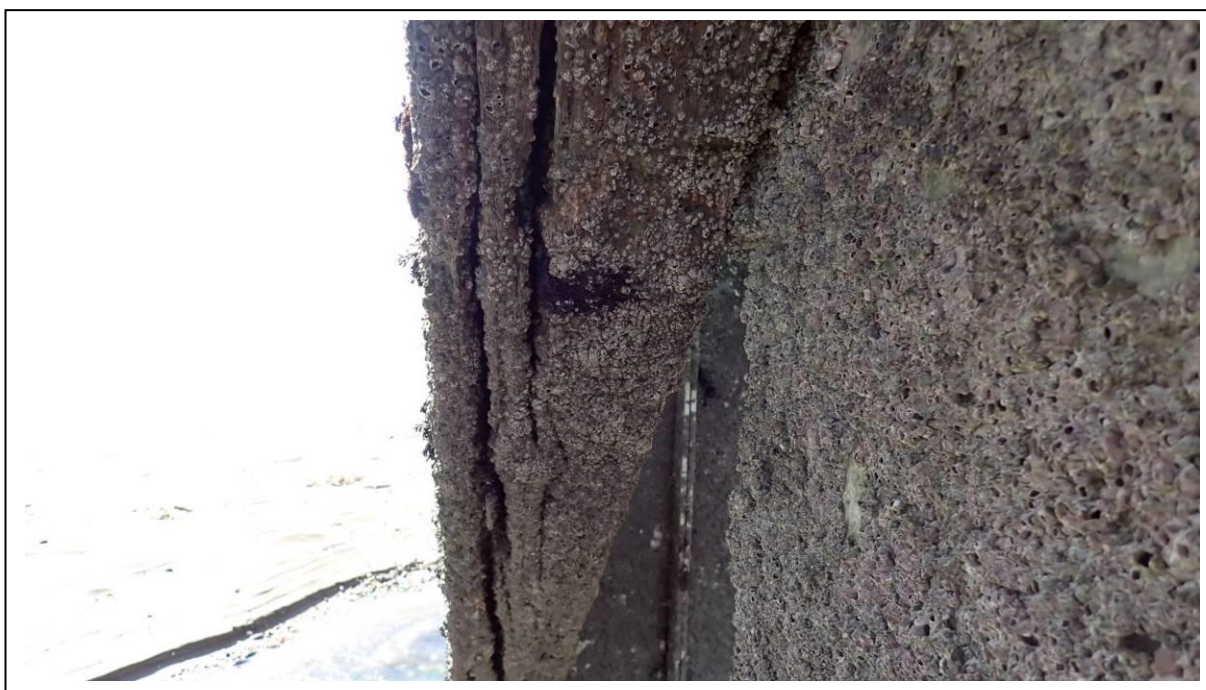
**Photo 32** Trestle 33 – LM diagonal brace has low level splits

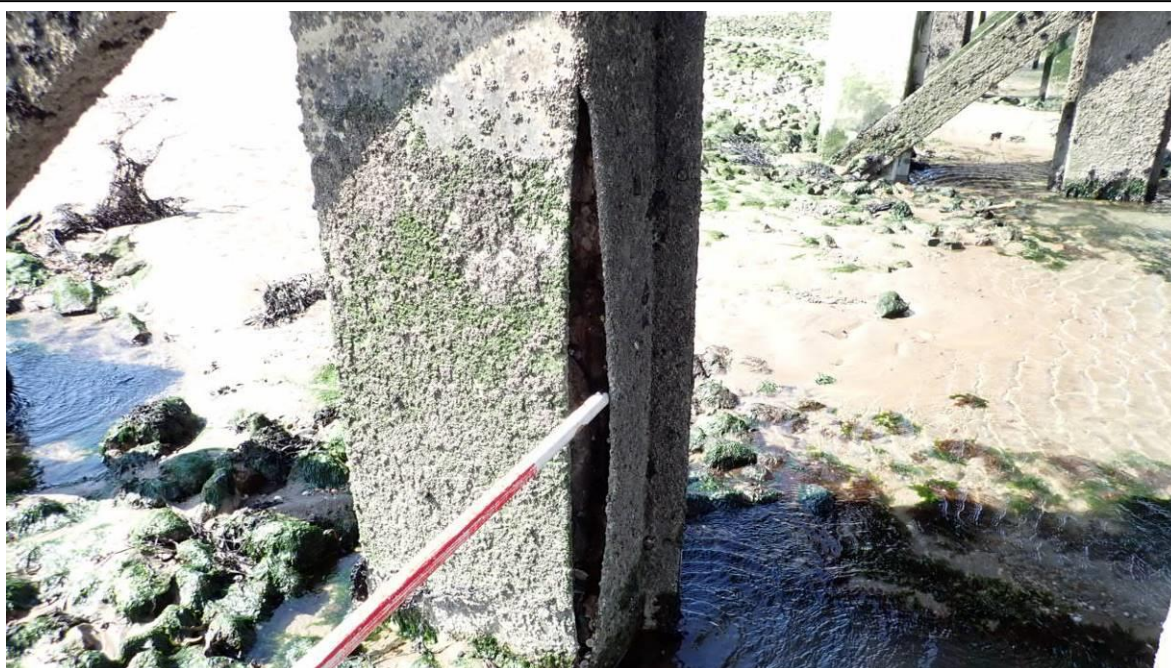
Photo 34 Trestle 42 – Pile 1, split to encasement to LM side

| | | <p align="center"><b>NETWORK RAIL</b></p> <p align="center"><b>Underwater Examination Report</b></p> | | | | | | | |
|---|---|---|---|---|---|---|---|---|---|
| 1 | Concrete repairs including crack injection to or widely cracked or damaged pile casings (Works ongoing) | T4/P1<br>T6/P1&4<br>T9/P3<br>T10/P1<br>T15/P3<br>T20/4<br>T27/P4<br>T39/P2<br>T42/P1&4<br>T54/P4 | 12K | 2yrs | 12unit | 1 | 4 | S4 | Concrete Repairs |

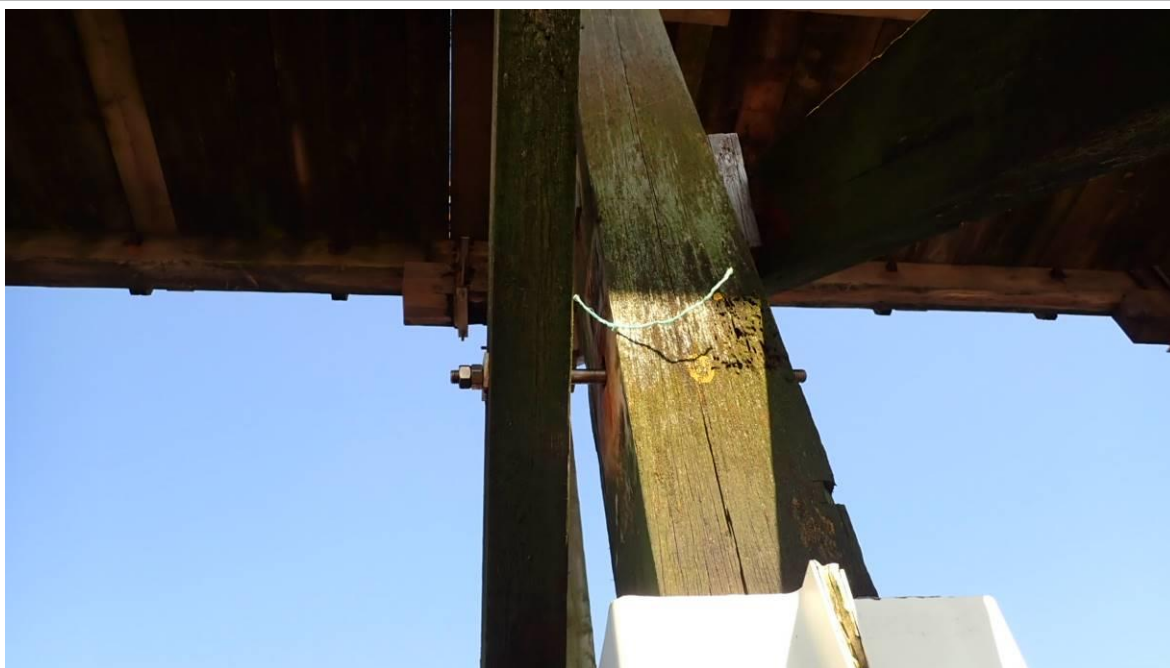
Photo 35 Trestle 48 – Pile 3, missing packer to HM Diagonal brace

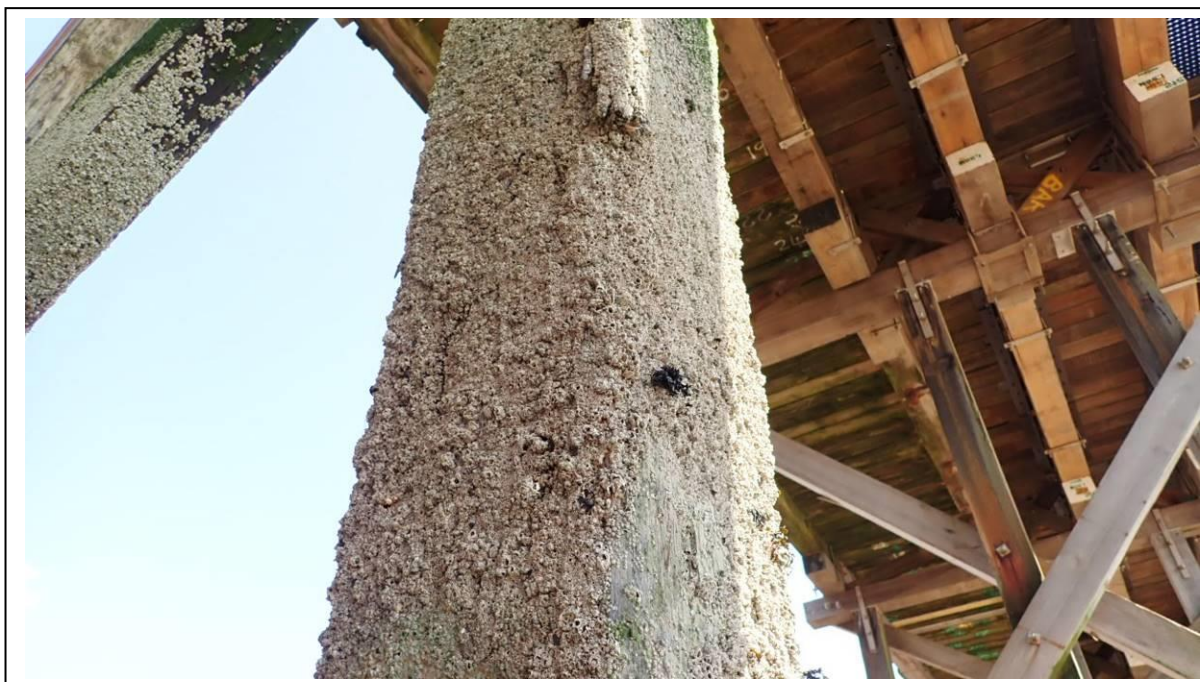
Photo 38 Trestle 109 – Pile 3, Splinter to DS HM corner

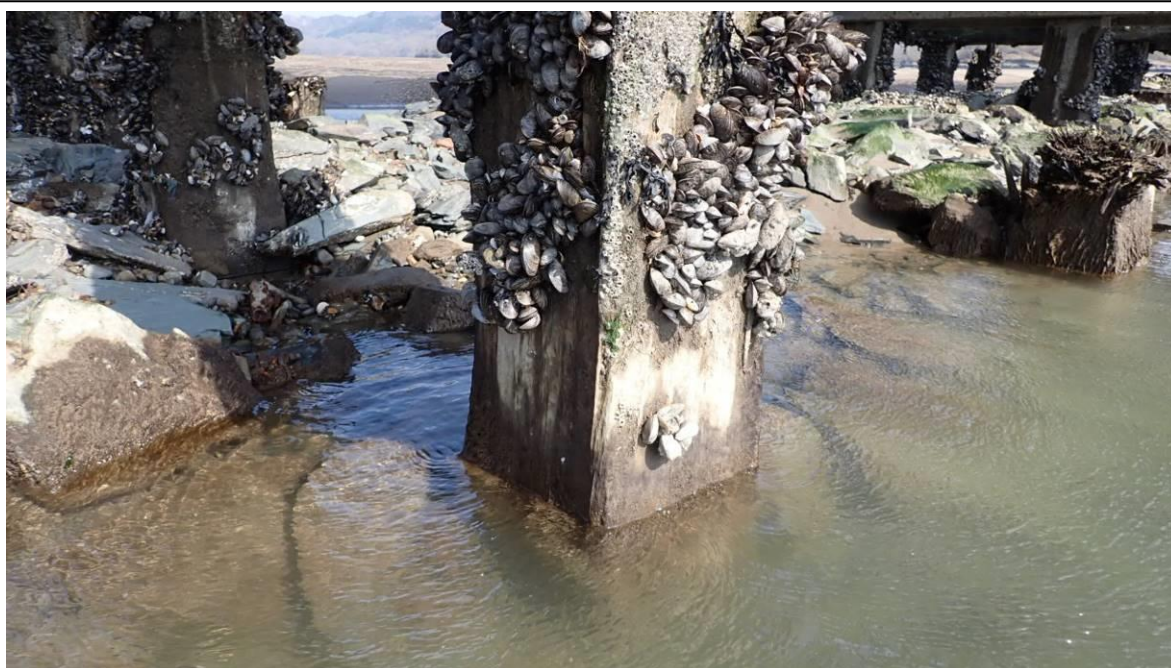
**Photo 41** Trestle 98 – Pile 1, splits and thinning

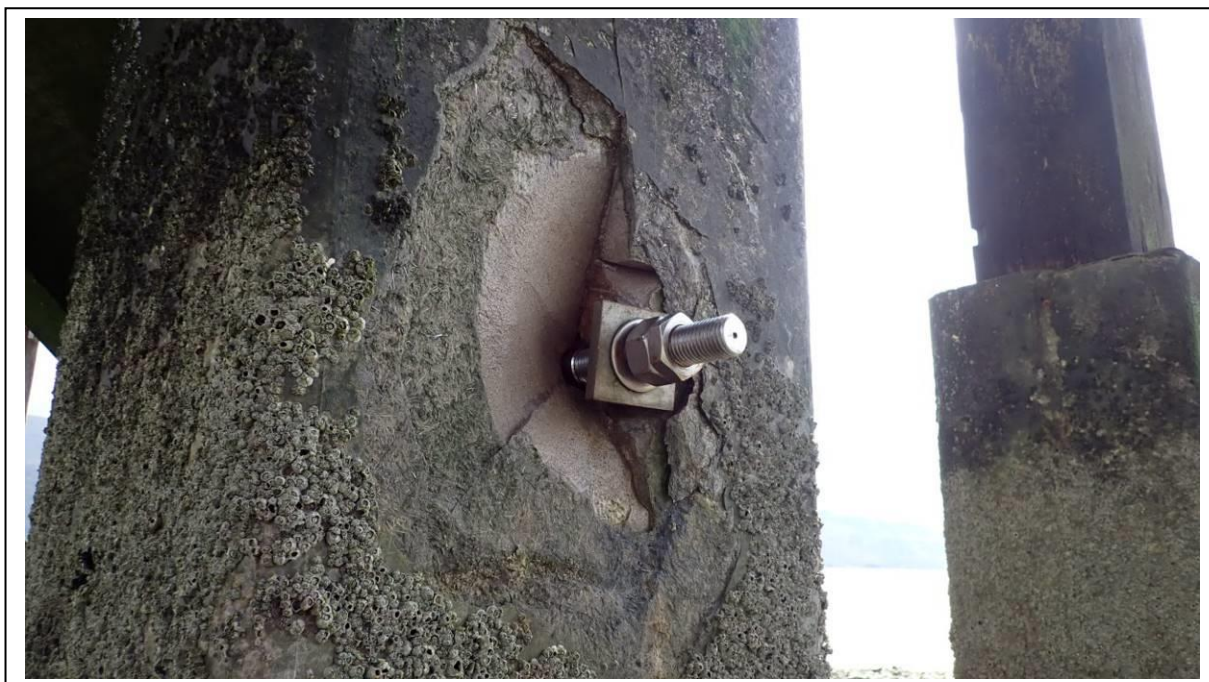
Photo 45 Trestle 51 – Pile 2, spalling at bolt [NEW]

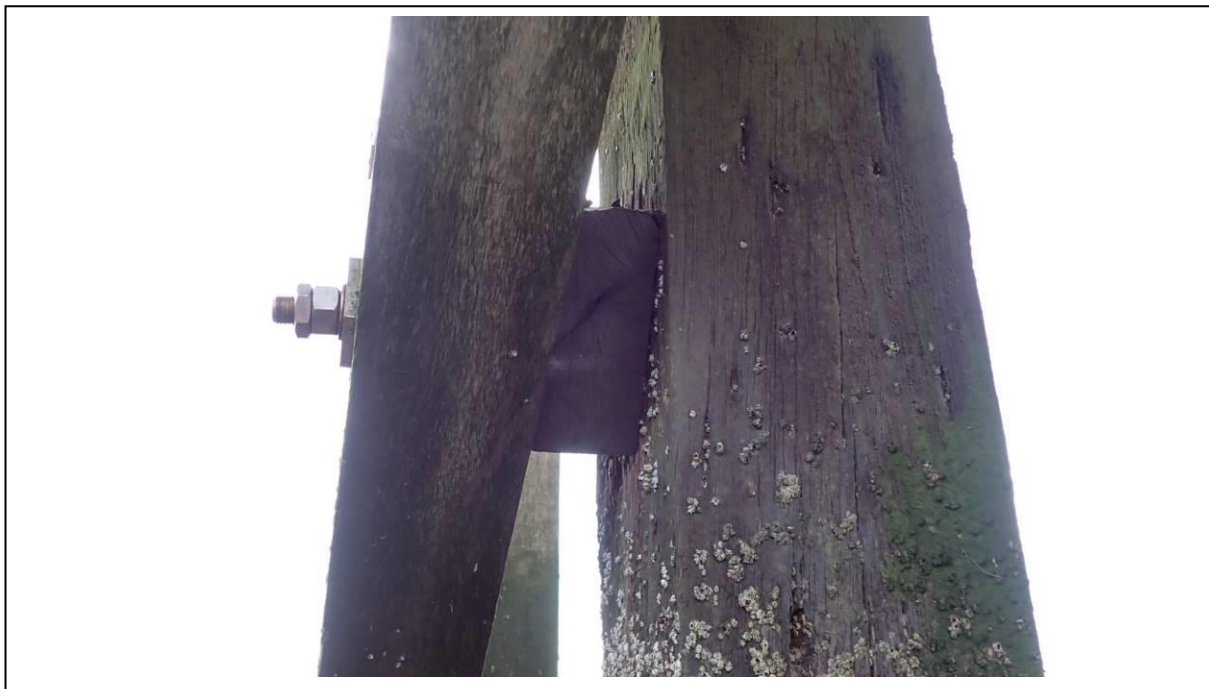
Photo 51 Trestle 73 – New packer installed to LM diagonal brace

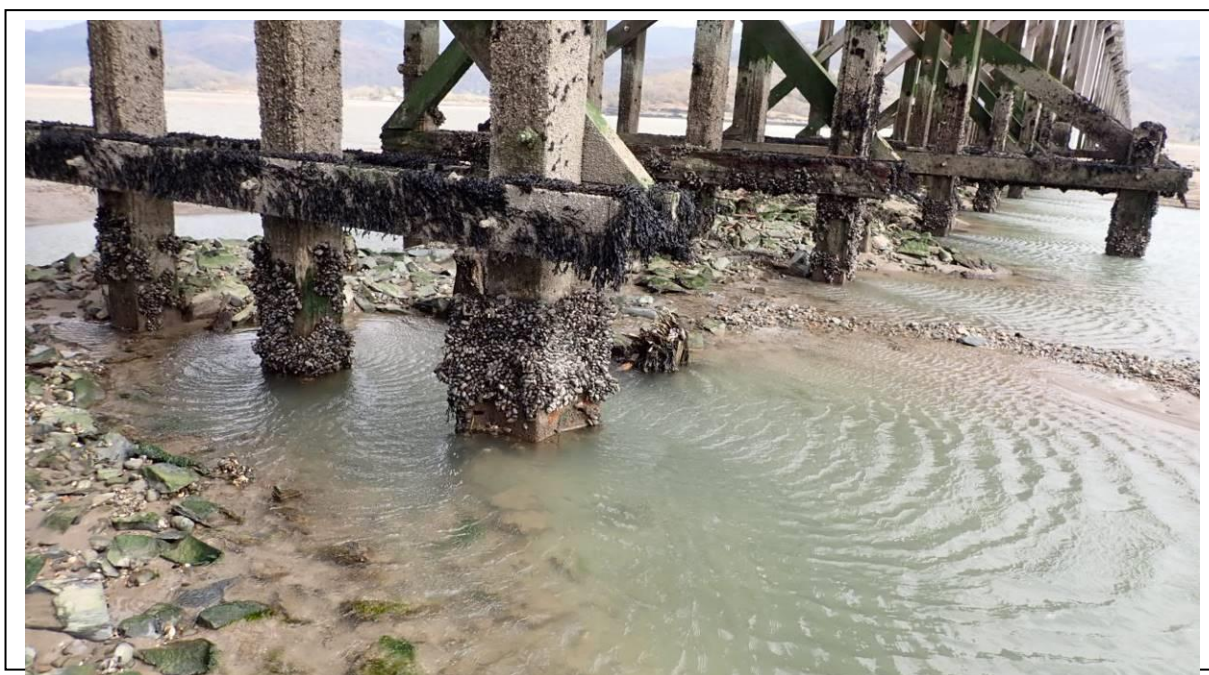
Photo 52 Trestles 74 – 80 & 84. Typical scour pools forming

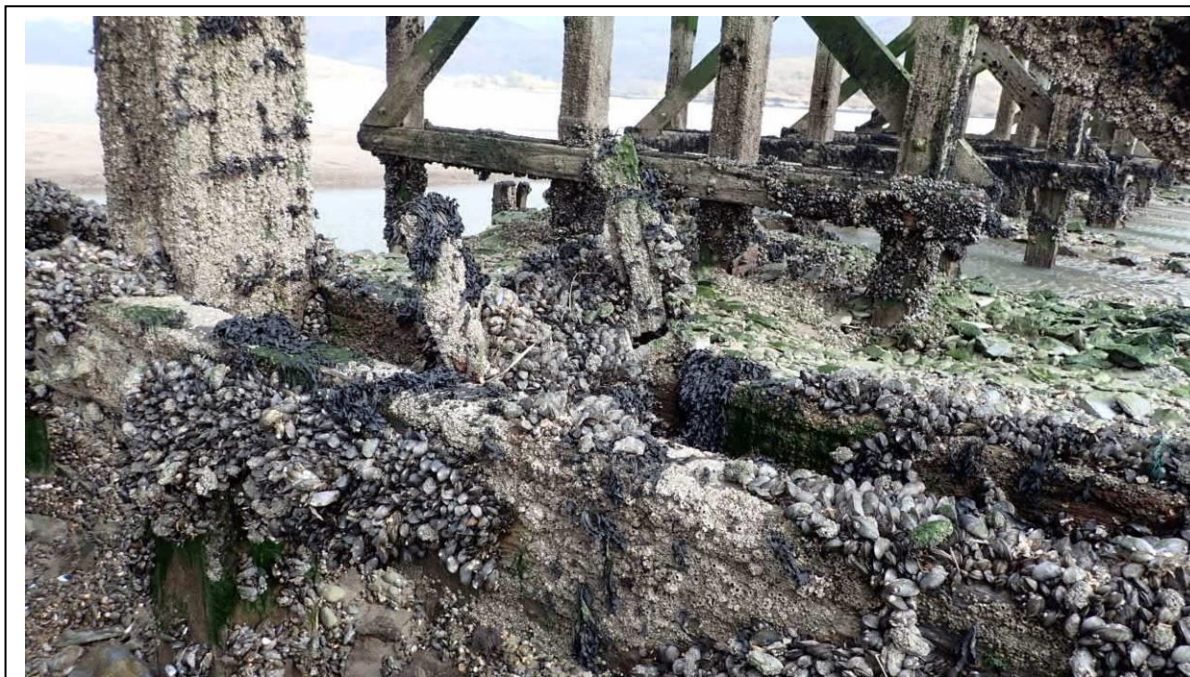
Photo 53 Trestle 82 – Down side outrigger, broken between horizontal and diagonal brace

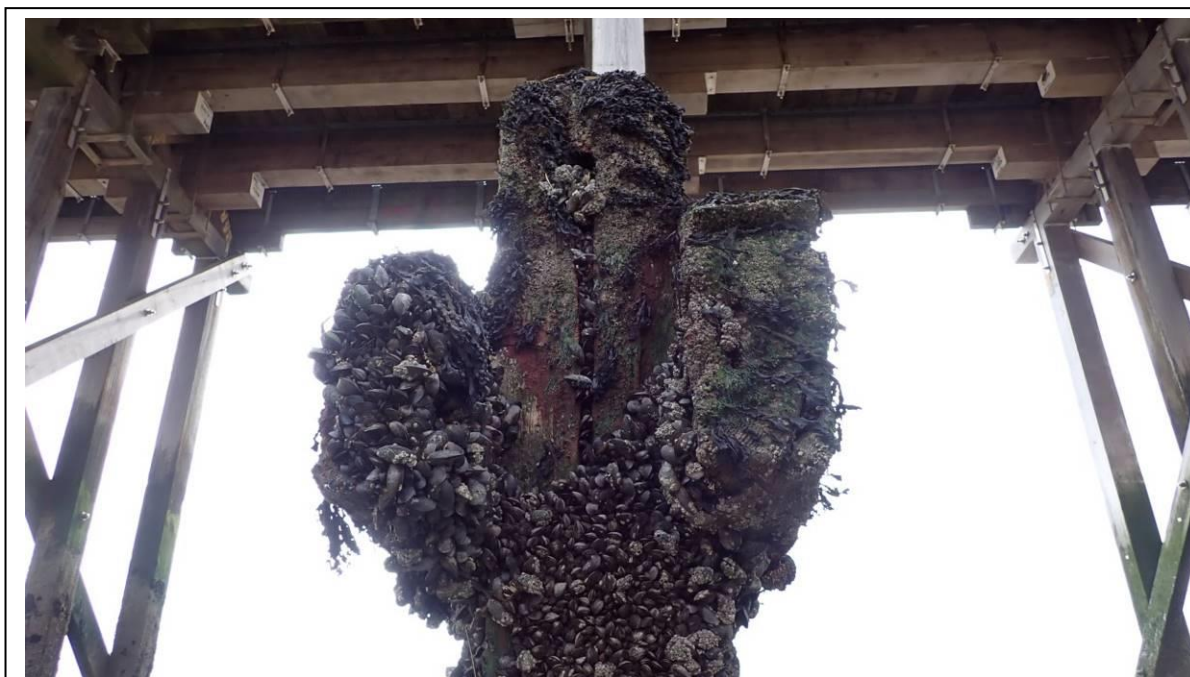
Photo 54 Trestle 82 – Upside outrigger, split
