| | | <p align="center"><b>NETWORK RAIL</b></p> <p align="center"><b>Underwater Examination Report</b></p> | | | | | | | |
| Examination Type: Underwater | | NR ID: | | | Exam Date: 18/04/2023 | | | | |
| Structure Name: Barmouth Viaduct (Timber) | | | | Type: | BV | | Exam ID: | 15614452 | |

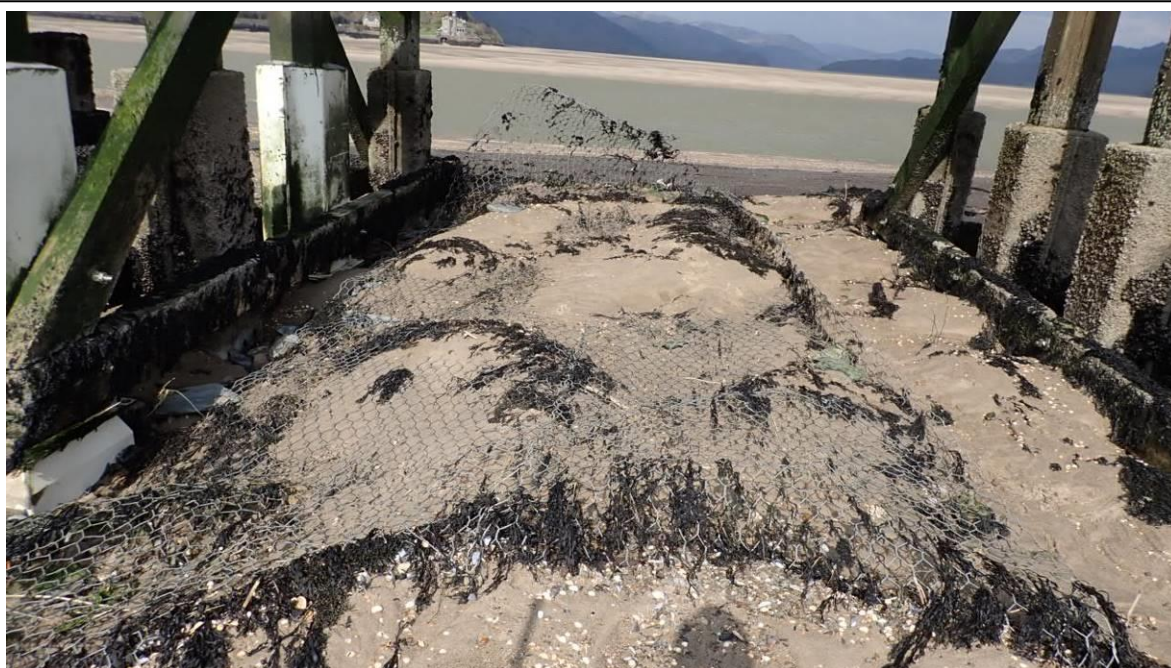
Photo 57 Typical mesh on bed – poor condition, lifting to span 1 - 80

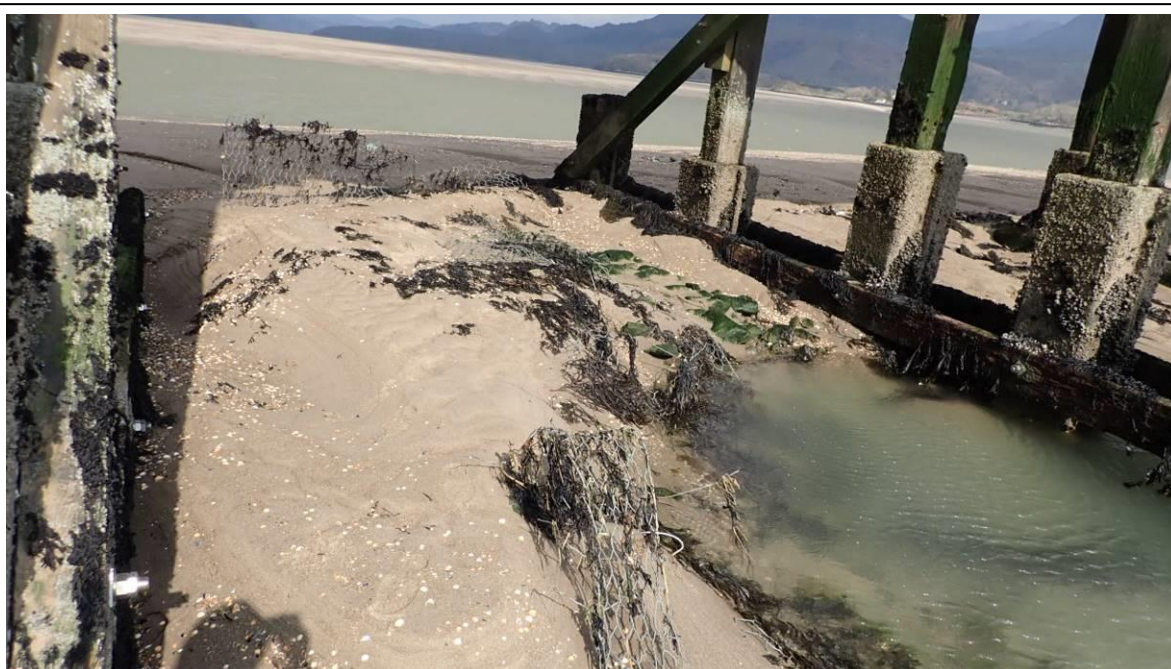
Photo 58 Typical view of damaged mesh
