Compliance Assessment Report CAR_NRW0043902

Permit being assessed: AN0337201

For: Site drainage under storm conditions at Hafod Quarry, held by TARMAC TRADING LIMITED

At: Hafod Quarry, Abercarn, Newbridge, Caerphilly, NP11 5LH.

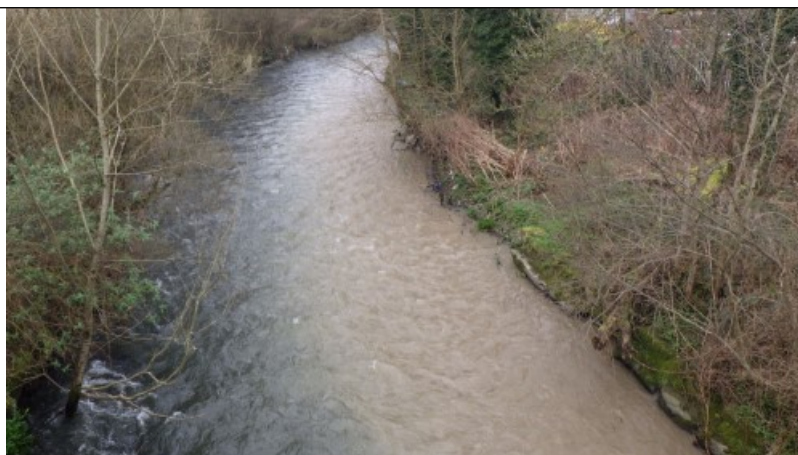
At 14:35, prior to attending the site, I inspected the watercourse (River Ebbw) from the footbridge at ST2169995607. Brown discolouration was observed upstream (source not visible) and downstream for ~250m before the watercourse meanders left out of sight. Some odour was present but it was not prominent or distinguishable. Photos were taken as evidence (Figures 1 and 2). I proceeded to investigate potential sources.

Figure 1 – Site visit photo: Upstream view of the main river from the footbridge at ST2169995607. Source not visible.

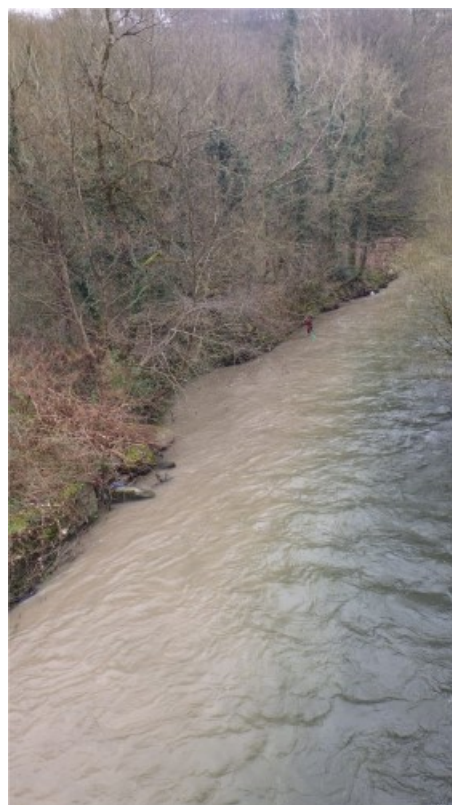
Figure 2 – Site visit photos: Downstream view of the main river from the footbridge at ST2169995607.

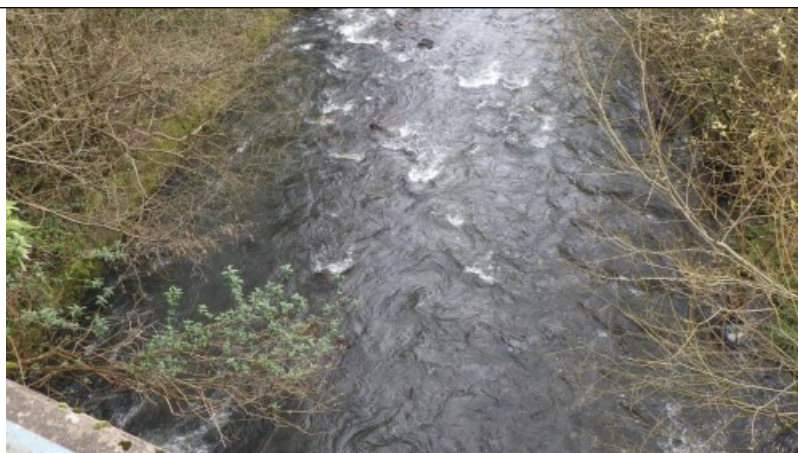
At 14:55 I checked upstream from the road bridge at ST2164295798. No discolouration was seen upstream of this bridge. A brown discharge was seen entering the watercourse from a tributary (identified later as Nant Hafod-fach) ~100m downstream of this point at ST2165995732. This tributary is known to flow from the Hafod Quarry site. Photos were taken as evidence (Figures 3 and 4).

Figure 3 – Site visit photos: Upstream view of the main river from the road bridge at ST2164295798. No pollution visible.

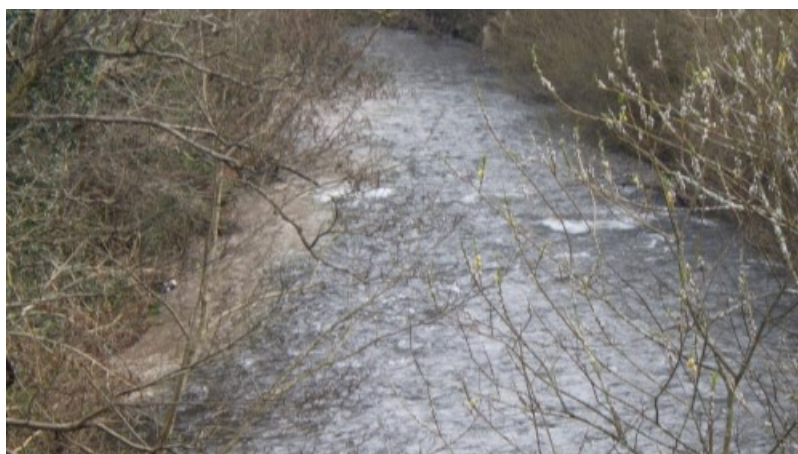
Figure 4 – Site visit photos: Downstream view of the main river from the road bridge at ST2164295798. Brown discharge seen entering the watercourse from Nant Hafod-fach ~100m downstream of this point at ST2165995732.

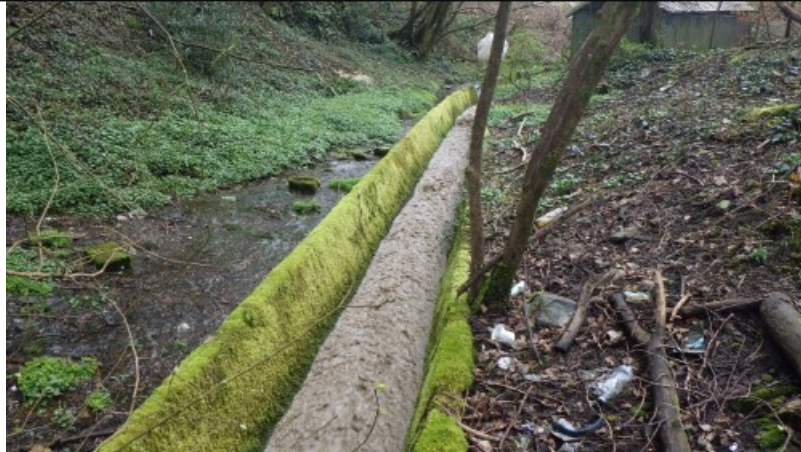
At 15:00 I observed the watercourse (Nant Hafod-fach) within a concrete channel at ST2194295860. It was heavily polluted with silt and displayed very high turbidity. Photos were taken as evidence (Figures 5 and 6). It was decided that the Hafod Quarry discharge point was to be checked. A silty runoff was also seen flowing down Lower Brook Street (Figure 7).

Figure 5 – Site visit photos: Downstream view of silty water seen running within the concrete channel at ST2194295860.

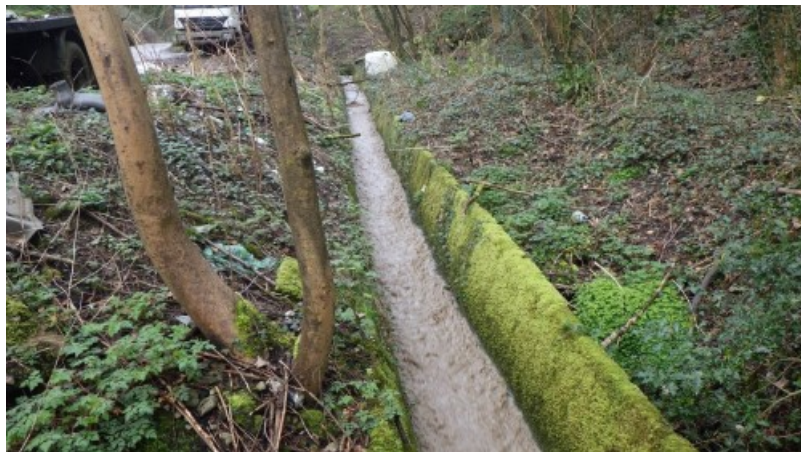
Figure 6 – Site visit photos: Upstream view of silty water seen running within the concrete channel at ST2194295860.

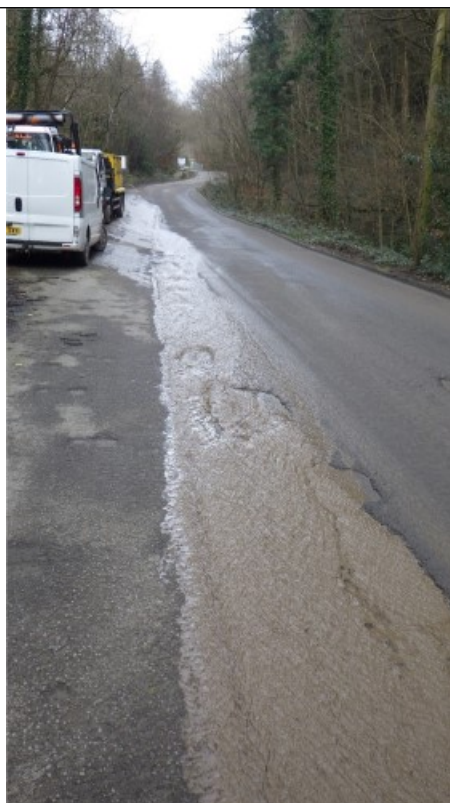
Figure 7 – Site visit photos: Silty runoff seen flowing down Lower Brook Street.

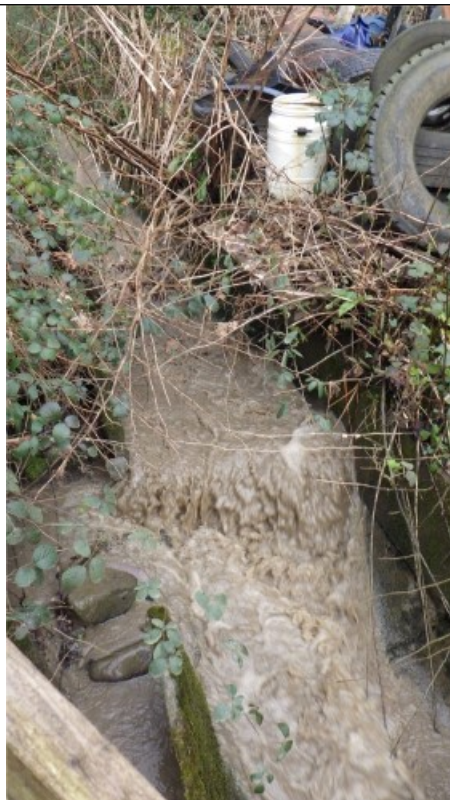
At 15:08 I checked Hafod Quarry's discharge point at ST2199795988. The same silty discharge was observed. At this stage it was assessed that an offence had been committed under The Environmental Permitting (England and Wales) Regulations 2016 (EPR 2016). Photos were taken as evidence (Figure 8). I took formal evidence samples from the monitoring point at ST2199195983 at 15:08 and 15:10 (2 litre Glass/GCMS and 2 litre Plastic/GEN). Photos were taken as evidence (Figure 9). Samples were to be split and served to site manager.

Figure 8 – Site visit photos: Silty water seen flowing at the permitted discharge point at ST2199795988.

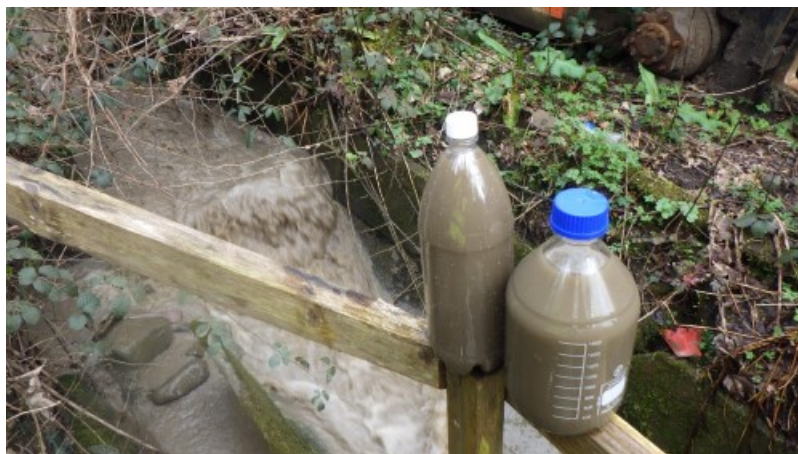
Figure 9 – Site visit photos: The formal evidence samples taken from ST2199195983 to be split and served to the site manager at Hafod Quarry.

Suspended solids results have been returned and have been measured at 2950mg/l, as seen in Table 1 below. NRW would raise concerns if suspended solids were measured at any concentration over 100mg/l.

Based on the sample results it is clear that both total suspended solids and semi volatile compound breaches are present in the sample results. This stands as a breach of this permit condition as well as the EPR 2016 regulations.

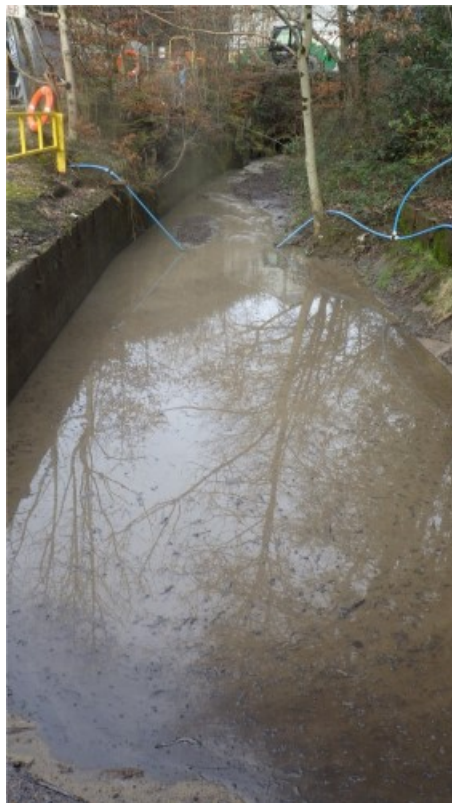
At 15:23 the settlement pond at ST2227096357 was checked. The water level was very high and silt was not settling out. This water was clearly overtopping the weir and leaving site untreated. Photos were taken as evidence (Figures 10 and 11). The site manager noted they were dealing with high flow rate due to recent heavy rainfall at the time of the visit.

Figure 10 – Site visit photos: The settlement pond at ST2227096357 as observed during the visit. Silt was clearly not settling out before discharging off site.

2. Undertake improvement works on site drainage infrastructure to ensure the system has capacity to manage the volumes of runoff experienced on site. This should also include techniques that ensures no polluting material is discharged to Nant Hafod-Fach.

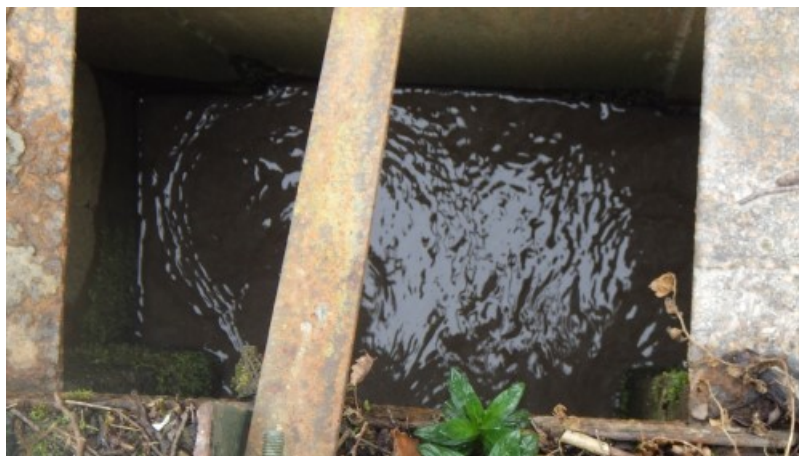
Figure 11 – Site visit photos: Silty water seen exiting the settlement pond at ST2227096357.

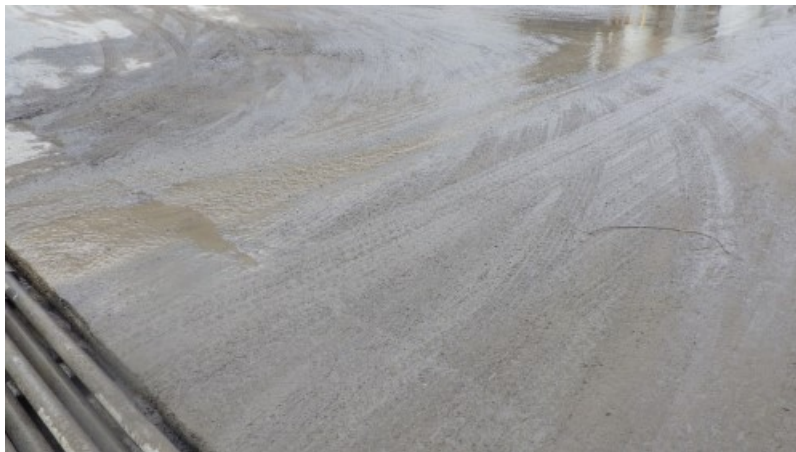
At 15:26 the site drainage catch pit at ST2223896331 was observed to be working effectively and preventing runoff from site discharging to the road. Photos were taken as evidence (Figures 12 and 13).

Figure 12 – Site visit photos: Quarry road runoff seen entering the catch pit at ST2223896331.

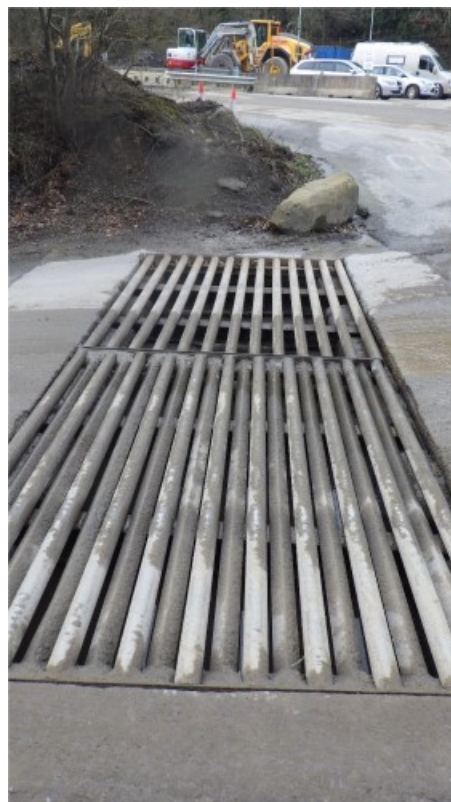
Figure 13 – Site visit photos: The catchpit as observed during the visit at ST2223896331. Appears to be working as designed. No concerns noted.

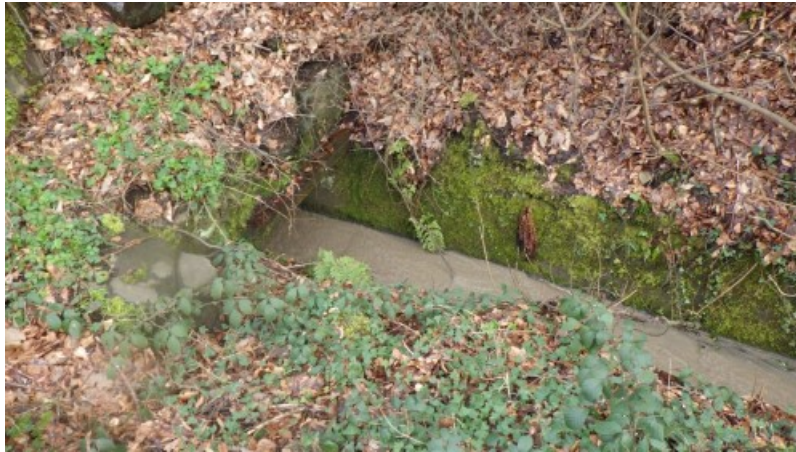
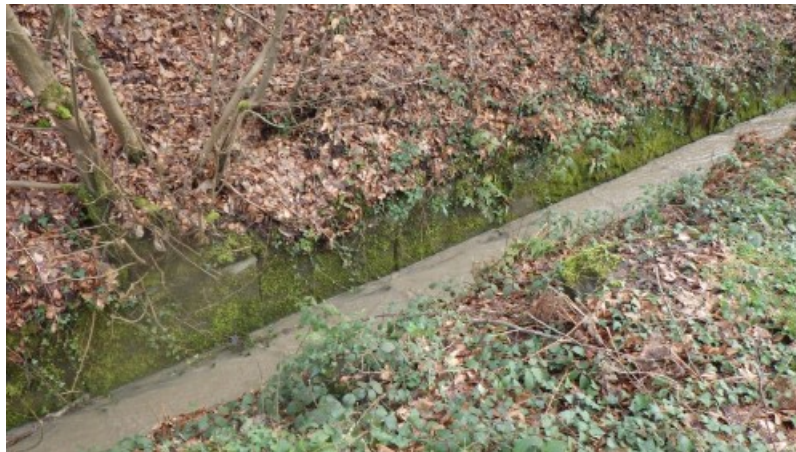
At 15:30, on inspection, contaminated water was clearly seen leaving site via the concrete channel at ST2223596317. Photos were taken as evidence (Figures 14 and 15). I

explained the regulations and responsibilities regarding site discharges to the site manager who accepted but noted that it was natural runoff which crosses site and goes into their drainage system. I requested to investigate drainage infrastructure on site with the site manager.

Figure 14 – Site visit photos: The silty discharge observed leaving site and discharging into the concrete channel at ST2223596317.

Figure 15 - Site visit photos: The silty discharge observed leaving site and into the concrete channel at ST2223596317.

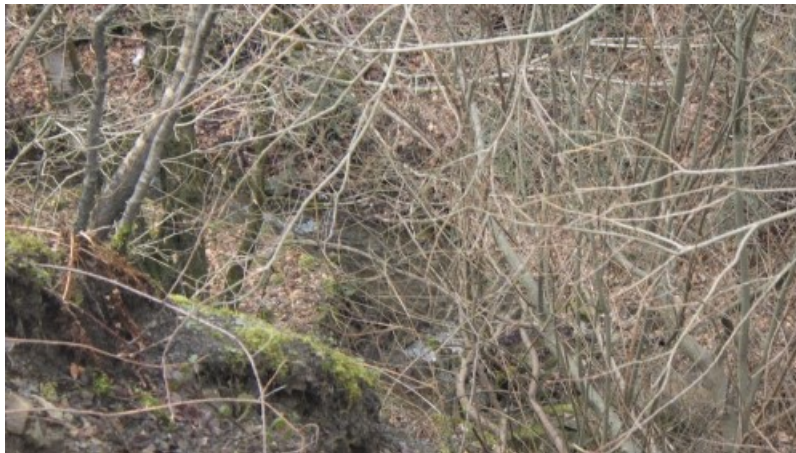
At 15:45 the watercourse (Nant Hafod-Fach) that runs onto site was observed at ST2265896942. There was no visible pollution present where the watercourse enters the site. Photos were taken as evidence (Figure 16). The site manager noted that this watercourse is culverted under settlement pond 2 and exits under the workshop/site office and discharges via the settlement pond near the site entrance at ST2227096357.

Figure 16 – Site visit photos: Nant Hafod-fach as observed during the visit where it enters the site. No visible pollution observed.

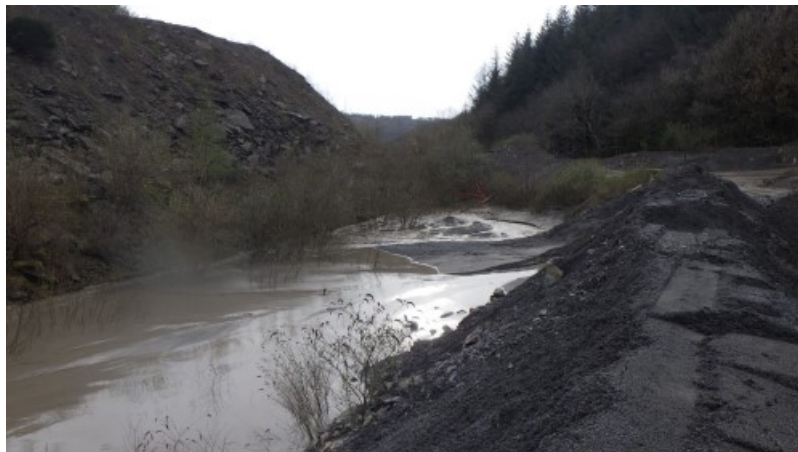
At 15:51 settlement pond 1 was observed at ST2257396557. Active pumping from settlement pond 2 was ongoing at the time of the visit. The site manager stated that the effluent "goes to ground" in settlement pond 1. I observed that the effluent was actively leaving settlement pond 1 and returning to settlement pond 2. The site manager clarified that the pump keeps the water in a circular loop in an attempt to keep it on site. He also stated that there is no drainage to manage these settlement ponds and that it is "all natural". Photos were taken as evidence (Figures 17, 18 and 19).

Figure 17 – Site visit photos: Settlement pond 1 as observed during the visit from ST2257396557. Active pumping from settlement pond 2 into settlement pond 1 is visible here.

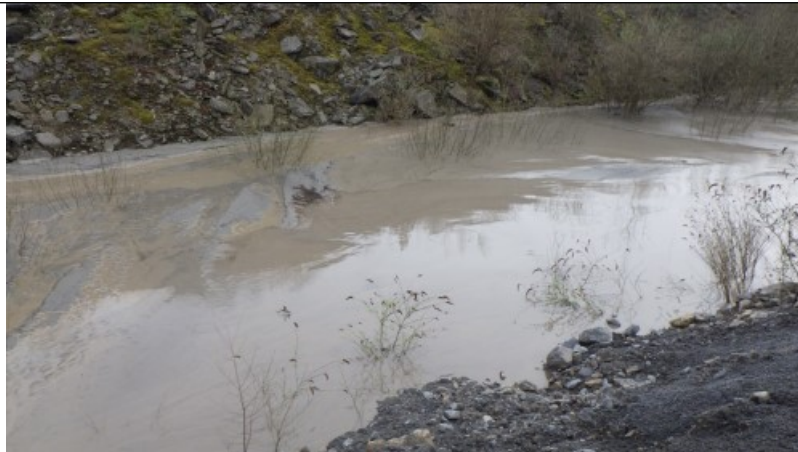
Figure 18 – Site visit photos: Settlement pond 1 as observed during the visit from ST2257396557. The water appears heavily silted throughout.

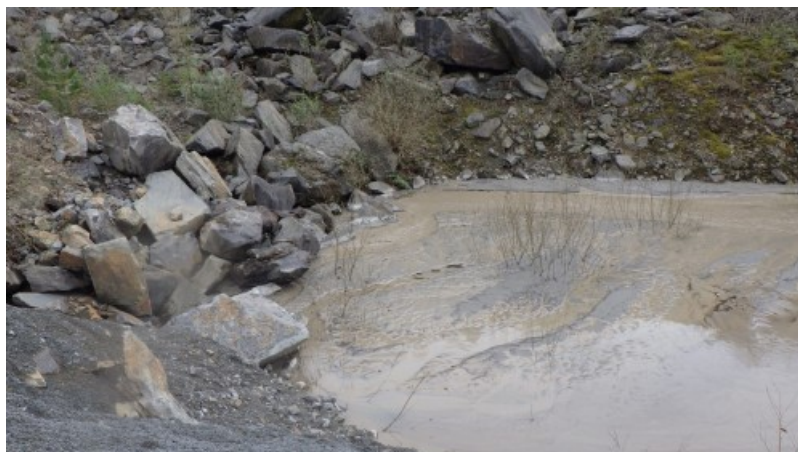
Figure 19 – Site visit photos: Settlement pond 1 as observed during the visit from ST2257396557. At this point it was stated that the water infiltrates to the ground.

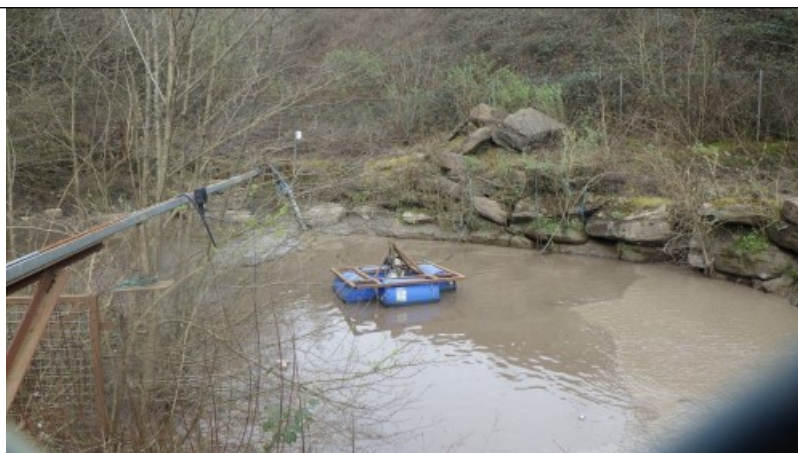
At 15:58 settlement pond 2 was observed at ST2243496478. An active flow was seen entering settlement pond 2, which GA confirmed was the discharge from settlement pond 1. Photos were taken as evidence (Figures 20 and 21). Pumping of effluent from settlement pond 2 was observed here which was described as an attempt to keep the effluent on site. The site manager then admitted that there is a leak of effluent into an open culvert with connections to the watercourse at the point where the discharge from pond 1 enters pond 2. He stated that they have attempted to reduce this leak by taking blocks out of the headwall and diverting as much effluent as possible into pond 2 and not into the open culvert. It was stated that the company have employed the services of a Hydro Geologist from Stantec to investigate the site drainage issues and to devise a solution. An initial report has been compiled with the main issue identified being the lack of area on site to deal with the volume of water present.

Figure 20 – Site visit photos: Settlement pond 2 as observed during the visit from ST2243496478. Pumping operations are seen here, which were noted to have been taking place on site for “a long time.”

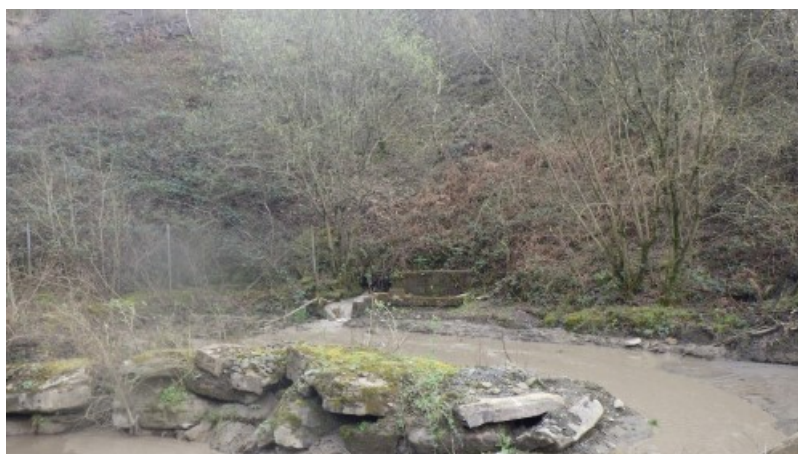
Figure 21 – Site visit photos: Settlement pond 2 as observed during the visit from ST2243496478. The point where the discharge from pond 1 enters pond 2 can be seen here.

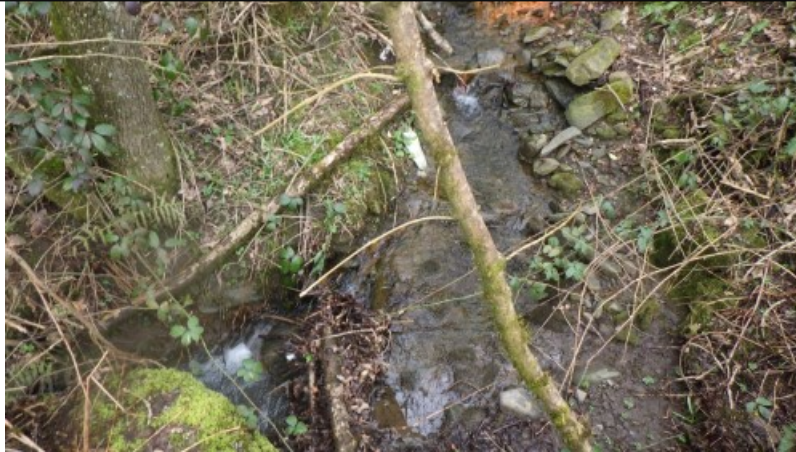
At 16:06 the point where the watercourse is culverted under the site was observed at ST2245396500. The water was clear on entry so any impact to it must be coming from the site. Photos were taken as evidence (Figure 22).

Figure 22 – Site visit photos: Nant Hafod-fach directly upstream of where it is culverted beneath the site at ST2245396500 as observed during the visit. No visible pollution present.

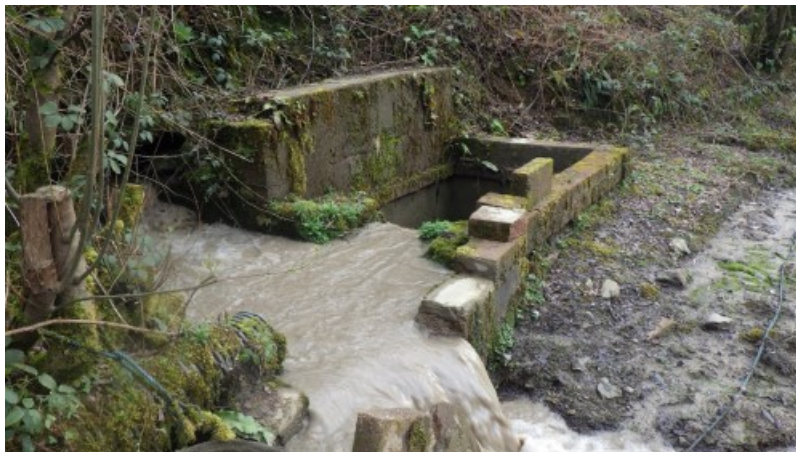
At 16:15 silted water was seen entering the open culvert at ST2245896470. This culvert connects to the culverted watercourse with no mitigation or treatment in place to remove the suspended solids or any other pollution. Photos were taken as evidence (Figure 23). I stated that the company must prevent the water leaving site via this culvert immediately e.g. by using sandbags or similar emergency methods. The site manager noted that this was not possible on the 19/03/24 but it would be actioned immediately and implemented as soon as possible on the 20/03/24. I requested that evidence of this emergency mitigation should be sent to me as soon as possible. No samples were taken due to access issues and H&S concerns. No further on-site investigations were undertaken after this point.

Figure 23 – Site visit photos: Silted water was seen entering the open culvert at ST2245896470. No samples were taken due to access and H&S concerns at the time of the visit.

The untreated/contaminated discharge is entering the Nant Hafod Fach via the open culvert at ST2245896470 and not via the consented discharge point stated in condition 3 of the permit.

1. Contain all site drainage on site and restrict any discharges leaving site via the open culvert at ST2245896470. This should be done as an emergency, temporary measure and not a long term site drainage solution.

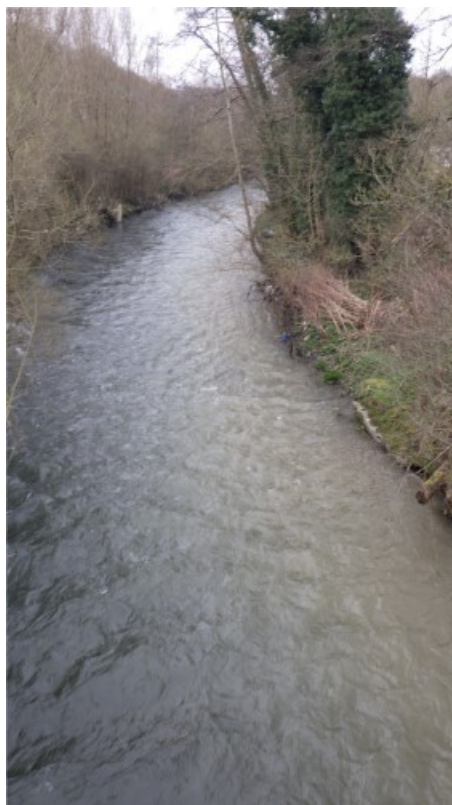
At 17:00 I checked the River Ebbw once more from the footbridge at ST2169995607. The silt was still visibly present as the site manager noted no actions to stop the pollution were feasible that evening. Daylight was diminishing at this point and access to watercourse was poor so no upstream or downstream samples could be taken at this time. Photos were taken as evidence (Figures 24 and 25).

Figure 24 – Site visit photos: Upstream view of the main river from the footbridge at ST2169995607 after site investigations concluded. Sediments still visible within the water.

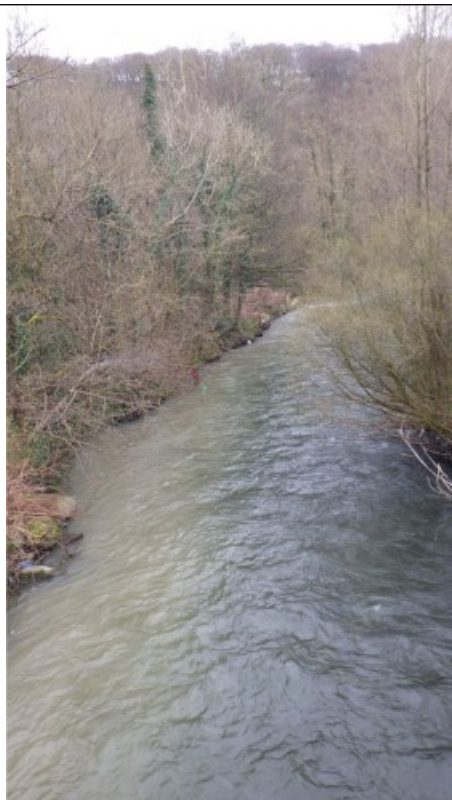
Figure 25 – Site visit photos: Downstream view of the main river from the footbridge at ST2169995607 after site investigations concluded. Sediments still visible within the water.

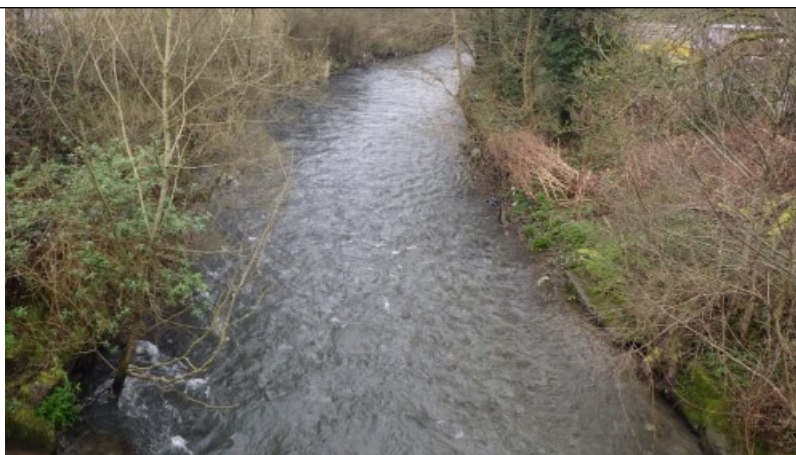
At 10:50 I arrived on site at the footbridge at ST2169995607. The watercourse was clear, with no silt or deposits visible. No visible downstream impact was observed. Photos were taken as evidence (Figures 26 and 27).

Figure 26 - Site visit photo: Upstream view of the main river from the footbridge at ST2169995607. Silt no longer visible in the watercourse.

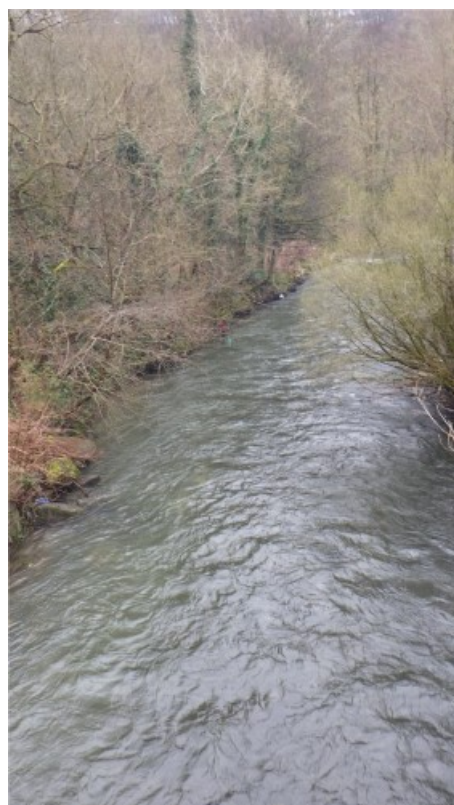
Figure 27 - Site visit photo: Downstream view of the main river from the footbridge at ST2169995607. Silt no longer visible in the watercourse.

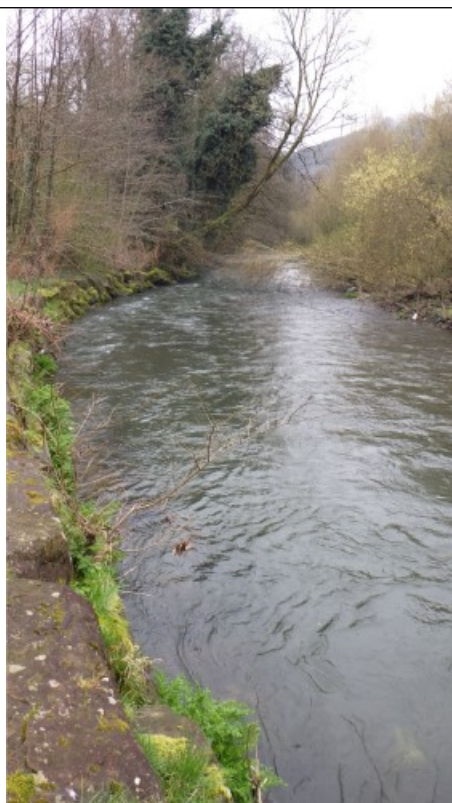
At 11:04 I checked downstream at ST2173295503. No visible impact was observed and no deposition of sediments was observed. Photos were taken as evidence (Figure 28).

Figure 28 – Site visit photos: Downstream of river checked at ST2173295503. No pollution or impact observed.

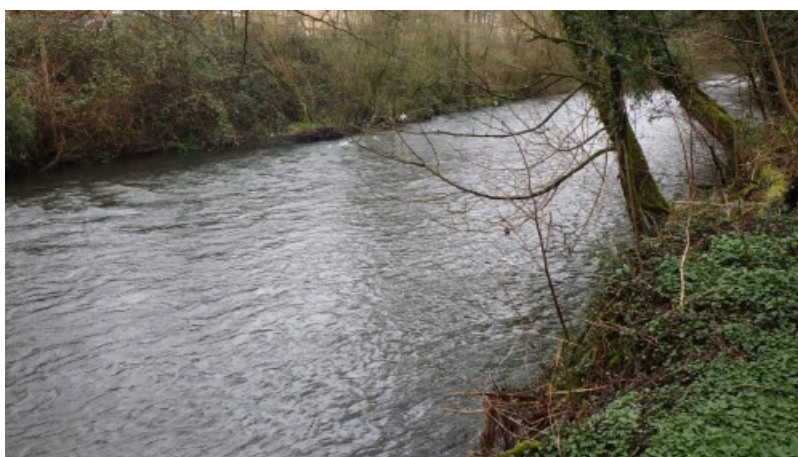
The downstream stretch of the river was checked as far as ST2166995381. At 10:10 I observed no impact and no deposition of sediments. Photos were taken as evidence (Figure 29).

Figure 29 – Site visit photos: Downstream of river checked as far as ST2166995381. No pollution or impact observed at any point.

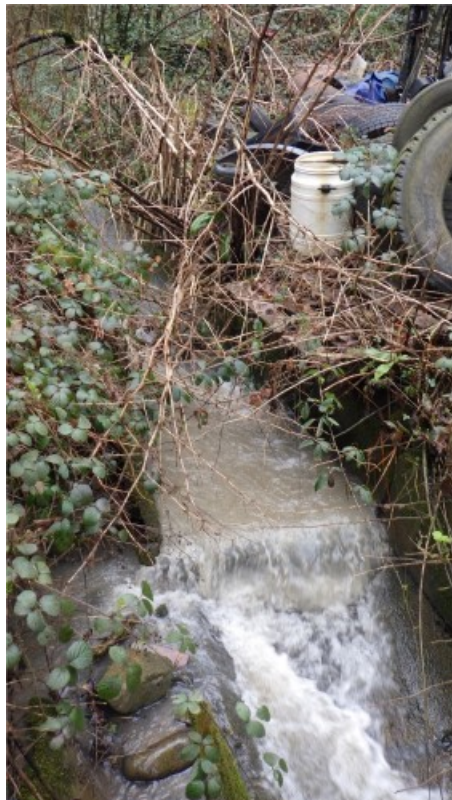
At 11:25 Hafod Quarry's consent point was checked at ST2199795988. Silt was still

present and holding in deeper pools but the water column was a lot clearer than observed on 19/03/24. Photos were taken as evidence (Figures 30 and 31). No samples were taken during this visit.

Figure 30 – Site visit photos: Consent point checked looking upstream at ST2199795988. Silt still present and holding in deeper pools but water column significantly clearer. No visible impact was observed downstream.

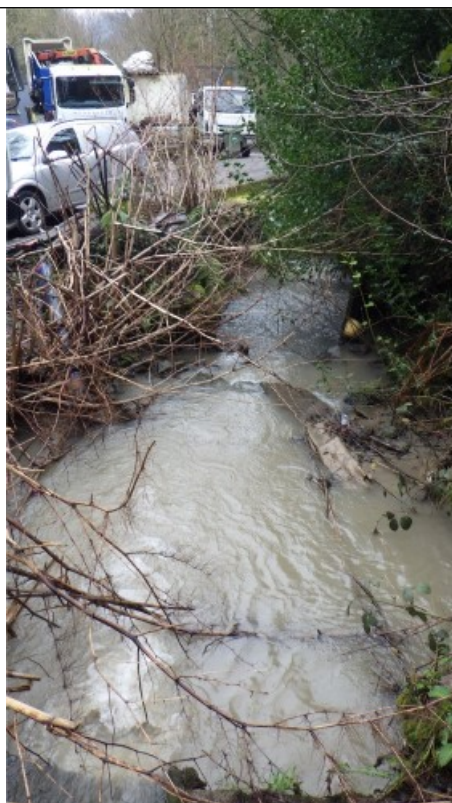
Figure 31 – Site visit photos: Consent point checked looking downstream at ST2199795988. Silt still present and holding in deeper pools but water column significantly clearer. No visible impact was observed downstream.
