**Penhesgyn Landfill Site**

**Landfill Exploratory Excavation Works**

**Construction Quality Assurance Report**

**ECL.10097.R02.001 Rev: -**

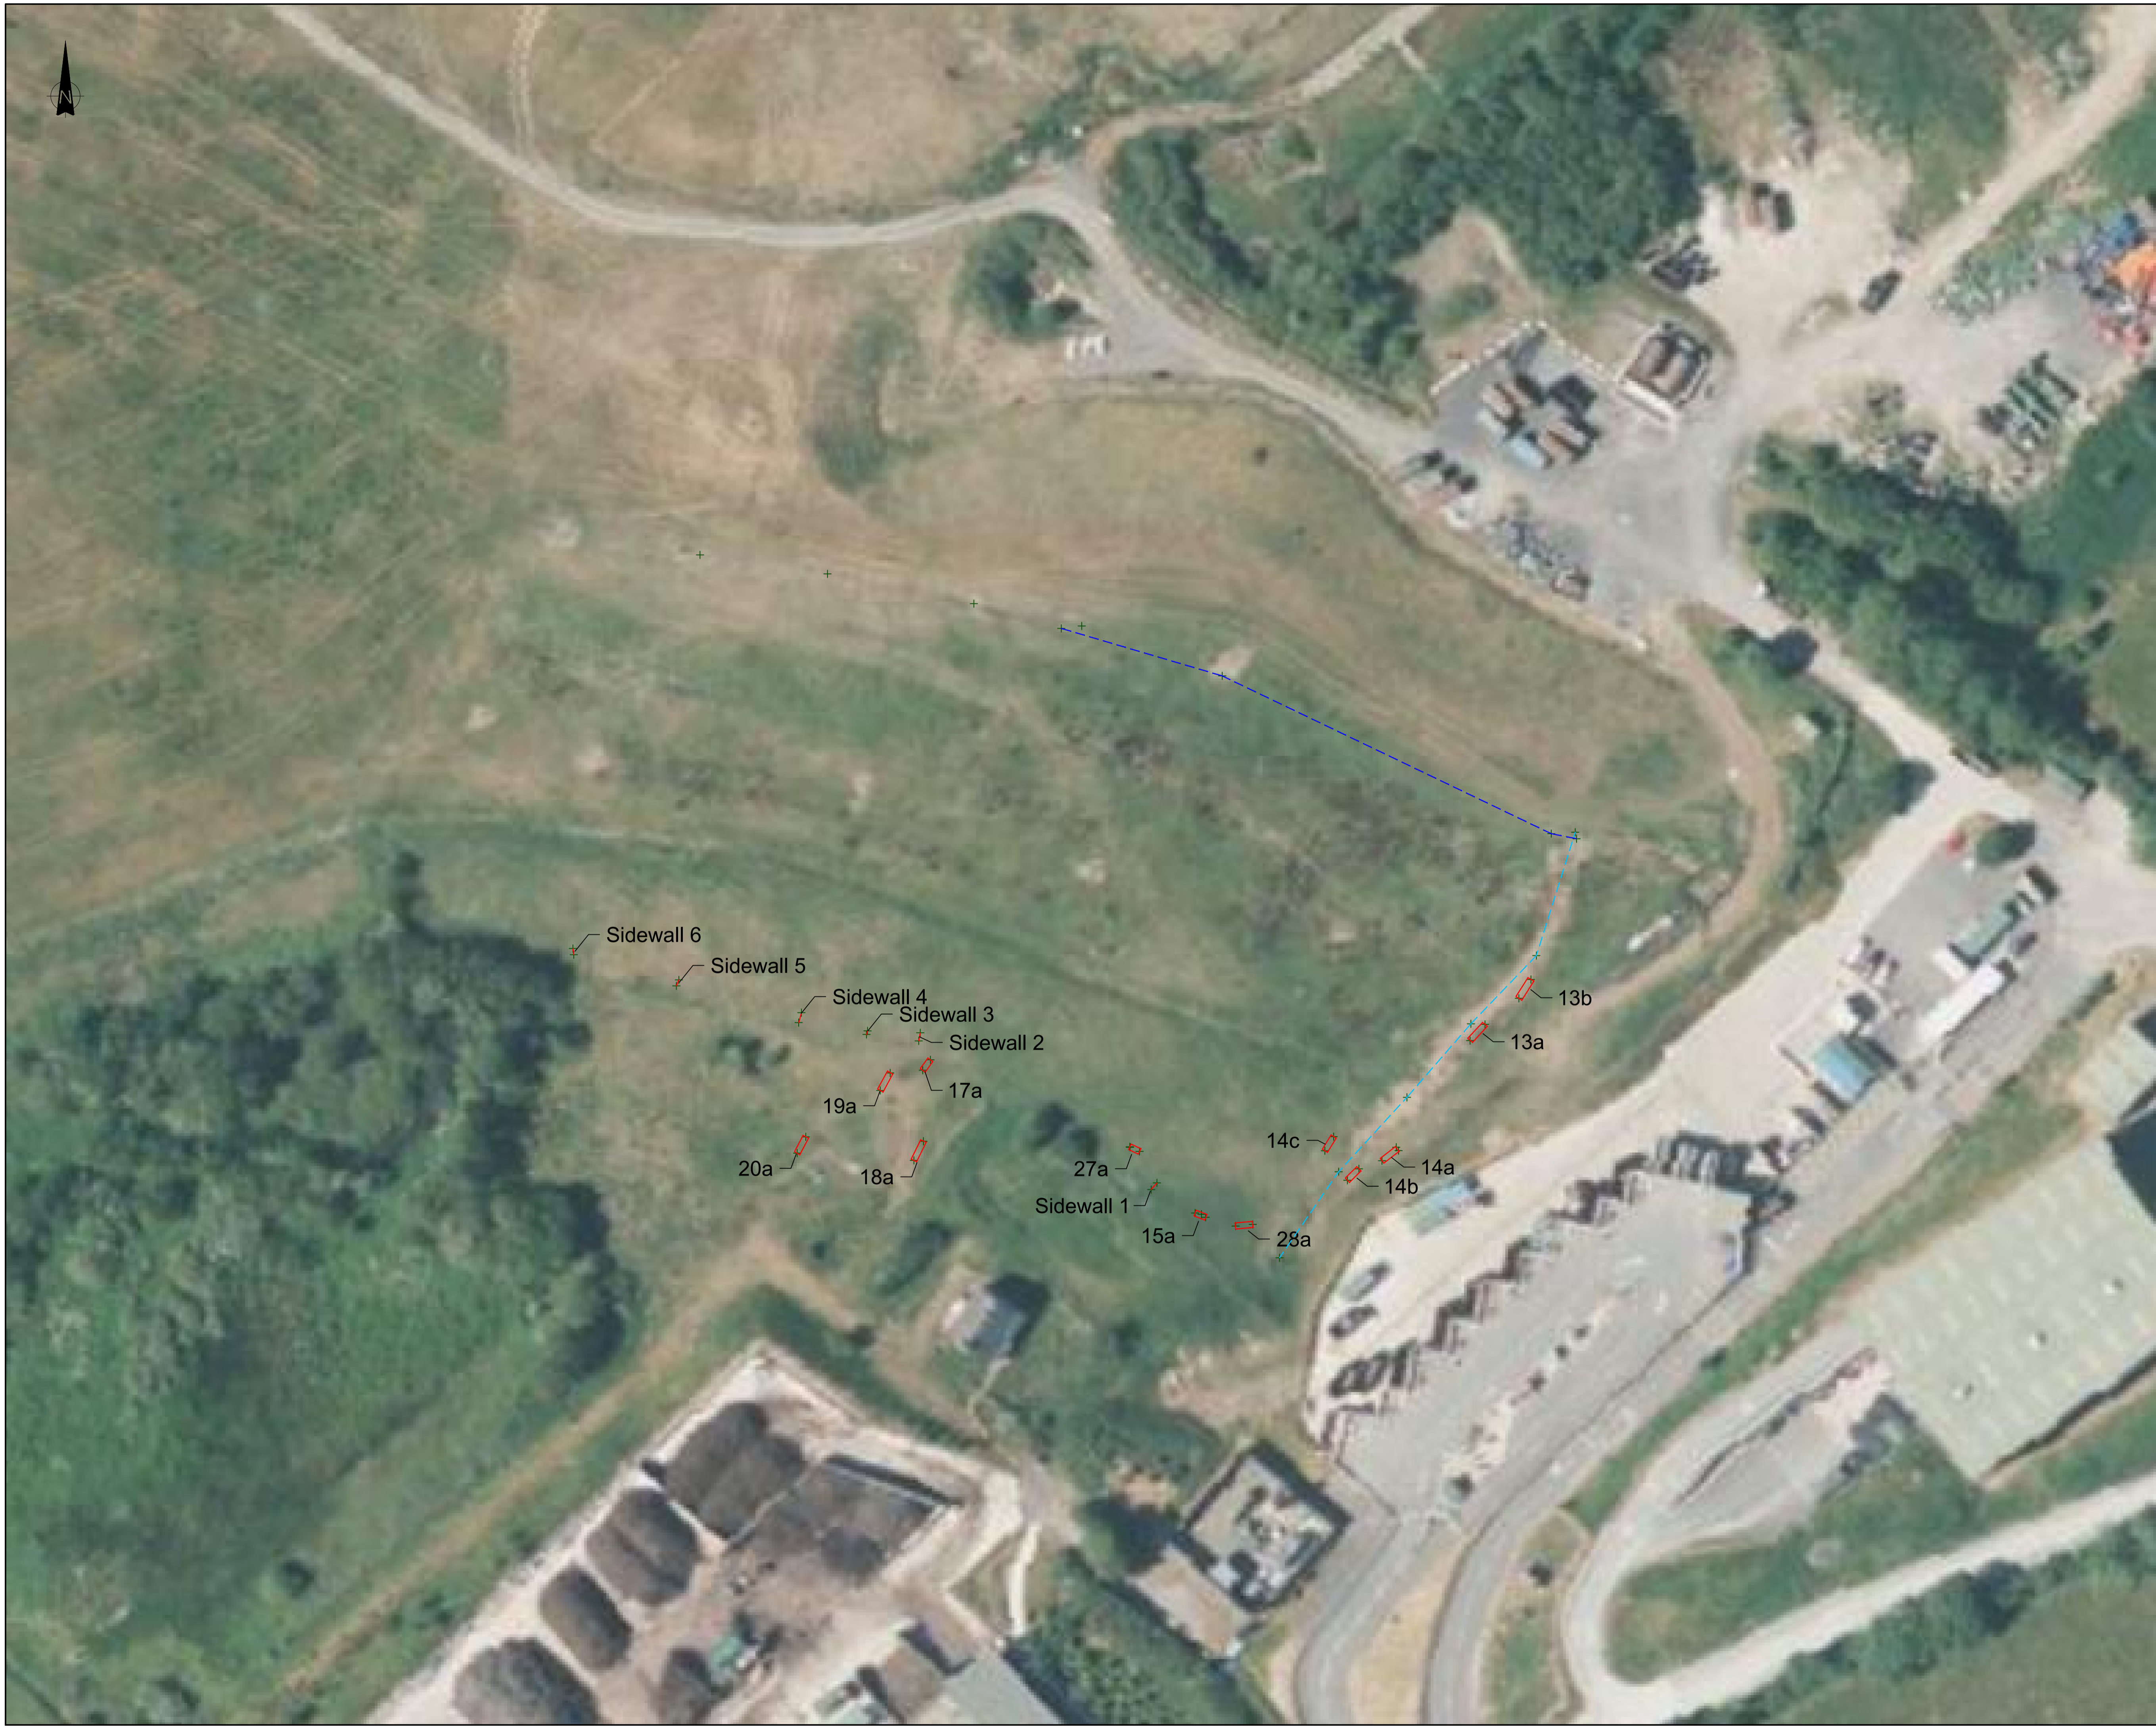
Drawing Number ECL.10097.D06.001	Revision -
-------------------------------------	---------------

- 3.3.1 Excavations were surveyed to provide accurate locations of the trial pit as shown on drawing ref: ECL.10097.D06.001 in Appendix 3. The location of the existing gas main in the area was also surveyed as shown in drawing referenced above.
- 3.3.2 Multiple survey points and surface levels were taken at each location - Survey data is included in Appendix 3 for information.

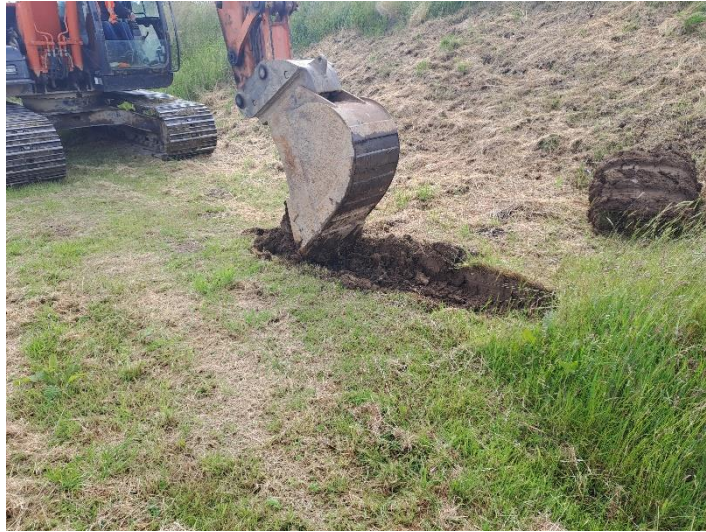
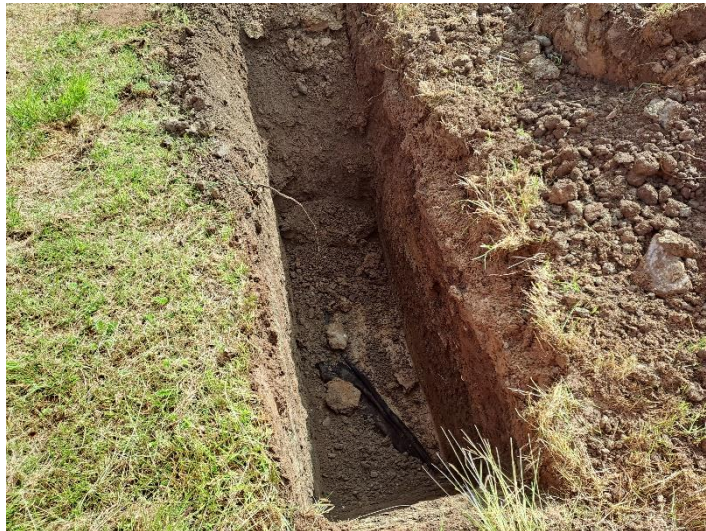
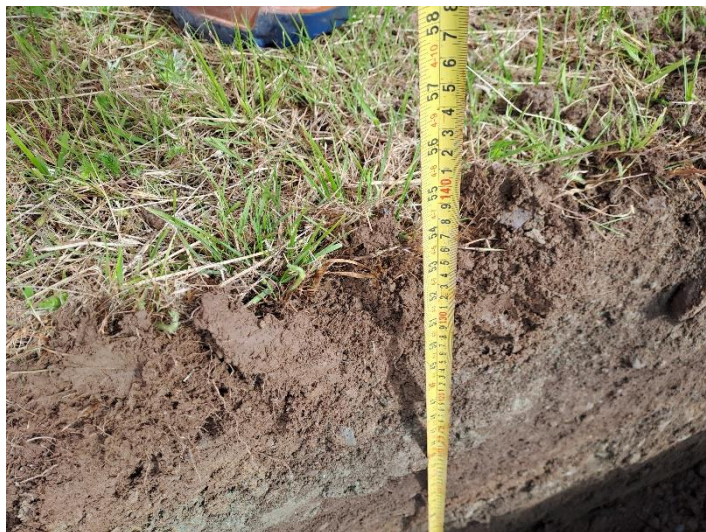
**Plate 1**

Commenced excavating (approximately 3000mm x 600mm) adjacent to bore hole BH14. Excavation continued incrementally and was stopped at depth of 1250mm when geotextile was exposed - presumed to be the capping system excavation. The excavation was surveyed and reinstated with the arisings.

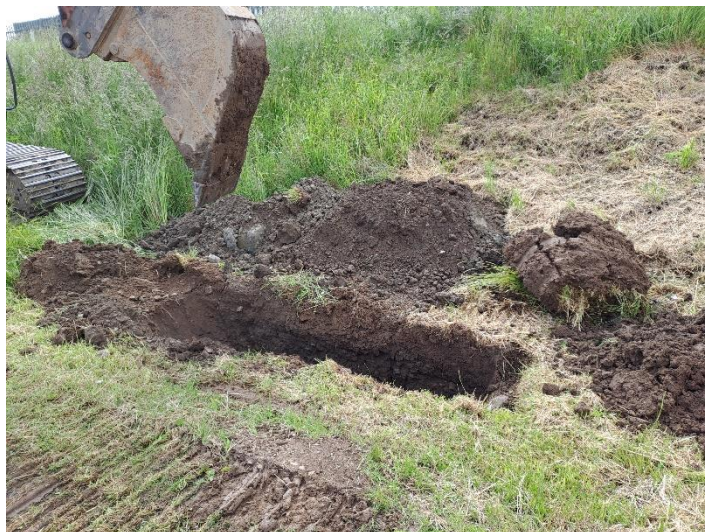
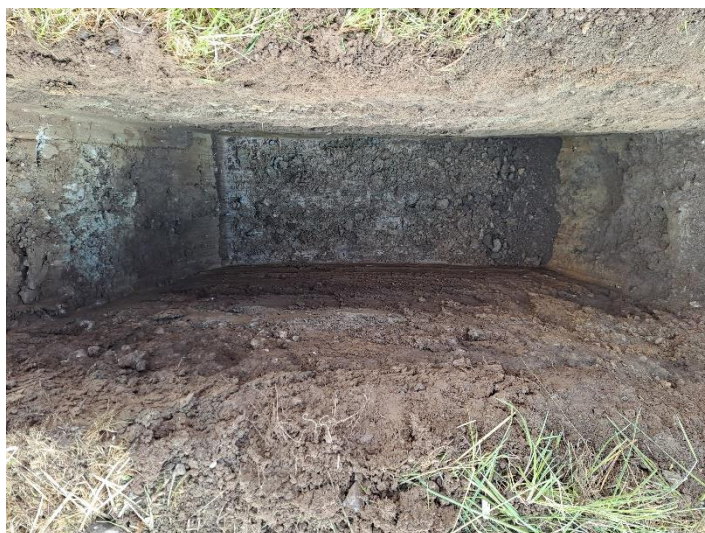
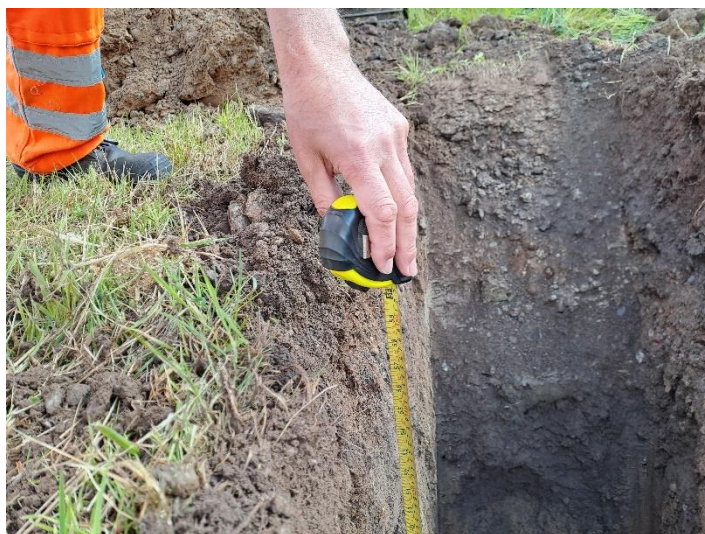
**Plate 2**

Commenced excavating (approximately 3000mm x 600mm) adjacent to bore hole BH14. Excavation continued incrementally removing the soils to a depth of 1500mm. No evidence of capping or waste was discovered. Photographs were taken and the excavation was measured and recorded. The excavation was surveyed and reinstated with the arisings.

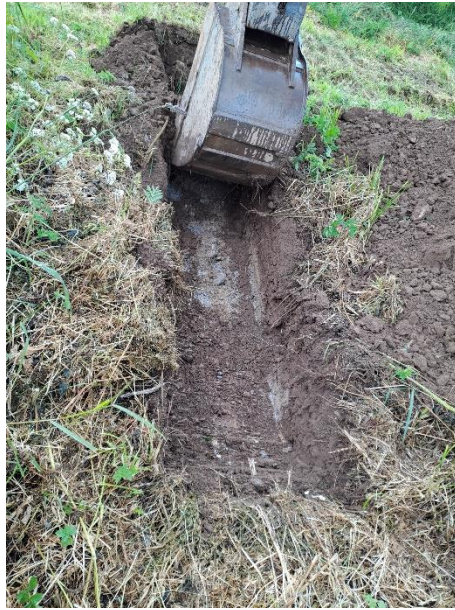
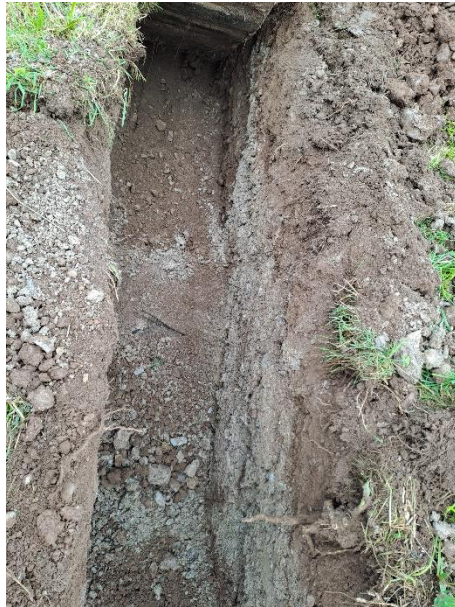
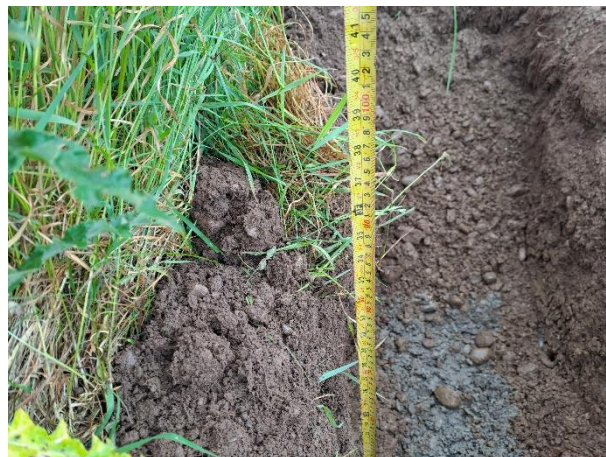
**Plate 3**

Commenced excavating (approximately 3000mm x 600mm) on the landfill side of the landfill gas main, opposite bore hole BH14. Excavation continued incrementally removing the soils to a depth of 800mm where a geotextile was encountered. Photographs were taken and the excavation was measured and recorded. The excavation was surveyed and reinstated with the arisings.

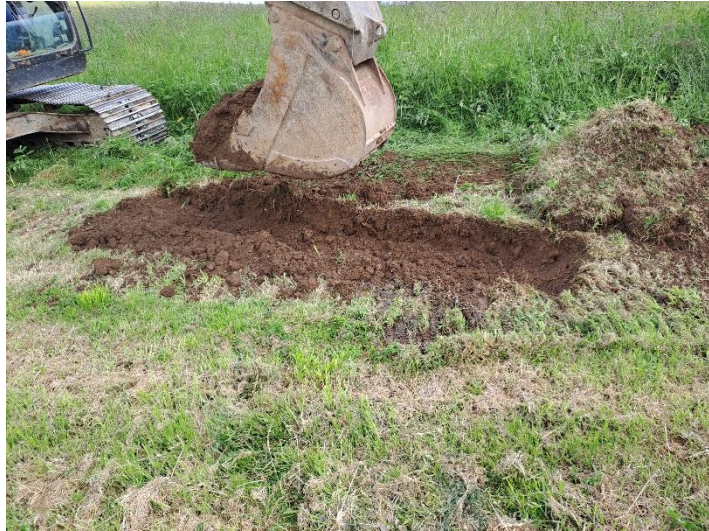
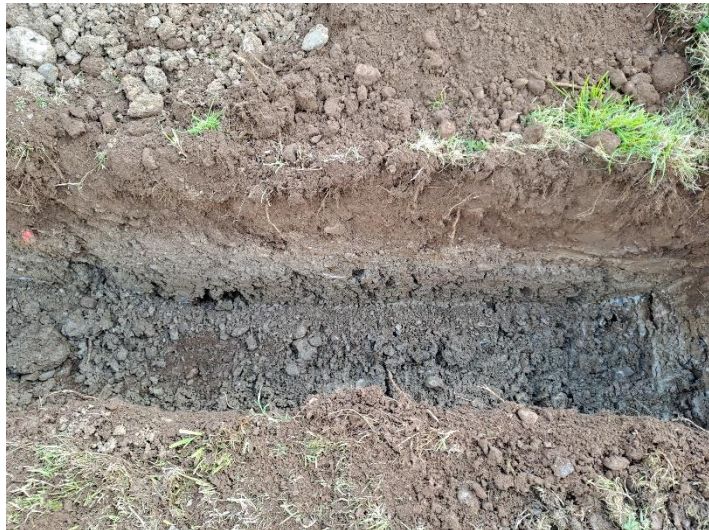
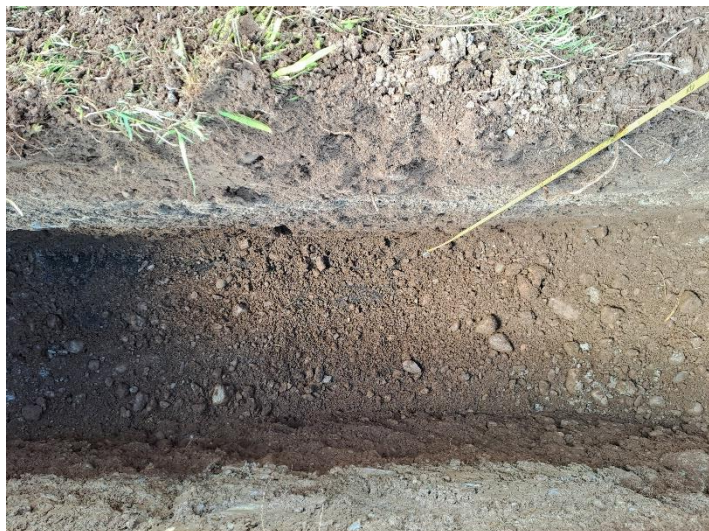
**Plate 4**

Commenced excavating (approximately 3000mm x 600mm) adjacent to bore hole BH15. Excavation continued incrementally removing the soils to a depth of 1250mm where a geotextile was encountered. Photographs were taken and the excavation was measured and recorded. The excavation was surveyed and reinstated with the arisings.
