| | | <b>NETWORK RAIL</b><br><b>Underwater Examination Report</b> | | | | | | | | | | |
| ELR: | SWM2 | Contract Mileage: 233 m 1023 yds 46.5 ch | | | | | | Struct Ref: | | 233 46.5 | | |
| Examination Type: Underwater | | NR ID: 20024778 | | | | Exam Date: 19/04/2022 | | | | | | |
| Structure Name: R. Gwendraeth Fawr | | | | Type: BU | | Exam ID: | | 14464241 | | | | |

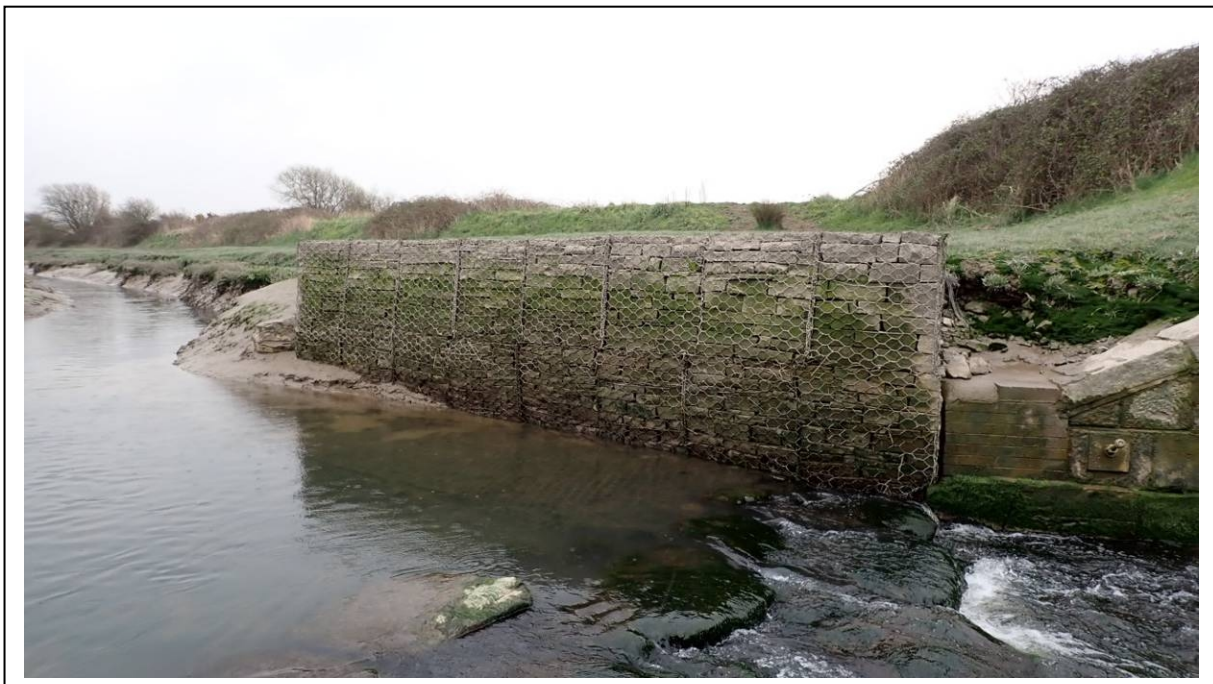
**Photo 3** Upside low mileage gabion training wall

Overall fair condition. (Photo 3)

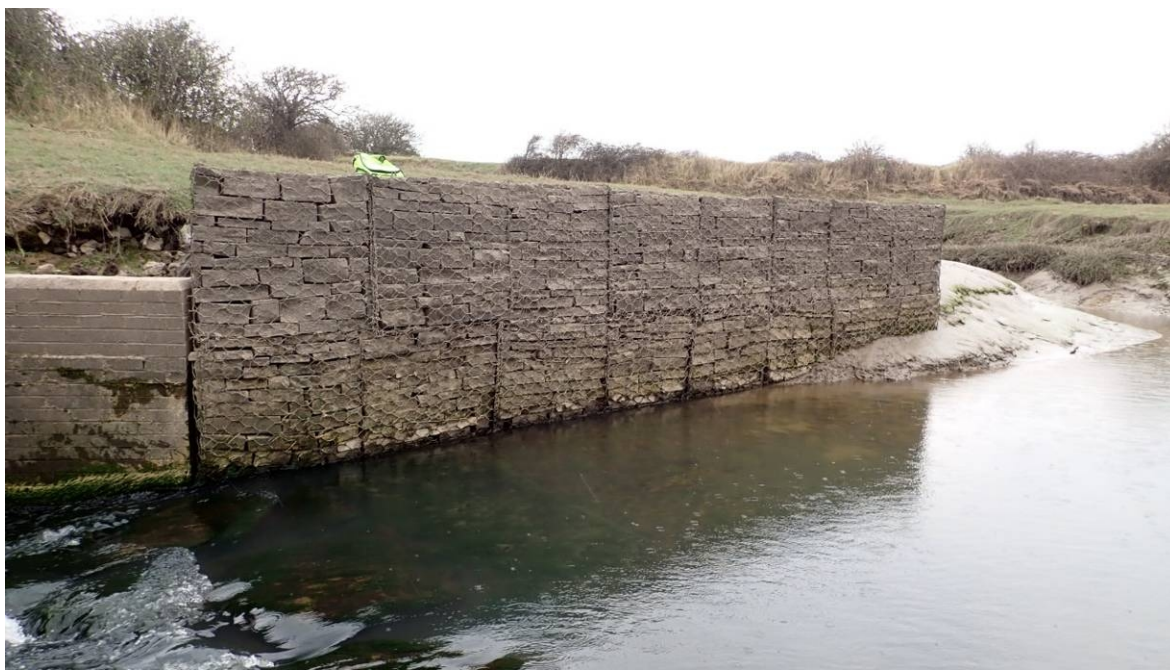
**Photo 5** Upside high mileage training wall

Overall fair condition. (Photo 5)

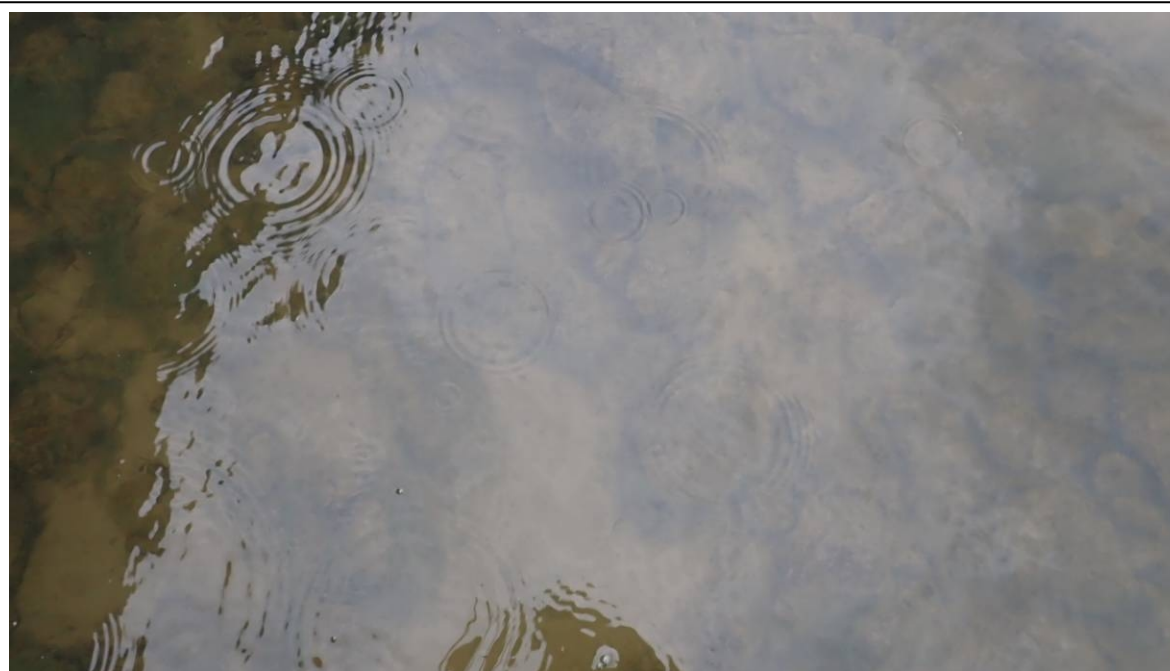
**Photo 6** Missing mesh to bed gabion baskets upside high mileage

Gabion baskets to upside high mileage have 2m<sup>2</sup> of missing mesh with stone fill starting to fall out. (Photo 6)

- (8) Good quality, comprehensive but concise report.
- Recommendations**
- (1) The score protection has failed and needs to be reinstated and the scour hole also needs to be infilled and protected with reno mattresses or rock armour. In the interim period until this can be organised maximum 6 monthly additional exams are to be carried out. I have created new work item(s) and live defects to this effect. The repairs should take in tying new wire mesh back to sound and making good the missing stone to the reno mattresses – see PH6.

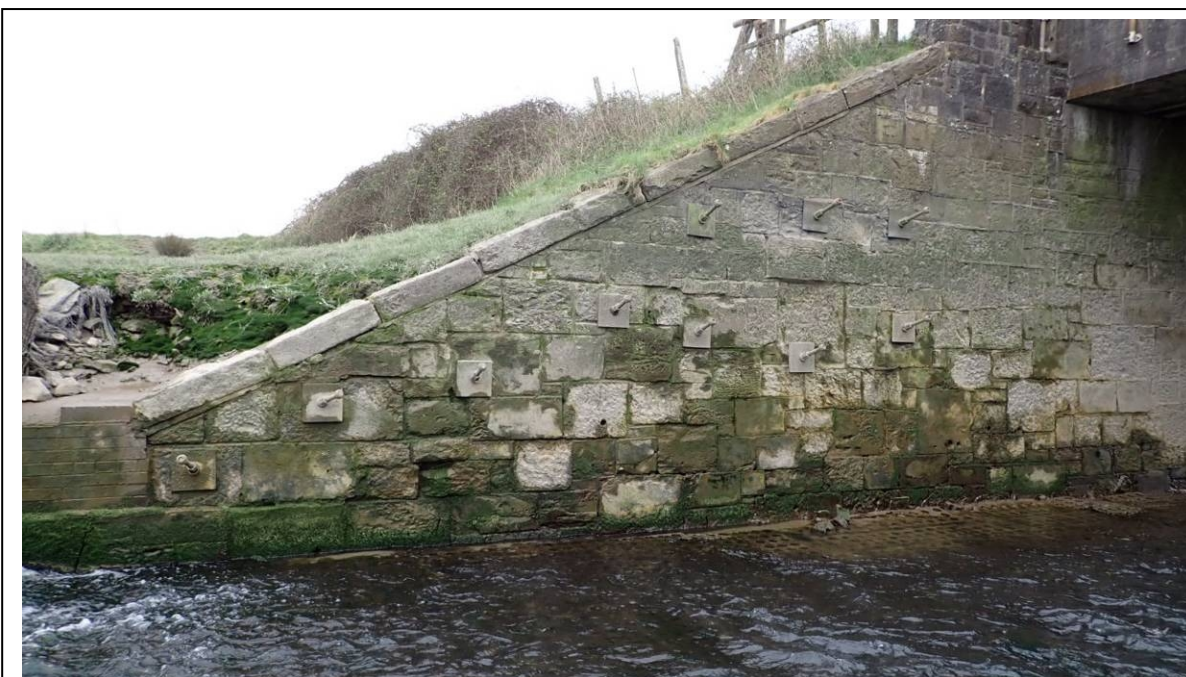
**Photo 8** Upside low mileage wingwall

Overall fair condition with 6.0m<sup>2</sup> of marine growth. (Photo 8)

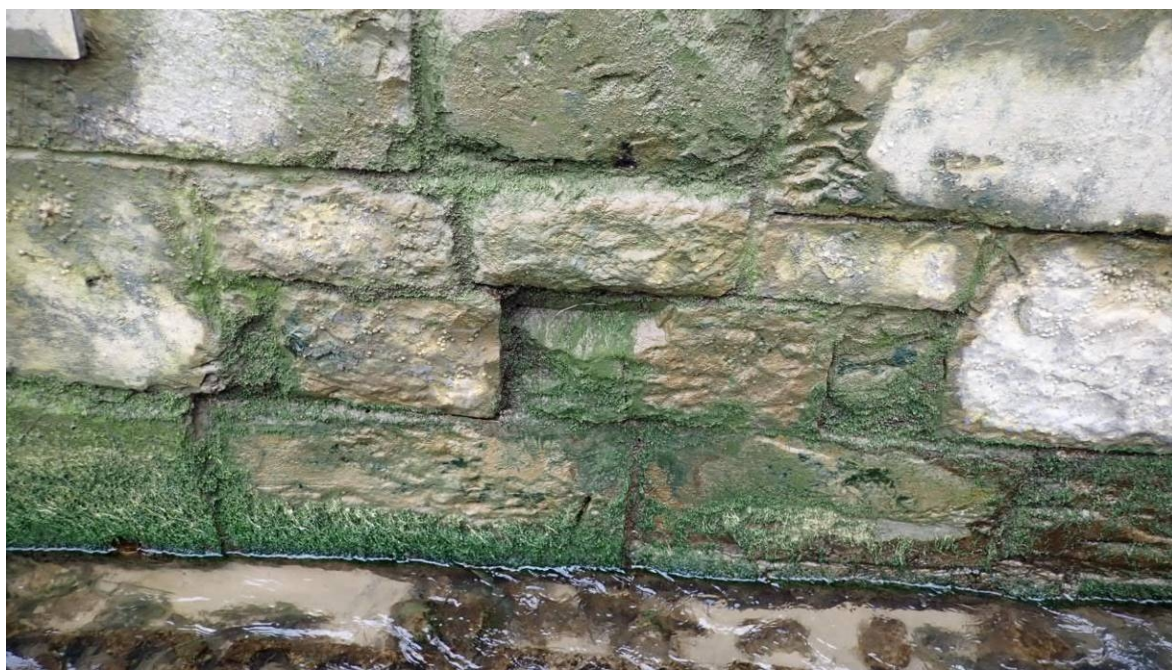
**Photo 9** Area of spalling

0.8m<sup>2</sup> of sporadic spalling at low level, average 20mm and maximum 50mm deep. (Photo 9) [N.F.D.]

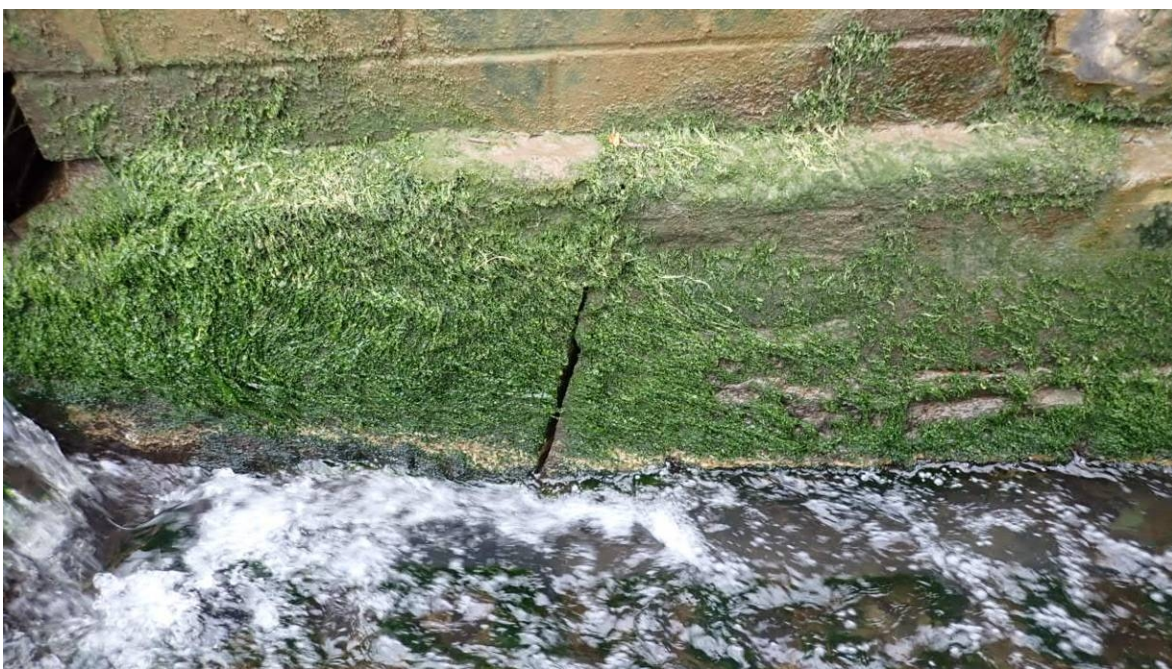
**Photo 10** Through block fracture

0.8m from the upstream end, there is a 0.4m long x 3mm wide through block fracture. (Photo 10) [N.F.D.]

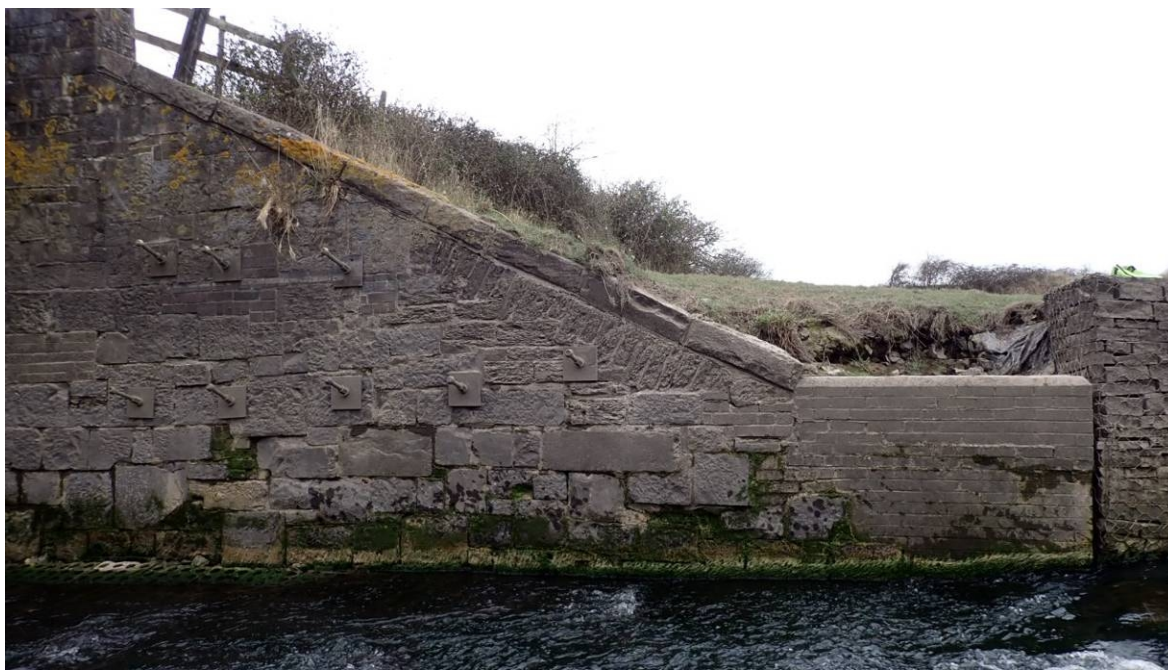
**Photo 11** Upside high mileage wingwall

Overall fair condition with 3.0m<sup>2</sup> of marine growth. (Photo 11)

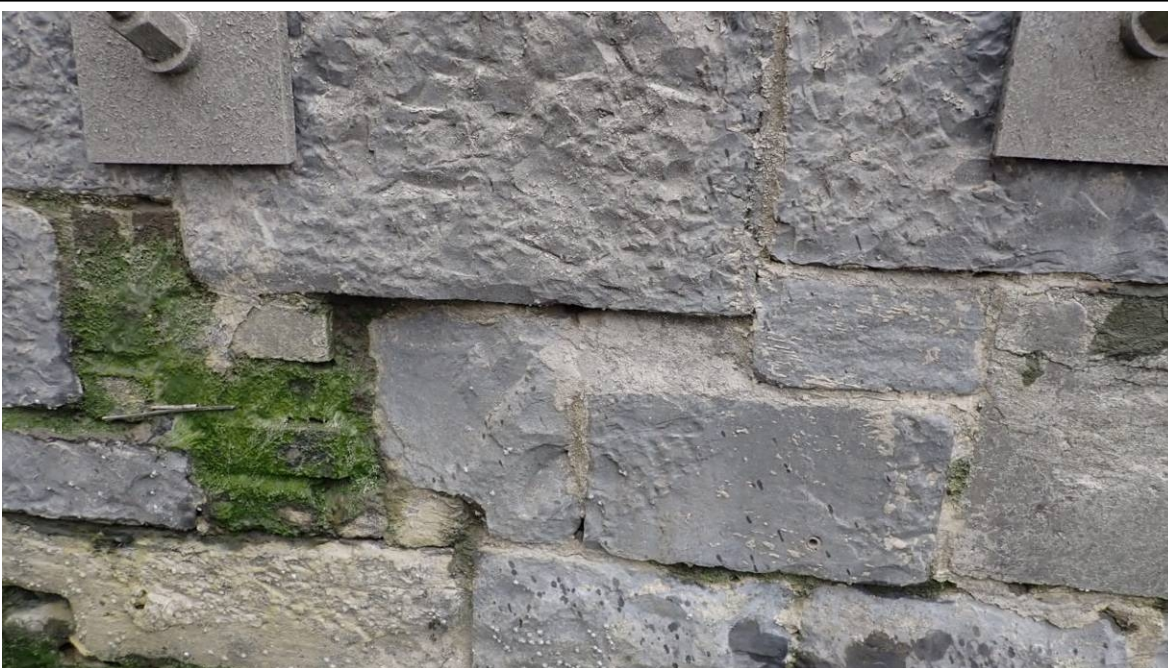
**Photo 12** Spalling at low level

0.8m<sup>2</sup> of low level sporadic spalling, average 20mm and maximum 50mm deep. (Photo 12) [N.F.D.]

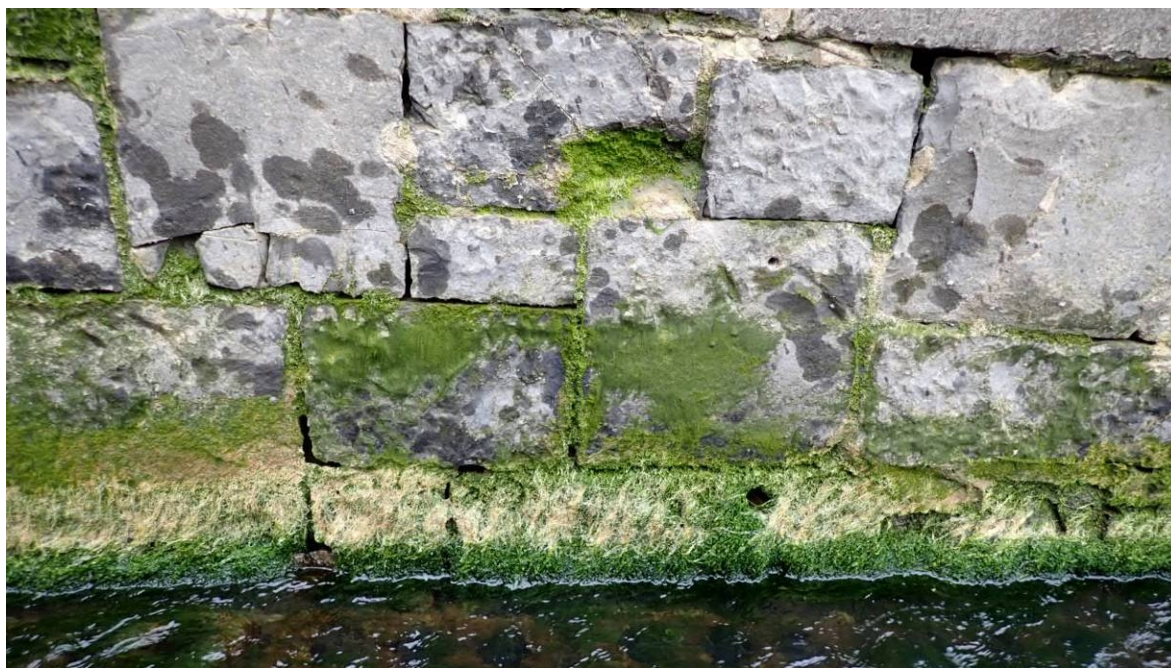
**Photo 13** Open joints

0.8m<sup>2</sup> of sporadic open joints, average 20mm and maximum 40mm deep. (Photo 13) [N.F.D.]

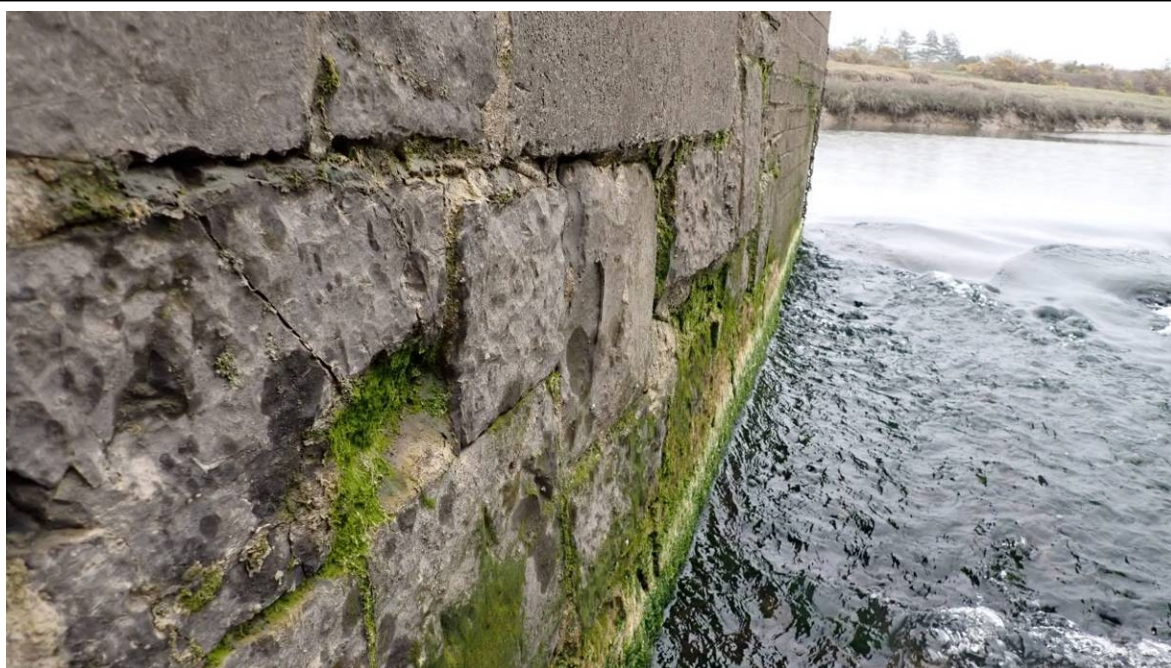
**Photo 14** Area of bulging

@3m from end of wall & 1m from top, there is 1.0m<sup>2</sup> of bulging up to 60mm. (Photo 14) [N.F.D.]

| | | <b>NETWORK RAIL</b><br><b>Underwater Examination Report</b> | | | | | | | | | | |
|---|---|---|---|---|---|---|---|---|---|---|---|---|
| 3 | Wingwall movement : cracks to be monitored with mortar datal tabs local displacement of blocks and extents of bulging to be recorded | US HM WWL, DS LM WWL | 2000 | 6 mths | 1 unit | 2 | 3 | S6 | Hand Pointing | | | |

- (2) There is history of wingwall movement / instability. It seems that ground anchors were preferred to fronting the wingwalls with sheet piles but movement is still present. The additional exams proposed should cover monitoring of wingwall movement both the bulging and cracks present and any further cracks or new lateral movement.

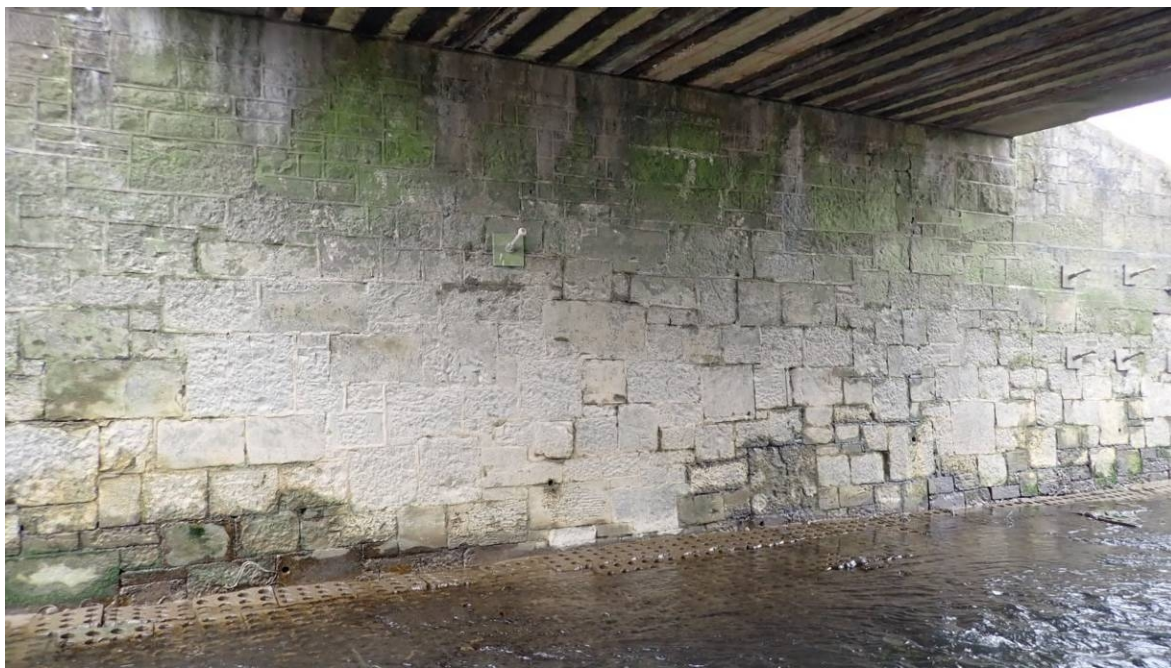
Photo 15 Low mileage abutment

Overall fair condition. (Photo 15)

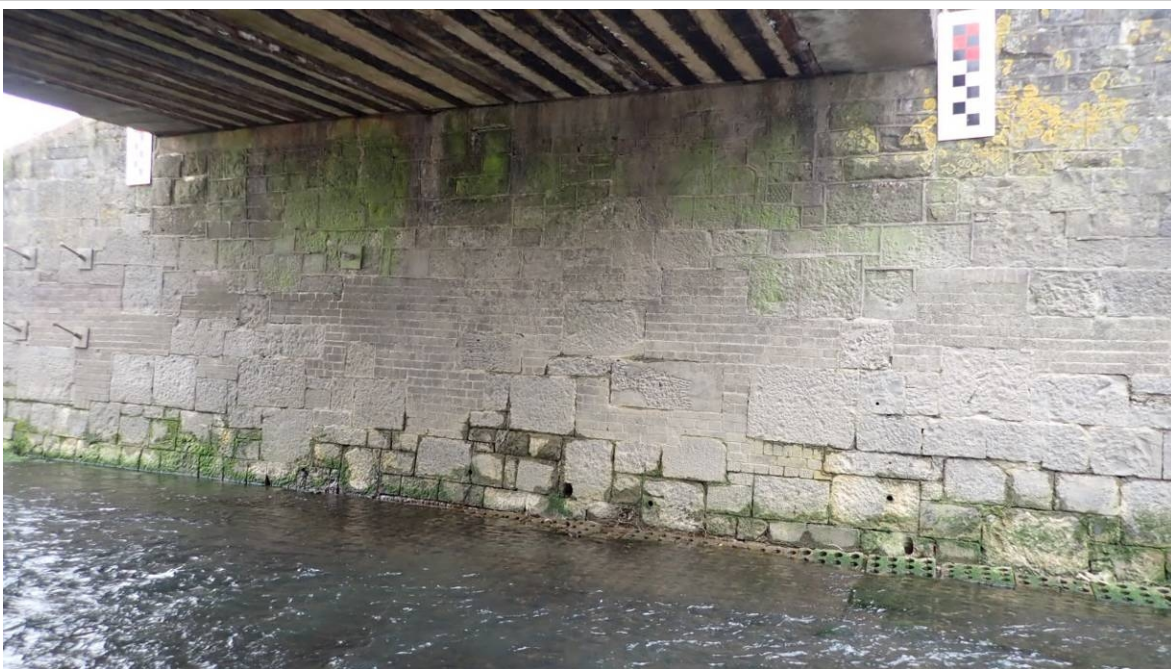
Photo 16 High Mileage abutment

Abutment in fair overall condition (Photo 16)

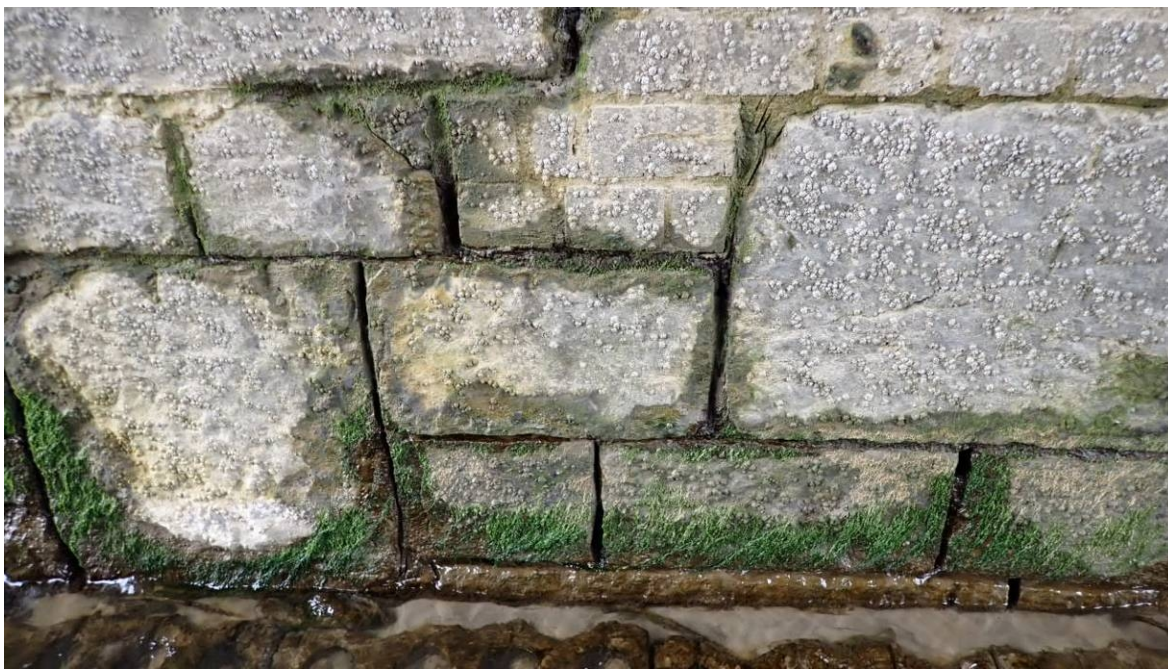
Photo 17 Open joints

1m<sup>2</sup> of sporadic open joints, average 20mm and maximum 30mm deep. (Photo 17) [N.F.D.]

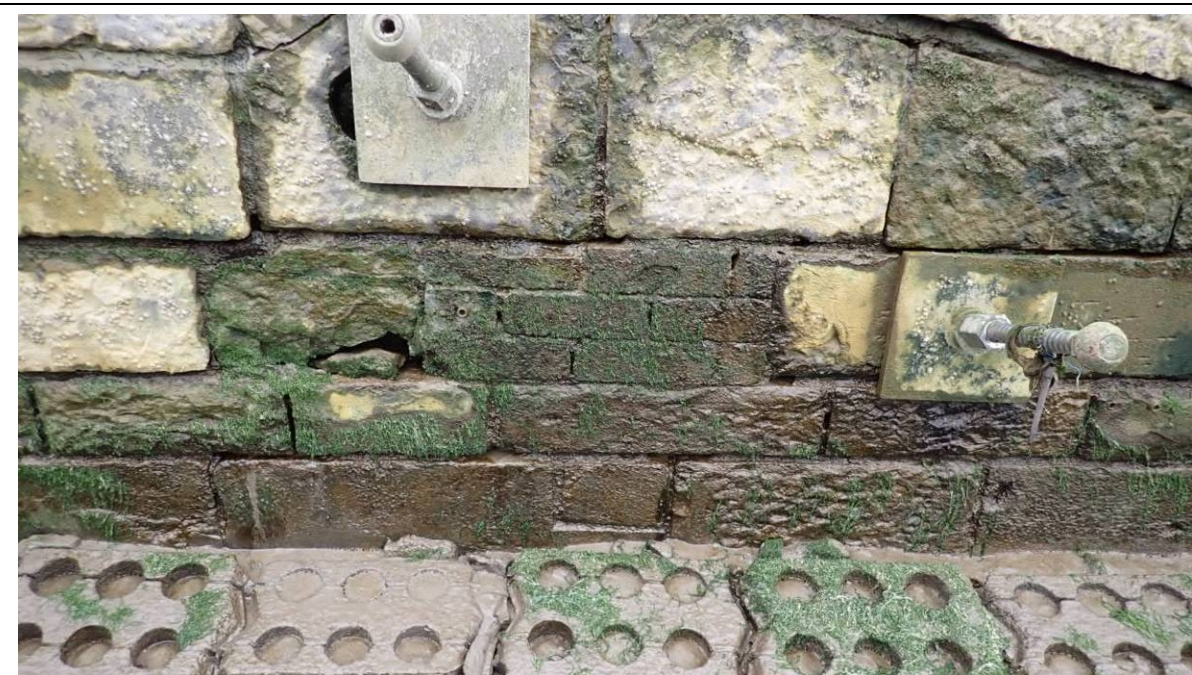
Photo 20 Open joints

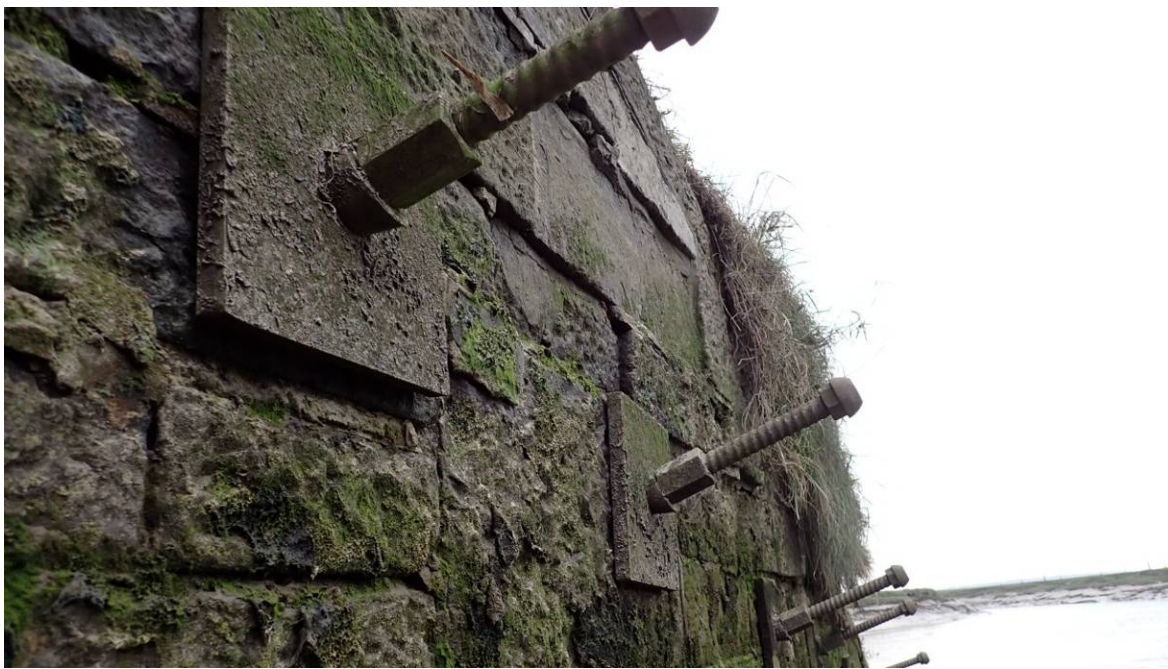
Photo 21 Bulge to wall

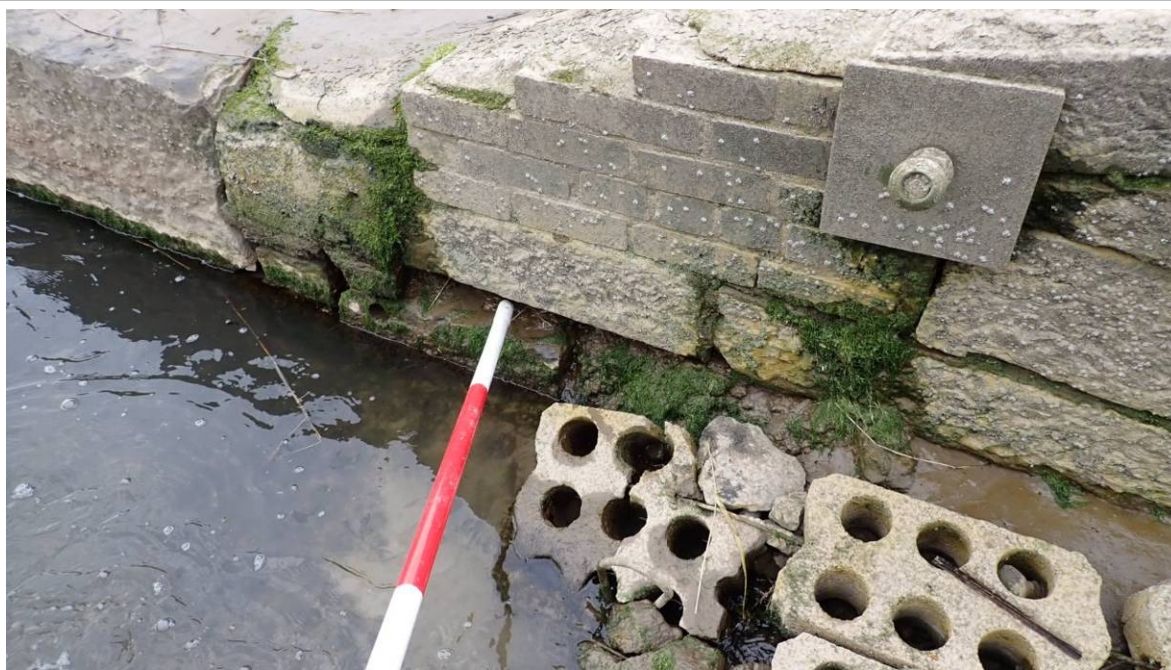
**Photo 23**    Void to downstream end

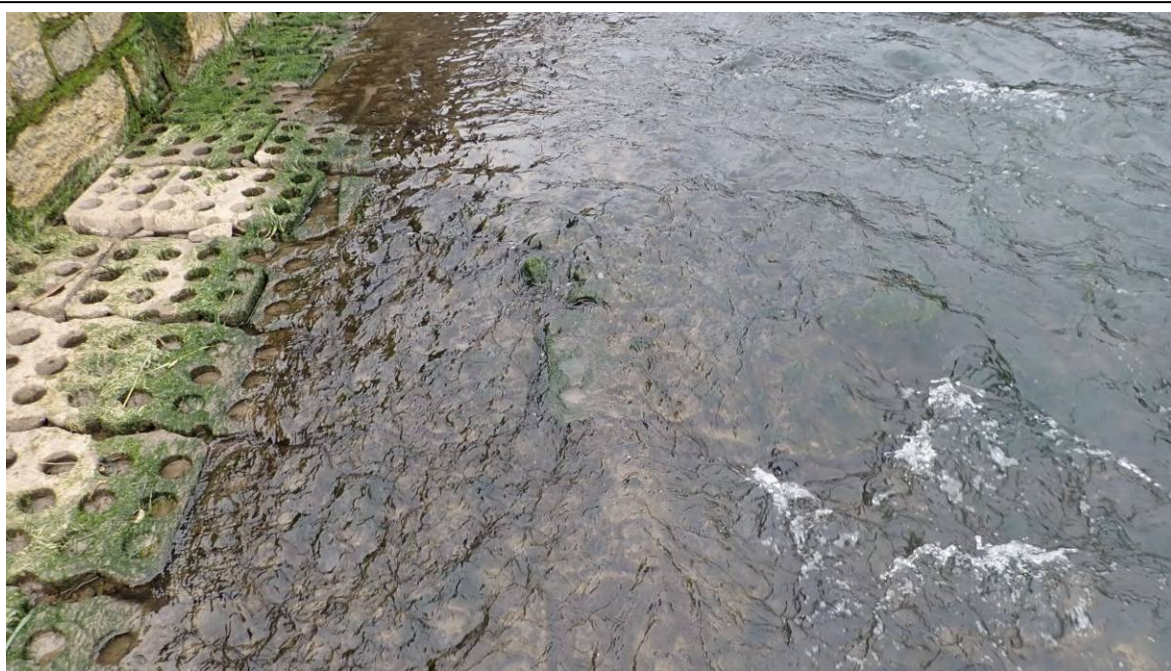
**Photo 24**    Typical view of invert

Concrete block invert which extends to the ends of the wingwalls in fair condition. (Photo 24)

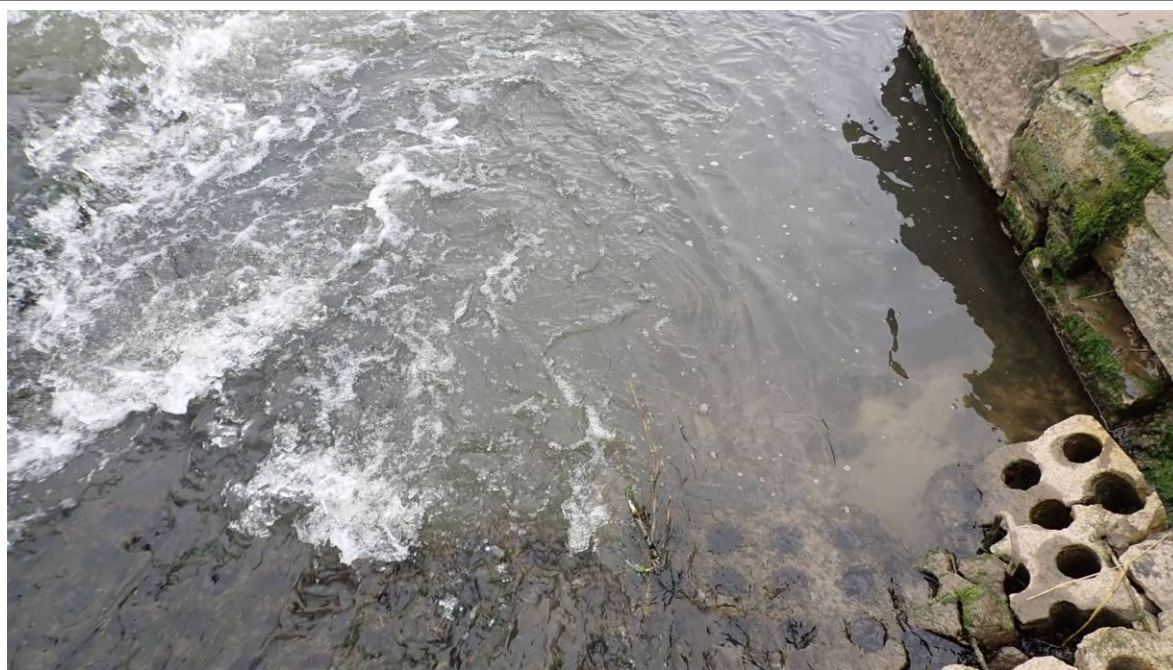
**Photo 25** Area of missing invert –downstream high mileage

| 11 | Missing blocks to invert | Downstream end | 19/04/22 | Y | UW | Y | 9 | N | Baseline | N | N | |

To the downstream end adjacent to the downside high mileage wingwall, there is an area missing 2m long x 2m wide. (Photo 25)

| | | <b>NETWORK RAIL</b><br><b>Underwater Examination Report</b> | | | | | | | | | | |
|---|---|---|---|---|---|---|---|---|---|---|---|---|
| 2 | Reinstate missing invert | Downstream high mileage | 1000 | 6 mths | 6 m2 | 3 | 3 | M9 | Scour | | | |

- Repair areas of missing invert.
- Monitor at future examinations areas of noted bulging to wingwalls.
- Install rock armour to scour hole.

| ITEM | DESCRIPTION | LOCATION | PRIORITY | COMMENTS |
|---|---|---|---|---|
| 1 | Repair areas of missing invert | Invert | 6 months | |
