| | | <p align="center"><b>NETWORK RAIL</b></p> <p align="center"><b>Detailed Examination - Culvert</b></p> | | | | | | | | | | |
| ELR: SWM2 | | Contract Mileage: 239m 0264yds 12.00chs | | | | | Struct Ref: 239 12 | | | | | |
| Structure Name: 5' stone arch with tidal flap on downside | | | | | | Route: Wales | | | | | | |
| Any Hidden Parts: Yes | | | | Observed Under Load: Yes | | | | Exam Date: * 12/09/2023 | | | | |

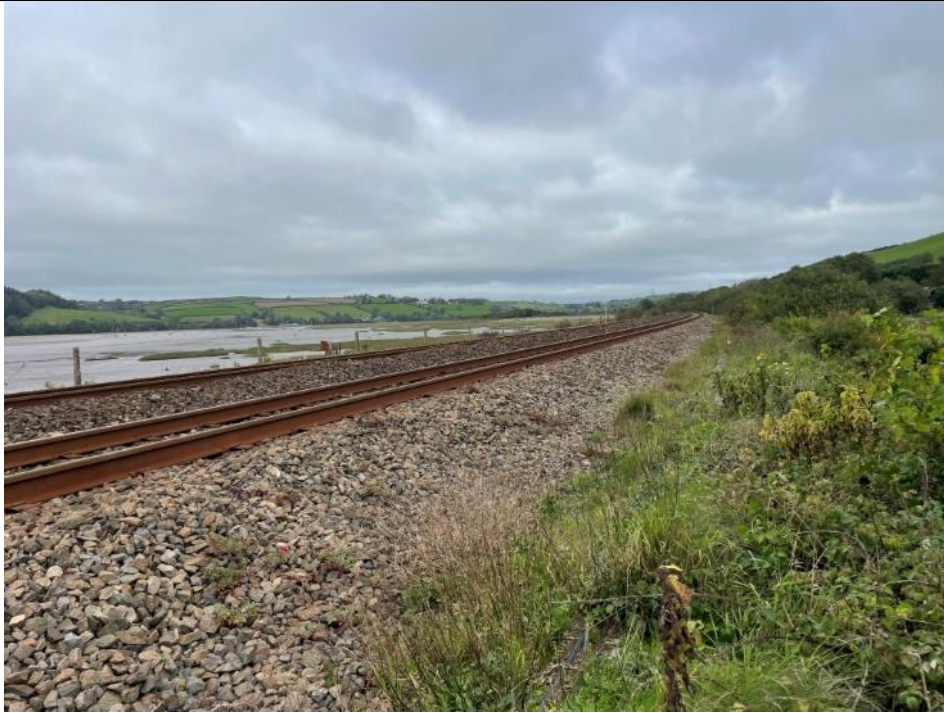
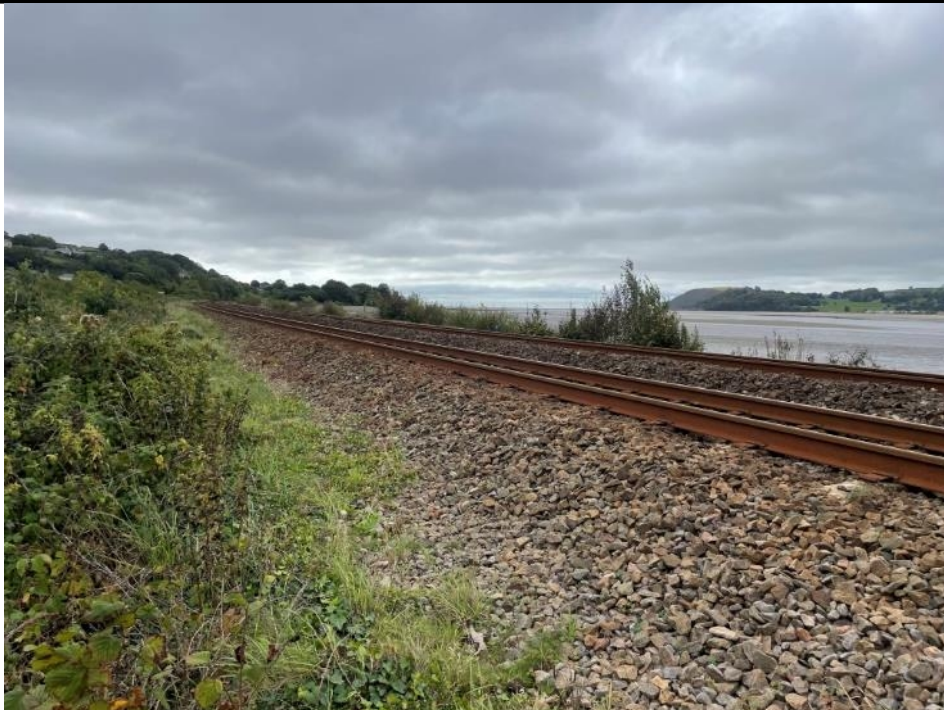
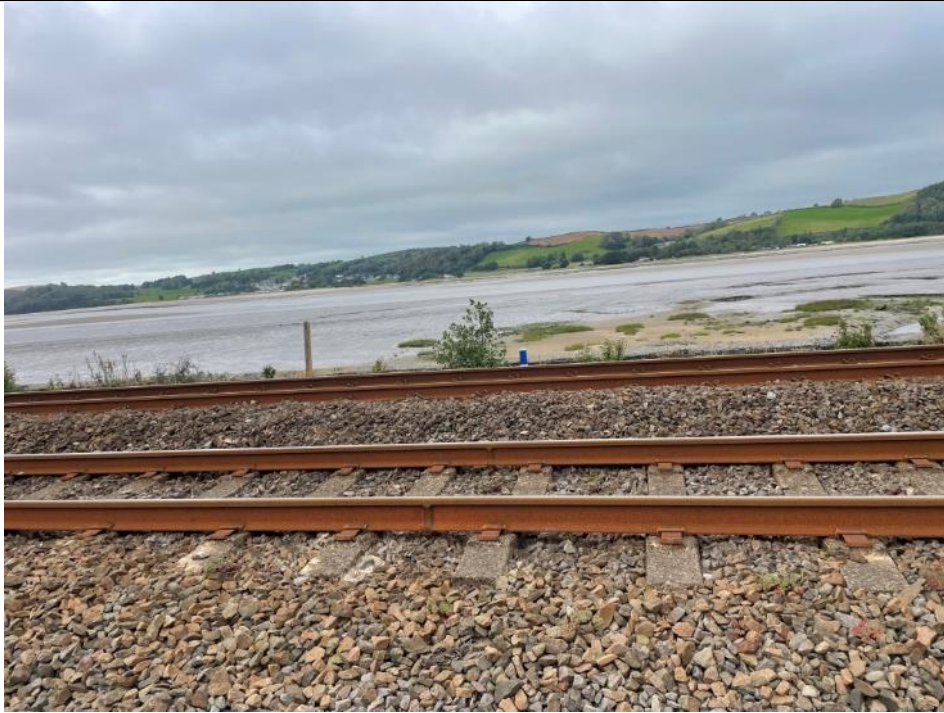
CWR on concrete sleepers with no deformation noted at track level when viewed from a position of safety. See P7, P8 and P9.

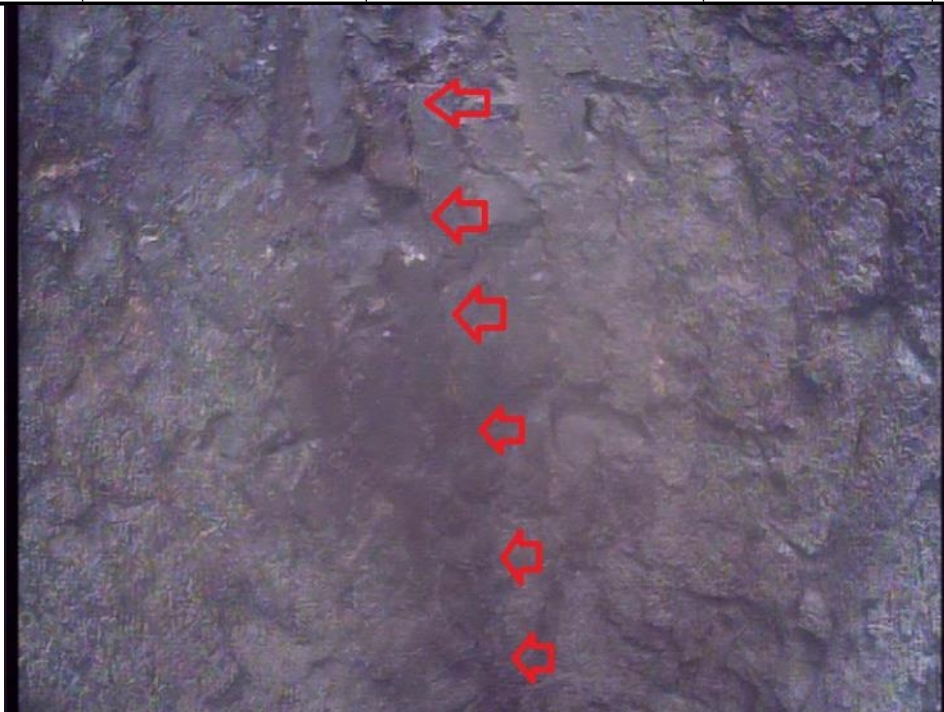
Photo Index\*: 10

@2.2m in crown, Transverse Fracture open approx. 2-4mm wide x 3.1m long. NEW. See P10.

Description\*: @2.2m  
Transverse Fracture

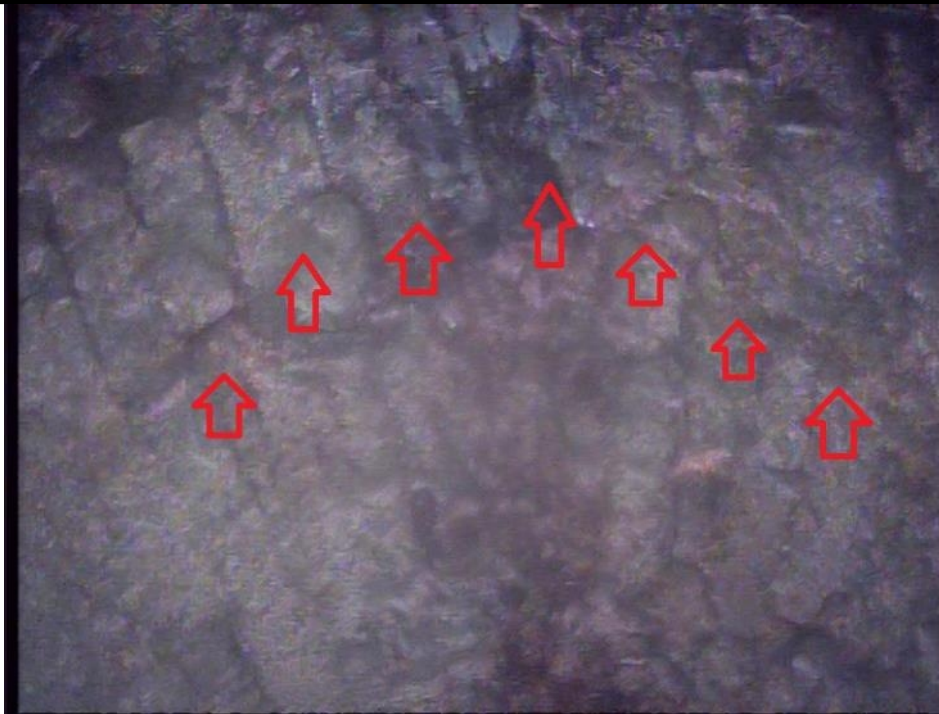
Photo Index\*: 11

@6m, Longitudinal Fracture open approx. 3mm wide x 1m long. NFD. See P11.

Description\*: @6m  
Longitudinal Fracture

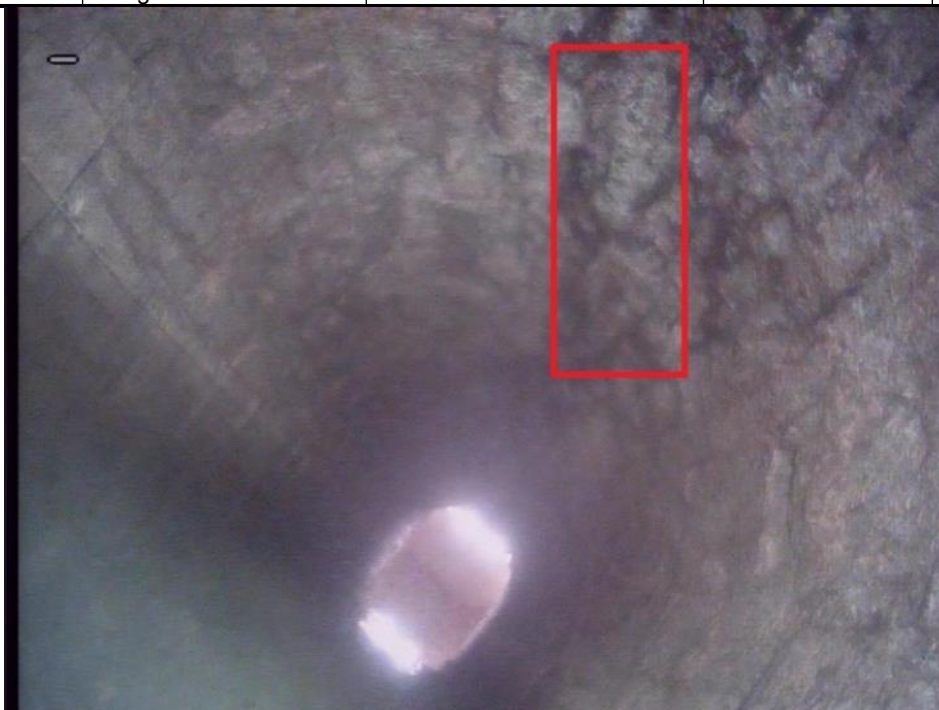
Photo Index\*: 12

Description\*: @9.3m  
Displacement

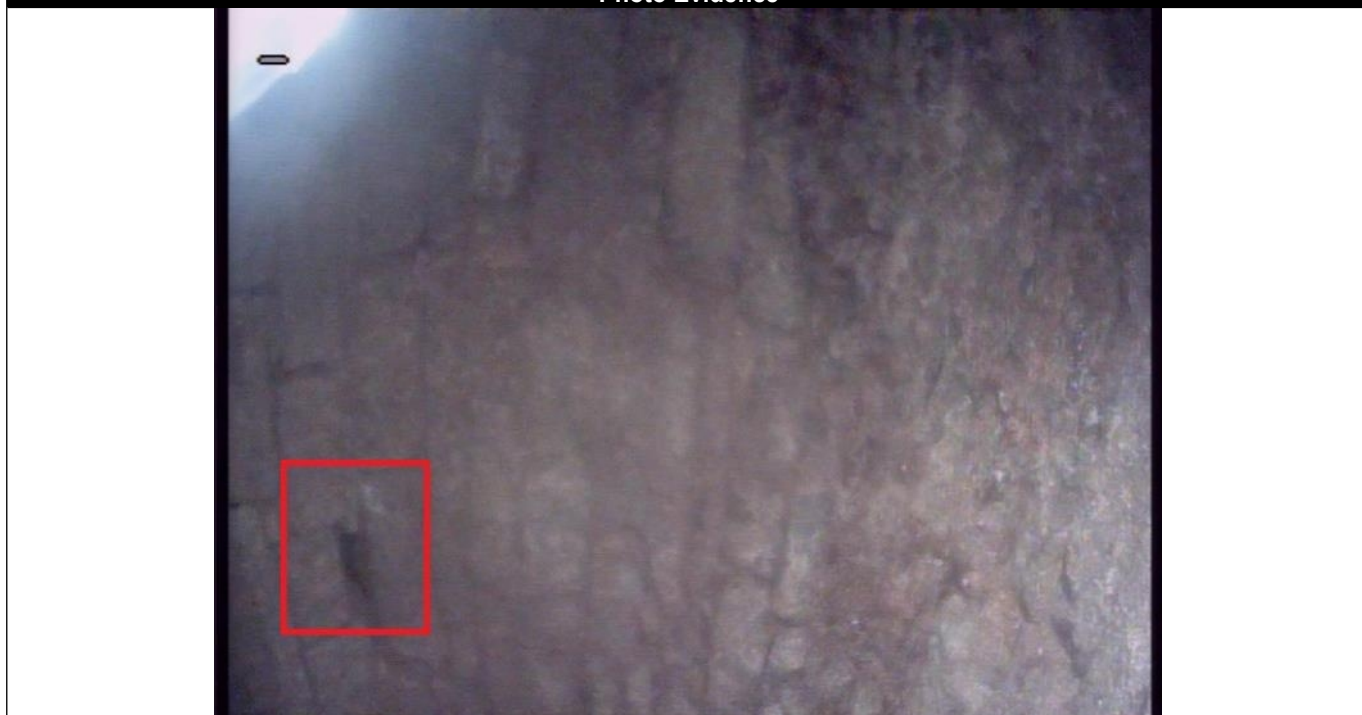
Photo Index\*: 13

@13.5m in Low Mileage sidewall, 1no missing stone. NEW. See P13.

Description\*: @13.5m  
Missing Stone

| | | <p align="center"><b>NETWORK RAIL</b></p> <p align="center"><b>Detailed Examination - Culvert</b></p> | | | | | | | | | | |
|---|---|---|---|---|---|---|---|---|---|---|---|---|
| 2 | Replace area of missing masonry (PR). | Low mileage abutment<br>4.3m from<br>Downside end | 1000.0 | 1yr | 1 m2 | 2 | 3 | S 6 | Brickwork/Stone Repairs | | | |

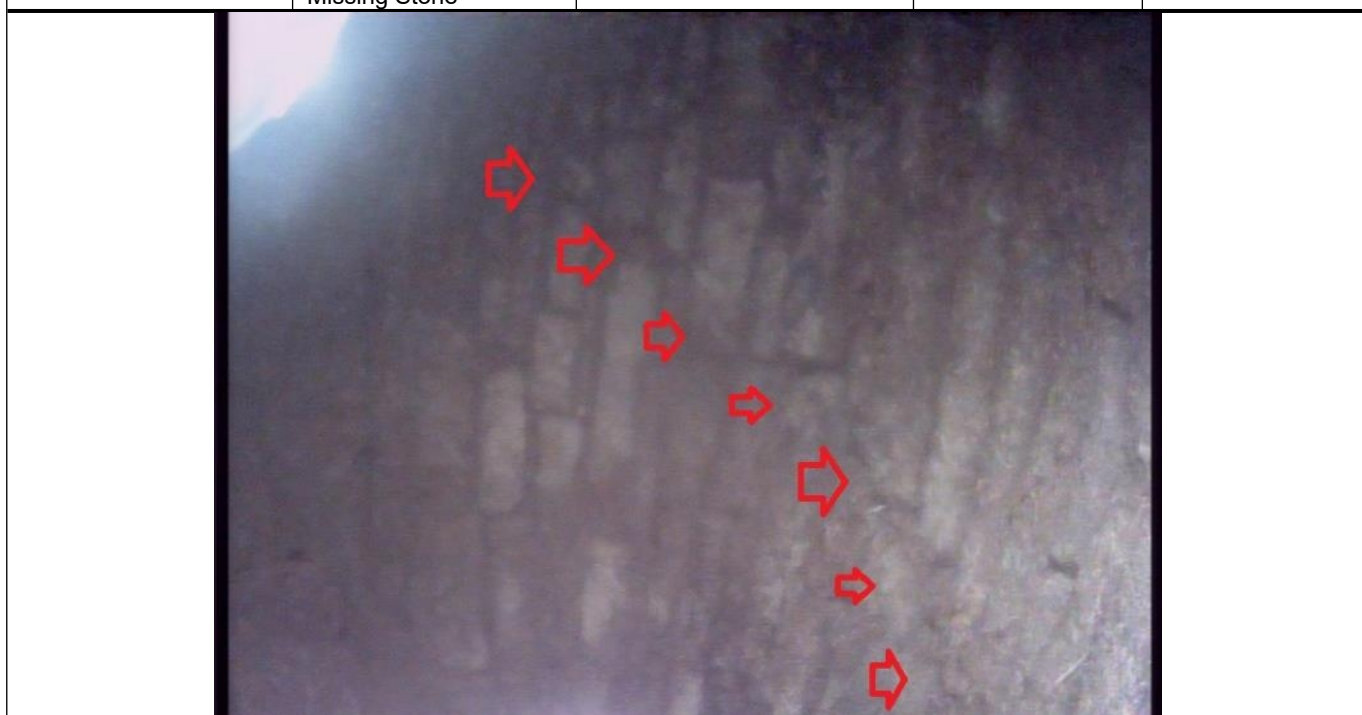
Photo Index\*: 14

@16.3m, Longitudinal Fracture open approx. 1-3mm wide x 1m long. NEW. See P14.

Description\*: @16.3m  
Longitudinal Fracture

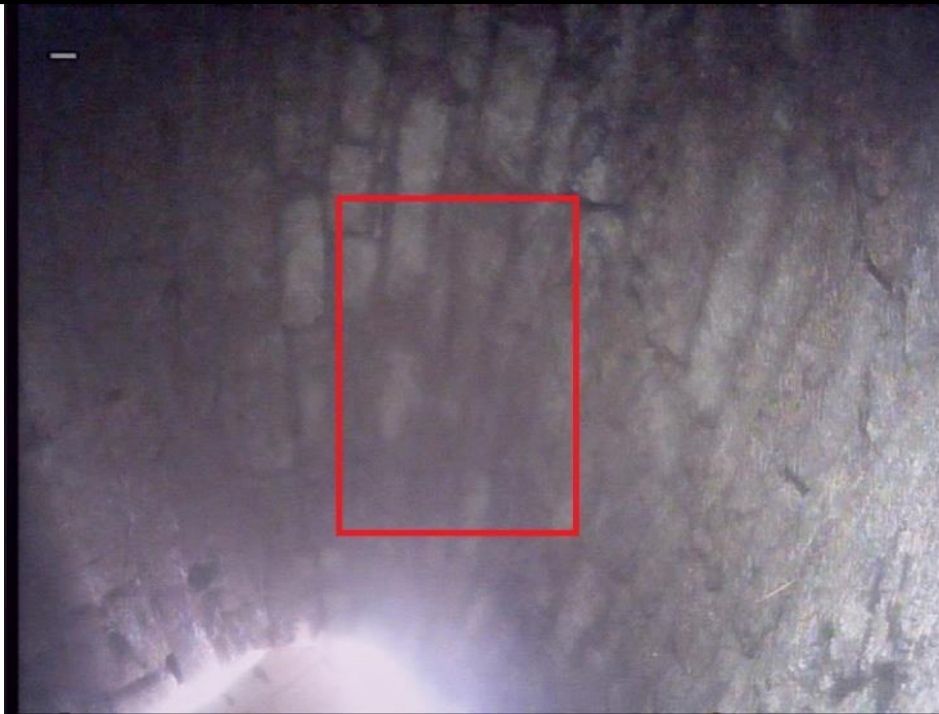
Photo Index\*: 15

Description\*: @17m  
Displacement

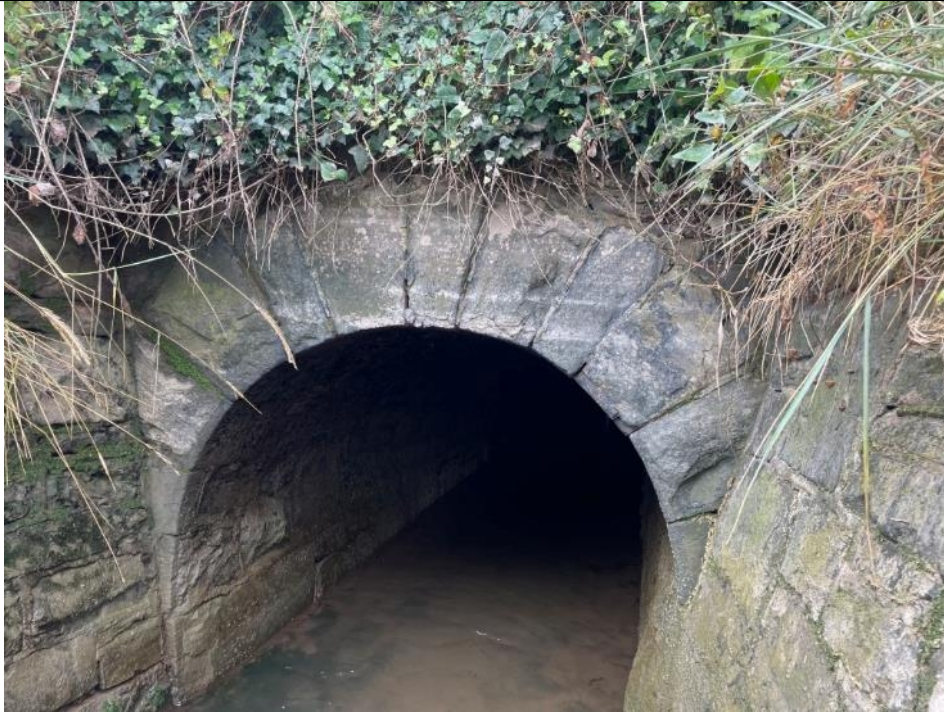
Photo Index\*: 19

No significant defects noted at time of exam. See P19.

Description\*: Upside  
Headwall

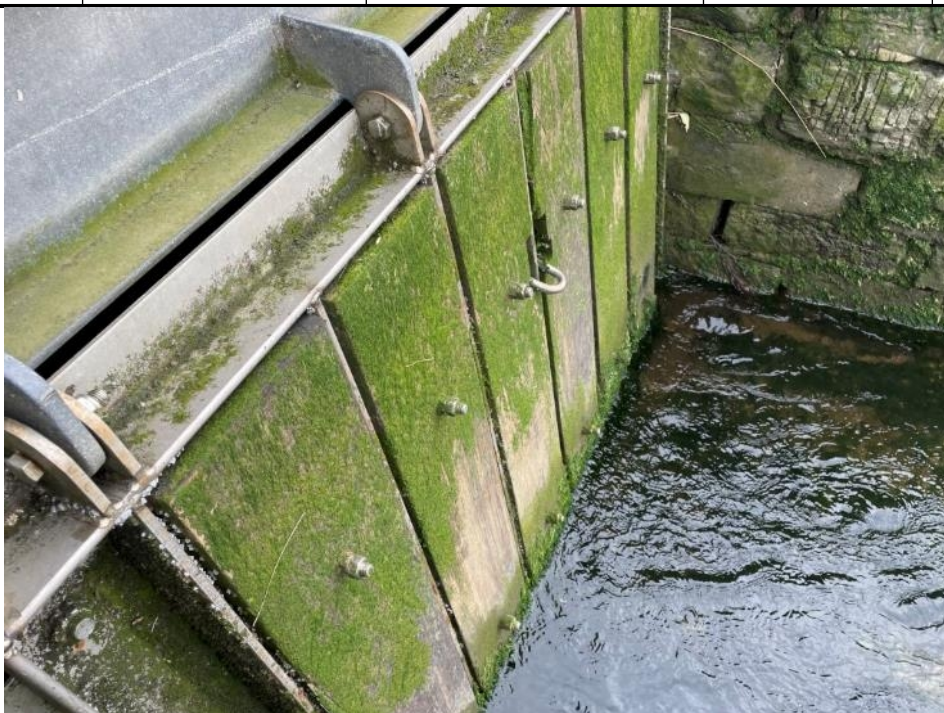
Photo Index\*: 20

Throughout tidal flap. Algae staining to front of tidal flap. See P20.

Description\*: Algae to  
Tidal Flap

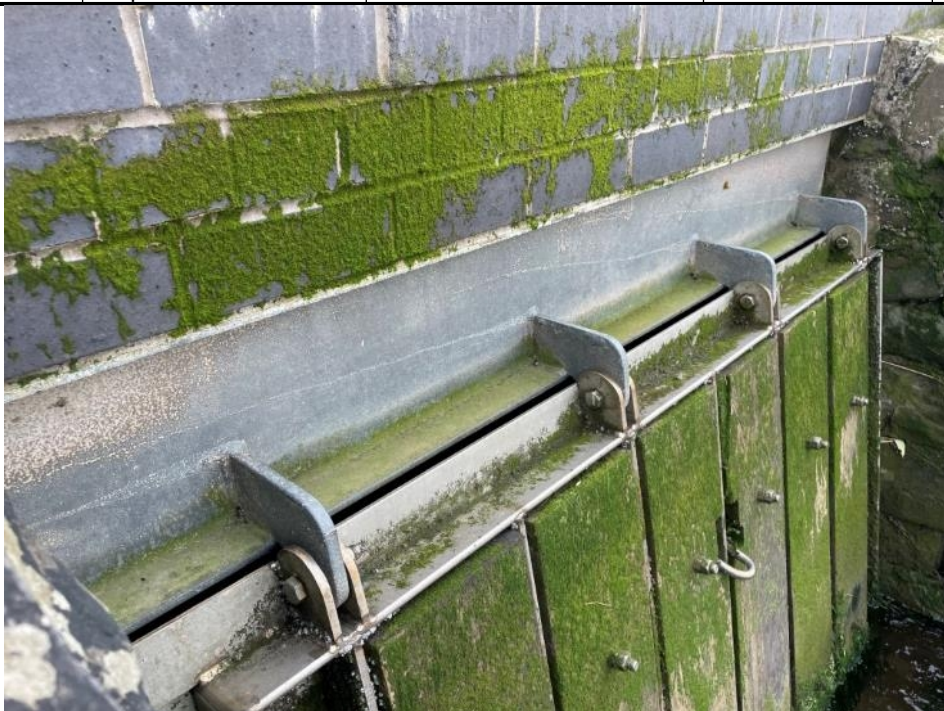
Photo Index\*: 22

Metallic fillet to topside of tidal flap has been replaced. See P22.

Description\*: Repairs  
to Tidal Flap

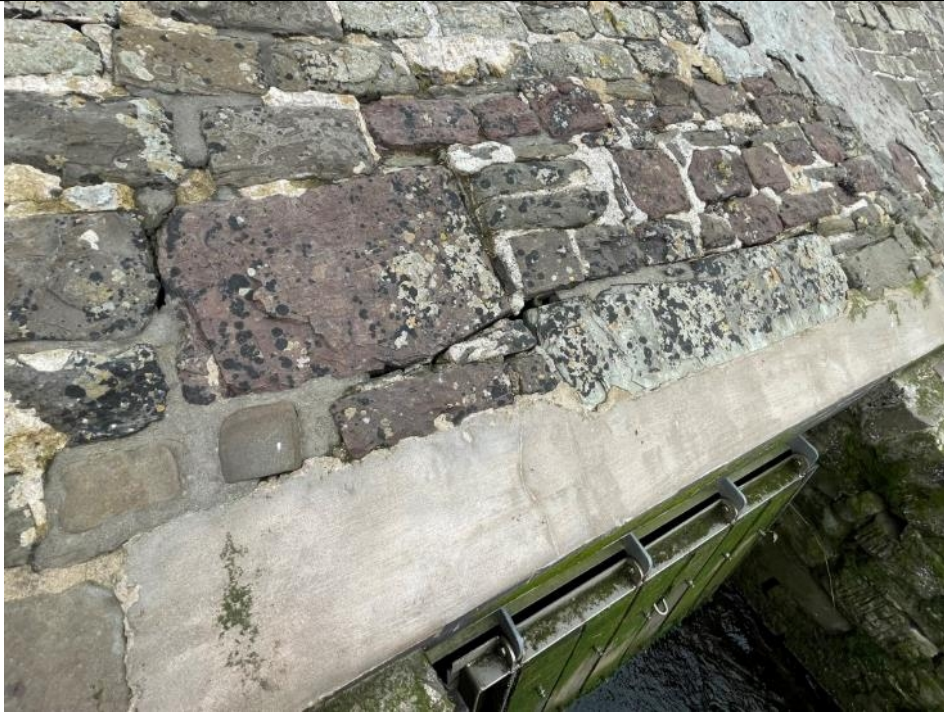
Photo Index\*: 23

To wall above tidal flap, vertical fracture open HL-1mm wide x 300mm long. NEW. See P23.

Description\*: Downside Vertical Fracture

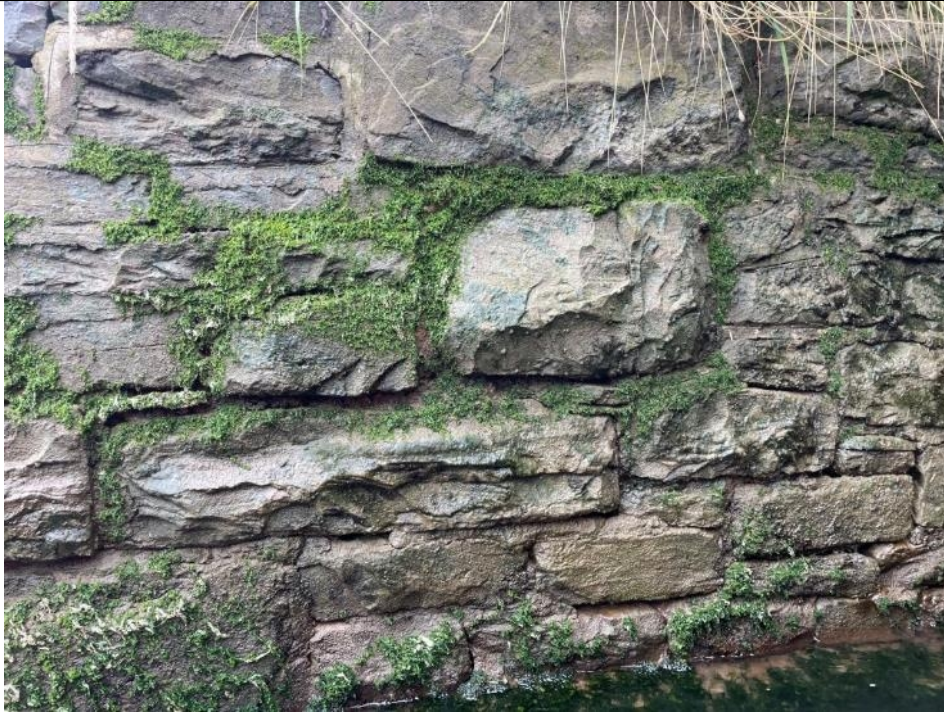
Photo Index\*: 25

@0.6m, diagonal step fracture open 1mm wide x 2.1m long. NEW. See P25.

Description\*: @0.6m  
Diagonal Step Fracture

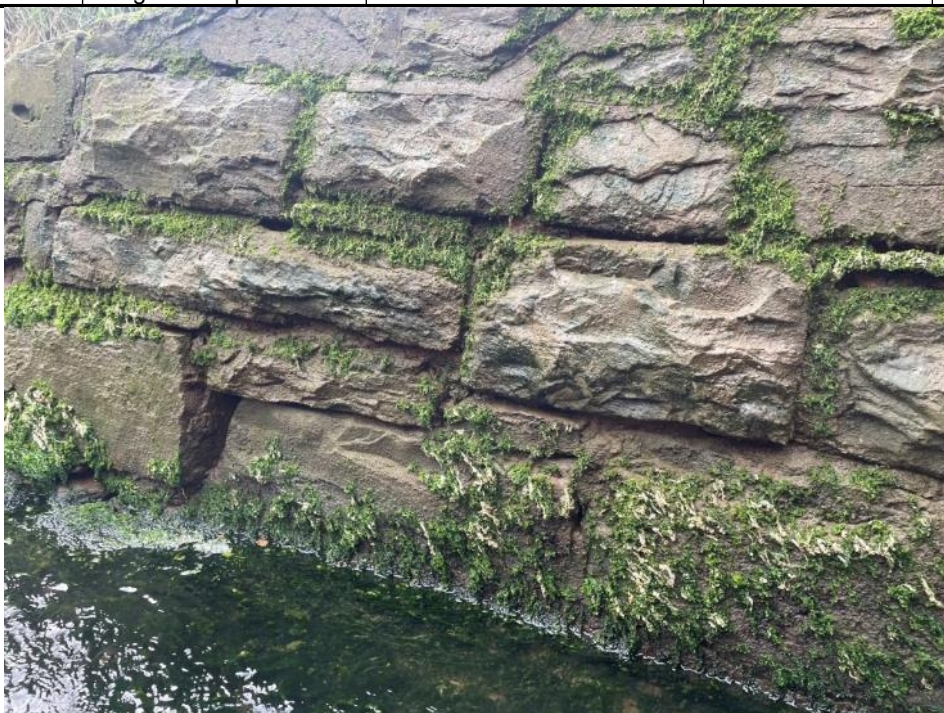
Photo Index\*: 26

@1.5m, diagonal step fracture open 2-4mm wide x 2.4m long. NEW. See P26.

Description\*: @1.5m  
Diagonal Step Fracture

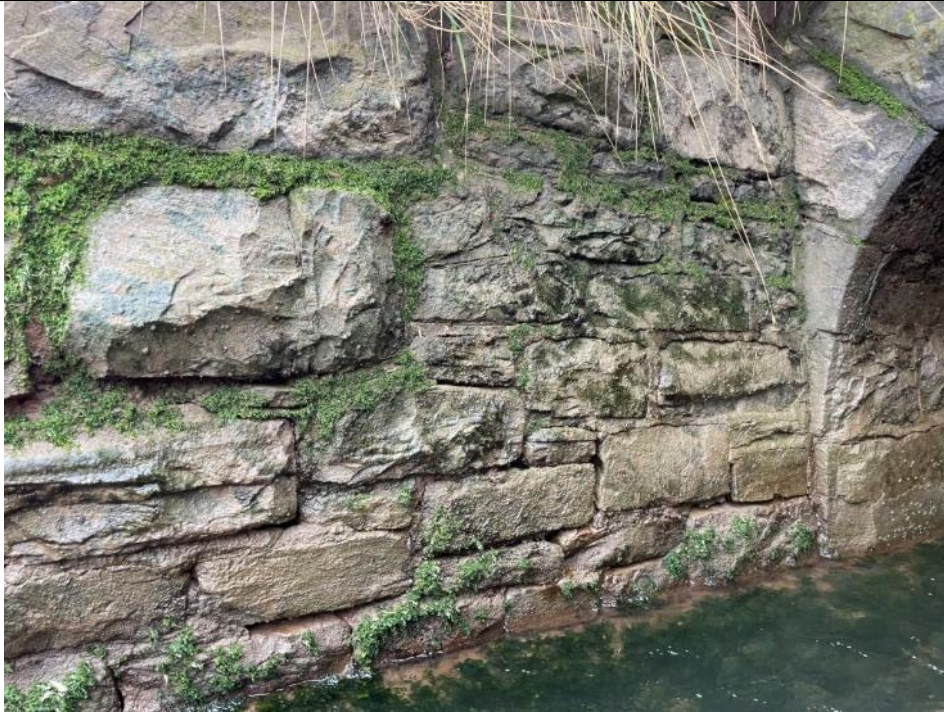
Photo Index\*: 27

Description\*: Typical  
Open Joints

| | | <p align="center"><b>NETWORK RAIL</b></p> <p align="center"><b>Detailed Examination - Culvert</b></p> | | | | | | | | | | |
|---|---|---|---|---|---|---|---|---|---|---|---|---|
| 1 | Rake out and repoint areas of open joints and displaced brickwork (PR). | Culvert barrel | 2000.0 | 1yr | 9 m2 | 2 | 3 | S 6 | Hand Pointing | | | |

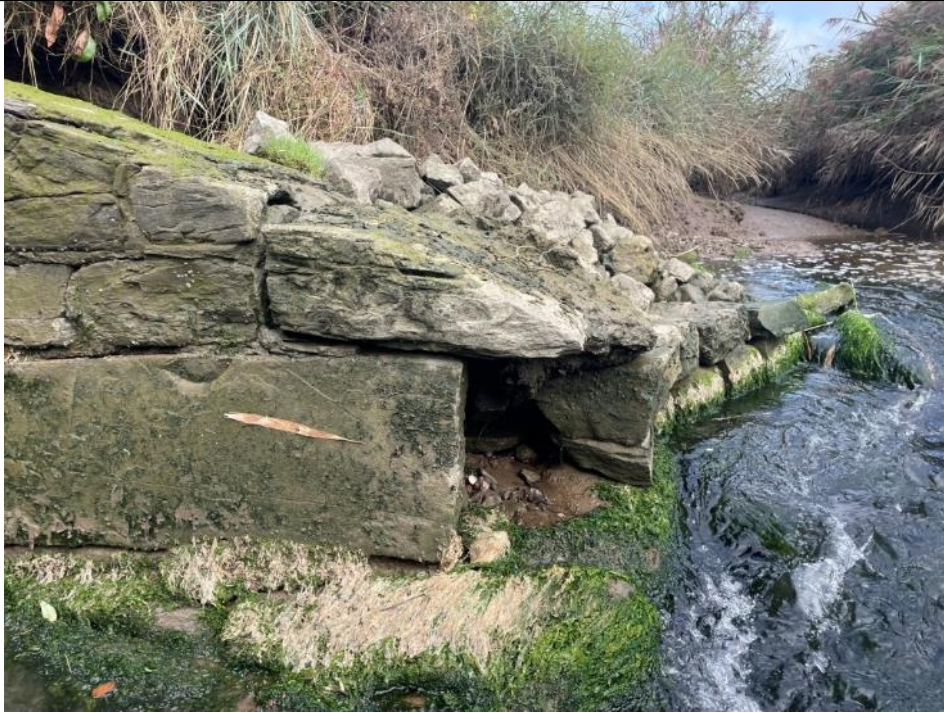
Photo Index\*: 29

At offside end of wingwall, area of missing stonework to 400mm deep x 400mm wide x 420mm high with 1no stone displaced forwards by 25mm. NEW. See P29

Description\*: Missing/  
Displaced Stonework

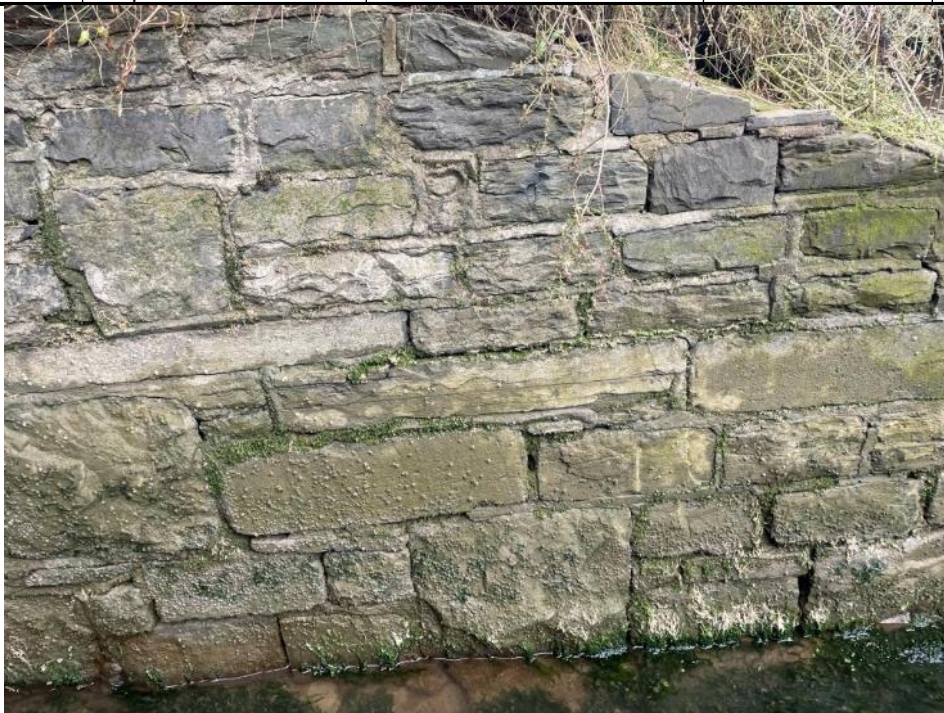
Photo Index\*: 30

Description\*: Typical  
Open Joints

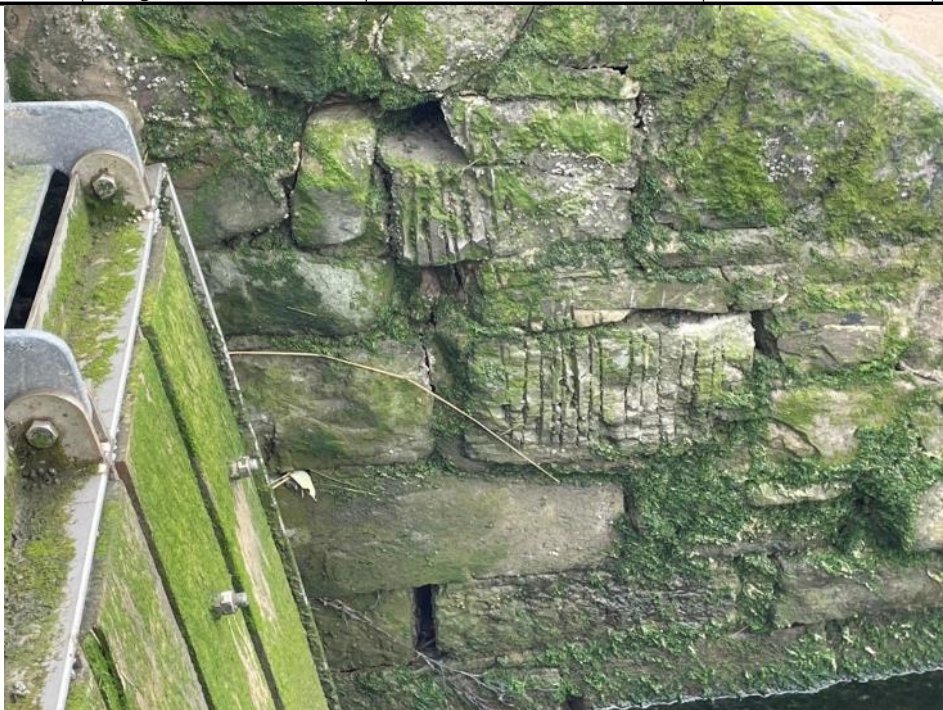
Photo Index\*: 32

Description\*: Loose Stonework

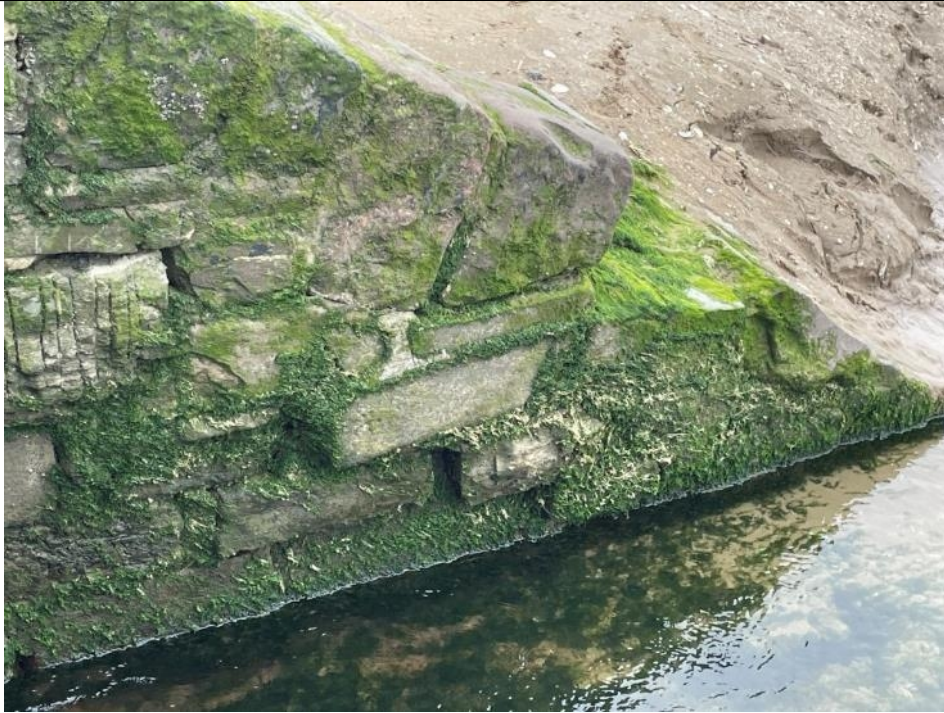
Photo Index\*: 33

Description\*:  
Displaced Stonework

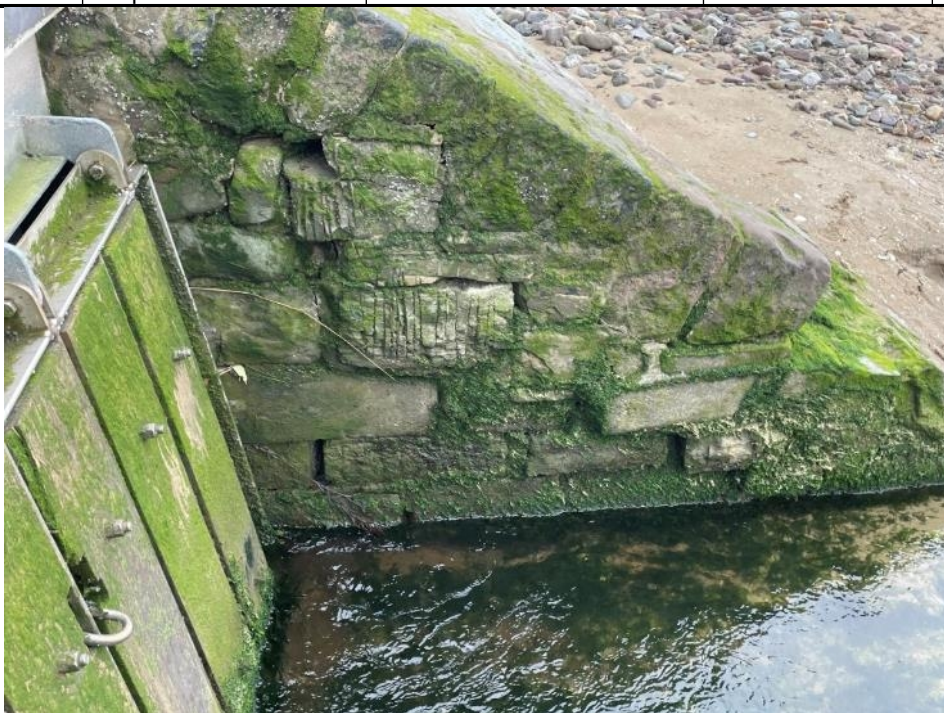
Photo Index\*: 34

Description\*: Typical  
Open Joints

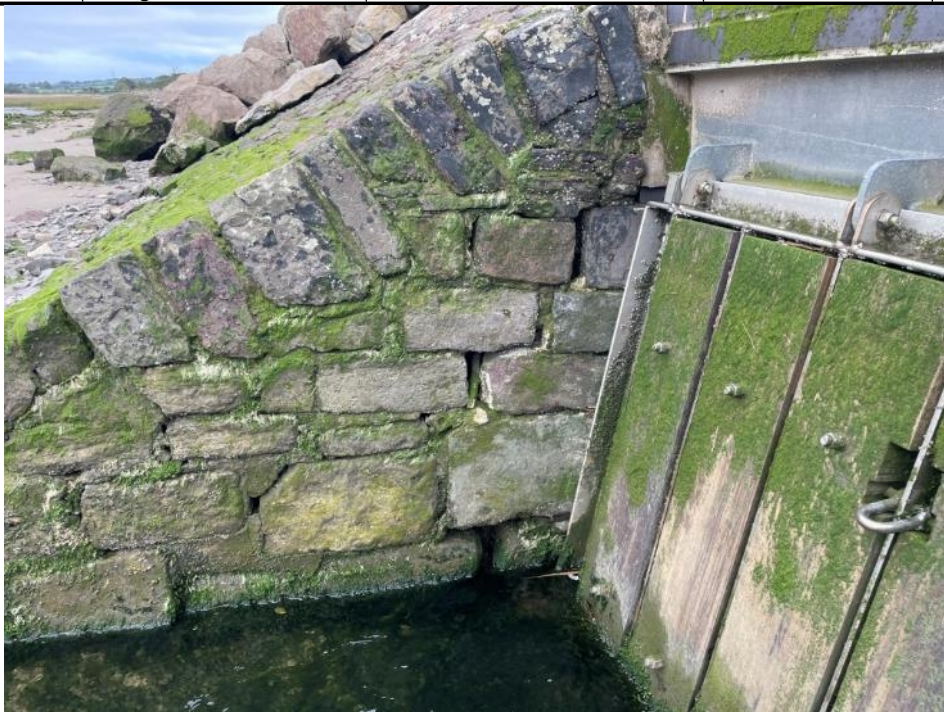
Photo Index\*: 36

Description\*: Typical  
Open Joints

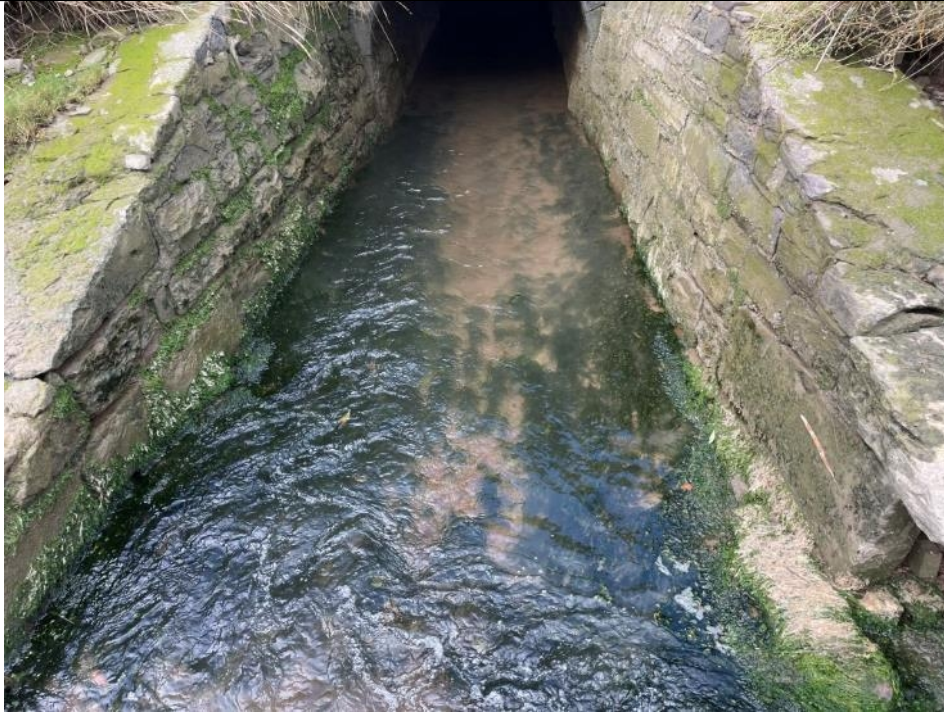
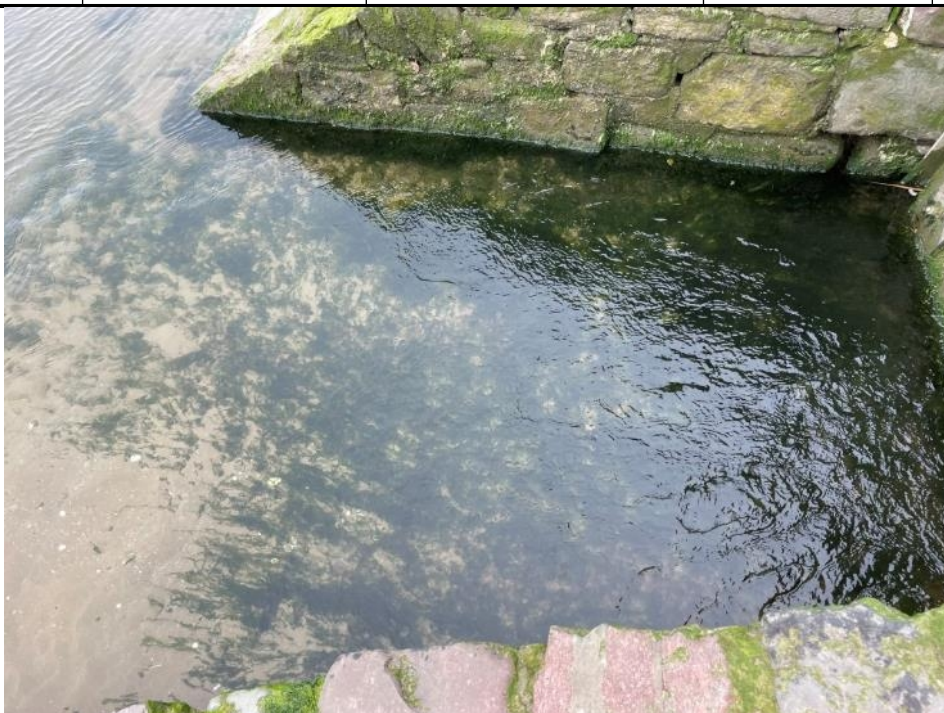
Where viewed, no significant defects noted at time of exam. See P37 and P38.
