**Rhondda Cynon Taf County Borough Council**

**A8066 Tynybryn River Channel Survey**

July 2020

Inspection team	Nicholas Tucker	Ifan Thomas
	Andrew Duncan	Mike Bond
Report by:	Nicholas Tucker	
Inspection date	29 <sup>th</sup> June 2020 & 1 <sup>st</sup> July 2020	
Report No.	A8066

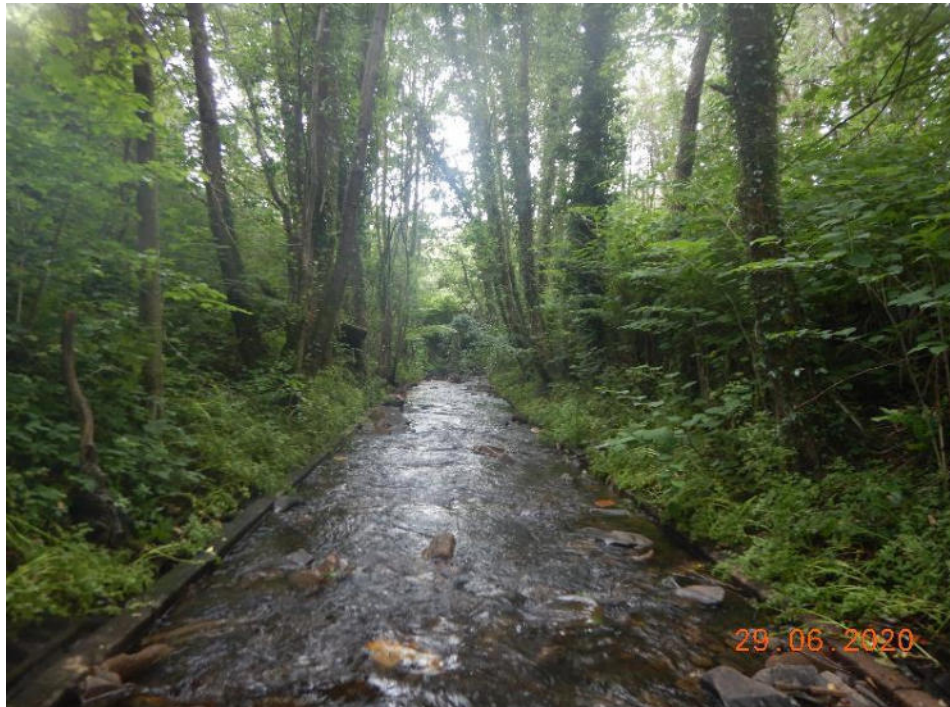
Chainage	Description	P	S	Ex	W	Ref.
-	The riverbed material consists of large loose stones. Multiple sections of concrete were present within the watercourse, indicating damage to the revetment upstream of the inspection start point. The riverbed is 3.2m wide at the start chainage.	3, 4	-	-	-	-
0m	Directly upstream of the inspection start point, the concrete toe is missing over a 3.8m length.	5	3	B	R	i.
0m – 101.2m	Large sections of the revetment are covered with heavy and dense vegetation including moss, Japanese Knotweed (from 67.4m) and trees which obscured the inspection of the revetment.	6, 7	2	E	RM	ii.

*Photo 3 – General view of the riverbed (0m – 101.2m)*

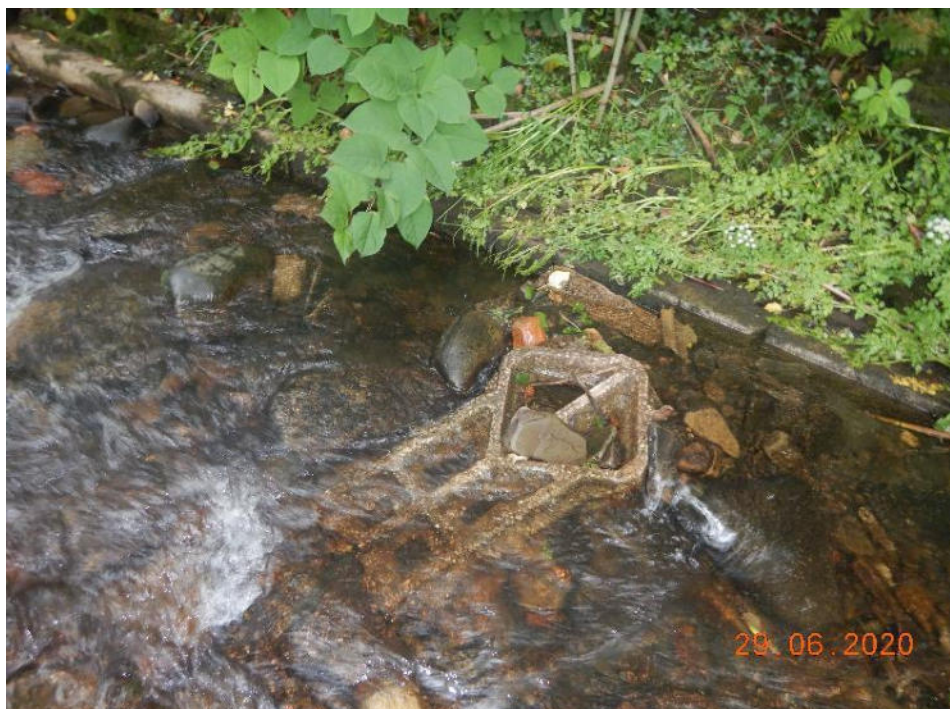
*Photo 4 – Sections of the revetment present in the watercourse (0m – 101.2m)*

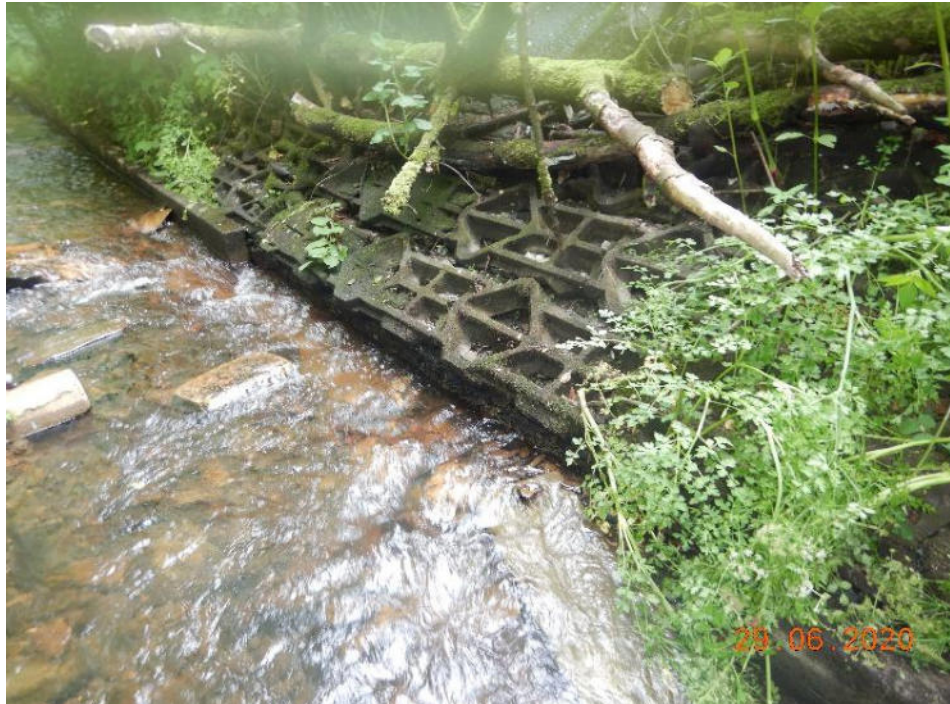
*Photo 5 – Missing concrete toe directly upstream of the inspection start point*

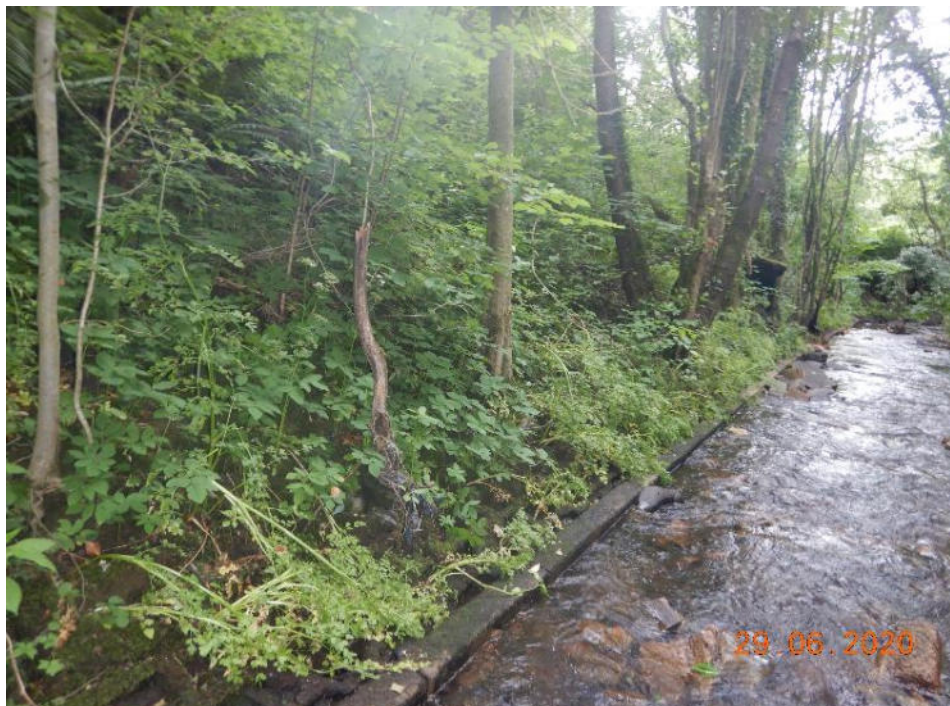
*Photo 6 – Vegetation growth to the revetment (0m – 101.2m)*

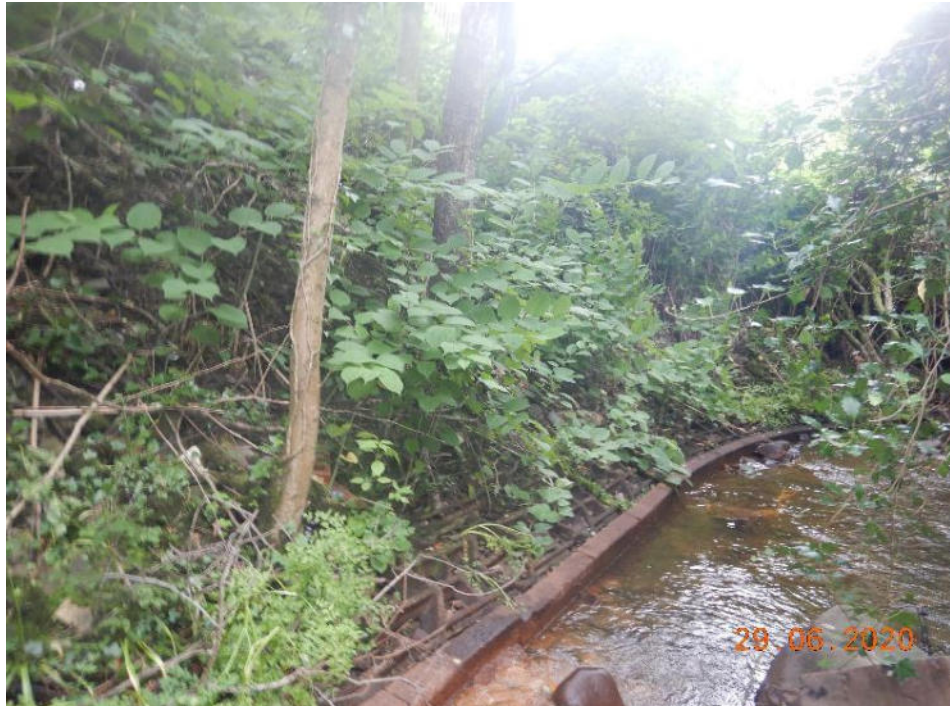
*Photo 7 – Japanese Knotweed growing on the revetment (0m – 101.2m)*

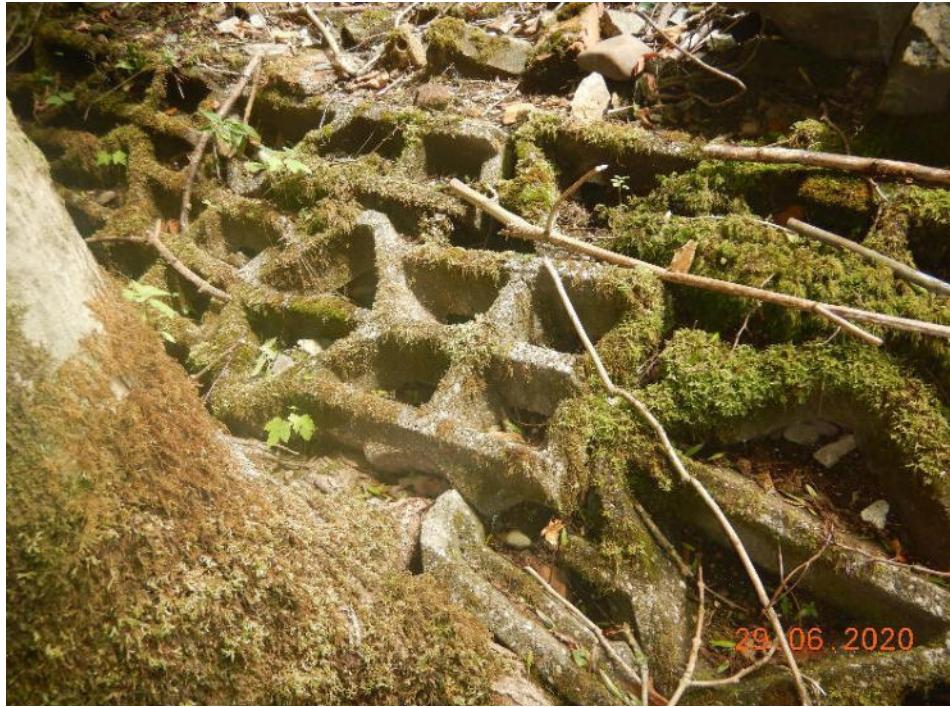
17.2m & 19.3m	There are two trees growing to the revetment measuring 180mm and 400mm in diameter, respectively. There are sections of loose and displaced concrete surrounding the trees both measuring 300mm high and 700mm long.	8, 9	2	E	RM	ii.

*Photo 9 – Tree growth causing displacement of concrete (19.3m)*

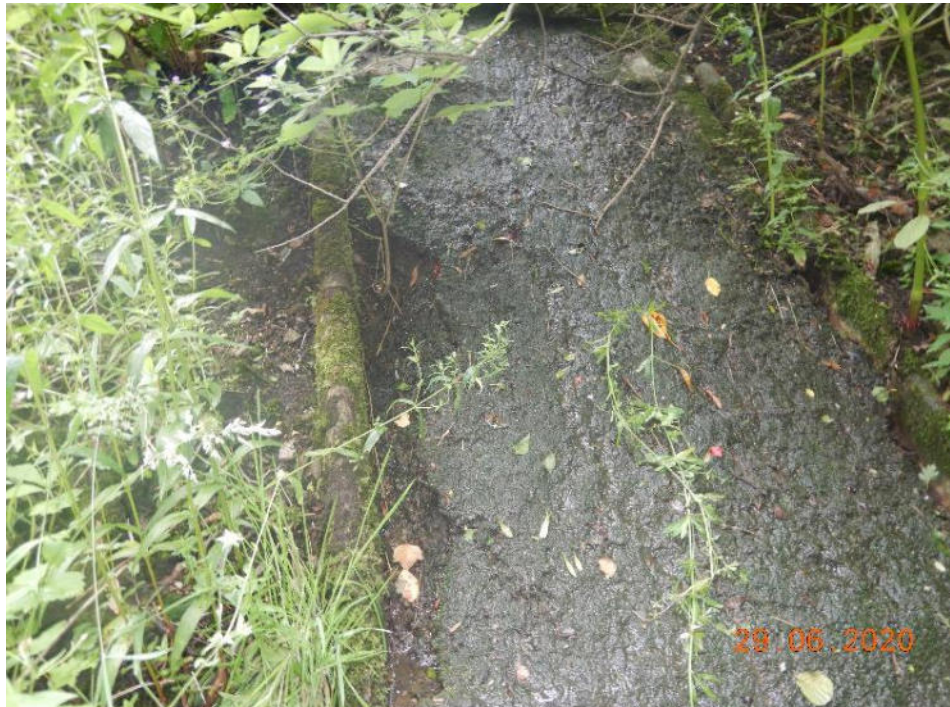
*Photo 11 – Scour to the concrete apron (27.4m)*

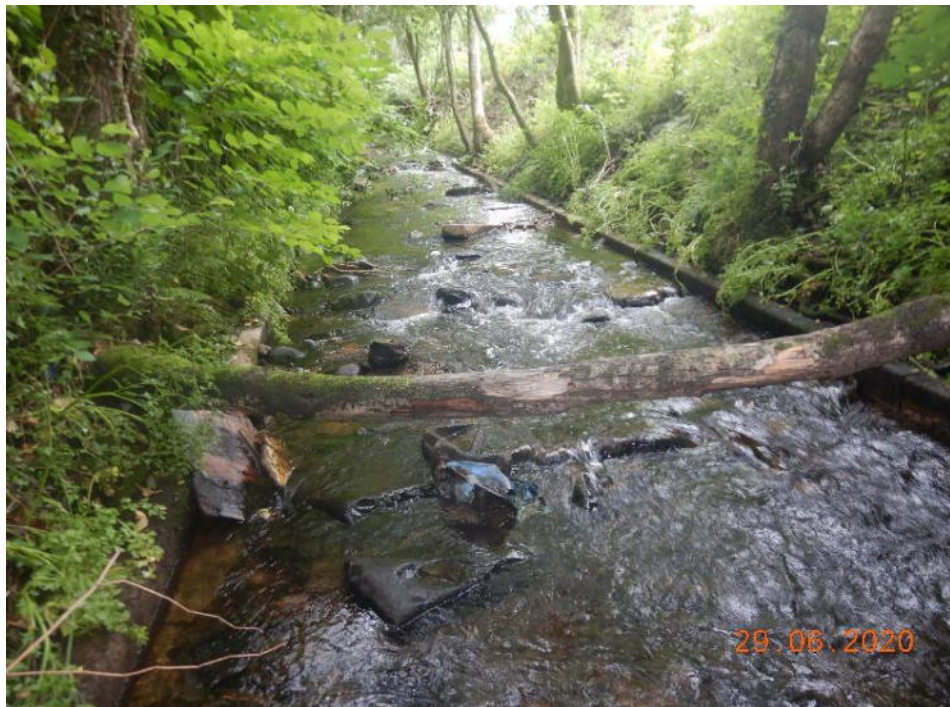
34.5m	A tree has fallen into the watercourse, measuring 180mm in diameter. The tree is not restricting the water flow at present.	12	2	B	RM	ii.
54.3m – 59.2m	The concrete toe has failed between these chainages. There are two 225mm diameter concrete drainage pipes at 55m. The upstream pipe is fully blocked, and the downstream pipe is partially blocked. Both pipes were dry at the time of inspection; water flow and orange coloured infiltration was present through the base of the wall adjacent to the pipes. This is located at grid reference ST00810 87667.	13 - 15	5	C	I	iii.

*Photo 12 – Fallen tree (34.5m)*

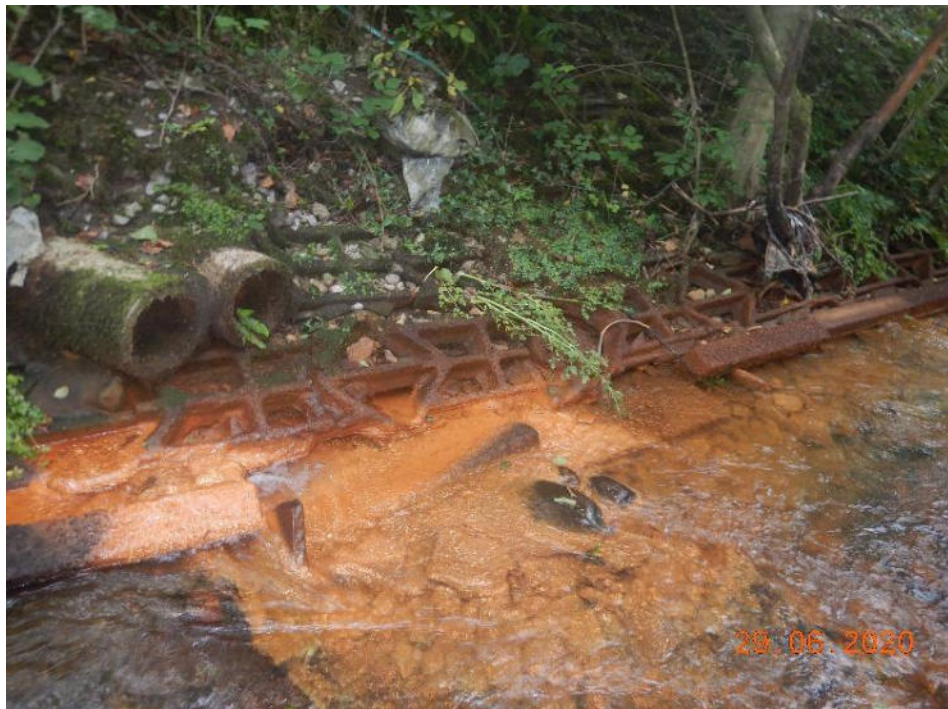
*Photo 13 – Failed concrete toe (54.3m – 59.2m)*

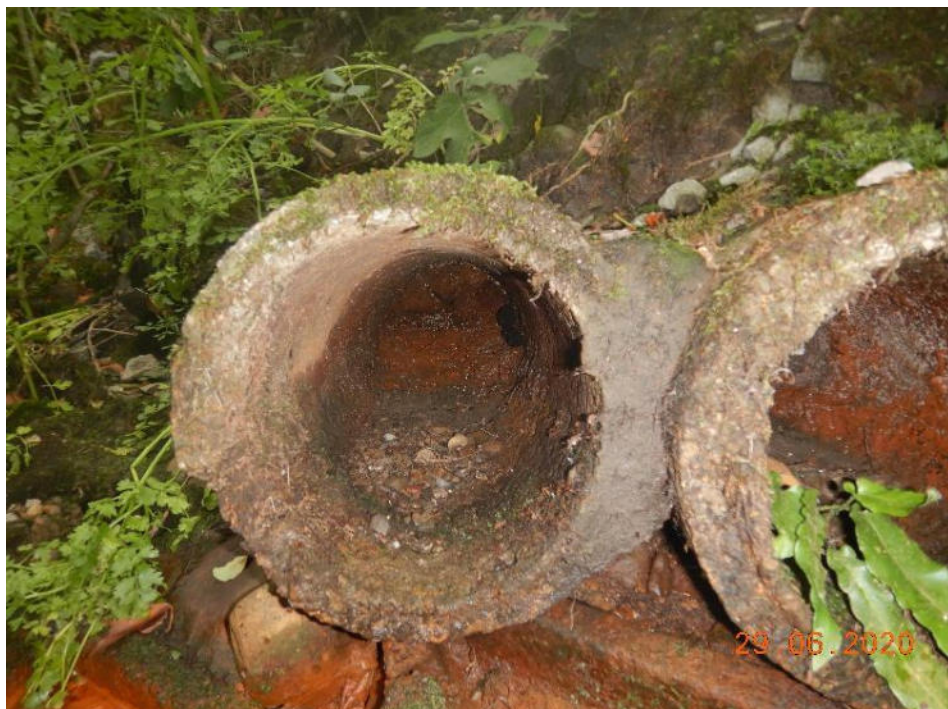
*Photo 14 – Fully blocked concrete pipe (55m)*

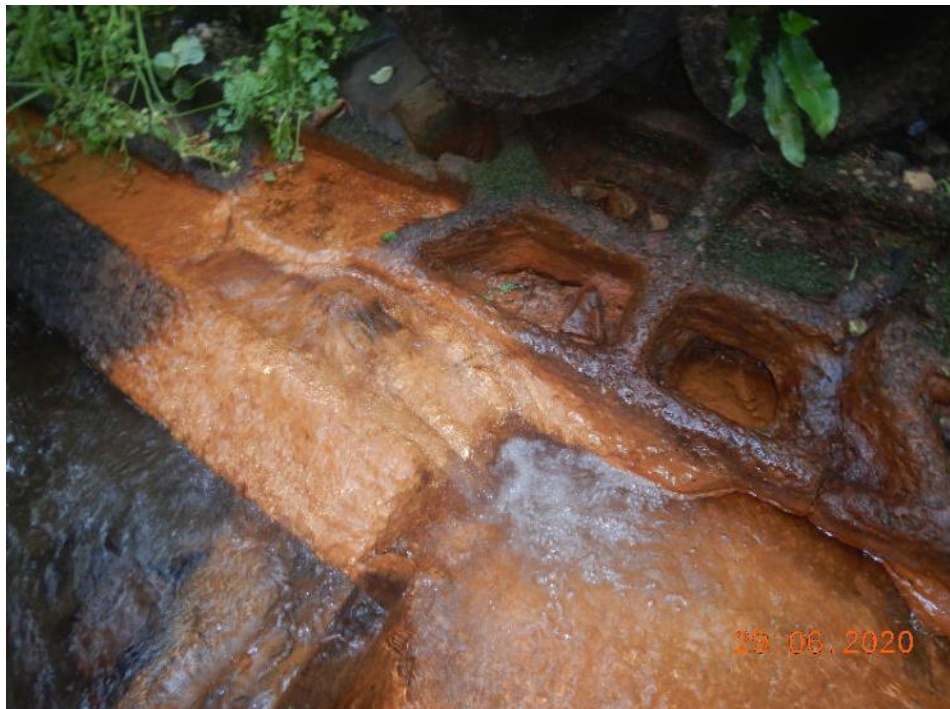
*Photo 15 – Water flow through the base of the wall (55m)*

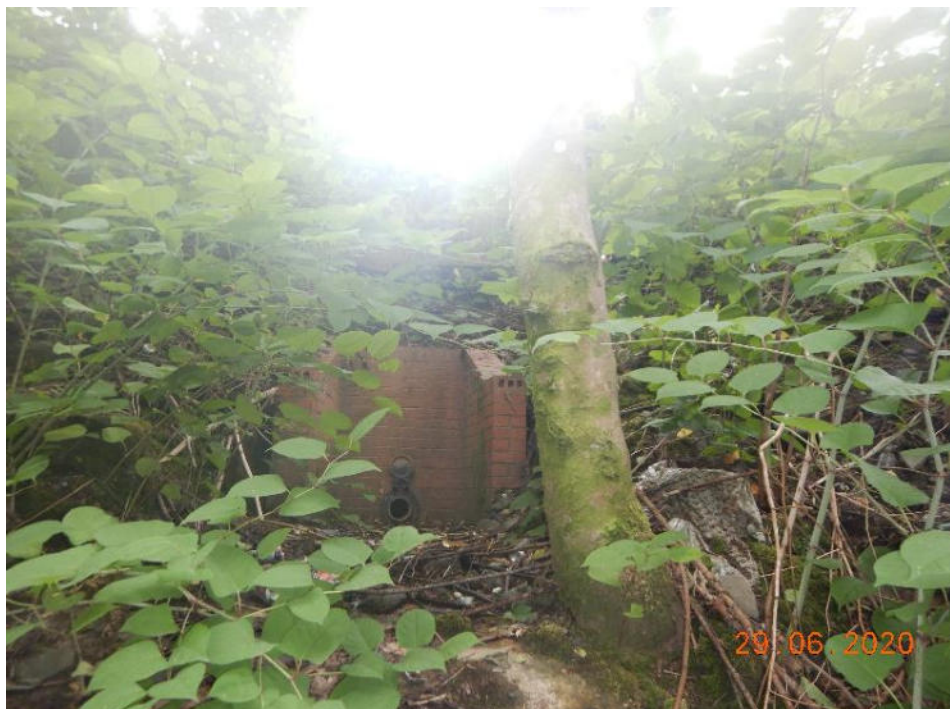
*Photo 16 – Steel drainage pipe (72.6m)*

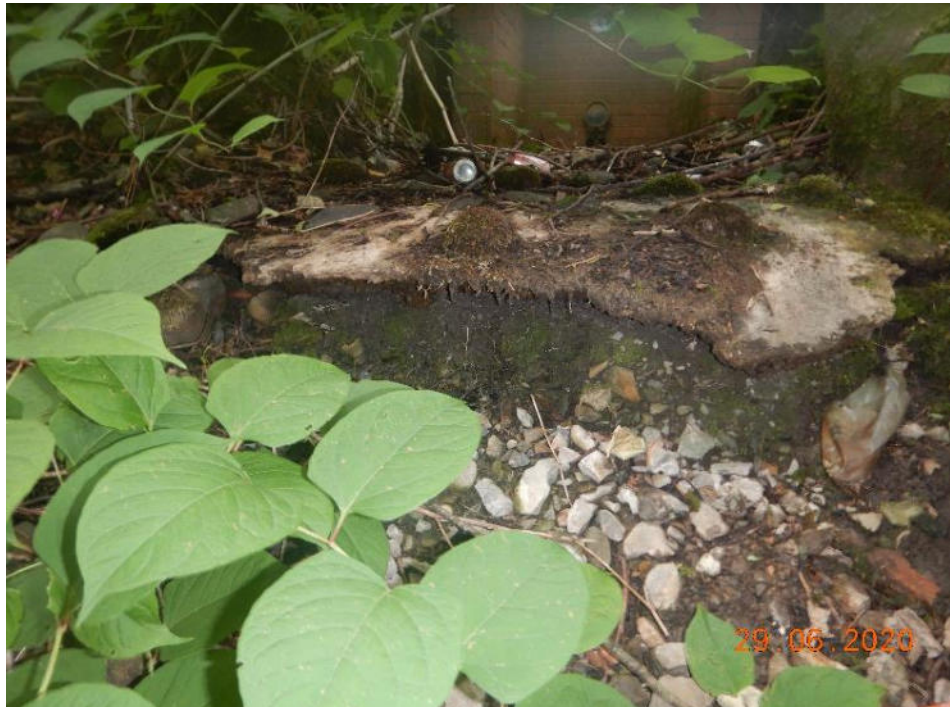
*Photo 17 – Undercut to concrete apron (72.6m)*

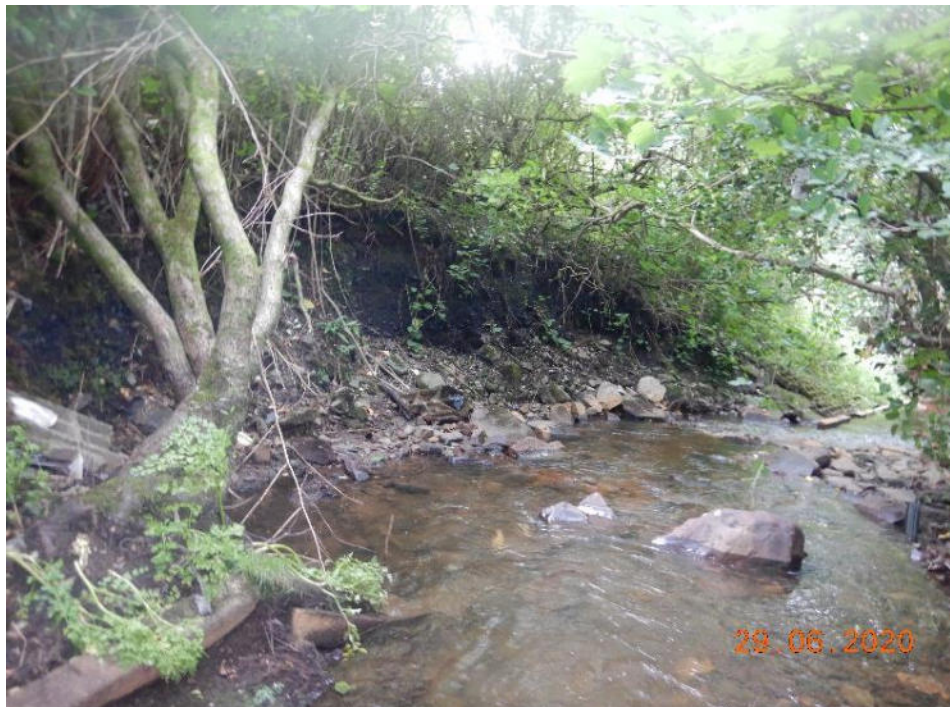
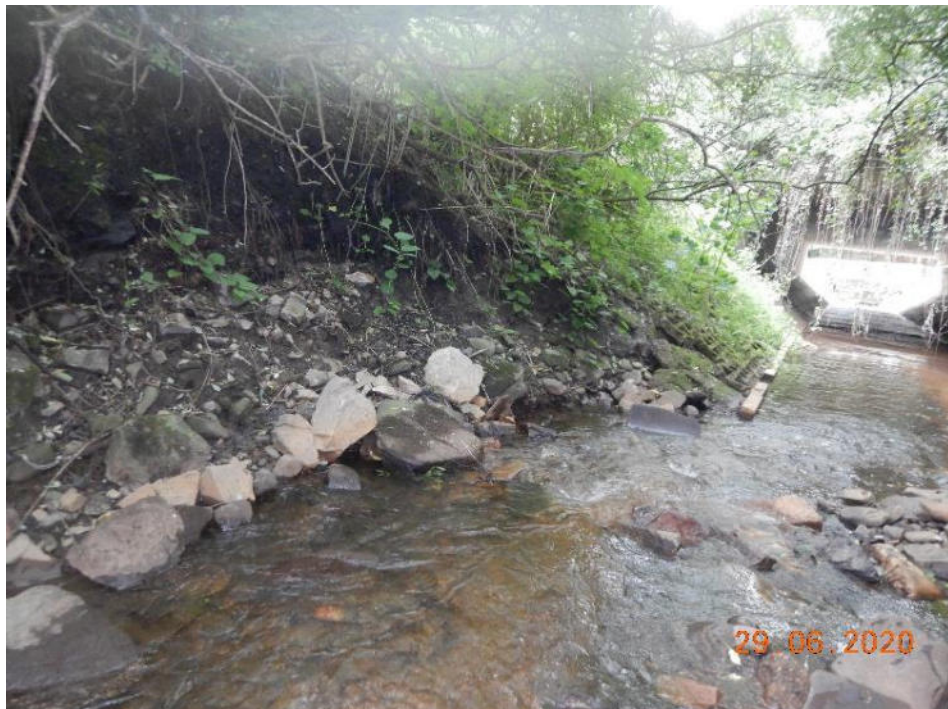
80.5m – 93.3m	–	The revetment has failed, resulting in scour to the embankment measuring 2.3m high and up to 3m deep. This is located at grid reference ST 00797 87635.	18, 19	5	C	R	iv.

*Photo 18 – Failed revetment resulting in scour to the embankment (80.5m – 93.3m)*

*Photo 19 – Failed revetment resulting in scour to the embankment (80.5m – 93.3m)*

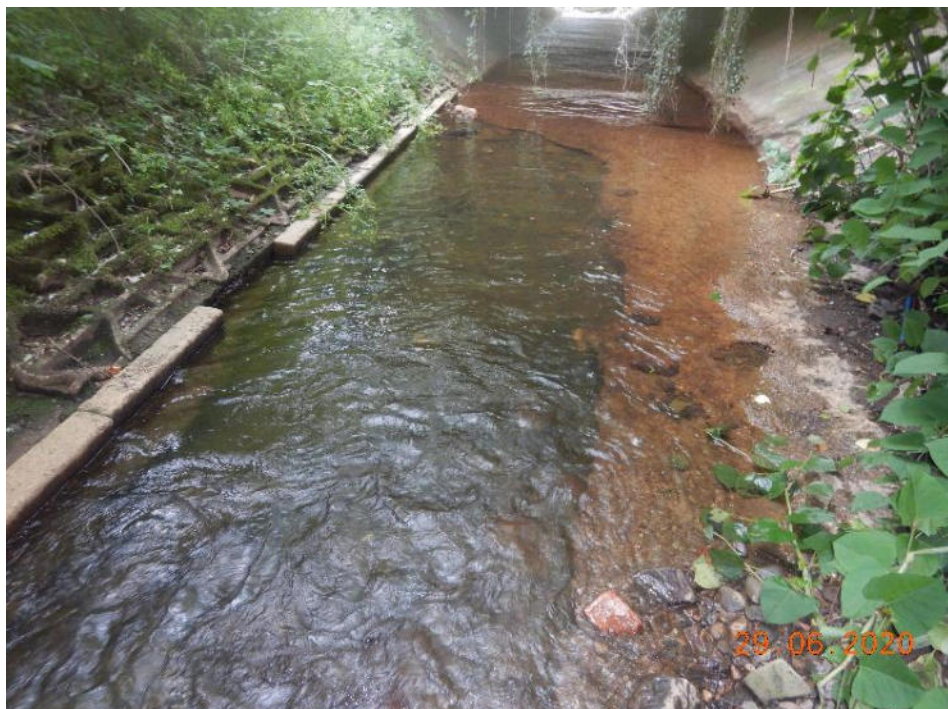
93.3m – 99.7m	–	There is a concrete invert extending upstream of Tynybryn Culvert. The invert is missing on the left side measuring 1.7m wide and up to 0.6m deep. This has resulted in undercutting of the revetment measuring 0.3m high and 0.5m deep, with a 1m long section of the concrete toe missing at 95m. The remaining concrete invert on the right side of the watercourse is undercut measuring 0.4m high and 0.5m deep. This is located at grid reference ST 00787 87631.	20 - 22	5	C	R	v.

*Photo 20 – Missing concrete invert (93.3m – 99.7m)*

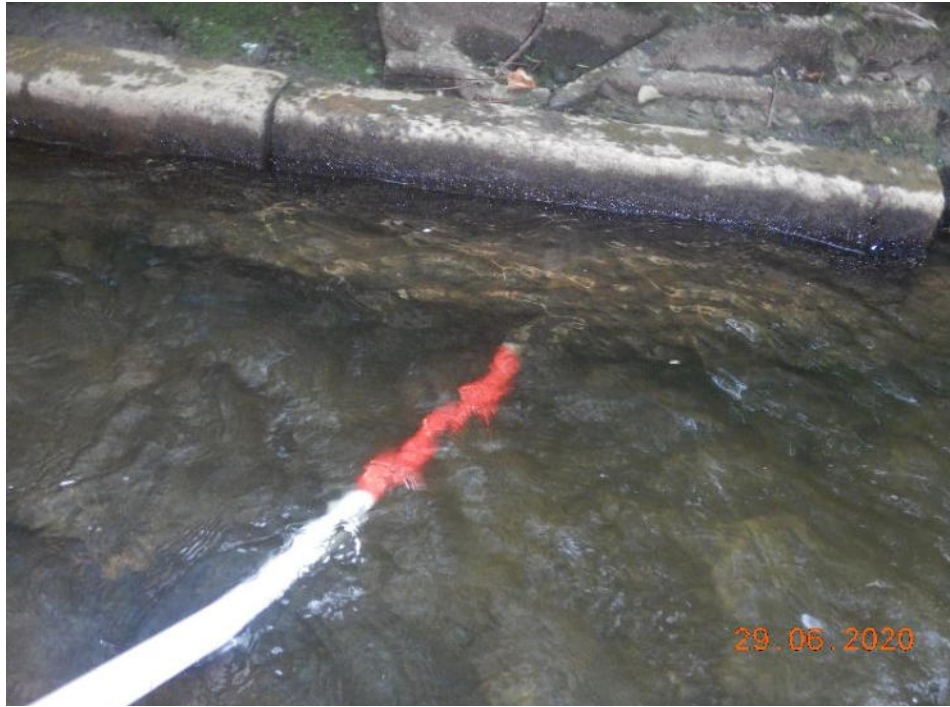
*Photo 21 – Undercutting to the revetment (93.3m – 99.7m)*

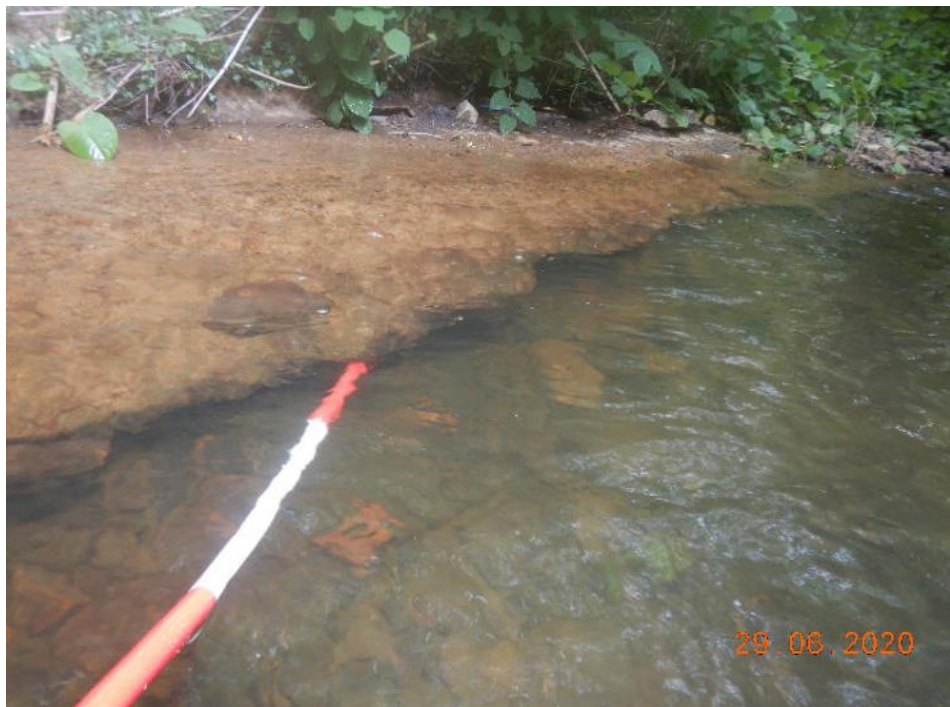
*Photo 22 – Undercutting to the right side of the invert (93.3m – 99.7m)*

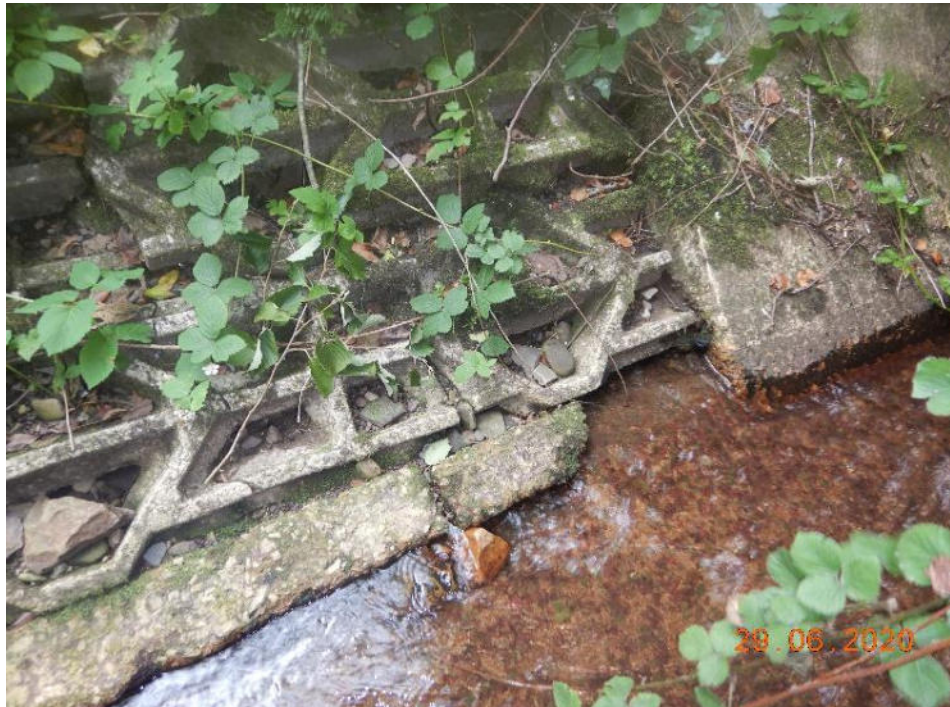
100.6m		A section of the concrete toe is missing over a 0.6m length.	23	3	B	R	i.

*Photo 23 – Missing concrete toe (100.6m)*

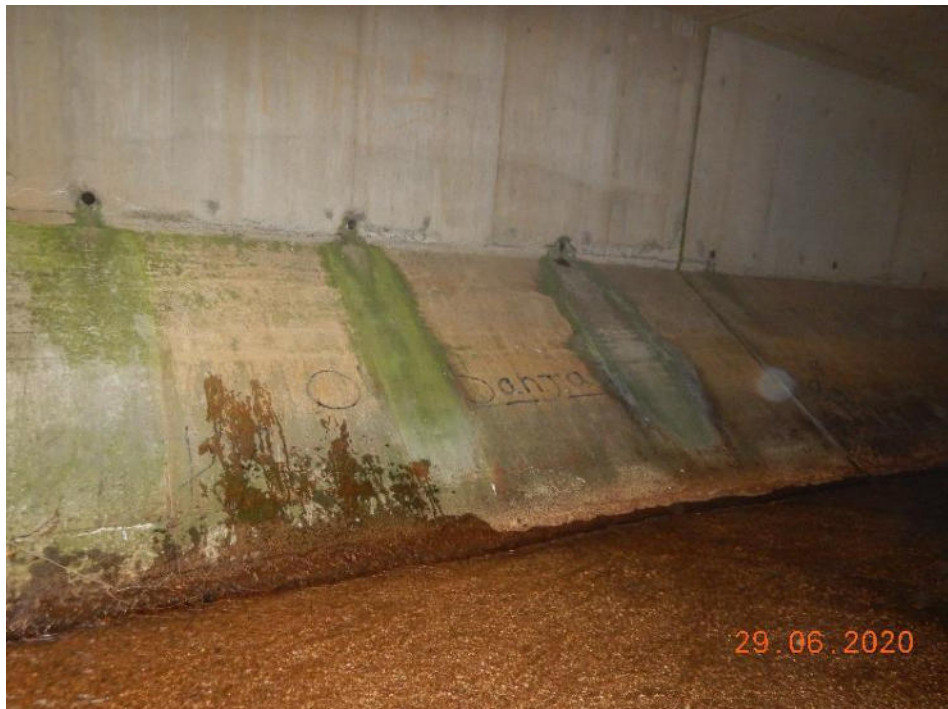
*Photo 25 – White and green coloured infiltration (101.2m – 139.7m)*

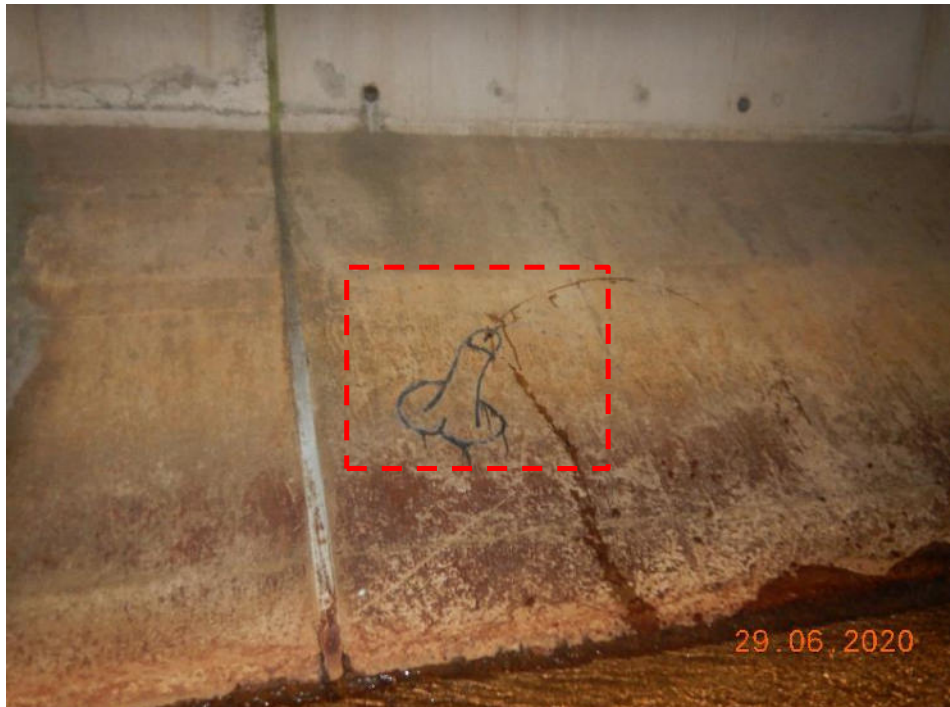
*Photo 27 – Location of offensive graffiti (110.3m)*

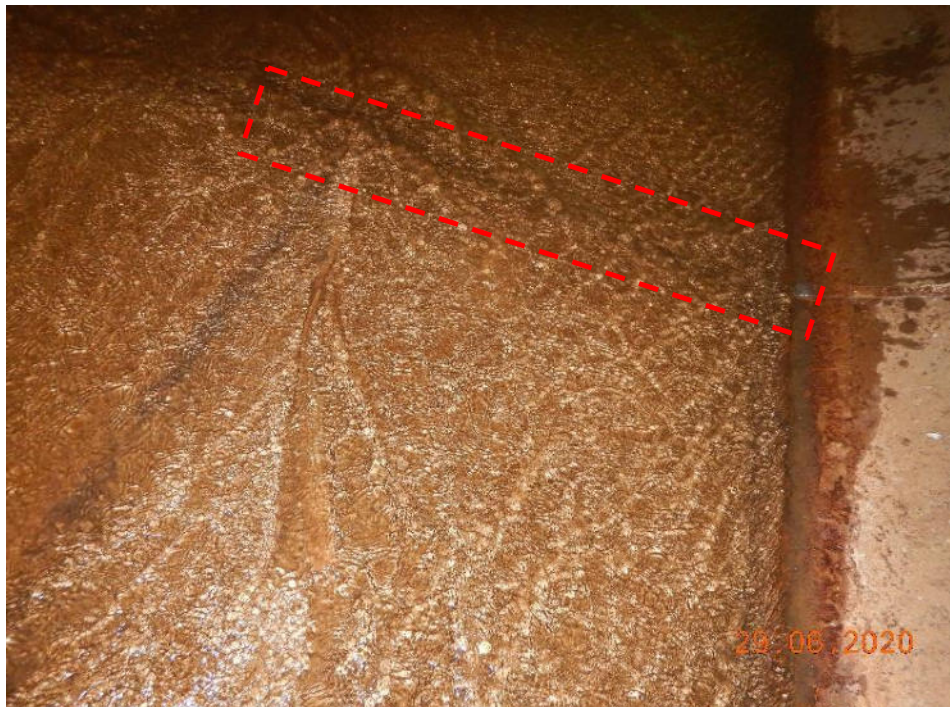
Chainage	Description	P	S	Ex	W	Ref.
-	The culvert was found to be in a good condition overall, with only minor defects identified.	24, 26	-	-	-	-
101.2m – 139.7m	There are 75mm diameter weep holes spaced 2m apart on both sides of the structure. There is white and green coloured infiltration coming from several of the weep holes.	25	2	C	N	-
110.3m	There is offensive graffiti present to the left side of the structure.	27	-	-	RM	vi.
129.4m	The jointing has come loose on the left side of the invert over a 1.2m length.	28	2	B	N	-

*Photo 28 – Loose jointing (129.4m)*

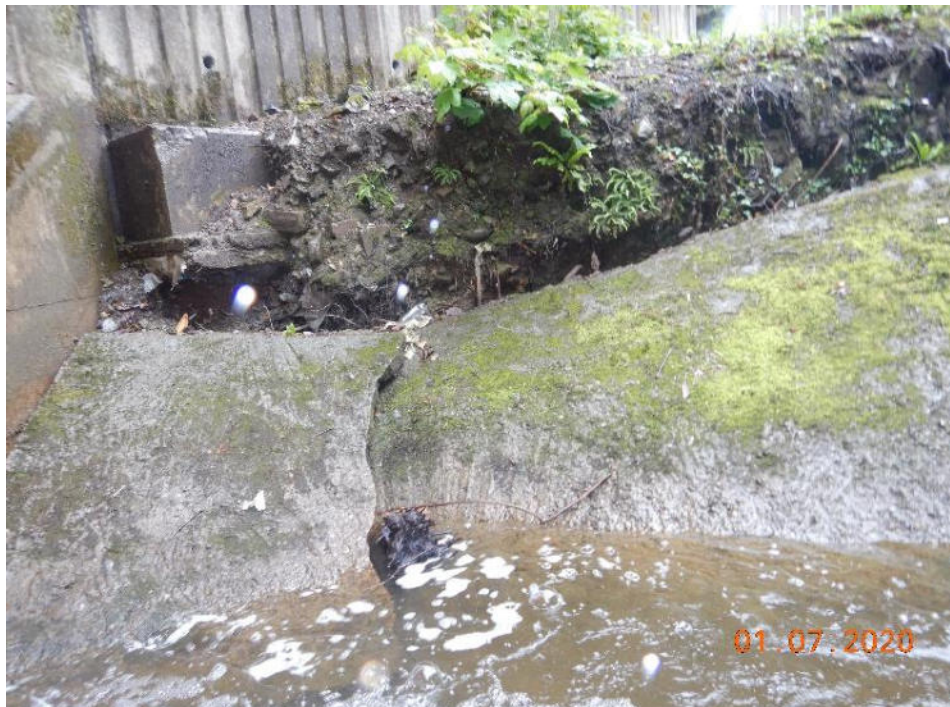
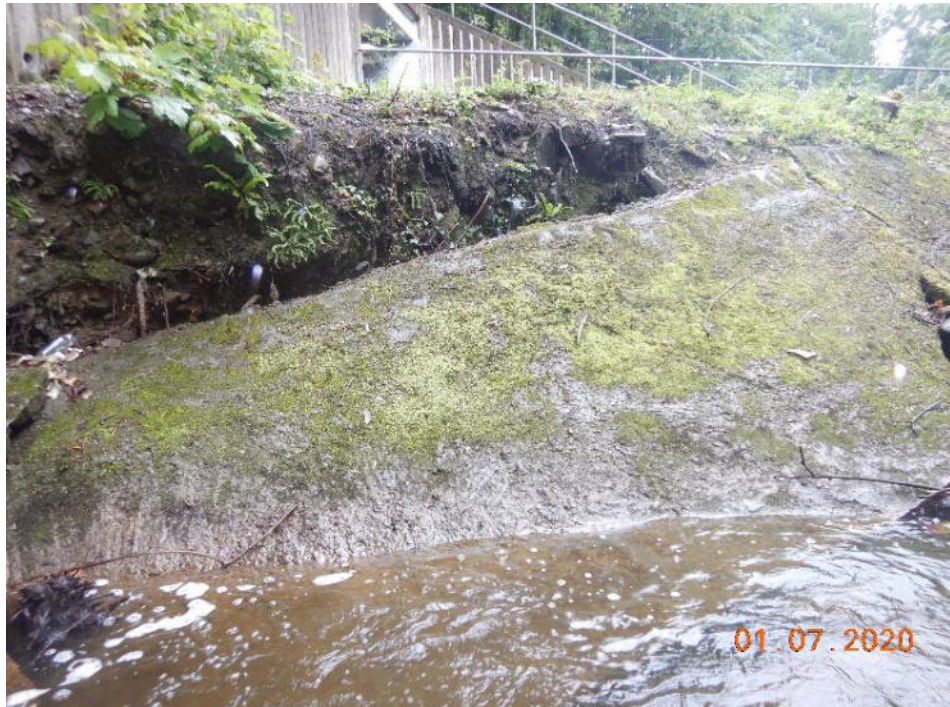
Chainage	Description	P	S	Ex	W	Ref.
139.7m – 145.4m	The revetment has failed adjacent to the downstream elevation of Tynybryn Culvert resulting in scour to the embankment measuring 1.5m high and up to 1m deep.	30, 31	5	C	R	iv.
145.4m – 156m	The concrete toe is undercut initially measuring 0.15m high and 0.2m deep, increasing to a maximum of 0.4m high and 0.6m deep at 153.7m.	32, 33	3	C	R	v.

*Photo 30 – Failed revetment (139.7m – 145.4m)*

*Photo 31 – Failed revetment (139.7m – 145.4m)*

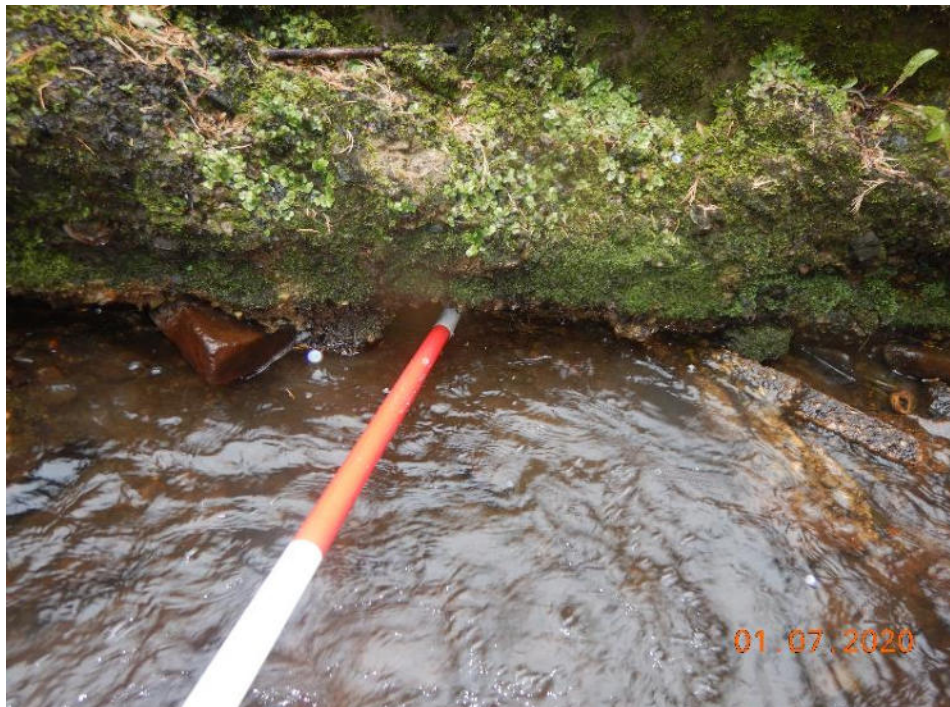
*Photo 32 – Scour to the concrete toe (145.4m – 156m)*

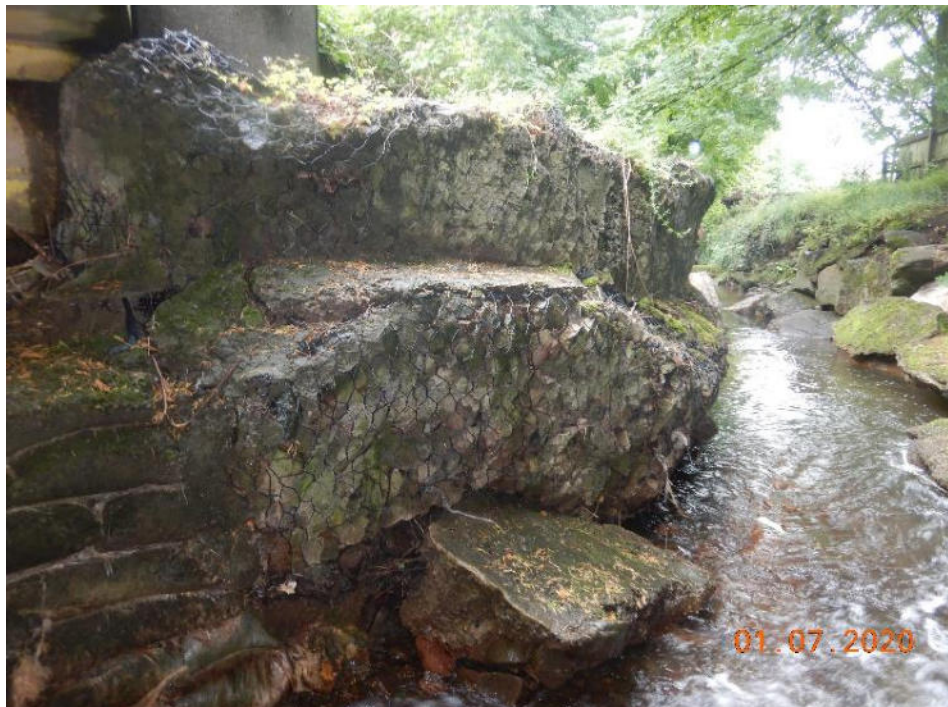
158.8m – 165.4m	Downstream of the footbridge the gabion basket training wall is in a poor condition and is leaning into the watercourse creating a void to the embankment behind measuring 0.7m high and 1m deep. At 163.4m the baskets are undercut over an area measuring 1.5m long, 0.8m high and 1.2m deep.  Additionally, there are remnants of a previous concrete invert that extends from the downstream elevation of the footbridge to the end of the training wall. The failure of the concrete invert is likely to have caused undercutting of the adjacent gabion baskets.	40 - 42	4	E	R	viii.
		43	5	E	R	viii.

*Photo 40 – Condition of the gabion basket training wall (158.8m – 165.4m)*

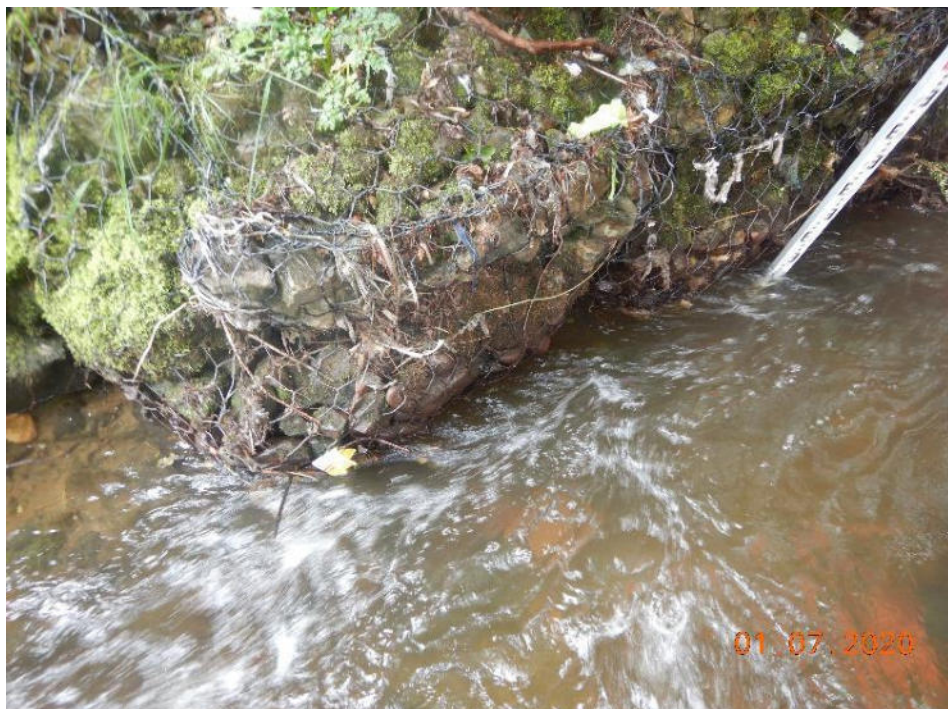
Chainage	Description	P	S	Ex	W	Ref.
185.7m – 192.7m	The gabion baskets are in a poor condition, with multiple bulging and leaning baskets present. The baskets are undercut from 185.7m – 191.4m measuring 0.3m high and 0.25m deep.	45 - 47	3	E	R	viii.

*Photo 46 – Bulging and leaning baskets (185.7m – 192.7m)*

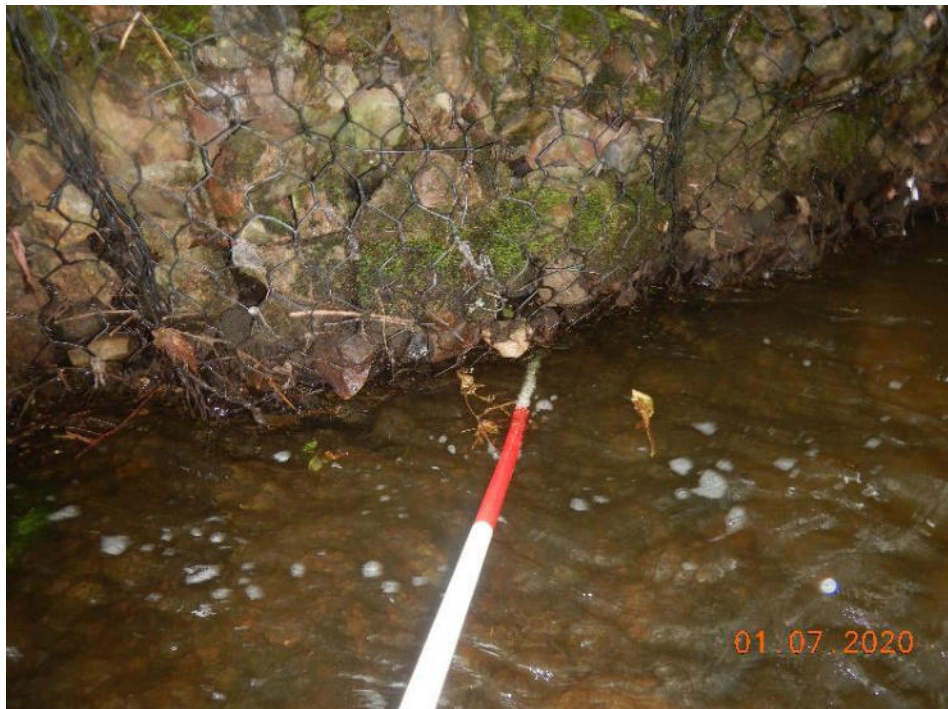
*Photo 47 – Undercutting to gabion baskets (185.7m – 192.7m)*

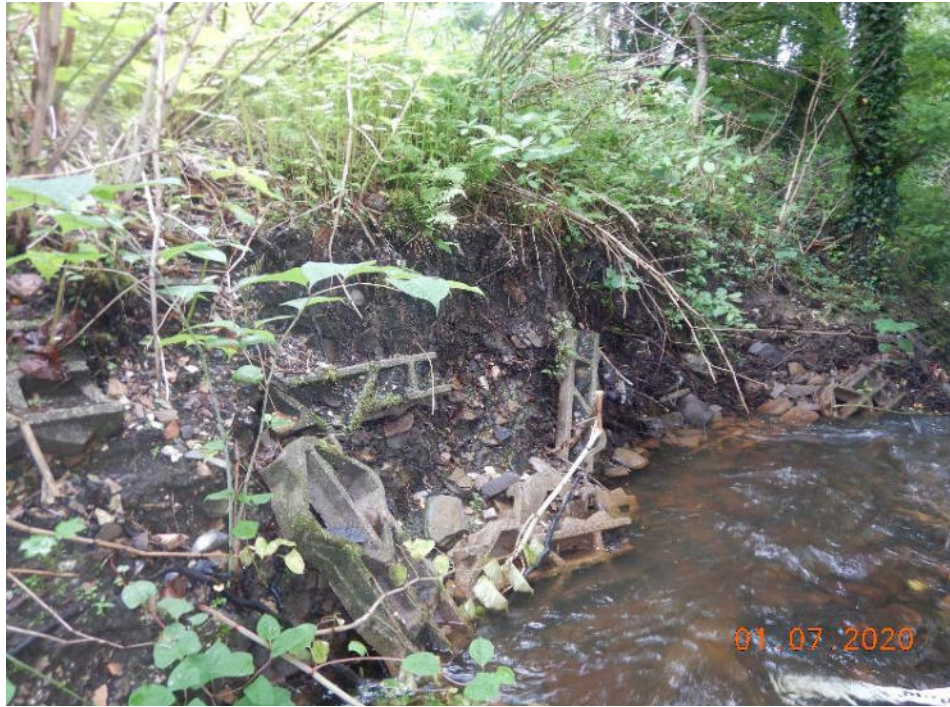
Chainage	Description	P	S	Ex	W	Ref.
296.1m – 306.4m	The revetment has failed resulting in scour to the embankment measuring 1.7m high and 1.5m deep. This is located at grid reference ST 00687 87481.	53	5	C	R	iv.
307.7m – 313.1m	There is a 0.25m wide concrete apron adjacent to the toe. The apron is undercut measuring 0.2m high and 0.3m deep indicating 0.05m penetration of the toe.	54	3	C	R	v.
313.1m – 320.5m	The revetment has failed causing scour to the embankment measuring 1.7m high and 0.7m deep.	55, 56	5	C	R	iv.

*Photo 53 – Failed revetment (296.1m – 306.4m)*

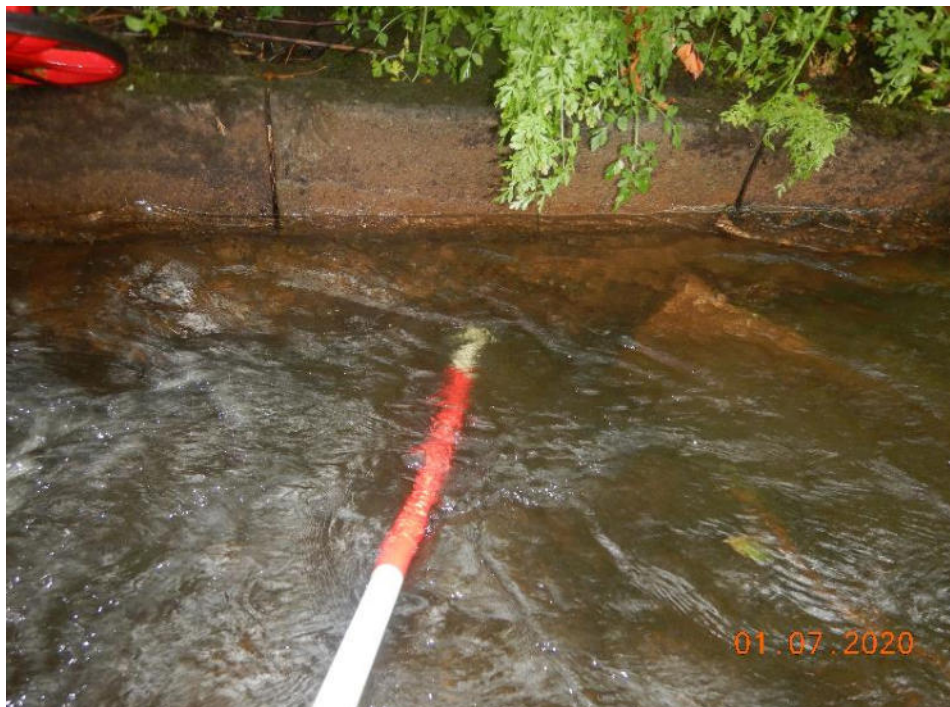
*Photo 54 – Undercut to concrete toe (307.7m – 313.1m)*
