**Rhondda Cynon Taf County Borough Council**

**A8066 Tynybryn River Channel Survey**

July 2020

Inspection team	Nicholas Tucker	Ifan Thomas
	Andrew Duncan	Mike Bond
Report by:	Nicholas Tucker	
Inspection date	29 <sup>th</sup> June 2020 & 1 <sup>st</sup> July 2020	
Report No.	A8066

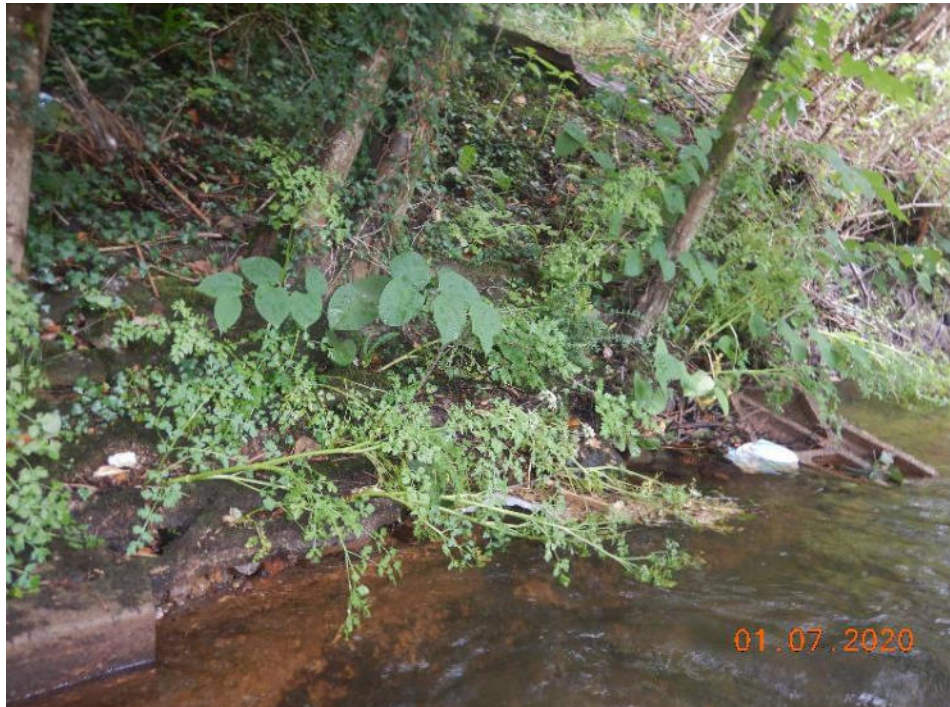
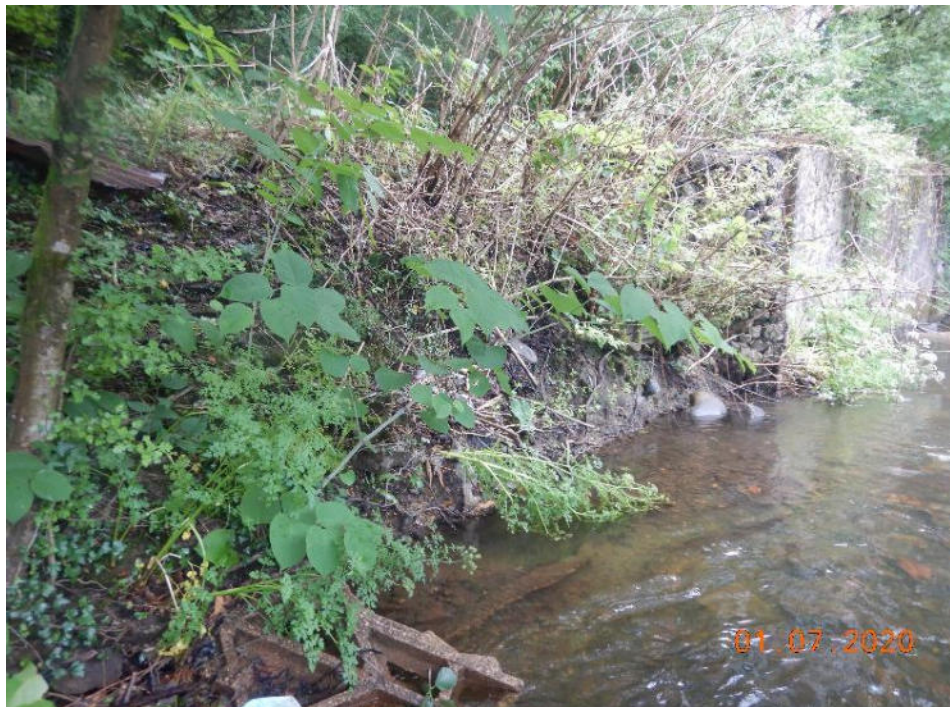
Chainage	Description	P	S	Ex	W	Ref.
296.1m – 306.4m	The revetment has failed resulting in scour to the embankment measuring 1.7m high and 1.5m deep. This is located at grid reference ST 00687 87481.	53	5	C	R	iv.
307.7m – 313.1m	There is a 0.25m wide concrete apron adjacent to the toe. The apron is undercut measuring 0.2m high and 0.3m deep indicating 0.05m penetration of the toe.	54	3	C	R	v.
313.1m – 320.5m	The revetment has failed causing scour to the embankment measuring 1.7m high and 0.7m deep.	55, 56	5	C	R	iv.

*Photo 55 – Failed revetment (313.1m – 320.5m)*

*Photo 56 – Failed revetment resulting in scour to the embankment (313.1m – 320.5m)*

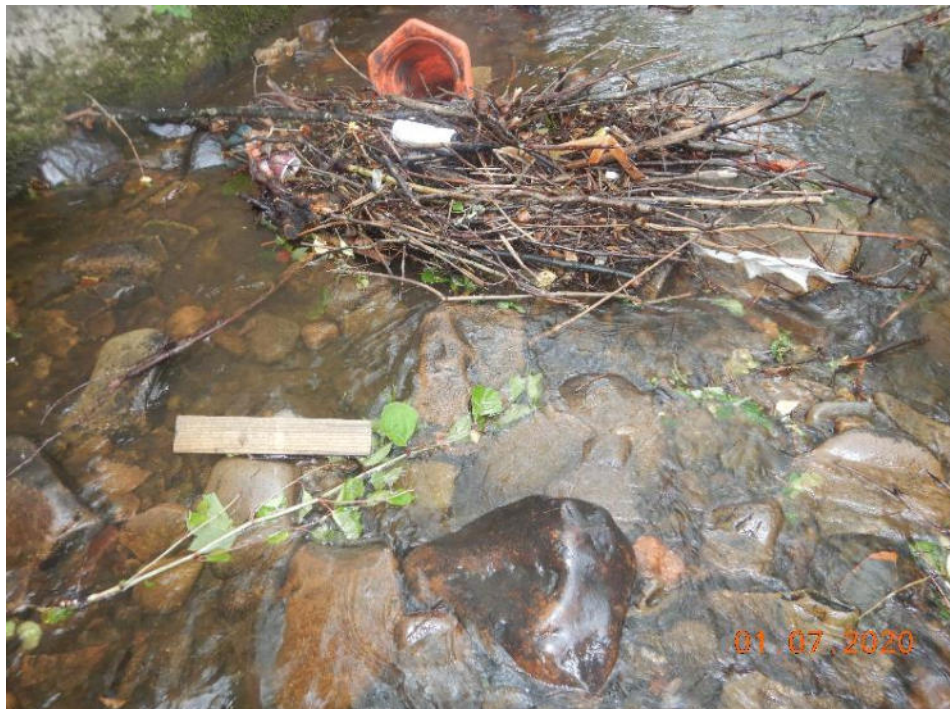
321.5m – 413m	The bed material generally consists of loose stone. At 331.5m chainage a section of the failed revetment is present within the watercourse. Additionally, there is a small build-up of debris to the left side of the watercourse at 372.8m.	60, 61	2	B	N	-

*Photo 61 – Build-up of debris to the left side of the watercourse (372.8m)*

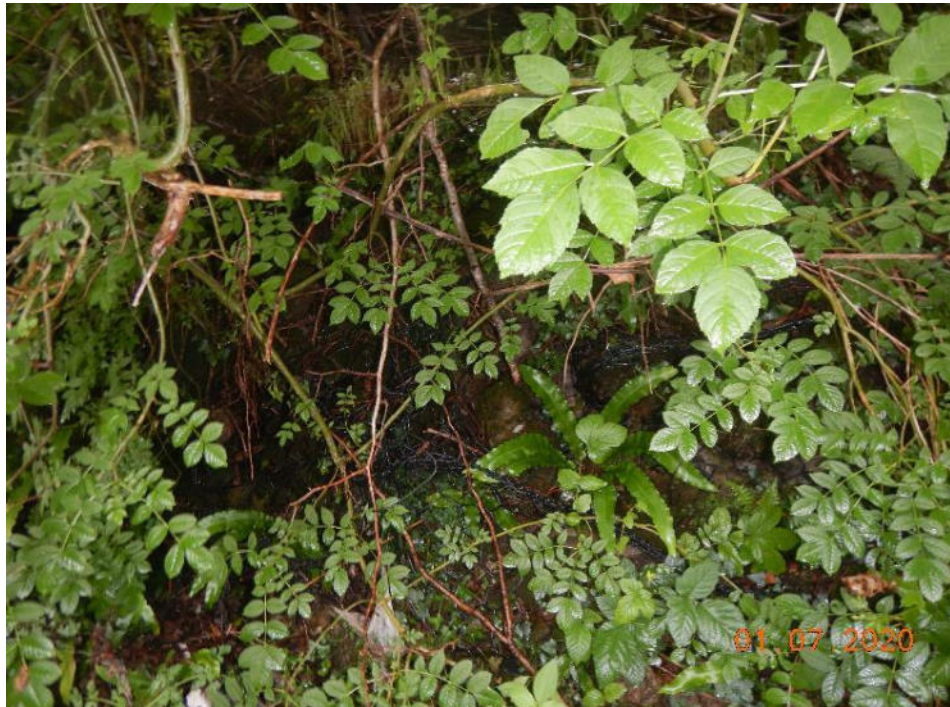
379.9m – 413m	From 379.9m there is Japanese Knotweed growth to the base of the retaining wall.	62	2	D	RM	ii.
394.3m – 406.4m	The east bridge abutment measures 4.6m high and was found to be in a good condition, with no scour identified. The abutment is protected by a 1.75m wide x 1.05m high concrete apron which was also in good condition. The upstream elevation of the bridge is located at grid reference ST 00629 87421.	63	1	A	-	-
409m	There is a fractured 150mm diameter clay drainage pipe to the retaining wall.	64	2	B	N	-
413m	At the downstream end of the retaining wall, gabion baskets have failed leading to washout behind the wall measuring 0.8m long, 2.4m high and 0.6m deep.	65, 66	5	B	R	viii.

*Photo 65 – Failed gabion baskets (413m)*

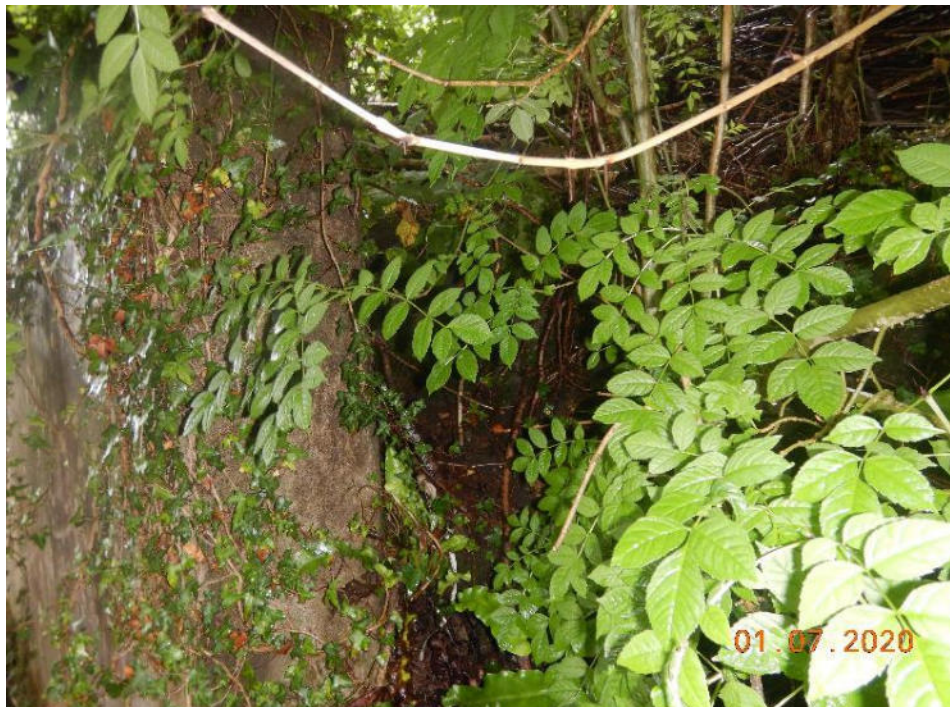
*Photo 66 – Washout behind retaining wall (413m)*

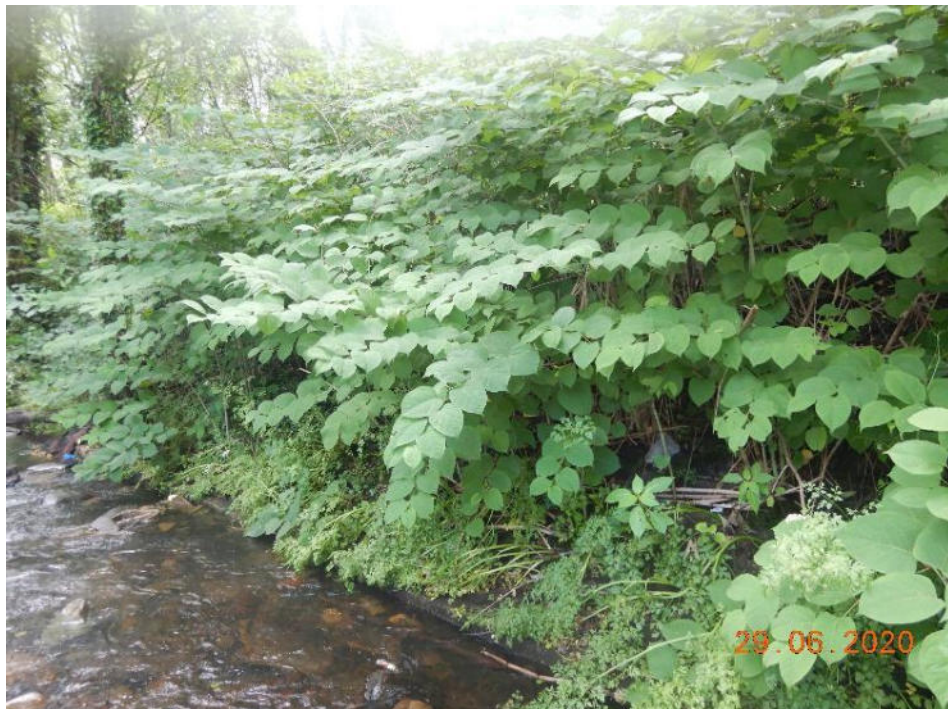
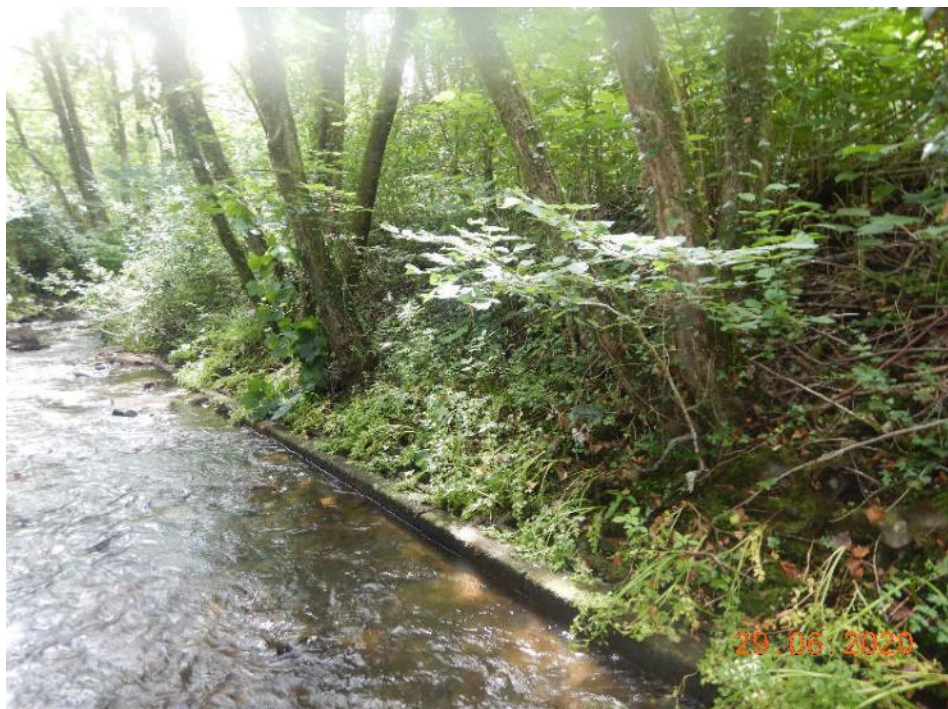
Chainage	Description	P	S	Ex	W	Ref.
0m – 84.3m	The revetment is covered with heavy and dense vegetation including Japanese Knotweed and large trees, which prevented a full inspection.	67, 68	2	E	RM	ii.
14m	There is a section of missing concrete measuring 0.9m long, 0.6m high and 0.2m deep.	69	3	B	R	vii.

*Photo 67 – Vegetation growth to the west revetment (0m – 84.3m)*

*Photo 68 – Vegetation growth to the west revetment (0m – 84.3m)*

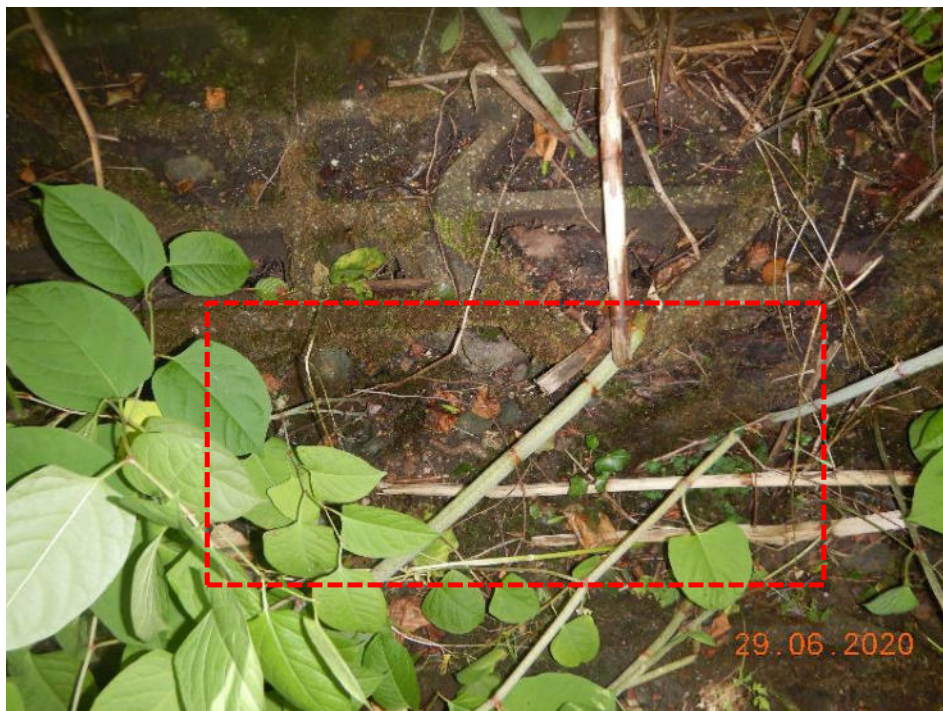
*Photo 69 – Missing concrete to the west revetment (14m)*

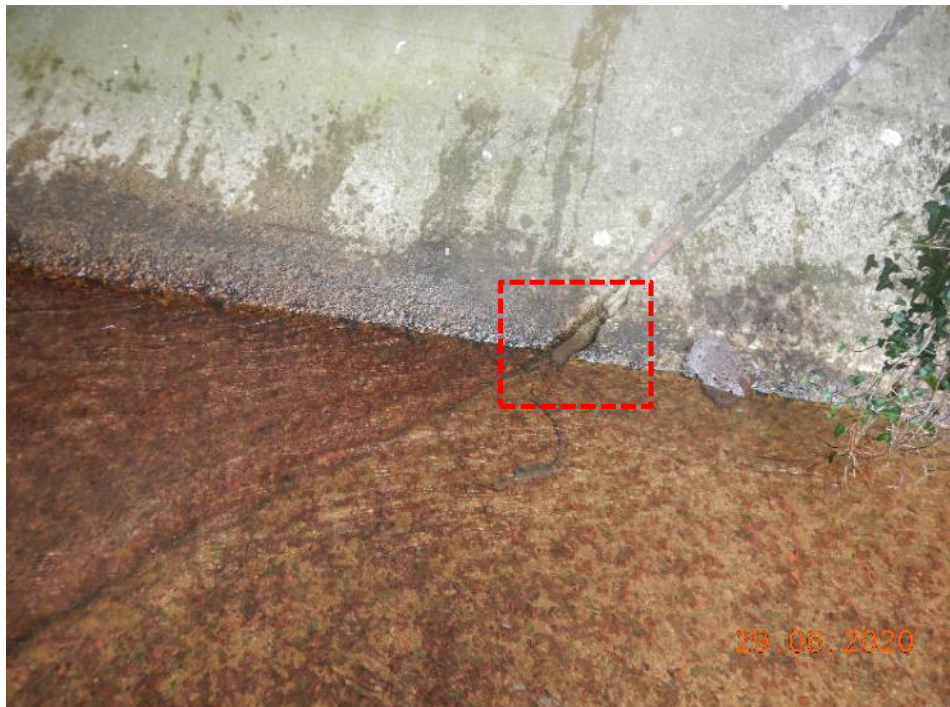
Chainage	Description	P	S	Ex	W	Ref.
101.2m	At the upstream elevation there is an area of missing jointing to the right side of the invert measuring 400mm long, 60mm wide and 70mm deep.	72	2	B	N	-
139.7m	There is a 0.6m high concrete weir at the outlet. There is a small area of scour to the right side of the weir measuring 150mm long, 150mm high and 100mm deep.	73	2	B	N	-

*Photo 72 – Missing jointing (101.2m)*

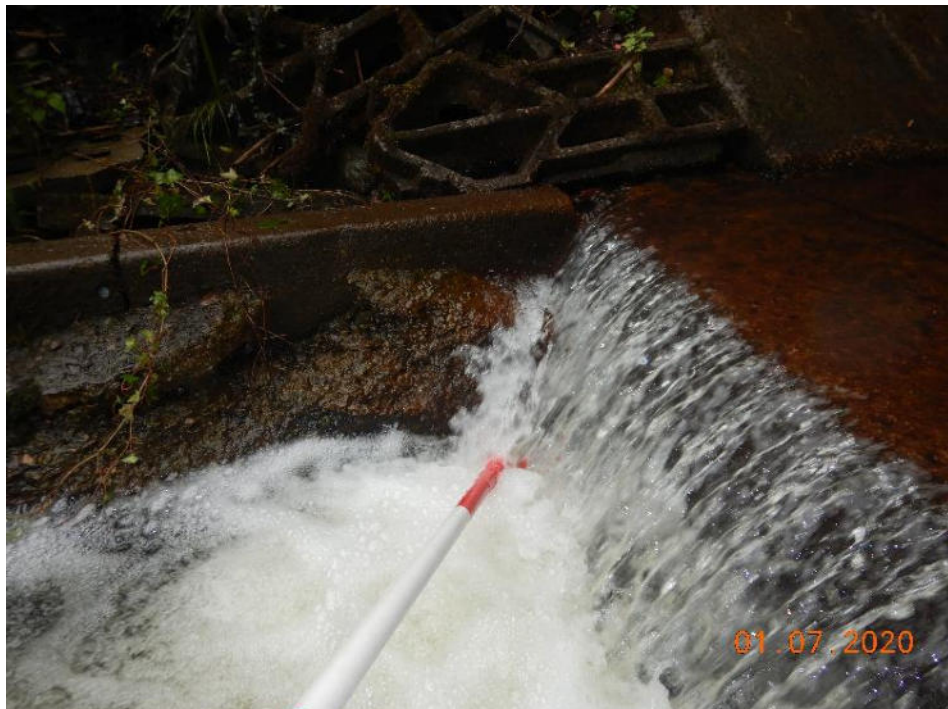
*Photo 73 – Location of scour to the weir (139.7m)*

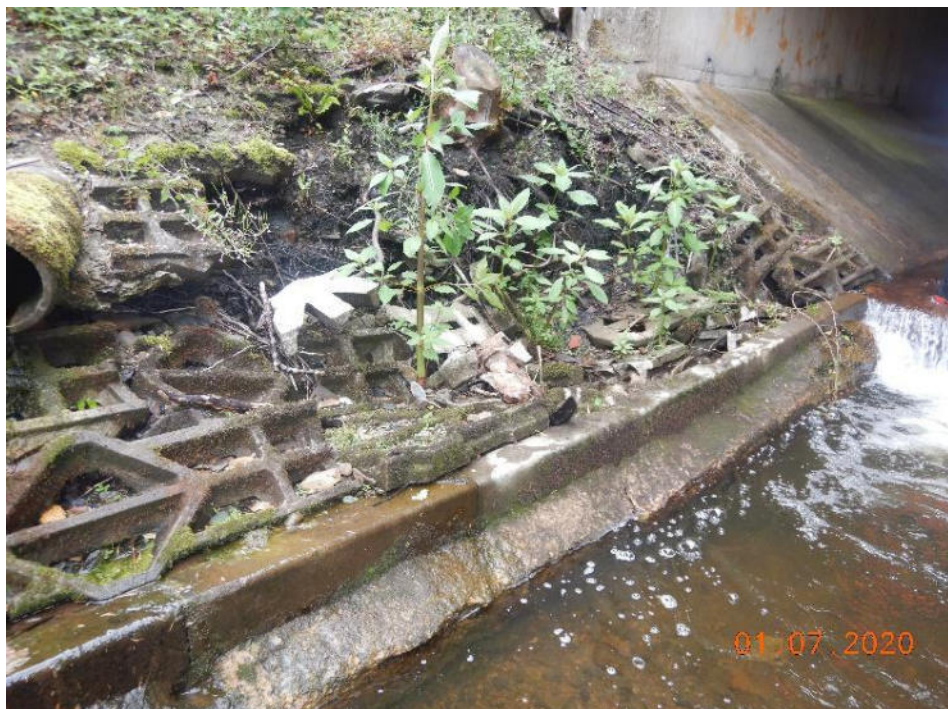
Chainage	Description	P	S	Ex	W	Ref.
139.7m – 143.7m	The revetment has failed resulting in scour to the embankment measuring 1.4m high and 0.6m deep.	74	5	D	R	iv.
144m – 147m	There is a 225mm diameter concrete drainage pipe. The revetment surrounding the drainage pipe is in a poor condition with large sections missing and displaced.	75	4	D	R	iv.

*Photo 74 – Failed revetment resulting in embankment scour (139.7m – 143.7m)*

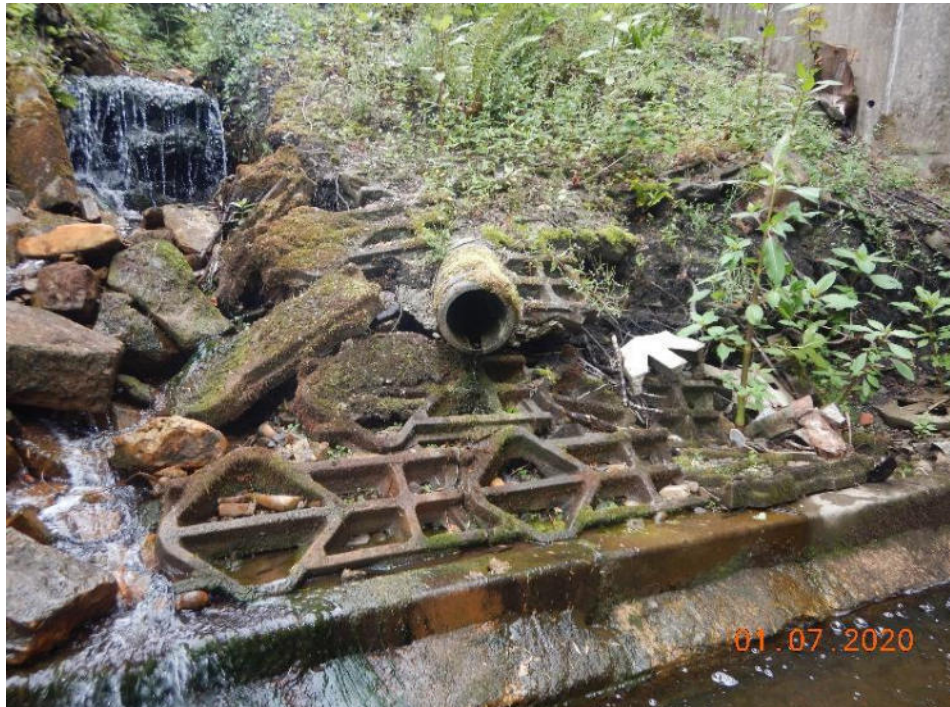
*Photo 75 – Missing and displaced concrete surrounding a drainage pipe (144m – 147m)*

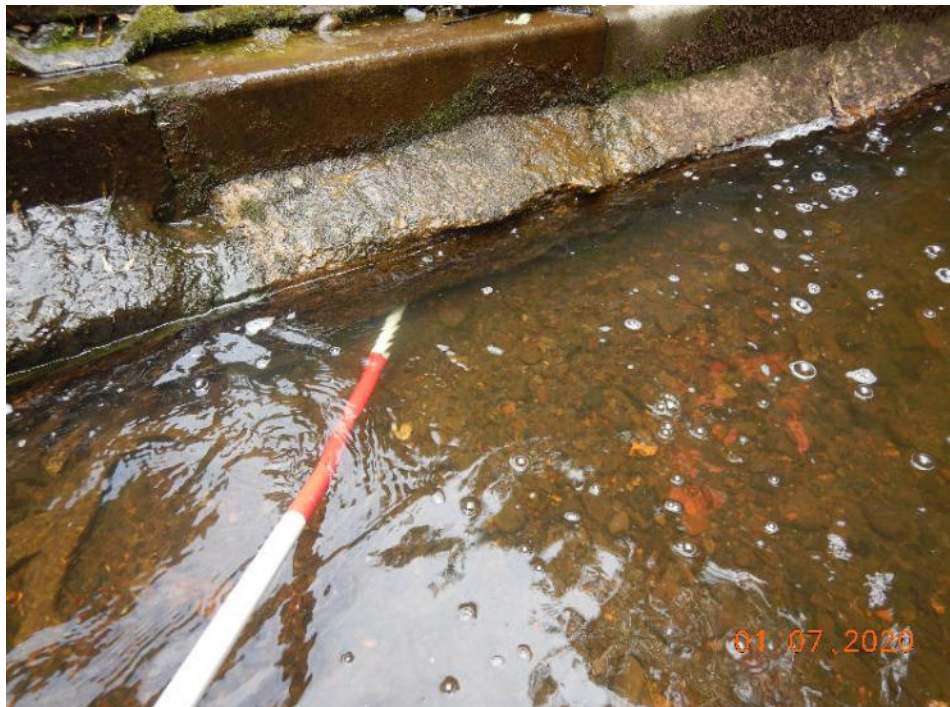
139.7m – <b>158.8m</b>	The concrete toe is undercut measuring a maximum of 0.4m high and 0.8m deep; typically, 0.15m high and 0.3m deep. <i>(This extends from Tynybryn Culvert outlet to the downstream elevation of Tynybryn footbridge)</i>	76, 77	3	C	R	v.
154m – 156m	The revetment has failed resulting in scour to the embankment measuring 1.7m high and 0.7m deep.	78	5	D	R	iv.

*Photo 76 – Undercut to concrete toe (139.7m – 158.8m)*

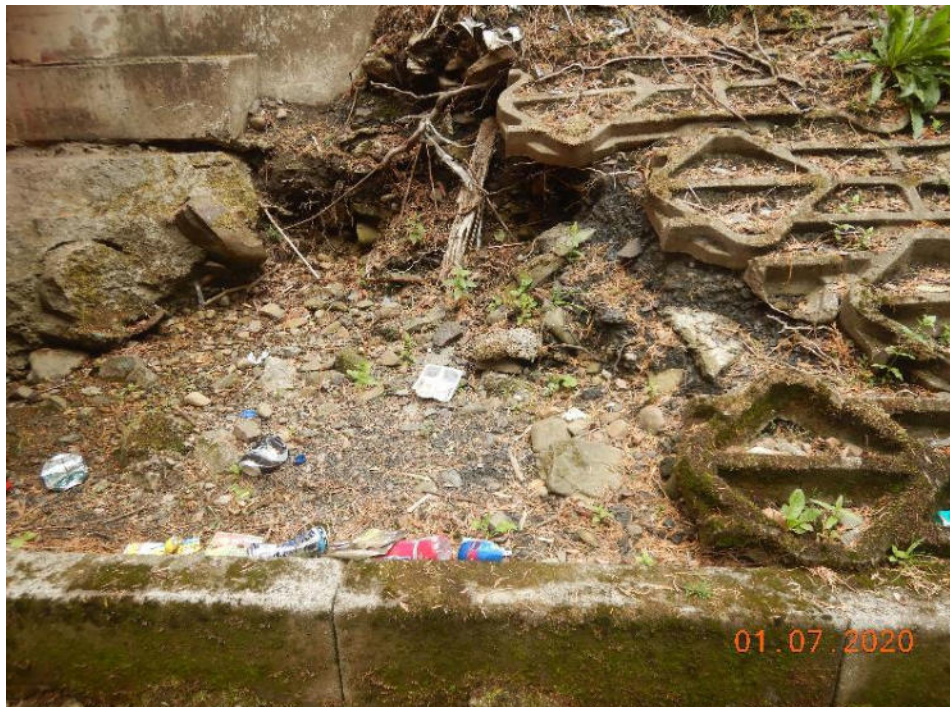
*Photo 78 – Failed revetment (154m – 156m)*

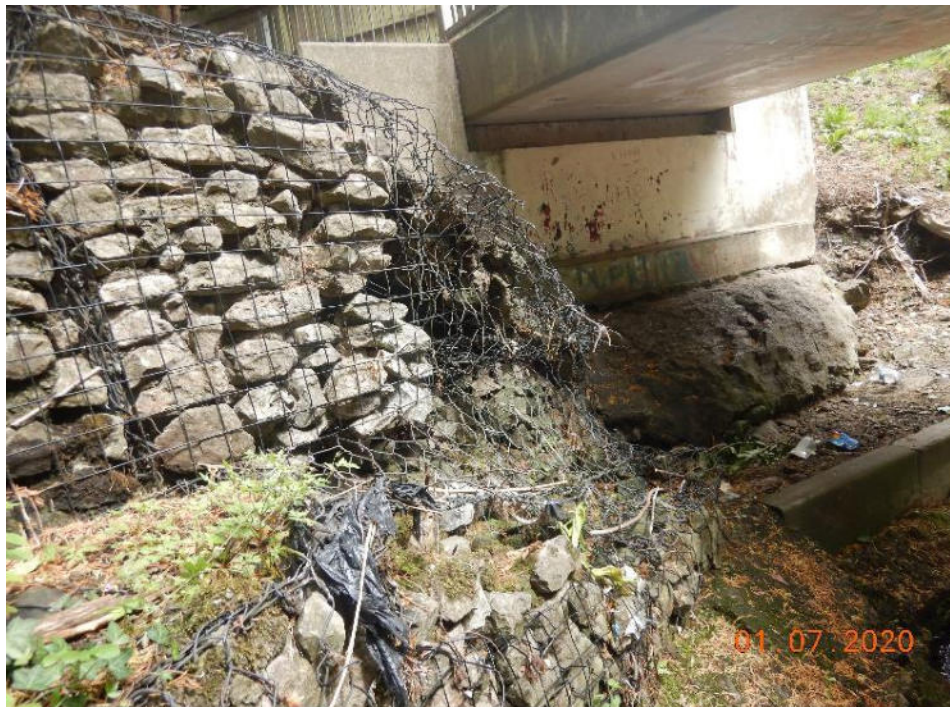
Chainage	Description	P	S	Ex	W	Ref.
156m – 158.8m	The west abutment was found to be in a good condition, with no scour identified. The abutment is protected by a concrete apron which is scoured at the downstream end over an area measuring 1.1m long, 0.07m high and 0.1m deep.	79	2	B	N	-
159m – 167m	A total of four gabion baskets have failed adjacent to the downstream elevation of the footbridge. The gabion baskets are supported by mass concrete which is undercut up to 0.85m high and 1m deep. The undercut penetrates the gabion baskets by up to 0.2m.	80, 81	5	C	R	viii.

*Photo 80 – Failed gabion baskets (159m)*

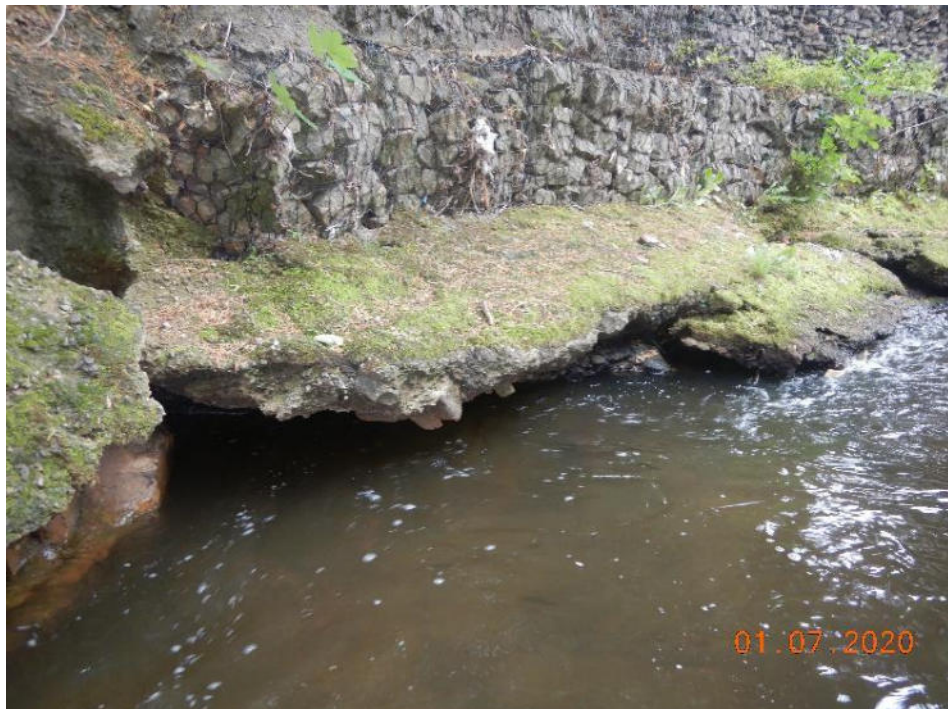
*Photo 81 – Undercut to mass concrete supporting gabion baskets (159m – 167m)*

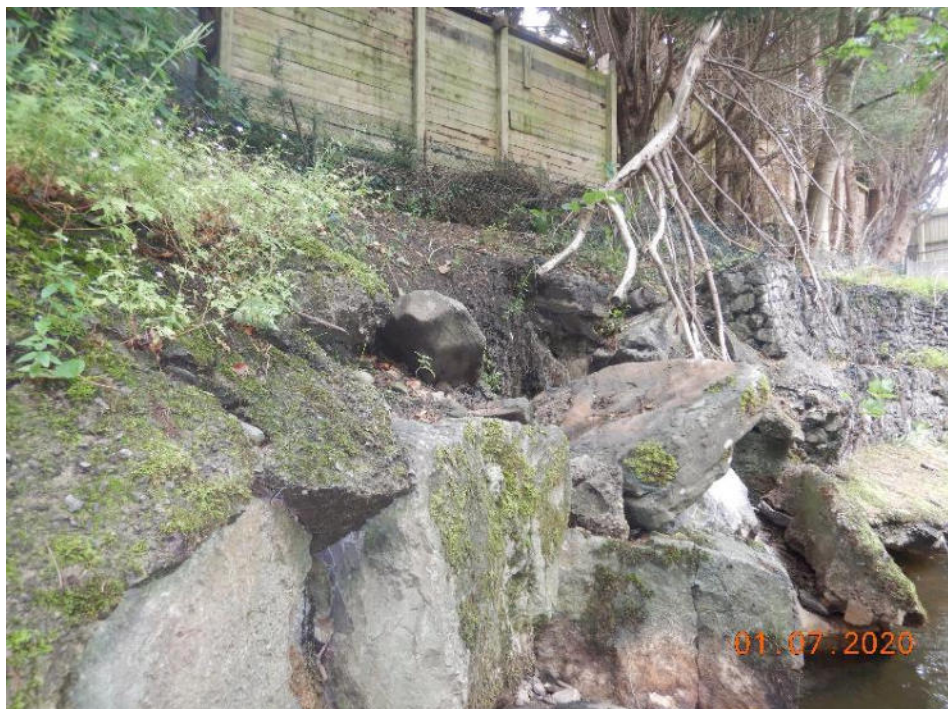
Chainage	Description	P	S	Ex	W	Ref.
167m – 169.1m	The rock armour has displaced from its original position resulting in scour to the embankment measuring 1.3m high and 0.6m deep.	82	3	C	R	ix.
174m – 180m	Displaced rock armour has caused scour to the earth embankment measuring 2.4m high and 1.6m deep.	83	3	D	R	ix.

*Photo 82 – Displaced rock armour causing embankment scour (167m – 169.1m)*

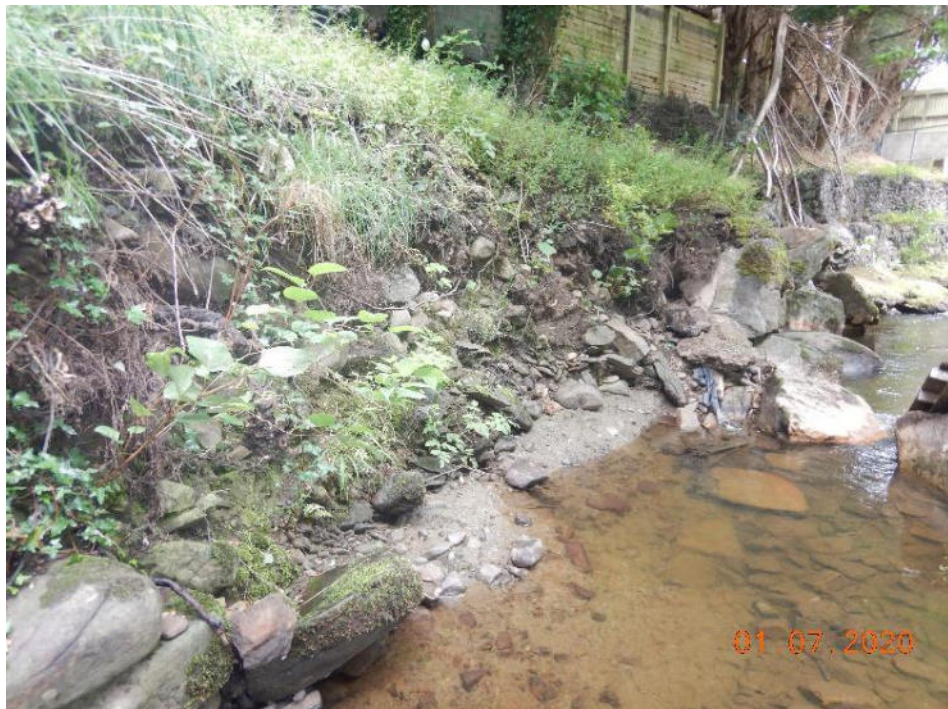
*Photo 83 – Scour caused by displaced rock armour (174m – 180m)*

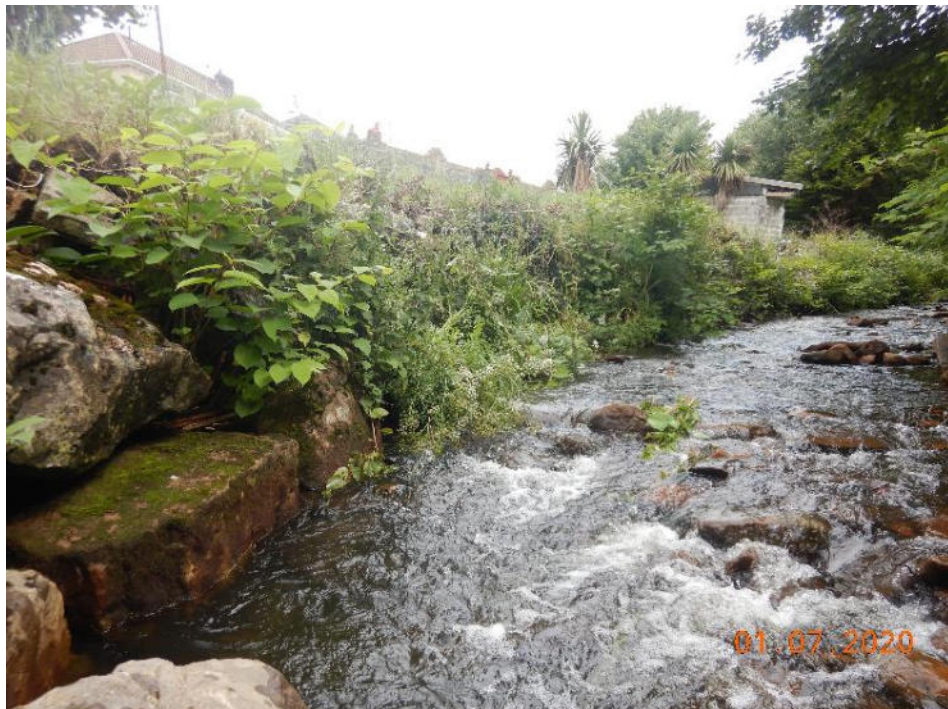
*Photo 87 – Dense vegetation growth to rock armour (246.6m – 280m)*

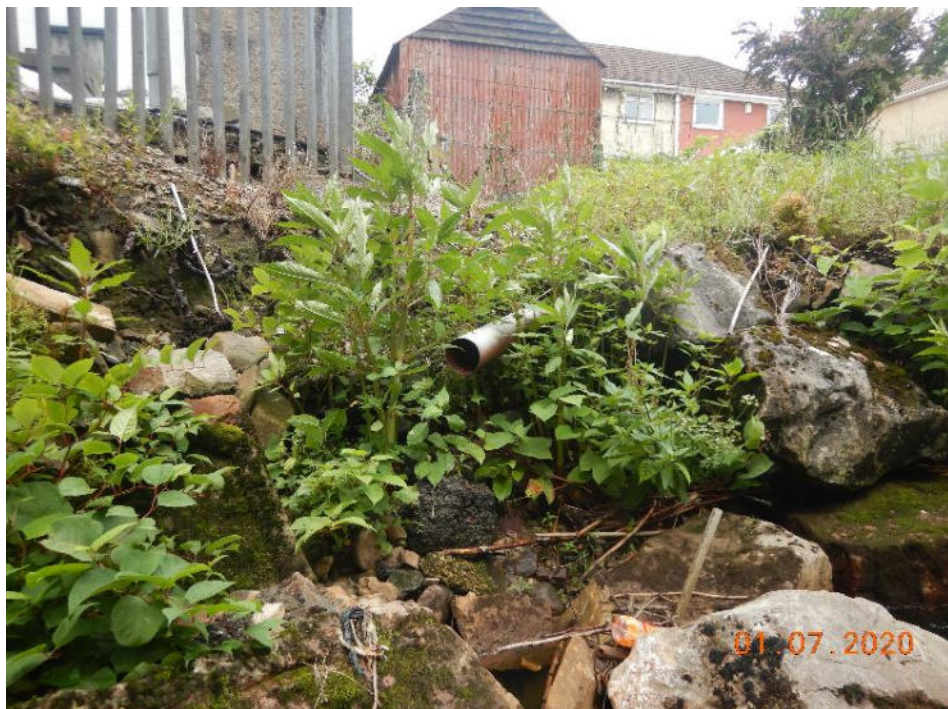
*Photo 88 – Displaced rock armour exposing a plastic drainage pipe (275.8m)*

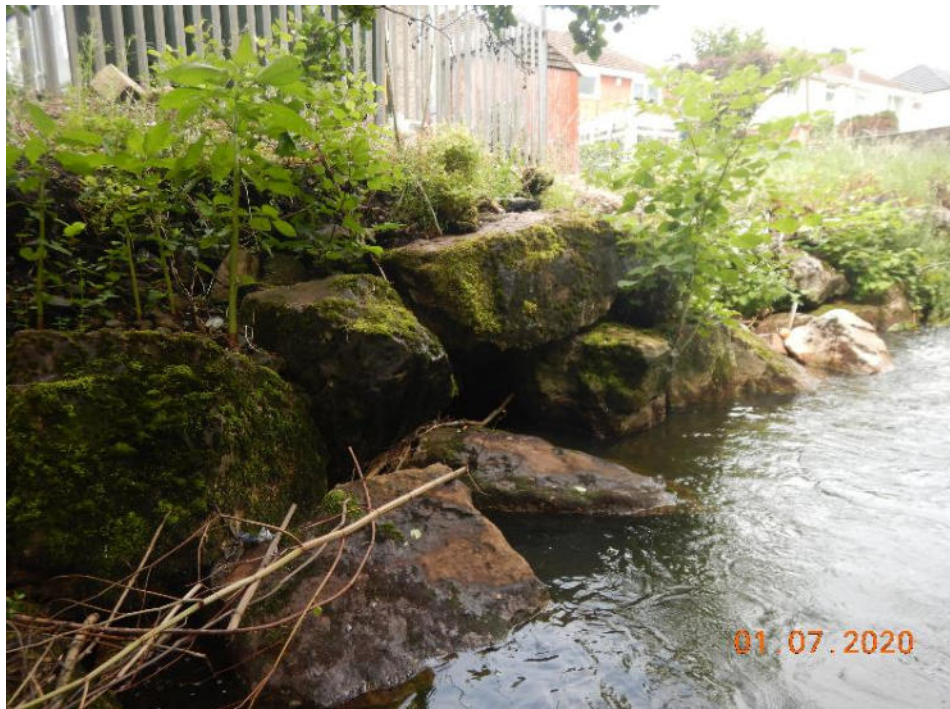
*Photo 89 – Displaced rock armour (283m)*

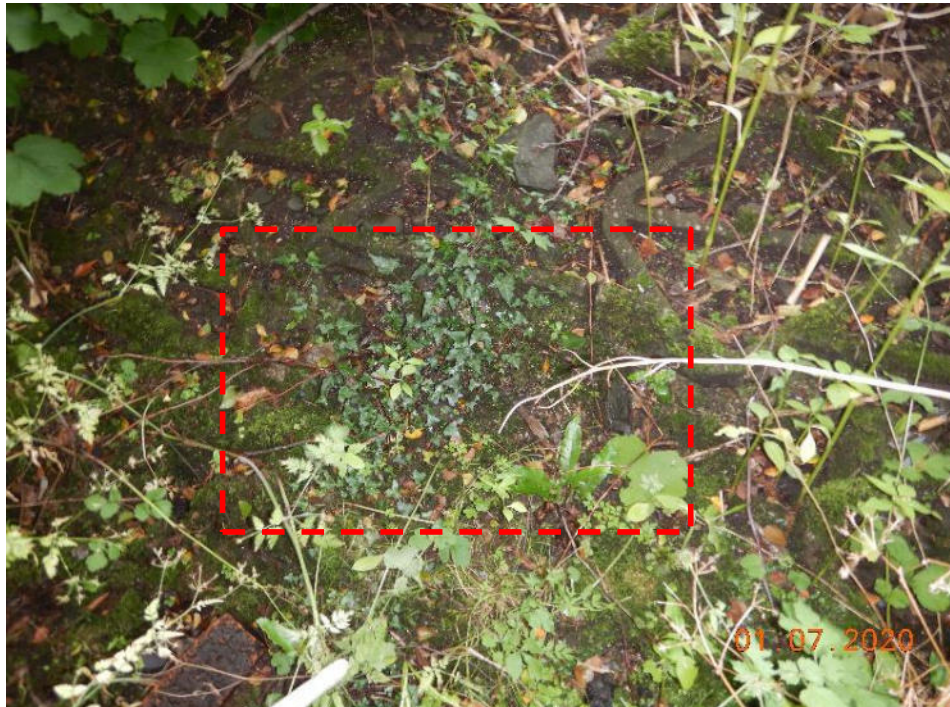
*Photo 91 – Section of missing concrete to the revetment (300m)*
