Compliance Assessment Report CAR_NRW0044647

For: Brecon Wastewater Treatment Works, held by DWR CYMRU CYFYNGEDIG
At: Access track opposite Lime Kiln Cottage, Canal Bank, Brecon, Powys, LD3 7PL.

Type of assessment carried out: Site Inspection, Reason: Routine.

On 24/06/2024, between 10:00 and 10:51.

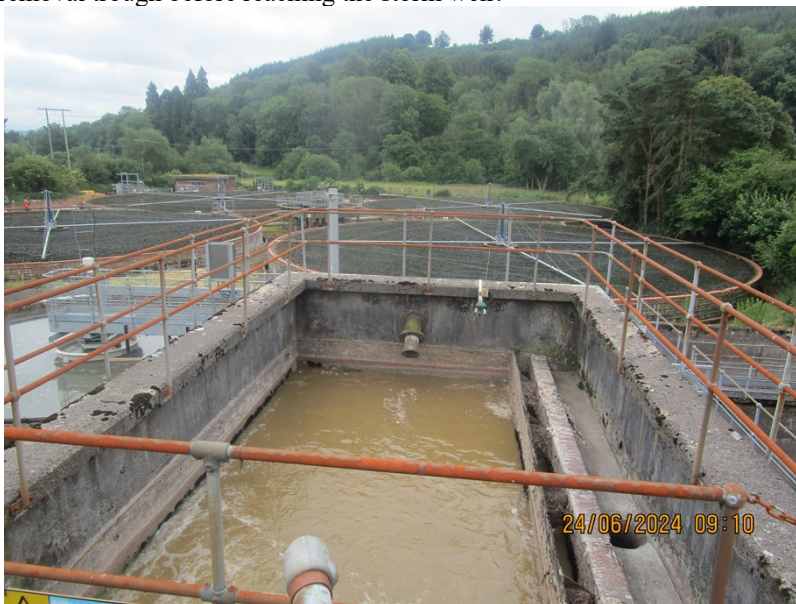
Inlet

The incoming flow to the site is pumped up to the inlet point. There is a mechanical step screen on the inlet with a 6mm screen size. I was advised the mechanical screen starts operating once the incoming flows reach a set level. This was clearly operational at the time of inspection and there were no signs of blockages in the screen, or signs of significant debris passing through. There is an additional bypass channel in place, which can be used during any maintenance or replacement of the mechanical screen.

The UWWTD crude influent sampling point was clearly marked and allowed a representative sample of the influent to be taken. The sampling equipment is fixed in place and self-contained. The incoming flows (post screening) then enter a grit removal trough before reaching the storm weir. This slows down the flow and allows grit to settle out at the bottom of the trough.

The storm weir on site is a hard-set weir setting, which only discharge once flows reach the set level. The flows were well below the storm weir setting in place and there were no flows entering the storm channel at the time of inspection. There was some dry debris present within the storm weir, but no signs of any recent discharge into the storm channel. The storm channel does not have additional screening as all flows into the site, pass through the 6mm screening and grit removal trough before reaching the storm weir.

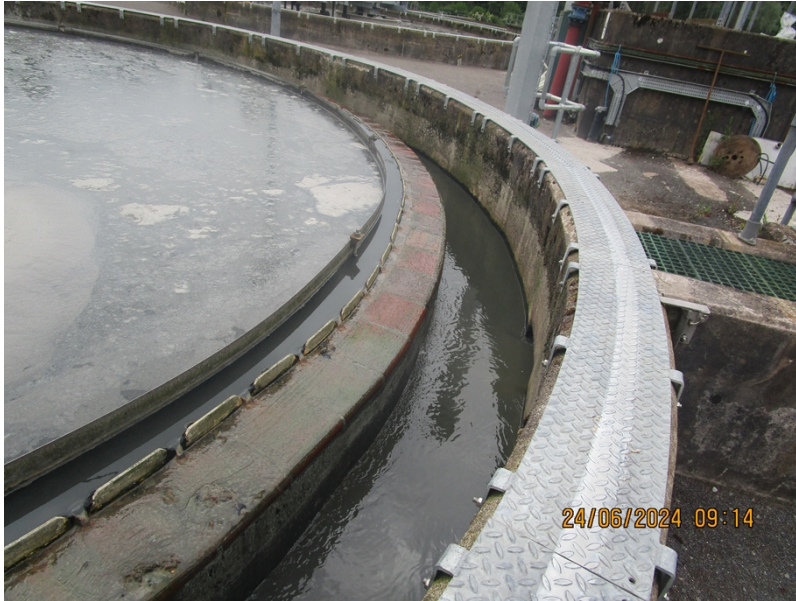
Primary Settlement

There are 4 circular primary settlement tanks on site, with rotating bridges, scum boards for retaining solids and brushes on the outfall channels. All settlement tanks have monitoring equipment in place. The settlement tanks all appeared to be operating effectively. there were no signs of significant solids passing through to the outfall channels. Currently the first primary settlement tank is set up for automatic sludge removal, and the rest are manually de-sludged as required. All primary tanks are being upgraded to automatic de-sludge as part of the planned works.

Overall, the settlement system appeared to be operating effectively in preventing significant solids passing through to the

next stages of treatment. The outfall from the primary settlement tanks leads to a 4-way distribution chamber. The purpose of which is to distribute the flows to the 4 filter beds on site. Once distributed, the flows pass on to treatment in the filter beds.

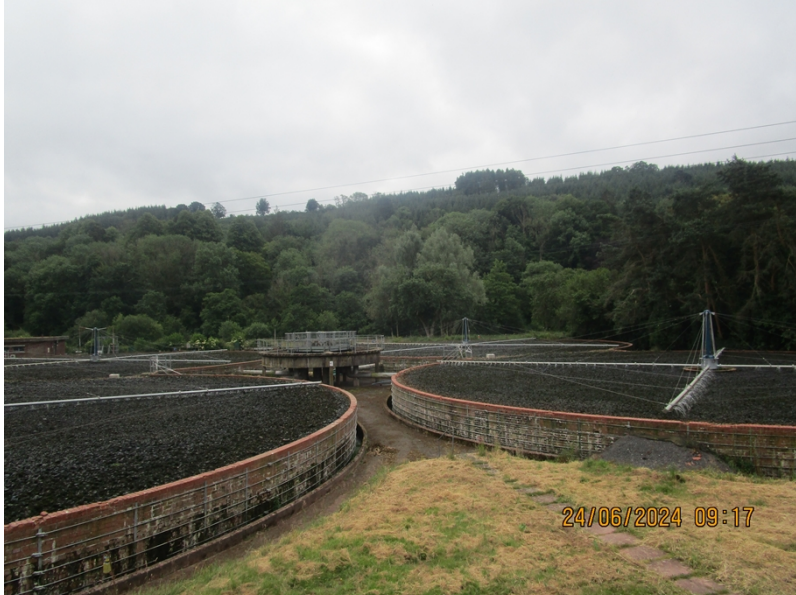
Filter Beds

The works contains a 4 circular filter beds containing stone media, each of which have a syphon in place, to build up sufficient pressure to power the filter arm rotation. The rotation arms on each were moving free and unhindered. There were no signs of ponding or dry patches across the filter beds and no excessive vegetation growth. The filter housings are of brick construction and appeared to have been in place for some time, showing signs of wear. Metal banding has been installed on the filter beds to support the brick walls, and this appears to be in good order. I did not observe any signs of major leakage from any of the filter bed walls on site.

The outfall channels from each of the filter beds appeared to be flowing free and clear at the time of inspection. There was a small amount of foam present in the distribution chamber between the filter beds and final settlement tanks, however this was not excessive. The filter bed systems on site appeared to be operating effectively.

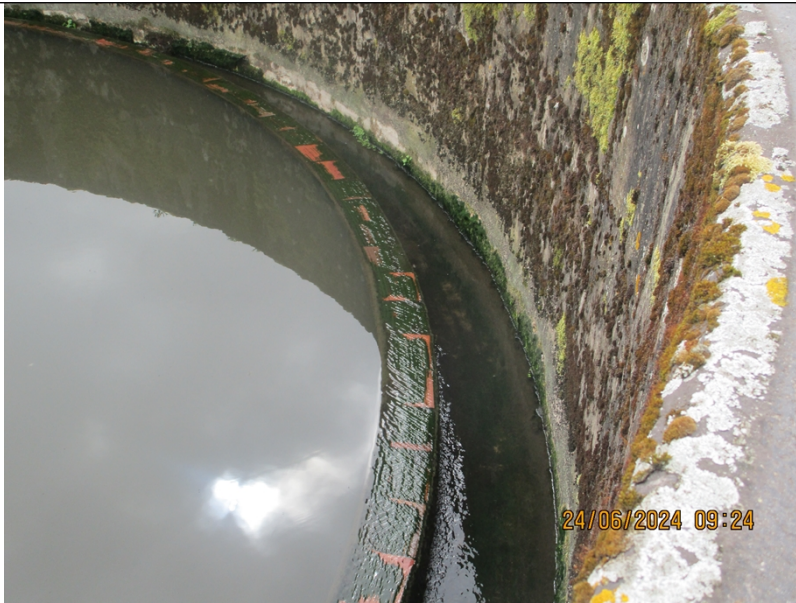
Final Settlement Tanks

There are three circular final settlement tanks on site, each with rotating bridges and brushes on the outfall channel. Monitoring equipment is in place. These all appeared to be operative effectively, and there were no signs of excessive carry over of solids or signs of sewage fungus present. The final settlement system appeared in good order.

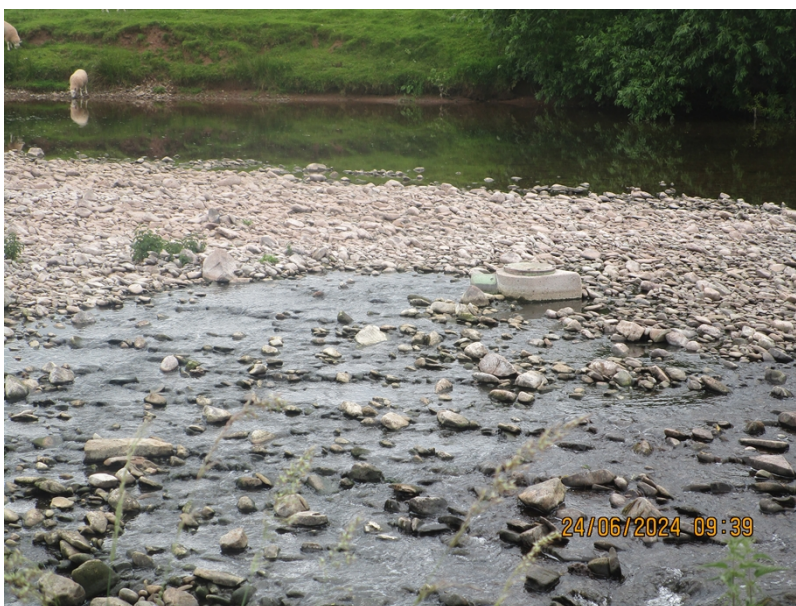
Outfall and Sampling point

The final effluent then passes through an MCERTs flow meter, which appeared to be operating as required and accessible for inspection. The Magflow meter is located in what appears to be a straight section of pipe, which is preferable to provide reliable flow readings. The MCERTs monitor was clearly operational at the time of inspection. The final effluent sampling point is clearly marked with appropriate signage including the sample point number. On this occasion a visual inspection of the outfall chamber and sample point was not completed, due to access being limited by construction works at the time of inspection. If required, the sample point is still accessible through the active construction area. On this occasion I decided this was not necessary given the health and safety considerations.

There is a UWWTD sampling point present with appropriate signage in place. The intake pipe for the sampling equipment is situated within the outfall chamber, and in a suitable location for an indicative sample to be taken.

We walked to the outfall location in the river Usk. The outfall is located within the riverbed towards the centre of the river, at the time of inspection this was clearly visible as the river levels were quite low. No signs of pollution or discolouration were seen near the outfall or further downstream.

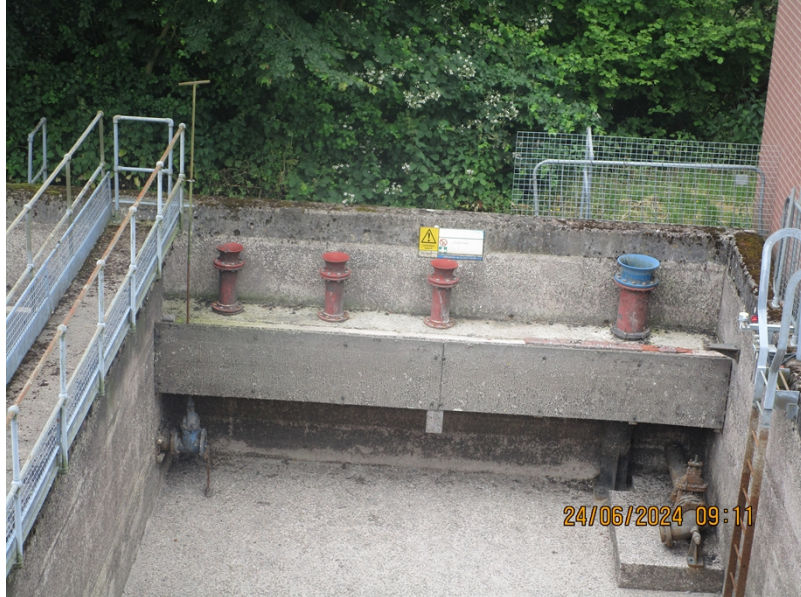
Storm Tanks

There are 4 connected, open rectangular storm tanks on site, which fill sequentially and have outlets on the final tank. The storm sewage must fill the final tank in the sequence to a set level before any effluent will pass into the storm outfall. The storm tanks are manually returned to the head of the works when required. The storm tanks were empty at the time of inspection and there were no indications that the tanks had recently been filled. There is EDM equipment present to monitor spilling from the storm system on site (storm to environment).

The storm effluent sampling point is located on the read of the final tank and is clearly labelled. (EA sample point sign). The storm outfall is located on the riverbank downstream of the main outfall location. There were no discharges from the storm outfall at the time of inspection and no signs of rag/sewage materials around the outfall.
