| Location Plan: | <b>Mostyn Sea Wall</b><br>Assessment Date: 16/03/2023 | |
| | CARRS Exam ID: | <b>15614043</b> |
| | Structure Reference: | <b>W1990286</b> |

# COASTAL ASSET CONDITION SURVEY REPORT

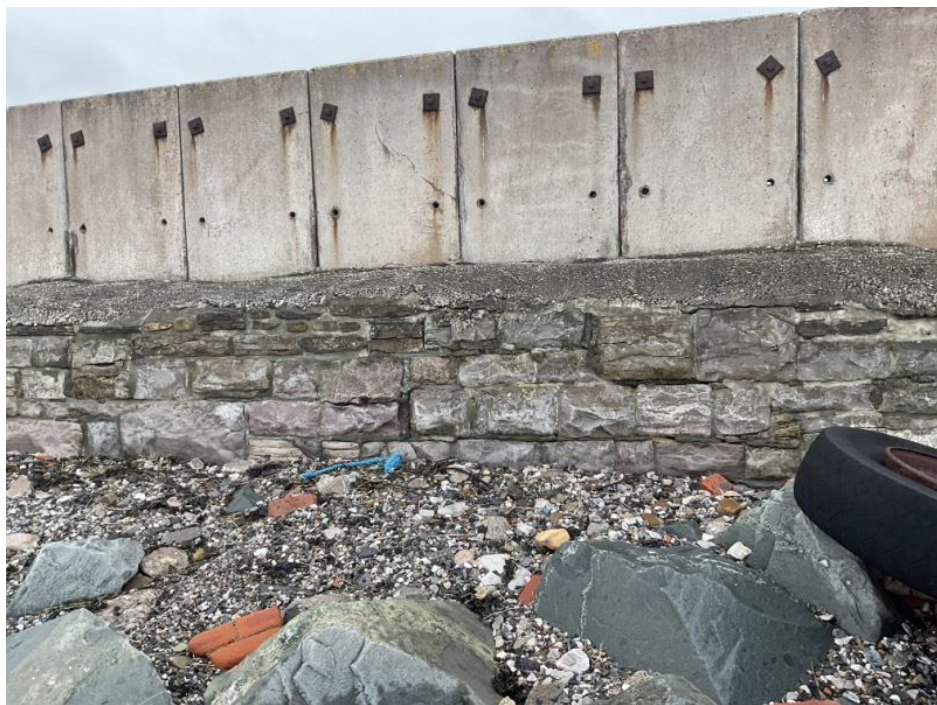
| Defect Ref No. | Defect Location (NGR) | Major Element | Minor Element | Photo Ref | Severity | Probability | Risk Score | Below MHWS | Defect Group | Defect Description | Recommendations | Defect Priority |
|---|---|---|---|---|---|---|---|---|---|---|---|---|
| D2 | 315253, 381177 | Wall | Wall section | 41, 82 | 2 | 2 | 4 | True | Repointing | Open joints. Some sections had been observed to have been repointed in the 2023 inspections, although open joints were still visible along asset length. | Repoint open joints. | 10 |

**Section A**  
**Wall section**  
**Defect Ref: D2**  
**Description:** Open joints. Some sections had been observed to have been repointed in the 2023 inspections, although open joints were still visible along asset length.  
**Photo number: 82**

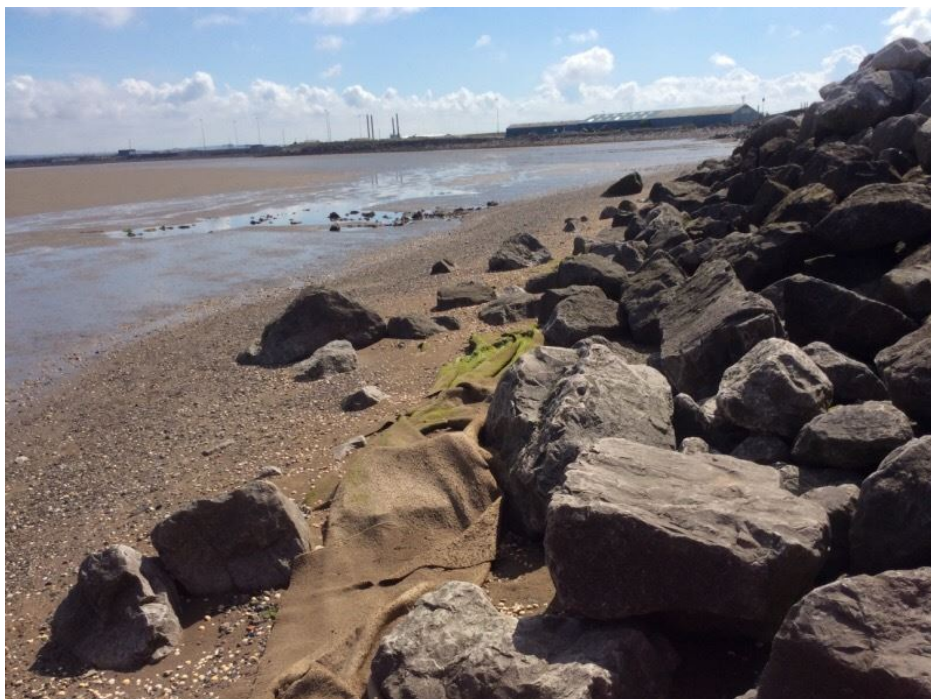
| Defect Ref No. | Defect Location (NGR) | Major Element | Minor Element | Photo Ref | Severity | Probability | Risk Score | Below MHWS | Defect Group | Defect Description | Recommendations | Defect Priority |
|---|---|---|---|---|---|---|---|---|---|---|---|---|
| D10 | 314999, 381300 CNH3 199.077 | Wall | Wall Armour | 22, 75 | 2 | 3 | 6 | True | Loss/damage of rock-armour | Expelled rock armour. No significant change observed in the 2023 examinations. | Replace expelled rock armour units. | 7 |

**Section A**  
**Wall Armour**  
**Defect Ref: D10**  
**Description:**  
Expelled rock armour.  
No significant change  
observed in the 2023  
examinations.  
**Photo number: 22**

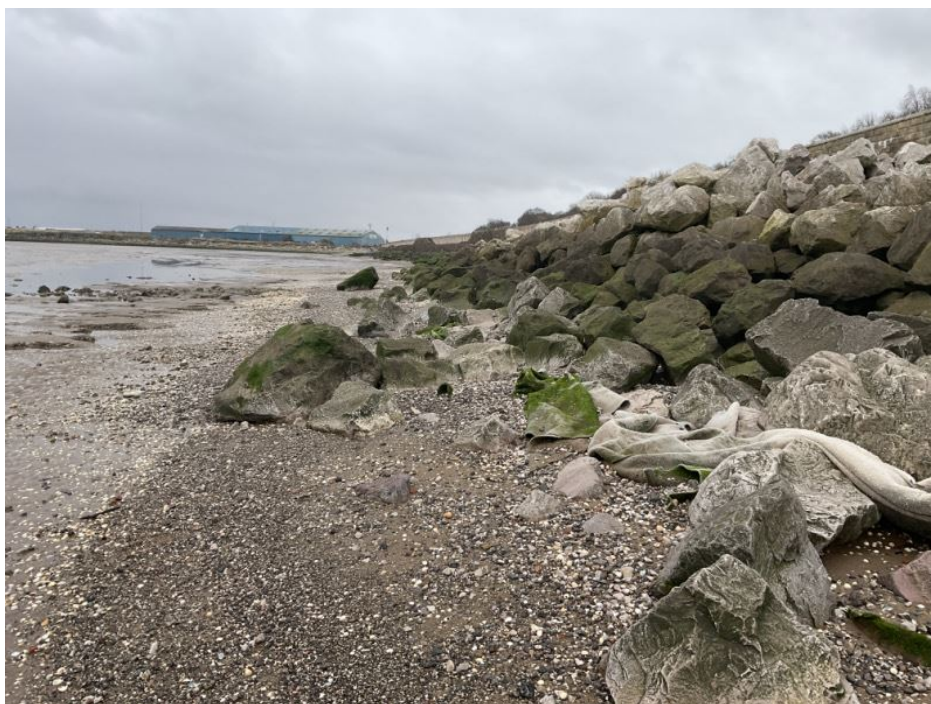
**Section A**  
**Wall Armour**  
**Defect Ref: D10**  
**Description:**  
Expelled rock armour.  
No significant change  
observed in the 2023  
examinations.  
**Photo number: 75**

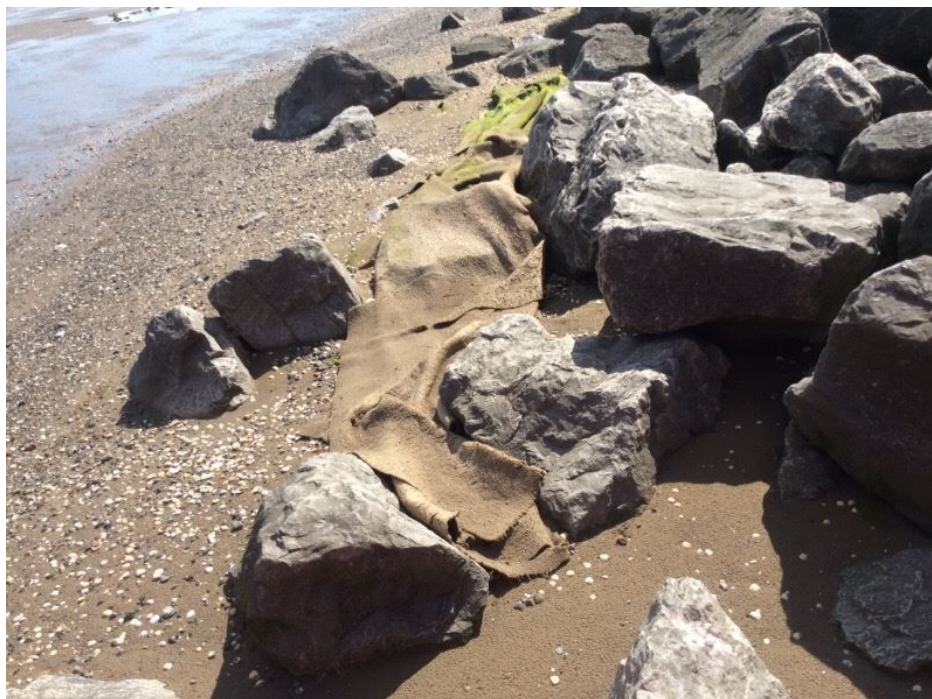
| Defect Ref No. | Defect Location (NGR) | Major Element | Minor Element | Photo Ref | Severity | Probability | Risk Score | Below MHWS | Defect Group | Defect Description | Recommendations | Defect Priority |
|---|---|---|---|---|---|---|---|---|---|---|---|---|
| D11 | 314984, 381307 CNH3 199.078 | Wall | Wall Armour | 21, 74 | 2 | 3 | 6 | True | Loss/damage of rock-armour | Loose geotextile. No significant change observed in the 2023 inspections. | Remove loose geotextile and replace where necessary. | 7 |

**Section A**  
**Wall Armour**  
**Defect Ref: D11**  
**Description:** Loose geotextile. No significant change observed in the 2023 inspections.  
**Photo number: 21**

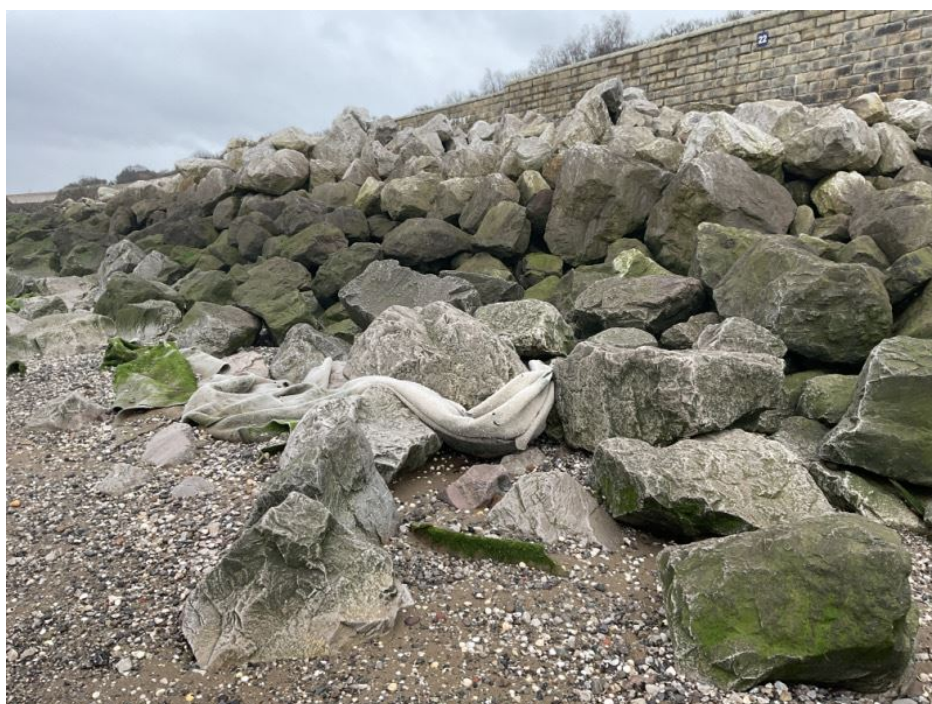
**Section A**  
**Wall Armour**  
**Defect Ref: D11**  
**Description:** Loose geotextile. No significant change observed in the 2023 inspections.  
**Photo number: 74**

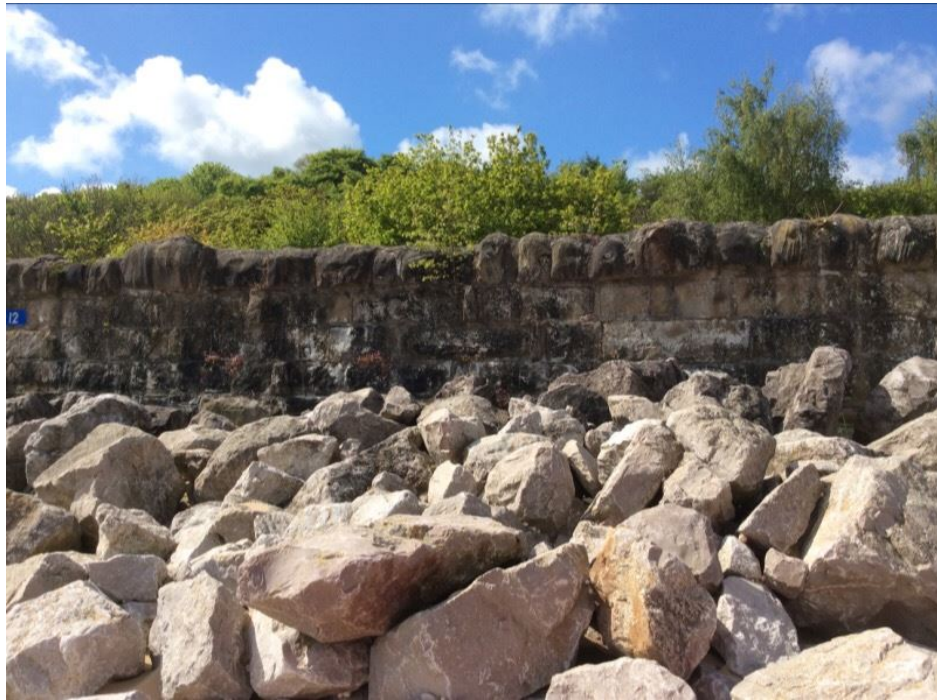
| Defect Ref No. | Defect Location (NGR) | Major Element | Minor Element | Photo Ref | Severity | Probability | Risk Score | Below MHWS | Defect Group | Defect Description | Recommendations | Defect Priority |
|---|---|---|---|---|---|---|---|---|---|---|---|---|
| D13 | 314748, 381470 | Wall | Wall section | 17, 70 | 2 | 2 | 4 | False | Vegetation clearance | Vegetation growth in the masonry wall. No significant change other than seasonal die back observed in the 2023 examinations. | Development of a staged vegetation clearance plan. | 11 |

**Section A**  
**Wall section**  
**Defect Ref: D13**  
**Description:**  
Vegetation growth in the masonry wall. No significant change other than seasonal die back observed in the 2023 examinations.  
**Photo number: 17**

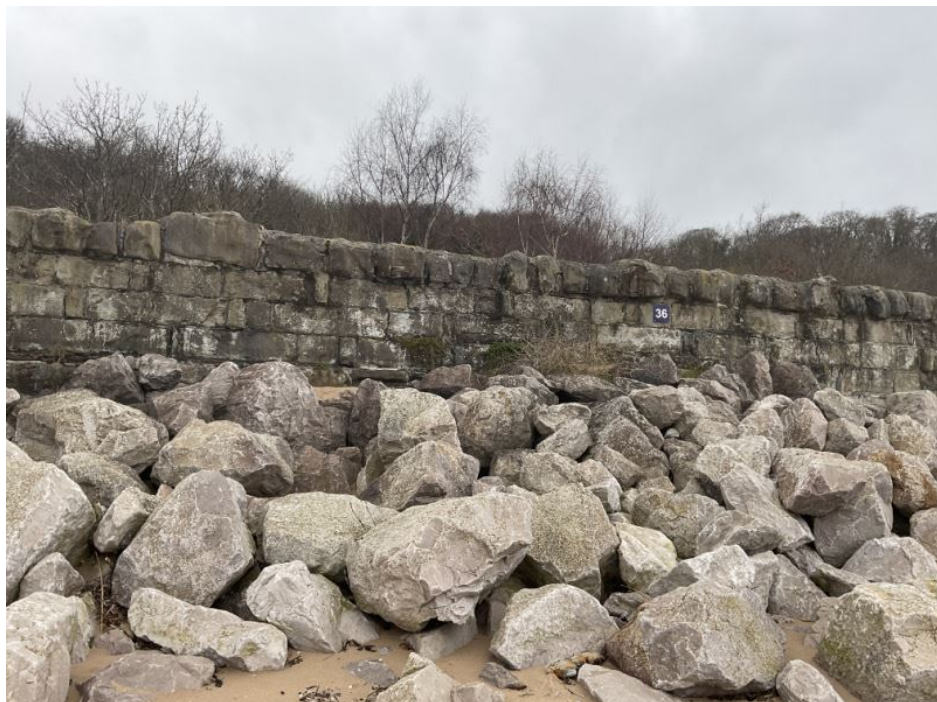
**Section A**  
**Wall section**  
**Defect Ref: D13**  
**Description:**  
Vegetation growth in the masonry wall. No significant change other than seasonal die back observed in the 2023 examinations.  
**Photo number: 70**

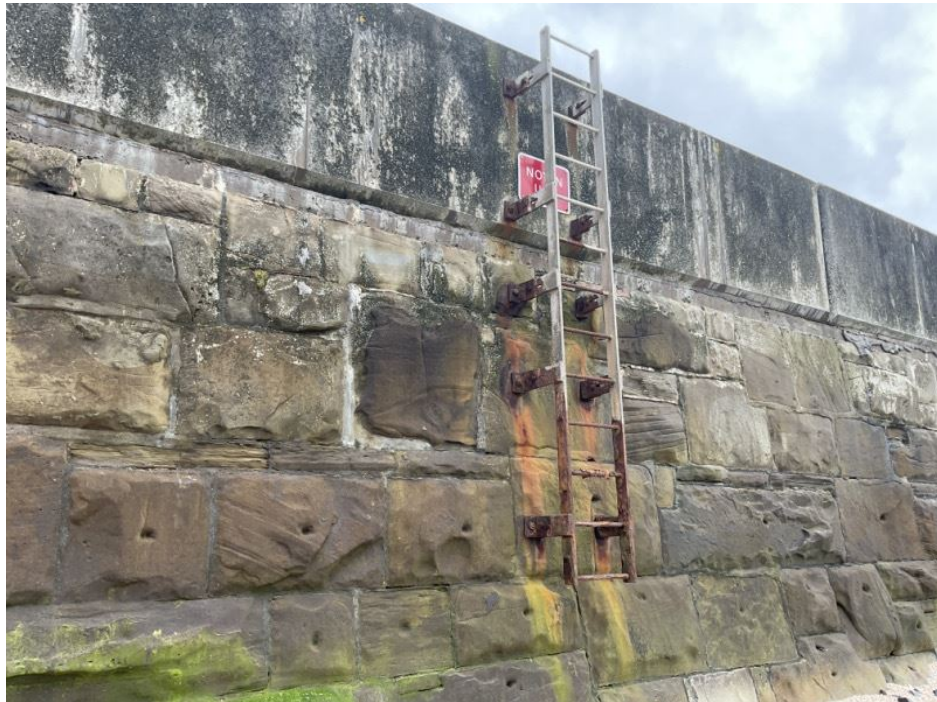
| Defect Ref No. | Defect Location (NGR) | Major Element | Minor Element | Photo Ref | Severity | Probability | Risk Score | Below MHWS | Defect Group | Defect Description | Recommendations | Defect Priority |
|---|---|---|---|---|---|---|---|---|---|---|---|---|
| D14 | 314588, 381604 | Wall | Wall section | 44, 69 | 4 | 3 | 12 | True | H&S | Corroded access ladder. Warning signage in place to deter public use. No significant change observed between the 2022 and 2023 inspections. | Remove corroded access ladder. | 2 |

**Section A**  
**Wall section**  
**Defect Ref: D14**  
**Description:**  
Corroded access ladder. Warning signage in place to deter public use. No significant change observed between the 2022 and 2023 inspections.  
**Photo number: 44**

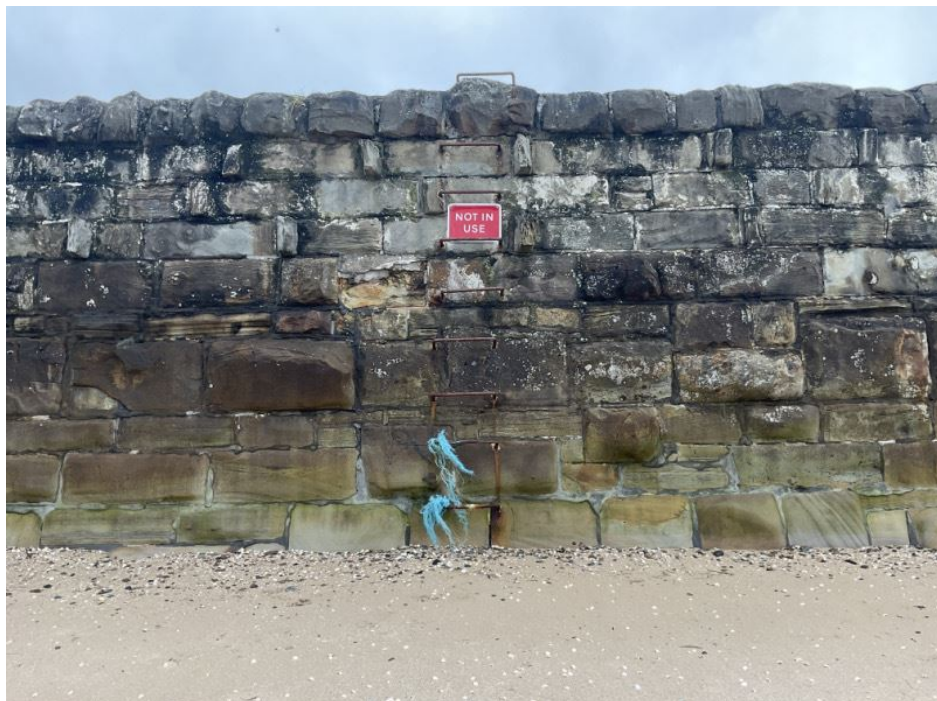
**Section A**  
**Wall section**  
**Defect Ref: D14**  
**Description:**  
Corroded access ladder. Warning signage in place to deter public use. No significant change observed between the 2022 and 2023 inspections.  
**Photo number: 69**

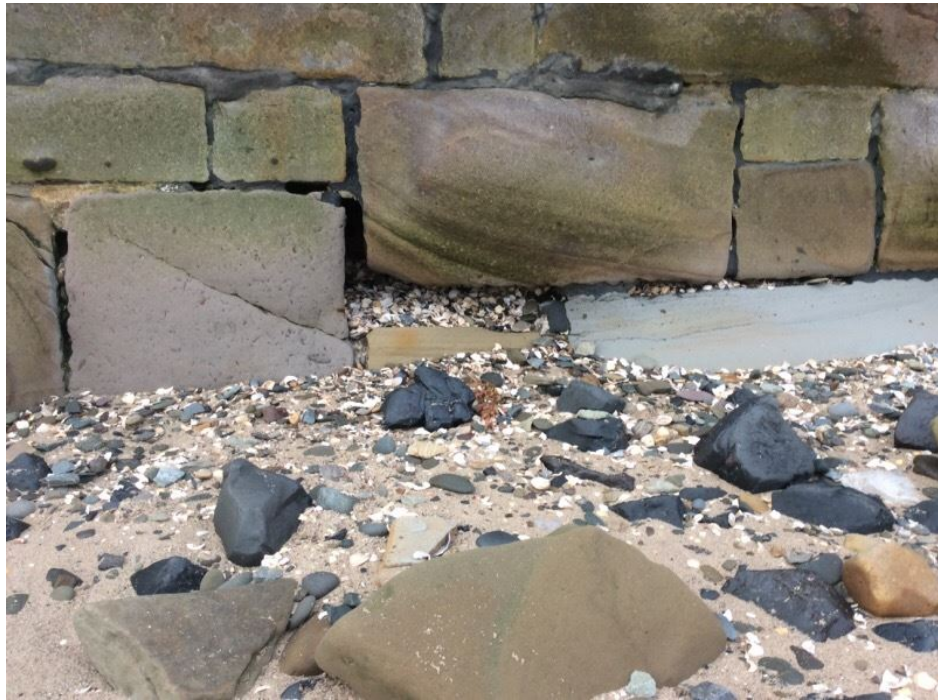
| Defect Ref No. | Defect Location (NGR) | Major Element | Minor Element | Photo Ref | Severity | Probability | Risk Score | Below MHWS | Defect Group | Defect Description | Recommendations | Defect Priority |
|---|---|---|---|---|---|---|---|---|---|---|---|---|
| D15 | 314348, 381818 | Wall | Wall section | 88, 68 | 3 | 3 | 9 | True | Missing blockwork | 300mm deep open joint exposing fill behind blockwork. During the 2023 inspection, the defect was not visible due to increased shingle levels. | Replace missing blockwork and reinstate wall. | 3 |

**Section A**  
**Wall section**  
**Defect Ref: D15**  
**Description:** 300mm deep open joint exposing fill behind blockwork. During the 2023 inspection, the defect was not visible due to increased shingle levels.  
**Photo number: 88**

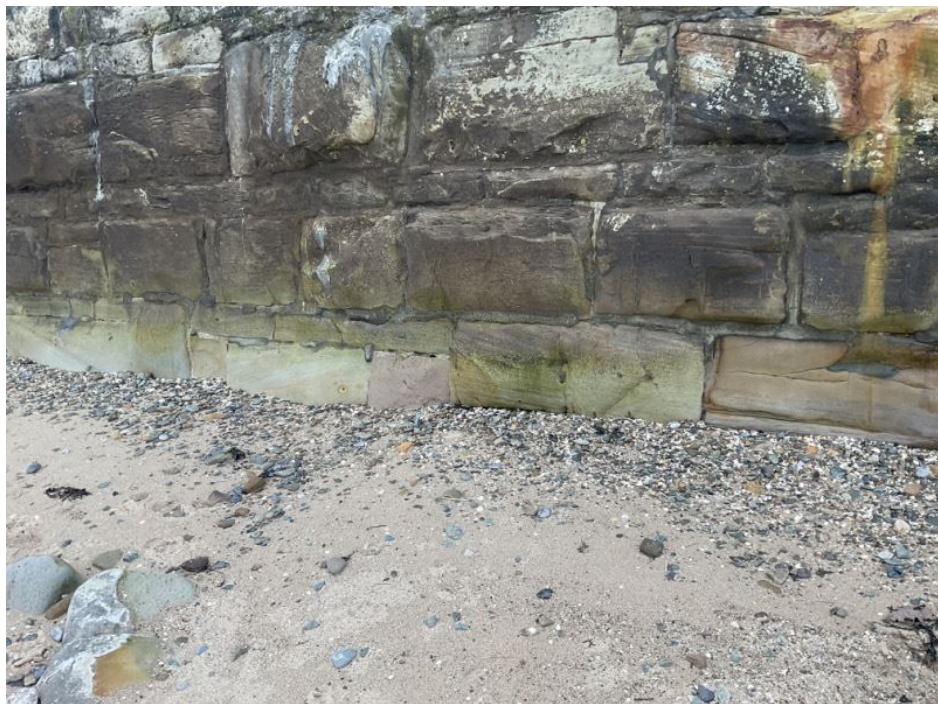
**Section A**  
**Wall section**  
**Defect Ref: D15**  
**Description:** 300mm deep open joint exposing fill behind blockwork. During the 2023 inspection, the defect was not visible due to increased shingle levels.  
**Photo number: 68**

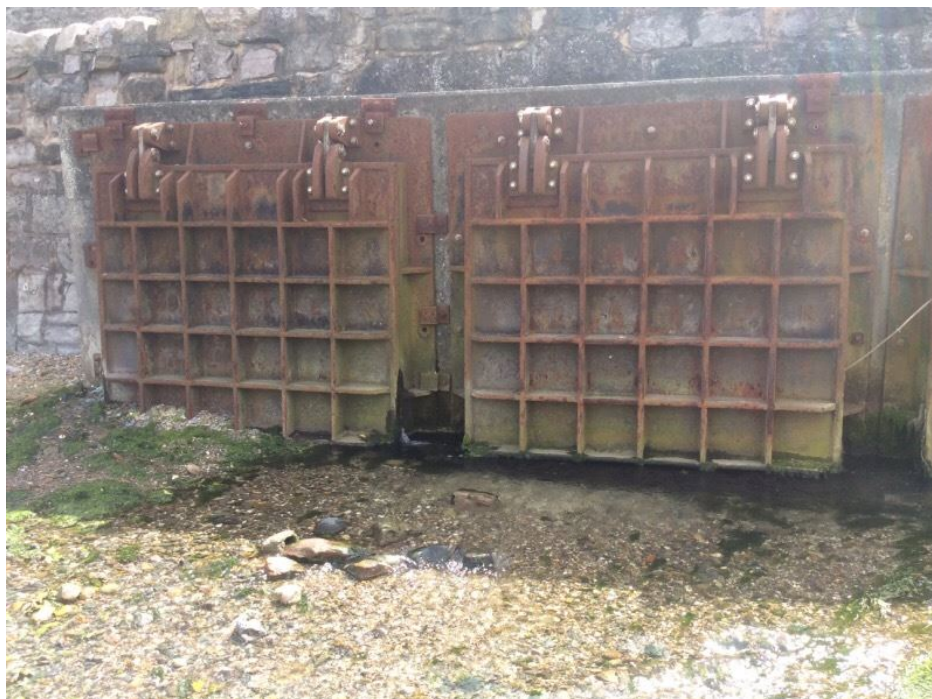
**Section A**  
**Wall section**  
**Defect Ref: D20**  
**Description:** Nuts and washers for wall mounted flap valve missing. No change observed between the 2022 and 2023 examinations.  
**Photo number: 35**

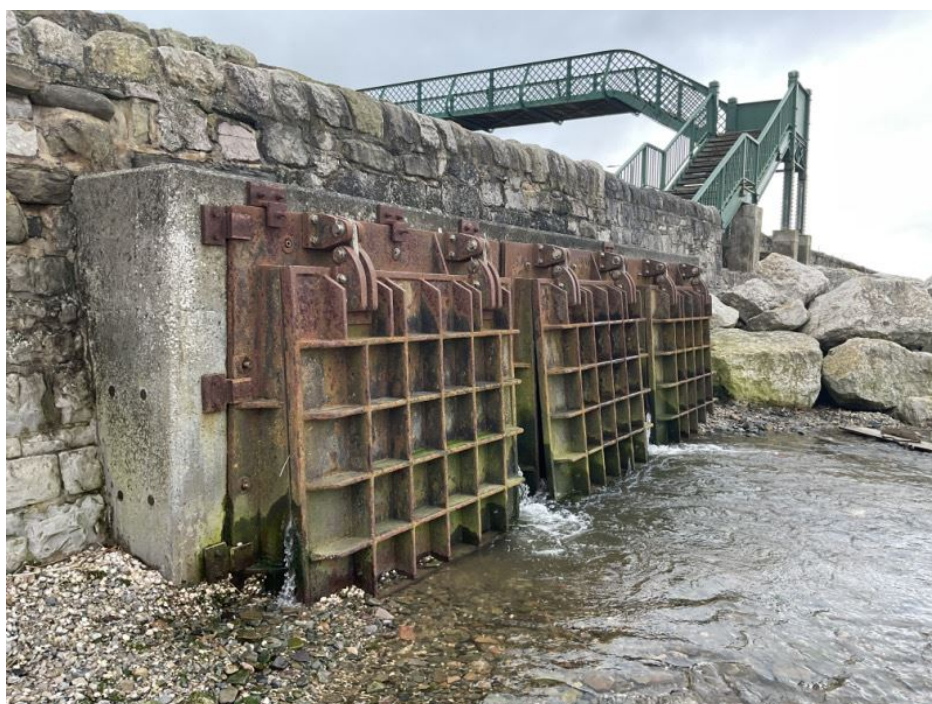
**Section A**  
**Wall section**  
**Defect Ref: D20**  
**Description:** Nuts and washers for wall mounted flap valve missing. No change observed between the 2022 and 2023 examinations.  
**Photo number: 58**

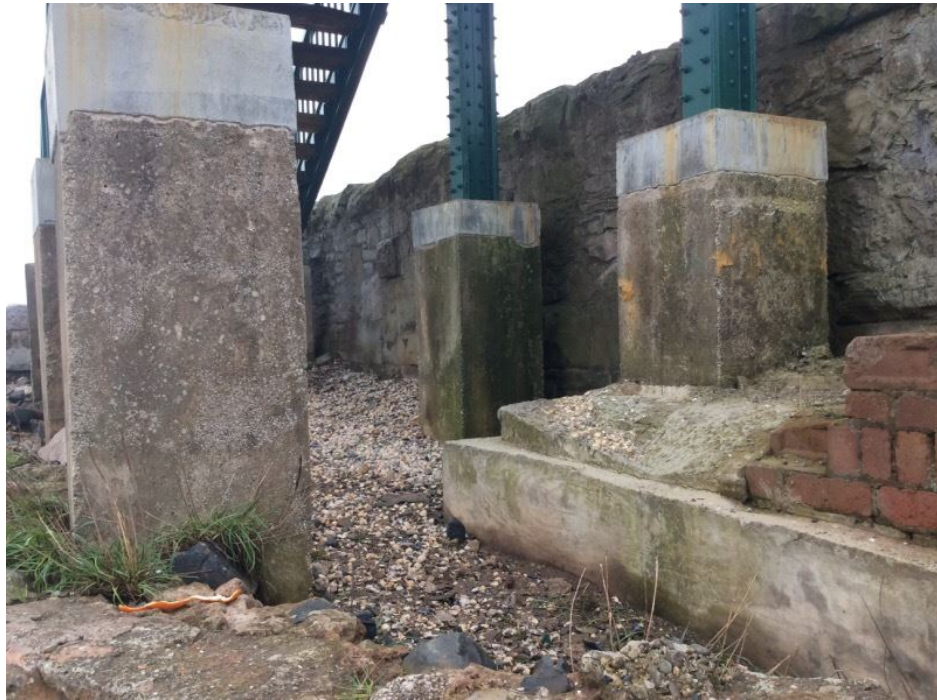
**Section A**  
**Wall section**  
**Defect Ref: D21**  
**Description:** Minor spalling on pedestrian access foundations. No significant change observed between the 2022 and 2023 inspections.  
**Photo number: 87**

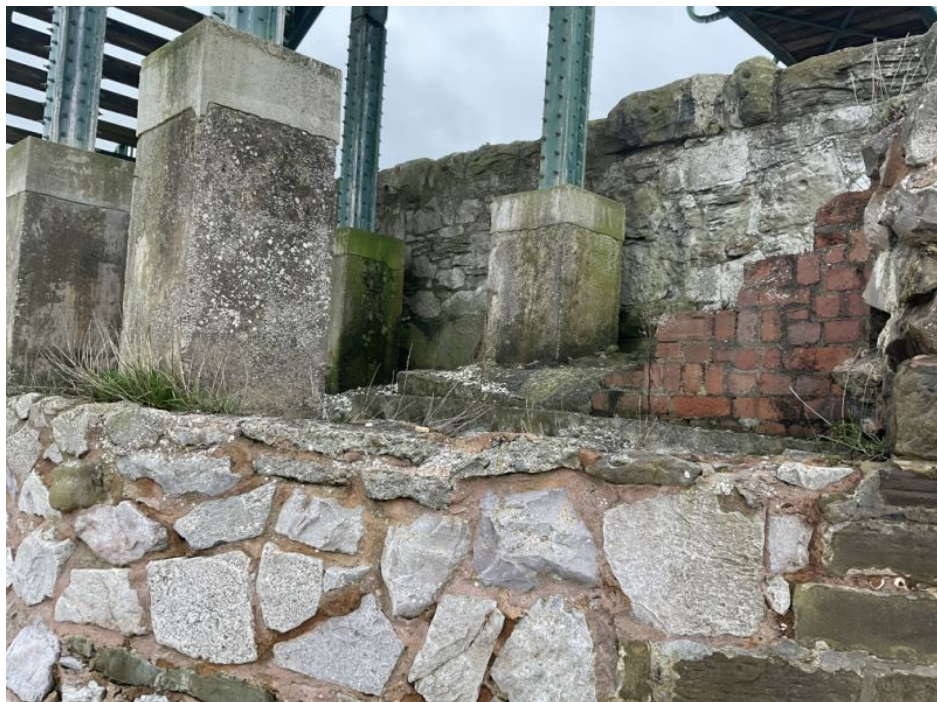
**Section A**  
**Wall section**  
**Defect Ref: D21**  
**Description:** Minor spalling on pedestrian access foundations. No significant change observed between the 2022 and 2023 inspections.  
**Photo number: 56**

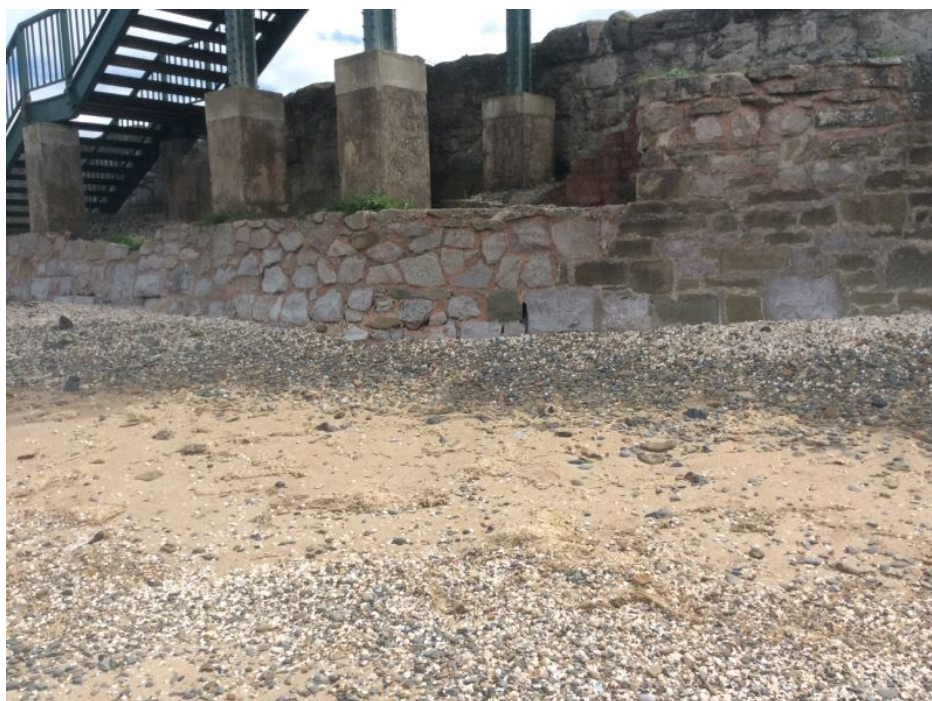
**Section A**  
**Wall section**  
**Defect Ref: D22**  
**Description:** Open joints in the wall by pedestrian access bridge. No significant change observed between the 2022 and 2023 examinations.  
**Photo number: 34**

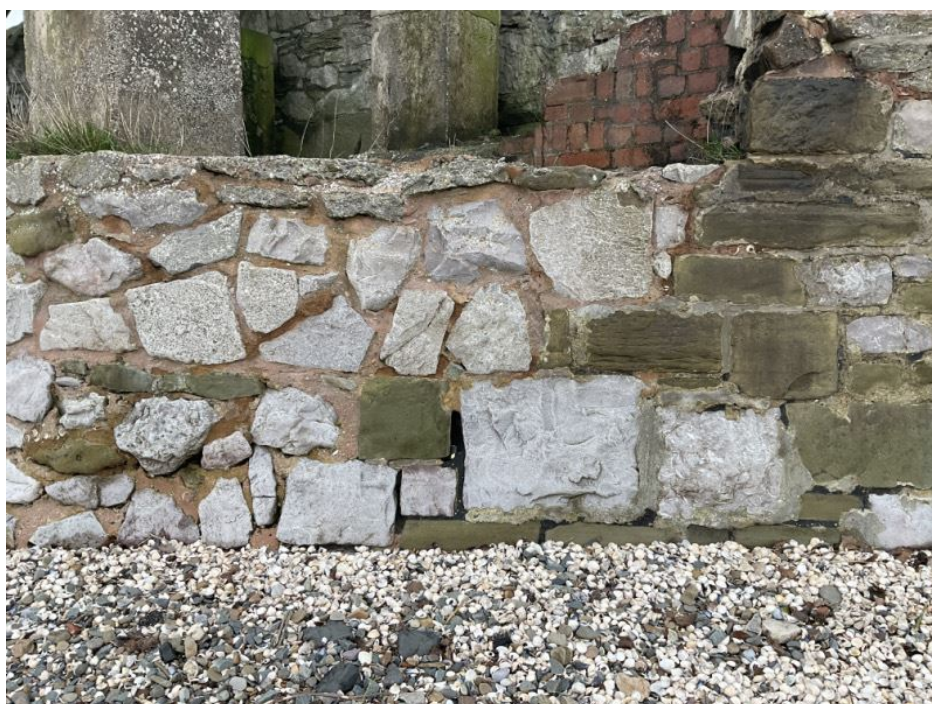
**Section A**  
**Wall section**  
**Defect Ref: D22**  
**Description:** Open joints in the wall by pedestrian access bridge. No significant change observed between the 2022 and 2023 examinations.  
**Photo number: 57**

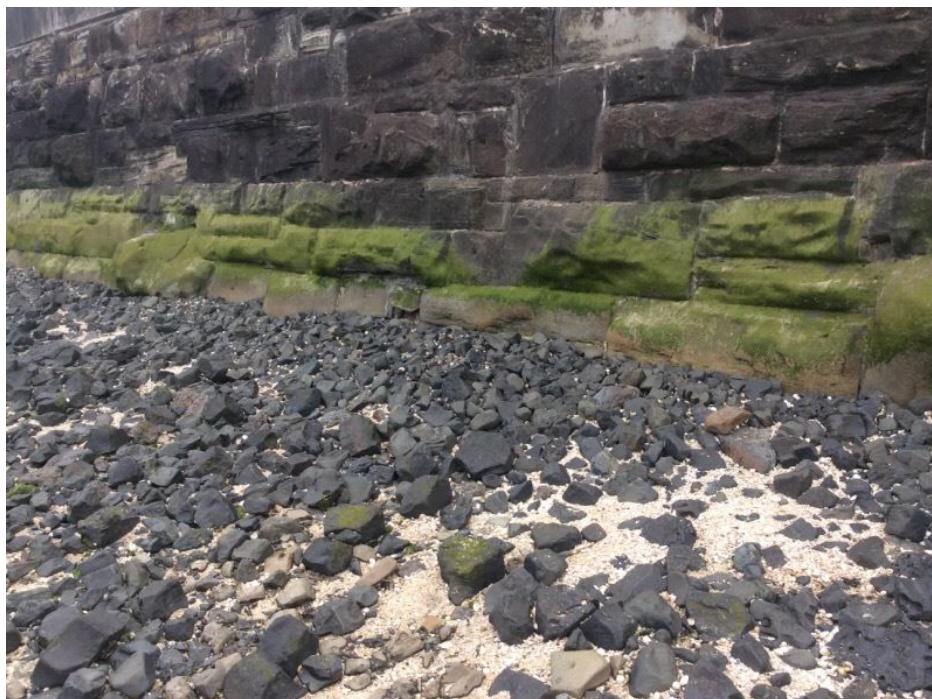
**Section A**  
**Wall section**  
**Defect Ref: D23**  
**Description:** Loose blockwork. Some areas have been repaired but several other areas remain. No significant change observed between the 2022 and 2023 examinations.  
**Photo number: 31**

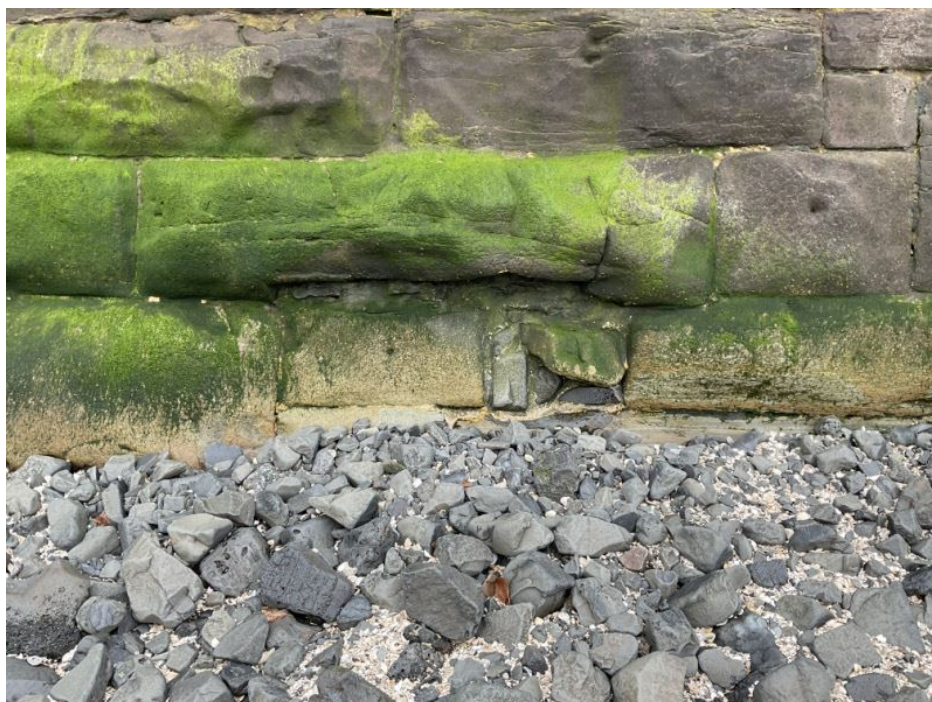
**Section A**  
**Wall section**  
**Defect Ref: D23**  
**Description:** Loose blockwork. Some areas have been repaired but several other areas remain. No significant change observed between the 2022 and 2023 examinations.  
**Photo number: 53**

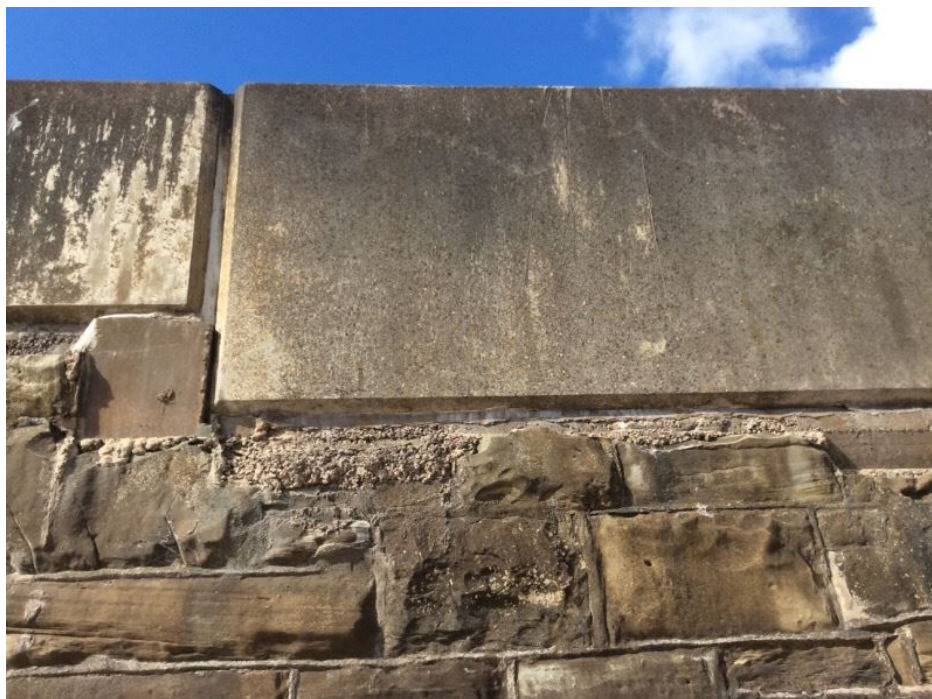
**Section A**  
**Wall section**  
**Defect Ref: D25**  
**Description:** Spalling  
/ poorly mixed  
concrete mix. No  
significant change  
observed between  
the 2022 and 2023  
examinations.  
**Photo number: 11**

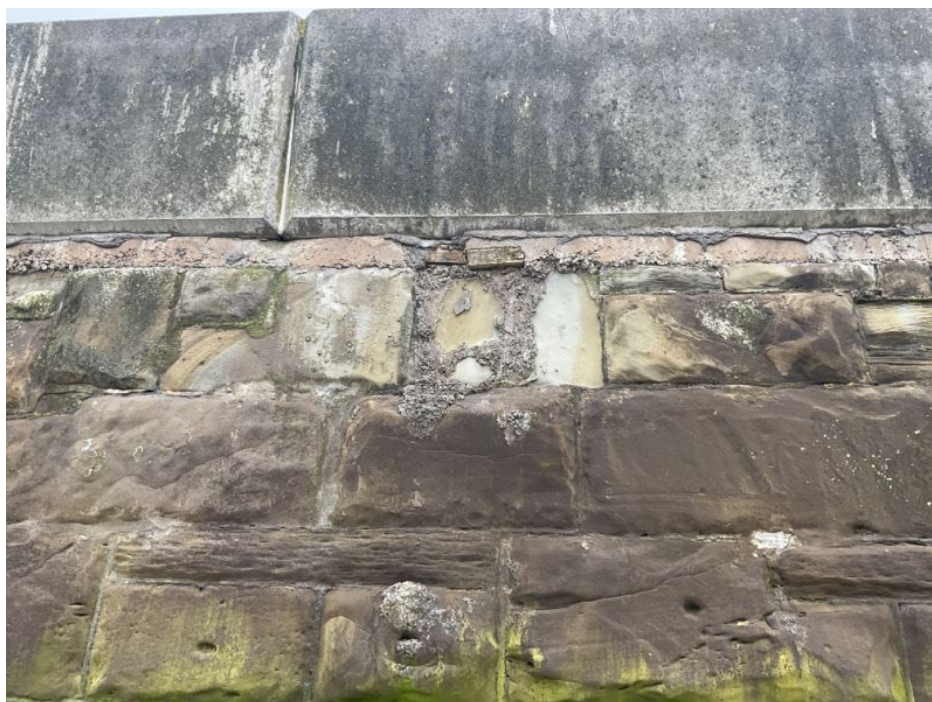
**Section A**  
**Wall section**  
**Defect Ref: D25**  
**Description:** Spalling  
/ poorly mixed  
concrete mix. No  
significant change  
observed between  
the 2022 and 2023  
examinations.  
**Photo number: 42**

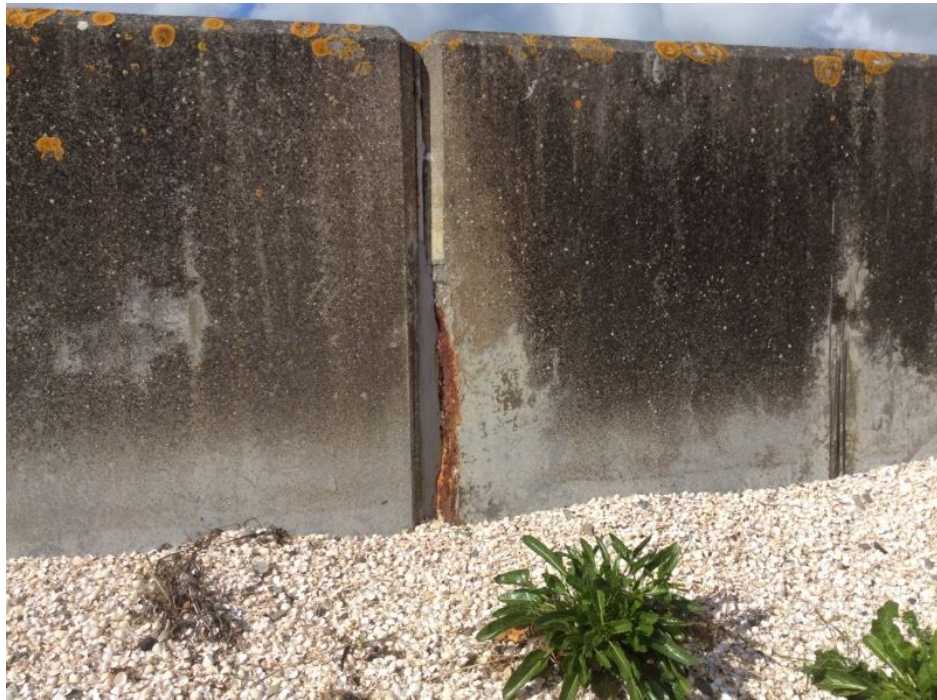
**Section A**  
**Wall section**  
**Defect Ref: D27**  
**Description:** Spalling and exposed reinforcement. Repairs noted between concrete units. No significant change observed between 2022 and 2023 examinations.  
**Photo number: 10**

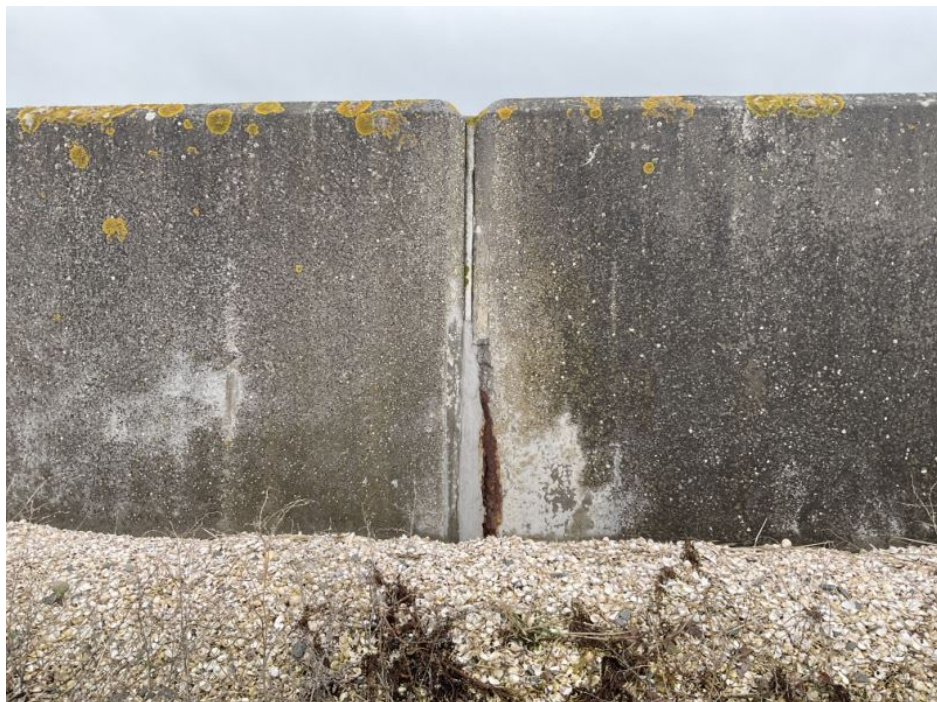
**Section A**  
**Wall section**  
**Defect Ref: D27**  
**Description:** Spalling and exposed reinforcement. Repairs noted between concrete units. No significant change observed between 2022 and 2023 examinations.  
**Photo number: 39**

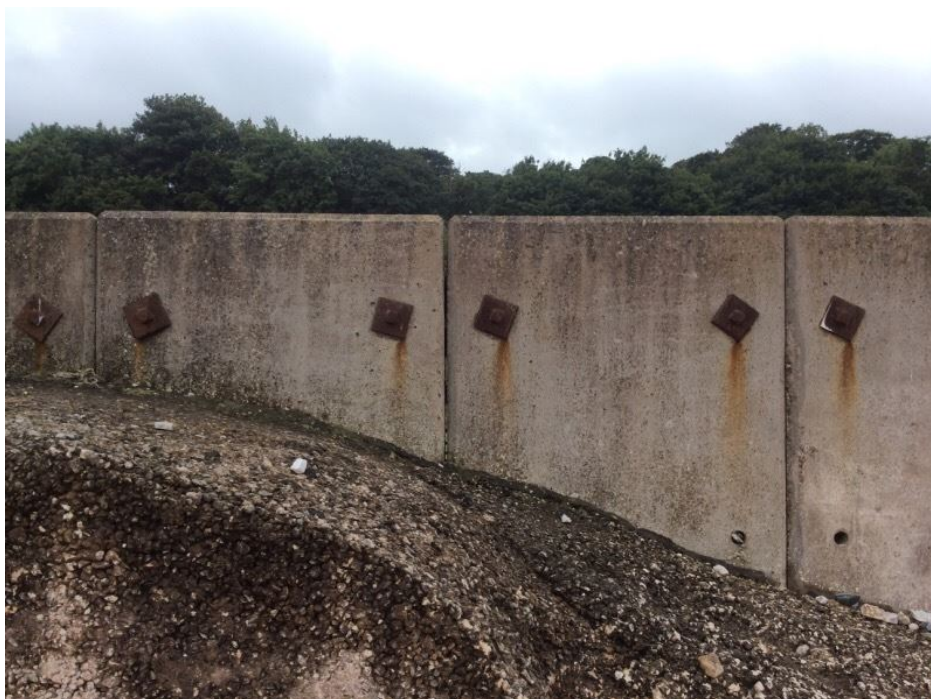
**Section A**  
**Wall section**  
**Defect Ref: D28**  
**Description:** Gaps between precast concrete sections. Appears to be consistent between most sections. No change observed between 2022 and 2023 examinations.  
**Photo number: 7**

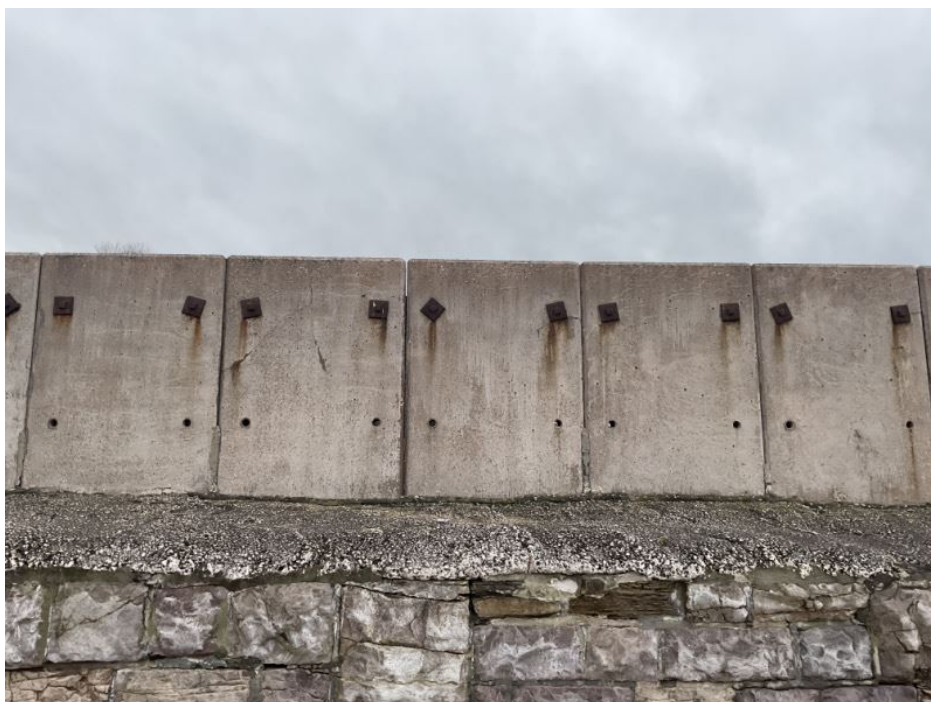
**Section A**  
**Wall section**  
**Defect Ref: D28**  
**Description:** Gaps between precast concrete sections. Appears to be consistent between most sections. No change observed between 2022 and 2023 examinations.  
**Photo number: 85**

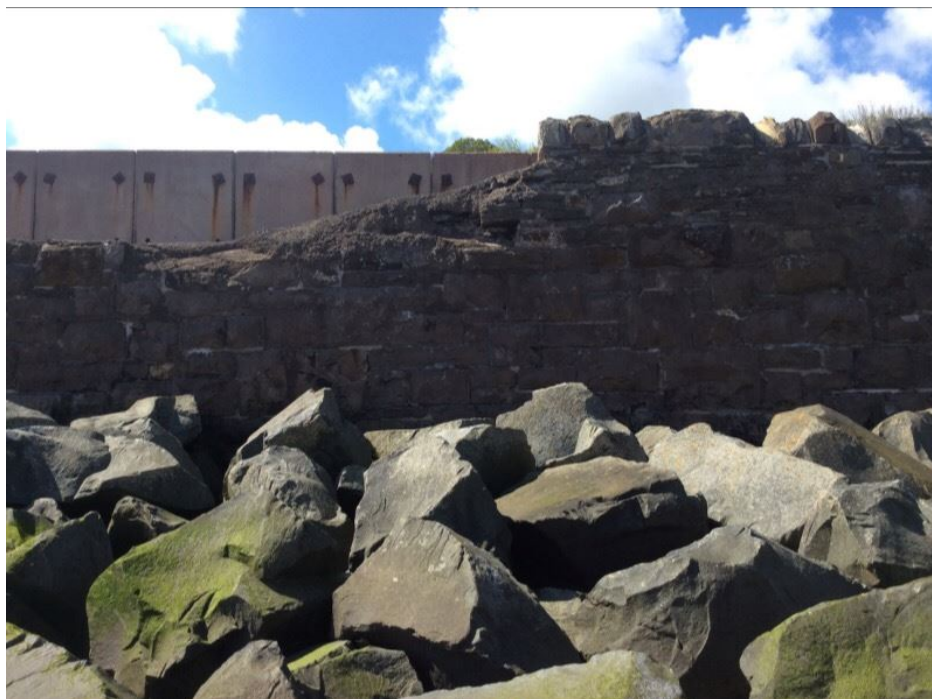
**Section A**  
**Wall section**  
**Defect Ref: D32**  
**Description:** Spalled concrete and missing block work. No change observed between the 2022 and 2023 examinations.  
**Photo number: 24**

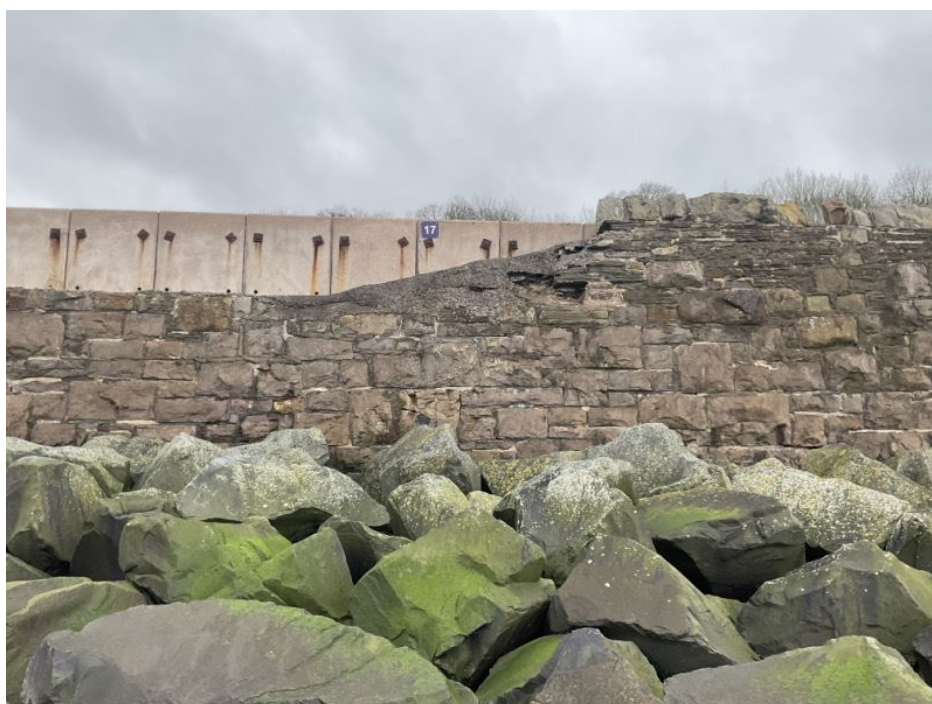
**Section A**  
**Wall section**  
**Defect Ref: D32**  
**Description:** Spalled concrete and missing block work. No change observed between the 2022 and 2023 examinations.  
**Photo number: 77**

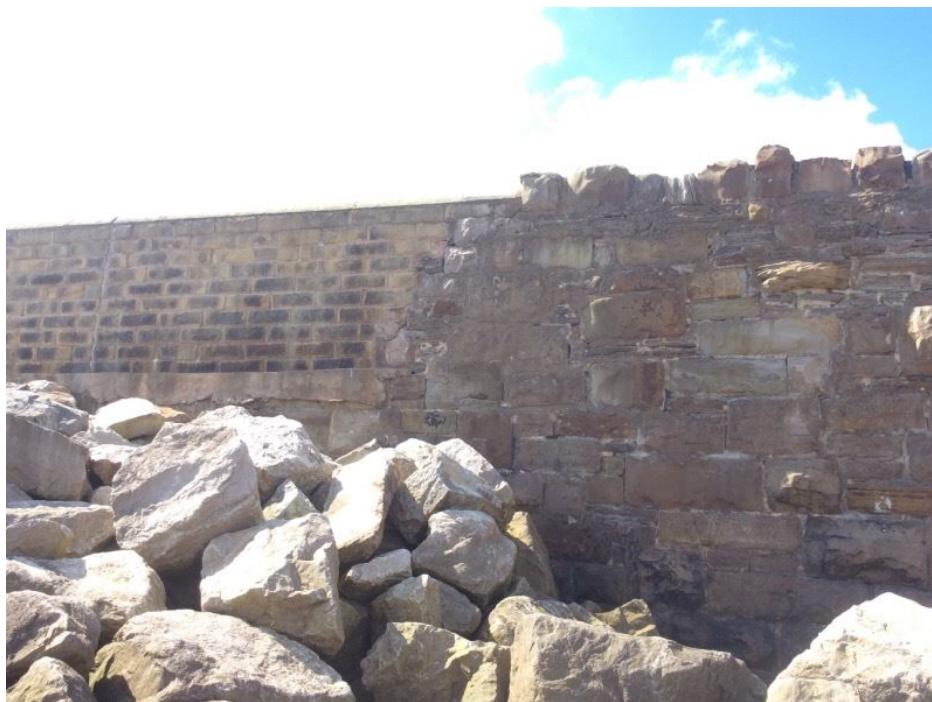
**Section A**  
**Wall section**  
**Defect Ref: D34**  
**Description:** Poor transition between material types at wall tie in. No change observed between the 2022 and 2023 examinations.  
**Photo number: 20**

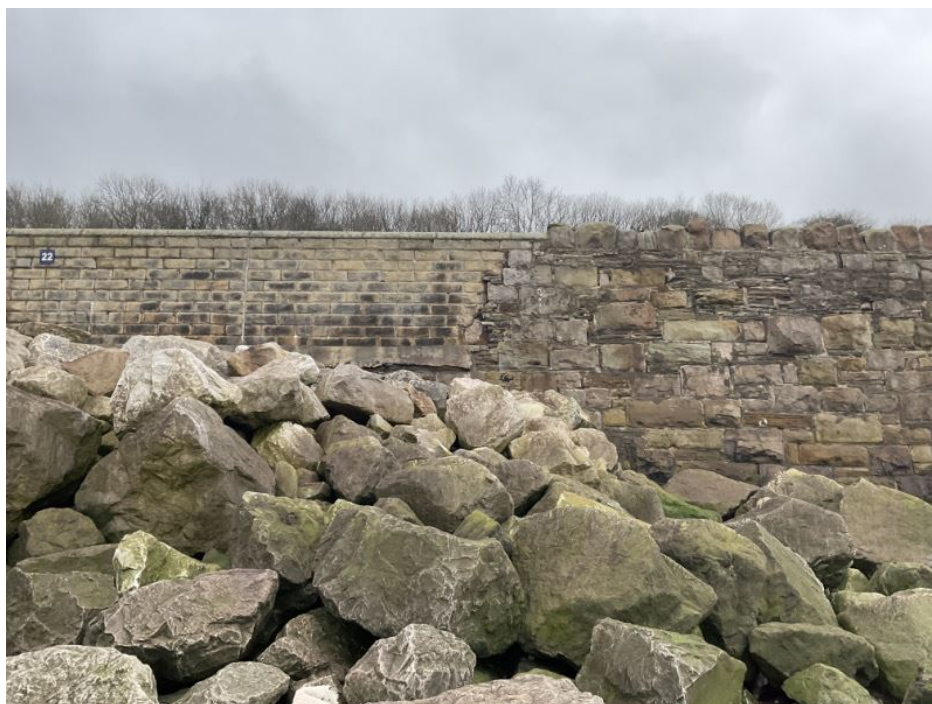
**Section A**  
**Wall section**  
**Defect Ref: D34**  
**Description:** Poor transition between material types at wall tie in. No change observed between the 2022 and 2023 examinations.  
**Photo number: 73**

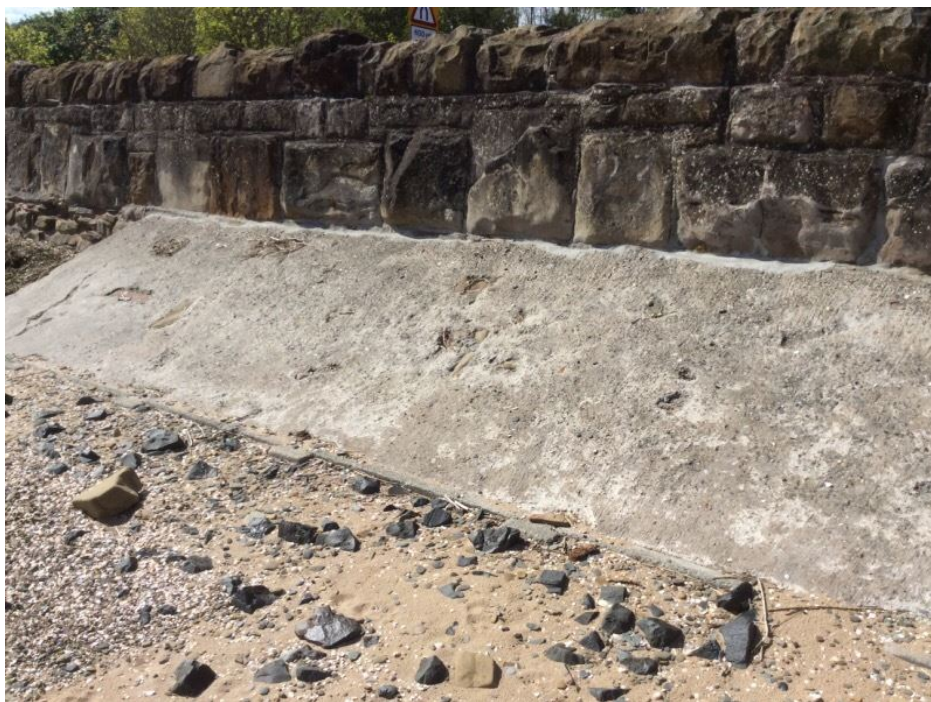
**Section A**  
**Wall section**  
**Defect Ref: D36**  
**Description:** Spalled and fractured concrete at toe of wall. Slight deterioration observed in 2023 examinations.  
**Photo number: 15**

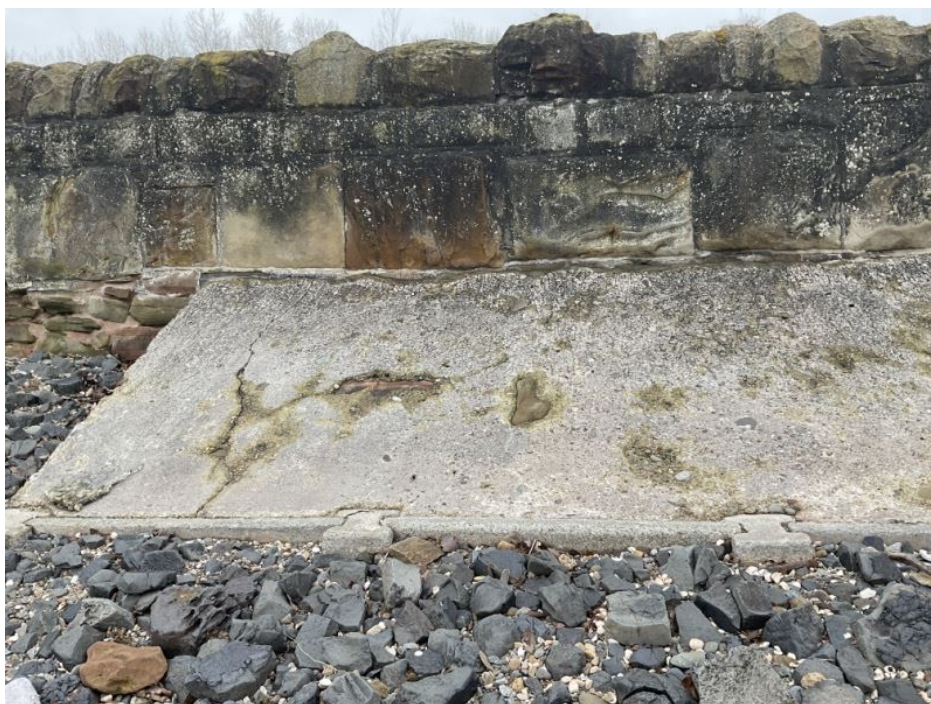
**Section A**  
**Wall section**  
**Defect Ref: D36**  
**Description:** Spalled and fractured concrete at toe of wall. Slight deterioration observed in 2023 examinations.  
**Photo number: 66**
